# NASA Contractor Report 3715

## DC-10 Composite Vertical Stabilizer Ground Test Program

J. M. Palmer, Jr., C. O. Stephens,  
and J. O. Sutton

CONTRACT NAS1-14869  
AUGUST 1983

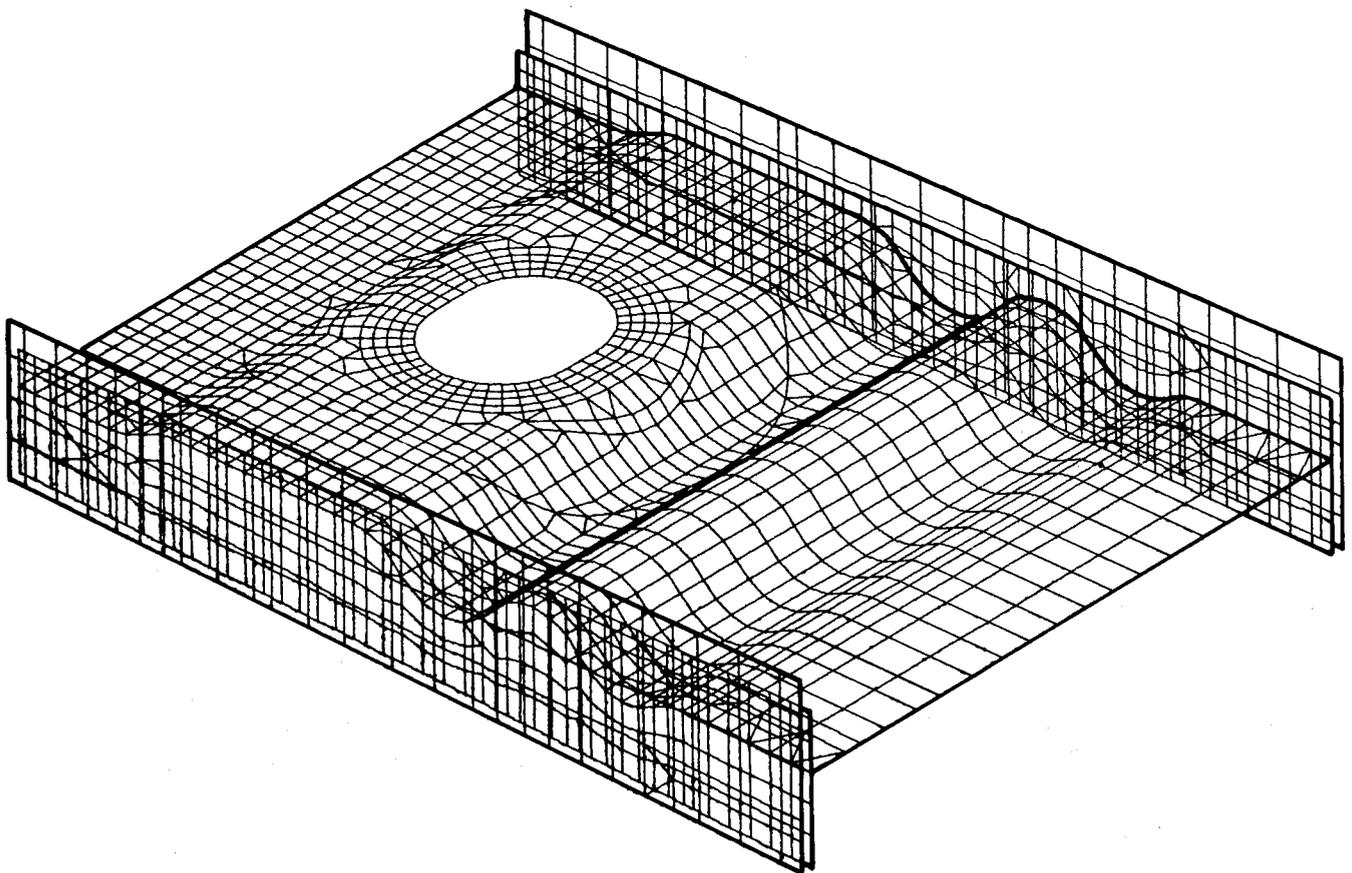
**FIGURE 24. NASTRAN MODEL OF REAR SPAR WEB**

The second area of investigation was the covered cutouts in the rear spar web and the center bay of the ZFR Station 314 rib. A simple planar analysis indicated that the strains at the perimeter of the cutouts were not critical even with the door missing. However, it was recognized that the sine wave web produces significant out of plane forces at the hole which would modify those results. Accordingly, a detailed three dimensional NASTRAN model of the critical rear spar web was developed (Figure 24). Web shear, spar cap and bolted joint interface loads were applied to the model while the attachment of the door module to the web module was analytically varied from full shear effectivity to zero shear effectivity. A reference case with no door installed was also run. The results are shown in Figure 25, where the laminate mid-plane strains at the perimeter of the access opening are plotted for each quality of fastener fit. Clearly, if sufficient slippage between the door and web is available, the presence of the fasteners provides almost no relief from the maximum strains, while fully effective fasteners (i.e., a fully effective door) provides considerable support at the edge of the cutouts.

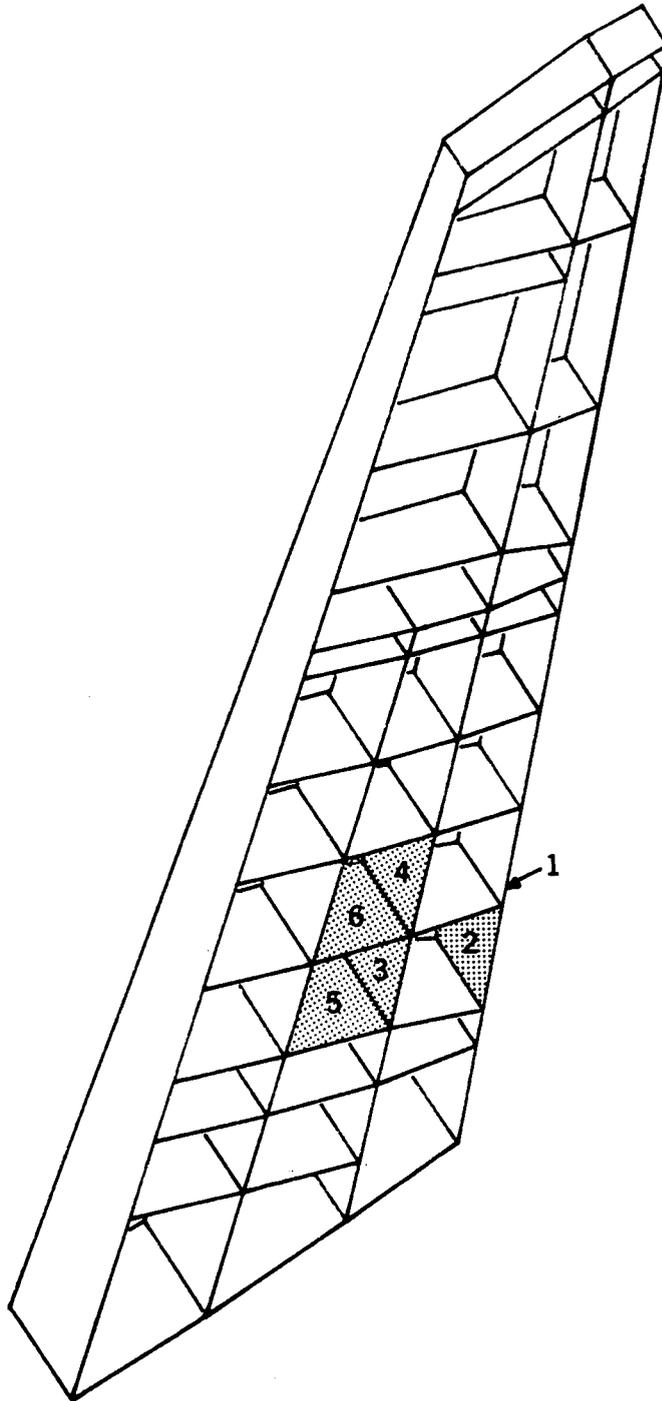
**FIGURE 26. FAILURE INITIATION INVESTIGATION POINTS**

The NASTRAN internal loads model for the complete stabilizer was next modified to reflect assumed failures in areas which were failed in both the stub box and GTU in order to establish the probable failure initiation point. The locations are shown in Figure 26. Loads equal to the test loads at failure were applied to the model. Only the assumed failure in the rear spar web between ZFR Stations 326 and 350 resulted in negative margins of safety for the remaining structure.

3. The cover failed to pick up load as a result of improper quality of fit in the fasteners attaching the door to the web.

The relative quality of fit of the GTU and stub box specimens was considered to be the reason for the significant difference in failure load between the two.

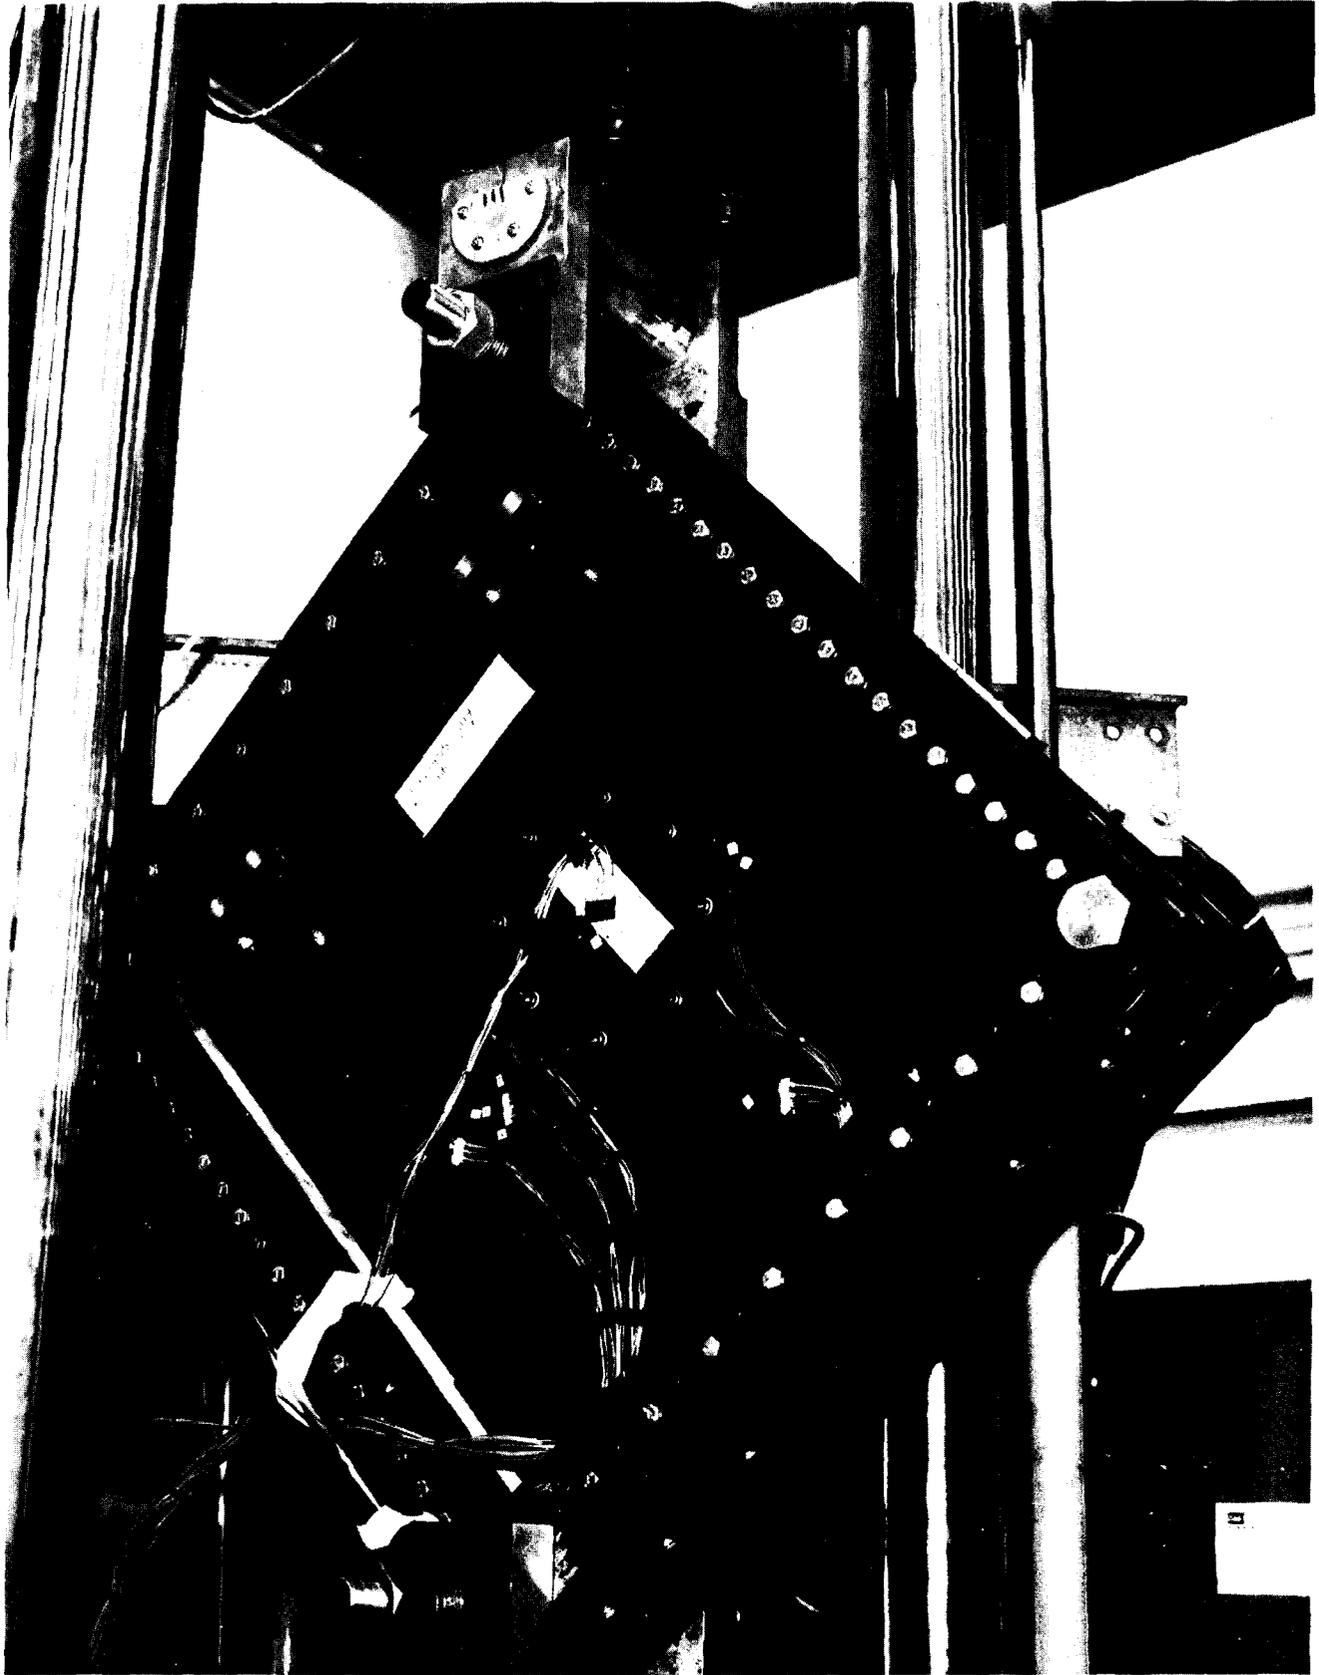
**FIGURE 28. AMC7855-5 RIB COMPONENT IN SHEAR TEST FIXTURE WITH DOOR INSTALLED**

A picture frame type of test fixture was built, and the rib component was tested in shear (Figure 28). The rib was first loaded with the door removed. The door was then installed with good fastener fits in all holes and the specimen reloaded. Next the fastener holes in the door were drilled out to correspond to the stub box configuration and the specimen was reloaded. The fastener holes in the web were then drilled out to correspond to the GTU configuration and the specimen was reloaded.

The results of these tests are shown in Figure 29, where the maximum strains measured at the perimeter of the access opening are plotted versus load. Without a door attached, the hole perimeter strains were extremely high. With the tight fit holes, the perimeter strains were considerably reduced. When the door holes were drilled out, the strains increased, as was expected. When the web holes were drilled out (not shown) no additional effect was observed. This is consistent with the failure theory, in that once the fasteners lose contact with the holes, additional clearance can do no additional harm. Only after sufficient distortion had occurred to bring the intermediate fit configuration fasteners into contact with their holes would any difference become apparent. This load level was not reached during the test due to the risk of prematurely damaging the specimen.

The analyses using the NASTRAN models of the stabilizer and the critical rear spar web together with the results of the tests on the rib component all confirmed the validity of the failure theory. The failures in both test articles was the result of high stress concentrations at the edge of the lower rear spar access opening. These high stress concentrations were the result of the clearance between the holes and fasteners attaching the load-carrying access covers to the spar webs. The discrepancy in load level at failure between the two test articles was the result of differences in fit of the fasteners.

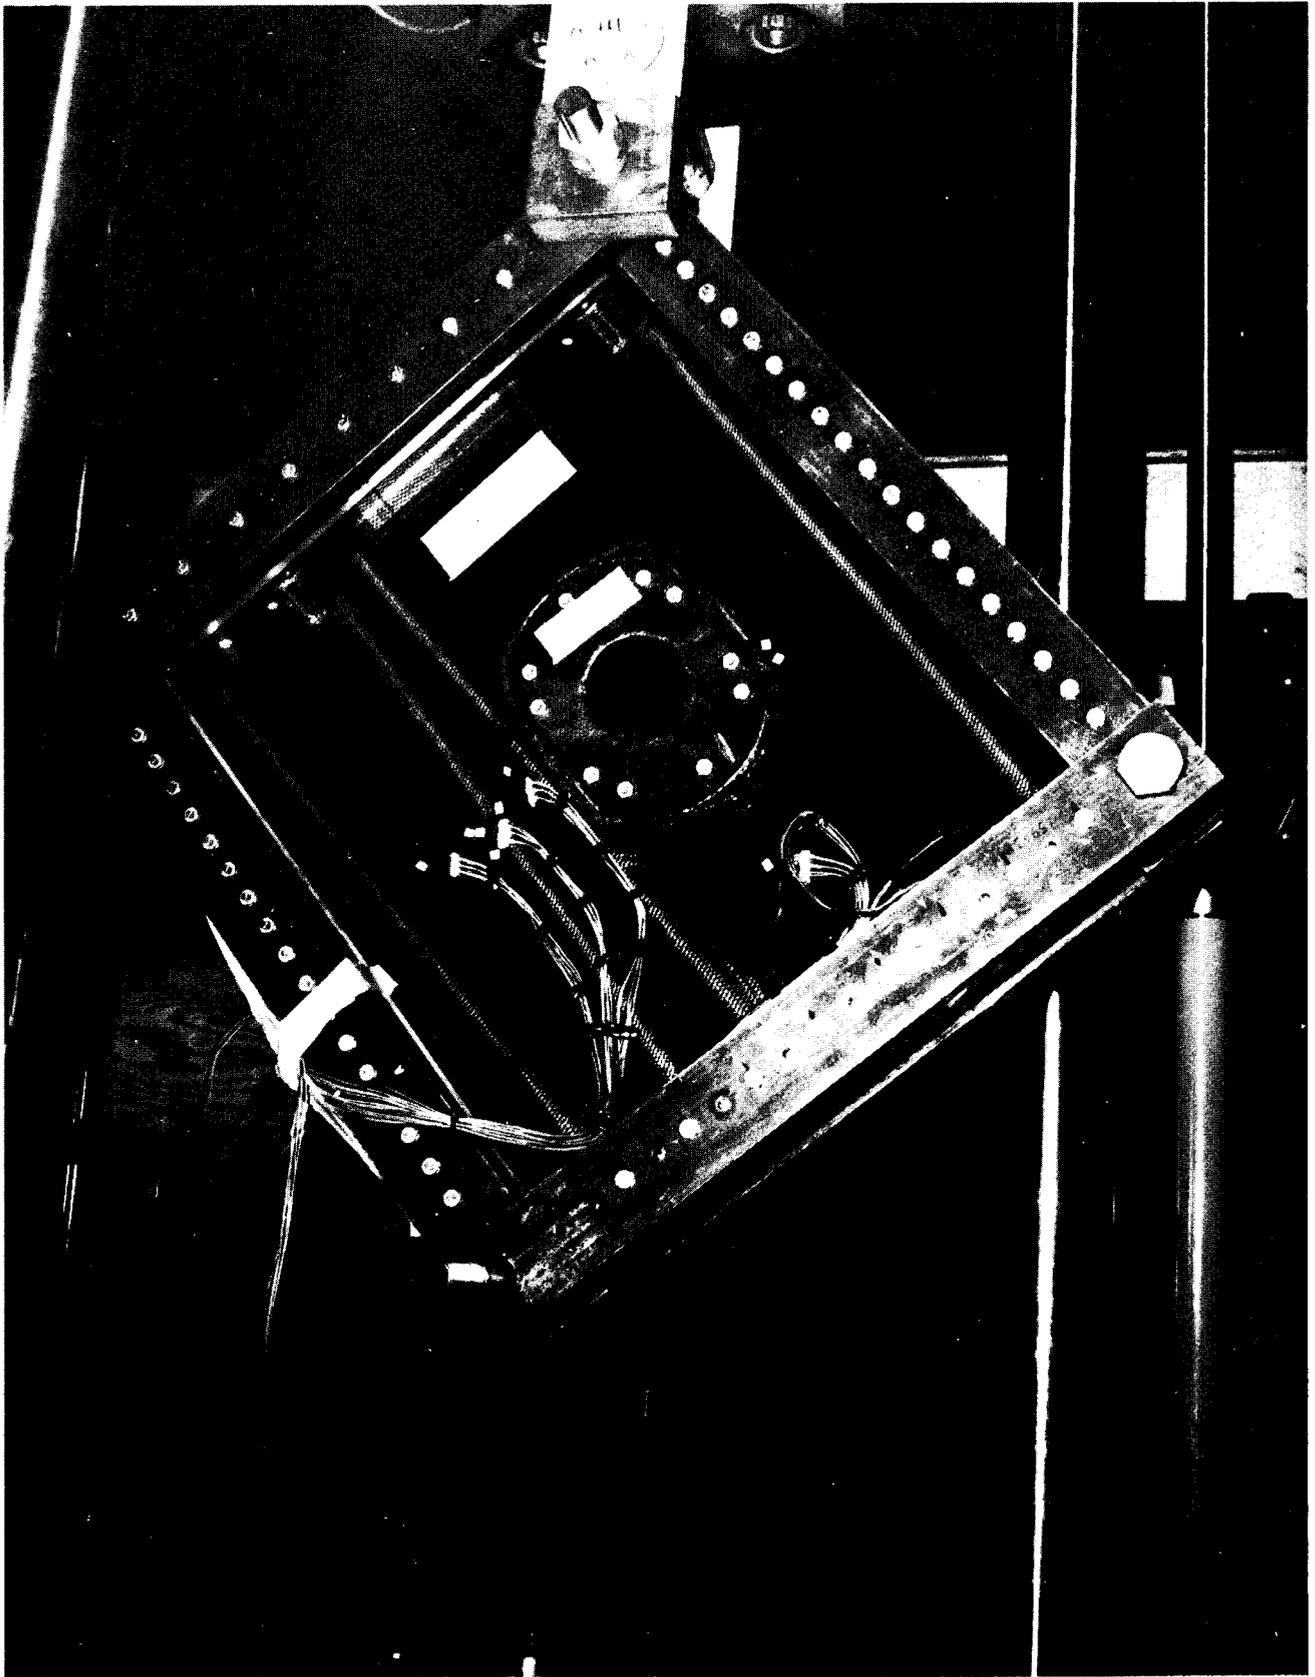
**FIGURE 31. AMC7855-5 RIB COMPONENT IN SHEAR TEST FIXTURE WITH FLANGED PLATE BONDED/BOLTED IN PLACE**

To test the validity of the concept, a flanged plate was made and installed on the AMC7855-5 rib test specimen (Figure 31). The panel was tested to failure, with failure occurring in the basic sine-wave web, well away from the opening (Figure 32). The strains measured at the perimeter of the hole with the bonded cover in place are shown in Figure 33.

Reworks in other areas of the substructure are required to upgrade the fail-safety of the stabilizer. This consisted of adding material to several shear webs to increase their buckling allowables and adding flange material to the front spar and forward center spar cut-outs to reduce strain levels to design criteria values (approximately 2,000 microstrain at DLL).
