Repair of Damage to Marine Sandwich  
Structures: Part I – Static Testing

Rodney Thomson, Raoul Luescher and  
Ivan Grabovac

DSTO-TR-0736

*October 1998*

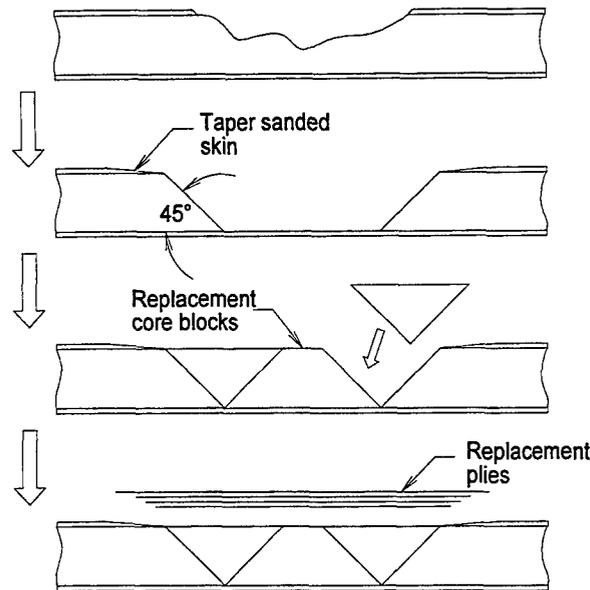
Figure 5: RAN method for the repair of Type B damage to GRP/foam sandwich panels.

Two primary deficiencies were noted with the RAN Type B repair technique. The first concerned preparing the core at a  $45^\circ$  angle which proved to be difficult. The second deficiency was entrapment of air between the replacement core and the existing skin during the bonding process. A series of trials were undertaken to develop techniques to overcome these problems. In developing these techniques, other repair methods, outlined previously, were taken into consideration. In particular, the methods used by the United States of America Coast Guard [8] and the Swedish Navy [9] were examined.

1. *Remove Damaged Material.*
  - a) Remove the damaged skin, working from the centre of the damaged region outwards until sound material is encountered.
  - b) Remove the exposed damaged core leaving the other skin intact.
2. *Prepare the area for repair.*
  - a) Prepare the foam core to an angle of 45°.
  - b) Sand the edge of the laminate to a taper of 20 mm per layer. This provides a scarf angle of approximately 6°.

3. *Install the replacement foam.*
  - a) Use a paste adhesive designed to bond PVC foam.
  - b) Use the appropriate grade of foam.
  - c) Use the minimum amount of adhesive (bondline thickness 3 mm maximum).
  - d) No voids should exist between the undamaged skin and the replacement foam.

4. *Replace the skin.*
  - a) Use the same number of layers as the original skin.
  - b) Each successive layer is to be 40 mm longer and wider than the previous layer.
  - c) Apply one extra layer of GRP extending 100 mm beyond the extent of all damage.

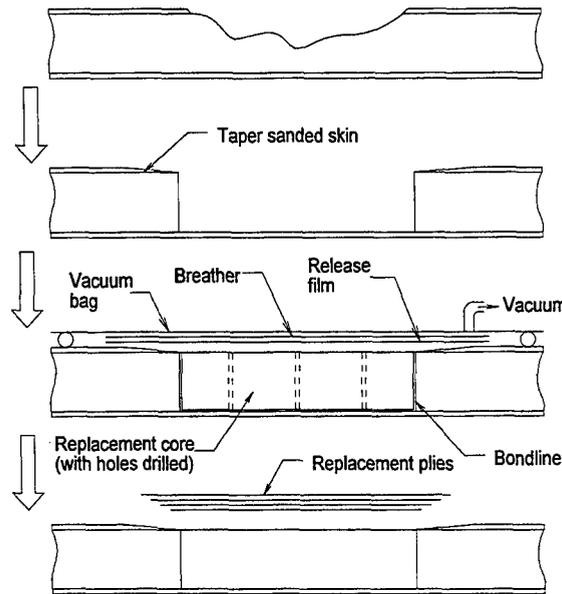
Figure 6: Modified method for the repair of Type B damage to GRP/foam sandwich panels.

In the modified Type B repair technique, emphasis was placed on simplifying the procedure. This was achieved by replacing the core in one section whenever practical and using 90° butt joints. The trials showed that effective, void free core replacement could be achieved using this approach. To avoid entrapment of air when the replacement core was positioned, holes were drilled through the core at a spacing of between 50 mm and 100 mm. A problem associated with the 90° joins in the core was the difficulty in filling the bondline between the replacement and existing core. To overcome this, the repair was placed under a vacuum bag to draw adhesive up around the edges. Vacuum pressure of around 70 kPa (20 inHg) was found to be sufficient and the adhesive should have a reasonably short gel time (30 - 50 min). Also, the correct amount of adhesive should be applied since significant bleed does not occur. Additionally, the adhesive should be applied only to the existing skin and core, not to the replacement core, as this prevents blockage of the holes drilled through the replacement core.

1. *Remove damaged material.*
  - a) Remove the damaged skin, working from the centre of the damaged region outwards until sound material is encountered.

- b) Remove the exposed damaged core leaving the other skin intact.
2. *Prepare the area for repair.*
  - a) Prepare the foam core to an angle of 90°.
  - b) Sand the edge of the laminate to a taper of 20 mm per layer, providing a scarf angle of approximately 6°.

3. *Install replacement foam.*
  - a) Use a paste adhesive designed to bond PVC foam.
  - b) Use the appropriate grade of foam.
  - c) Allow 1 mm all round for the bondline.

- f) Carefully place the core, forcing it down lightly to remove entrapped air.
4. *Vacuum bag the core.*
  - a) Apply a layer of perforated release film and breather over the repair area.

- b) Position the vacuum bag over the repair area, sealing it to the surrounding structure.
  - c) Apply vacuum of 70 kPa until the adhesive has cured.

- d) Clean up area for laminating.

5. *Replace the skin.*
  - a) Use the same number of layers as the original skin.
  - b) Each successive layer is to 40 mm longer and wider than the previous layer.
  - c) Apply one extra layer of GRP extending 100 mm beyond the extent of all damage.

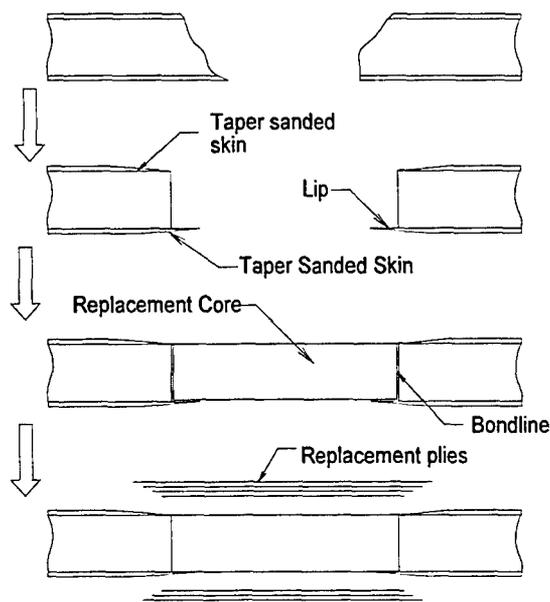
Figure 9: Modified method for the repair of Type C damage to GRP/foam sandwich panels.

The primary aims of the modified technique were to simplify the repair and to make it more reliable. Many of the modifications to the Type B repair were incorporated into the modified Type C repair technique. These included the use of 90° joins in the core and replacing the core in one section where possible. Again, the most difficult part of the repair was bonding the replacement core in position accurately without creating voids in the bondline. To avoid the requirement of a backing plate, a lip was left in one skin against which the replacement core could rest. Holes were drilled through the replacement core into the bondline gap as shown in Figure 8. The holes should emerge near the bottom of the bondline gap so air does not become trapped when the adhesive is injected. The spacing between the holes should be twice the core thickness. Bonding the core in place was then conducted in two stages using a caulking gun. First, a bead

1. *Remove damaged material.*
  - a) Remove the damaged skins, working from the centre of the damaged region of each skin outwards until sound material is encountered.

- b) Remove the exposed damaged core.
2. *Prepare the area for repair.*
  - a) Prepare the foam core to an angle of  $90^\circ$ .
  - b) Leave a lip of approximately 10 mm width on one skin around the entire repair.

- b) Sand the edges of both skins to a taper of 20 mm per layer providing a scarf angle of approximately  $6^\circ$ .
3. *Install replacement foam.*
  - a) Use a paste adhesive designed to bond PVC foam.

- b) Use the appropriate grade of foam.
  - c) Cut a piece of foam, allowing 1 mm all round for the bondline.
  - d) Drill 3 mm diameter holes through the core into the bondline gap, as shown in Figure 8. The spacing of the holes should be twice the core thickness.

- e) Place a bead of adhesive around the lip and position the foam, forcing it down lightly.
  - f) After the adhesive has cured, inject adhesive into the bondline through the holes using a caulking gun. Clean up the area before the adhesive cures.

4. *Replace the skins.*
  - a) Use the same number of layers as the original skins.
  - b) Each successive layer is to be 40 mm longer and wider than the previous layer.
  - c) Apply one extra layer of GRP extending 100 mm beyond the extent of all damage.

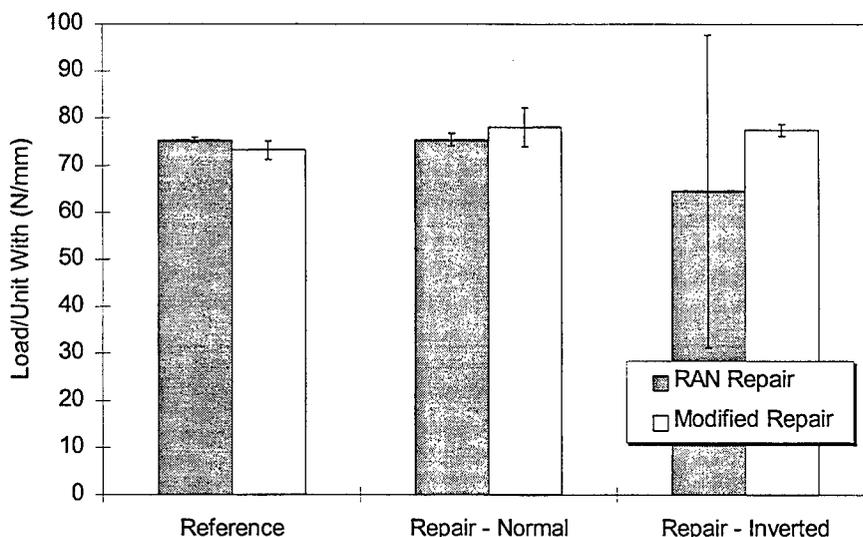
Figure 18: Bar graphs showing the average strength and standard deviation for Type B repaired four-point-bend specimens.

A comparison of the results for the 400 mm span Type B repaired specimens is presented in Table 2 and Figure 18. The superior performance of the modified Type B repair technique is clearly demonstrated. The averaged strengths of specimens repaired using the RAN Type B technique were up to 14% lower than the reference specimens when tested in both the normal and inverted positions. However, the scatter in results was much higher in the inverted position which was due to the

The strengths of specimens repaired using the modified Type B technique were generally greater than the reference specimens. The average strength of specimens tested in both positions was up to 10% greater than the reference standards. The scatter in the results was also very low. This indicates that the bond strength of the repair was adequate while the extra ply used in the repair added to the strength.

The stiffness of the repair was also of importance since an overly stiff repair could lead to load redistribution and the potential for failure at the edge of the repair. The stiffness of the RAN Type B repair technique under four-point bending was approximately 10% and 20% greater than the reference specimens when tested in the normal and inverted positions, respectively. The modified Type B repair technique was approximately 8% stiffer than the reference specimens in both positions. In the RAN technique, the 45° bondline increased the shear stiffness of the core by a small amount. However, the most significant increase in stiffness was due to the extra thickness of the repaired skin, which was identical for both repair techniques. The additional skin thickness reduced local indentation under the loading and support points during four-point bending. The scarf repair on the skin in the RAN repair extended further than in the modified technique and, in the inverted case, extended under the support rollers reducing the amount of indentation. It was therefore concluded that the stiffness under bending of the two repair techniques was very similar.

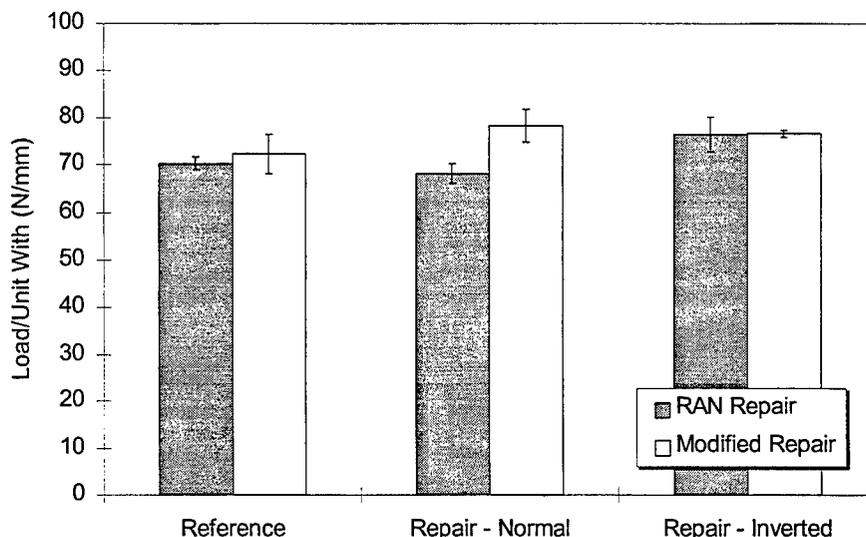
Figure 23: Bar graphs showing the average strength and standard deviation for Type C repaired four-point-bend specimens.

In preparing the Type C repair test specimens, it was observed that the RAN technique was more time consuming and demanding to prepare. A real repair which could be elliptical in shape would be very difficult because of the 45° joins in the core. On the other hand, the modified technique was very straightforward to perform. A comparison of the strengths of the two Type C repair techniques is shown in Table 3 and Figure 23 for the 400 mm span tests. It is apparent that in general, both repair techniques effectively restored the strength of the specimens and, with respect to the effectiveness of the repairs from a strength perspective, little separates the two methods. However, the modified method proved to be superior from a processing viewpoint.

The strengths of the RAN repair technique for Type C damage were generally similar to, and in most cases greater than, reference standards. The reduced strength of some specimens was attributed to interface failure along the 45° bondline under compression. This indicated that the bondline between the existing and replacement core was the weak link in this repair. The standard deviation for the strengths was less than 5% in all cases indicating consistent repair quality.
