---TECHNICAL REPORT---

No. 13755

Test and Evaluation of the
LMTV Driveline
1998

By Stephen J. Aamodt

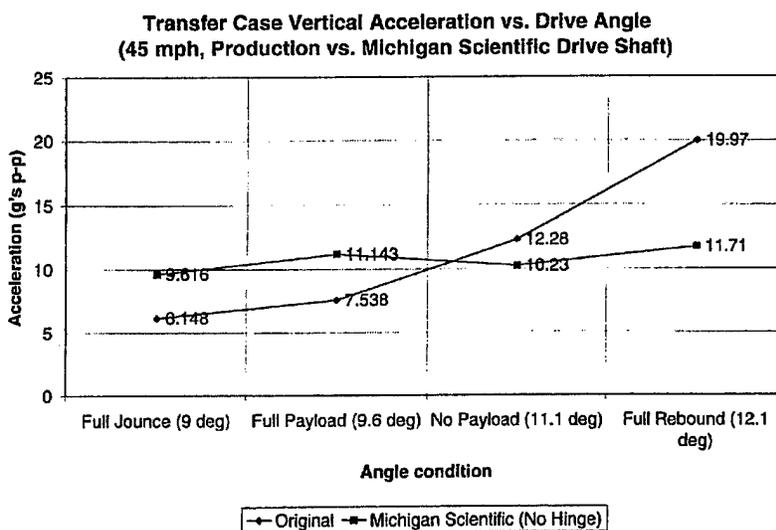
Figure 11 - Comparison of Vertical Accelerations in Resonant Range

The data for both the MSC driveshaft and the production driveshaft indicated marked increase in acceleration levels as the driveline angle increased. The MSC driveshaft, with the elimination of the hinging effect, proved more effective than the production driveshaft with nylon thrust washers in the resonant frequency range at the high angles. Outside of the resonant range and high angles, no particular driveshaft had an advantage all the time. Figure 11 shows a visual representation of the performance of these two shafts within a resonant frequency range measuring g-loads from peak to peak.

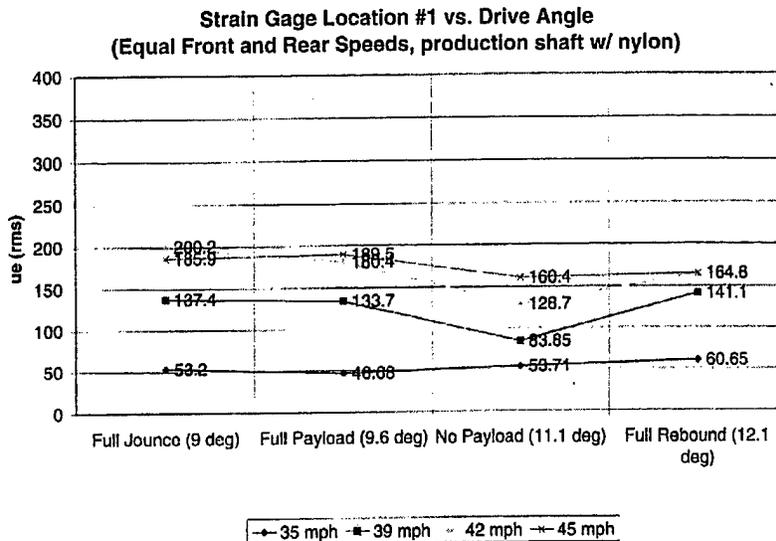
Figure 12 - Production Flywheel Housing strain versus speed and angle

The flywheel housing strain, measured at strain gauge one, does not appear to be effected by drivetrain angle. What does affect the flywheel housing strain appears to be the speed at which the vehicle is moving. From figure 12, it is visible that this type of relationship exists.

Reduced speed then is the key issue behind keeping the strain levels down on the flywheel housing while a reduced driveline angle is the key to keeping the accelerations down at the transfer case universal joint.
