**US Army Corps  
of Engineers**  
Engineer Research and  
Development Center

Technical Report REMR-CS-63  
September 1999

## **Repair and Rehabilitation of Dams: Case Studies**

*by James E. McDonald, Nancy F. Curtis*

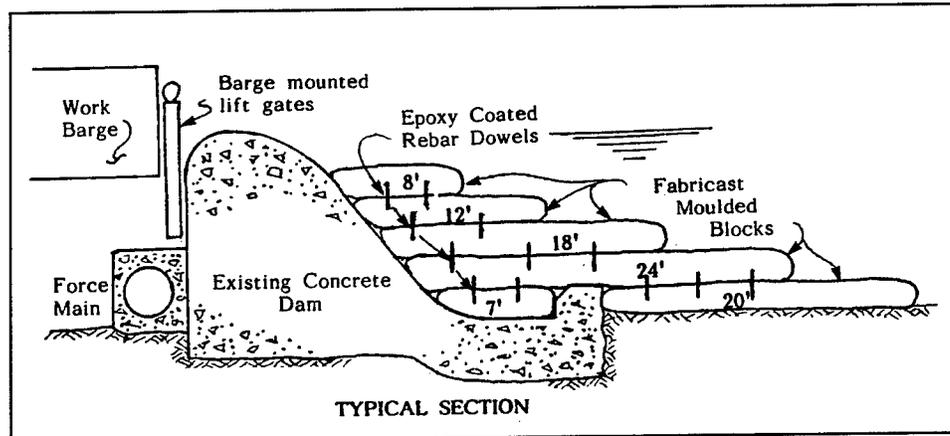
The most obvious solution was to remove the remnants of the rock crib dam, which was originally constructed to divert water into the Chesapeake and Ohio Canal, but the dam could not be removed because of its historic features. The USACE began model testing various alternatives for eliminating the roller. The alternative selected was to use grout-filled bags to create a 3:1 stepped slope that would extend about 6 m (20 ft) beyond the toe of the apron (Davis and George 1985). Figure 10 shows the alternative design.

Figure 10. Plan for placement of grout-filled bags to eliminate the roller at Little Falls Dam (from Intrusion-Prepakt, Inc. 1986)

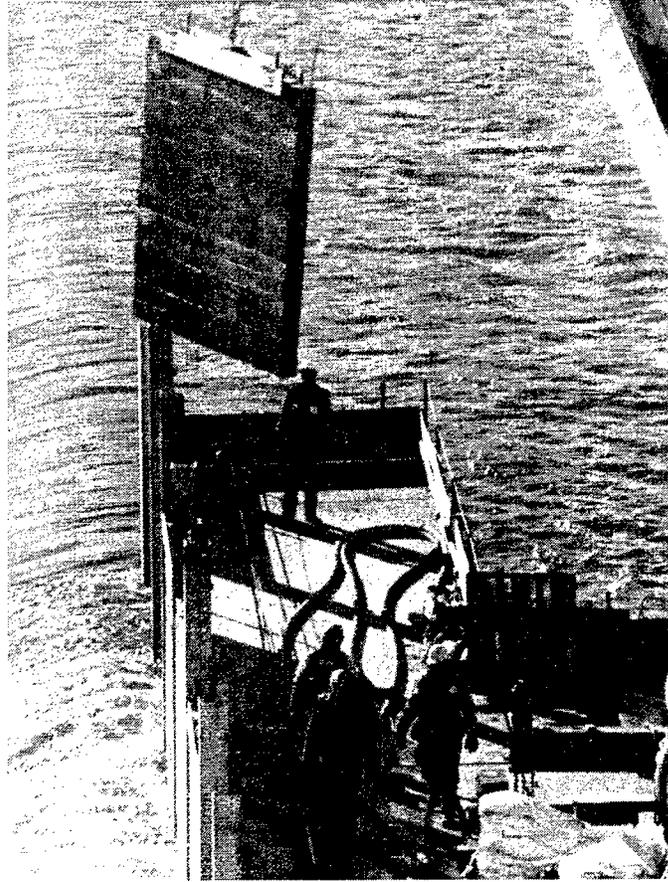
Figure 11. Work barge with raised deflection gate, Little Falls Dam (from Intrusion-Prepakt, Inc. 1986)

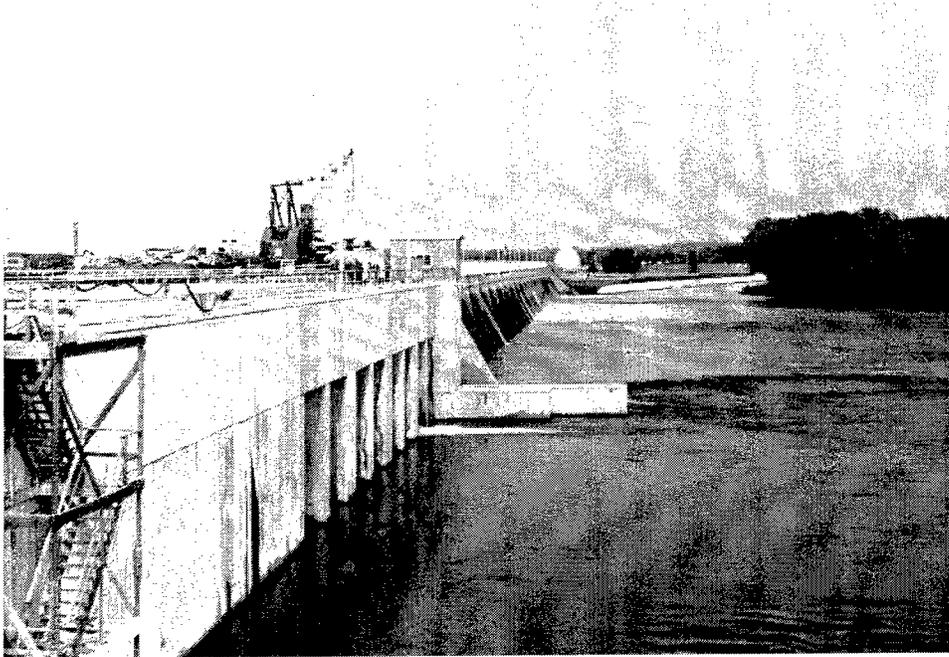
was removed and a wooden dowel was driven into the hole. The grout pipe was then inserted into an adjacent hole until grout again flowed through adjacent holes. This process was continued until the forms were completely filled. The performance of the PAC was more satisfactory than that of the conventional concrete from the standpoint of shrinkage cracking. The rehabilitated downstream face of the head gate section is shown in Figure 14.

Figure 14. Head gate section of Brandon Road Dam after rehabilitation

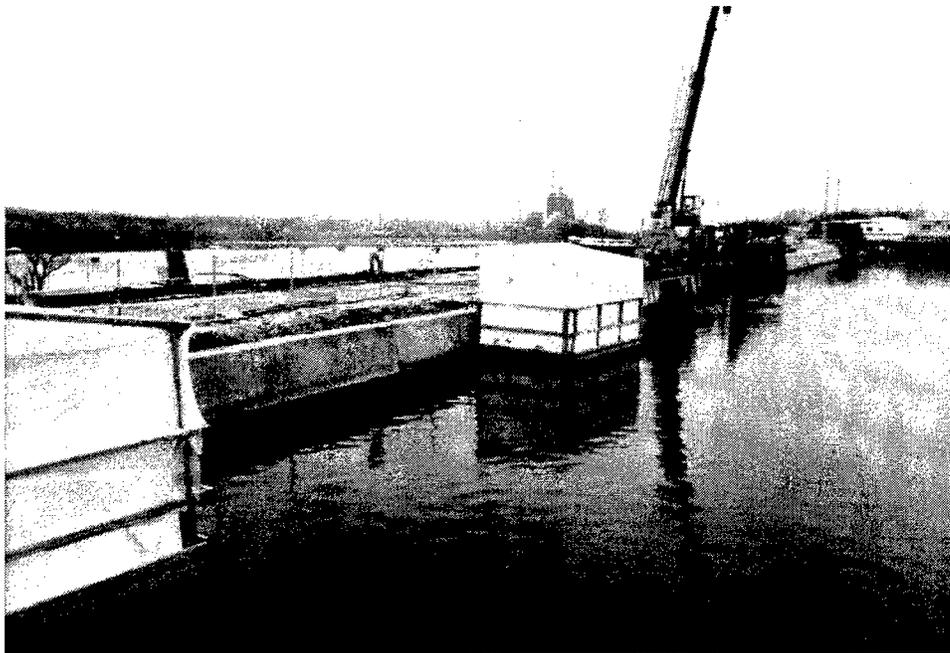
Figure 15. Head gate section on upstream face at Brandon Road Dam after rehabilitation

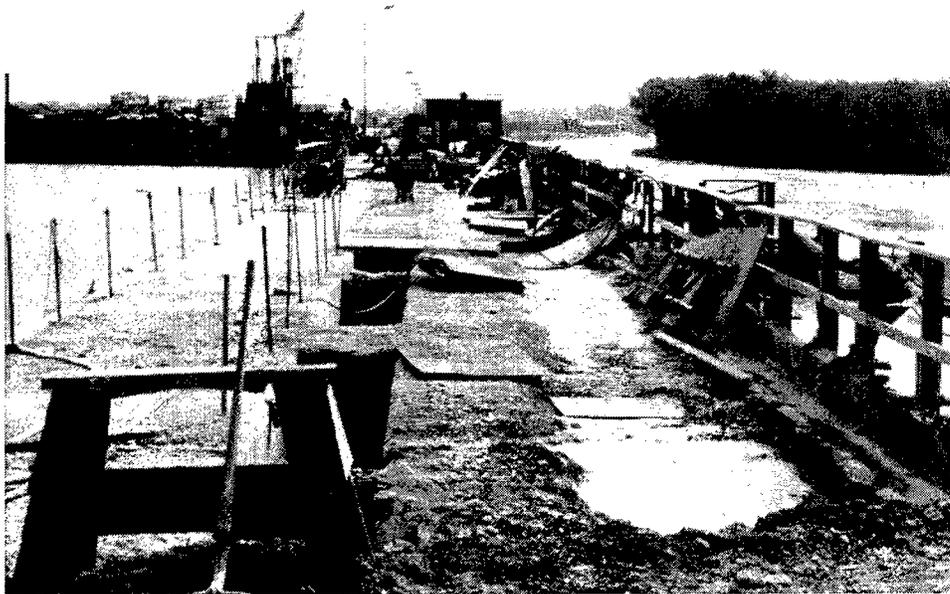
Concrete was removed to a depth of 229 mm (9 in.) on the horizontal surfaces of the head gate section. No. 6 steel bars at 305-mm (12-in.) spacings each way provided reinforcing for the horizontal surfaces of the head gate section. Additional reinforcing was added across the openings in the existing concrete. An asphaltic bond breaker was applied to the existing concrete before the conventional air-entrained concrete overlay was placed (Figure 15). Repair to the horizontal deck of the head gate section was similar to that of the sides; a 229-mm- (9-in.-) thick, unbonded overlay was used to replace deteriorated concrete (Figure 16).

Figure 16. Repairs to the horizontal deck of the head gate section at Brandon Road Dam

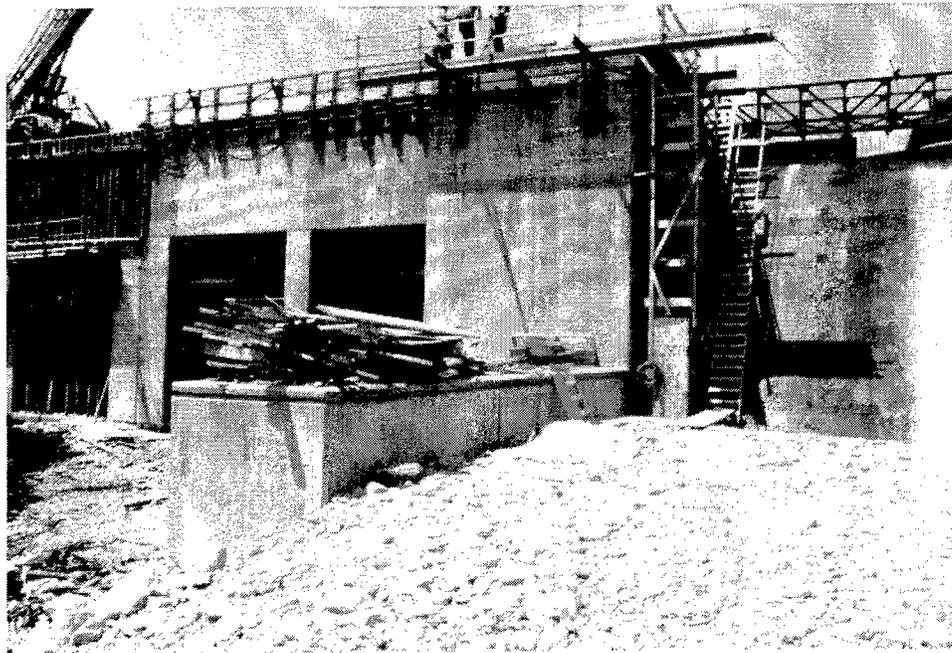
The boiler house monolith was extensively modified. Rehabilitation included removal of a large portion of the downstream section, resurfacing vertical and horizontal surfaces, and filling existing openings. Conventional concrete was used, and a new metal maintenance building was erected on top of the rehabilitated monolith (Figure 17).

Figure 17. Boiler house after rehabilitation, Brandon Road Dam

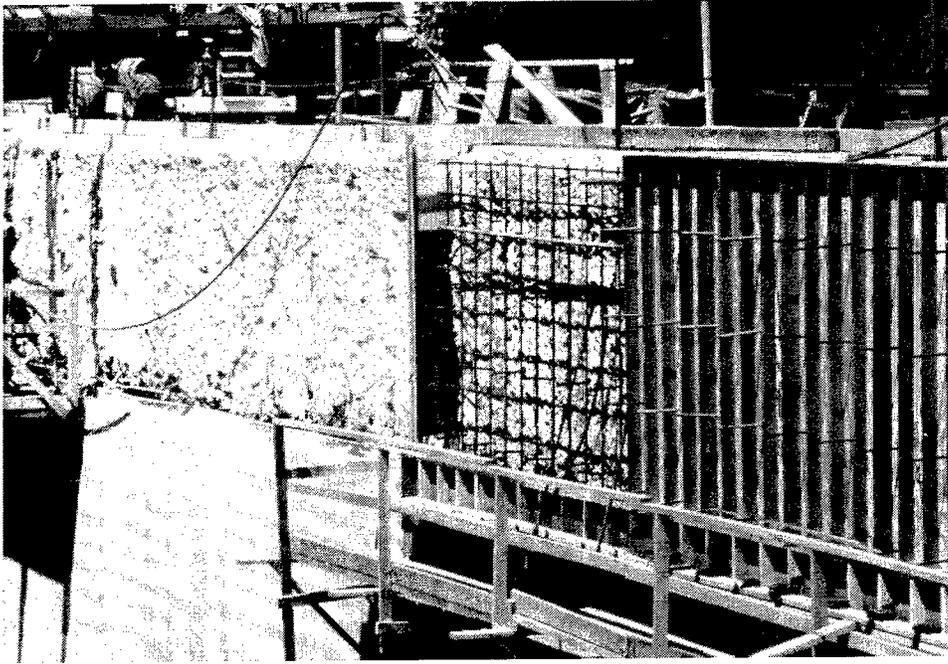
The head gate closure panels were installed on the downstream face of the structure. The panels, which were 4.6 m (13 ft 4 in. ) wide, 4.9 m (16 ft) high, and 1.2 m (4 ft) thick, were reinforced with No. 6 steel bars on 305-mm (12-in.) centers each way on both faces. No. 6 steel bars on 457-mm (18-in.) centers vertically were used to anchor the panels to the existing piers. Anchors were also installed at the bottom of the panels (Figure 18). The head gate section after rehabilitation is shown in Figure 19.

Figure 18. Reinforcing and forms for head gate closure panels at Dresden Island Lock and Dam

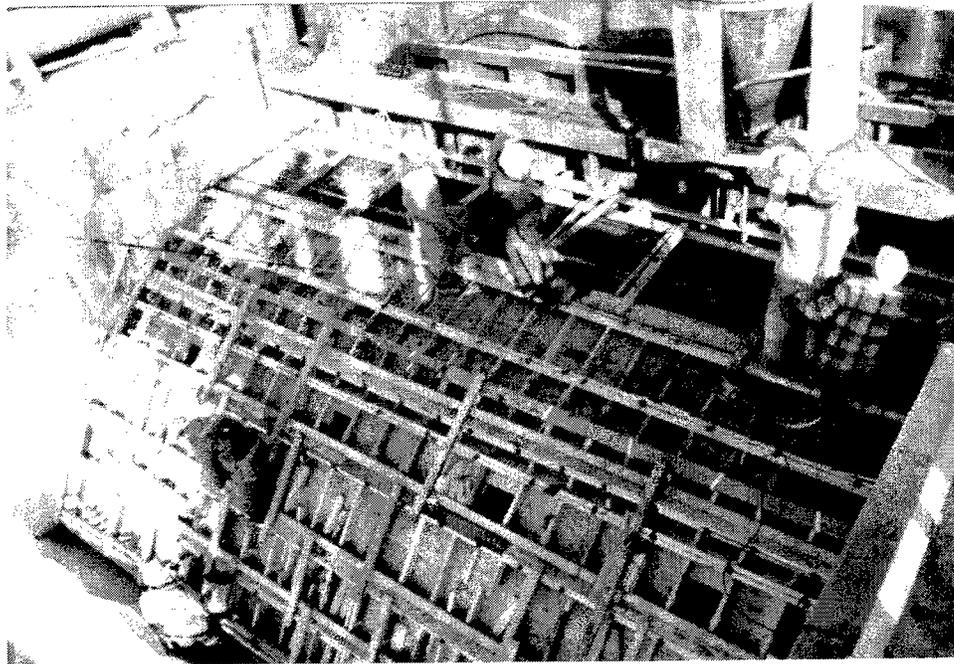
The gated ice chute was converted to an uncontrolled ogee crest. Concrete was removed, forms were built, and the concrete replaced to obtain the ogee configuration (Figure 22). The converted ice chute is shown in Figure 23. The downstream face of the gate sill was resurfaced, and the gate recess in the sill was filled with concrete. The same methods were used to resurface this section as had been used on the arch dam.

Figure 22. Concrete placed in the ice chute during conversion to ogee crest, Dresden Island Lock and Dam

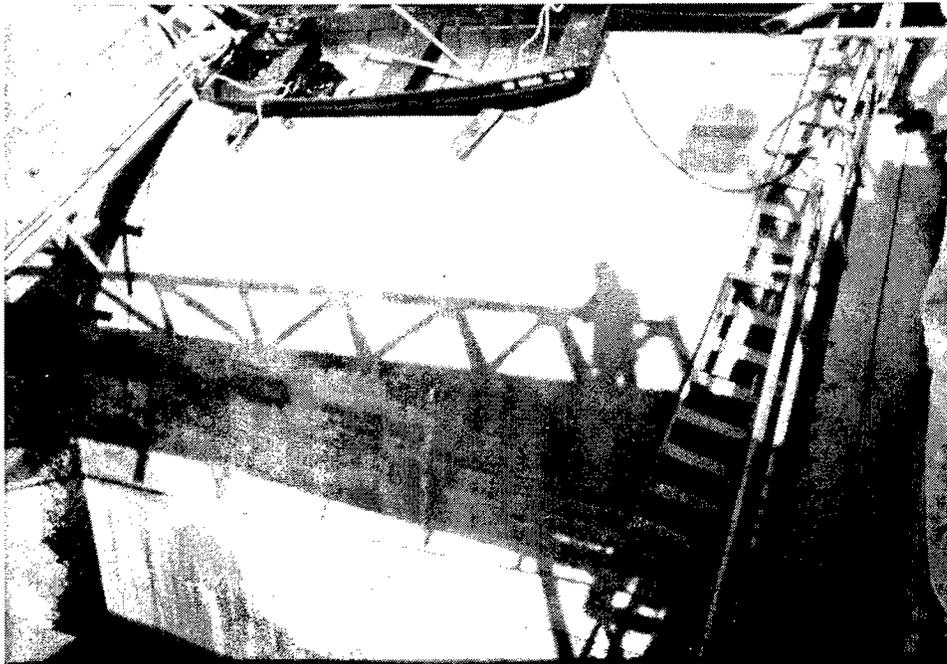
Figure 23. Completed ice chute, Dresden Island Lock and Dam

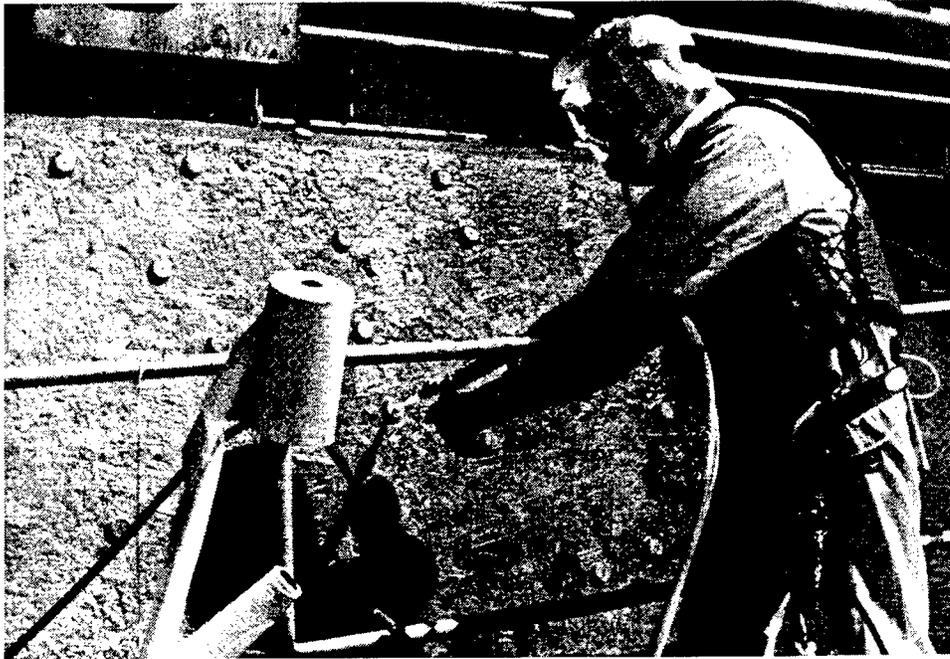
Figure 27. Epoxy injection of pier stem at Lock and Dam No. 20, Mississippi River

A further test of in situ repair was conducted on Pier 27 during August 1987 (Webster, Kukacka, and Elling 1989). For this test, an ultra-low-viscosity material was used, and injection was made through holes in wood dowels bonded directly to the concrete surface (Figure 27). This test demonstrated that pressure injection repair techniques can restore the integrity of cracked concrete hydraulic structures.

In August 1982, Pier 39 was selected as a test site for in situ repair of cracked concrete (Doak 1988). The repair method was to use high pressure to inject a low-viscosity epoxy grout into the crack. The worst areas of deterioration on the pier were so severe that intact cores could not be extracted, and the crack system was too extensive for individual crack repair to be considered. The contractor had 25-mm (1-in.) injection ports installed in a grid pattern. The pier faces were sandblasted to ensure that they were clean, and then water was injected to locate extensive interconnection. The pier was sealed with a trowel-on epoxy, and then low-viscosity epoxy was injected through the ports with pressures up to 1.1 MPa (160 psi). The injection procedure was downward from the top of the pier, upward in the archway, and horizontally on the downstream and east sides; the upstream and west sides were not injected. Approximately 30 l (8 gal) of epoxy was injected into the pier.

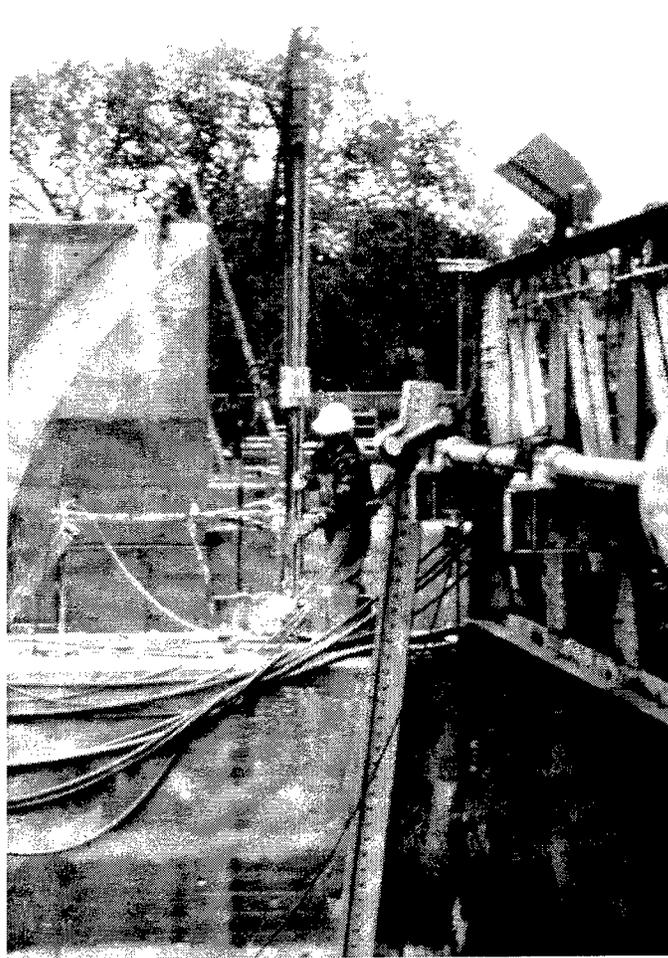
from 102 to 254 mm (4 to 10 in.) deep and that the compressive strength of sound concrete was from 55 to 69 MPa (8,000 to 10,000 psi). Damaged concrete was removed to sound concrete, approximately 229 mm (9 in.). Deteriorated concrete was line drilled (Figure 30) and then removed with jackhammers and expansive grout. Diamond wire cutting was used to remove end blocks of concrete from the piers to allow for the installation of the new trunnion supports (Figure 31). With a cutting speed of 0.9 to 3.7 sq m/hr (10 to 40 sq ft/hr), the diamond wire was faster than conventional methods, and it required fewer workers. The pier sections were cut free in two work shifts.

Figure 30. Line drilling for concrete removal at Marseilles Dam

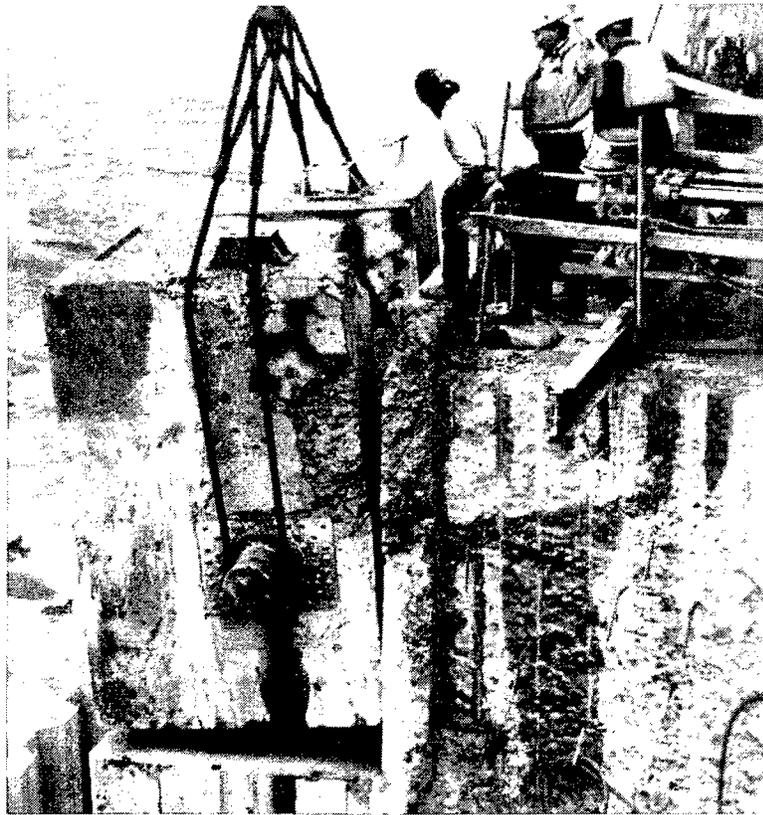
Figure 31. Twenty-nine thousand thirty and four-tenths-kilogram (32-ton) section cut from pier with diamond wire cutter, Marseilles Dam (from Cutting Technologies, Inc. 1990)

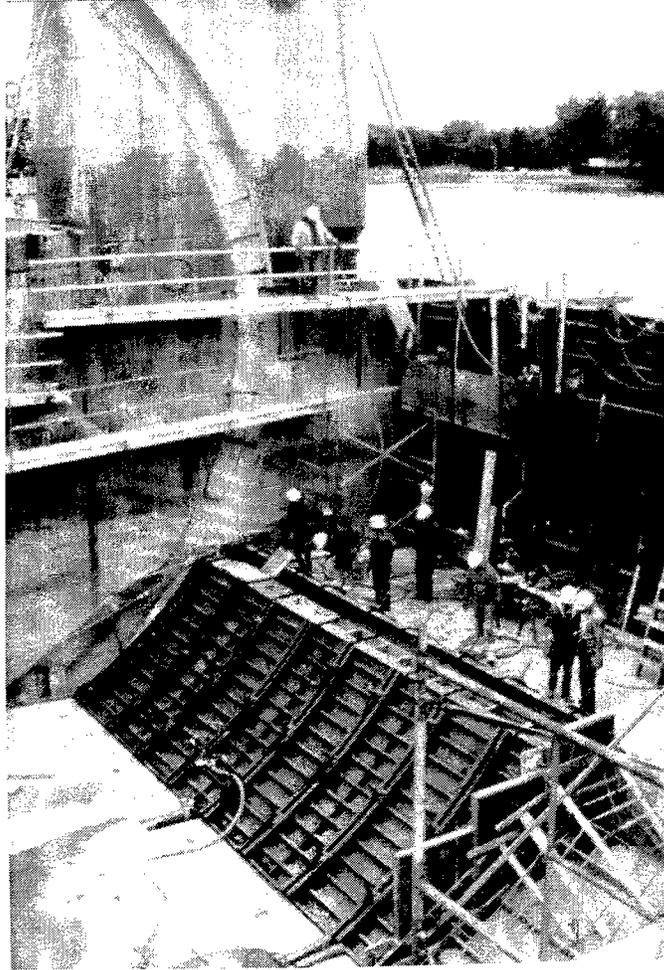
All horizontal surfaces were sloped slightly to prevent water ponding. A 0.5-m- (14-ft-) high extension was added to each pier so the gates could be raised to maximum elevation. Sills for the tainter gates were altered from an ogee shape to one that would allow the gates to be submerged (Figure 32). Post-tensioned tendons on the pier sides were used to support the trunnion anchor beam and resist trunnion loads. The tendon load was transferred into the parent

Figure 32. Concrete placement in new gate sill, Marseilles Dam

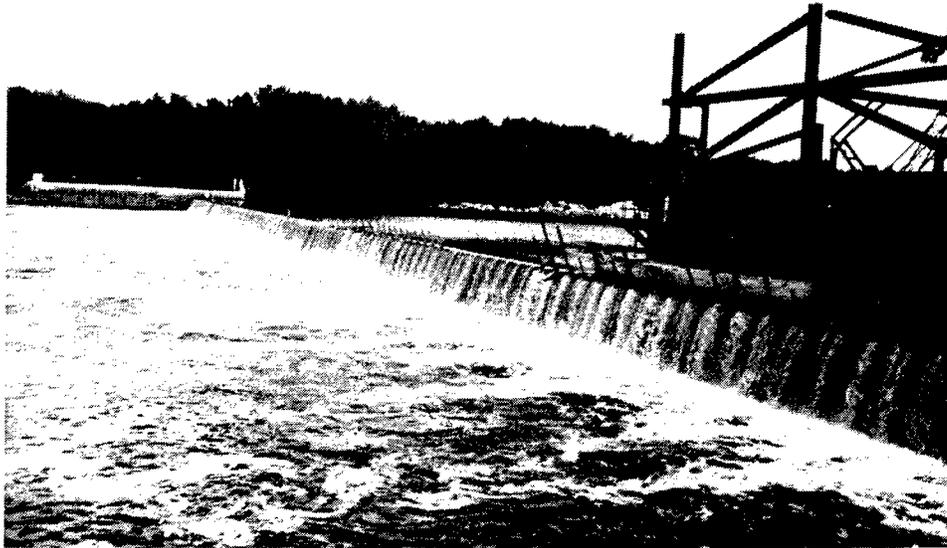
The wicket dam allows towboats to bypass the lock in open-pass navigation when flows are sufficient to lower all of the wickets. This condition occurs about 40 percent of the time during a year. There are, however, several problems with wicket dams, the biggest being that ice and debris cannot pass through the dam while the wickets are raised, which they must be during low river flows. Even the flip-top, hinged wickets, which can lower the top 0.9 m (3 ft), cannot sufficiently pass heavy ice flows. The dam had no other section for passing ice or debris. Backed up ice inhibits the movement of tows and slow lockages; ice lockages are frequently required to remove large quantities of ice while tows wait for a clear lock. Other problems with the wickets are that, in the lowered position, they pass a column of water that causes severe scouring action. Also, raising or lowering the wickets as flows change is a slow process.

Figure 33. Peoria Dam before a section of the wicket dam was replaced with a submersible gate

To alleviate some of the problems of the wicket dam and to provide ice passage capability and a safer means of regulating flow, a section of the wicket dam was replaced with a 25.6 m (84-ft) wide, submersible gate adjacent to the lock wall. Appurtenant piers, gate sills, an apron, and a service bridge were included in the modification plan.

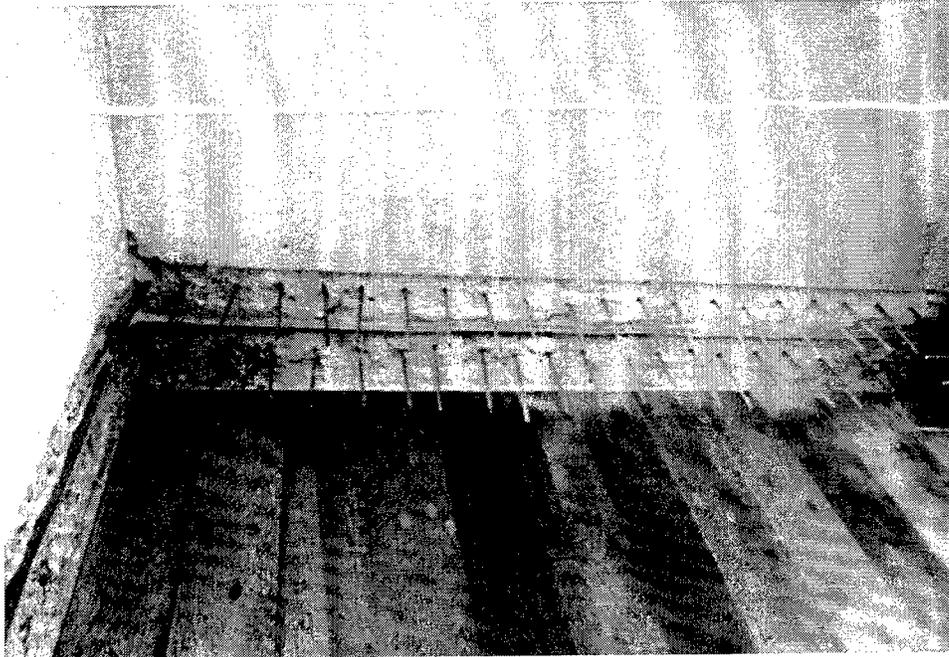
The closure panels for the head gate section were 4.3 m (14 ft) wide, 4.9 m (16 ft) high, and 0.8 m (2 ft 6 in.) thick. Two rows of No. 6 steel bars on 229-mm (9-in.) centers were installed to anchor the panels (Figure 37). Deteriorated concrete was removed from the roof of the head gate opening, and a waterstop was installed along the perimeter of the opening. The concrete for the closure panel was pumped to just below the opening (Figure 38), and then the opening was filled with nonshrink grout. Vibrators were used to consolidate the concrete. A curing compound was used for curing.

Figure 37. Anchors and waterstop installed in head gate section, Starved Rock Lock and Dam

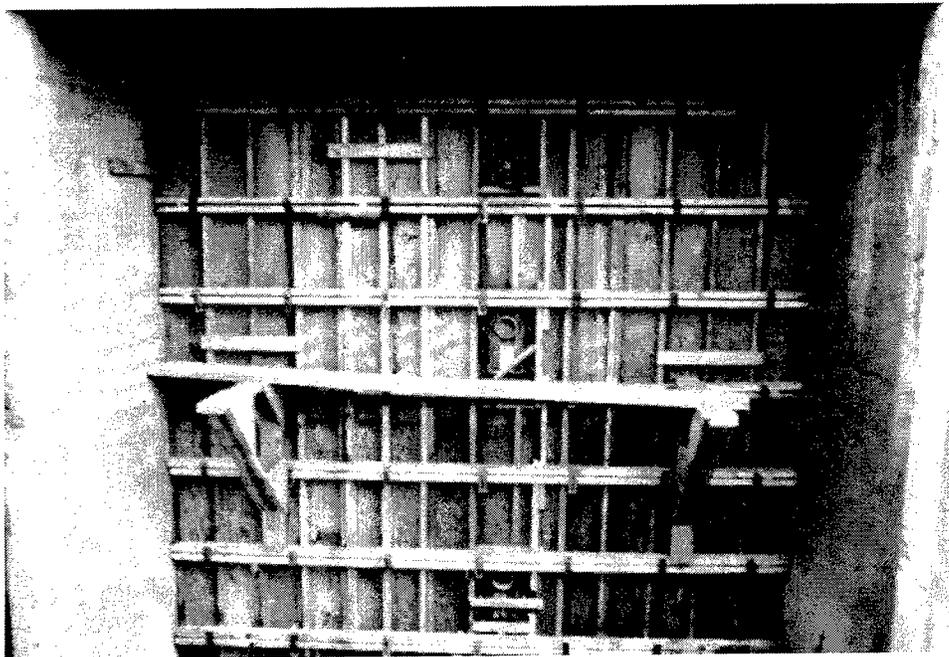
Figure 38. Forms and openings for pumping concrete for closure panels in head gate section, Starved Rock Lock and Dam

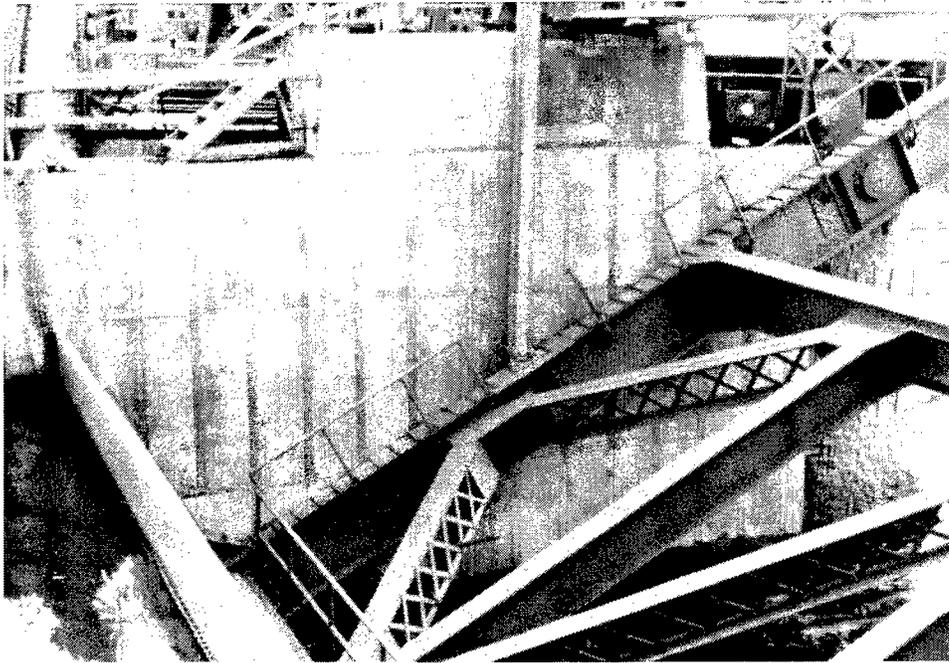
Concrete was removed to a depth of 152 mm (6 in.) for vertical and horizontal resurfacing. The replacement concrete was anchored to the piers with No. 6B steel bars on 0.6-m (2-ft) centers. Reinforcing consisted of welded wire fabric. A steel angle was embedded at the upstream bullnose of the piers. The contractor was concerned about being able to place the required 19-mm (3/4-in.) maximum concrete in the relatively narrow 152-mm (6-in.) section, which was congested with anchors, reinforcing, and other embedded items, so he requested permission to use a high range water reducer admixture (HRWRA) to increase workability of the concrete.

Figure 39. Tainter gate pier after rehabilitation, Starved Rock Dam

Rehabilitation of the tainter gate section consisted of removing and replacing concrete on the surface of the piers, installing new gate seal plates and heating elements along the sides of the piers, and modifying concrete to accommodate new bridge bearing details.

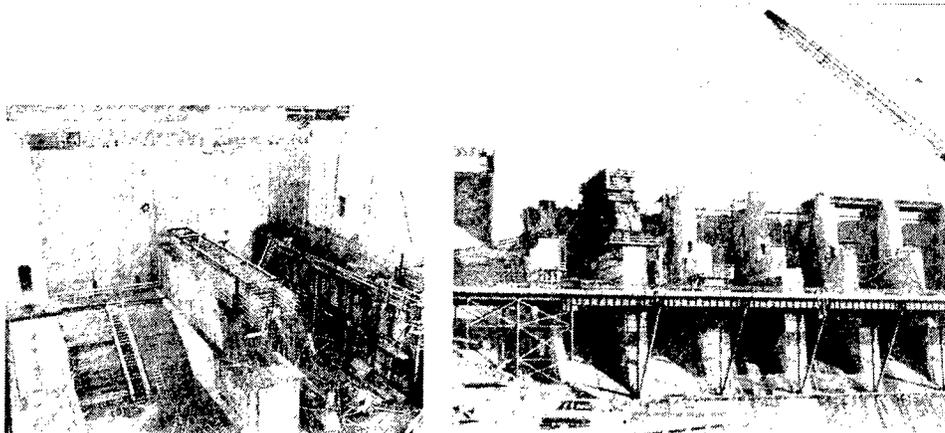
contractor developed a plan for concrete removal that included presplitting the pier noses with drills and then placing fractions of dynamite sticks in the holes and detonating them with blasting cord. With this method, a pier top could be removed in about 3 weeks. Installing dowels and rebuilding the piers took several months (Figure 44). When work on a pair of piers was completed, the crew placed stop logs in the bays and then moved the

Figure 44. Piers raised and widened to resist greater head at Chief Joseph Dam (from ENR 1978)

To raise the height of the piers, the contractor had to first remove the reinforced concrete down to the pier bases, install dowels in the bases and rebuild the piers. Removal of the reinforced concrete required some experimentation. The piers were only 1.83 m (6 ft) from the face of the floating cofferdam, therefore, placing a restraint on blasting. Particle velocity was limited to 101.6 mm (4 in.) per second in any material that stayed in place. The

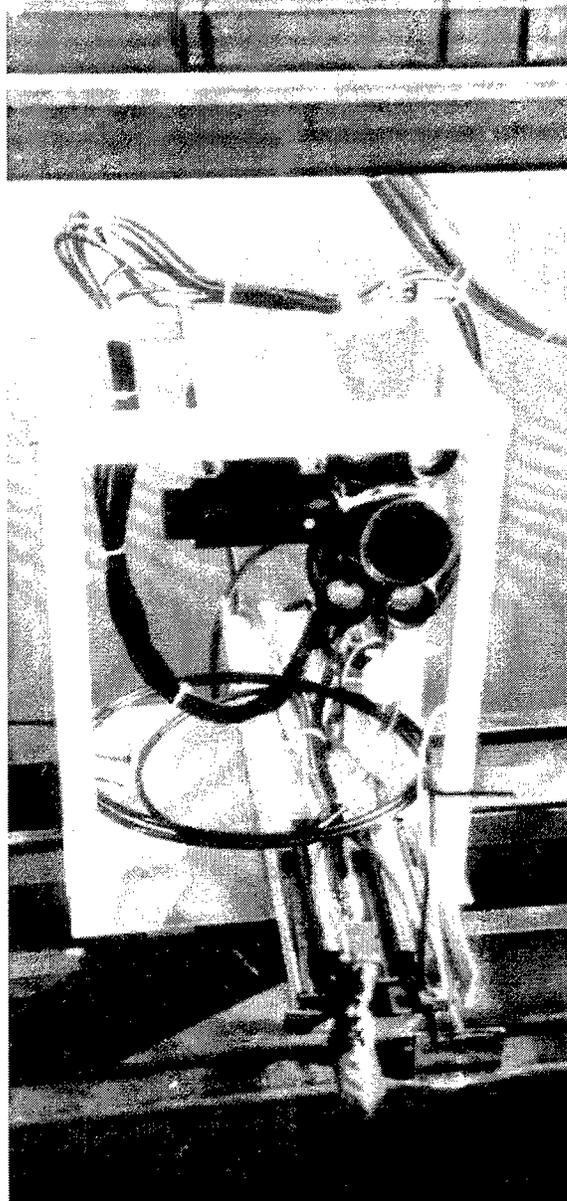
All repairs were performed underwater. A remote-controlled camera with a 360-deg pan, 360-deg tilt, and 8-power zoom was used to monitor the repair work. A pneumatic grout pump supplied grout to the application nozzle, and a pressure pot supplied dye to leak-detection equipment. The camera, cleaning equipment, dye injection hose, lights, and grout injection nozzle were mounted on an underwater frame supported by a crane. A pneumatic motor moved the cleaning-inspection-grouting equipment along the length of the frame, which was positioned over a lift joint (Figure 46). Controls for the camera, lights, and grouting equipment were on top of the spillway bridge. As each joint was sealed, the amount of leakage through drain outflows was measured and inspected visually. The leakage reduction in each instance was significant.

The repair methods used in this project appeared to be effective on lift joints in general. Observations during repair of the monolith joints indicated that a few of the copper water stops were ineffective along their entire lengths and other monolith joints appeared to have localized points of leakage. The remedial underwater joint sealing techniques in these instances were very difficult and cumbersome. However, significant leakage reductions resulted for all monolith joints where the repair procedure was used.

Figure 46. Frame-mounted remote-controlled camera and pneumatic equipment used for inspection and repair of monoliths at Chief Joseph Dam (from ENR 1978)

Following the underwater joint sealing effort, an alternative procedure was used for repairing monolith joint leaks. The procedure used conventional drill-hole grouting and chemical grouting equipment and techniques to seal the joint drain centered between two copper waterstops spaced 0.9 m (3 ft) apart (Sondergard 1991b). These joint drains extend from the spillway ogee surface to 1.5 m (5 ft) above the foundation. Two balloon-type drill-hole packers, each 178 mm (7 in.) in diam and 1.2 m (4 ft long), were assembled in tandem with 0.6 m (2 ft) of space between them. A 165-mm- (6-1/2 in.-) diam sealed pipe was placed into this space to reduce the volume, thereby minimizing the chemical grout consumption. A compressed-air supply line, a hoist cable, and the grout supply line were attached to the top of the packer assembly. The entire assembly was positioned in the joint drain by an overhead hoist. When the packers were in the desired position, they were inflated, and then chemical grout was injected into the space between them. The grout entered the monolith joint between the water stops and filled the void. The (1.2-m-) 4-ft-long packers acted as a surface barrier to prevent the grout from exiting the joint. Injection at each location was continued until grout in the joint void reached the top of the packer. The packer assembly was then deflated, repositioned, and reinflated, and the process was repeated. The grout used was a hydrophobic, water-activated, isocyanate-based, polyurethane-foam-forming chemical grout with a viscosity of approximately 1,000 cp at 21 °C (70 °F). This method used the existing features of the structures, required no drilling or structural modifications, resulted in a sealed

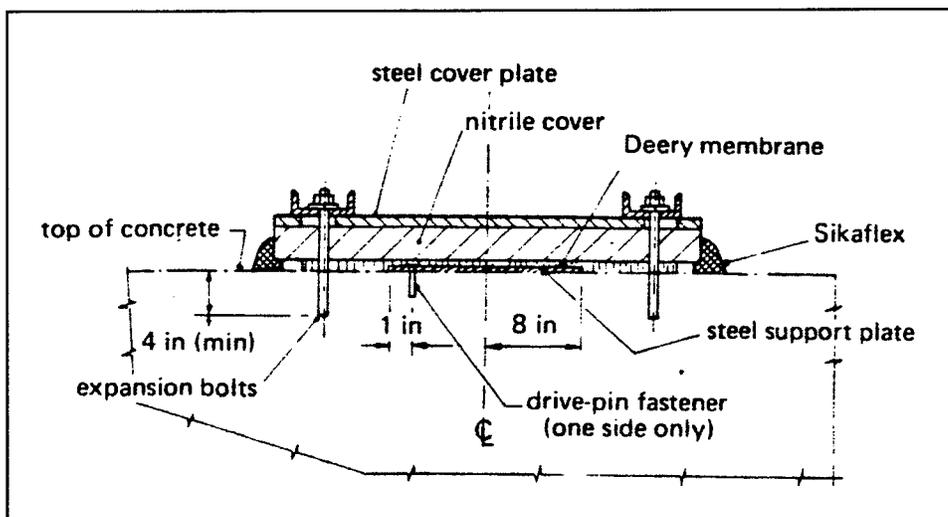
Figure 48. Details of joint covers used at New Exchequer Dam (from Brown and Kneitz 1987)

for anchor bolts and the bolts were installed and tightened with a torque wrench. A sealing compound was placed at the edges of the joint cover between the nitrile and the concrete face slab (Figure 48).

Open joints that had leaked in the past were inspected for voids. The voids were filled with a sand-cement grout mixture, which was typically injected through holes in the waterstop. In those joints where the copper waterstop was torn, the waterstop was removed and the void was filled with shotcrete.

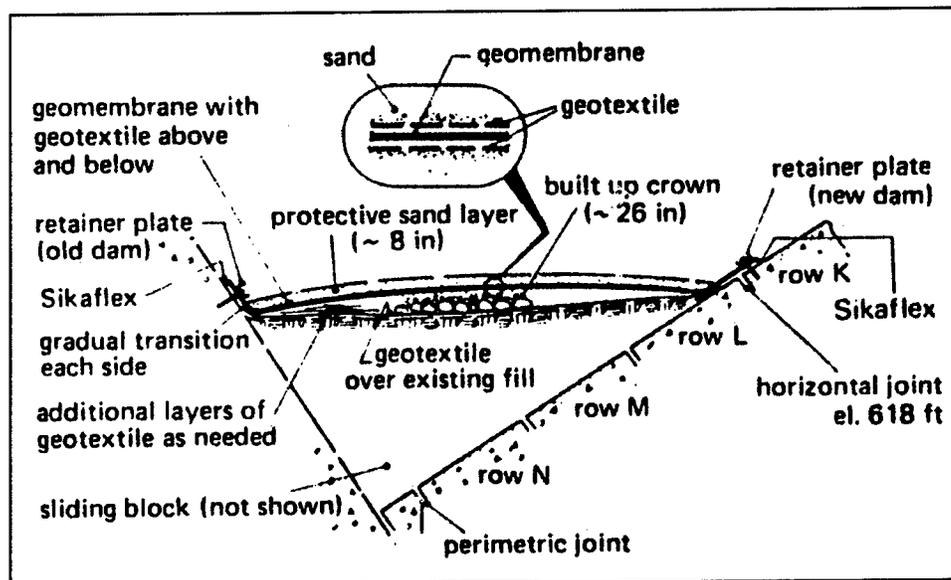
Figure 49. Details of installation of geomembrane over toe fill at New Exchequer Dam (from Brown and Kneitz 1987)

Although the toe fill was in good condition, with no sinkholes, the repairs planned for this area were completed (Figure 49). Two light bulldozers were used to remove extraneous material and grade the fill. Next, a layer of geotextile was placed over the fill, followed by imported material dumped from the crest of the old dam and spread by the dozers. This material was covered with a second layer of geotextile. A watertight geomembrane was placed over this layer of geotextile. The geomembrane had been precut and seamed in three large panels. An additional piece had to be added because of the difference between the expected and actual toe-fill geometry and to provide for adjustment of the membrane to the toe fill after the reservoir filled. A tented enclosure and heaters were used to maintain proper temperatures for making the field joints.

The geomembrane was covered with a layer of geotextile topped with a layer of sand. The entire toe-fill repair was carefully wetted, and then the area was rewatered. By mid-January 1986, the water level had reached el 706 and had a static head of 26.8 m (88 ft) on the surface of the toe fill. No measurable leakage had occurred. The reservoir continued to fill; not until 3 March 1986, were traces of leakage noted. When the reservoir peaked 28 June 1986, 3.4 m (11 ft) below normal maximum reservoir level, leakage was 0.098 cms (3.5 cfs), a significant reduction when compared to leakage of 3.9 cms (140 cfs) at this same level in 1983. Leakage at the dam reported in July 1986 was 0.1 cms (3.7 cfs). Some personnel believe as much as half of this amount is coming through the old dam gallery and the new dam access gallery.

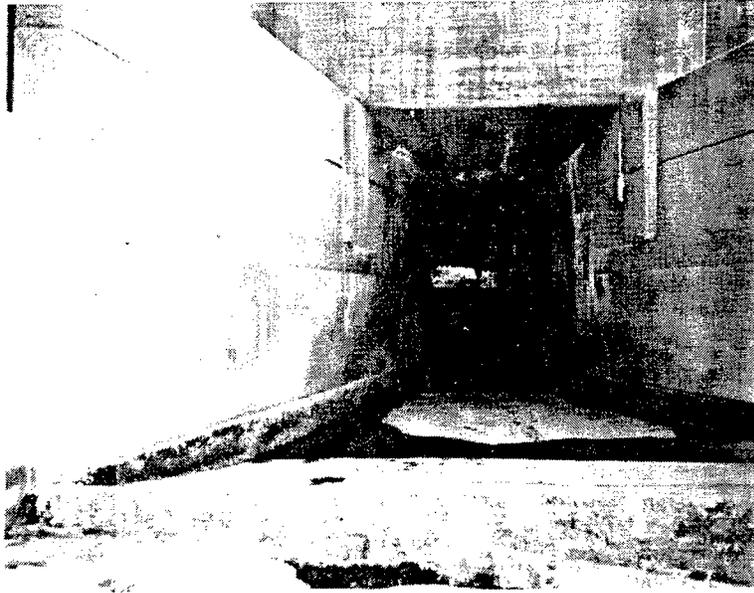
Figure 52. Outlet channel of flip bucket no. 4 with steel plates on the walls, Lucky Peak Dam (from U.S. Army Engineer District, Walla Walla 1983)

In 1974, a hydraulic study of the outlet was conducted. The study concluded that the major factors contributing to the erosion damage on the concrete aprons downstream of the modified flip buckets were the reduced flip angle of the affected flip buckets, the deterioration of the flip lip, normal air flow to the underside of the flow jet being blocked by the training walls, and high-velocity flows, in the range of 2.5 to 3.5 cu m/s (88 to 124 fps).

In 1972, cavitation damage in the flip bucket channel floors were repaired with fibrous concrete. In 1984, a contract was let for repair of the outlet work. The alternative selected for these repairs was to: (a) fully cover the floors of each flip with 19-mm (3/4-in.) steel plate, including the vertical faces at the edge of the flip lip; (b) to restructure Channels 2, 3, and 4 with provisions for air vents in the training walls to supply air to the channel floors just downstream of the flip lips (wall heights in the area of the air vents would be raised by 1.5m (5 ft) to raise the air intakes above the level of the waterflow and prevent suction of water into the air vents); (c) fully line Channels 2, 3, and 4 with steel (Figure 53); (d) patch and repair the existing concrete surfaces of Channels 5 and 6; (e) cut back and resurface the concrete aprons of Channels 3 and 4 to provide a 10 percent downstream slope from the edge of the flip lip; (f) replace the severely damaged training walls 2, 3, and 4 with new 19-mm (3/4-in.) steel welded to W10 × 45 columns and filled with concrete; and (g) establish a mandatory operation schedule for flip buckets 5 and 6 to minimize road hazard, making sure the gate would be operational in an emergency.

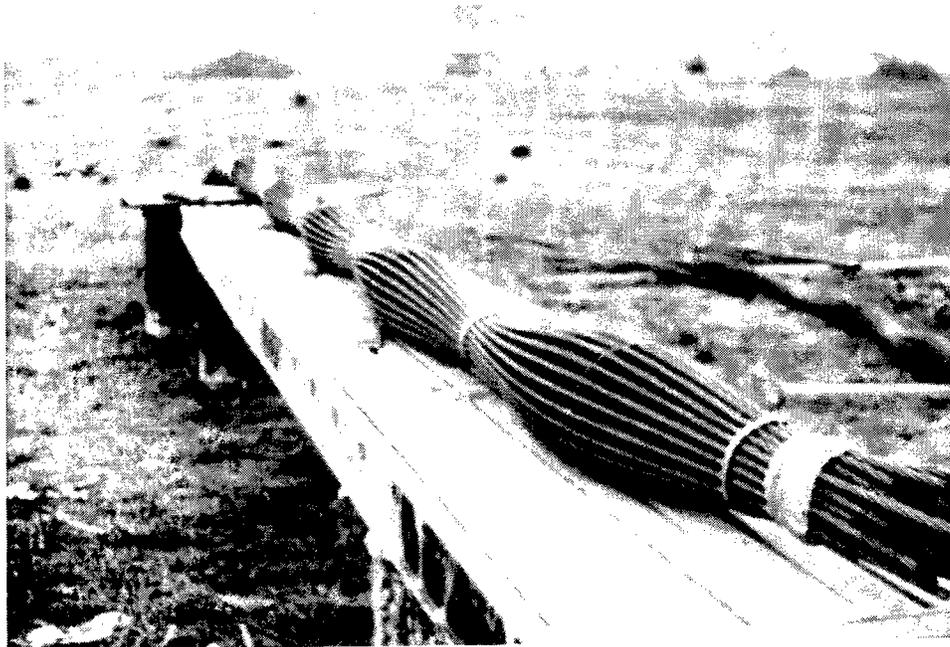
Figure 55. Anchor strands, cut and bound, for Alum Creek Dam (from Barnes 1982a)

Another contract alteration allowed the contractor to use a 52-strand anchor with a minimum of 1,900 MPa (275 ksi) per strand instead of the designed 53-strand anchor with 1,700 MPa (250 ksi). The strands were cut and bound together (Figure 55) to form an anchor. A helicopter was used to install the anchors; each anchor unit weighed approximately 1,540 kg (3,400 lb). The operation was completed in 5 hr on 6 September 1977. The next 3 days were used to grout the anchors in place. The grout contained 19 ℓ (5 gal) of water per bag of cement and 1-percent Intraplast-N. Fifty one-millimeter- (2-in.-) cube specimens were taken and tested at both 7 and 21 days; they passed the contract specification of 27.6 MPa (4,000 psi) with compressive strengths of 29.1 and 42.7 MPa (4,220 and 6,200 psi), respectively.

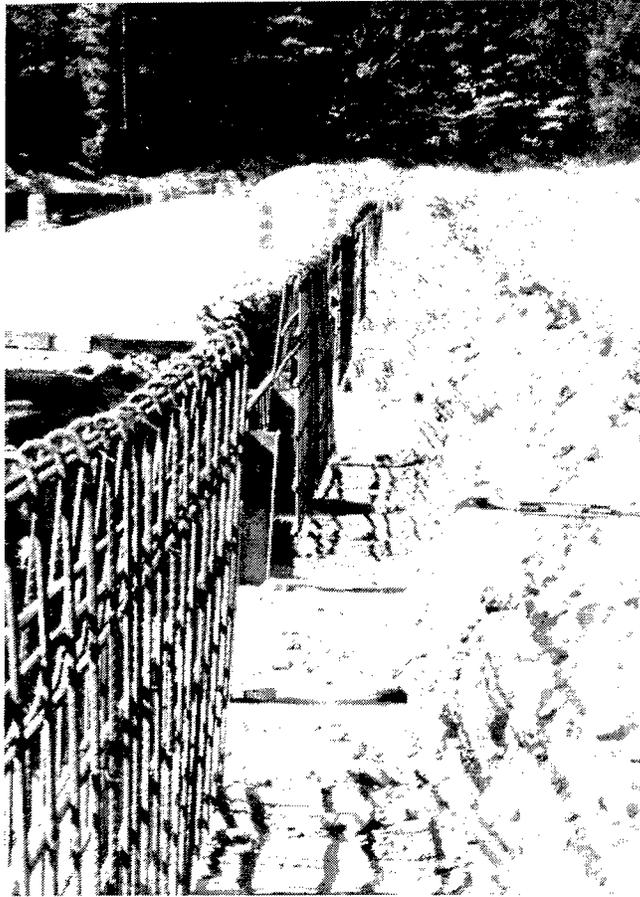
Figure 56. Construction of a parapet wall on the upstream crest of Mohawk Dam (from U.S. Army Engineer District, Huntington 1990b)

The procedure for raising the crest of the dam was to place a layer of random fill on the upstream face of the embankment and then cover it with a layer of random rock fill. The original upstream slope varied from 2 to 3:1. The rock fill and random rock blanket provide a 4:1 stability berm to el 840 where a 15.5-m- (50-ft-) wide bench was constructed. The 4:1 slope continues above the bench to el 891 where it transitions to 2.5:1 and continues from there to the crest. Because space near the intake structure was limited, it was not possible to maintain the 4:1 stability berm cross section. In this area, select fill was placed on a 2:1 slope to el 900 before transitioning to a 2.5:1 slope from that point onward to the crest. The crest of the dam was covered with impervious fill. After the embankment was raised, a 0.9-m- (3-ft-) high concrete parapet wall was installed to provide the minimum required freeboard (Figure 56).

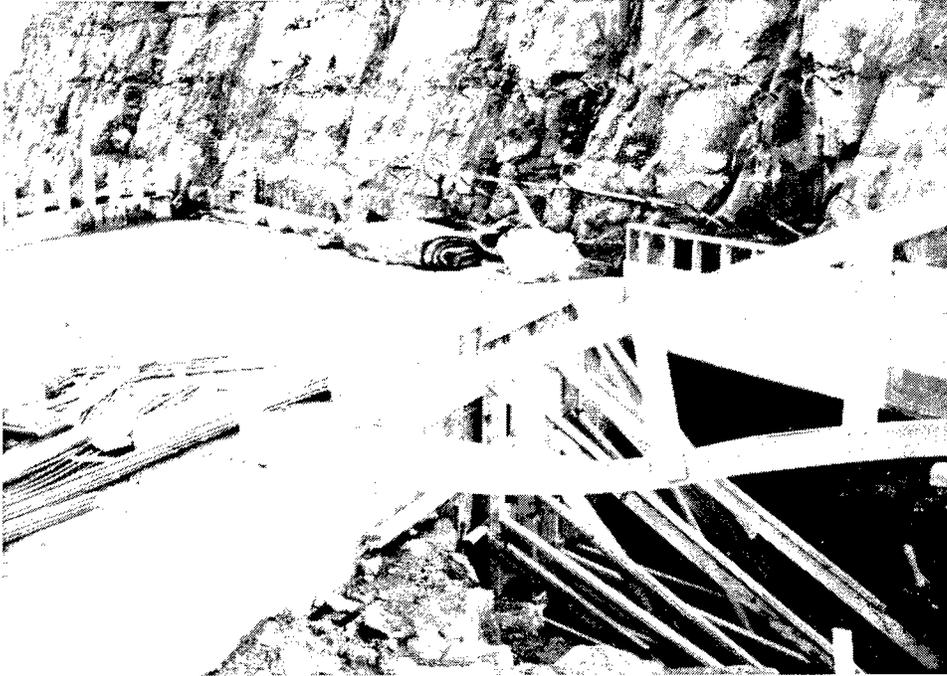
Figure 57. Forming for construction of additional monolith on the right side of the spillway, Mohawk Dam (from U.S. Army Engineer District, Huntington 1990b)

The spillway was widened from 195 to 200 m (640 to 657 ft) to improve entrance conditions and to provide a suitable foundation for the newly added spillway approach sidewalls. A monolith was added to each end of the curved concrete weir that protects the spillway crest in the event of spillway flow (Figure 57). Concrete hang-on walls for the spillway approach were constructed at the contacts between the weir and the excavated spillway sidewalls. A one-row grout curtain, 9 m (30 ft) deep, 3-m (10-ft) centers was also placed along the line of the concrete weir. Additionally, the concrete hang-on walls and the existing weir monoliths were anchored into the rock. No. 8 reinforcing bars were grouted into drill holes spaced on 3-m (10-ft) centers (Figure 58). The anchors were then posttensioned to 149 kN (33.5 kips).

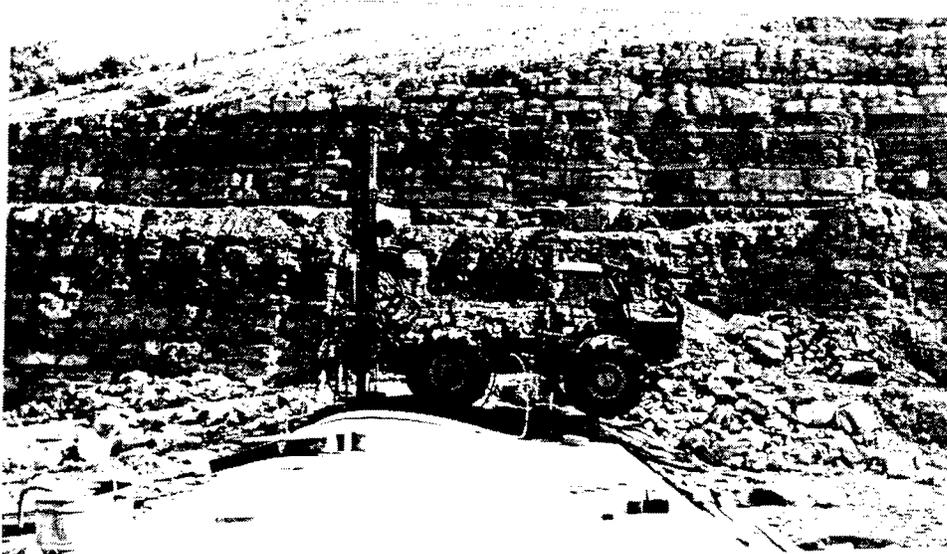
Figure 58. Holes drilled for installation of posttensioning anchors on spillway crest, Mohawk Dam (from U.S. Army Engineer District, Huntington 1990b)

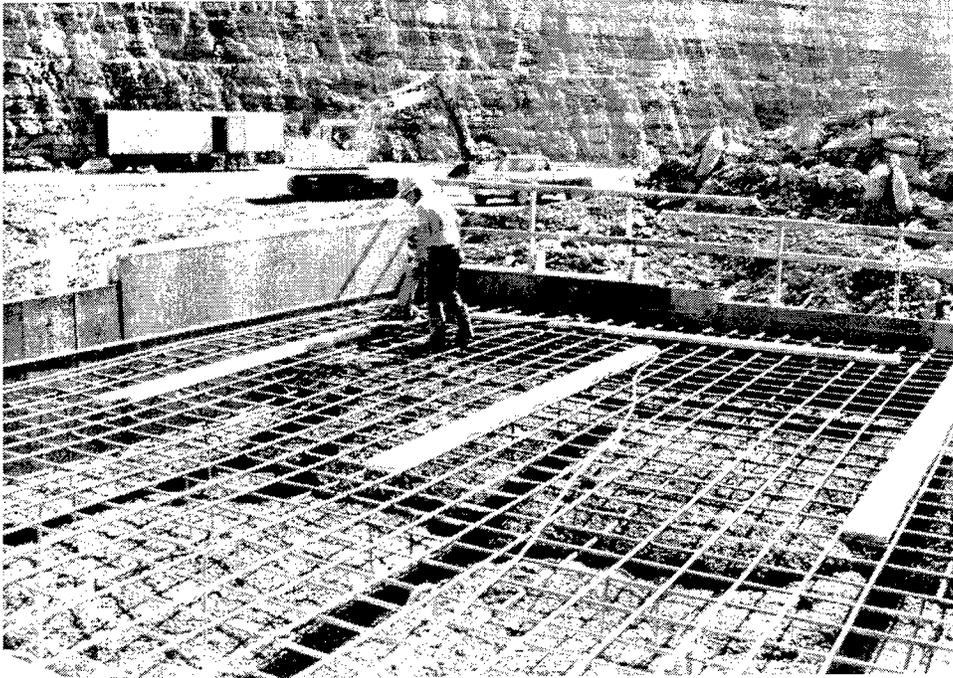
Figure 59. Forming and reinforcing for the top lift of concrete for the apron, Mowhak Dam (from U.S. Army Engineer District, Huntington 1990b)

An apron keyed into the rock was added to the existing weir cross section. Reinforcing bars anchored into the existing weir were used to secure the apron. Only the top lift of concrete for the apron was reinforced (Figure 59). The surfaces was screeded smooth (Figure 60).

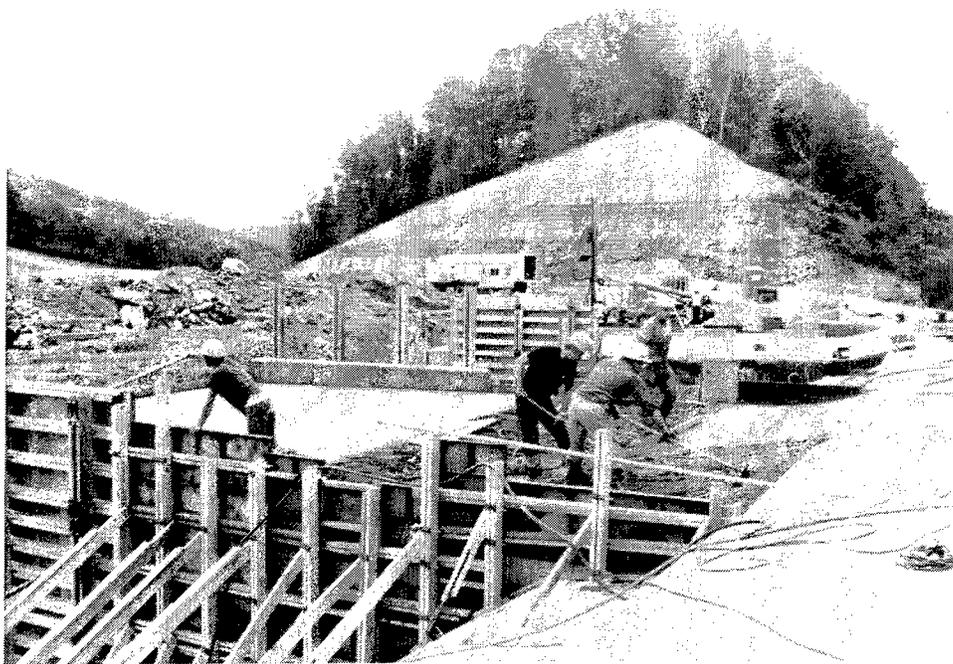
Figure 60. Placing and finishing concrete for the top of the spillway apron, Mohawk Dam (from U.S. Army Engineer District, Huntington 1990b)
