**US Army Corps  
of Engineers**  
Engineer Research and  
Development Center

Technical Report REMR-CS-63  
September 1999

## **Repair and Rehabilitation of Dams: Case Studies**

*by James E. McDonald, Nancy F. Curtis*

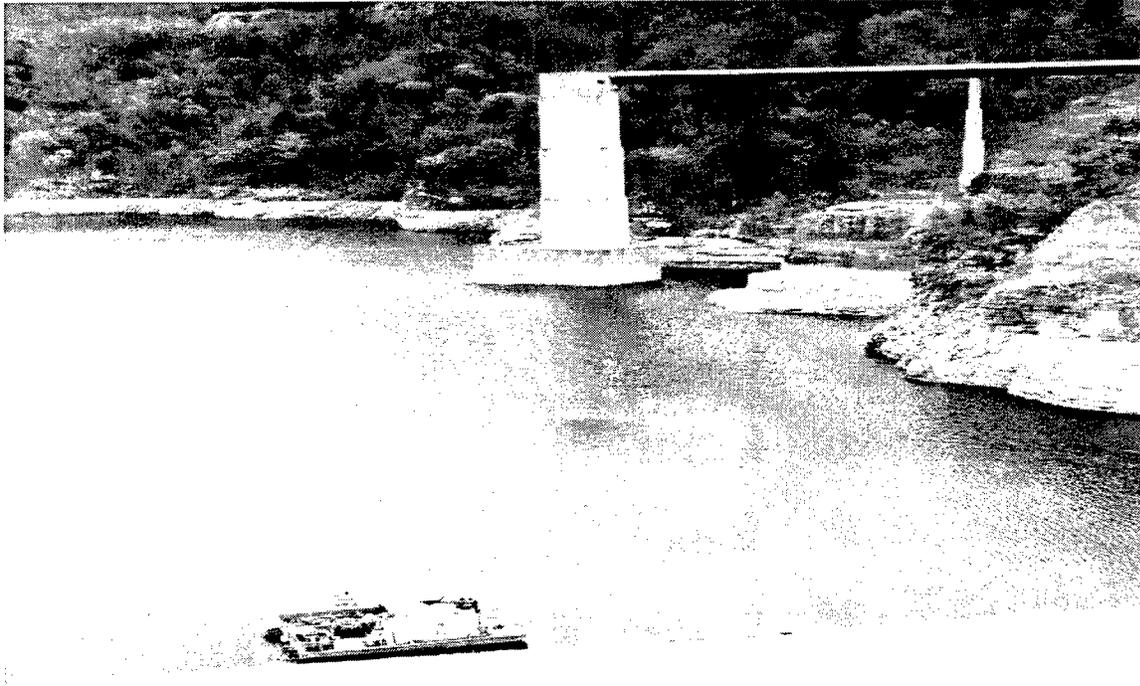
In 1989, a plan to cover the outside of the intake structure (Figure 62) with an adhesive-mounted rubber membrane similar to roofing-type materials was considered. However, because of concern for loss of fish and other aquatic life and the impact upon recreational activities resulting from the proposed drawdown, a decision was made to make another attempt at sealing the cracks, this time from the inside.

Figure 62. Intake structure and access bridge, R. D. Bailey Dam

In January 1990, plans and specifications for sealing the cracks from inside the intake structure were completed, and work was scheduled to begin in the spring of 1990. However, the specified materials were determined to be hazardous because of their low flashpoint. A recommendation was made that safer materials be used. Specifications were rewritten to use a polyurethane grout with a high flashpoint. The cracks were injected in 1991 with a single-component, moisture-reactive urethane liquid, which, upon curing, expands and forms a water-impermeable, elastomeric-polyurethane foam. The cracks injected ran vertically in a wall 4 m (3 ft) thick and then continued horizontally in a floor slab 2.4 m (8 ft) thick. The maximum external hydrostatic head on any crack

during sealing was 34 m (12 ft). The injection was done by contract. Although the sealing appeared to be successful at first, the 1993 inspection revealed continued problems with the elevator, other electrical items, and metal components caused by leakage through cracks and condensation. A decision to try to solve the moisture problem by dehumidification was made, and a request for bids for providing and installing a complete dehumidifier system was issued in November 1993. This decision was based on the success of this method at other district project intake structures with similar moisture problems.

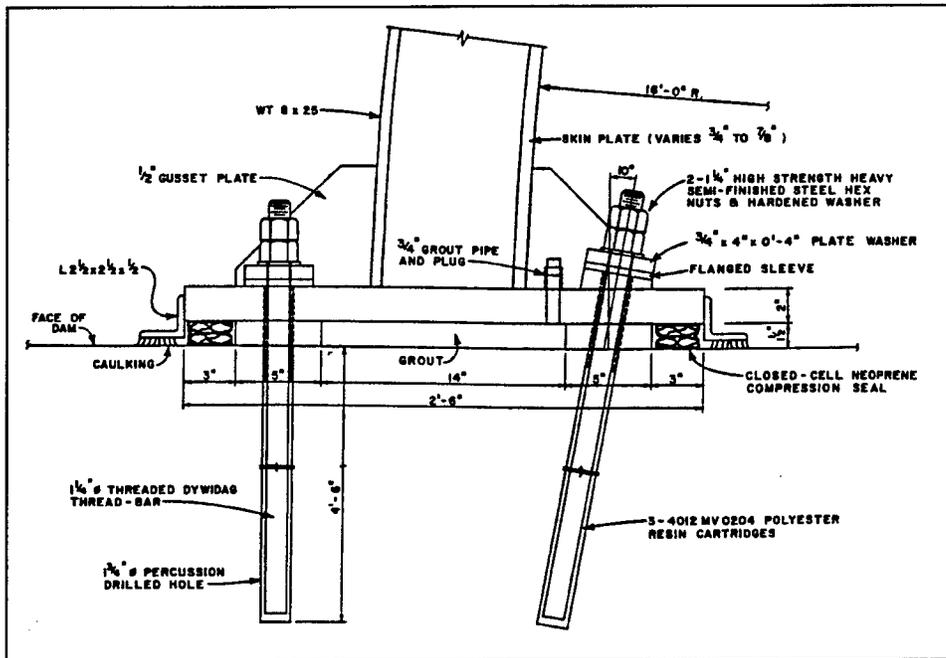
Figure 65. Connection detail for intake at Sutton Dam (from Barnes 1982b)

The foundation and bottom of the structure were formed of concrete, tremied into place. The 136-mg (150-ton) structure of plate-and-rib design was fabricated in three pieces and attached to the face of the dam with high-strength rock bolts (Figure 65). A circumferential concrete fillet was added at the invert in the bottom of the structure to improve flow conditions in accordance with model testing performed at WES. An inlet-with-bulkhead was installed below the top of the structure to permit the passage of water during low lake levels. Finally, the top of the structure was capped with concrete to a depth of 6 m (20 ft). The concrete cap would improve flow, provide support for the trashrack, and provide an aesthetically “finished” appearance (Barnes 1982b).

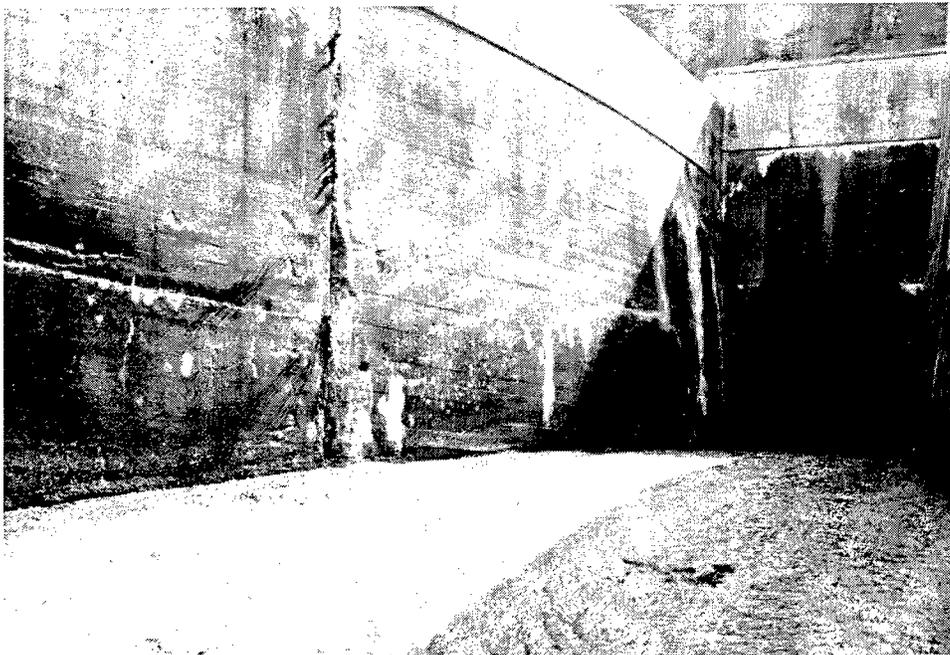
The stilling basin was dewatered for the Fifth Periodic Inspection (Figure 66). All components were in satisfactory condition. A depression from 25 to 51 mm (1 to 2 in.) was found in the center of the basin floor, but no remedial action was planned. Monolith joints in the training walls had slight damage, spalling, and popouts (Figure 67) but none that required repairing.

Figure 67. Spalled area in monolith joint on right basin wall, Tom Jenkins Dam (from U.S. Army Engineer District, Huntington 1990c)

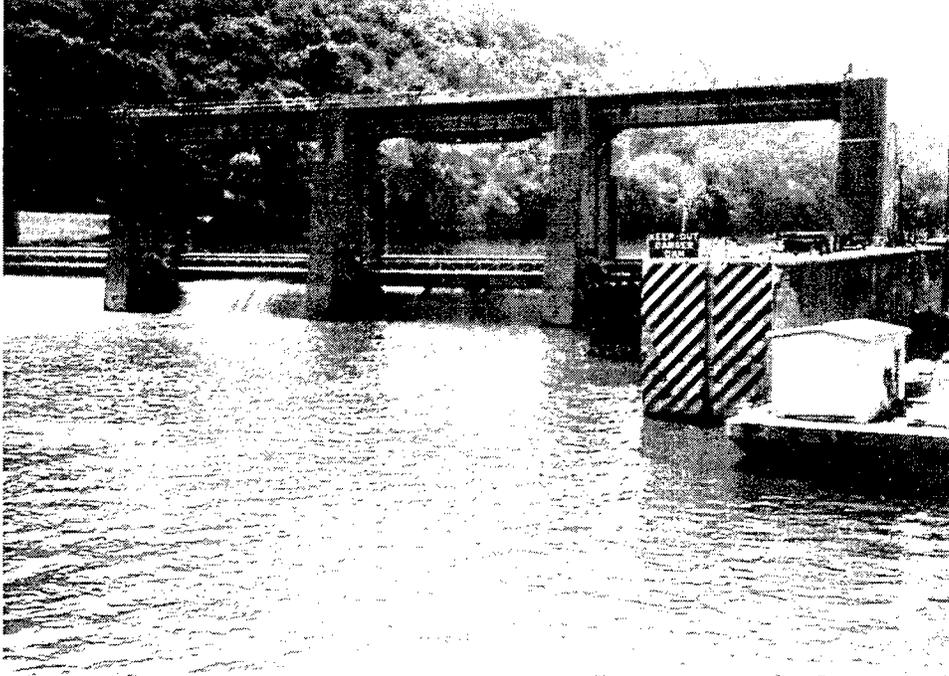
The Seventh Periodic Inspection (USAED, Pittsburgh 1994) found that the condition of the dam and appurtenances was good (Figure 72). Fine, random cracks in refaced areas below the upstream bridge bearings on Piers 5 and 7 have developed; these will be visually monitored by staff and will be sealed as time and funding are available. Corrosion on the top flange of the upstream bridge girder has caused cracking and spalling in the overlying concrete deck slab. The recommendation for these areas is to clean and reseal the expansion joints to eliminate leakage that is causing the corrosion.

Figure 72. Downstream face of Point Marion Dam; end of old land wall is at right (from U.S. Army Engineer District, Pittsburgh 1994)

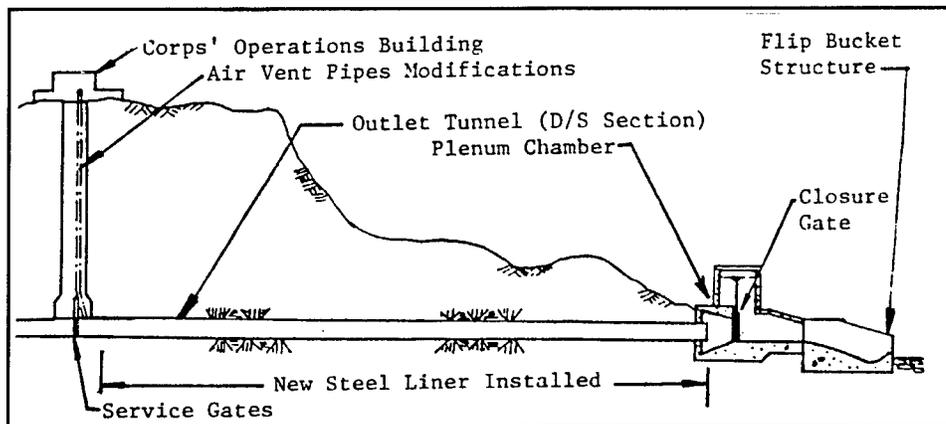
The addition of the hydroelectric power project at the dam required modification of the outlet works so that reservoir releases previously made through the dam outlet works would pass through the hydroelectric facility. During power generation, the entire outlet tunnel had to be pressurized to the existing reservoir water surface. Modifications required to accomplish this task included lining the tunnel with steel, strengthening the air vent pipes to support the additional loadings, and constructing a plenum chamber to connect the hydrofacility penstock to the outlet works (Figure 80). With the completion of these modifications, discharges up to 71 cu m/s (2,507 cu ft/s) are now directed through the hydrofacility; discharges in excess of this amount bring powerhouse shutdown and the return of flow regulation to the USACE.

Figure 80. Plan for outlet works modification at Abiquiu Dam

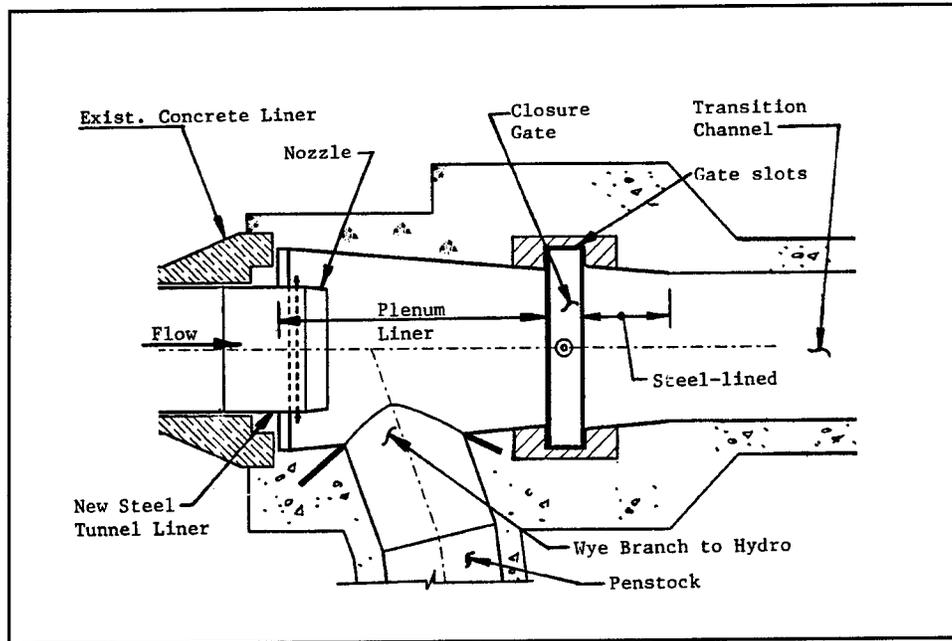
A plenum chamber was installed at the end of the downstream tunnel liner to convey water from the tunnel to the hydrofacility under the power generation mode and to supply a transition from the tunnel to the flip bucket during flood control (Figure 81). Hydraulic model studies of the plenum chamber configuration were conducted in late 1986 at Colorado State University to ensure the design would not create a shape of discharge from the flip-bucket structure significantly different from the discharge that would occur in the outlet works without the plenum chamber addition, would create no significant negative

Figure 81. Plenum chamber at Abiquiu Dam (from Kneitz 1991)

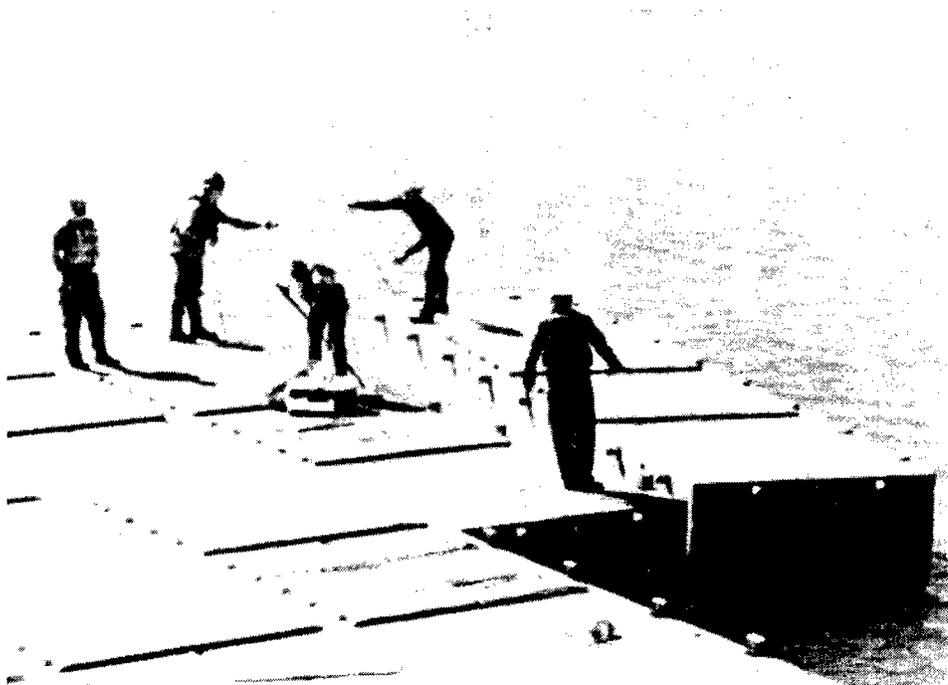
they would seal the intake control structure of the dam. Because of shoreline and intake geometry, a crane operating from land could not be used to maneuver the 9,979-kN (11,000-lb) gates. Instead, a waterborne crane mounted on a Flexifloat barge and a team of divers were contracted from Oceaneering International, Inc., for the project. The 16- by 13.7 by 1.2-m (52.5- by 45- by 3.8-ft) "L"-shaped operations barge was assembled with seven 9.1 by 2.2 by 1.2-m (30- by 7.5-ft by 3.8-ft) Quadra-floats, four 4.6 by 2.3 by 1.2-m (15- by 7.5- by 3.8-ft) Duo-floats, and two 4.6 by 2.3-m (15- by 7.5-ft) loading ramps (Figure 82). The barge was powered to the work site by three Army MK-1 jet boats and anchored on location with cables and buoys.

Figure 82. Flexifloat barge assembly, Abiquiu Dam (from Oceaneering International, Inc. 1991)

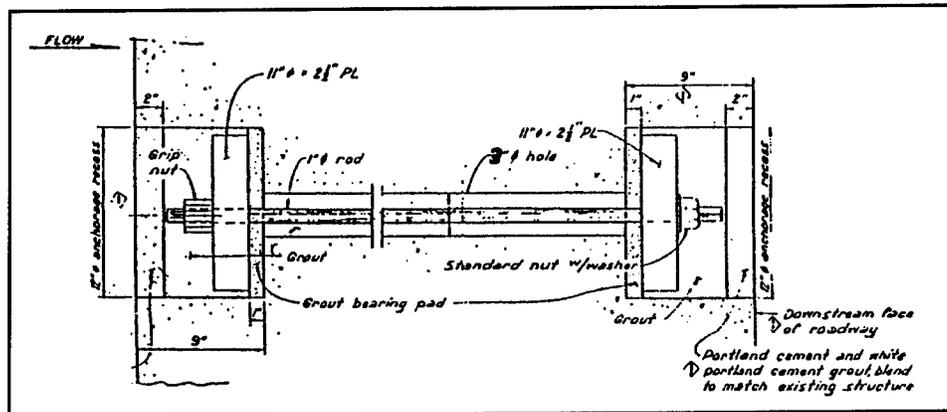
Figure 86. Steel rods used to reinforce cantilever portion of Norfolk Dam (multiply inches by 25.4 to obtain millimetres)

In 1982, the concrete in the roadway on top of the nonoverflow monoliths was reinforced by retrofitting and posttensioning 25-mm- (1-in.-) diam steel rods on 1.8-m (6-ft) centers, transverse to the roadway cracks, in each of 38 monoliths (Figure 86). After installation of stress rods, 76-mm (3-in.) holes were drilled through the top of the dam monoliths and then grouted. The cantilevered portion of the dam roadway was reinforced with special strength 581-mm (2-in.) reinforcing bars. A 152-mm (6-in.) hole was drilled through the 12.2-m (40-ft) roadway of the dam; the reinforcing bar with a threaded end was inserted through the hole and tensioned with 550 MPa (80,000 psi). Nuts on the end of the reinforcing bar were tightened down on steel washers. The hole was grouted with high-strength grout, and the cavity for the nut and washer on each end of the reinforcing bar was concreted over. These reinforcing bars were placed every 6 m (20 ft). In 1983, the roadway cracks were sealed with a nonflexible epoxy. Cost of the repair was \$525,600.

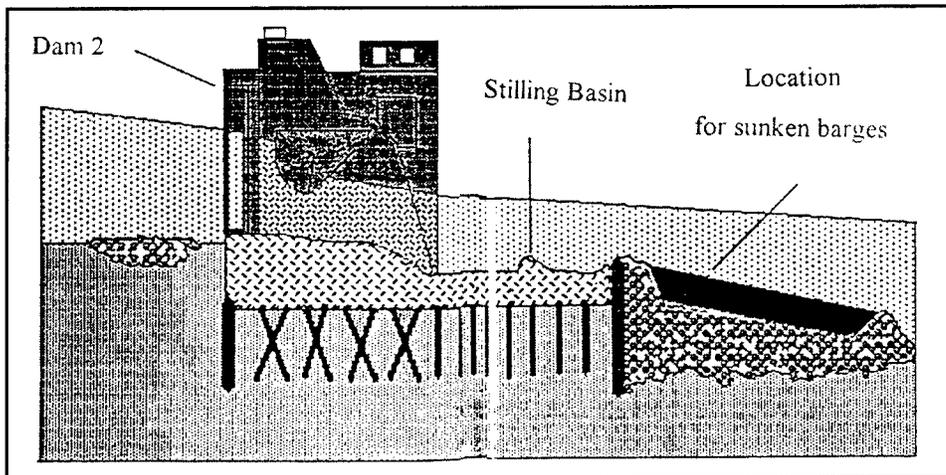
Figure 87. Repair stilling basin at Wilbur D. Mills Dam (from *Construction News* 1992)

In October 1990, work began on a permanent repair to the scour problem downstream of the dam. This repair involved the use of a novel concept (sunken barges filled with riprap) to extend the stilling basin 64 m (210 ft) downstream (Figure 87) (*Construction News* 1992).

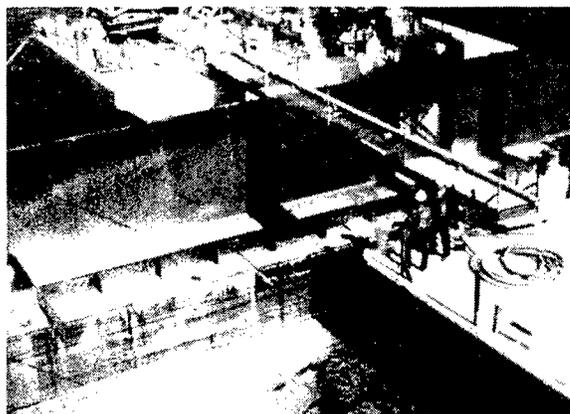
Figure 88. Lay barge with hopper barge positioned for sinking at Wilbur D. Mills Dam (from Spaul and Virden 1992)

Once the riverbed was ready, the lay barge was constructed (Figure 88). Two rake barges were connected with two huge plate girders to form a giant catamaran. Cross-bracing and walkways between the barges were added. The space between the "pontoons" was 13 m (43 ft) wide, to allow positioning of the hopper barge for sinking. The flotation chambers of the hopper barge were filled with 650 cu m (850 cy yd) of concrete for a total weight of 1,451 Mg (1,600 tons). A tow boat then pushed the lay barge

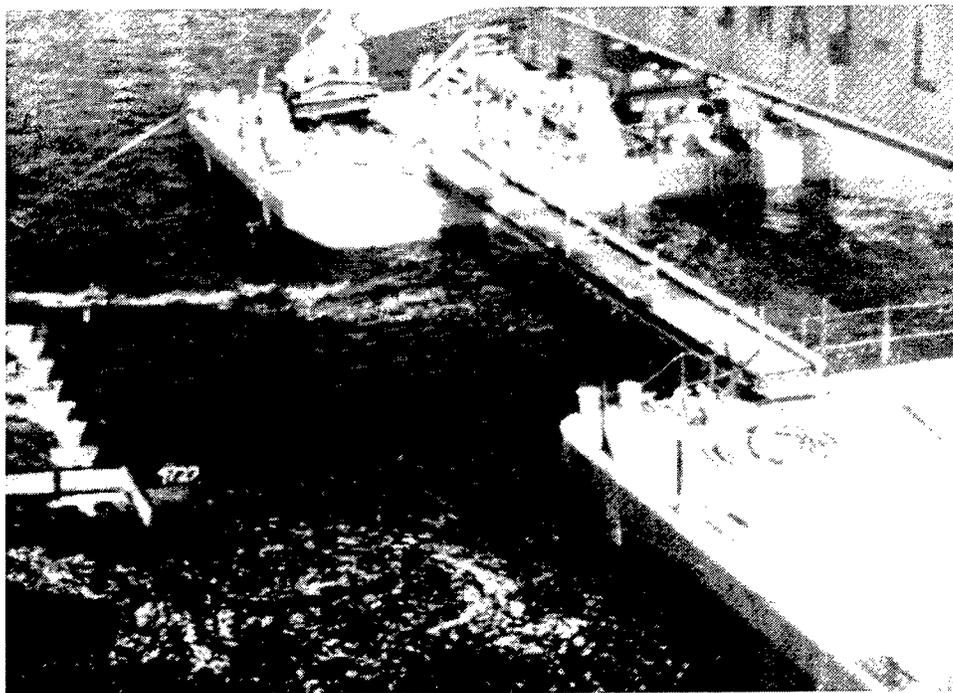
Figure 89. Lay barge with a flooded hopper barge being lowered to the river bed at Wilbur D. Mills Dam (from Spaul and Virden 1992)

into position below the dam. Anchor lines were moored to piles downstream of the dam and to the stern and bow of the lay barge. These lines were used to adjust the position of the hopper barge. When it was in the correct position, the hopper barge was sunk to the river bottom; the back of the barge was lowered so water could flood the cargo hole (Figure 89). The barge was then lowered to the bottom by four winches with 32-mm (1-1/4-in.) cables.

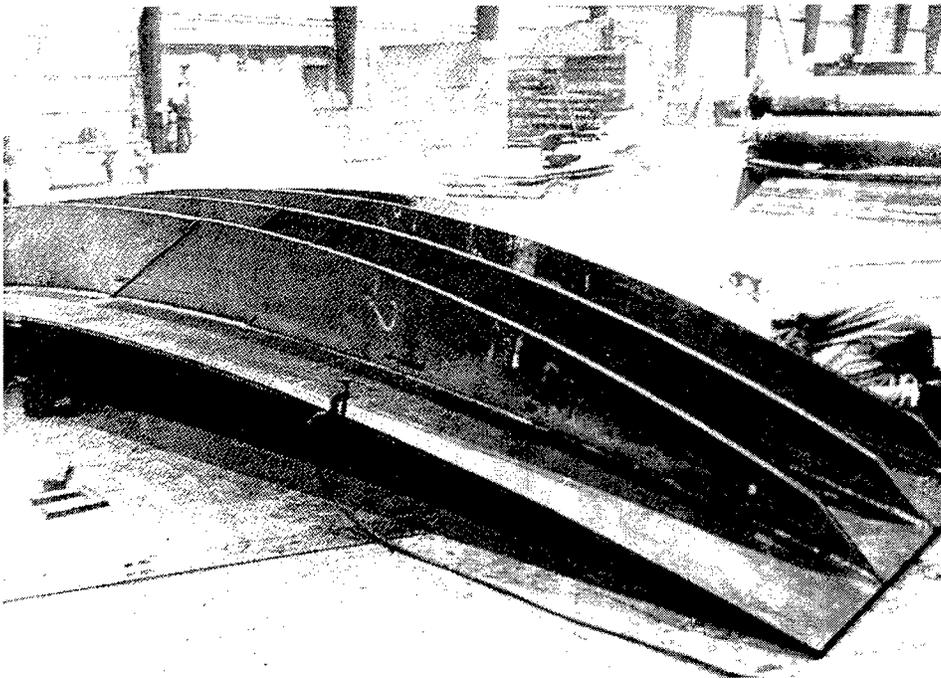
Alkali-aggregate reaction caused the expansion of the concrete at the outermost piers of the downstream face of the dam (Figure 90). The expansion caused binding of the drum gates, thus affecting operation of the dam.

Figure 91. Fabrication of Obermeyer Pneumatic Spillway Gates for installation  
at Friant Dam (from *Hydro Power and Dam* 1997)

The Obermeyer Pneumatic Spillway Gate System planned for installation at Friant Dam was being designed to match the curvature of the existing lowered drum gates (Figure 91). The project was scheduled to be completed in February 1998.

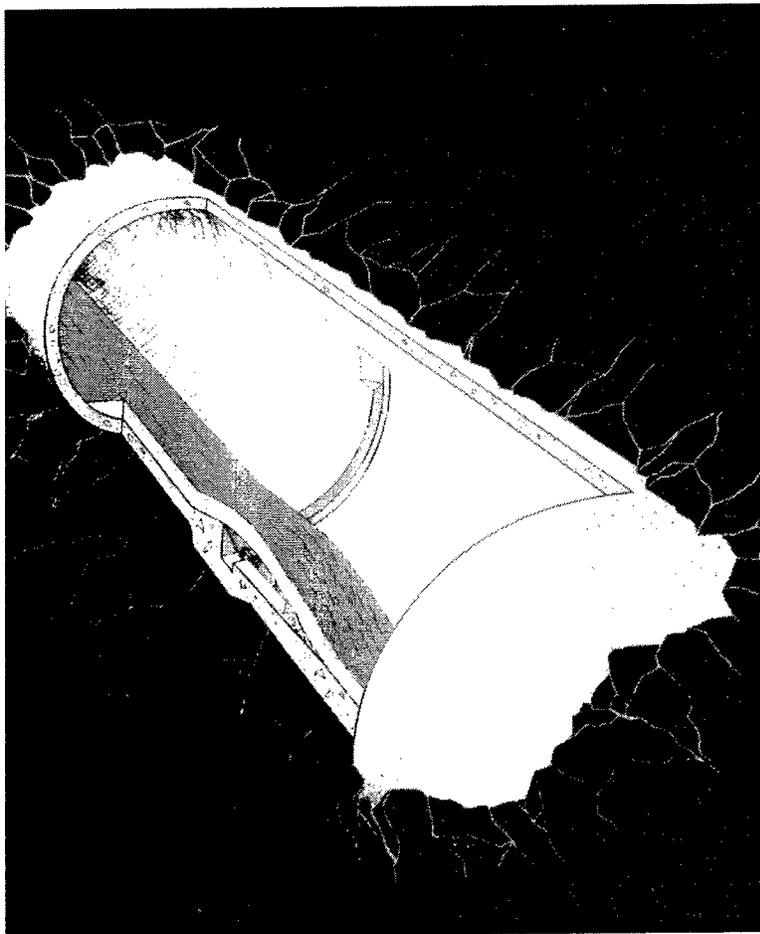
Figure 95. Aeration slot, Glen Canyon Dam (from Burgi and Eckley 1987)

The aeration-slot design for Glen Canyon Dam consists of a short length of ramp that lifts the flowing water over the air supply slot to prevent the slot from filling with water (Figure 95). The slot, which is 1.2 by 1.2 m (4 by 4 ft) in cross section, extends around the lower three-quarters of the tunnel. It is located on the 0.96 radians (55 deg) incline approximately 45.7 m (150 ft) above the start of the elbow and just below the 178-mm- (7-in.-) high ramp. The ramp is designed to create a low-pressure zone under the water jet which draws air into both sides of the slot from the tunnel above the water surface. The air drawn under the water jet is concentrated in the lower surface of the jet nappe and flows along the boundary through the elbow.

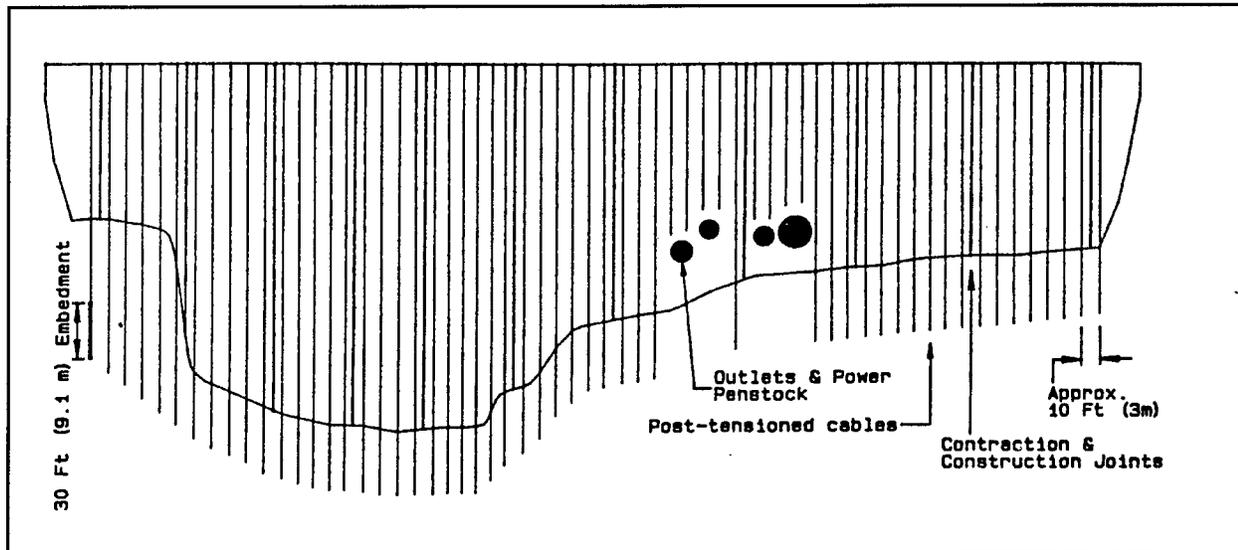
Figure 97. Profile Stewart Mountain Dam, showing locations of posttensioned tendons (from Nuss and Fielder 1988)

The installation of posttensioned cables was judged to be the least expensive, most viable solution for stabilizing the arch dam. Sixty-two tendons with free lengths ranging up to 65.8 m (216 ft) and bond lengths in the foundation from 9 to 13.7 m (30 to 45-ft) were installed on approximately 2.7-m (9-ft) centers (Figure 97). Each arched tendon was made up of 22 (152-mm- (0.6-in.-) diam)

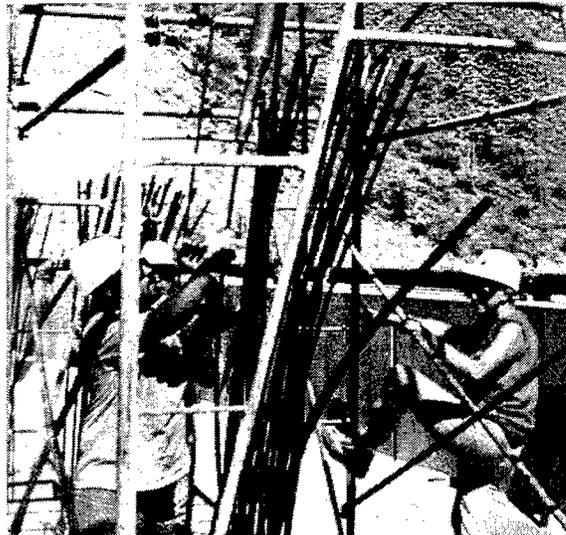
epoxy-coated strands (Figure 98). Design working loads averaged approximately 2,958 kN (665 kips), the equivalent of about 50 percent guaranteed ultimate tensile strength (GUTS).

Figure 98. Arched tendons used to stabilize Stewart Mountain Dam (from Bruce, Fielder, and Triplett 1991)

The curved thin arch shape of the dam required precise positioning of the posttensioned cables (inclination varied from vertical to 0.15 radians (8 deg, 40 min) from vertical). Square recesses (1.4 by 0.6 m (4-ft, 9-in. by 2-ft) deep) were formed in the dam crest. At precise locations, bearing and inclination, a 305-mm- (12-in.-) diam hole was drilled about 1.5 m (5 ft) deep. A 254-mm- (10-in.-) diam steel guide tube was then surveyed and cemented into this hole to ensure the anchor-hole drilling

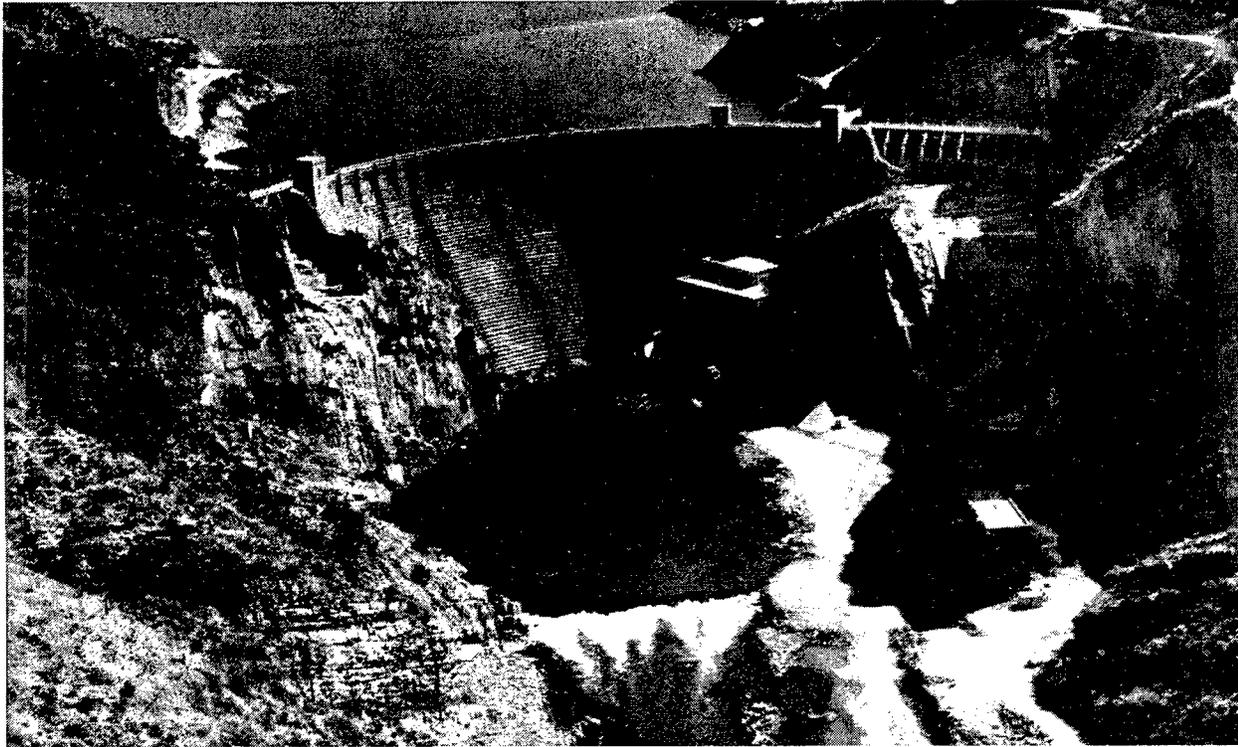
Figure 99. Theodore Roosevelt Dam prior to rehabilitation (from Quint and Fielder 1989)

In 1978, during investigations for the Federal Safety of Dams Act, Roosevelt Dam, which impounds Roosevelt Lake, was identified as a high-hazard dam in need of modifications. According to revised PMF figures (a peak inflow of 18,500 cms (654,000 cfs) and a volume of 7 billion cu m (3 million acre-ft) during a 16-day period), Roosevelt Dam would be overtopped, causing a loss of the spillways and the power plant and possibly causing failure of the three dams downstream. The loss of these dams would probably result in loss of life as well as extensive damage, including flooding in Phoenix. In addition, revised maximum credible earthquake (MCE) figures indicated Roosevelt Dam could fail in the event of an MCE. If the dam did not fail but suffered significant cracking, the low-level outlets were not adequate to empty the 1.6 billion-cu m (1.3 million-acre-ft) Roosevelt Lake in an emergency (Hepler and Drake 1995).

**Modification plan to raise and strengthen dam.** BuRec's recommendations for modifying Theodore Roosevelt Dam were approved by Congress in 1984. Work on the project began in 1989. Modifications included raising the height of the dam from 23.5 to 109 m (77 ft to 357 ft) and increasing the length to 369 m (1,210 ft). This increase in the size of the dam increased storage capacity to 1.97 billion cu m (1.6 million acre-ft). The dam's capacity to hold floodwater was increased to 2.2 billion cu m (1.8 million acre-ft). A new river outlet works was added to provide for a more efficient emptying of the reservoir

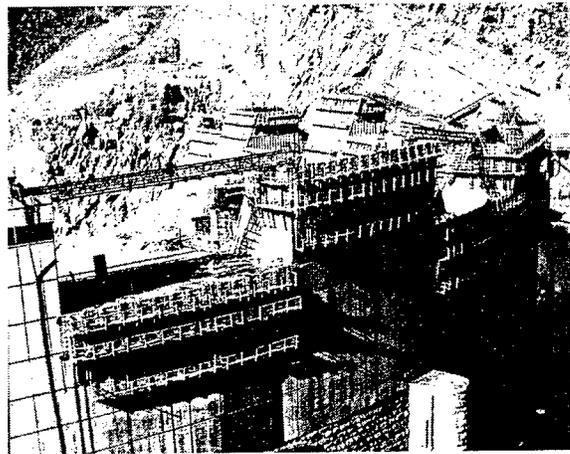
Figure 100. Alternating cantilevered placement of mass concrete blocks at Theodore Roosevelt Dam (from Balogh 1996)

Basing their decision on finite element and thermal analyses, BuRec engineers decided to use a single-curvature arch design and to use mass concrete placed in 3-m- (10-ft-) high, 21.3-m- (70-ft-) wide blocks that ranged in thickness from 13 to 15.2 m (10 to 50 ft) to raise and thicken Roosevelt Dam. The blocks were placed in alternating cantilevers (Figure 100). Also, mass concrete was used for the two large thrust blocks constructed on the right and left dam abutments to transfer arch loads from the dam into the foundation.

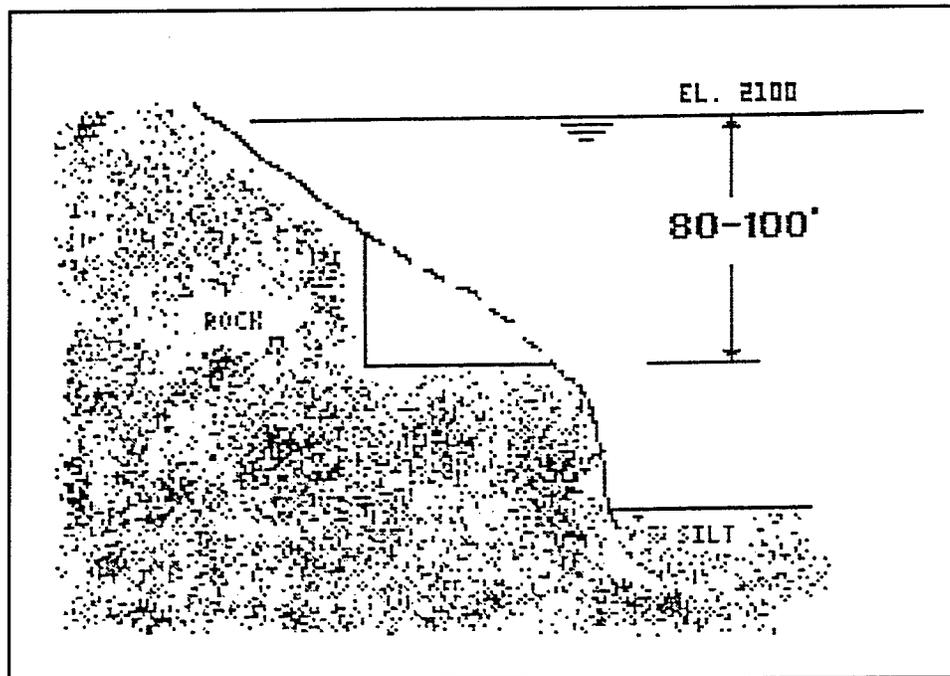
Figure 101. Bench excavation for Theodore Roosevelt Dam lake tap

To effect this construction, a lake tap was needed. Instead of a conventional uncontrolled lake tap, BuRec engineers designed a completely controlled tap for Roosevelt Dam. To construct the lake tap, workers excavated a horizontal bench (Figure 101) and a 6-m- (20-ft-) diam vertical shaft underwater. A drill mounted on a barge was used to drill the 18-m (60-ft) bench about 30 m (100 ft) underwater. A 22.6-m- (74-ft-) long template with a sonar mounted on it was used to position the drill. Information from the sonar was displayed on a cathode ray tube (CRT) with a gridded screen that showed the drill operator where to place the drill. Also, divers and a remote operated submarine with a camera monitored the work. Cuttings from the bench were sucked up an air lift, screened, and returned to the lake in a return pipe (Beall 1991).

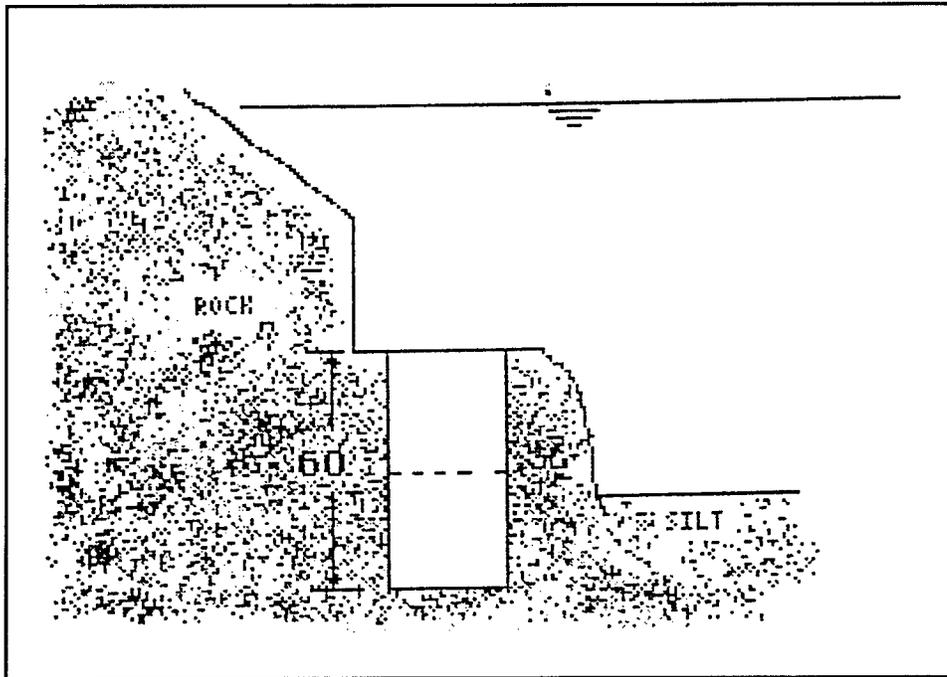
Figure 102. Inlet tube shaft at Theodore Roosevelt Dam

Once the bench was completed, the template was cut and reformed and used for the inlet tube shaft, which was excavated in a horseshoe shape to accommodate the 1.6-radian (90-deg) angle in the inlet tube (Figure 102). The steel inlet tube was floated out to the site and inserted in the completed shaft. The inlet tube was grouted into place with tremie concrete (Figure 103). Specifications for the tremie concrete called for a 27.6 MPa (4,000-psi) compressive strength. The mixture contained 25-mm (1-in.) aggregate and a plasticizer. The ROW tunnel is 200.6 m (658 ft) long with a 4.9-m (16-ft) finished diam. Reinforced concrete was used to line the section of the ROW upstream of the gate chamber, and the cross section downstream of the bifurcation structure is lined with steel and reinforced concrete. After the inlet tube was installed, capped with a bulkhead, and dewatered, the remainder of the ROW was mined along the pilot tunnel to the inlet and from the gate shaft to the outlet. Then the 108.2-m- (355-ft-) long, 3.8-m- (12.5-ft-) diam power penstock tunnel was constructed, the

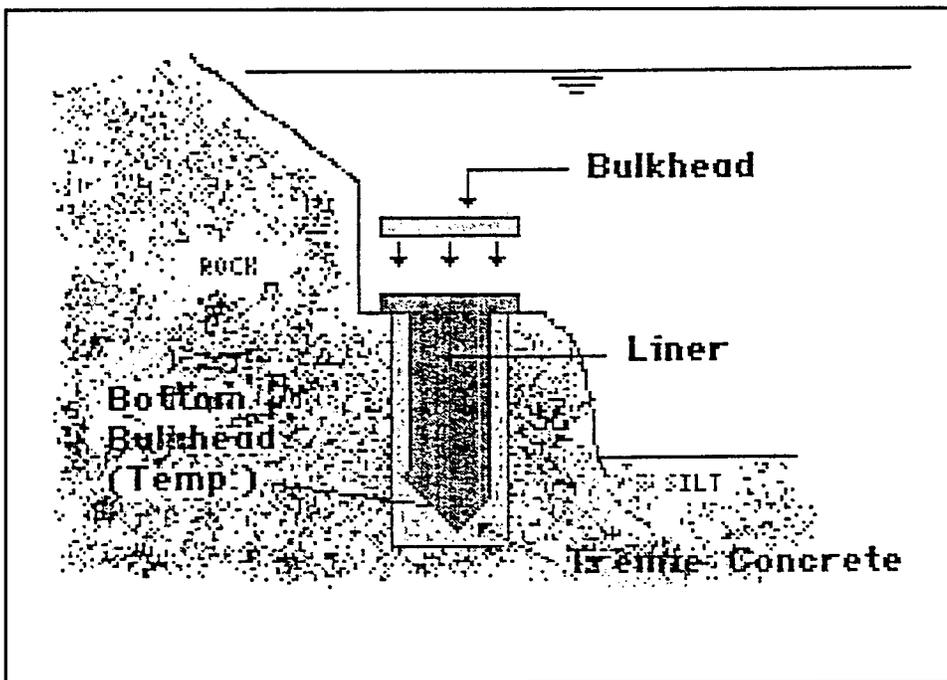
Figure 103. Inlet tub placement with tremie concrete at Theodore Roosevelt Dam

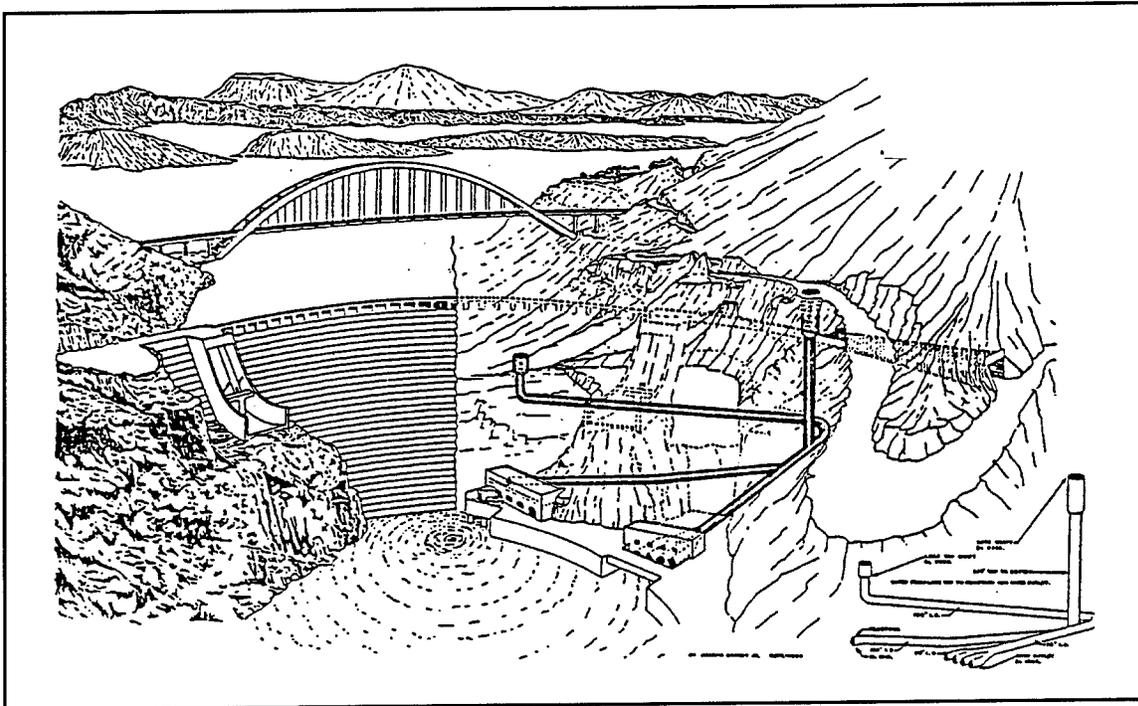
Figure 104. Penstock tunnel installed at Theodore Roosevelt Dam

gate was installed in the gate shaft, and alterations were made to the power plant (Figure 104). The original 49,500-horse-power (hp) turbine was replaced with a new, smaller turbine having the same capacity and capable of operating at the new higher reservoir heads (Beall 1991).

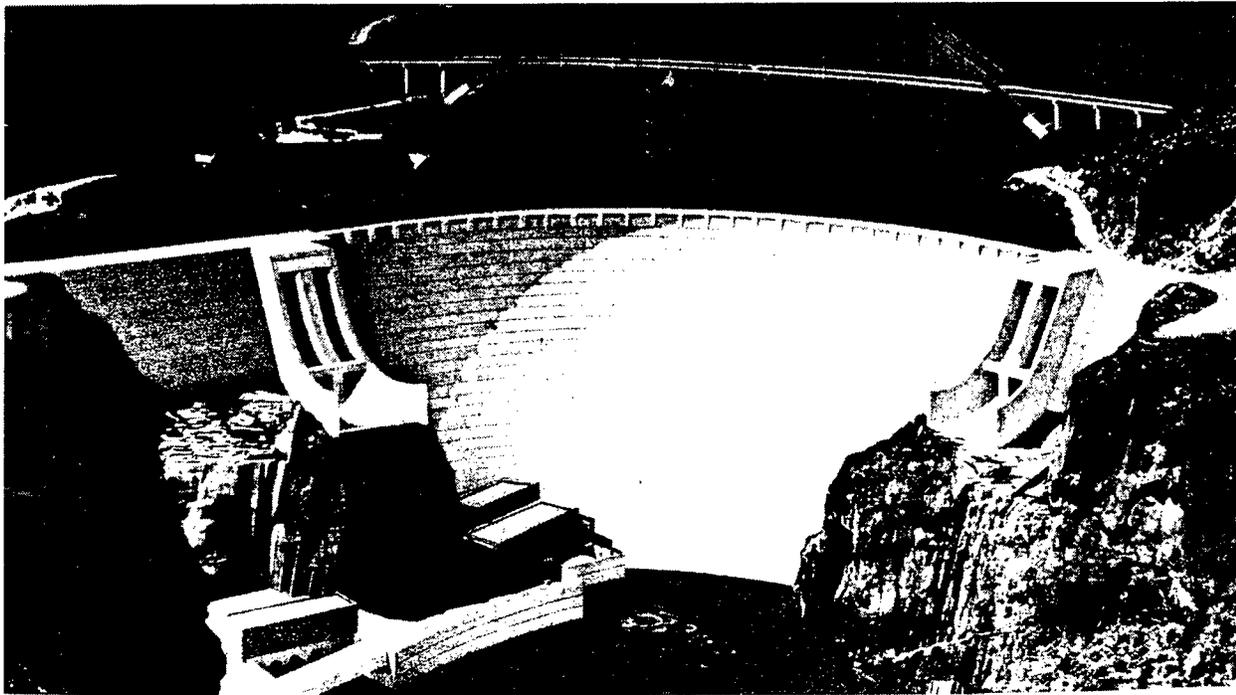
Figure 105. Modifications performed at Theodore Roosevelt Dam

Once the concrete overlay was installed, exposed concrete surfaces were cleaned and stained so they would more closely match the surrounding rock. Figure 105 provides an overall view of the modifications to the structure.

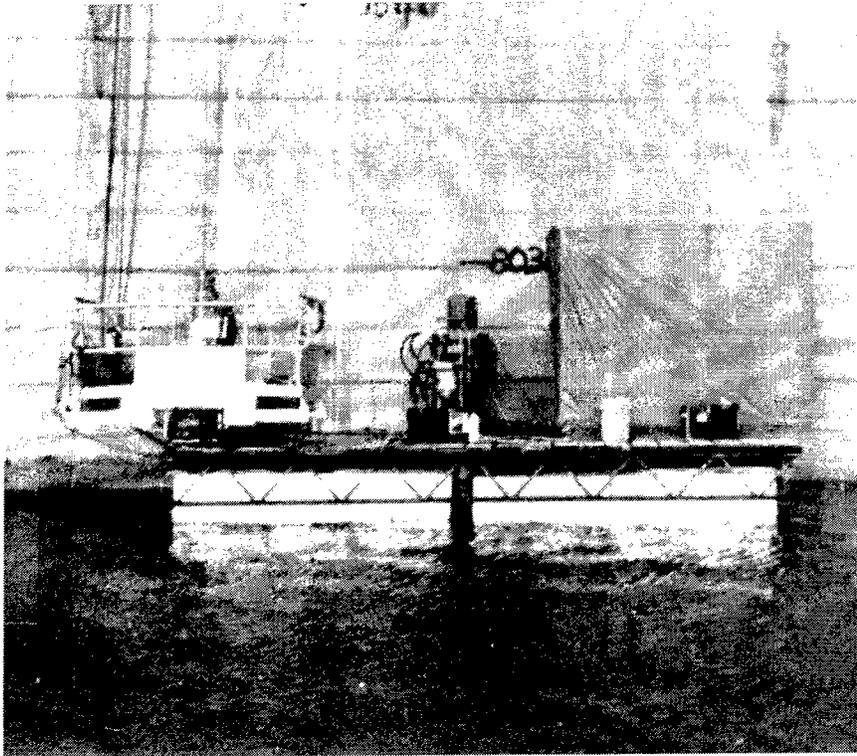
Figure 109. Work platform used at Upper Stillwater Dam (from Smoak 1991)

The third stage of the injection involved sealing the crack on the upstream face of the dam above the drawn-down water level. A floating barge and a spider platform suspended from the top of the dam were used as work platforms during the drilling and injection procedures (Figure 109). Crack intercept holes were drilled 305 to 610 mm (12 to 24 in.) apart on alternate sides of the crack and angled so they would intercept the crack about 0.6 m (2 ft) from the upstream face. Wall spears were installed and then the holes were pressure injected with resin. Workers started at the lowest injection hole and moved up the crack to the top of the dam. Resin volumes were calculated to permit injection of a zone approximately 3 m (10 ft) into the dam; however, in some instances, miscalculations resulted in the resin penetrating the entire section and coming out on the downstream face. A 1:1 water-to-resin ratio was used for the crack at these elevations. Check holes were used to determine whether the crack was sealed.

A similar procedure was used to seal the smaller cracks in the dam. After the repair of the cracks, and at full reservoir, no measurable leakage was detected at any of the smaller cracks. The leakage at the largest crack was reduced from 11,700  $\ell$ pm (3,100 gpm) to less than 3,030  $\ell$ pm (800 gpm).

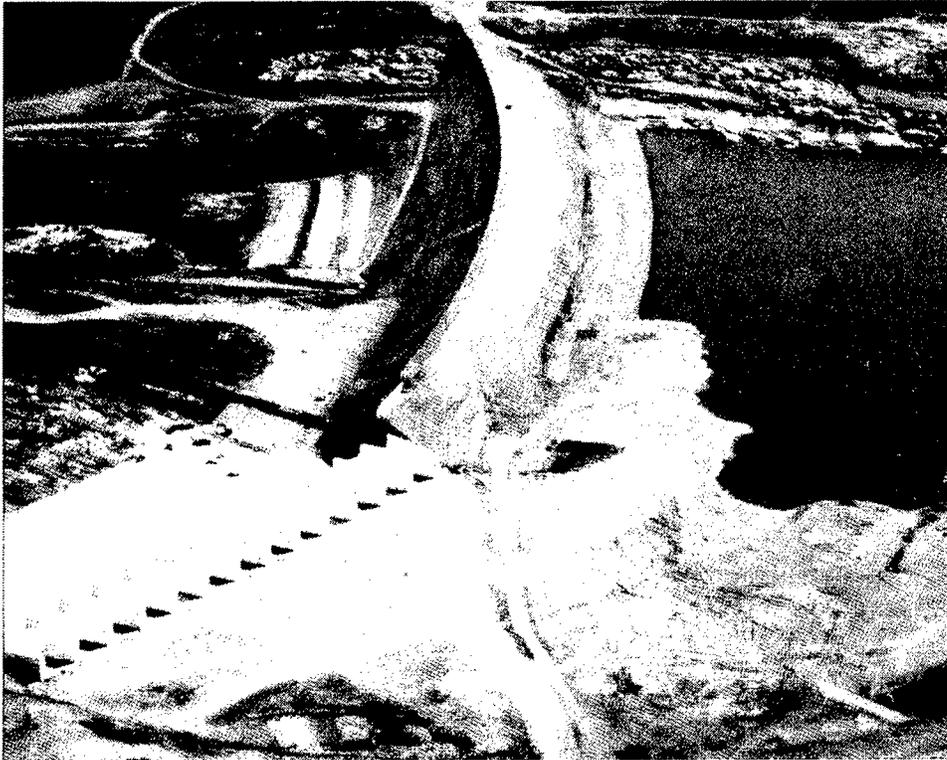
Figure 110. Ute Dam with completed labyrinth spillway (from Parrett 1986)

Discharge flowing over the labyrinth spillway increases in direct proportion to crest length; however, hydraulic model tests show that when hydraulic head increases, discharge efficiency decreases. Piers were placed along the spillway crest at Ute Dam to split the flow and allow air to enter under the flow nappe; the split flow reduces oscillation in atmospheric pressure and noise produced when the spillway is operated under low hydraulic head (Parrett 1986). The completed labyrinth spillway is shown in Figure 110.

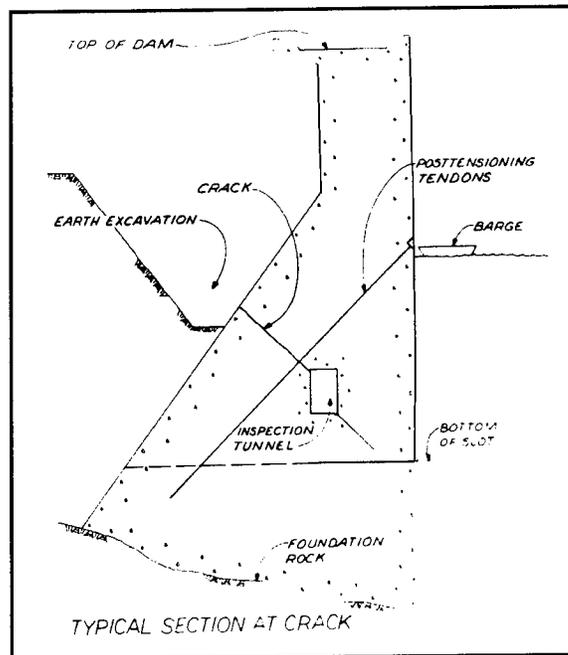
Figure 111. Crack repair with posttensioning tendons at Fontana Dam (from *TVA Today* 1976)

When the crack was discovered, TVA took action immediately to ensure the integrity of the dam. One of the first measures taken was to "stitch up" or posttension the crack (Figure 111). The work was performed from a barge on the lake face of the dam. Holes were percussion drilled into the dam on a diagonal that crossed the crack and went far enough past it to provide grouted anchorage for the tendons. Hole depths for adjacent tendons were varied to prevent a concentration of anchorage zone loads. The posttensioning cables were inserted in the holes. A total of 25 tendons were used in the three most affected blocks, which included the two curved blocks. Each tendon consisted of 90 wires, each 6.4 mm (1/4-in.) in diam. Initially the tendons were posttensioned to 20 percent of their ultimate strength. The grouting served the dual purpose of restoring shear resistance along the plane of the crack and preventing possible movement of the blocks during cable tensioning. The stitching was completed in September 1973 and will be a part of the permanent repair. However, while the posttensioning was in progress, TVA engineers learned through instrumentation that the crack might still be growing. As an interim measure, they installed a pipe system to spray cold reservoir water onto the downstream face. The beneficial efforts of this spraying were quickly apparent, as the rate of crack opening diminished significantly within a few days after the spraying began.

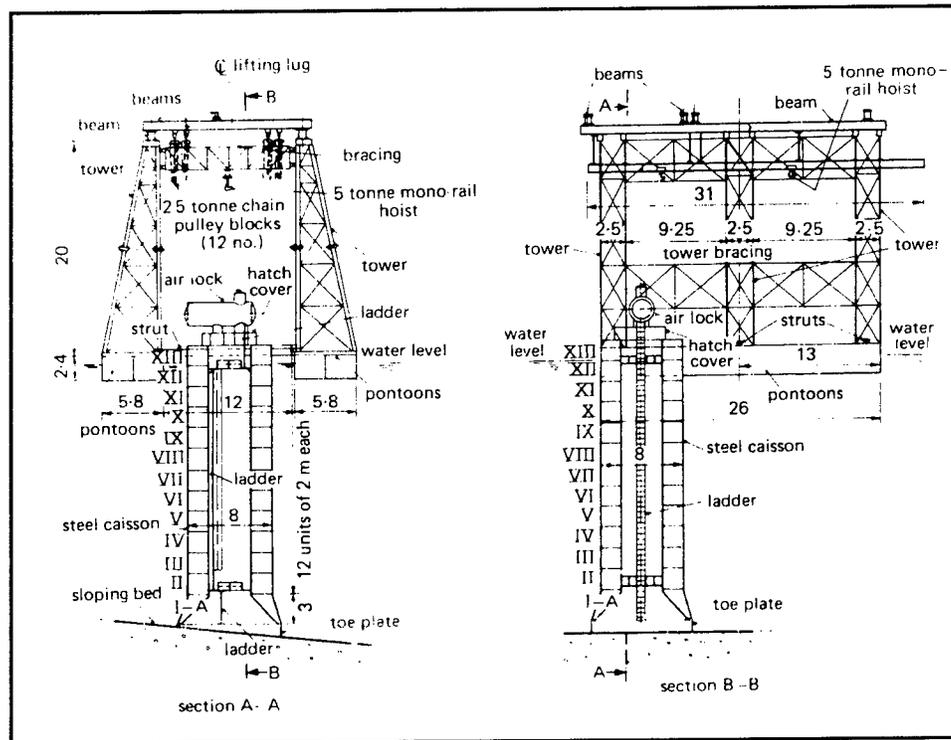
Figure 112. Design of pneumatic caisson and the sinking set used at Bhakra Dam (from Malholtra et al. 1987)

The solution was to construct a 26-m (85-ft-) high steel caisson that could be used to dewater the repair area and then use conventional concrete repair methods in the near-dry area. The square double-walled caisson consisted of 12 upper units and a bottom unit containing two sections. A toe plate on the bottom section maintained the vertical position of the caisson when repairs were made to sloping surfaces. The 4- by 4-m (13.1- by 13.1-ft) center hole had a

double hatch cover for an air lock and was used to regulate the passing of men and materials. The bottom section area was increased to provide a 9.5- by 9.5-m (31-by 31-ft) working area. The air lock consisted of a compression and decompression chamber. The primary air compressor supplied air at a rate of 78 cu m/min (2,750 cu ft/min) and was capable of running continuously for 10 to 15 days. A standby air compressor had a capacity of 21 cu m/min (740 cu ft/min) (Figure 112).

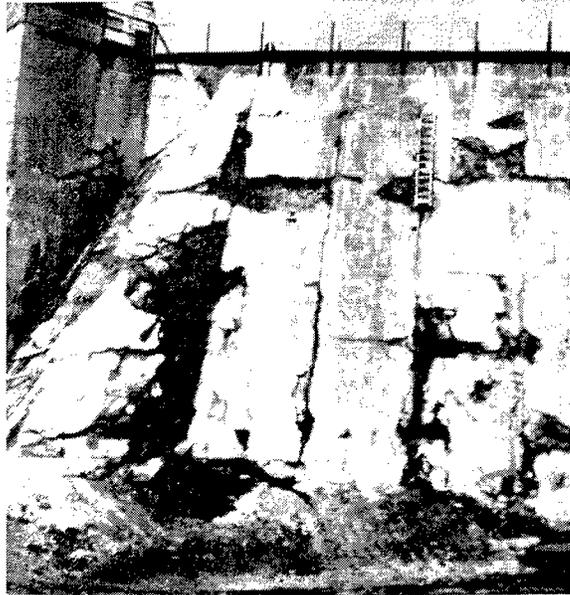
Since its construction, Big Eddy Dam has suffered severe visible deterioration of the concrete and has experienced extensive seepage of water throughout the dam. A variety of repair methods was tried; all failed to halt the concrete deterioration and the seepage. The failure of a shotcrete repair of the downstream face is shown in Figure 114.

In 1974, International Nickel Company, owner of the dam, initiated an investigation to determine the cause of the major problems at the dam. A visual inspection and testing of cores taken from the east wing wall were accomplished. The main causes of deterioration were identified as cycles of freezing and thawing and alkali-aggregate reaction. Further investigation in 1975 indicated a need for a comprehensive study of the dam. Gore and Bickley (1987) reported the investigation and subsequent remedial steps taken. This case history is a summary of their report.

Figure 114. Deteriorated shotcrete repair on the downstream face of Big Eddy Dam (from Gore and Bickley 1987)
