**US Army Corps  
of Engineers**  
Engineer Research and  
Development Center

Technical Report REMR-CS-63  
September 1999

## **Repair and Rehabilitation of Dams: Case Studies**

*by James E. McDonald, Nancy F. Curtis*

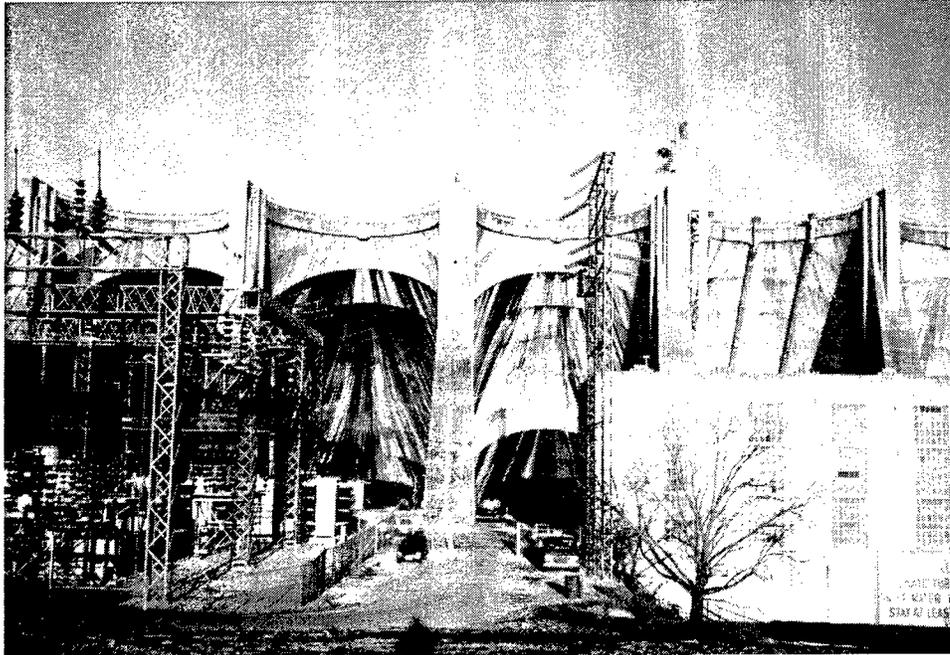
Figure 115. Downstream view of Lake Buchanan Dam

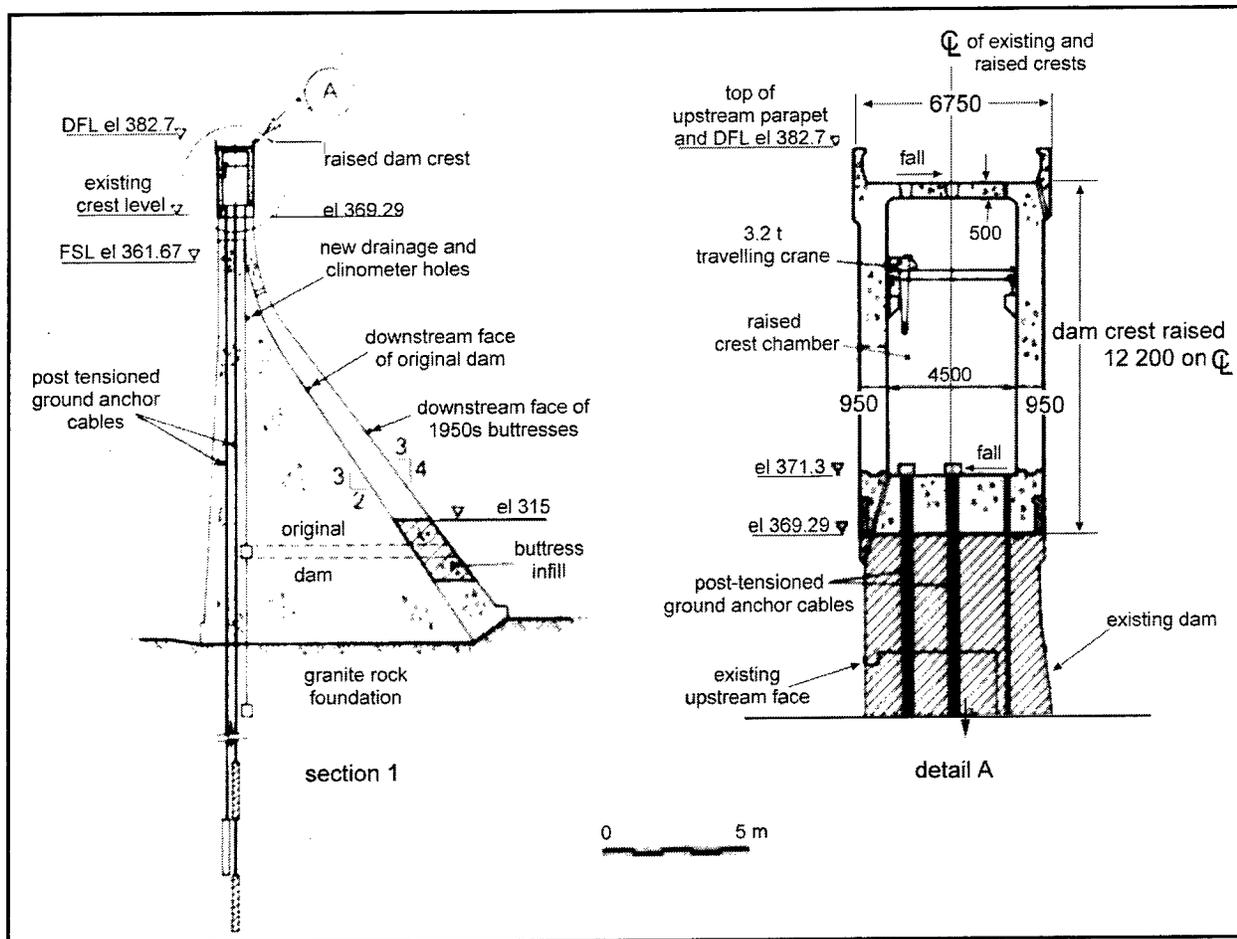
Figure 118. Section through Burrinjuck Dam, showing details of raising height of dam 12.2 m (40 ft)

In 1990, work began on a project to increase the height of the dam by 12.2 m (40 ft). An open reinforced-concrete chamber was constructed at the existing crest level of the dam, and the dam was stabilized with posttensioned ground anchor cables (Figure 118). During high flood levels, the chamber fills with water, thus providing additional stability. Two rows of posttensioned ground anchors provide a stabilizing force of 14,200 kN/m (5,240 tons/ft) for the dam. The anchor cables, each consisting of 63 strands (15.2-mm- (0.6-in-) diam) were placed on 1.5-m (5-ft) centers. To provide corrosion protection, strands were encapsulated in grease-filled polyethylene tubes above the anchorage zone, and cables in the anchorage zone and the free length of cable were installed in a single-stage grouting operation. Type G oil well cement was specified for the grout; it produced a high-strength, low-shrinkage, and low-bleed mixture. Cable load is monitored, and the anchors can be restressed if necessary.

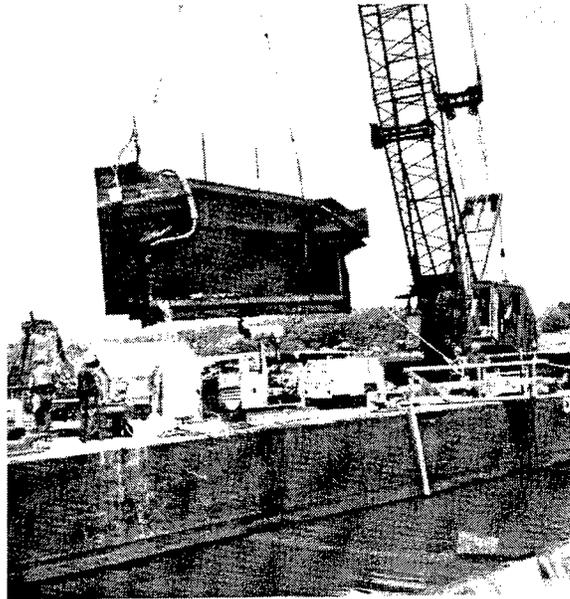
Figure 120. Portable cofferdam used upstream at Crescent Dams (from Sumner, Nash, and Haag 1991)

Structural repairs made to the dam faces followed two underwater inspections: the first inspection gave a basis for bidding while the second (an underwater video inspection) aided the contractor in identifying specific areas to be dewatered and repaired. Portable cofferdams were fabricated and assembled onsite to dewater repair areas. On the upstream side of the dam, all repairs were within 1.5 m (5 ft) from the crest. The 1.2-m-wide by 1.7-m-deep (4-ft-wide by 5-1/2-ft-) deep by 90-m- (30-ft-) long cofferdams used in this area were fabricated to match dam contours (Figure 120). Cofferdams used to dewater the downstream toe and apron sections were 7.6 m (25 ft) wide by 4.3 m (14 ft) deep by 9 m (30 ft) long.

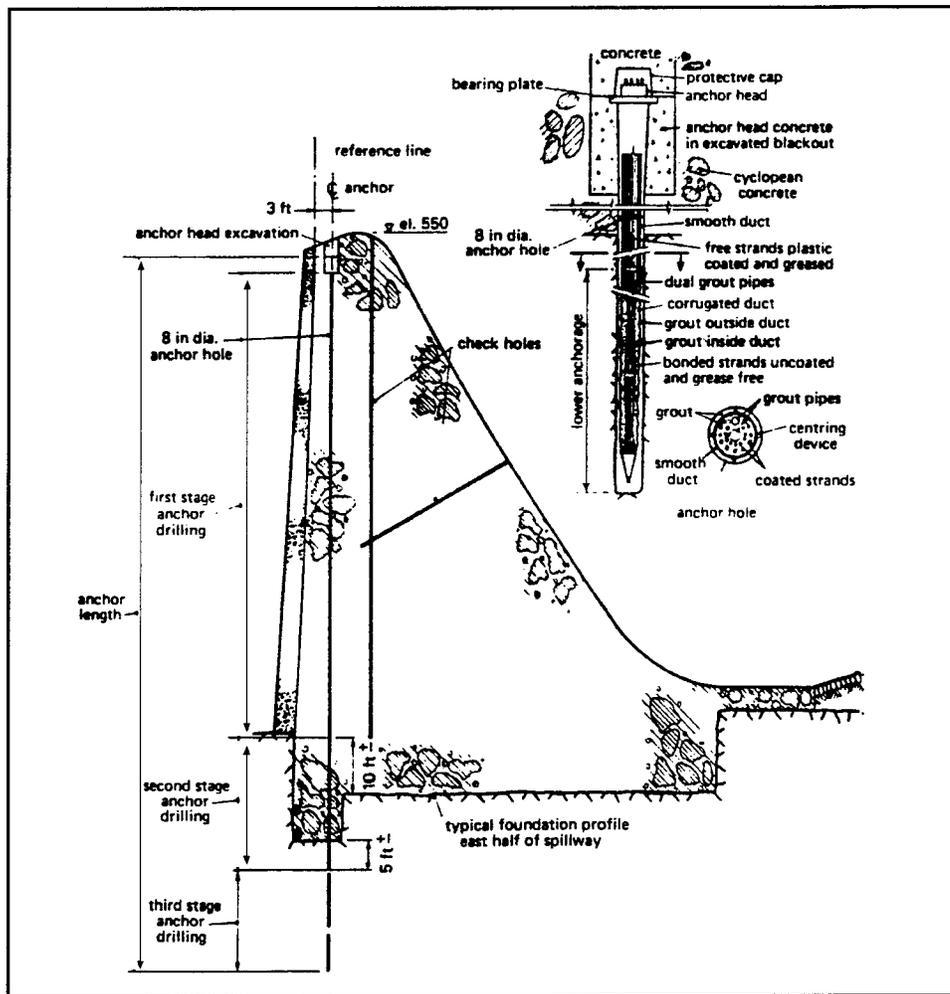
Figure 123. Details for installation of posttensioning anchors at Delta Dam (from Standig 1984)

The system of posttensioned anchors included 93 anchors on 1.8-m (6-ft) centers in the spillway section, where the greatest strengthening was needed, and on 4.6-m (15-ft) centers in the abutment areas. The steel strands specified for the anchors had a guaranteed ultimate tensile strength (GUTS) of 186 kN/sq cm (270 ksi). The design load of each anchor was based on 60 percent GUTS of the material but was actually locked off at 70 percent GUTS to account for losses from creep in the rock and relaxation of the steel strands. Each anchor was stressed to a proof load of 80 percent GUTS during installation to ensure that the lower anchorage could transfer the load to the rock. The strands were installed with double corrosion protection consisting of a plastic duct and grouting. The grouting system included simultaneous tremie-placement of grout both between the strand and casing and the casing and anchor hole. Anchor embedment depth ensured resistance of the lower anchorage to applied upward pull. In the free length of the anchor, the smooth duct and a grease and plastic coating on the strands kept the strands from bonding to the grout. Figure 123 shows the anchor detail.

Each anchor hole was drilled in three stages: the first stage to within 3 m (10 ft) of the concrete rock interface; the second stage to 1.5 m (5 ft) below the interface; the third stage to the final anchor depth. Water-pressure tests performed after each stage of drilling identified the region of water loss. When drilling was completed, anchor holes that failed the watertightness specification were tremied with Portland cement grout. A thin mixture was used for small cracks and a thicker mixture for large voids. Grouted anchor holes were redrilled and retested to the same watertightness specification. Small-diameter check holes were drilled into the dam and pressure tested to determine the effectiveness of the grouting of the anchor holes. These check holes were then grouted.

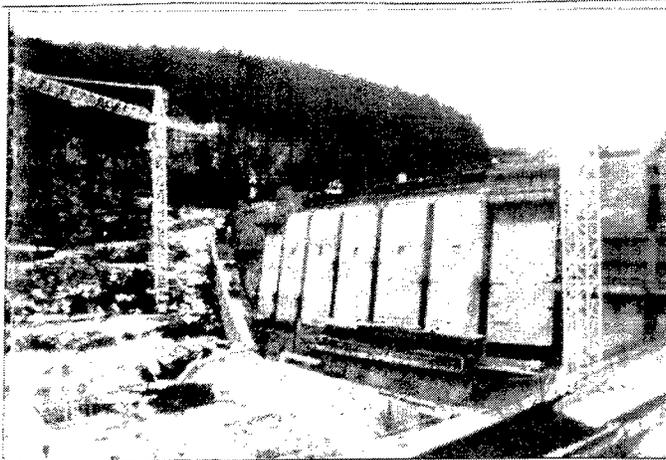
Figure 124. Permeability control with Zemdrain liner used at Fuelbecke Dam (from *Water Power and Dam Construction* 1991a)

Zemdrain is a permeable, 0.7-mm- (0.028-in.-) thick, 100 percent thermally bonded polypropylene fabric that allows air and water to enter its matrix but not cement particles. Natural hydrostatic head within the wet concrete along with internal vibration cause the air and water to pass through the liner (Figure 124).

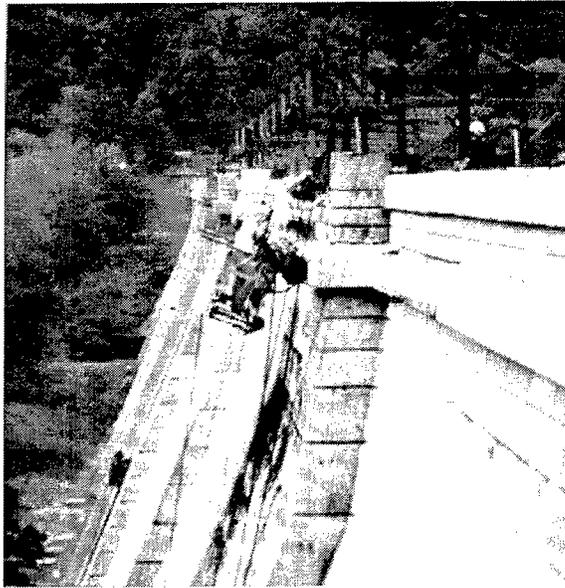
Figure 126. Power-operated cradles used for making repairs to downstream face of Haweswater Dam (from Fosroc Focus 1990)

Work was performed from power-operated cradles (Figure 126). Repair areas were first cleaned with air chisels, high-pressure water jets between 27.6 and 41.4 MPa (4,000 and 6,000 psi), and sand blasting. These methods enabled workers to remove spalling to depths of 100 mm (4 in.). The repair-mortar was mixed with water in a forced-action mixer and applied by

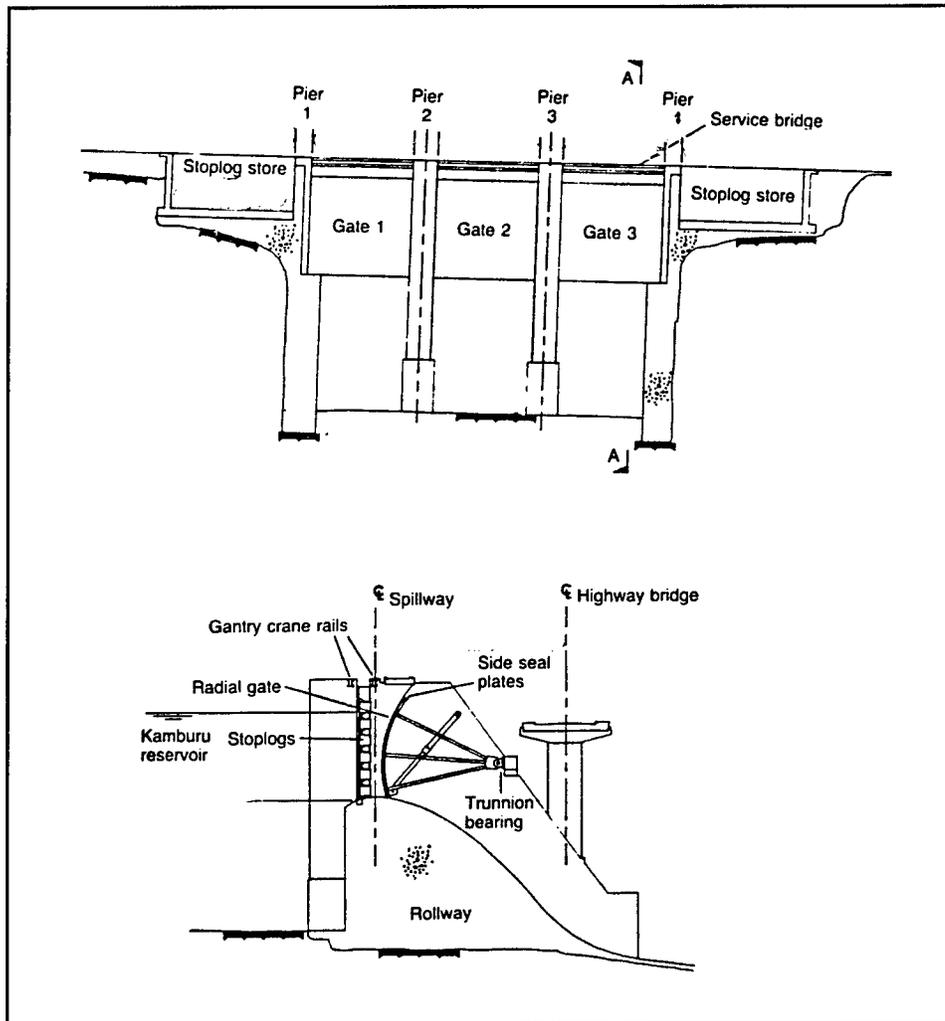
In 1982, eight years after the construction of the spillway, relative movement was observed between Pier 1 and the adjacent stoplog store. This movement was monitored for 3 years until, in 1985, it was found that Pier 1 had deformed into the gate opening to such an extent that gate operation was impossible. An investigation at that time revealed cracks in the concrete on Pier 1 and water seepage through horizontal cracks 20-30 mm wide that were parallel to and adjacent to the tendons securing the gate trunnion. The cracking pattern within

Figure 130. Upstream elevation and typical section of Kamburu Dam Spillway (from Sims and Evans 1988)

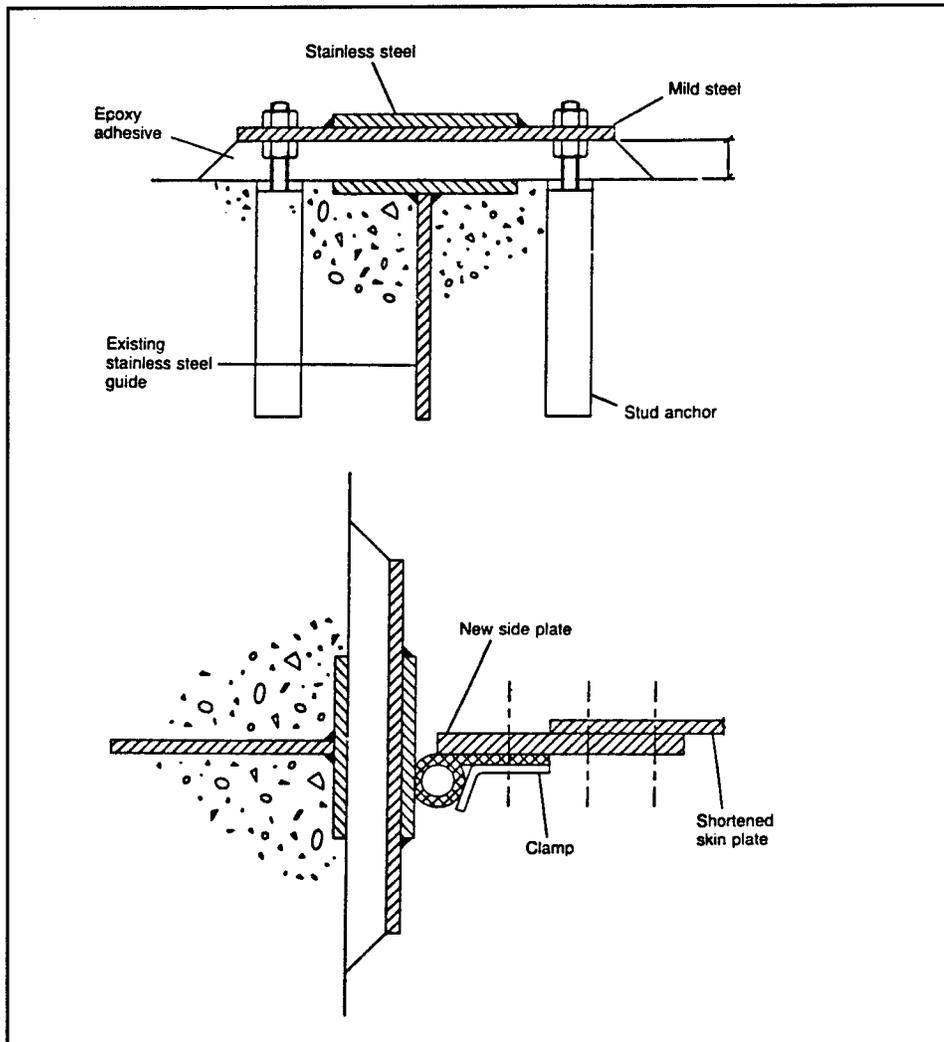
Figure 131. Modifications to radial gate, embedded parts and skin plate, at Kamburu Dam Spillway (from Sims and Evans 1988)

Gate 1 was released by trimming 140 mm (5.5 in.) off the side of the gate adjacent to Pier 1. Figure 131 shows the revised arrangement for the seal and also the new stainless steel sealing face. After the gate was released, the alignment of the gate arms and trunnion bearings were checked, and minor adjustments had to be made to relieve stresses induced by the misalignment of the gate and piers.

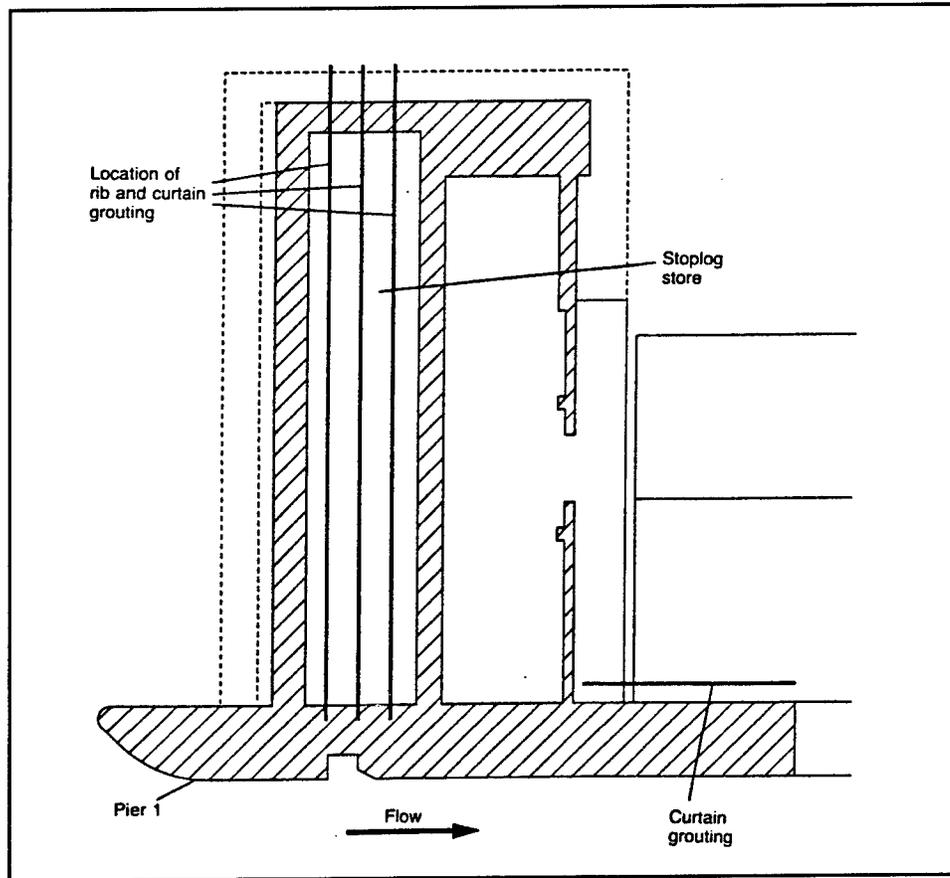
Figure 132. Grout locations on Pier 1 of the spillway at Kamburu Dam (from Sims and Evans 1988)

The measure taken to reduce the water available to the concrete included the following. The existing grout curtain under the stoplog stores was reinforced by placement of both a low-alkali cement grout and resorcinol-formaldehyde resin grout (Figure 132). Immediately under the stoplog store, a combination of curtain grouting and rib grouting was used, the curtain grouting being straight down to the spillway foundation level and the rib grouting inclined at about 1 radian (60 deg) to the vertical to intersect with the rear face of the pier. Both the curtain and rib grouting were carried out in three rows. The two outer rows were grouted first with cement grout. The central row was grouted later, first with cement and subsequently with chemical grout. This grouting reduced the overall permeability of the abutment rock. Additional protection to Piers 1 and 4 was provided by a further curtain of cement grout followed by chemical grout between each pier and the abutment rock.

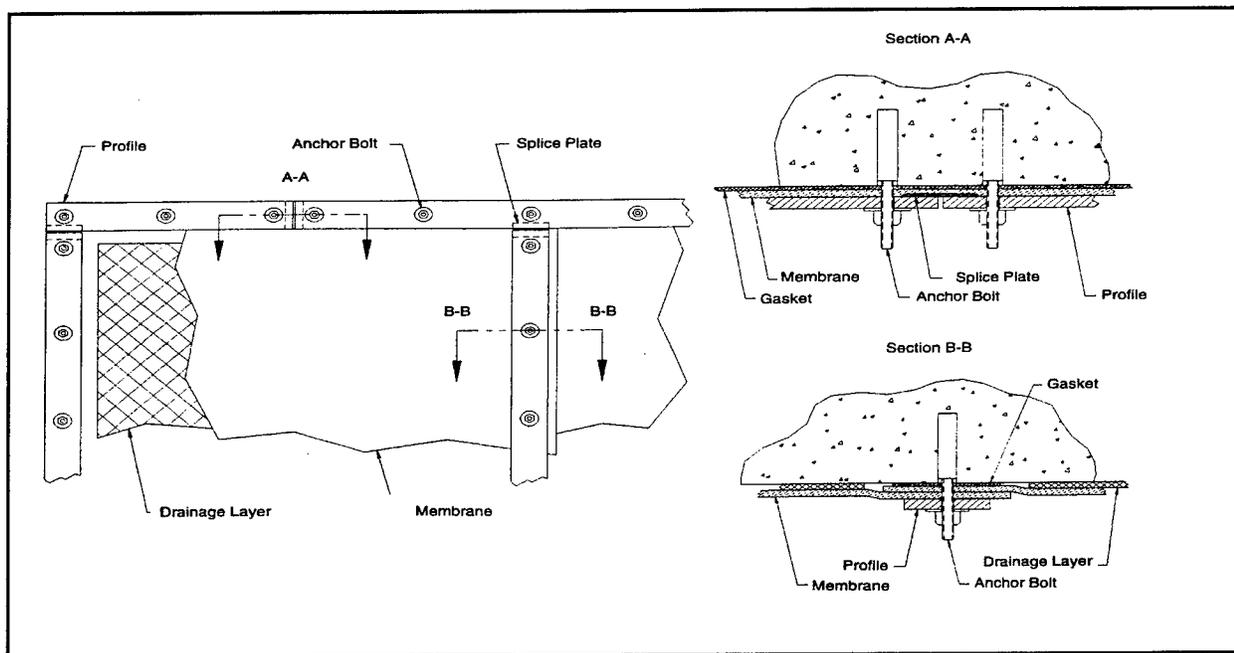
Material recommendations based on project research were as follows: for the membrane, PVC with geotextile backing; for the drainage layer, high-density polyethylene (HDPE); for anchor bolts, stainless steel wedge bolts; for anchoring profiles, stainless steel flat bars; for gaskets, high-tack butyl-based sealant. It was also recommended that, if needed, a two-part epoxy resin be applied to smooth the surface concrete. The conceptual design of a typical geomembrane installation is shown in Figure 133.

Figure 133. Conceptual design for a typical geomembrane system installation (from McDonald 1998)

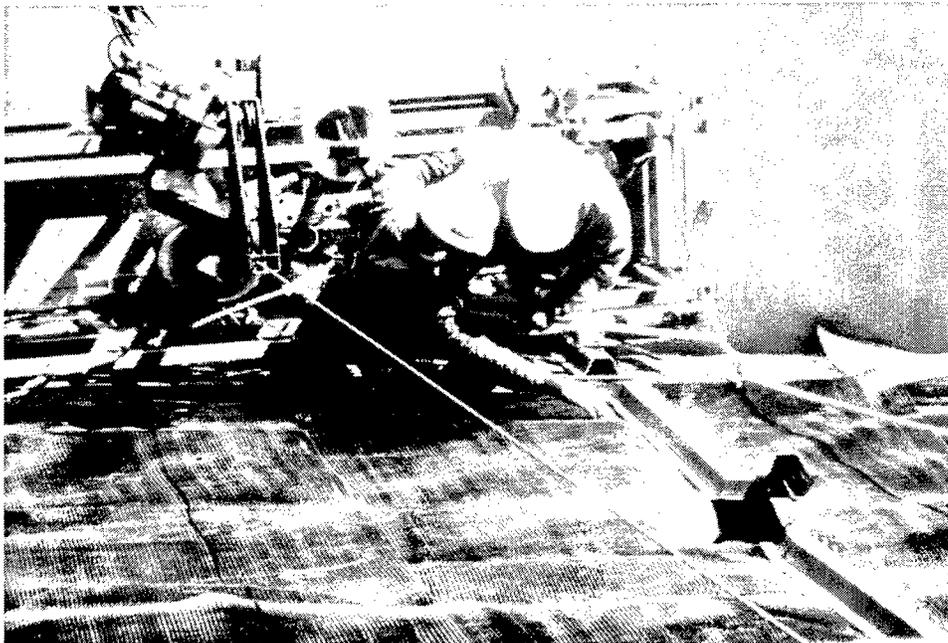
Two-part vertical profiles, stainless steel frames, were installed above water on the geonet (Figure 135). The first, or internal, section of the vertical profile was anchored to the dam face with threaded, stainless steel anchor rods and chemical epoxy; the geomembrane was attached to this frame, and then the exterior vertical profile was bolted to the internal profile, tensioning the geomembrane.

Figure 135. Workers anchor internal vertical profiles over geonet at Lost Creek Dam in preparation for installation of a geomembrane (from Onken 1998)

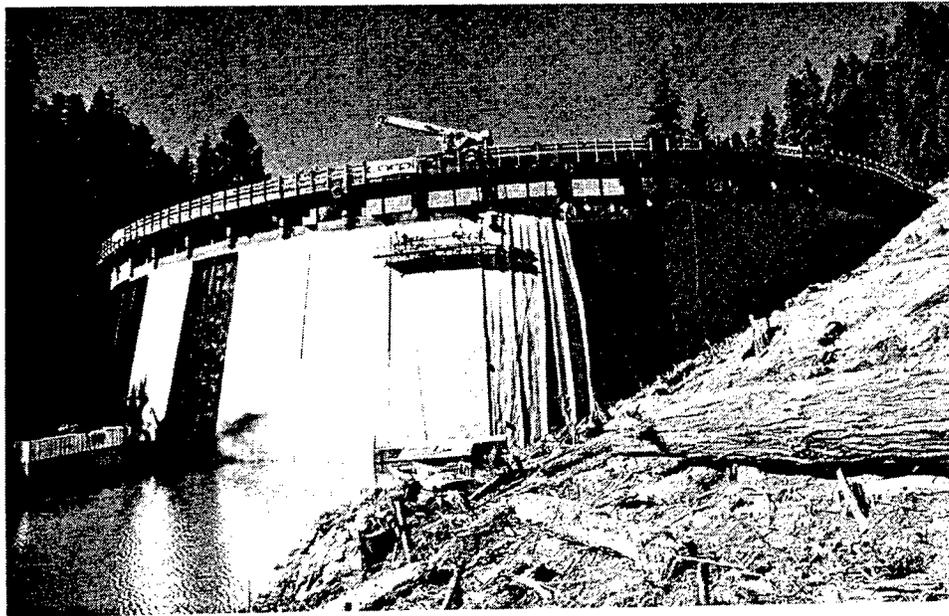
To install internal profiles underwater, divers worked from swing platforms that were controlled from a materials barge. They used grid lines as guides to ensure the internal profiles were installed in a perfect vertical line. Gasket material was placed on the installed vertical profiles to provide a watertight seal at the membrane joints. The geomembrane was installed next. Using a crane, workers lifted the top end of each of the 16 panels until it was level with the upper perimeter seal, pulled it to the dam face, and then unrolled the remainder of the panel onto the materials barge and into the water. Divers aligned the panels with the installed internal vertical profiles, making sure the panels overlapped sufficiently (Figure 136). The installation team on the bridge deck used chain falls and winches to make adjustments according to instructions from the divers. Once the panels were aligned, divers secured them to the dam face above the perimeter seal. Another layer of gasket material was placed over the geomembrane, and the external vertical profiles were clamped to the internal vertical profiles, creating tension between the two profiles and pulling the panels toward the face of the dam.

Figure 136. Workers on swing stages install 16 precut geomembrane panels on the upstream face of Lost Creek Dam (from Onken 1998)

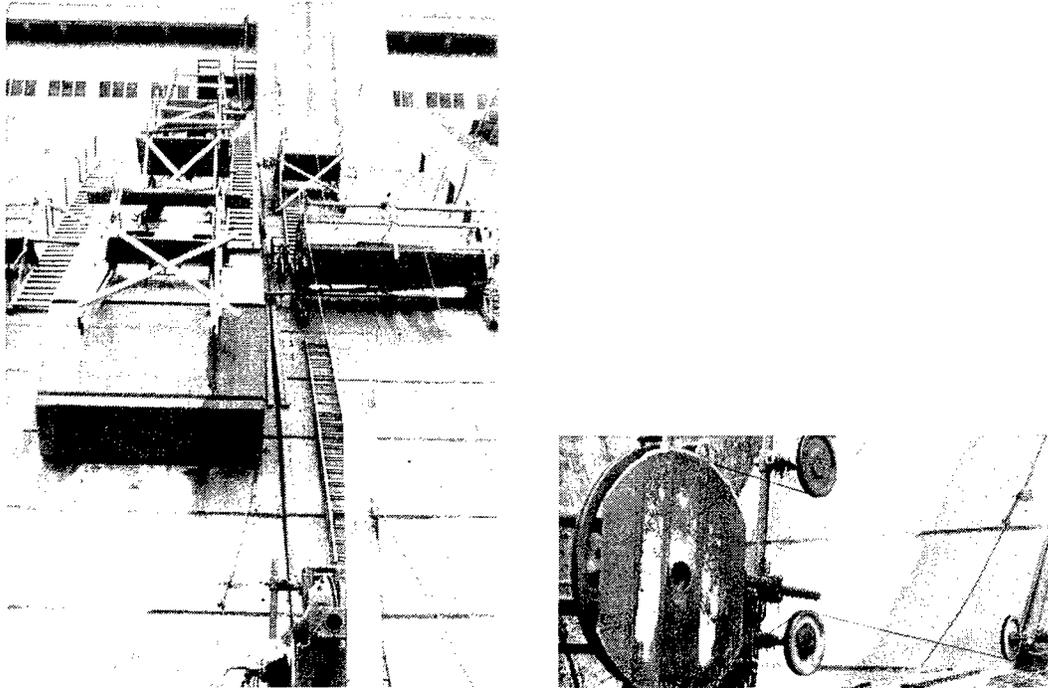
From the time the dam was constructed in the late 1960s, it had been slowly but steadily expanding. As a result, by 1988, a spillway structure pier had moved 30 mm (1-1/4 in.) off-line, there had been some gate obstruction and some cracking in the powerhouse generator floor. The expansion of the concrete

Figure 138. Diamond wire cutting of Mactaquac Dam

As the first cut closed behind the wire saw, the 'load' or pressure caused by the growth was transferred to the top half of the dam. Trentec's crew then moved their equipment to the very top of the dam (Figure 138) to begin the second vertical cut. The 10-mm- (3/8-in.-)wide cut began to close when the diamond wire saw was about 6 m (20 ft) from the top. The second vertical cut intersected the slot of the first cut, completing the project. The second cut relieved pressure on the top half of the dam.

Crews worked around-the-clock for 13 full days to make the two cuts, which covered a 483-sq m- (578-sq yd) cross-sectional area of the concrete structure. The 10-mm (0.4-in.) cut closed almost completely, and any small gaps were grouted and sealed. The leaning spillway pier “rebounded” by about 6 mm (1/4 in.) as the dam moved in and about (5/32 in.) 4 mm on the other side of the cut. The cutting program had “shrunk” the growing dam section about 10 mm (0.4 in.), the exact width of the cuts. This amount was estimated to be the equivalent of 1 year’s growth at the spillway east end pier.

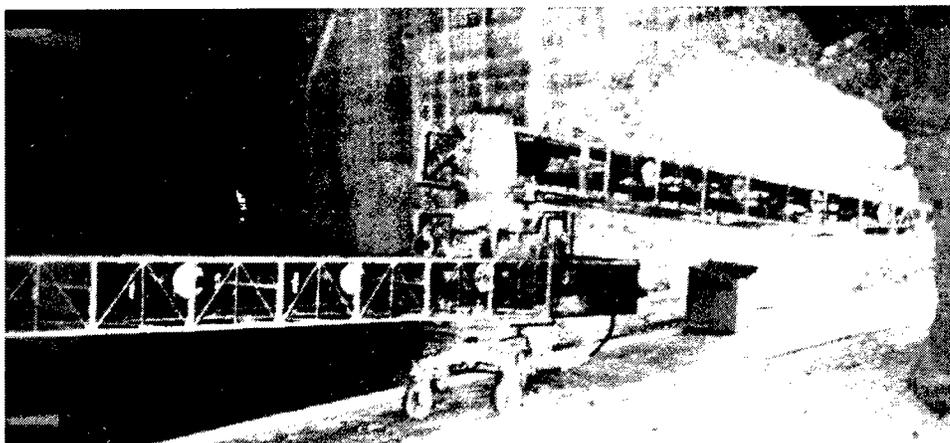
**Inspection results.** A 5-year inspection of the project was conducted in December of 1986. The inspection revealed movement of the service spillway buttresses downstream, shearing of the surface at the level of the upstream toe wall and a hydrostatic pressure equivalent to 65 percent of the lake head acting on the upstream toe wall, erosion along the south bank of the river downstream of the hearth, cracking in the hearth slabs downstream of buttresses 16 to 26 and structural cracking of the buttress corbels between buttresses 26 and 33, insufficient openings of the spillway buttresses between bays to prevent a rising high tailwater from creating a buoyancy condition that would adversely affect the stability of the dam during large floods, and nine gates in the service spillway capable of accommodating only 60 percent of the calculated present-day PMF. A recommendation based on these findings led to further investigation and the implementation of corrective actions (Thompson and Waters 1989).

Figure 140. Muck being removed from bay at Morris Sheppard (from *ENR* 1988)

**Construction and investigation.** The construction and geotechnical investigations proceeded concurrently. A footing level, 2.4-m- (8-ft-) diam, passageway was drilled through buttresses into the enclosed spillway bays. Once the passageway had been constructed, each bay was mucked out and filled with crushed gravel to form a working platform for relief well and instrumentation installation (Figure 140). As the working platform was constructed, additional instrumentation and piezometers were installed farther upstream in the spillway bays. In total, 132 piezometers, 10 inclinometers, and 18 extensometers were installed to monitor the piezometric pressure and movement of the dam (Thompson and Waters 1989).

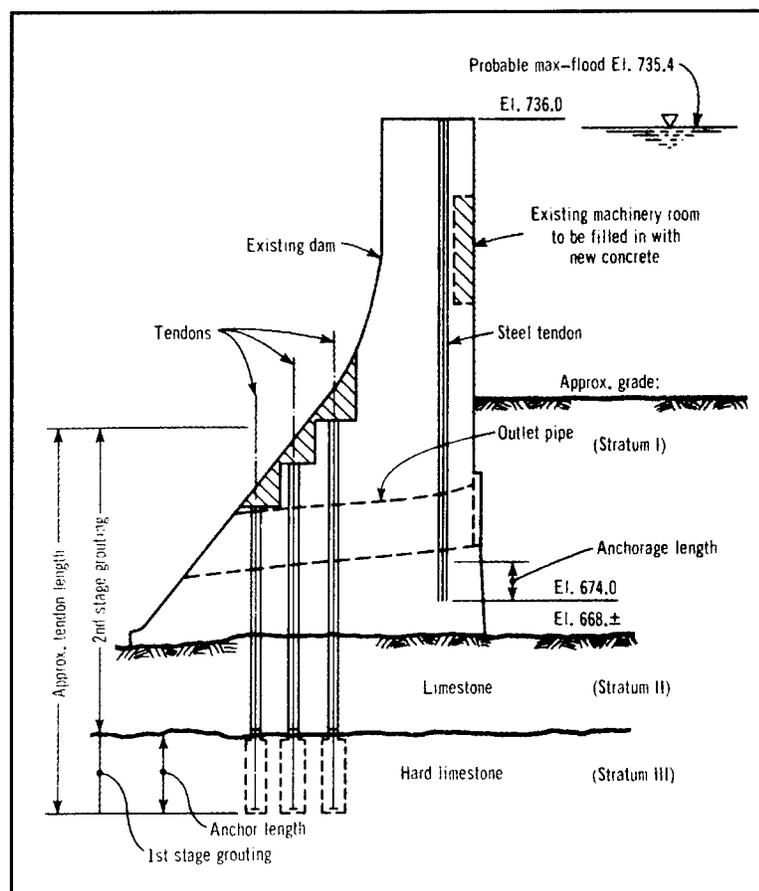
Figure 141. Placement of prestressed reinforcing to strengthen nonoverflow sections at Olmos Dam (from *Civil Engineering* 1982)

The first alternative considered was the placement of mass concrete on the entire downstream face of the dam. This option was rejected because of costs and the modifications to the existing stilling basin and sluice-way discharge at Olmos Creek that it would have required. The alternative selected was to strengthen the two nonoverflow sections with prestressed anchors installed in 2- to 3-m- (7- to 10-ft-) thick, hard limestone 15 m (50 ft) below the base of the dam (Figure 141) and to increase the stability of the spillway with mass concrete (Figure 142).

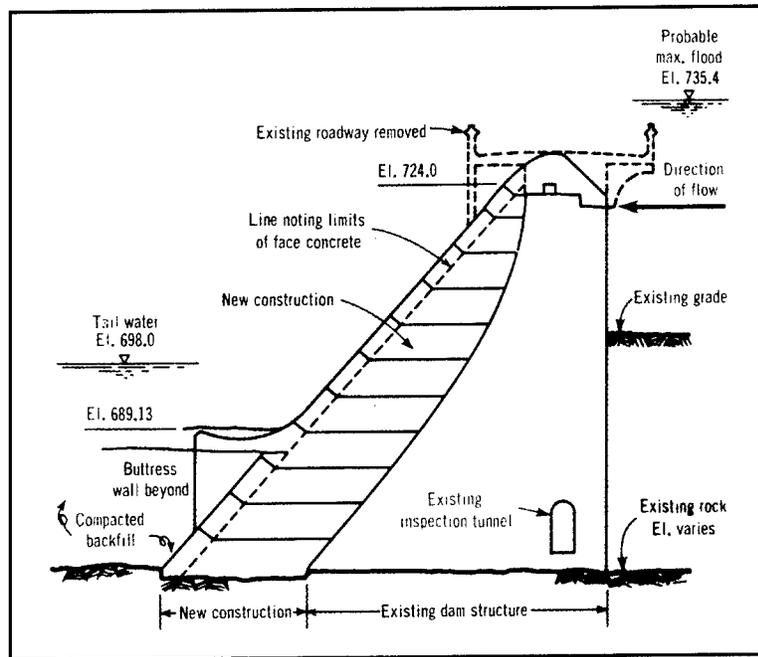
Figure 142. Spillway section strengthened with mass concrete at Olmos Dam (from *Civil Engineering* 1982)

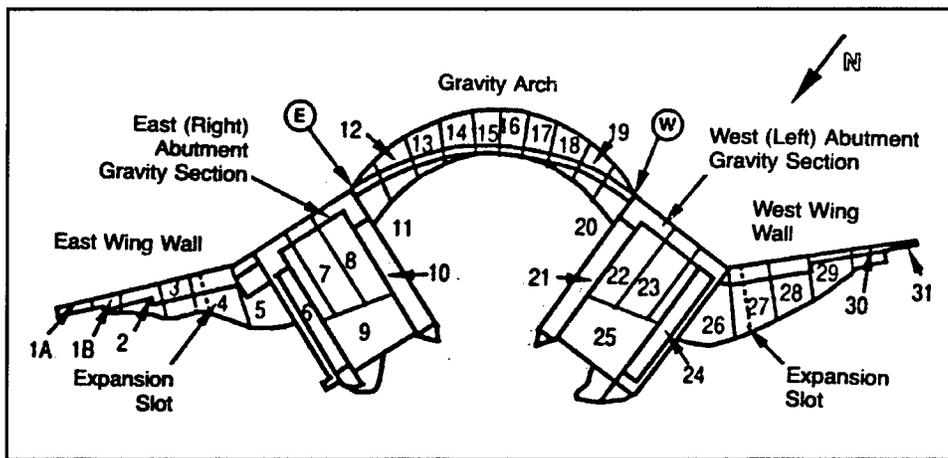
Figure 143. Layout of Shanteetlah Dam (from Bruce and Porcellinis 1991)

Routine measurement of deformation of the dam crest over a period of 25 years indicated that the crest had ratcheted (moved upstream in a cyclically increasing manner) since the 1930 and 1938 modifications, and the seepage volume had increased considerably. By 1987, seepage in the west abutment had reached over 4,000  $\mu\text{m}$  (1,050  $\text{gpm}$ ) and was entering the lower gallery at higher pressures and over larger areas than ever before. In addition, seepage from the downstream side of the gallery was also apparent (Bruce and De Porcellinis 1991).

Old construction records revealed that when repairs were made in 1930 and 1938 no structural connection was used to bond the new concrete to the old, except near the crest. Therefore, engineers attributed the steady ratcheting of the crest to thermal expansion caused by seasonal cycling. Displacements occurred along the interface between the original and new concrete. These upward deformations also caused construction joints to open seasonally, creating the possibility for concrete leaching (Bruce and De Porcellinis 1991).

A decision was made to use epoxy-resin grout to seal the joints and cracks in Santeetlah Dam. A 23-m- (75-ft-) long section in the most critical area was selected for treatment, which was conducted from within the lower gallery. The gallery is located about 3 m (10 ft) above the foundation and 4.5 m (15 ft) back from the upstream face. Cores up to 6 m (20 ft) long were taken from the upstream section of the dam to allow for inspection of the joints (Figure 144). The core holes revealed that water flows were traveling through the joints; the cores indicated the concrete was sound. A number of holes intercepted flows of 400  $\mu$ m (105 gpm) at full hydrostatic head (Bruce 1989).

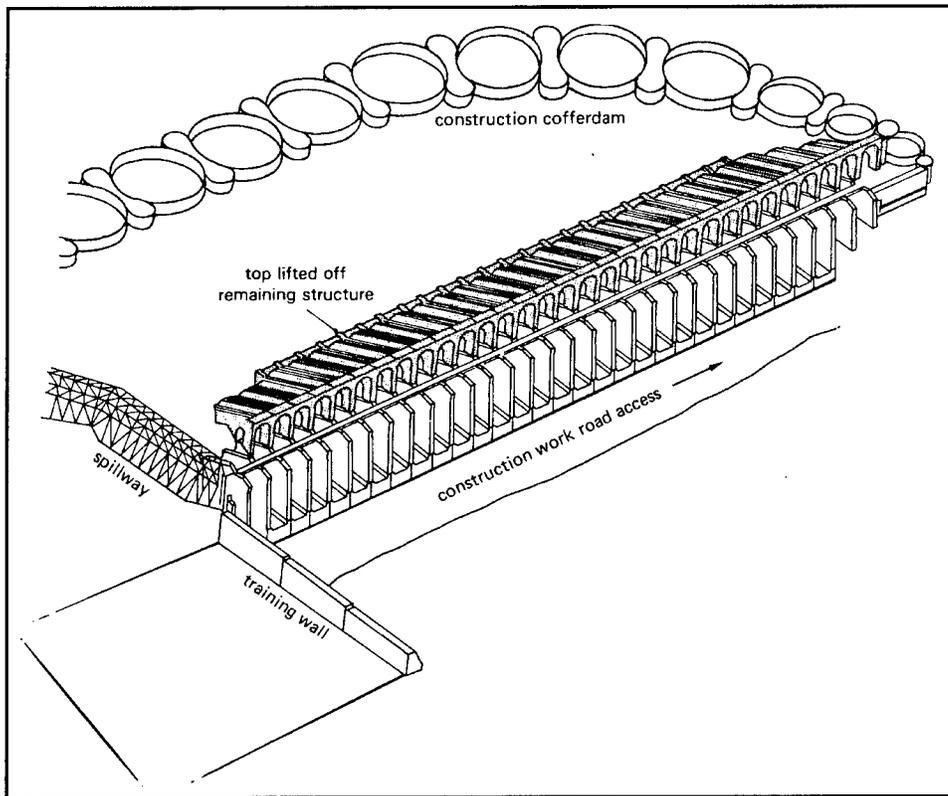
Over time the dam, which is more than 70 years old, suffered concrete damage as a result of chemical reaction and cycles of freezing and thawing. Despite extensive maintenance the deterioration continued to occur. By the mid-1980s, severe cracking in the dam's arches and buttresses was allowing water to penetrate the structure and cause structural damage (*Concrete Construction* 1994). A cellular cofferdam was installed to allow for a careful evaluation of the structure. This evaluation resulted in the decision to conduct a major rehabilitation, including modifying the buttress-arch design of the dam to a flat-slab design.

Figure 145. Overview of Sherman Island Dam rehabilitation project. The arch section of the dam was removed by diamond wire cutting (from Beckman and Hulick 1991)

Next came the demolition work on the dam. The foundation and lower buttress portions of the dam that had not been exposed to weathering were sound and usable; therefore, total concrete demolition was not required (*Concrete Construction* 1994). The entire reinforced concrete arch roof and selected areas of the buttresses would have to be removed (Figure 145). Partial removal of the concrete arches and severing reinforcing steel would affect the stability of the structure and increase the need to restrict heavy vibration. The contractor elected to use diamond wire-cutting technology to remove the concrete at Sherman Island Dam because of its successful use in recent years at large hydro-schemes.

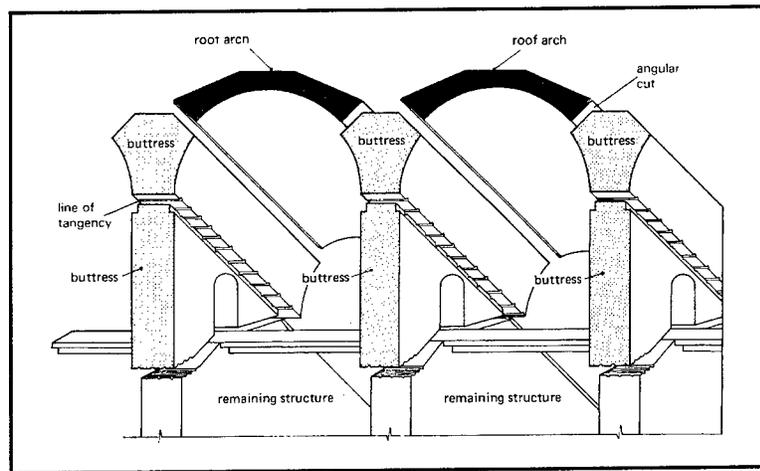
Figure 147. View of two arches prepared for removal at Sherman Island (from Beckman and Hulick 1991)

Work began on the upper arch sections. Two transverse cuts were made between the arches and buttresses in each bay across the 31-m (102-ft) width of the dam (Figure 147), and then three longitudinal cuts were made in steps along the 185-m (600-ft) length of the dam. The cut angle allowed the concrete arch to remain in position, without any additional shoring, until the contractor was ready to remove it. Access holes for the diamond wires, 20 to 40 mm (0.8 to 1.6 in.) in diameter and approximately 700 mm (28 in.) long, were drilled with percussion drills at the points where transverse cuts intersected longitudinal cuts. The wire saws were operated from the ground, from scissor lifts, or on large platforms anchored to the face of the dam. Some cuts required wires up to 80 m (260 ft) long (Beckman and Hulick 1991).

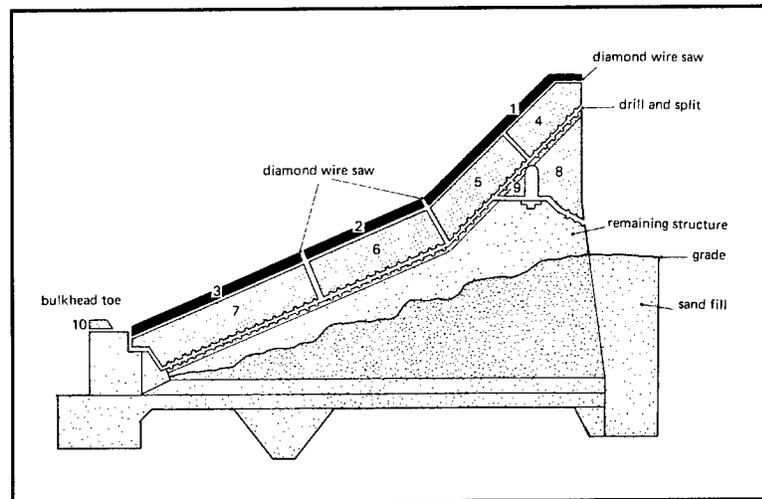
Figure 148. Order of removal of typical transverse section of Sherman Island Dam

Using the transverse and longitudinal cutting pattern allowed the contractor to remove sections in a checkerboard fashion. Buttress No. 4 was removed to grade to facilitate access through the dam. To prevent unwanted deflection of the remaining buttresses, temporary I-beam braces were bolted across each bay and then removed after arch sections on either side of a buttress had been lifted (Beckman and Hulick 1991).

Once the arches had been removed, the buttresses were drilled horizontally through the 1-m- (3-ft-) thick section along the line of tangency. Then hydraulic rock splitters separated the buttress along the unreinforced construction joint. Additional buttress sections were removed adjacent to the inspection gallery walkway, along with smaller sections at the bulkhead toe. Finally, bulkhead toe sections and other sections of concrete were removed from the lower upstream edge of the dam (Figure 148). The main scope of the concrete cutting work was completed within the required 16-week schedule (Beckman and Hulick 1991).

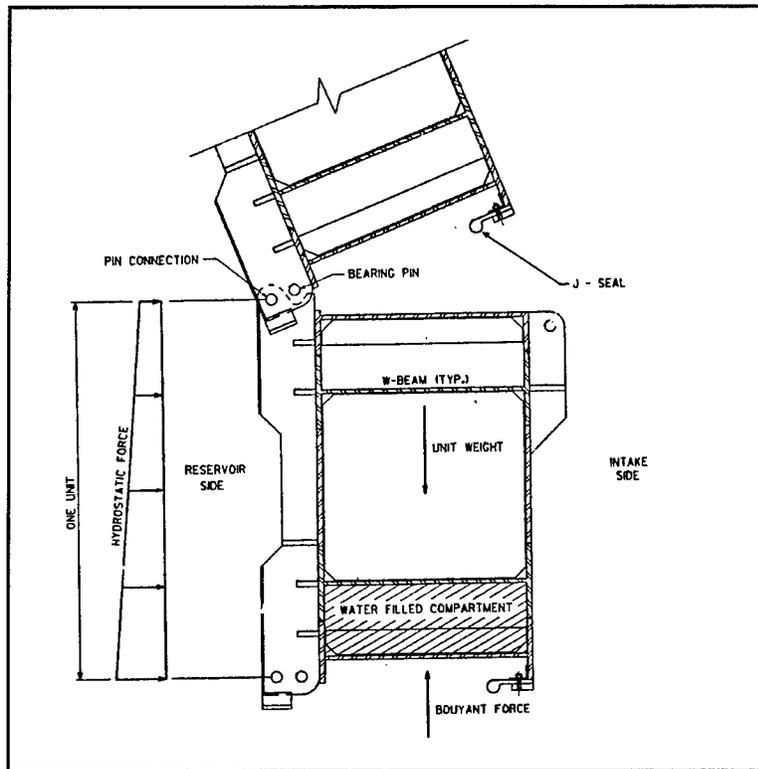
Figure 149. Individual floating caisson used to construct floating bulkhead at Snake River Dams (from Lux and Regner 1991)

A floating bulkhead consists of individual floating caissons linked together to form a unit. Individual caissons, which can be used separately, have a flotation compartment and another compartment that is filled with water to sink the caisson or emptied to float it (Figure 149). Each caisson is lowered into the water and then towed into position by a boat. The caissons are pinned together to form the bulkhead, and then individual caissons are filled with water so that they slowly submerge in a controlled manner, pulling the rest of the units behind (Figure 150). The unit resembles a giant garage door as it floats on the water. Installation of a floating bulkhead has required less than 2 hr.

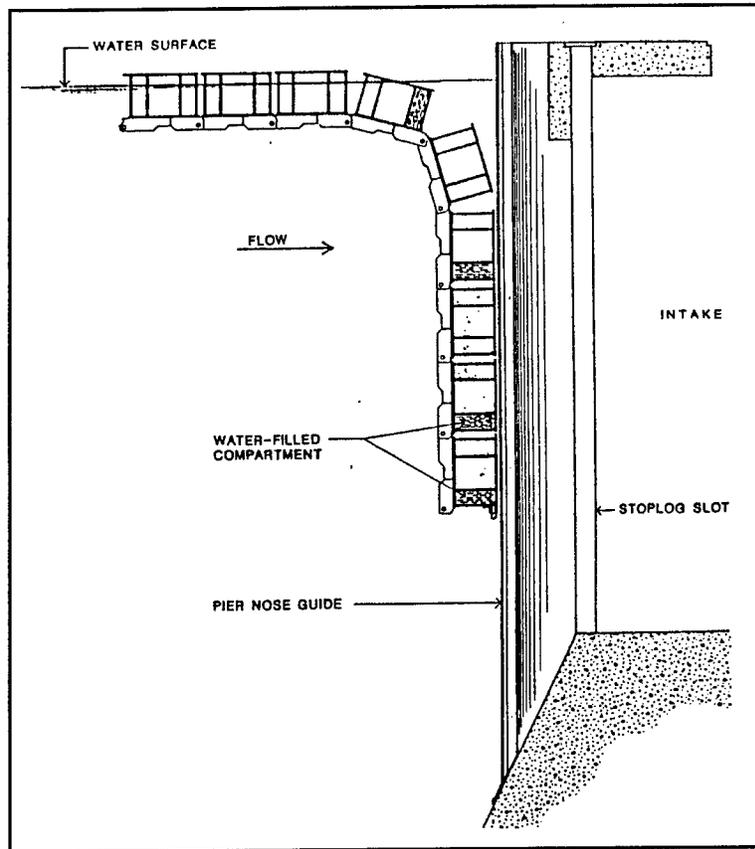
Figure 150. Floating caissons joined to form floating bulkhead at Snake River Dams (from Lux and Regner 1991)

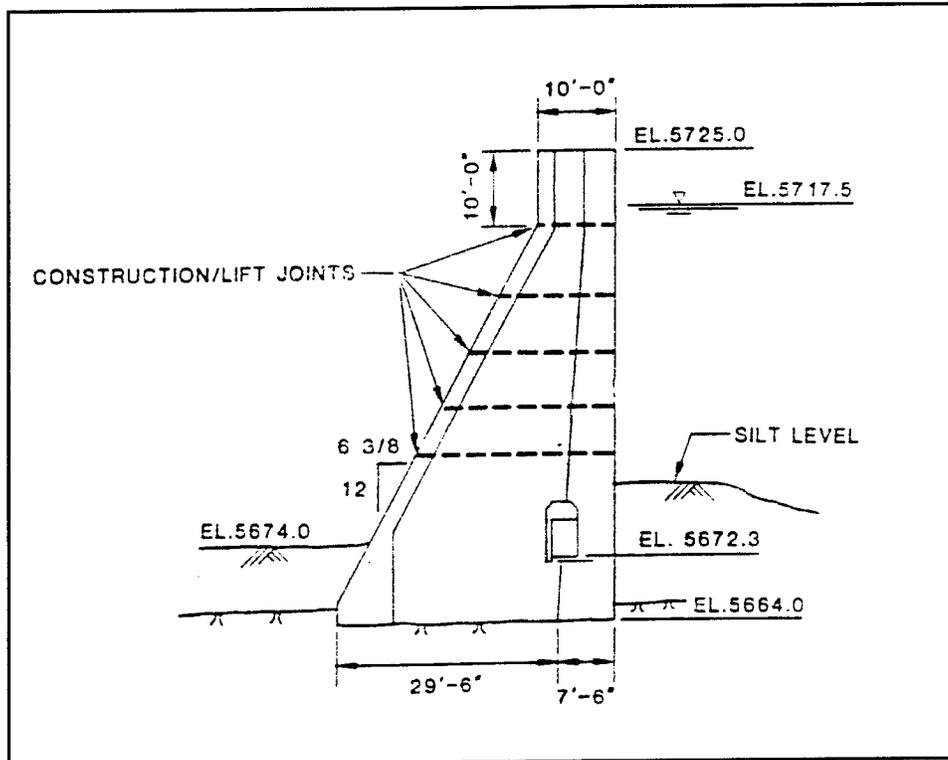
Minor leakage along lift joints has occurred during the life of the project. In the 1950s, a thin layer of shotcrete was placed on the downstream face of the dam in an effort to arrest concrete deterioration. Initially, this layer may have protected the surface from further deterioration, but ultimately, it probably contributed to increasing the rate of deterioration as minor leakage resulted in water being trapped behind the shotcrete. Inspections during 1990 revealed the existing shotcrete layer was delaminating from the underlying surface. This discovery prompted an investigation to determine the extent of deterioration. This case history is a summary of a report on the investigation and repair of Soda Dam by Marold, Koniarski, and Bruen (1992).

Figure 151. Nonoverflow gravity dam section at Soda Dam (from Marold, Koniarski, and Bruen 1992) (multiply feet by 0.3048 to obtain metres; inches by 25.4 to obtain millimetres)

reactivity; compressive strengths in the downstream face and upper 3 m (10 ft) of the structure ranged from 10 to 20.7 MPa (1,500 to 3,000 psi), while concrete in the body of the structure had compressive strengths ranging from 20.7 to 27.6 MPa (3,000 to 4,000 psi); reactive aggregates were identified as part of the concrete, especially (rhyolites and other silica-rich aggregates); cracking was attributed to swelling of the calcium-alkali-silica gel by-product of the alkali-aggregate reaction and subsequent cycles of freezing and thawing.

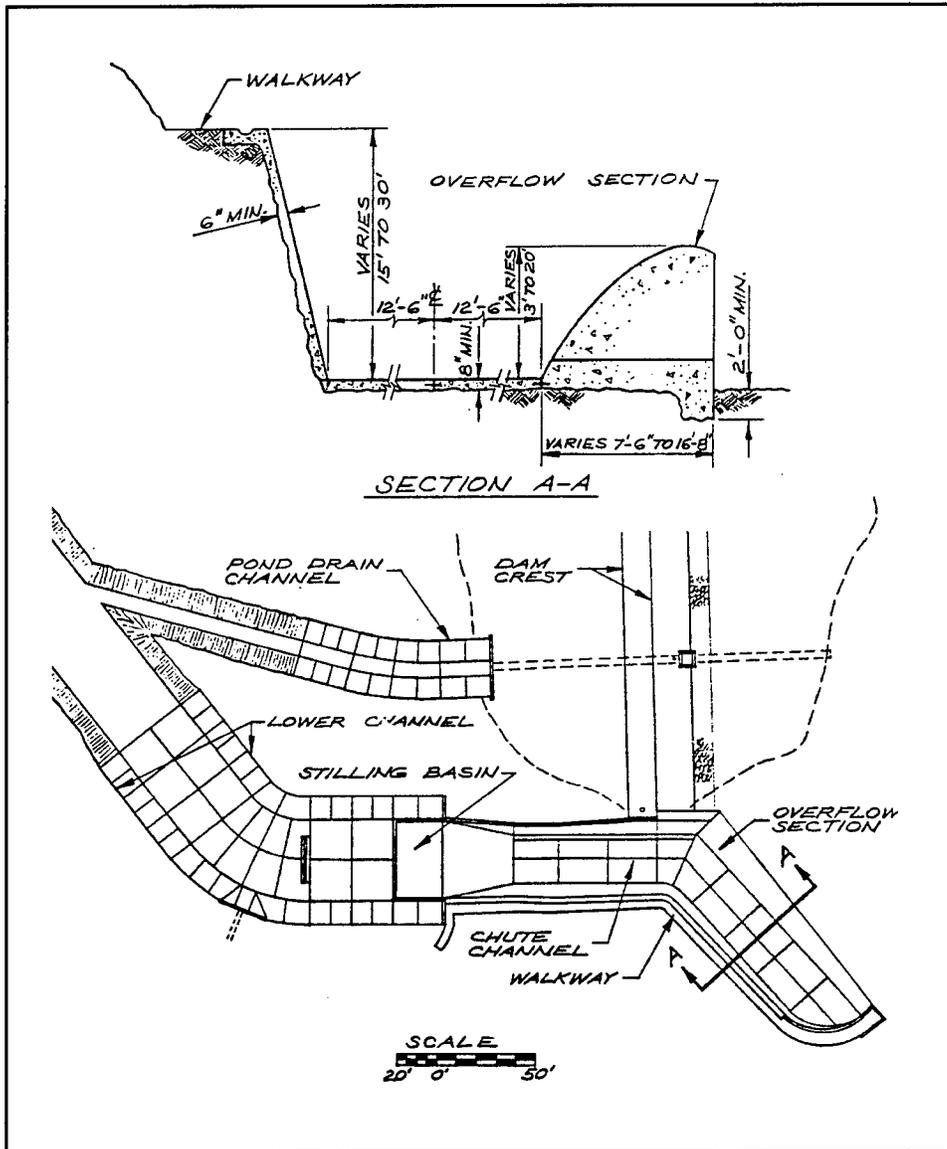
The concrete continued to deteriorate--cracking, spalling, raveling rock pockets, and efflorescence were evident. By 1977 there was concern about the structural integrity of the structure, so a decision was made to inspect all concrete areas in the spillway and pond drain channels and to make repairs where needed. This case history is a summary of a report by Coghlan and Vanderpoel (1980) on the investigation and repairs made at Vesuvius Dam spillway.

Figure 154. General plan for Vesuvius Dam and spillway (from Coghlan and Vanderpoel 1980) (multiply feet by 0.3048 to obtain metres; inches by 25.4 to obtain millimetres)

The lowest of four bidders was an experienced shotcrete firm from Alabama. Repair work began in May. Chipping hammers were used to remove the deteriorated concrete. Then the exposed surface was washed and sandblasted. Wire mesh reinforcing was installed, and the shotcrete was sprayed on the prepared area to an overdepth. The surface was troweled smooth and brush finished. Because large repair surfaces were noticeably rougher than the original surface, the concrete in these areas was removed and repaired in 0.9-m (3-ft) sections. Plywood forms with chamfer strips served as a straight-line guide and support for finishing longer edge repairs. The repairs were completed in July.
