**US Army Corps  
of Engineers**  
Engineer Research and  
Development Center

Technical Report REMR-CS-63  
September 1999

## **Repair and Rehabilitation of Dams: Case Studies**

*by James E. McDonald, Nancy F. Curtis*

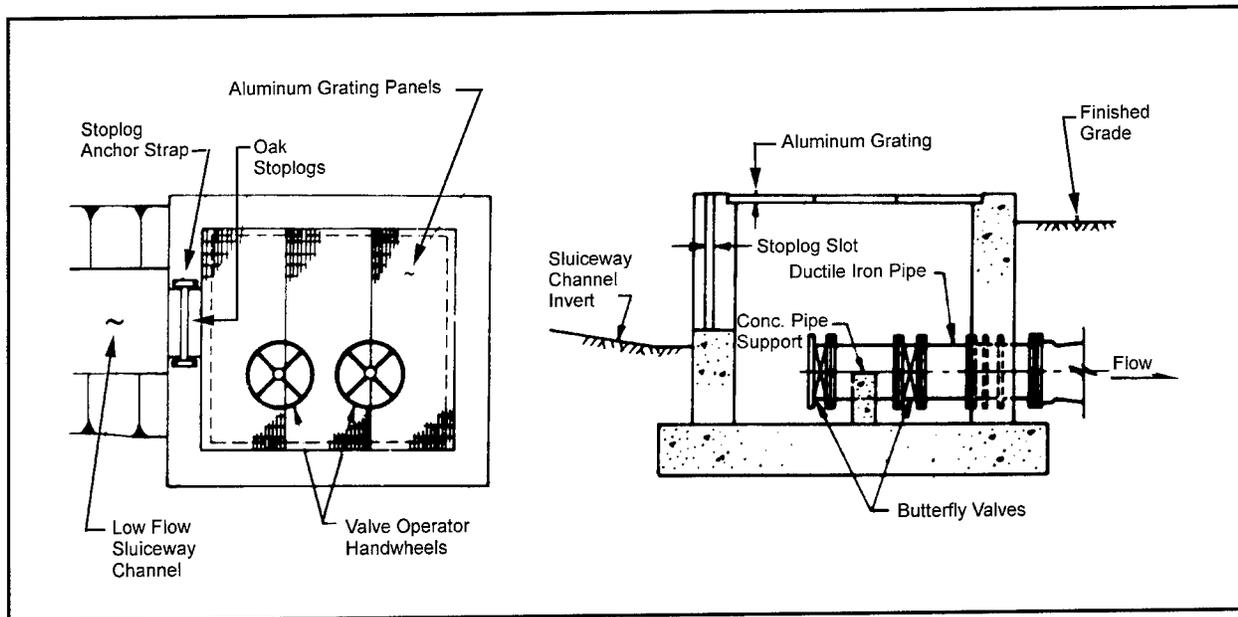
As a result of age and lack of maintenance, the outlet works facilities at both dams were in need of repair. Seepage observed near the outlet works at each dam raised the question as to whether the leakage came from the outlet pipe or through the embankment. Piping had been noted in the embankment material at Dam No. 1. Neither outlet works had a way of closing its outlet pipe. Remedial measures to remedy these deficiencies were undertaken.

Figure 155. Plan for submerged intake structure at Waste House Dam No. 1 (from Kline 1992)

The submerged intake chamber (Figure 155) allowed for various foundation conditions and diver safety in valve operation. The intakes consist of a cast-in-place concrete chamber housing two valves in series mounted at the upstream end of the outlet pipe. The actuators for the valves were specially fitted with stainless steel parts to resist corrosion. The second valve was a backup for the first valve in case it failed to operate. A flap gate mounted on the pipe entrance would also meet this purpose. Aluminum floor grating placed on the cast-in-place valve housing served as an intake screen and working platform for the operator. In the event of an emergency, a diver could be onsite for valve operation within a day. Downstream valves controlled routine reservoir release.

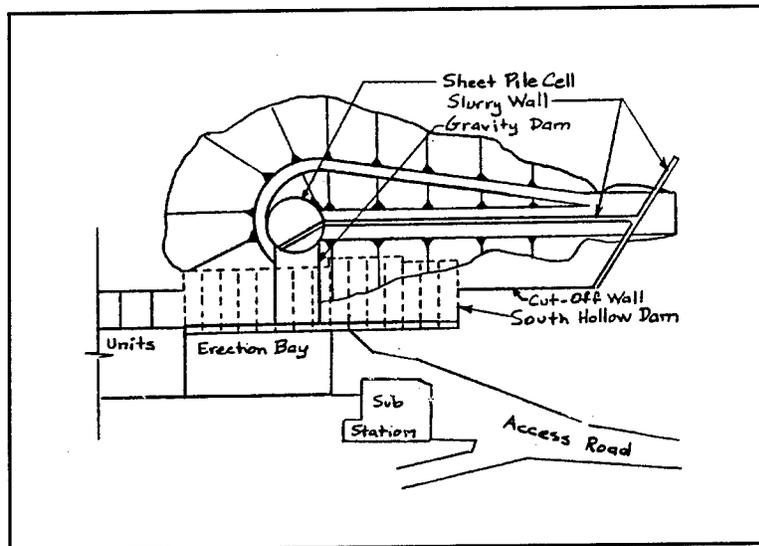
Figure 156. Plan for replacement of South dam at Wissota Hydroelectric Project (from LaMar, Iverson, and Tonke-White 1991)

Two types of replacement dams were considered: a cellular sheet-pile dam or a sand-fill dam with an impervious cutoff. Also, a matter of consideration was how new and rehabilitated structures would be connected. A study indicated a sheet-pile cell would provide the easiest way to connect the two structures. The cell would also provide support for dewatering a small area or for placing tremie concrete. The study also indicated a sand-fill dam would be the most cost effective alternative, but that connecting it to the existing dam would be difficult. The final decision was a combination of the two alternatives (Figure 156).

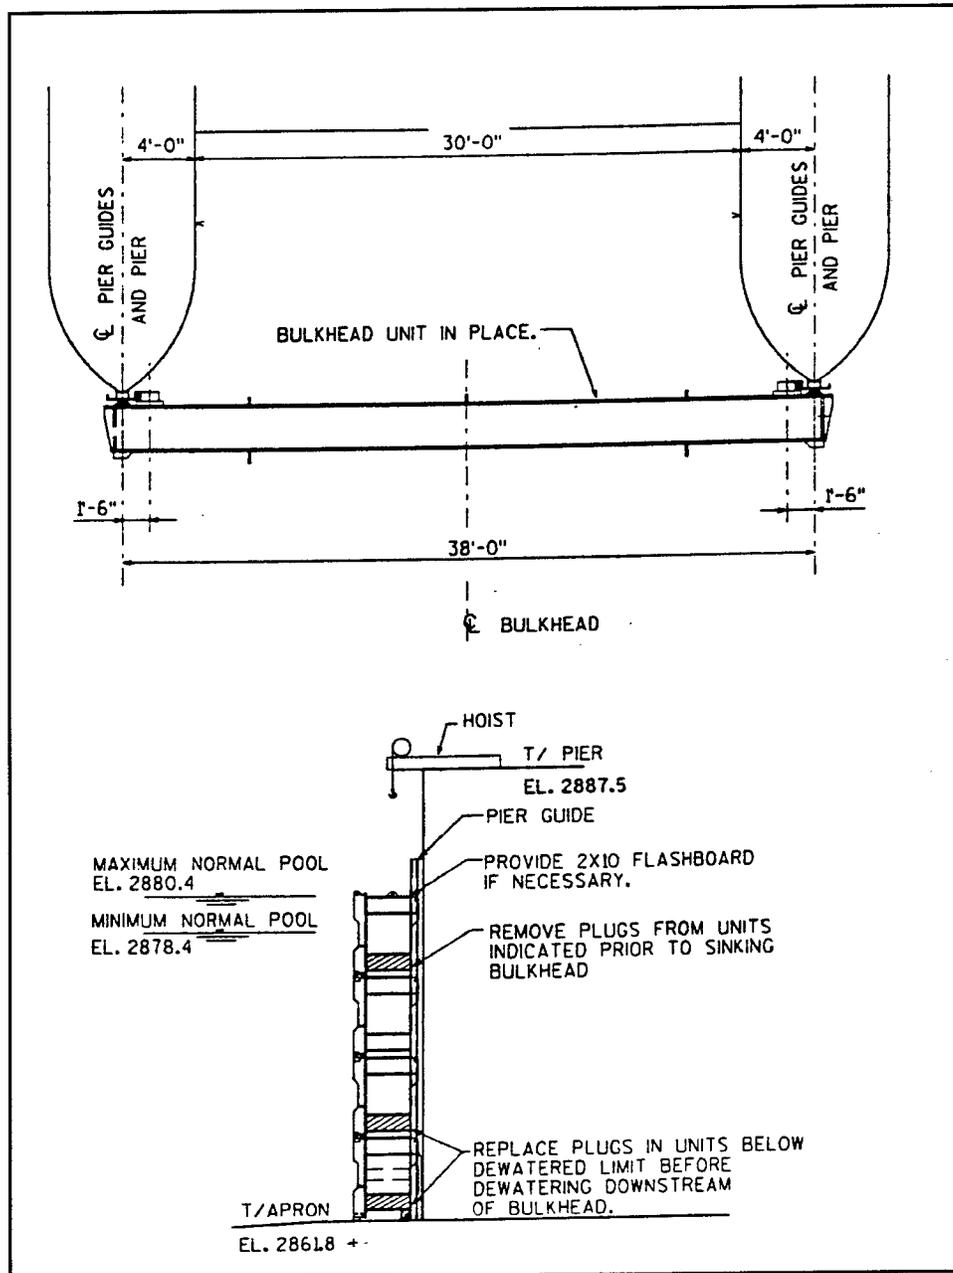
Figure 157. Cross section of design of floating bulkhead, Wissota Hydro Project

To repair head gates, stoplog slots, and trash racks, NSP had to develop a way to seal the entire fore bay of each unit or lower the reservoir to perform the repairs. Work in the head gate area would require a minimum of 4.6-m (15-ft) drawdown of Lake Wissota, which has a normal full-reservoir volume of 69,076,000 cu m (56,000 acre-ft), and the existing stop-log support trusses were too badly deteriorated to be considered. Rather than rent a barge and crane, NSP had an articulated floating bulkhead designed and fabricated for the project. The floating bulkhead was very similar in design to the one used at Snake River Dams. It was installed at the intakes of Lake Wissota hydroplant in 1987 (Figure 157) (Lux and Regner 1991).

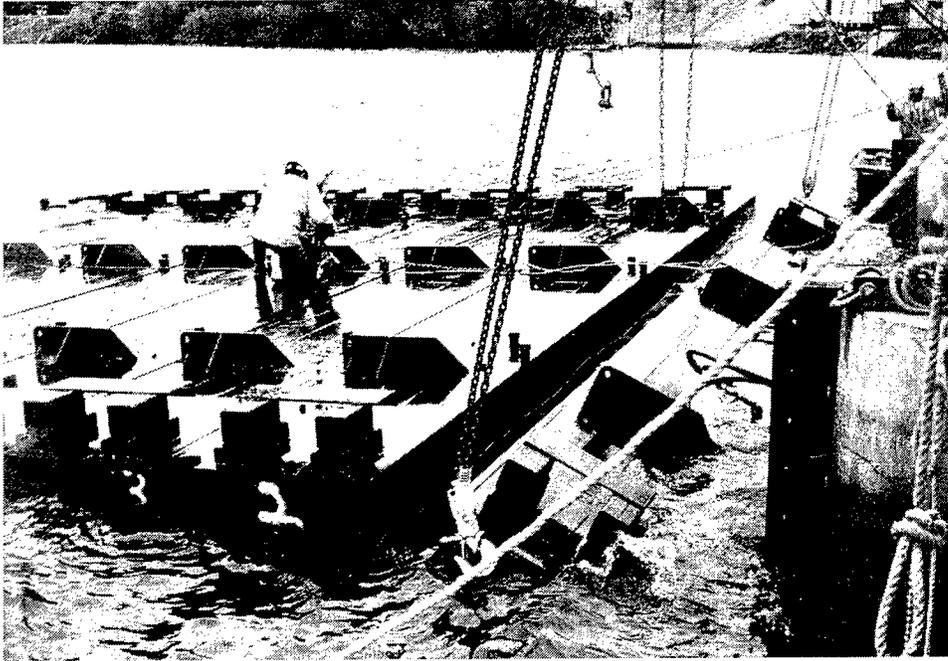
Figure 158. Caissons fill on floating bulkhead, causing bulkhead to sink, Wissota Hydro project

The floating bulkhead is constructed of nine caissons, each comprised of three compartments, which are used to float or sink the unit (Figure 158). The caissons are placed in the water and then linked together to form the bulkhead. The floating bulkhead fabricated for Wissota Hydro Project is 11 m (36 ft) square and 0.7 m (27 in.) thick when fully assembled (Figure 159). Because of its buoyancy, only 1,270 kg (2,800 lb) of the 62-Mg (68-ton) mass of the structure rests on the concrete below the headgate. Steel and wooden vertical guides installed on the pier noses are used to align the bulkhead. To sink the unit, the caissons are selectively filled. Water pressure from the lake seals the bulkhead. When repairs are completed, the water-filled compartments of the caissons are emptied, and the unit rises to the surface. The bulkhead has been installed in less than 2 hr and removed within 30 min. The bulkhead cost about \$130,000 (Lux and Regner 1991).

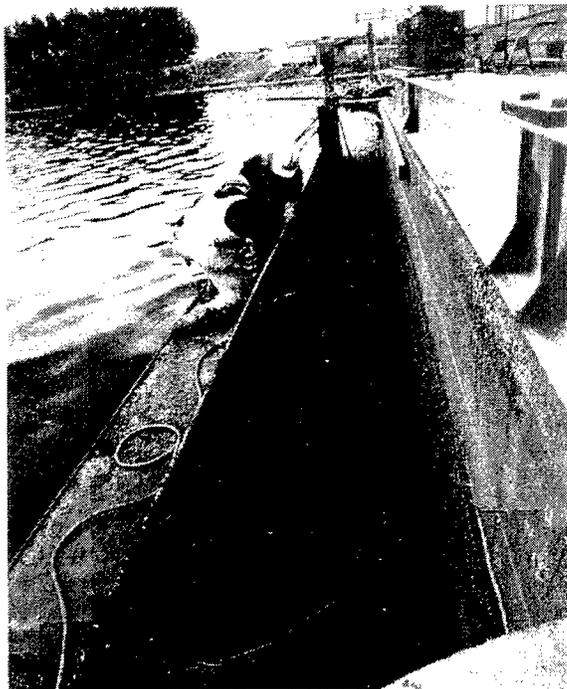
Figure 159. Floating bulkhead used to repair head gates, stop logs, and trash racks at Wissota Hydro Project
