# SANDIA REPORT

SAND88-2902 • UC-70

## **Analysis of the Accidental Explosion at Pepcon, Henderson, Nevada, May 4, 1988**

Jack W. Reed

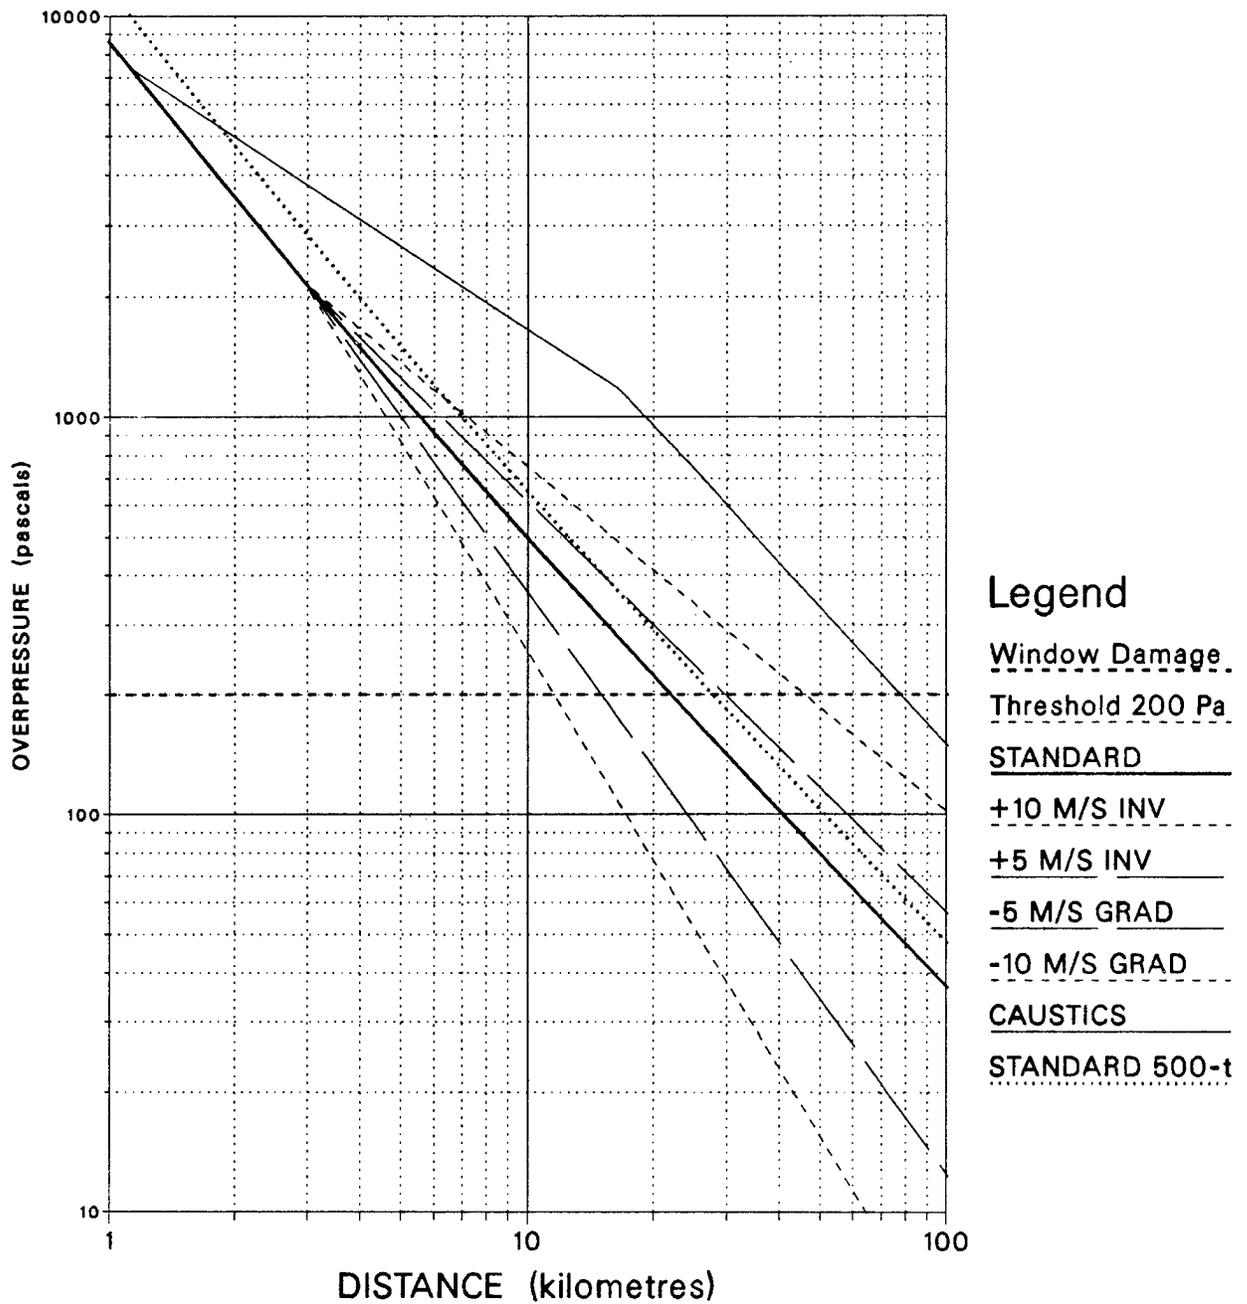
Figure 4. Airblast overpressure versus distance curves for 1-kt NE free-air burst (or 250-ton TNT surface burst), at 579 m MSL altitude, 94.1 kPa ambient pressure.

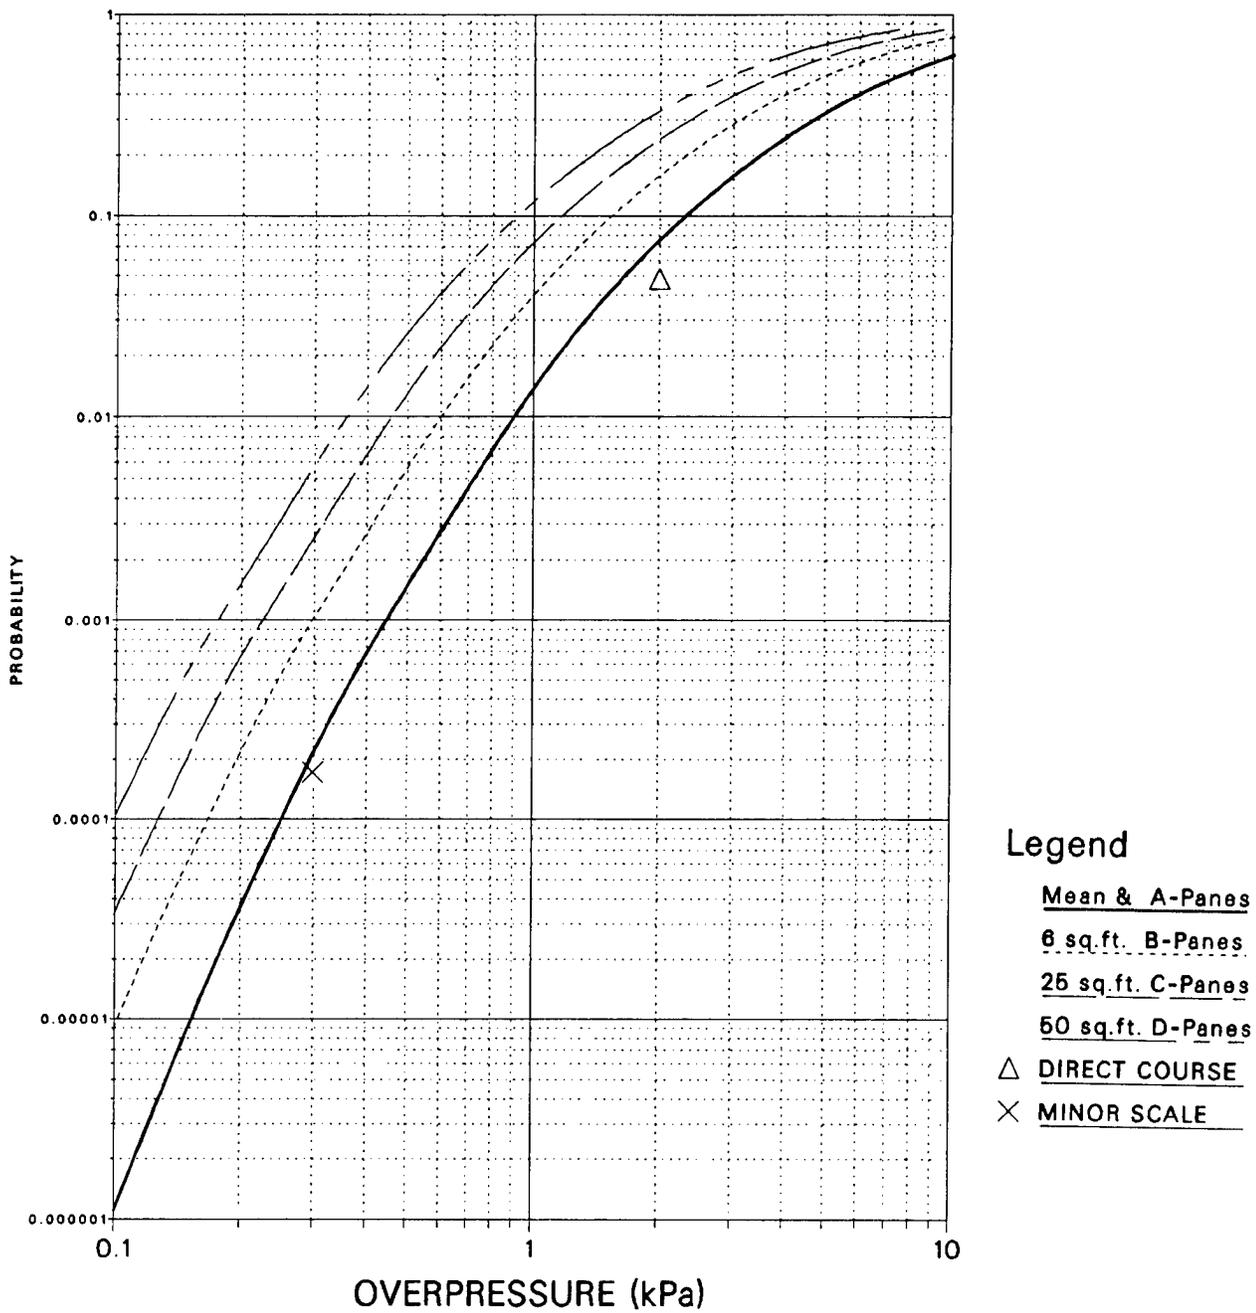
Medina results were also categorized by windowpane area in Figure 5 for small casement windows, typical double-hung windows, large picture windows, and very large store windows. An expression for the mean breaking load,  $b$ , for square plates is

Figure 5. Window breakage probability versus incident side-on (gaged) overpressure. Mean curve based on 1964 San Antonio, Texas, window pane size distributions.

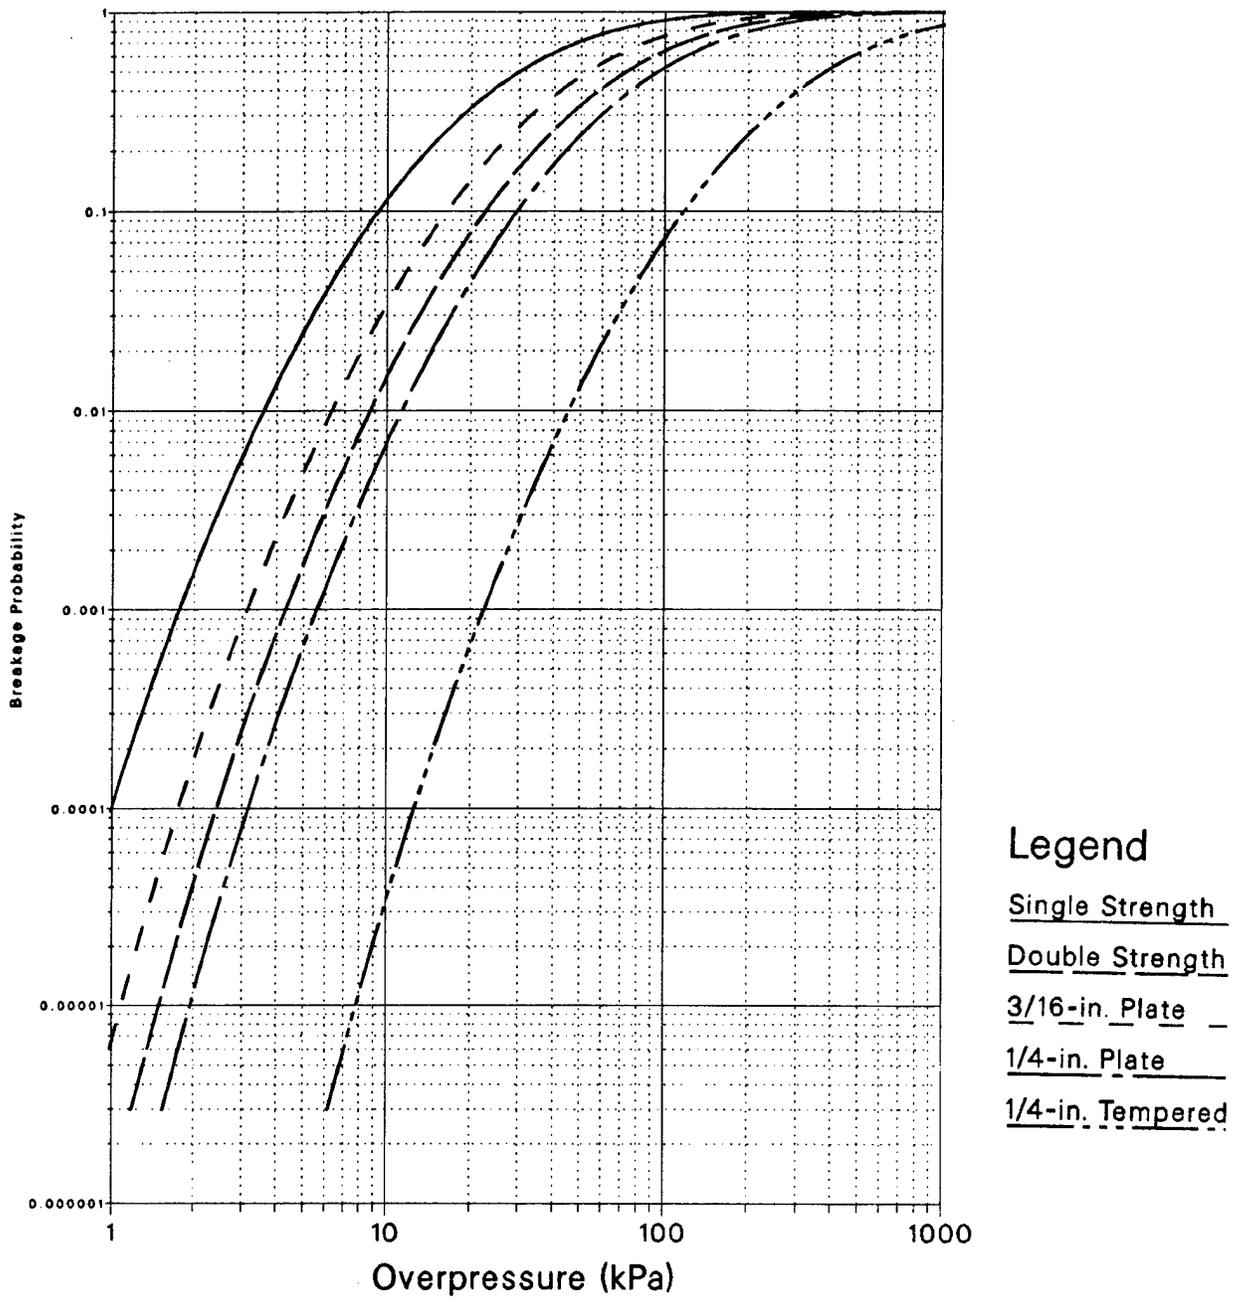
Figure 6. Window breakage probabilities normalized for 1 ft<sup>2</sup> pane area.  
For 10 ft<sup>2</sup> panes, divide overpressure by 10.

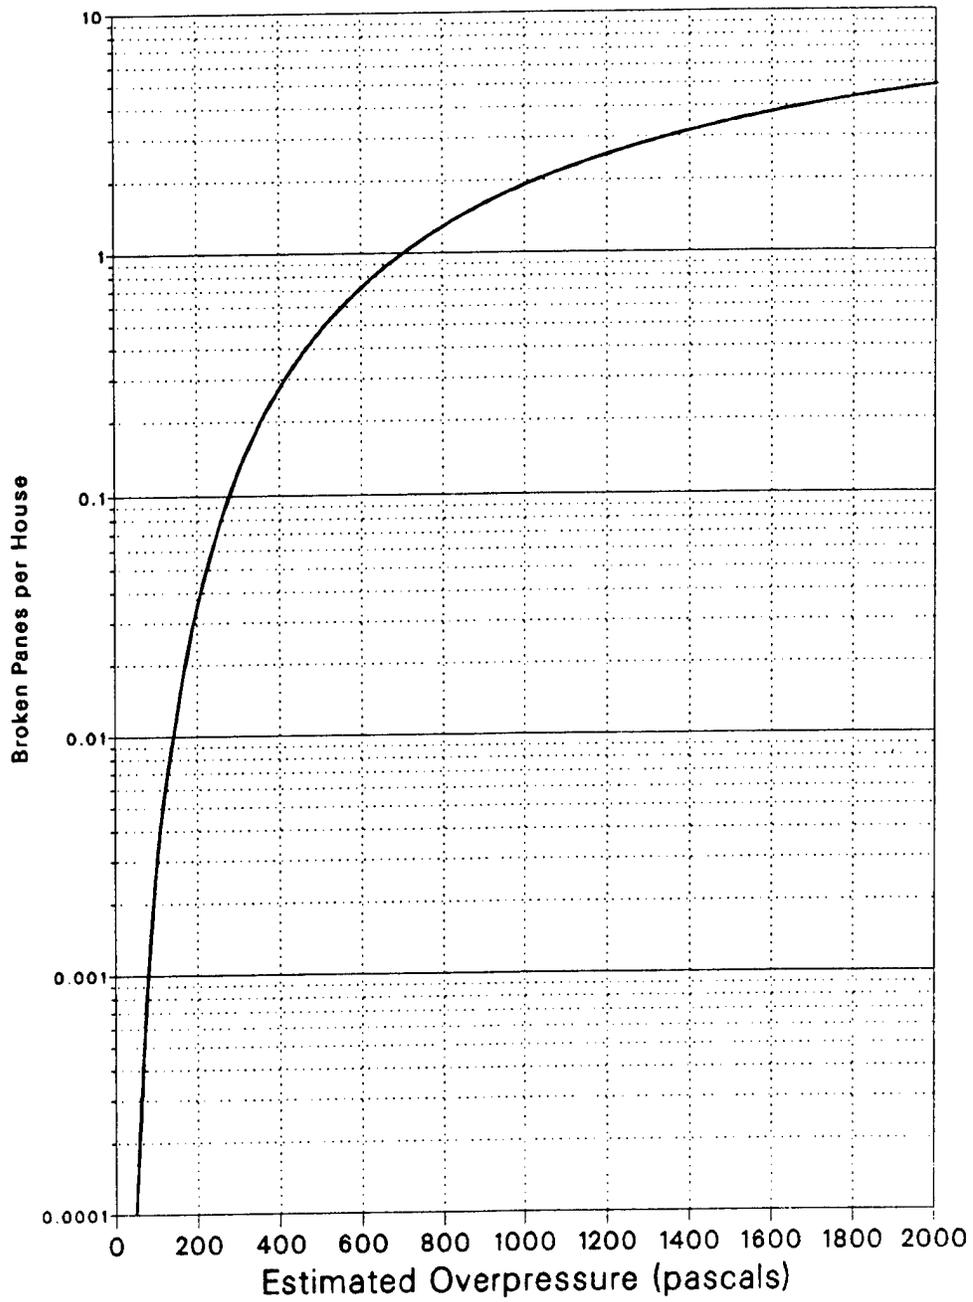
Figure 7. Broken window panes per house, visible from the street, versus incident airblast overpressure. (Curve adjusted for Las Vegas architectural practices).

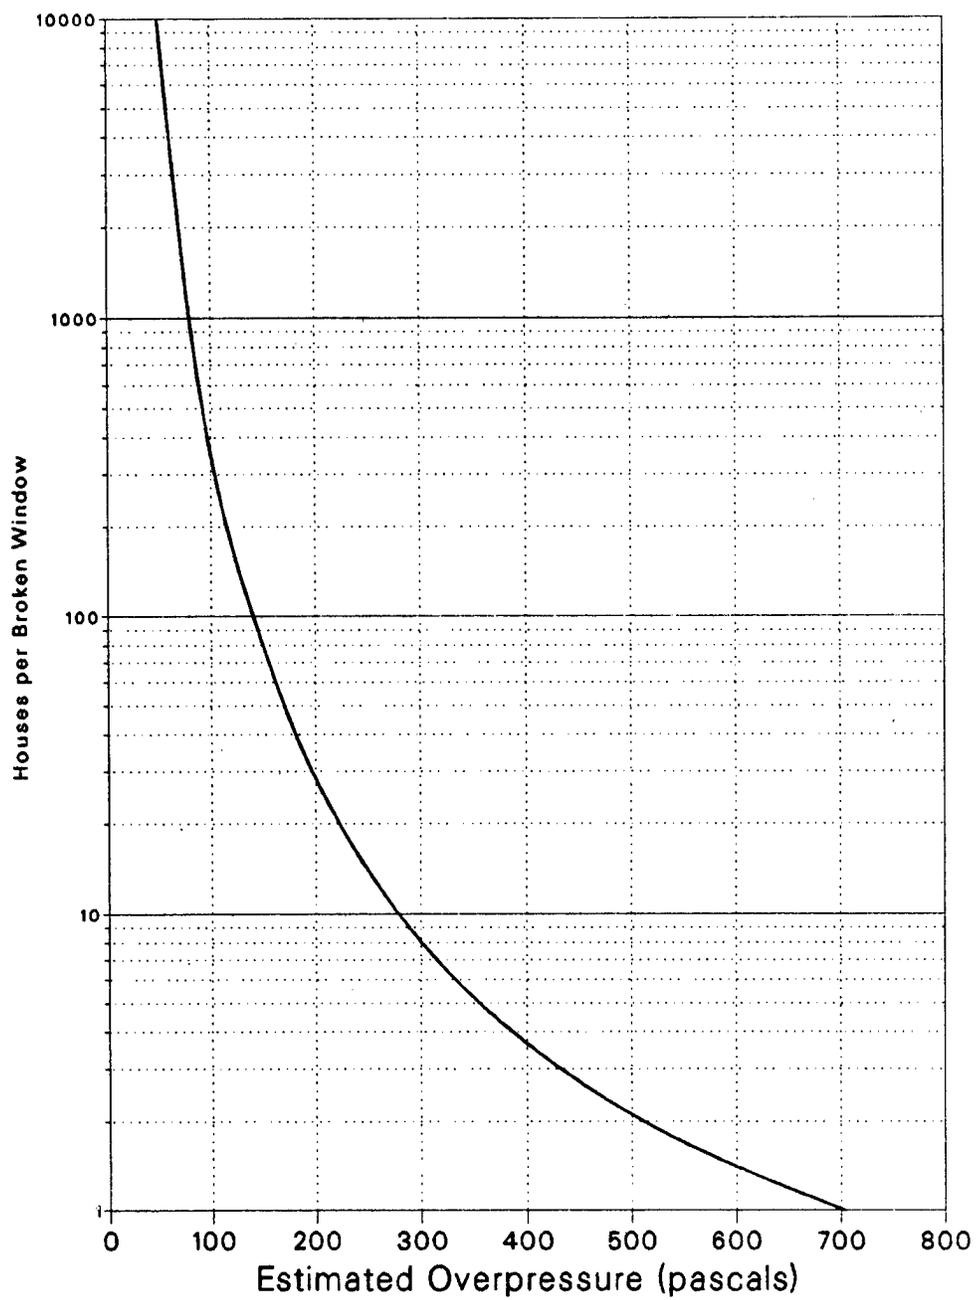
Figure 8. Number of houses per visible broken window pane, versus incident airblast overpressure. (Curve adjusted for Las Vegas architecture).

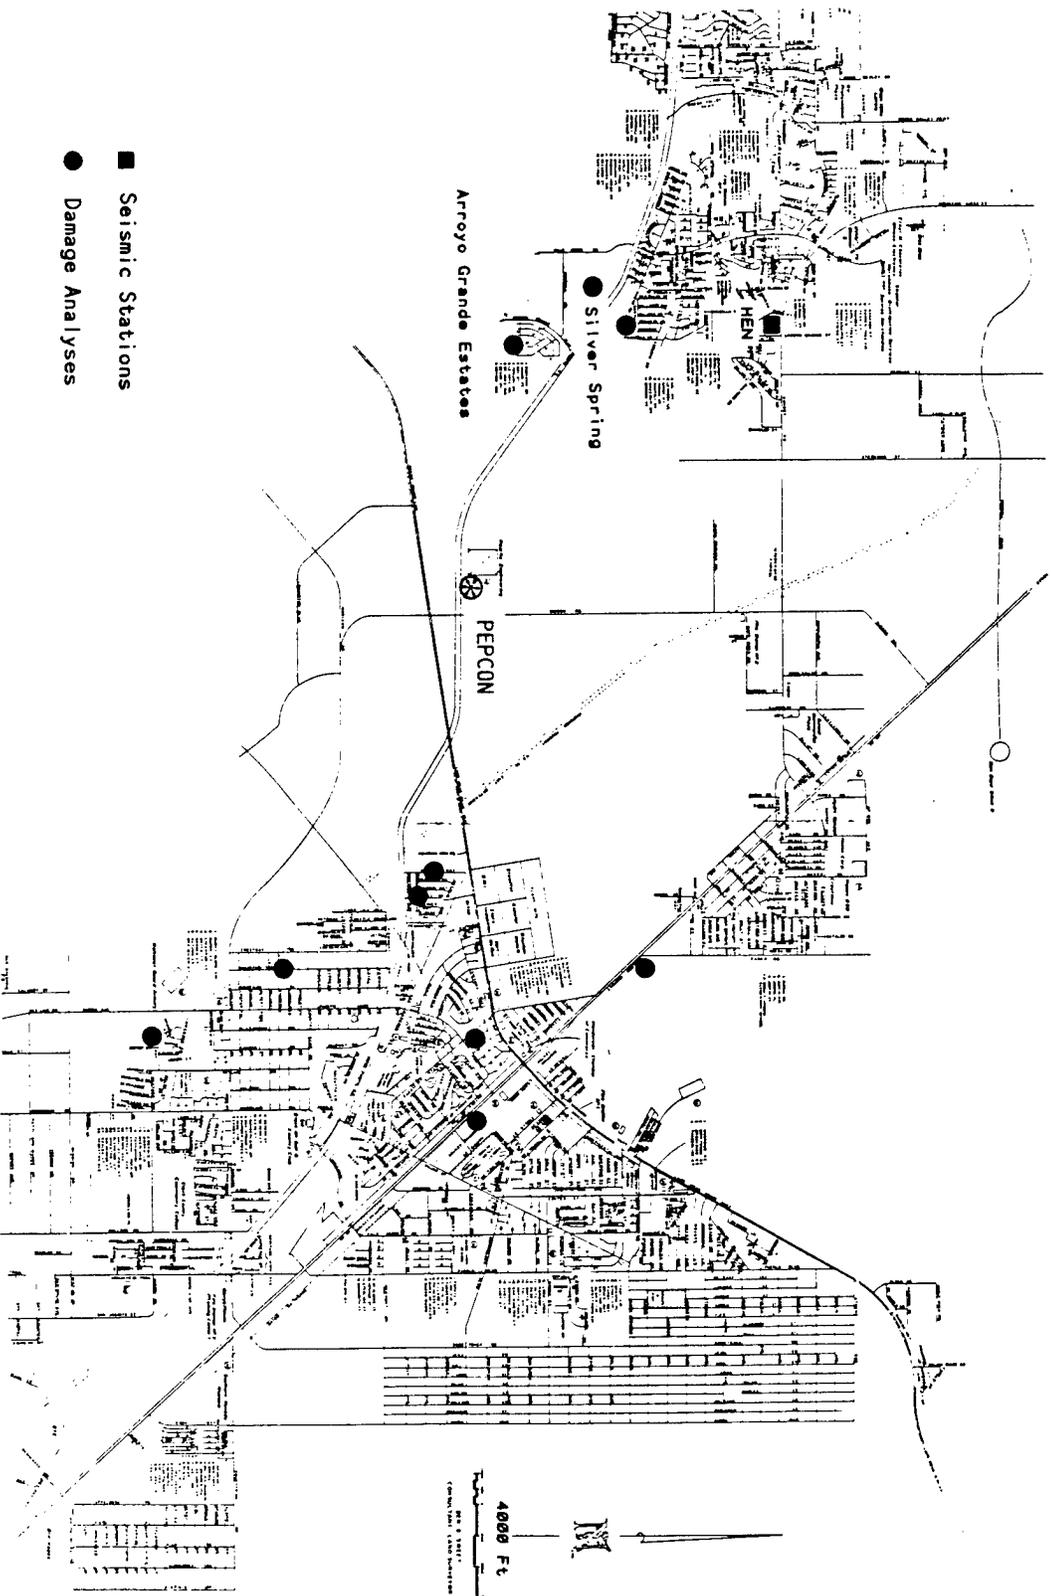
Figure 9. Street map of Henderson, Nevada, (from Henderson Chamber of Commerce), with explosion site and locations for damage analyses.

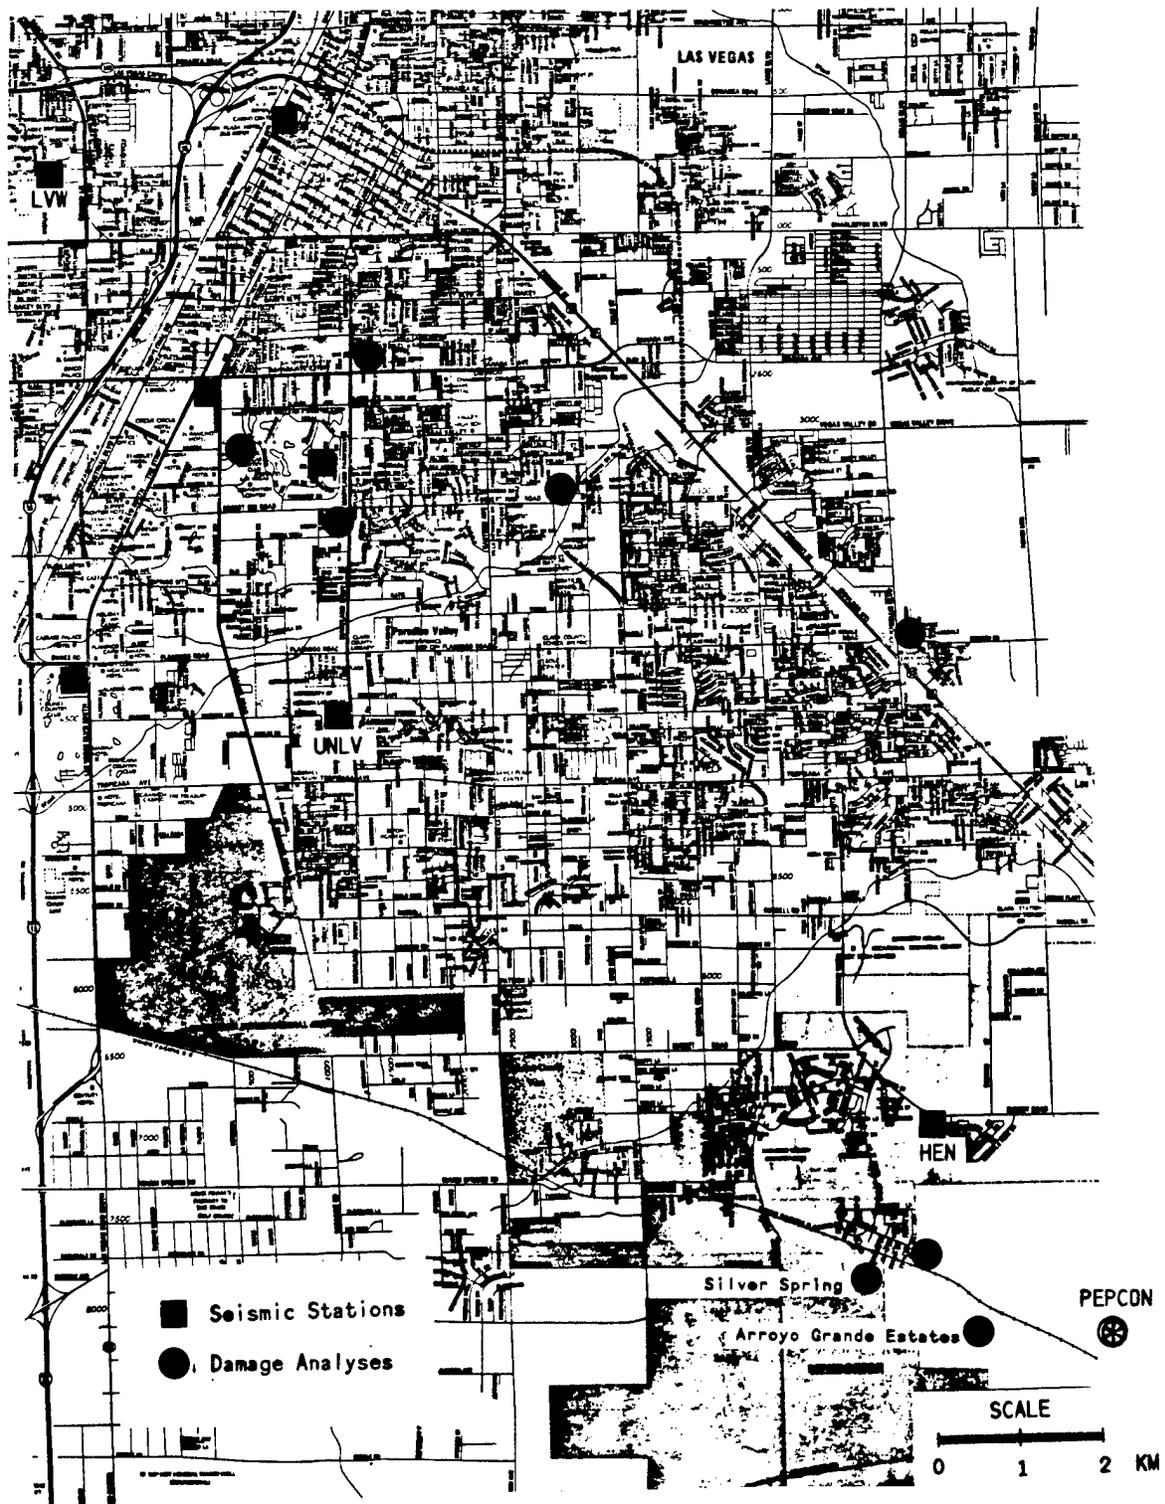
J. L. Woodruff, of URS/John A. Blume & Associates, seismic consultants to DOE-NVO, lives near Boulder Highway and Flamingo Road, Las Vegas, about 9 km from the blast according to the Las Vegas map in Figure 11. He reported that about one-third of his neighbors had window damage. This was interpreted as 330-Pa overpressure, near the -10 m/s gradient curve and clearly lacking any strong enhancement in spite of their generally downwind direction. They were probably in the "silent zone" between focused caustic arcs.

Continuous recordings are made at Station S-2, at the University of Nevada Las Vegas (UNLV) Chemistry Building, off Maryland Parkway and south of Flamingo Road, and at the Las Vegas water pumping plant, S-8, north of Charleston Avenue in northwest Las Vegas, as shown in Figure 11. It had been hoped that these recordings could be used to determine times for the various reported explosions, but it appears that only the first and third explosion were strong enough to cause a readable oscillation. Some recorders were not even triggered to operate by ground motion arriving from the first explosion wave, and only recorded the airblast wave. Clear audibility of only two blasts was also reported (R. C. Bass, SNLA-7111, pers. comm., 1988) from a point on Sahara Boulevard, between Paradise Road and Maryland Parkway. On the other hand, as previously cited, a video-camera recording gave both video and audio indications of a moderately large explosion about one second before the final, large blast.

Figure 11. Street map of Las Vegas, Nevada (from Rand McNally), with explosion site and locations for damage analyses.
