FAILURE OF TUNGSTEN HEAVY ALLOYS SUBJECTED TO DYNAMIC TRANSVERSE LOADING

K. Tarcza^{1,2}, S. J. Bless*¹, and E. Taleff³

¹ Institute for Advanced Technology, University of Texas at Austin

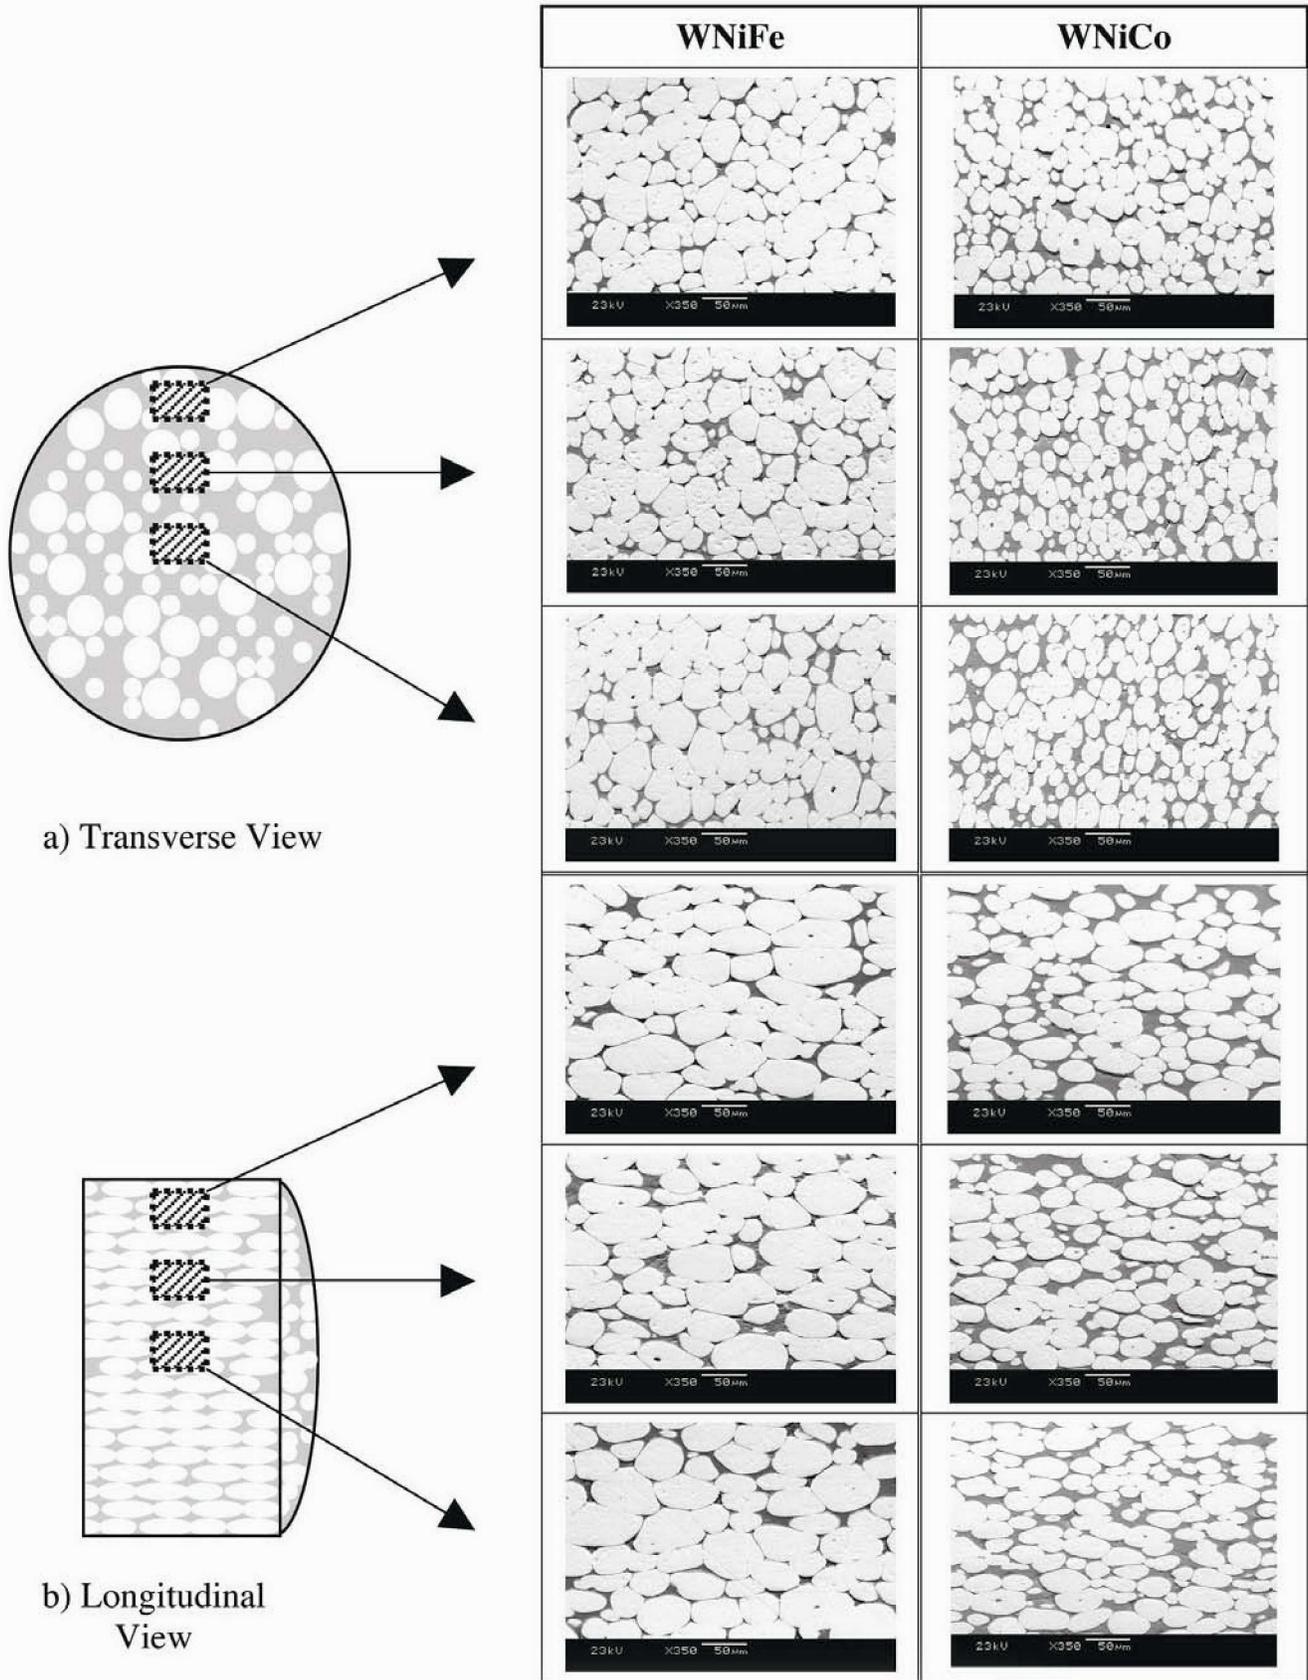
Results are shown in Fig. 2. Each material is remarkably homogenous. The WNiCo alloy has a notably finer W grain size than the WNiFe alloy.

Figure 2. Microstructure of the as-received tungsten stock

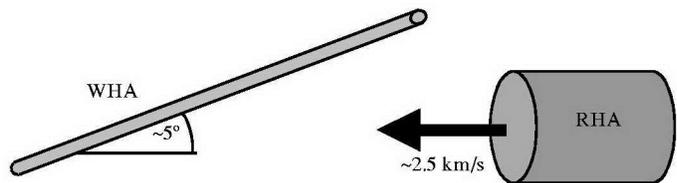
Figure 4. Reverse impact setup.
