Chesapeake Bay Breakwater Database Project, Section 227 Demonstration Site: Hurricane Isabel Impacts to Four Breakwater Systems

July 2006

Final Report

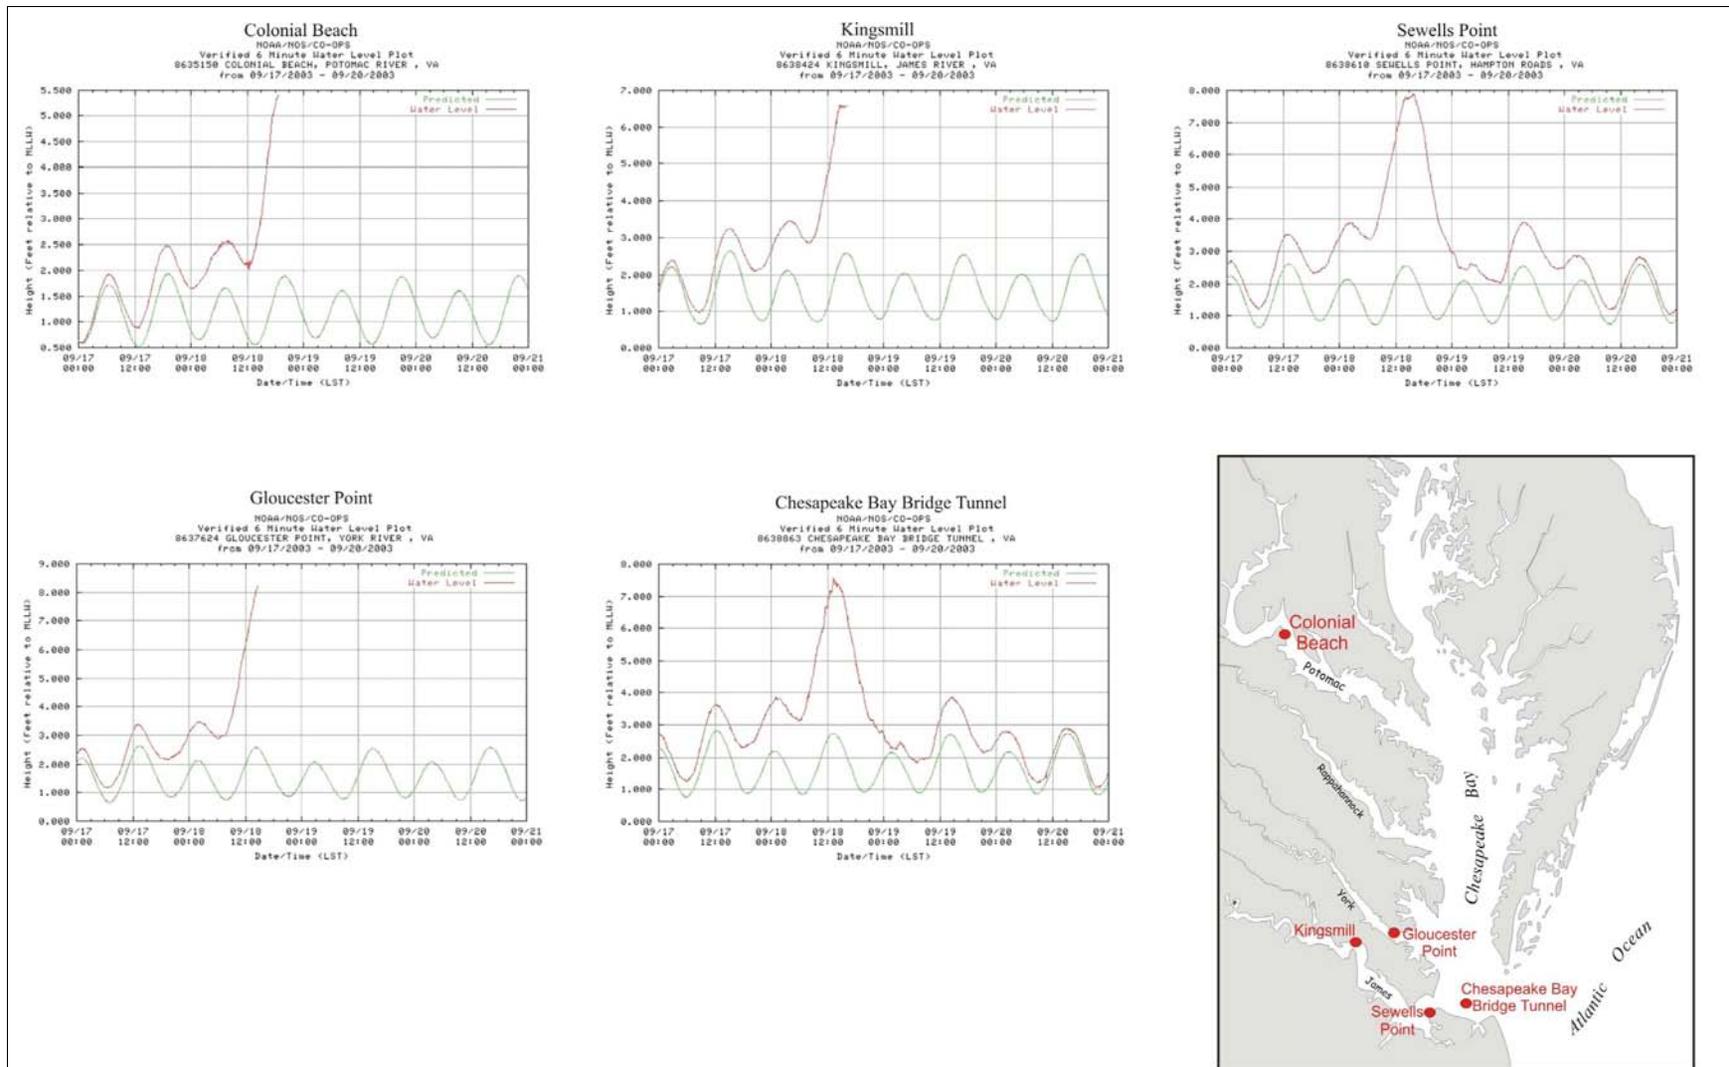
Figure 14. Verified water levels at wave gauges around Chesapeake Bay during the storm and approximate gauge location. From the NOAA Web Site (<http://www.co-ops.nos.noaa.gov/>)

Yorktown is located across the York River from VIMS where NOAA maintains the Gloucester Point tide gauge (Figure 14). During Isabel the gauge stopped at about 2:30 p.m. with a reading of about el +8.3 as the tide was still rising. Wind speed measurements at VIMS provided by instruments atop VIMS' Byrd Hall showed that maximum sustained winds on the campus reached 65 mph, with 144.8-km/hr (90-mph) gusts. The barometer bottomed out at 74.1 cm (29.2 in.), with a rainfall accumulation of about 5.6 cm (2.2 in.). At the height of the storm, VIMS' ADCP measured what might be considered a deepwater wave of 1.8 m (6 ft) with a 5 sec period. Still-water level at Yorktown was measured at el 8.6 (mean tide range is 0.7 m (2.4 ft)), and the combination of maximum storm surge and wave runup was measured at about el 12.5. One could infer that there could have been a 1.2 m (4 ft) or greater wave breaking across the breakwater system and into the adjacent infrastructure.

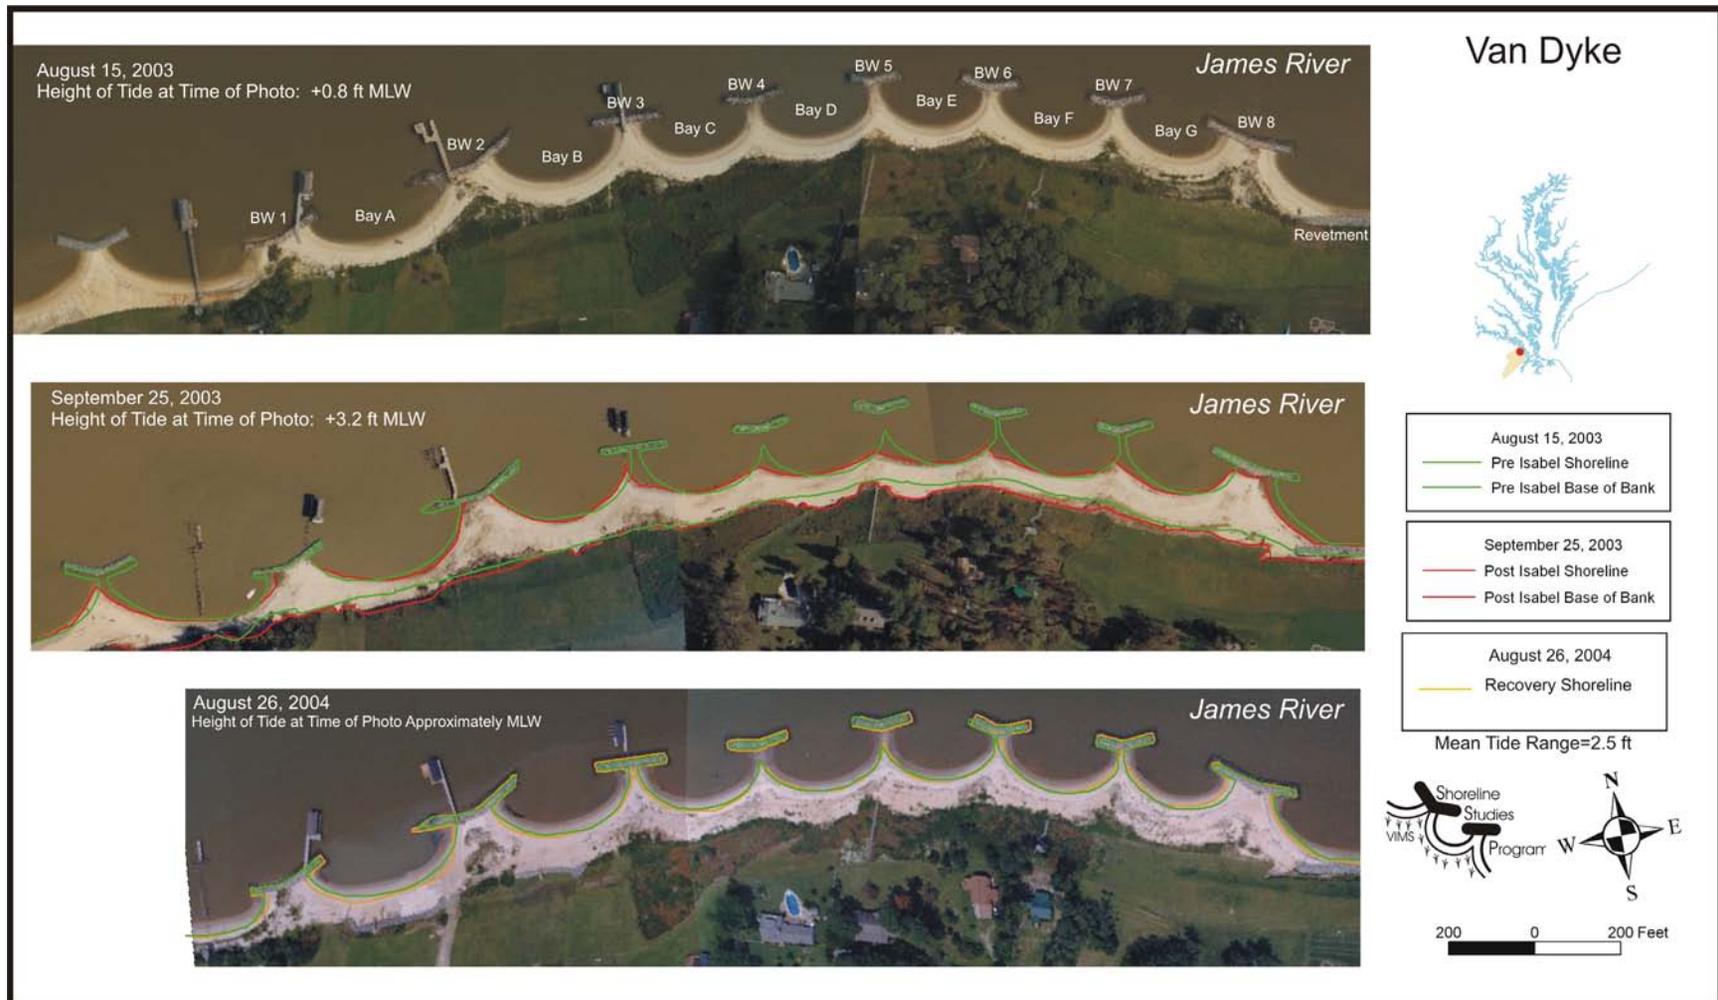
Figure 23. Van Dyke low-level pre- and post-Hurricane Isabel and recovery ortho-rectified aerial photographs

Aerial imagery pre- and post-Isabel shows mostly landward shifts in the positions of both the shoreline and base of bank (Figure 23). Reduction in tombolo size are seen behind BW3, BW4, BW5, BW6, and also BW7, which had the narrowest attachment before the storm. The adjacent BOB along these structures also receded. Significant BOB recession also occurred in Bay A. General BOB stability is seen between BW2 and BW4 as well as between BW7

and BW8. These trends are shown in typical profiles for select bays and breakwaters (Figure 24). The combination of storm surge and wave height exceeded el 11, about 0.9 m (3 ft) higher than project design. Post-storm recovery shows the shore planforms have returned to approximately their pre-storm configuration (Figure 23).

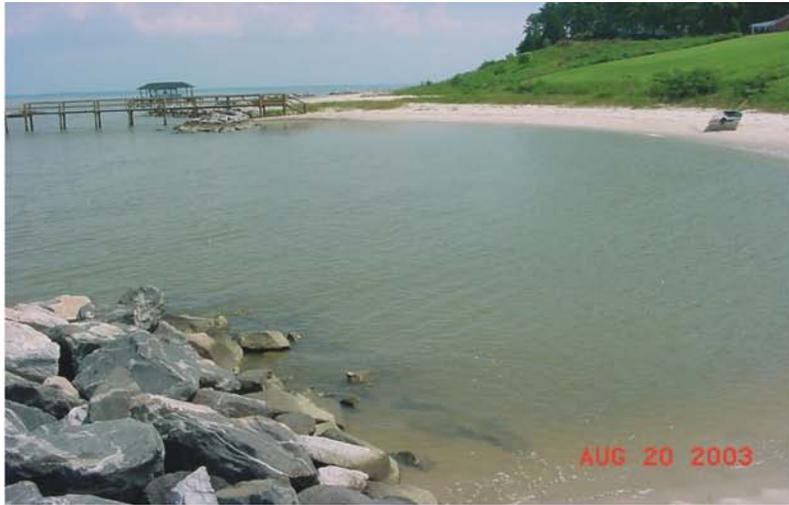
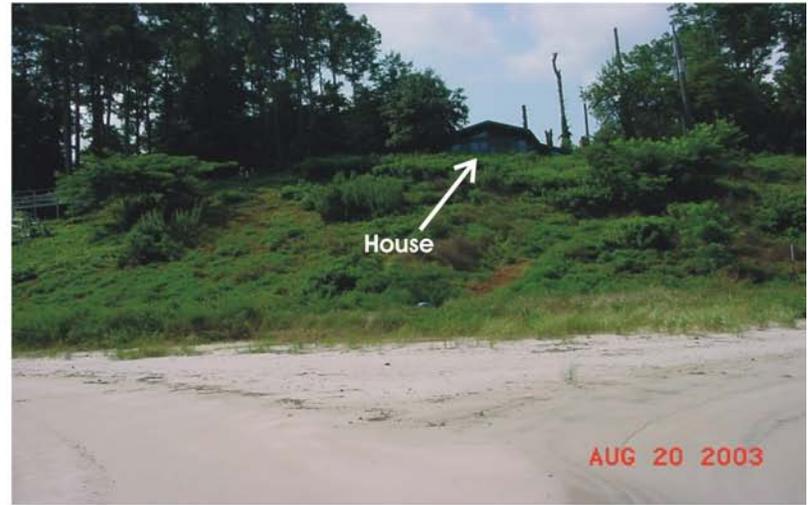
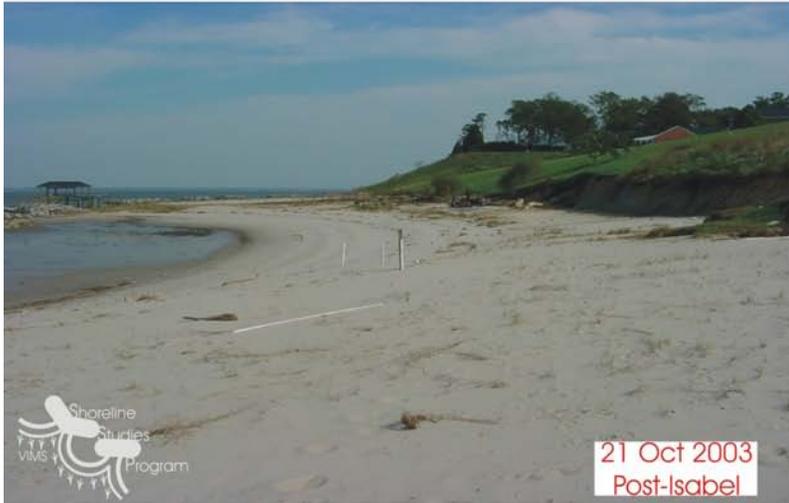
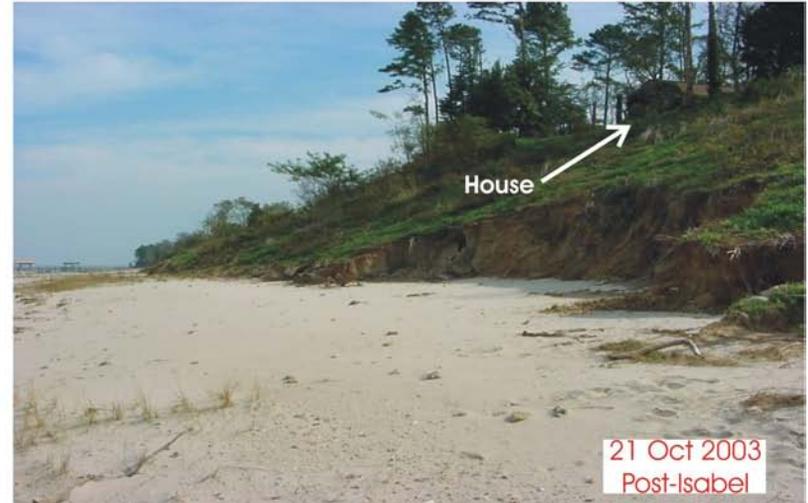
Figure 25. Van Dyke ground photographs before and after Hurricane Isabel

Ground photos taken before and after Hurricane Isabel show the extent of the upland bank scarping by the combination of storm surge and wave impacts (Figure 25). The retreat of the BOB was generally more severe in the embayments than behind the breakwaters and associated tombolos. Also, BOB impacts were minimal where the interface between the backshore and BOB had a less steep gradient. This occurred where the banks had been mined for sand, at Bay B and Bay G.

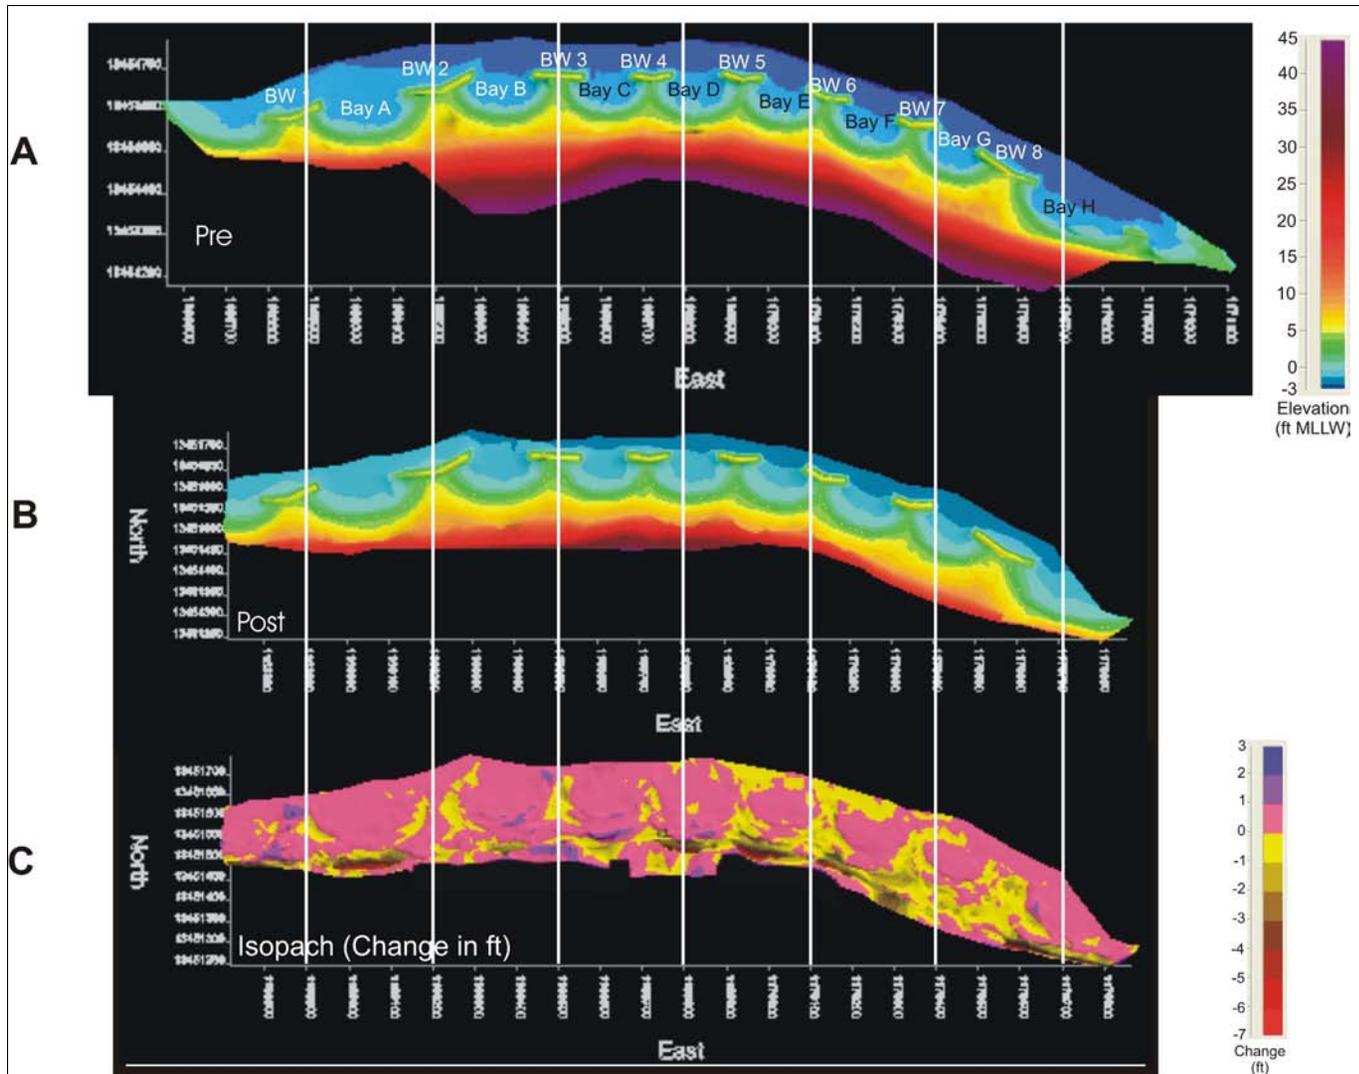
Figure 26. Van Dyke: (a) pre- and (b) post-storm color contour maps, and (c) isopach map showing elevation changes between surveys

The overall change in topography at this site is seen in Figure 26. Negative topographic changes are evident at each tombolo and around and in front of BW5, BW6, and BW7. Severe land reduction occurs along the aforementioned BOB and along the top of the downriver revetment. Consequent increases or no change in topography are generally greater in the nearshore areas as indicated by the pink patterns ($0\text{ m} < \text{change} < 0.3\text{ m}$) ($0\text{ ft} < \text{change} < 1\text{ ft}$).

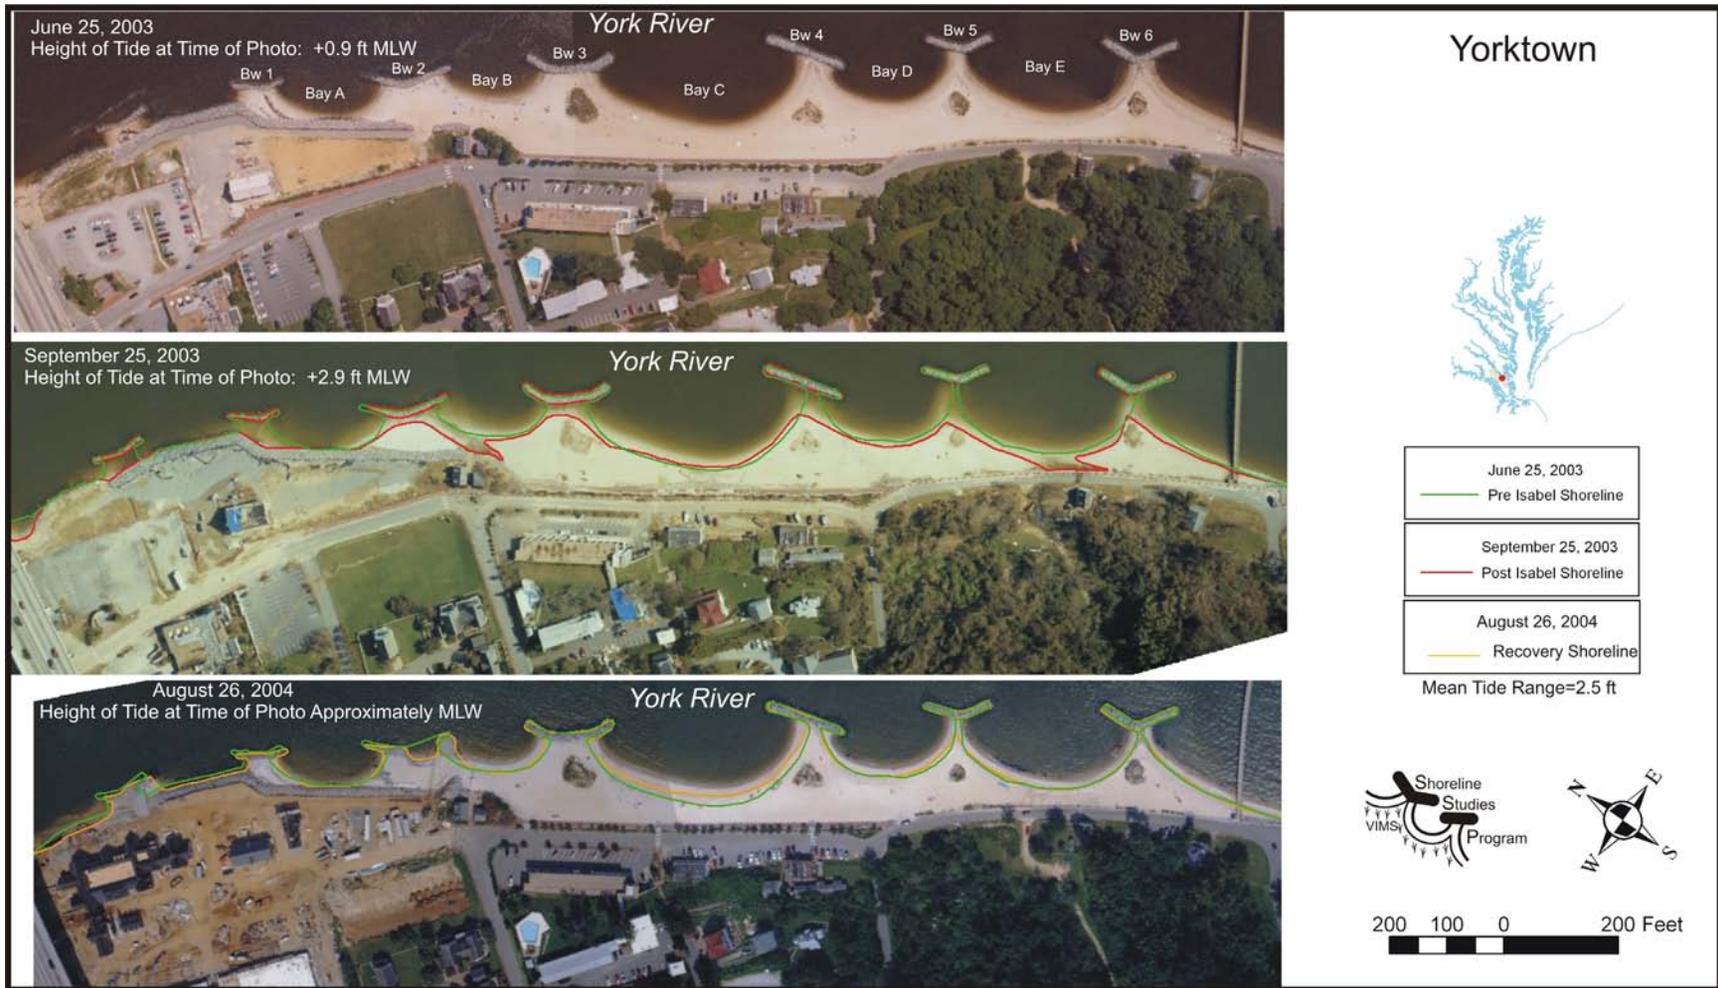
Figure 27. Yorktown low-level pre- and post-Hurricane Isabel and recovery ortho-rectified aerial photographs

Pre- and post-Isabel low-level aerial imagery show a narrowing of each tombolo and a landward shift of sand behind each breakwater unit (Figure 27). The shoreline position in the two middle and largest embayments showed only slight changes after the storm. Typical profiles show cross-sectional changes as a basic cut and fill in the embayments (Figure 28). Shearing occurred across the top of the tombolos as well. Some sand was lost to the offshore after the storm, but the county filled the beach to its pre-storm profile shortly after the hurricane. Post-storm recovery about 1 year later shows shore planforms to have returned to their pre-storm position. A noticeable shore advance is seen in Bay B and D.

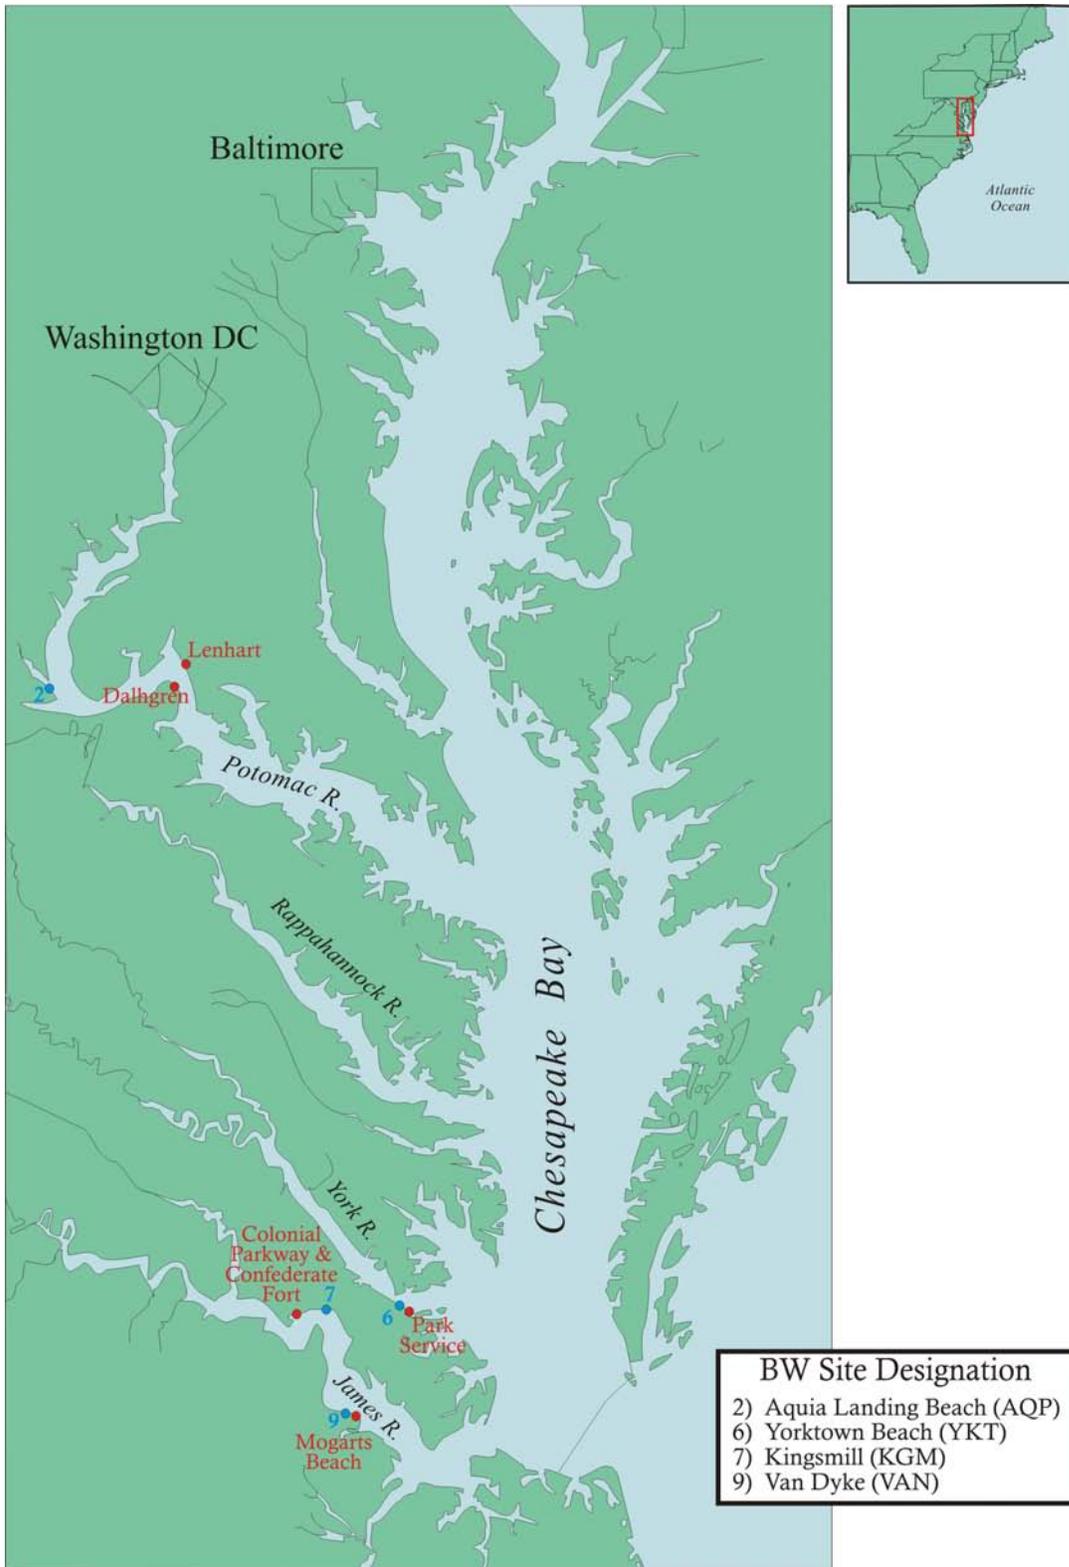
Figure 31. Location of breakwater sites used in this report (blue) and other affected sites (red)

Just downriver at two other sites which had no shore protection system, significant change occurred (Figure 31). Dahlgren is on the south side of the Potomac River just downriver from the Route 301 Potomac River Bridge. Its bank was eroded 4.6 to 6.1 m (15 to 20 ft) threatening upland infrastructure (Figure 32). On the north side of the Potomac River, Lenhart is slated for development. During the storm, its bank retreated 3.0-4.6 m (10-15 ft) (Figure 33).
