TECHNICAL REPORT 1943
July 2006

**Impulse Flashover Tests at
Edgar Beauchamp High Voltage
Test Facility, Dixon, California**
In Support of Cutler Insulator Failure Investigation

P. M. Hansen
SSC San Diego

G. Dann
Naval Facilities Engineering Service Center

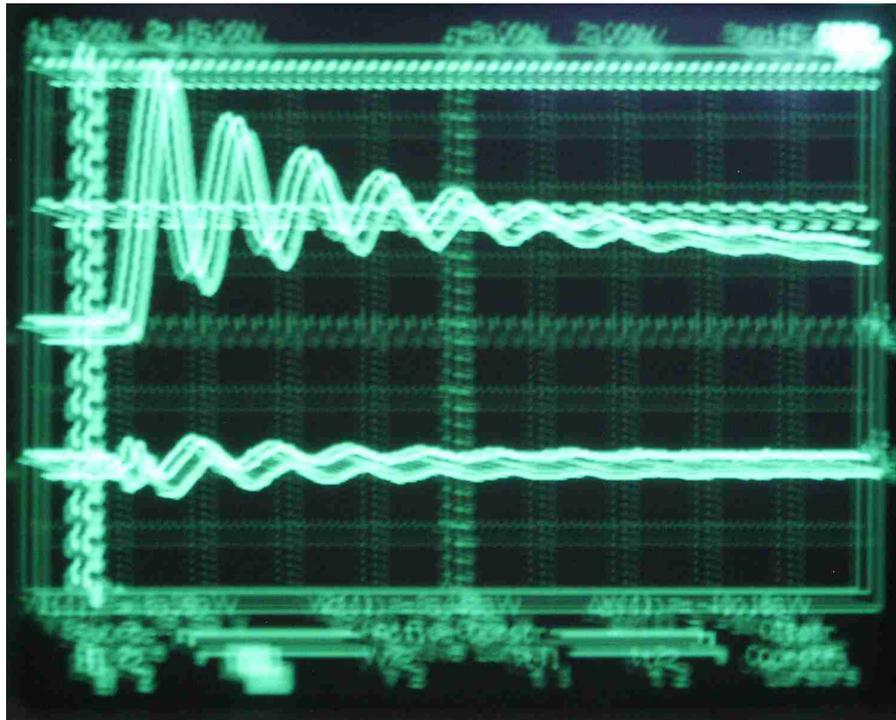
With shorting bars in place of front resistors, the voltage wave displayed decaying oscillation. The rise time was about 0.6 μ s. Note that in Figure 4 that flashover has not occurred and the current shown is leakage current.

Figure 4. V and I with shorting bars for the front resistor, V below flashover. Flashover has not occurred.

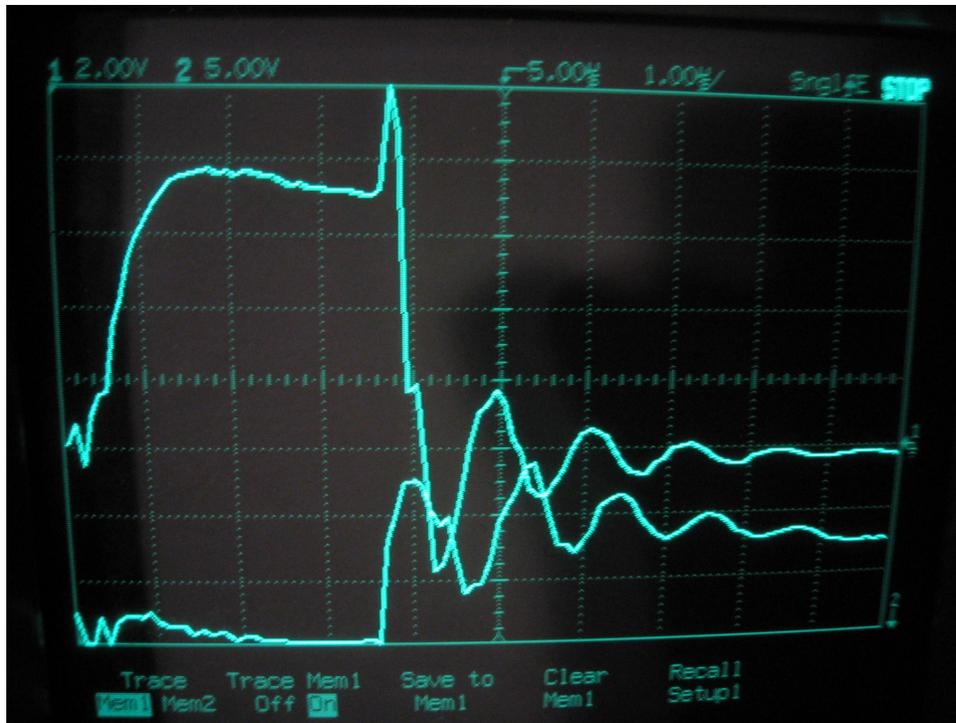
As the charging voltage is increased, the first flashovers occur well after the voltage peak. Figure 5 shows an example of the voltage and current waveforms for that condition. The large peak in the current waveform at the same time that the voltage waveform is cut off is the evidence of flashover. The current rings down as an exponentially damped sine wave.

Figure 5. V and I with shorting bars for the front resistor, V just above flashover. Flashover occurs well after voltage peak.

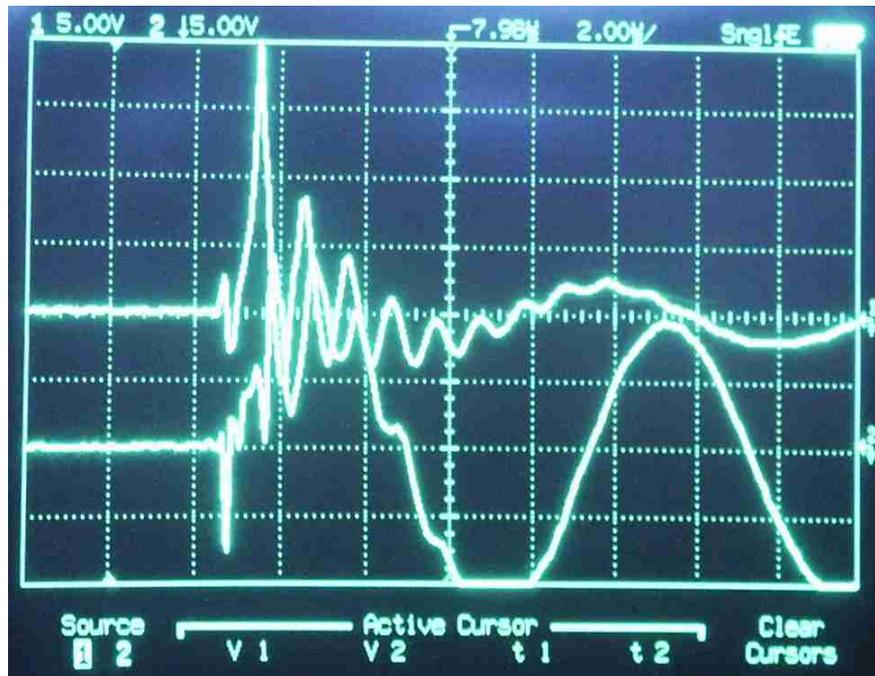
As the charging voltage is raised further, dV/dt increases and flashover occurs earlier in the pulse so that the current peak and voltage drop move to the left. At sufficiently high dV/dt , flashover occurs on the leading edge of the voltage waveform before it reaches the maximum peak. An example of this is shown in Figure 6.

Figure 6. V and I with shorting bars for the front resistor, voltage well above flashover. Flashover occurs on leading edge of pulse.

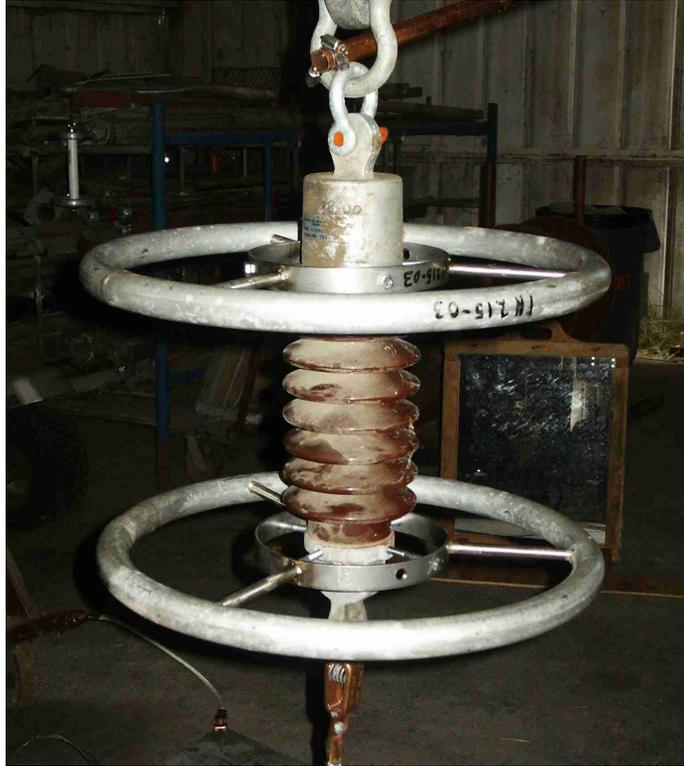
Figure 7. Austin A-S3003S safety core insulator with two large rings.

This configuration (Figure 7) was hit with a series of pulses starting with a charging voltage of 10 kV/stage and ending with 80 kV/stage. When there was no flashover, the peak voltage reached more than six times the charging voltage due to the circuit ringing. No flashover was observed for charging voltages up to 30 kV/stage (~200 kV peak).

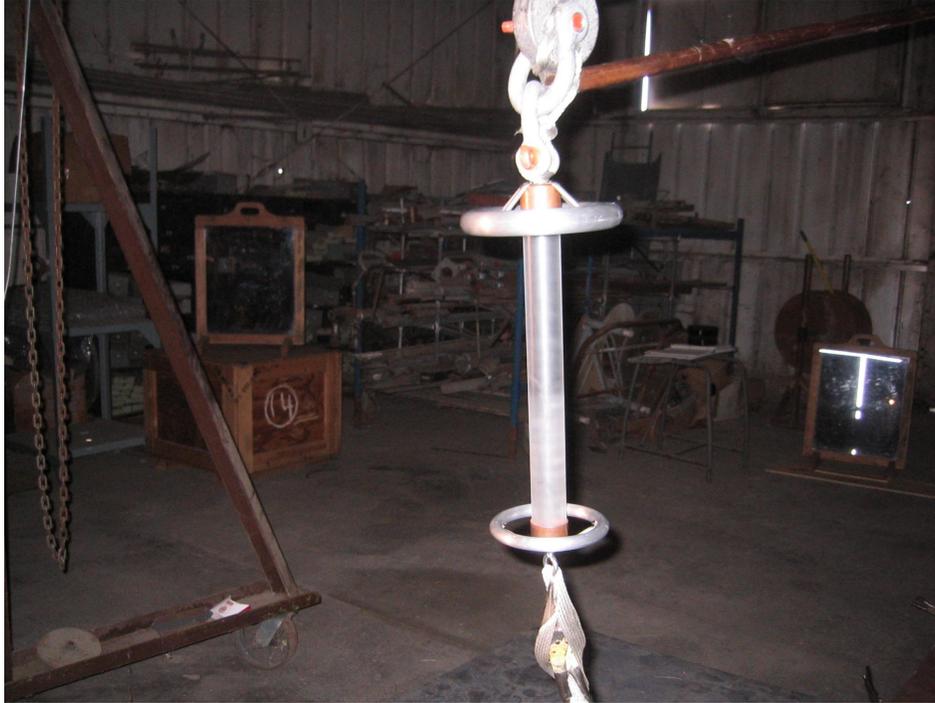
For that reason, we constructed the remaining scale model insulators using similar copper end fittings and aluminum rings and attaching hardware but replacing the hollow PVC pipe with a solid polycarbonate rod. The polycarbonate plastic rod makes an excellent insulator. This material is similar to the material used for the see-through body of the full-scale insulator tested at Hydro Quebec (Figure 2). The specifications for the plastic in this insulator are given in Appendix A: Polycarbonate Plastic Specification. The scale model of the Cutler insulator suspended in place for testing is shown in Figure 10.

Figure 10. 1/7th Scale model of the Cutler safety core insulator.

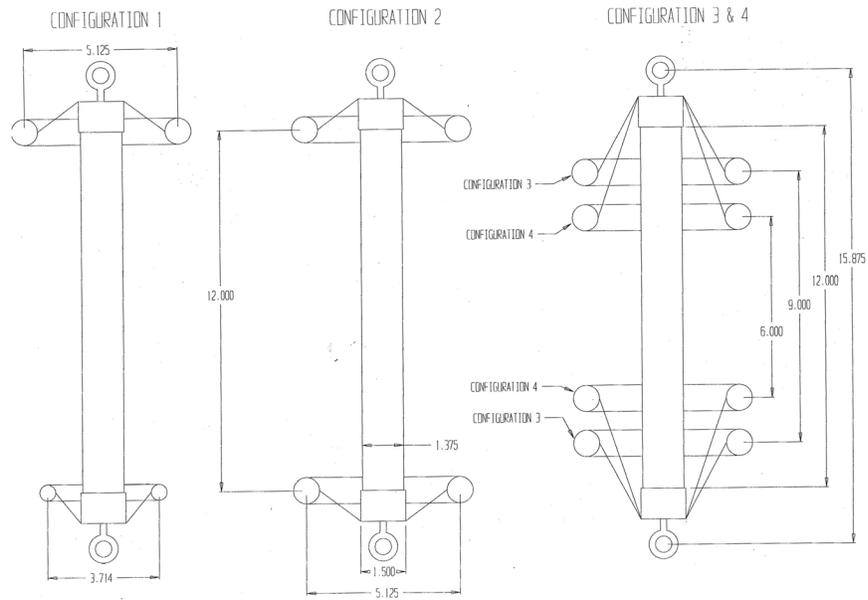
Configuration 1, on the left in Figure 11, is a drawing of the scale model Cutler insulator pictured in Figure 10. Configuration 2, in the center of the figure, is similar, but the small ring at the grounded end has been replaced with a larger ring, making it symmetric. This configuration has only slightly less air gap than configuration 1.

Configurations 3 and 4 are shown on the right in Figure 11. They are also symmetrical and use rings of the same size as the high-voltage end of the Cutler insulator but they have been moved closer together so that a portion of the insulator body is covered. This shortens the flashover path in air and significantly reduces the field on the triple points at the end of the insulator body. Configuration 3 reduces the air gap between the rings to 2/3 of that of configuration 2.

Figure 11. Scale model insulator configurations tested.

The proposed concept for protecting the safety core insulator from lightning involves reducing the air gap distance and moving the air (flashover) path farther away from the insulator. The concept is to decrease the ratio of the air gap path to the surface flashover path. At the same time, it is desirable to move the air gap path farther away from the insulator surface. We tested five configurations to investigate this concept. Four of the test configurations are shown in Figure 11. Some of these configurations have reduced RF withstand capability over the original configuration because the air gap has been shortened. The amount of reduction in RF withstand voltage is approximately equal to the percentage the air gap is reduced.

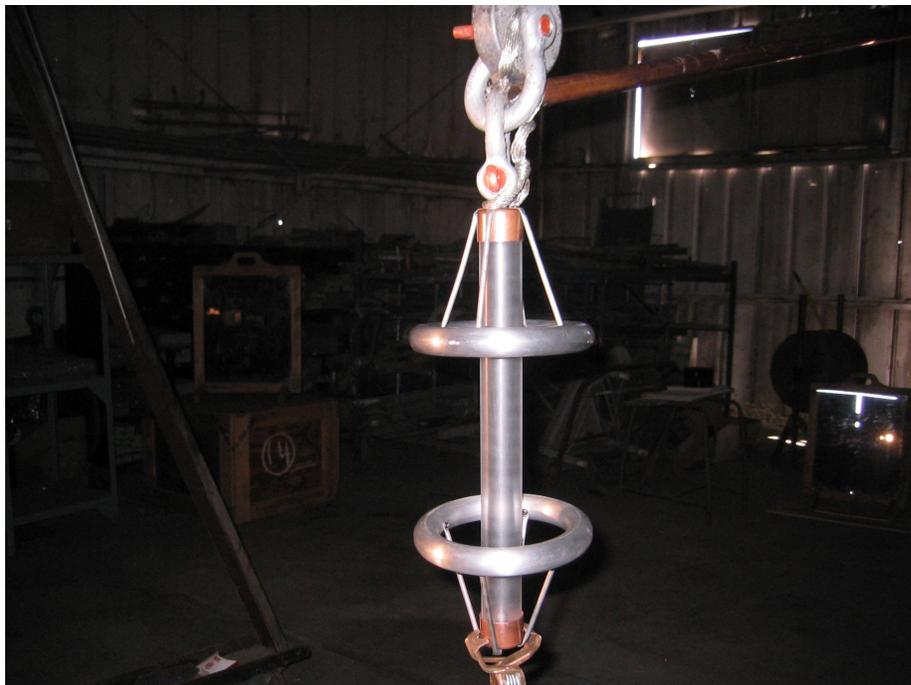
Configuration 4 is similar to configuration 3 except that the rings are moved closer together so that the air gap is reduced to 1/2 that of configuration 2. A test sample of configuration 4 is shown in Figure 12.

Figure 12. Configuration 4 test sample in place.

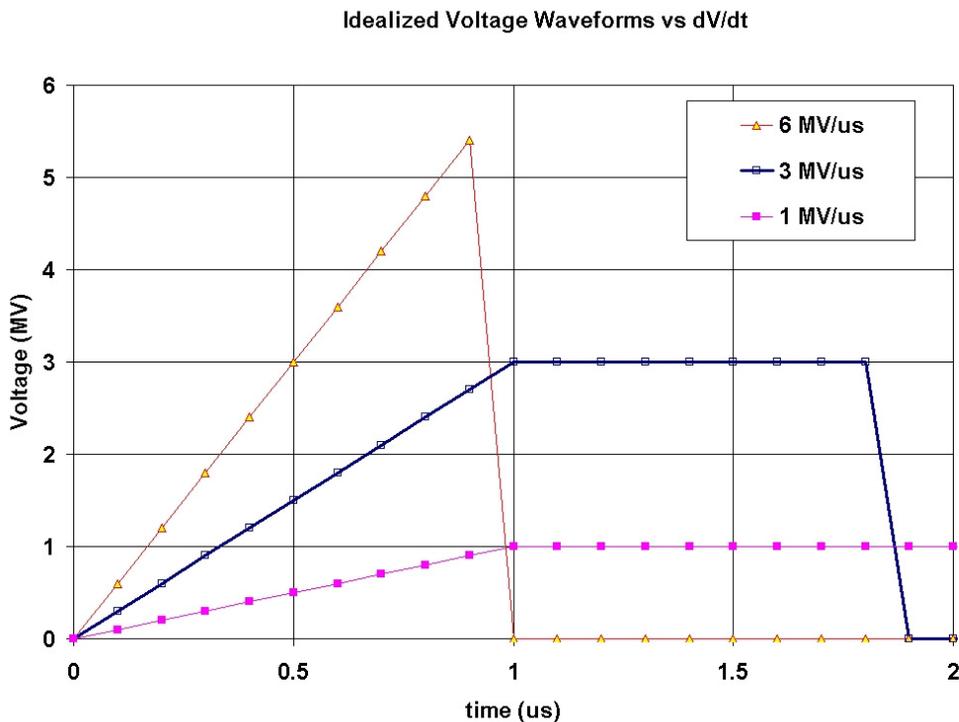
Figure 17. Flashover phenomena for low dV/dt waveforms.

At low values of dV/dt , flashover occurs well after the peak of the waveform. The $1\text{ MV}/\mu s$ curve has a peak voltage of 1 MV . This was the threshold for flashover in the Hydro Quebec tests. At that level, flashover did not occur until almost $10\ \mu s$ after the waveform started (off scale to the right in the figure). As dV/dt increases, the delay to flashover in air reduces. This can be seen in the curve for $3\text{ MV}/\mu s$ curve, which is similar but the delay is less, with flashover occurring at $1.8\ \mu s$. When $6\text{ MV}/\mu s$ is reached, flashover occurs on the leading edge of the pulse and the peak pulse voltage is reduced over what it would be if flashover had not occurred.

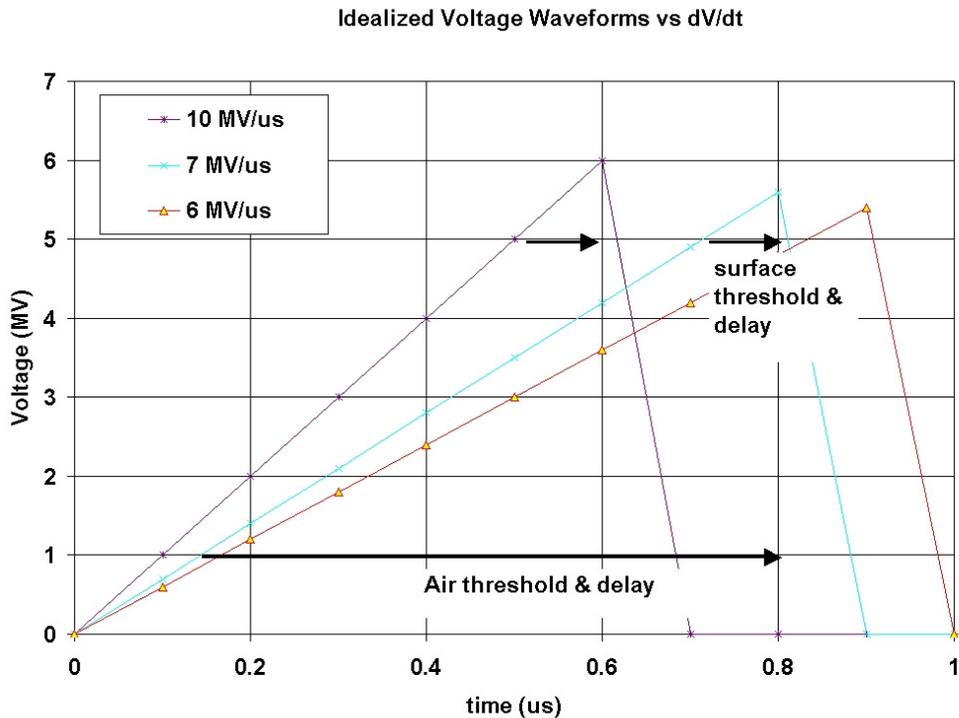
Figure 18. Flashover phenomena for high dV/dt waveforms.

This figure includes the 6-MV/ μ s curve where flashover just started to occur on the leading edge of the pulse. The next curve, 7 MV/ μ s, is where flashover began occurring on the surface. The picture in Figure 16 shows the flashover path observed for this level of dV/dt. At greater values of dV/dt the flashover path was entirely along the surface (Figure 2).

The observed air flashover initiation threshold is 1 MV. Assuming the surface flashover initiation threshold is 5 MV gives a much faster surface propagation time than the factor of 2 to 4 estimated from the ratio of surface and air path lengths in Figure 16. To illustrate this, arrows have been placed in Figure 18 indicating both the air flashover threshold and delay time and an estimated surface flashover threshold and delay. From the figure, it can be seen that for values of dV/dt less than 7 MV/ μ s the timing is such that flashover will be in the air. At a value of dV/dt of 7 MV/ μ s, the combination of thresholds and delays makes it such that flashover occurs at the same time for surface and air phenomena. Thus, at this value of dV/dt, flashover will occur sometimes on the surface, sometimes in the air, and sometimes a combination of surface and air. The figure shows that when dV/dt > 7 MV/ μ s, the shorter delay time for surface flashover results in the surface flashover path, completing well before the air path is completed.

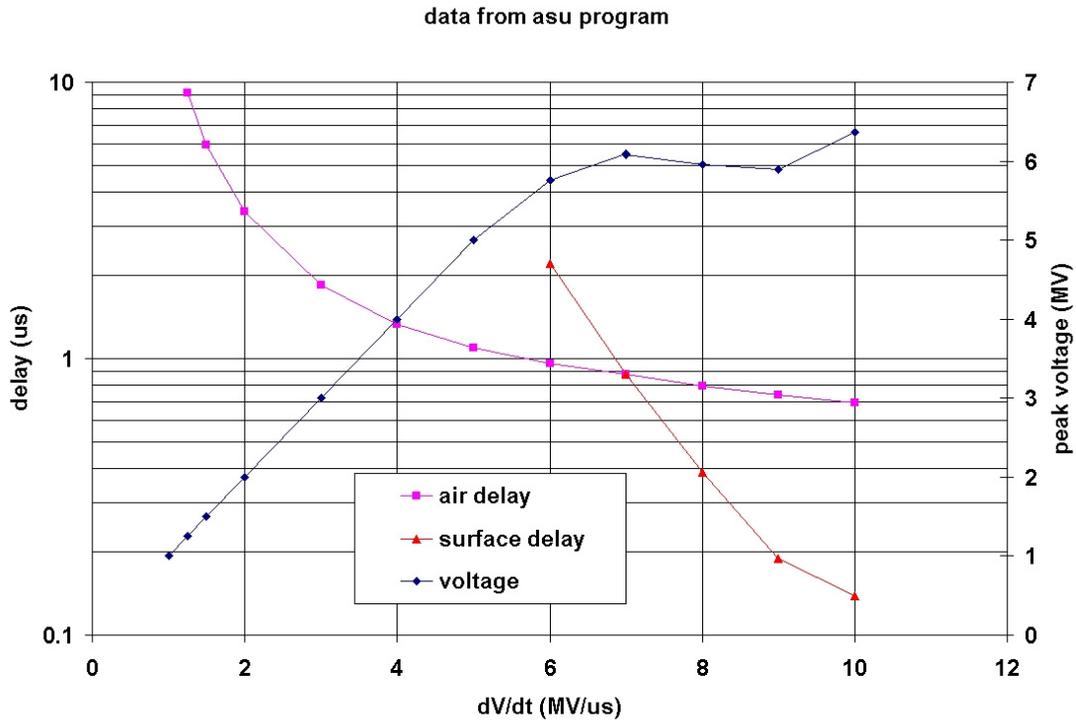
Figure 19. Delay and peak voltage for air and surface flashover.

The threshold for air breakdown was a peak pulse voltage of 1 MV, corresponding to dV/dt of 1 MV/ μ s. The delay curve in the figure shows a corresponding time delay of 9 μ s. As the voltage increases, the delay decreases, asymptotically approaching a value of 0.6 μ s. The figure also contains a speculative curve for surface flashover assuming a threshold of 5 MV and an assumed delay curve. When dV/dt is less than 7 MV/ μ s, the delay of the air flashover is less than that for surface flashover and flashover occurs in the air. The voltages for air flashover are those from the program. However, when dV/dt is greater than 7 MV/ μ s, surface delay is less and flashover occurs on the surface. For this region, the peak voltage shown was estimated using the postulated threshold and delay curve shown. Under these assumptions, the peak voltage actually decreases in a range of dV/dt just above where surface flashover starts. This reduction in peak voltage was observed in the Dixon scale model tests.

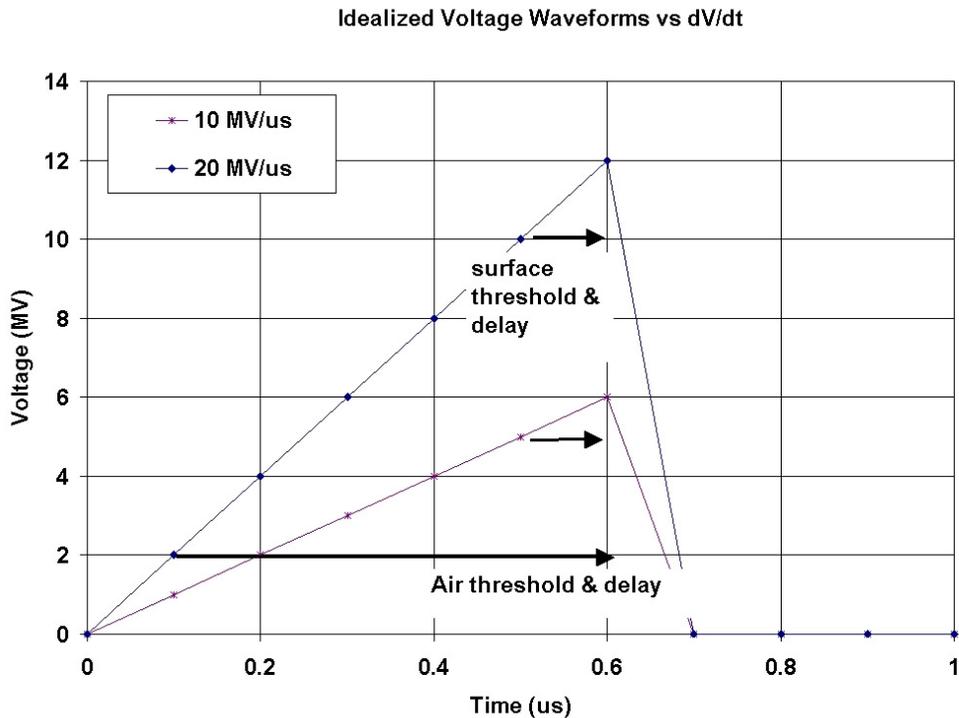
Figure 20. Flashover phenomena with increased surface flashover threshold.

Note that very high dV/dt rates lead to very large voltages across the insulator. For example, in Figure 20 the peak voltage experienced would be 12 MV. This voltage does not last long but there may be failure mechanisms that can result from this voltage. For example, dielectric punch-through happens fast, and this could result when the voltage is high enough even though it was there for a very short period. Computer analysis of the cutler safety core insulator interior was done to examine the possibility that breakdown could occur on the pin inside the high-voltage end-cap if enough oil leaked out to expose a portion of the pin to air [20].

The above explanation of the dV/dt surface flashover threshold phenomena leads to one potential method for increasing the surface flashover threshold by adding shielding around the triple points to increase the surface flashover initiation voltage. An example is shown in Figure 20, where the threshold for surface flashover has been increased to 10 MV. In this case, using the previously postulated delay, surface flashover will not occur until dV/dt reaches 20 MV/ μ s.
