Laboratory and Field Investigations of Small Crater Repair Technologies

Lucy P. Priddy, Jeb S. Tingle, Timothy J. McCaffrey,
and Ray S. Rollings

September 2007

Final report

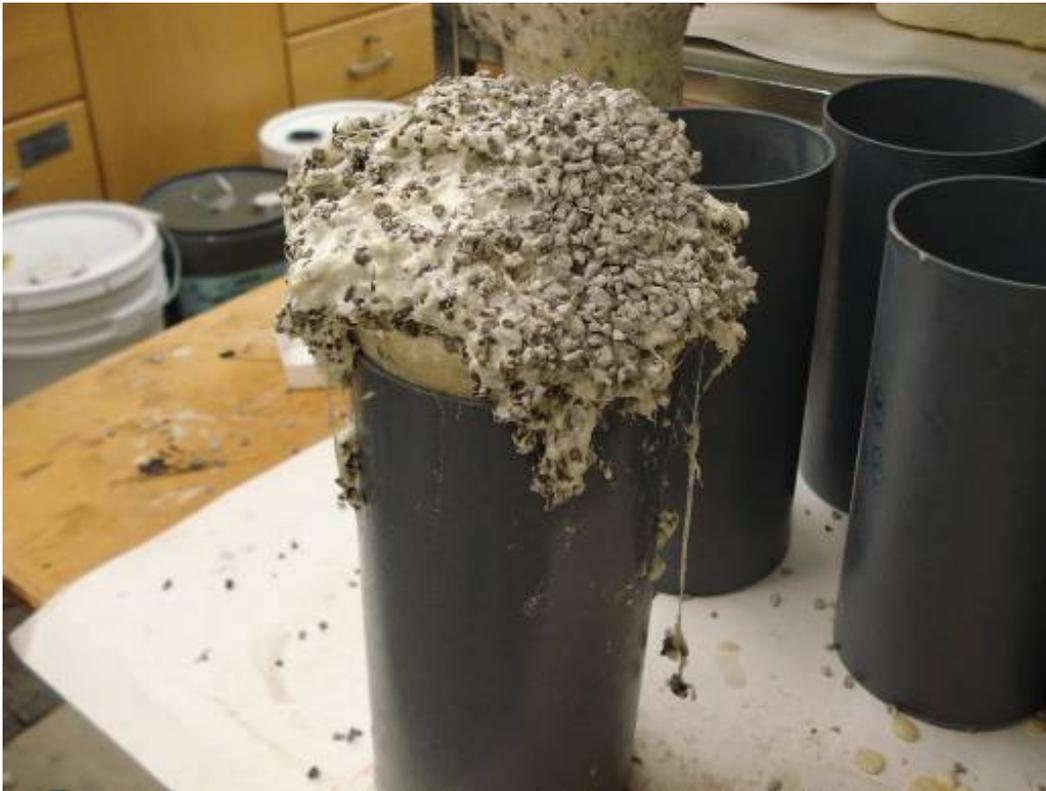
There was no way possible to prepare half-extended samples for Foam-iT! 15 (FI-15) with 0.25-in. and 0.125-in. aggregate because of the difficulty in preparing samples. This difficulty was due to the reduced space between the aggregate grains and the light weight of the small grains. The reduced space made it difficult to penetrate completely through the aggregate, and when the foam penetrated, the grains were expelled from the container as it expanded. This can be observed in Figure 29.

Figure 29. Small aggregate (0.125 in.) pushed from cylinder by expanding foam.

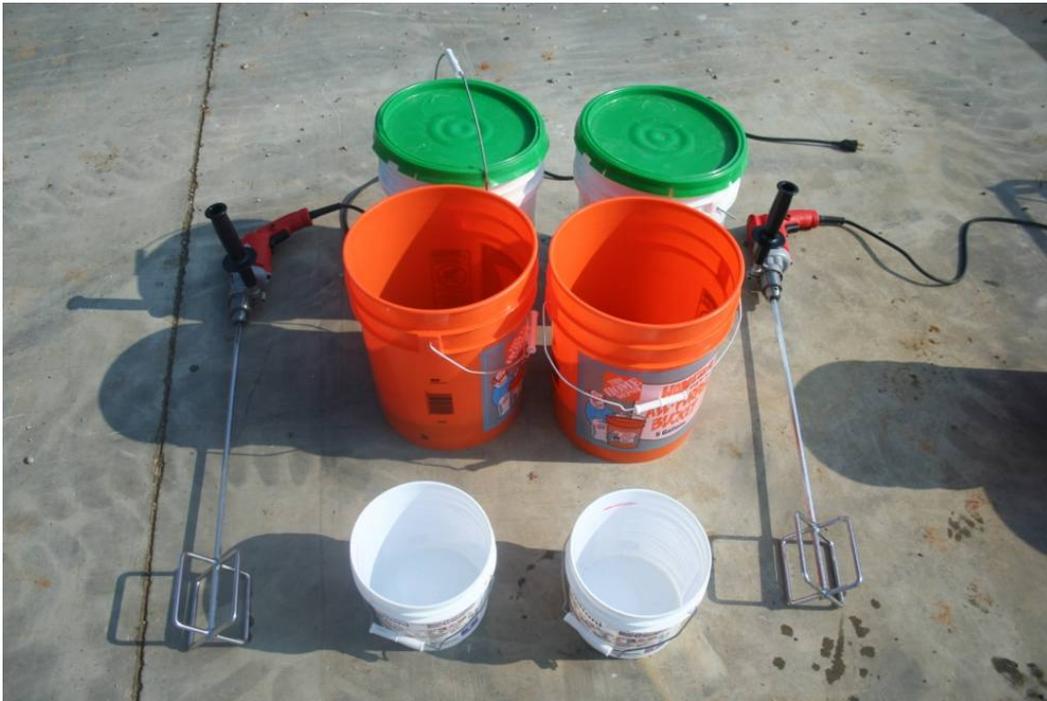
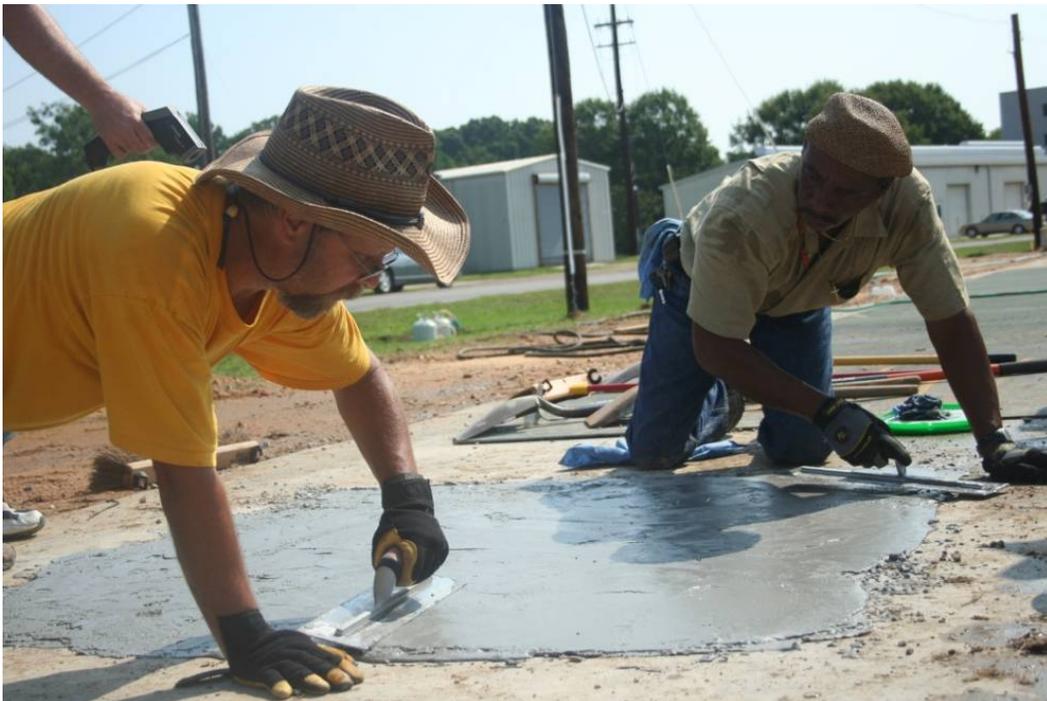
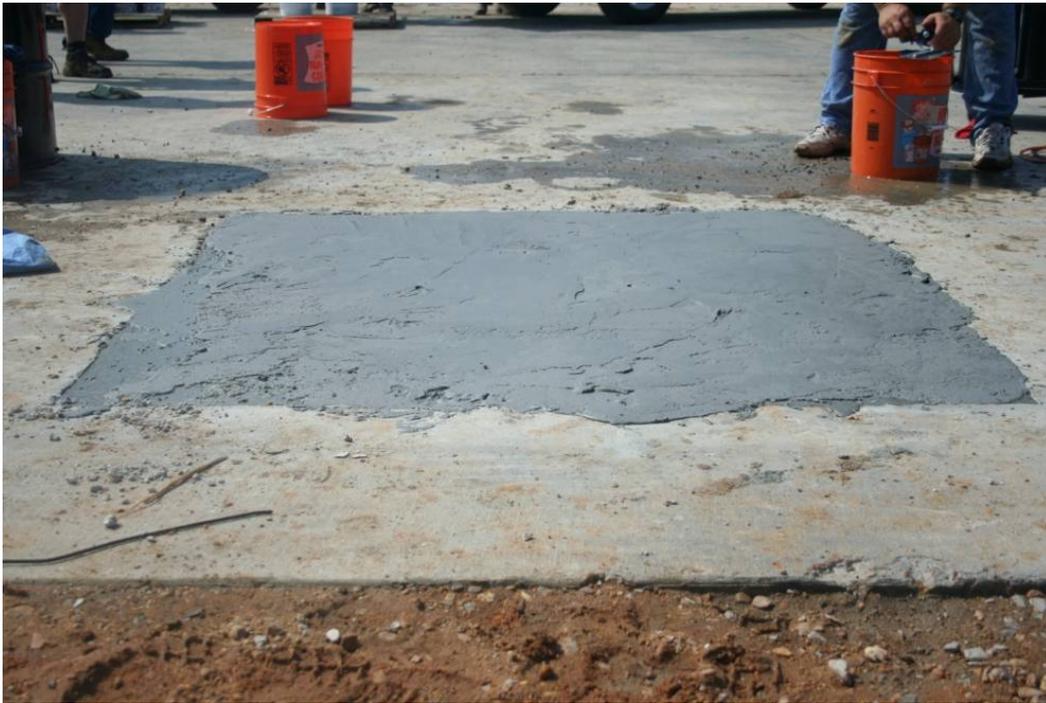
Pavemend SLQ™ is a rapid repair mortar that is used for rapid concrete pavement repair. Nearly 5 in. of rain fell prior to the repair of Crater C, so on the day of placement, the crater was filled with 4 in. of water. The crater

was pumped free of standing water with a sump pump. DCP tests revealed a weakened subgrade. Fans were set up to dry the material in the crater. The vendor wished to continue with the scheduled repair despite the wet conditions. A survey of the base surface indicated that it had settled due to the excess water. Approximately 1 in. of crushed limestone base material was placed on the surface to increase the base thickness to the appropriate level and was hand tamped to compact. Moisture, density, and additional DCP tests were conducted.

Figure 48. Crater C-1. Pavement SLQ equipment and materials.

Figure 49. Crater C-1. Finishing surface.

Figure 50. Crater C-1. Finished surface.

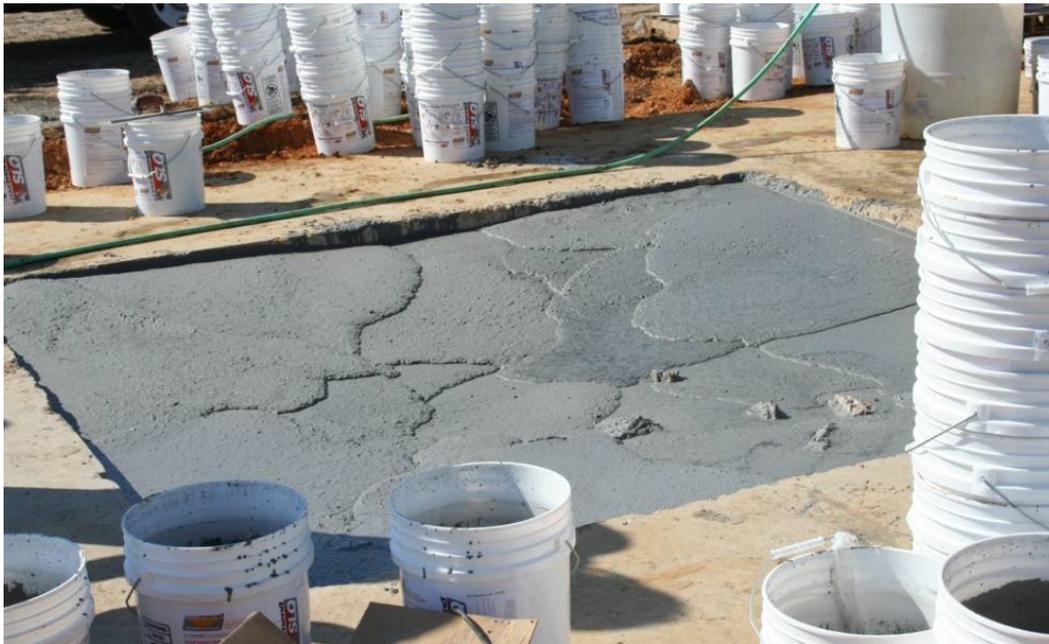
Pavemend SLQ™ was selected for Crater Q. The same mixing and placement as used in Series 2 was followed with the addition of two drills. The material was quickly poured over the debris. The material easily penetrated to the bottom of the repair and flowed towards the center. Approximately 2 hr, 54 min was required to mix 213 buckets of repair material. The material was placed and finished with hand trowels and a straightedge. The mixing was very labor intensive, but the addition of two extra drills reduced the time required to mix the large quantity of material with hand drills. Figure 87 presents the placement and finished surface of the repair. As with the other Pavemend repairs, it was difficult to achieve a smooth surface finish as can be seen in Figure 88.

Figure 88. Crater Q. Surface of Pavemend SLQ™ crater before finishing.

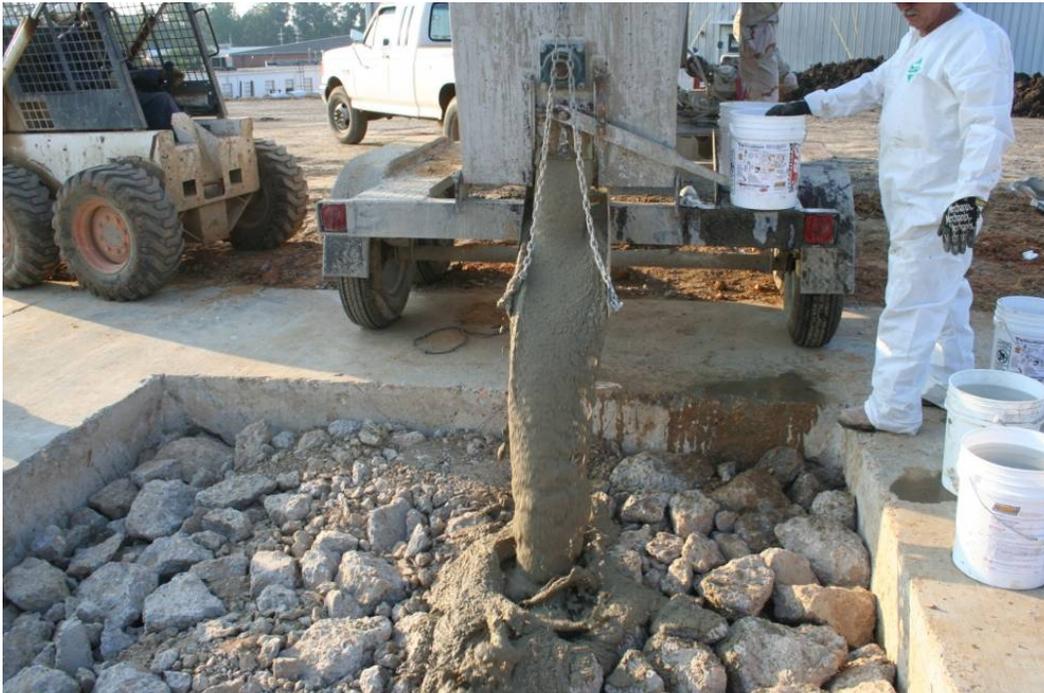
sand, 20.5 gal of water, 1 lb of calcium chloride (CaCl), and one 3-oz bag of RheoFill were mixed in the mixer for 5 min. The CaCl amount was recommended by the vendor representative prior to mixing. The material was then emptied into the crater on top of the debris. The material did not readily penetrate the voids in the debris, and it settled on the surface as can be seen in Figure 89. A small vibratory plate compactor was used to aid the penetration as seen in Figure 90. After 4 hr, the material had not fully cured and was very wet in some places. The cap was not placed until 4 days later. ThoRoc 10-61 was available for the placement of the cap. Once all materials were in place, mixing and placing began. The material was mixed in five batches in the 2-yd³ mixer ranging from 20 to 25 bags of ThoRoc 10-61. Each batch was allowed to mix for 3 min; additional water was added by the half-gallon as needed. When mixing was complete, the material was emptied directly into the crater and was spread with rakes from the north end to the south end. A total of 120 bags of material were required to repair the crater and were mixed using manufacturer instructions. Approximately 1 hr, 13 min was required to mix, place, and finish the material. The material was struck level with a straightedge and finished with a bull float. Water was sprayed on the surface, and the crater was covered with plastic sheeting and allowed to cure. Figure 91 presents the placement of the material, and Figure 92 presents the finished cap.

Figure 89. Crater R. RheoFill placement.

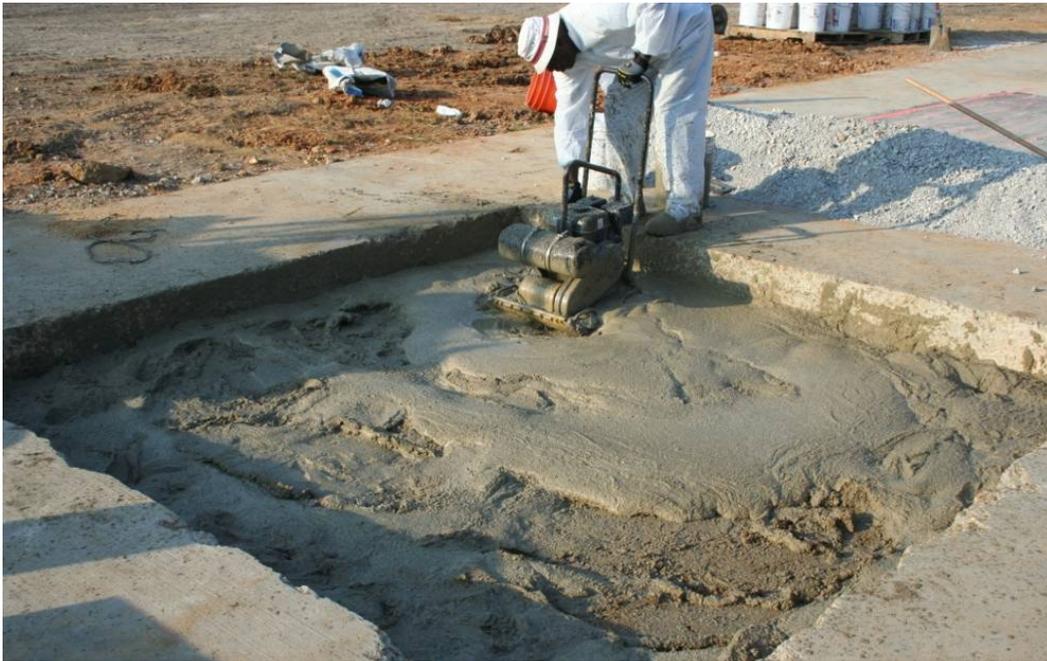
Figure 90. Crater R: Using plate compactor to aid in RheoFill flow.

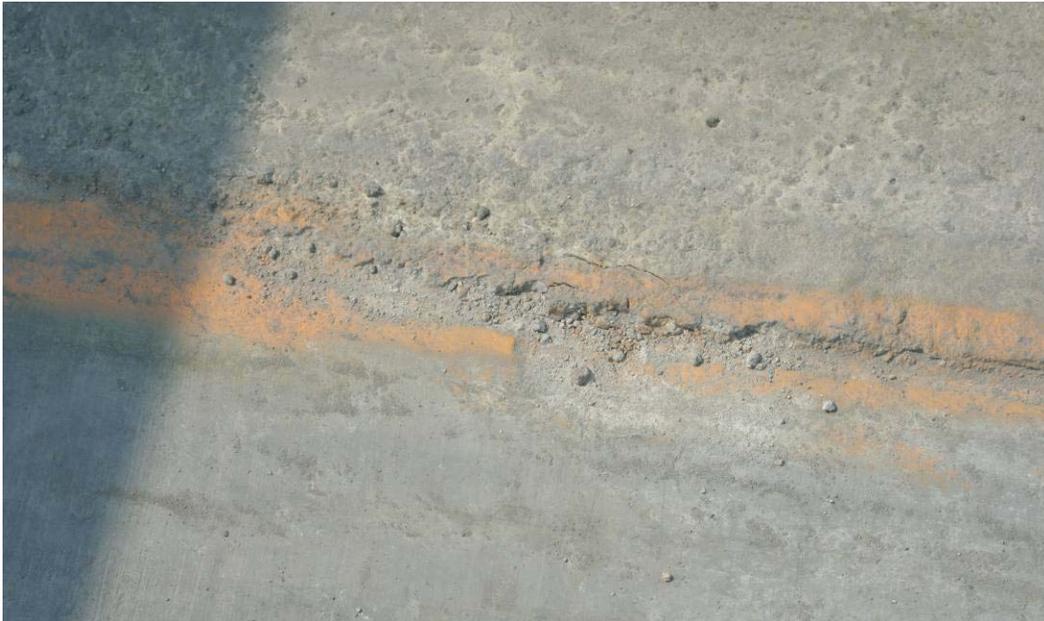
HWD and roughness measurements were performed prior to traffic. For consistency, load cart tests for this repair and the remaining craters in Series 1 would not be performed until 3 hr after the repair completion. After 32 passes, minor spalling was noticed where the repair overlapped the existing concrete (Figure 103). The spalling did not progress significantly, and a total of 112 passes were completed by the load cart with no cracking, noticeable deformation, or additional FOD. HWD and survey data were collected after 112 passes. Expedient criteria were met with this repair.

Figure 103. Crater B: Spalling after 32 passes.

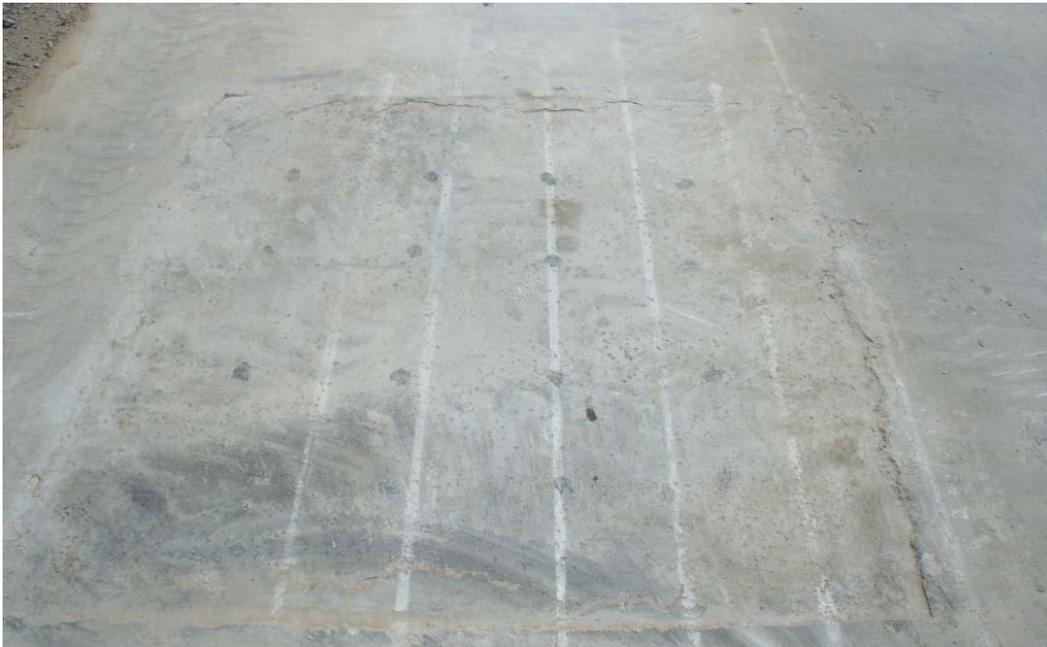
Additional HWD measurements were performed prior to continuation of traffic. Craters B–H were simultaneously trafficked in a straight line until failure was reached. At 176 passes, a corner spall formed at the southeast corner, and at 182 passes, the crater began audibly popping. At 224 passes, cracks along the east and west edges began to appear (Figure 104), and at 256 passes, the corner spall and edge cracks continued to lose material. After pass 304, spalling was more noticeable on the northwest edge. Deterioration continued, and after 320 passes, a crack became noticeable along the south edge (Figure 105). After pass 336, a new crack was noticed along the east edge. At pass 480, significant joint spalls were formed along the south, east, and west edges of the repair (Figure 106). At 512 passes, additional HWD and roughness measurements were performed. Trafficking was discontinued on this repair at 688 passes due to high FOD potential along the south, east, and west edges (Figure 107). This material met expedient criteria but produced significant FOD along the loaded edges prior to the desired 5,000 sustainment passes. The performance of this material in a larger repair may be better. Because of this, the product was recommended for Series 2 testing.

Figure 104. Crater B: Spalling and cracking- east and west edges after 224 passes.

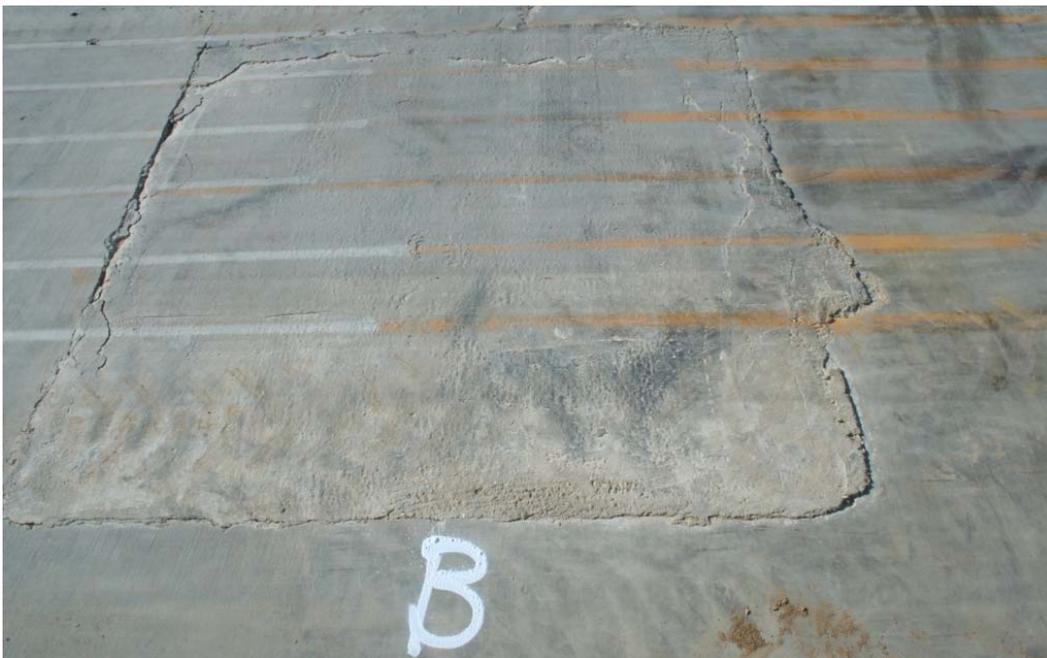
Figure 105. Crater B: Spalling and cracking- south, east, and west edges after 320 passes.

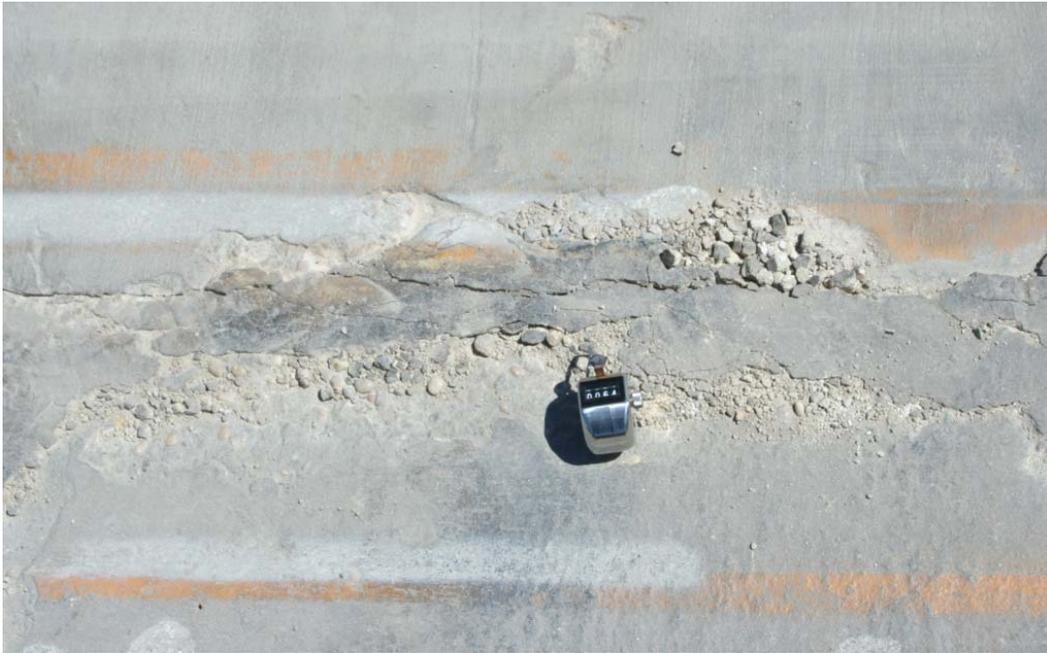
Figure 106. Crater B. Spalling and cracking along south edge after 480 passes.

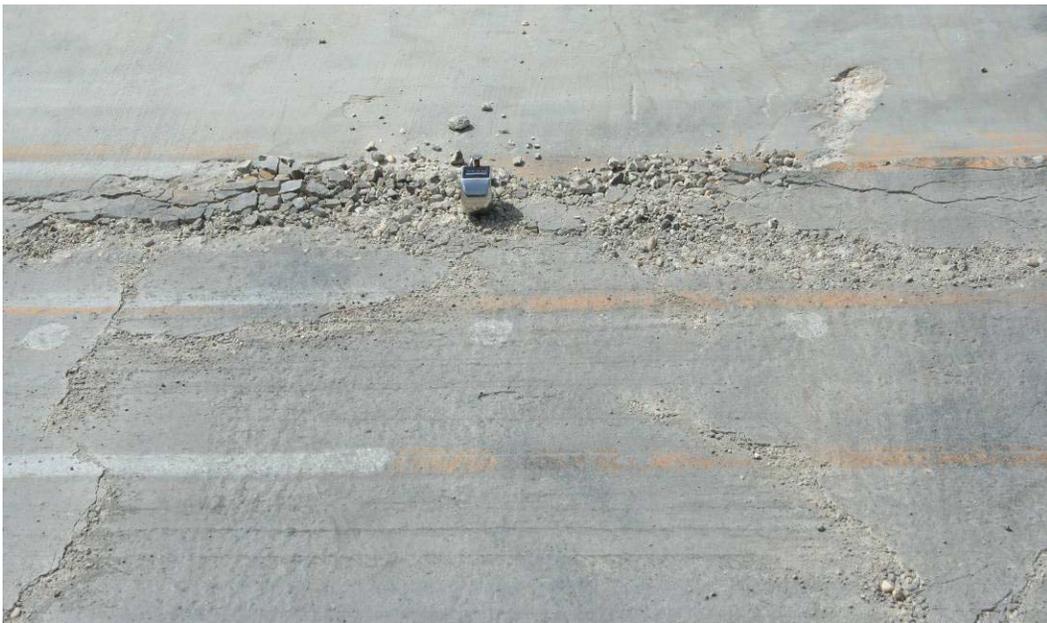
Figure 107. Crater B: Significant FOD and cracking along south edge after 688 passes.

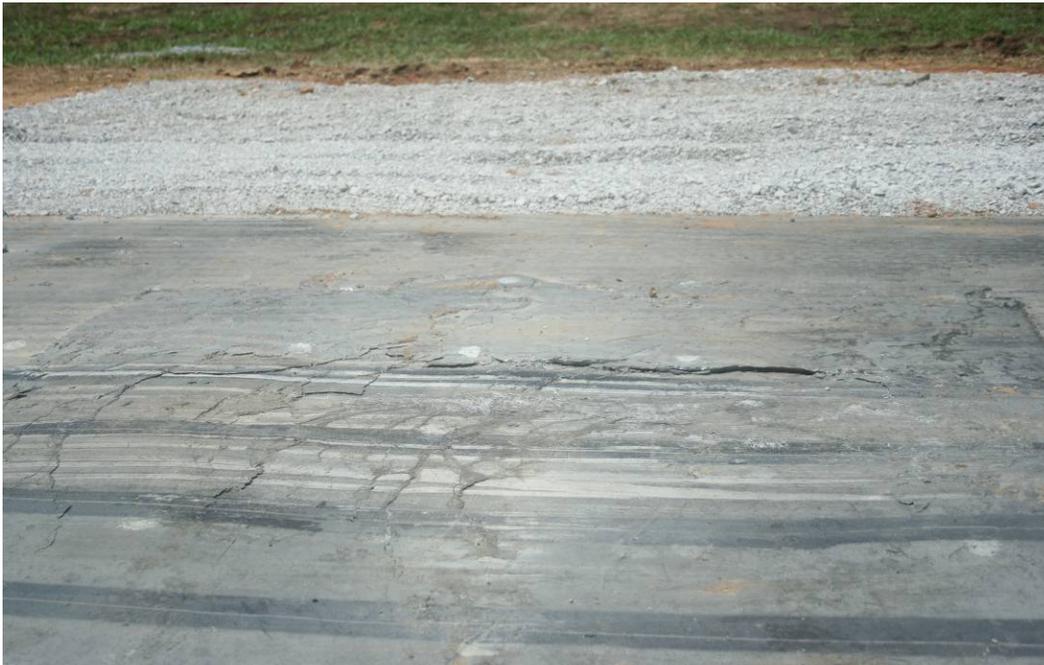
HWD and roughness measurements were performed prior to traffic. High deflections were noted with the HWD, indicating that the subgrade was still weakened from the heavy rain the day prior. After 80 passes, settlement and cracking were noticed in lanes 1 and 2. After 96 passes, settlement increased, major cracking occurred, and the surface was pulverized in lane 4. A bowl shaped depression became evident, and subgrade failure was confirmed as shown in Figure 108. Trafficking was discontinued on this repair, and a repeat repair was scheduled for the following week.

Figure 108. Crater C-1: Significant cracking and settlement after 96 passes.

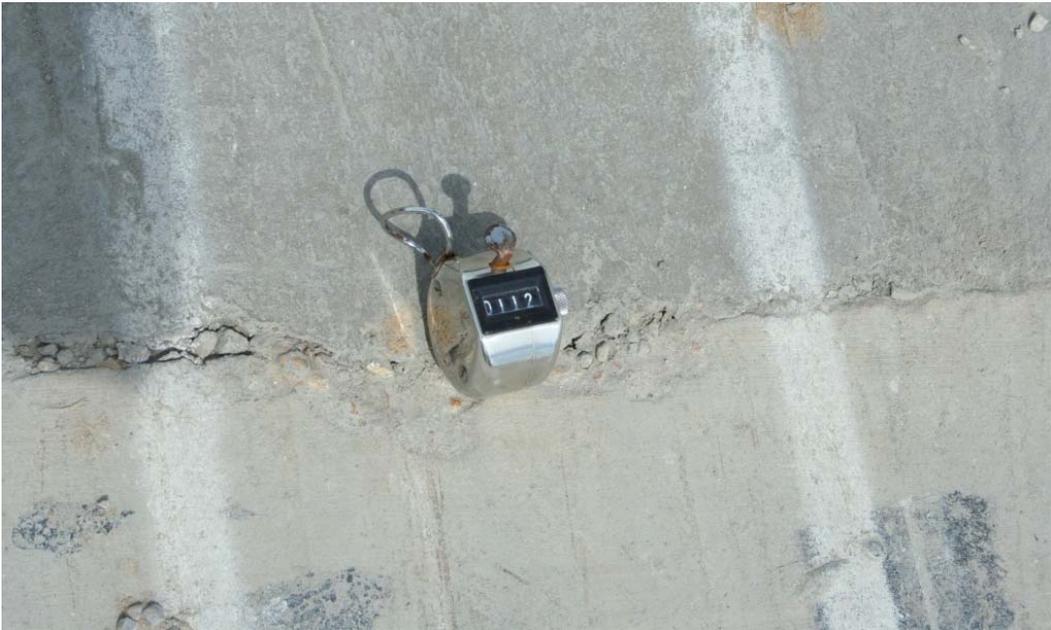
HWD and roughness measurements were performed prior to traffic. After 80 passes, minor spalling was noticed on the northwest edge as shown in Figure 109. The spalling did not progress significantly and a total of 112 passes were applied with the load cart with no cracking, noticeable deformation, or additional FOD. Expedient criteria were met with this repair. Figure 110 shows the crater spalling on the northwest edge.

Figure 110. Crater C-2. Spalling - northwest edge after 112 passes.

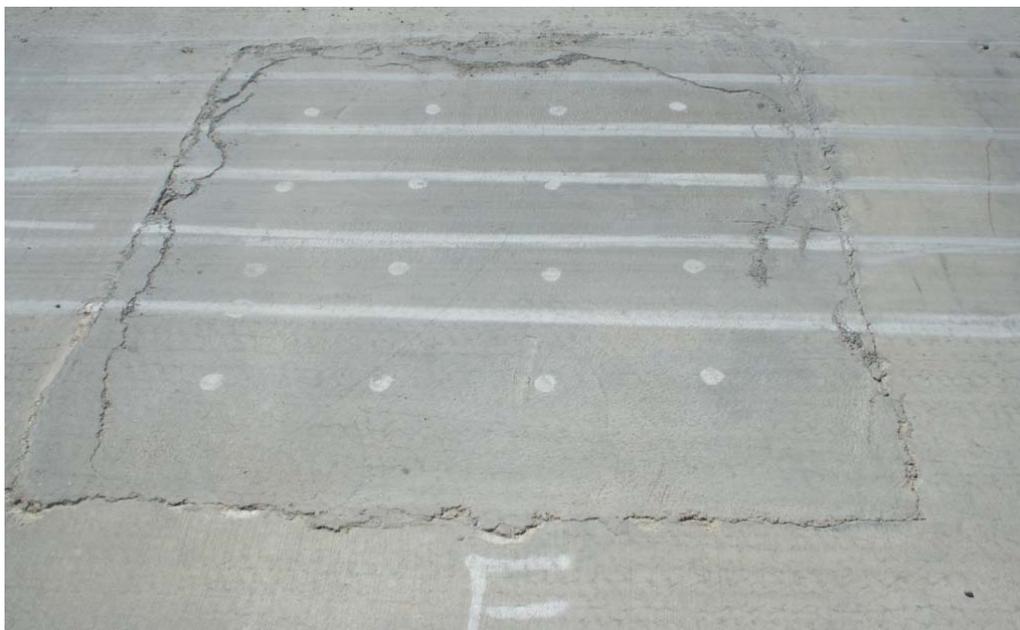
Spalling continued along the joints at 384 passes as shown in Figure 118. At 512 passes, additional HWD and roughness measurements were performed. After 688 passes, the south, east, and west joint spalls were widening and progressing rapidly to failure due to significant FOD. Spalled edges were visibly deflecting under load. After 720 passes, the repair was considered failed due to high FOD potential and movement as shown in Figure 119. This product was recommended for Series 2 testing.

Figure 118. Crater F. Cracking along the east, south, and west edges after 384 passes.

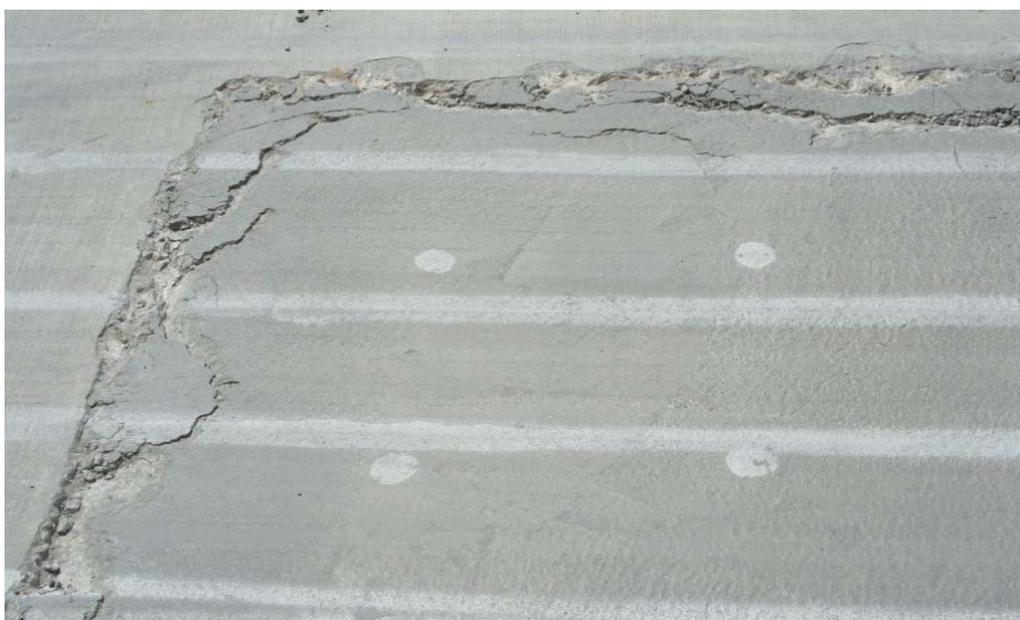
Figure 119. Crater F. FOD and cracking along the southeast corner after 720 passes.

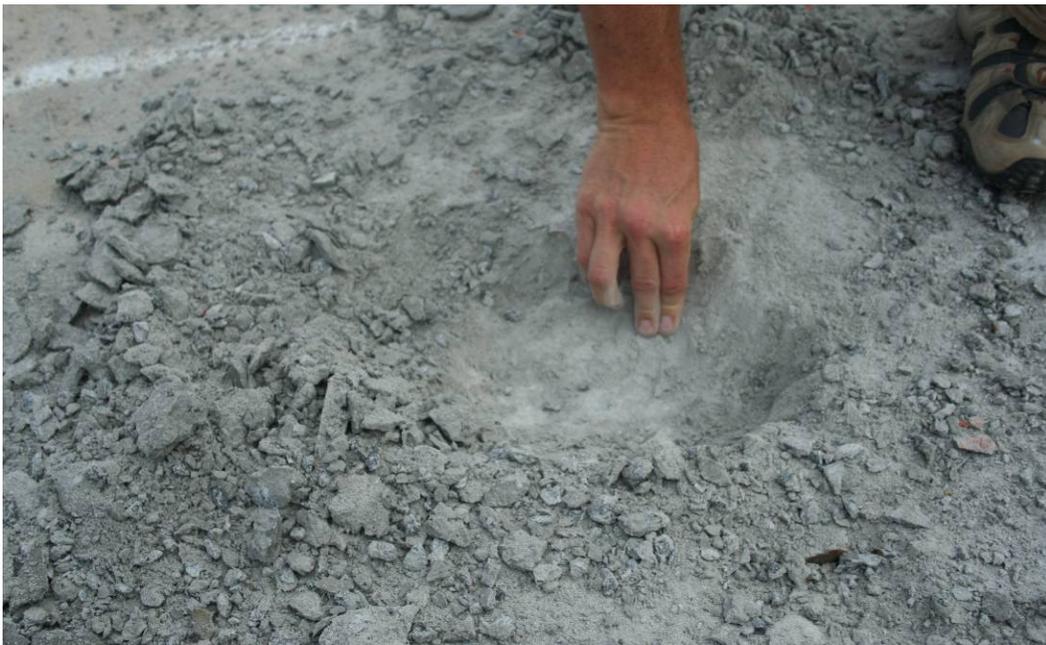
HWD and roughness measurements were performed prior to traffic. High deflections were noticed with the HWD, and cracking occurred under the HWD load in the center of the crater as shown in Figure 120. A low tire delayed trafficking nearly 45 min. After the completion of one pass, the surface began cracking. After 16 passes, traffic was discontinued due to a completely fractured surface (Figure 121). The surface was excavated by hand and picks to discover the top 4 in. of capping material was still curing. Below this level, the material was set. The surface material could be reanimated by rubbing loose material together to form a paste as seen in Figure 122. The vendor is investigating why the product did not cure as advertised. This product did not meet expedient pass criteria and was not recommended for Series 2 testing.

Figure 122. Crater G-1. Uncured material.

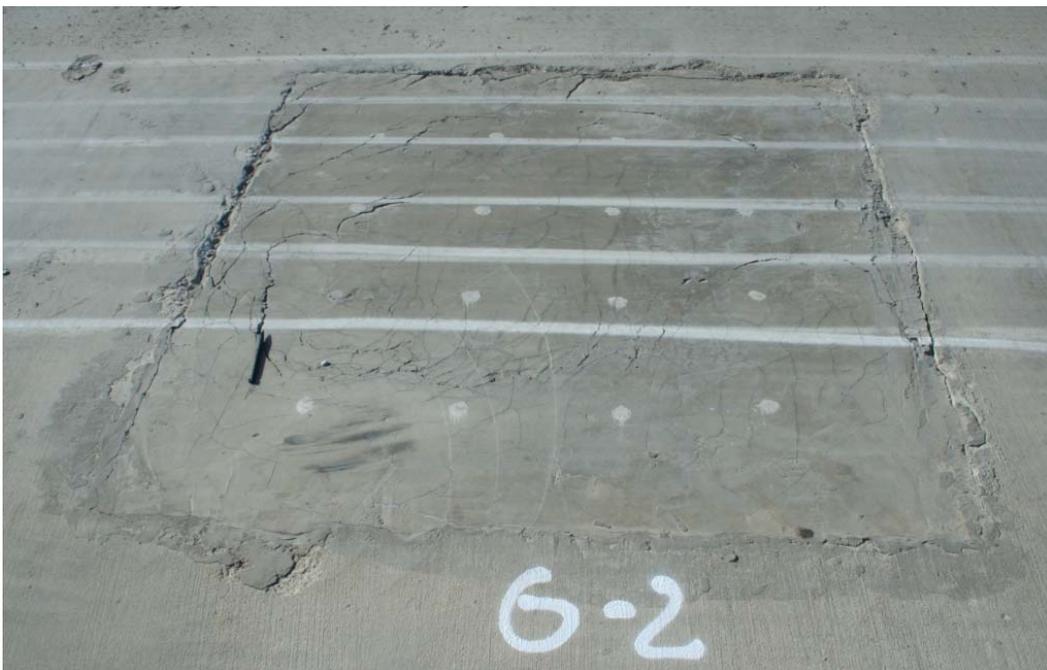
Additional HWD measurements were performed prior to continuation of traffic. Craters B–H were trafficked in a straight line until failure was reached. The map cracking was monitored for additional crack progression or the loosening of surface material due to the cracking. At 144 passes, more raveling along these cracks occurred, and popping noises occurred along the south, east, and west joints. Cracks continued to spall, and at 182 passes, visible deflections under the tire became more noticeable. At 224, roughness measurements were taken to determine if any settlement had occurred. A 0.25-in. difference in elevation from 0 passes occurred in traffic lanes 1–3. The surface cracks were widening, and large pieces of material were rocking under traffic. Figure 124 shows the repair after 224 passes. The repair was considered failed due to significant cracking and FOD potential. Trafficking was continued over the crater so that the other craters could still receive traffic. The crater continued to be monitored even after it had exceeded the failure criteria. At 304 passes, a new spall developed in the northeast corner, and cracking, popping, and spalling continued to progress. After 384 passes, spalling continued along corners and cracks. After pass 480, movement became more apparent in the repair under traffic. Spalls progressed along the east and west edges of the crater. At 512 passes, additional HWD and roughness measurements were performed. After 688 passes, no more traffic could be applied to this repair due to the high FOD potential. A photo after 688 passes is presented in Figure 125. Although this product met expedient pass criteria, the product was not recommended for Series 2 testing.

Figure 124. Crater G-2. After 224 passes.

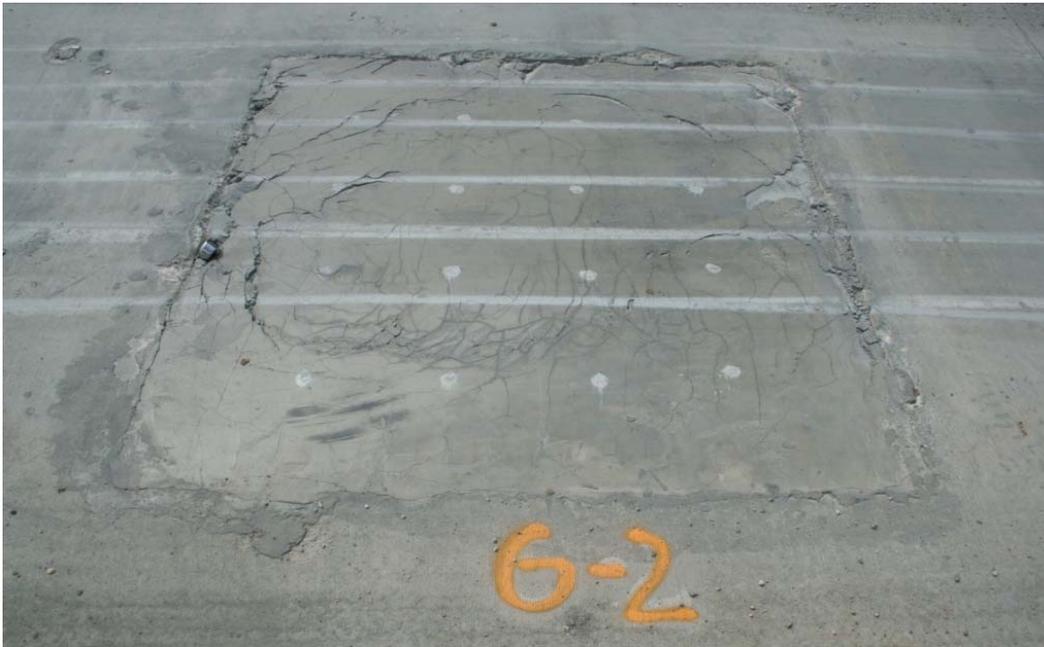
Figure 125. Crater G-2. After 688 passes.

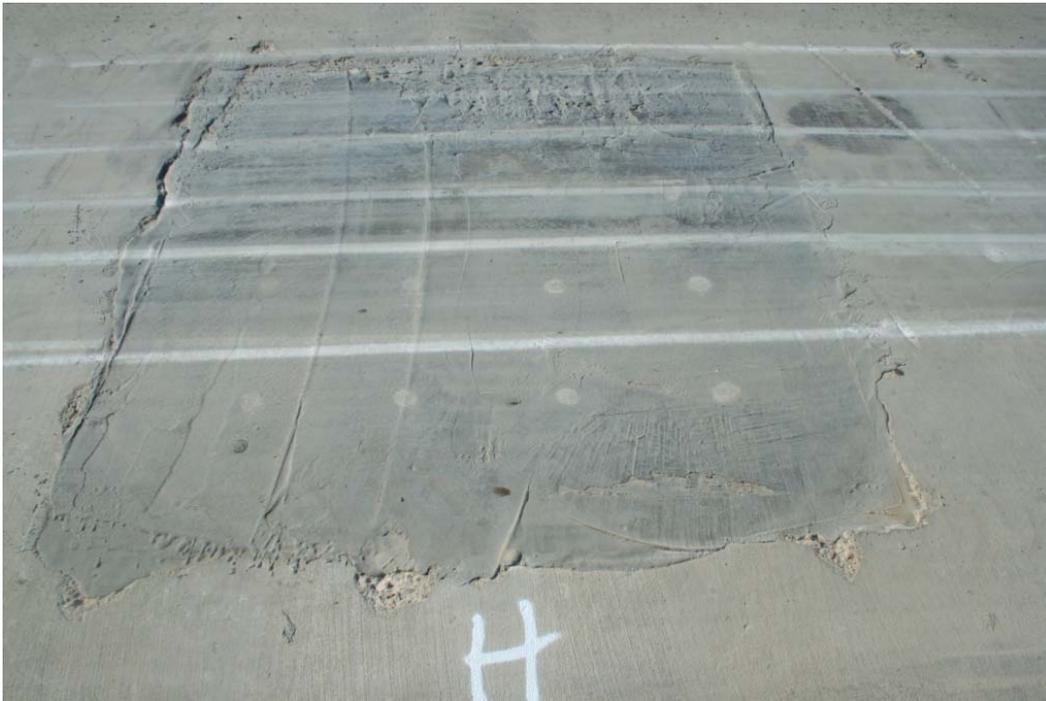
HWD and roughness measurements were performed prior to traffic. No FOD, cracking, or permanent deformation was noted during traffic. After 112 passes, a small hairline crack was noticed on the northwest joint. Figure 126 presents the repair after 112 passes. Expedient criteria were met with this repair.

Figure 126. Crater H. After 112 passes.

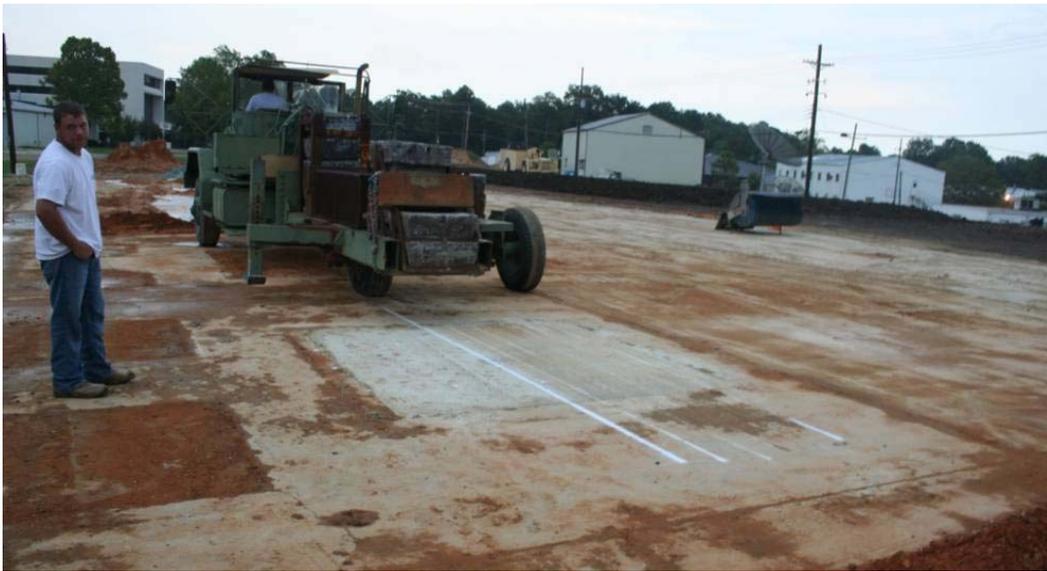
Figure 131. Crater J. Trafficking.

Craters J–L were trafficked simultaneously in a straight line until failure was reached as shown in Figure 131. After 155 passes, a hairline crack developed on the south and east edges. After 224 passes, low severity corner spalls on the southwest corner of the repair and joint spalls with light raveling on the south and east edges were recorded. After 336 passes, the crack on the south edge extended the full length of the crater. Spalling continued on the south and west edges. Popping noises were noticed on the west edge at 328 passes. After 495 passes, spalling was recorded on the southwest corner. After 512 passes, spalling continued to progress on the south edge. After 1,008 passes, no significant increase in the severity of the recorded distresses was noticed. After 1,232 passes, spalling progressed on the west, east, and south joints. Trafficking was discontinued on this repair after 2,000 passes due to significant FOD along the south, east, and west edges. This material met expedient criteria but produced significant FOD along the loaded edges prior to reaching 5,000 passes. The product was recommended for Series 3 testing. Figures 132-135 illustrate the deterioration of the crater under traffic.

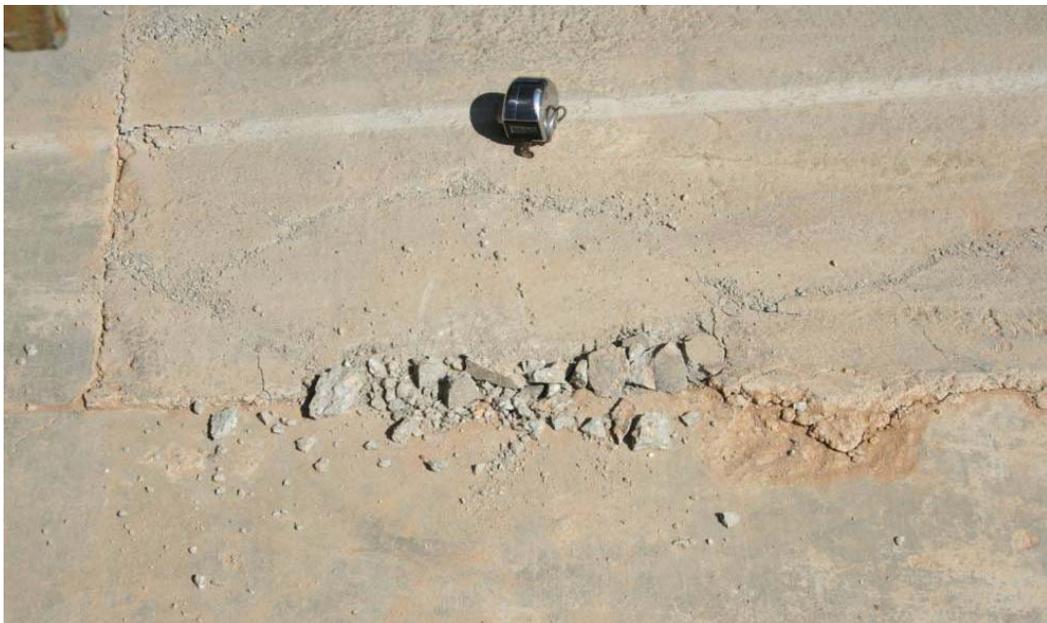
Figure 132. Crater J. Spalling on the south edge after 336 passes.

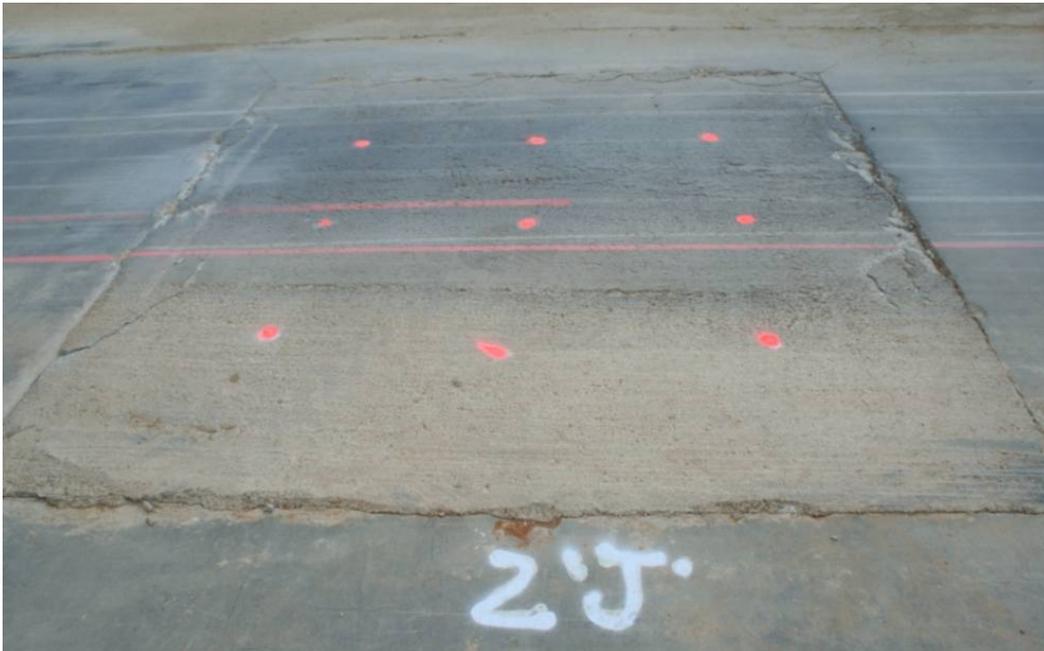
Figure 135. Crater J. Spalling on trafficked edge after 2,000 passes.

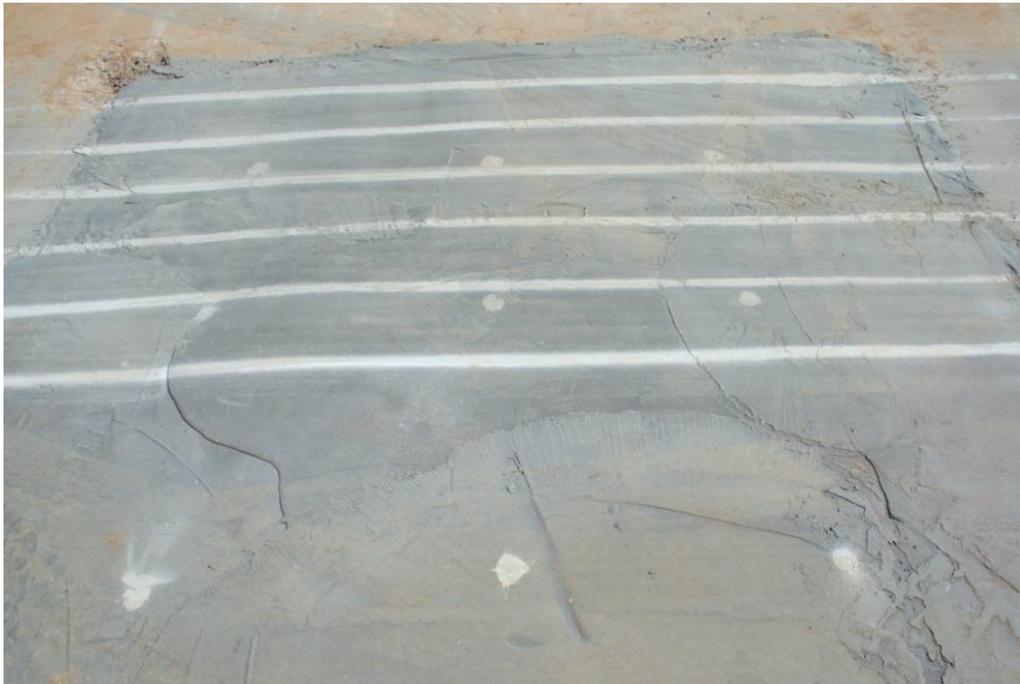
Figure 136. Crater K. After 112 passes.

Craters J–L were trafficked simultaneously in a straight line until failure was reached. No distresses were recorded on this repair until 570 passes with the east edge beginning to make popping noises under traffic. After 1,232 passes, a 1-ft long hairline crack developed on the east edge. Trafficking was discontinued on this repair after 5,008 passes. Figures 136 and 137 detail the deterioration of the crater under traffic.

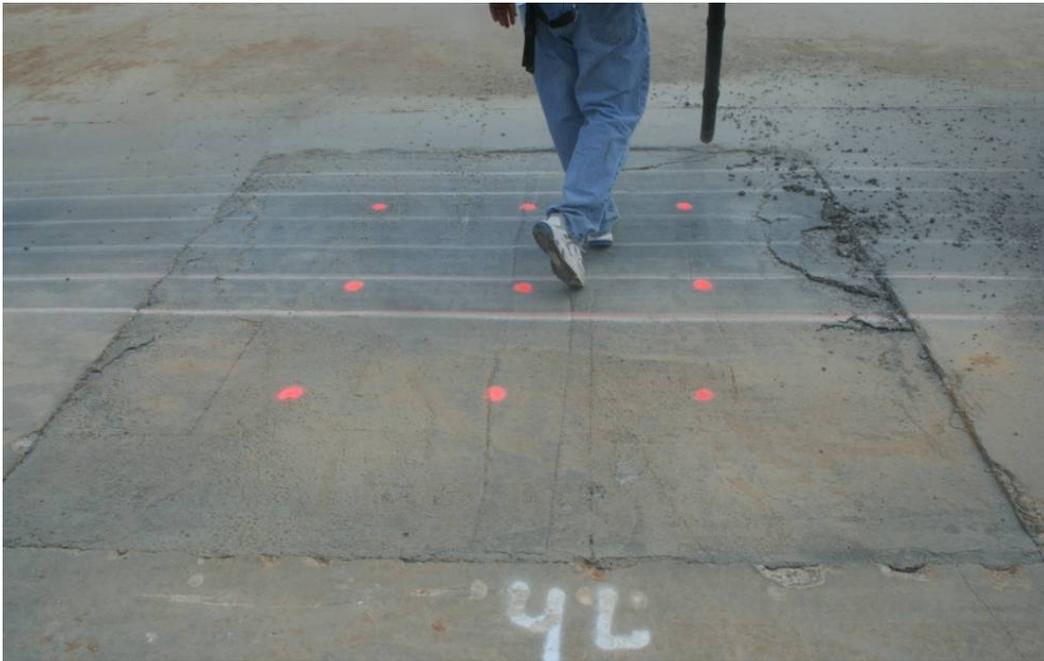
Craters J–L were trafficked simultaneously in a straight line until failure was reached. After 182 passes, popping noises were noticed when the tire crossed the west edge. After 224 passes, a hairline crack 2 ft long was recorded on the south edge. Light raveling also had developed on the west and south joints. After 336 passes, a hairline crack developed on the east edge (Figure 138). Popping noises were heard after 380 passes on the west and south edges of the repair. After 495 passes, more spalling was recorded on the west edge and another hairline crack developed on the east edge. After 512 passes, raveling continued on the east and west joints, and the crack on the south edge continued to spall. After 1,008 passes, no significant increase in the severity of the recorded distresses was noticed (Figure 139). After 1,232 passes, the south, east, and west joints began raveling at an increased rate. A longitudinal crack also developed from the north to the south edge. FOD was becoming more evident. Trafficking was discontinued on this repair after 2,000 passes due to high FOD potential along the south, east, and west edges (Figure 140). This material met expedient criteria but produced significant FOD along the loaded edges prior to reaching 5,000 sustainment passes. The product was recommended for Series 3 testing.

Figure 140. Crater L. Spalling and edge cracking on loaded edges after 2,000 passes.

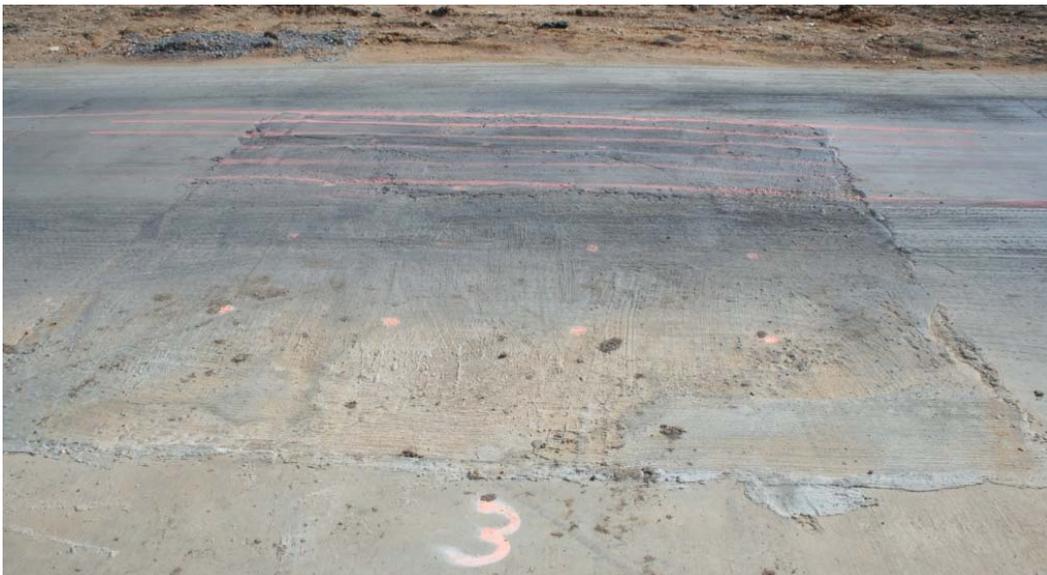
Craters Q–T were trafficked simultaneously in a straight line until 5,008 passes or failure was reached. No settling of the debris was noticed. After 2,000 passes, light cracking resembling map cracking became noticeable but did not progress or spall. After 3,500 passes, two hairline cracks formed on the southern edge, and light spalling on the southwest edge was noticed. These cracks and spalls did not progress. This repair met expedient and sustainment criteria reaching greater than 5,000 passes without failing (Figure 143).

Figure 143. Crater R. Pavemend SLQ repair after 5,000 passes.

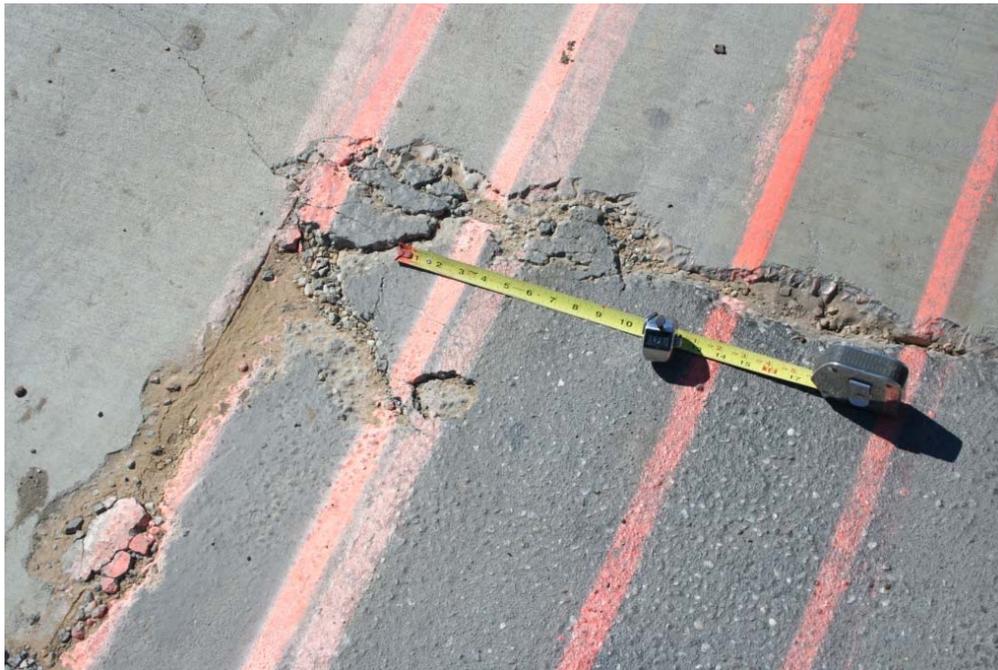
Craters Q–T were trafficked simultaneously in a straight line until failure or 5,008 passes were reached. After 281 passes, the hairline cracks on the south edge began to progress to a joint spall after 603 passes. These cracks began to have noticeable spalling after 1,150 passes. After 3,000 passes, the spall began to ravel more as seen in Figure 144. After 4,000 passes, more spalling and FOD was noticeable on the loaded edges. This repair material met expedient and sustainment criteria reaching greater than 5,000 passes without failing.

Figure 144. Crater S. ThoRoc 10-61 joint spall after 3,000 passes.
