Laboratory and Field Investigations of Small Crater Repair Technologies

Lucy P. Priddy, Jeb S. Tingle, Timothy J. McCaffrey,
and Ray S. Rollings

September 2007

Final report

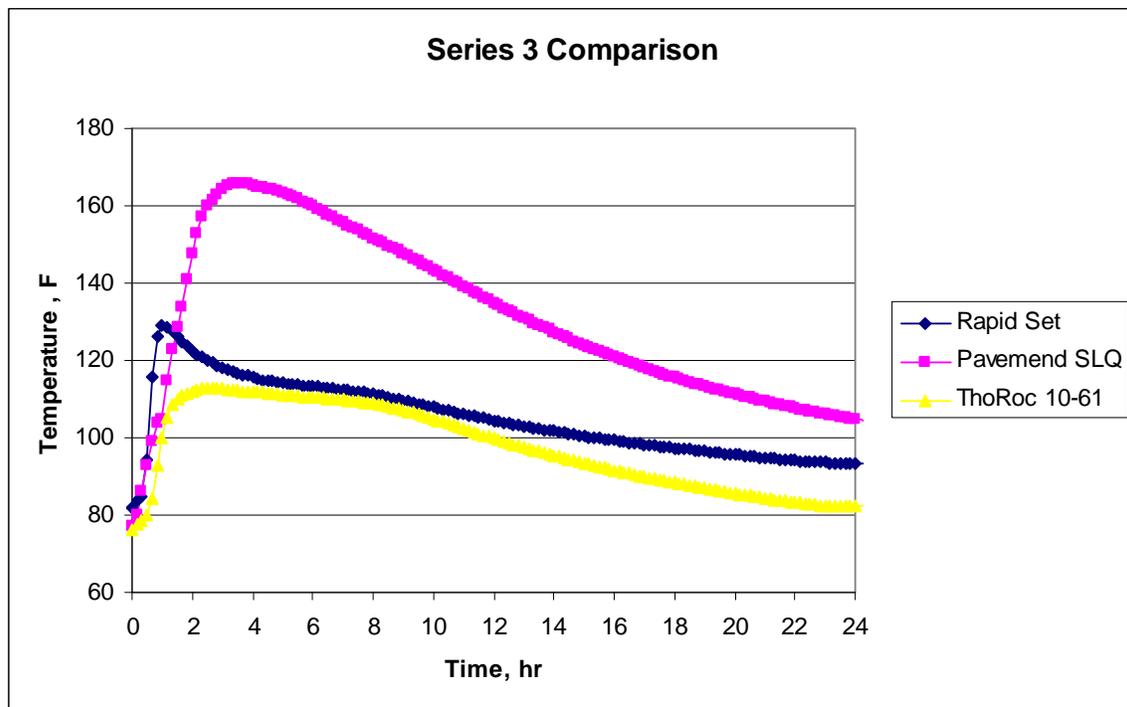
Figure 163. Temperature rise comparison for Series 3 craters.

A comparison of the average temperatures generated in each cap for Series 3 craters is presented in Figure 163. As with Series 1 and 2, Pavemend SLQ generated the most heat overall as in Series 1 with a maximum average temperature of 166 °F. Due to a broken cable, no data is presented for the Ultimax Concrete repair. A comparison of the temperature rise with depth for these craters is presented in Figures 164–166. From these figures, Rapid Set and ThoRoc 10-61 reached maximum temperatures at approximately 1 hr of cure. Pavemend reached its maximum temperature after approximately 2 hr. From these figures, it can be seen that although the materials were trafficable within 3 hr of repair, the optimum time for traffic would have been when the temperatures returned to pre-cure conditions. For these materials, Rapid Set, Pavemend SLQ, and ThoRoc 10-61, 40, 18, and 12 hr, respectively, would have been ideal. These are similar to those needed in Series 1 and 2 with the exception of Rapid Set in Series 2 with only 8 hr needed.

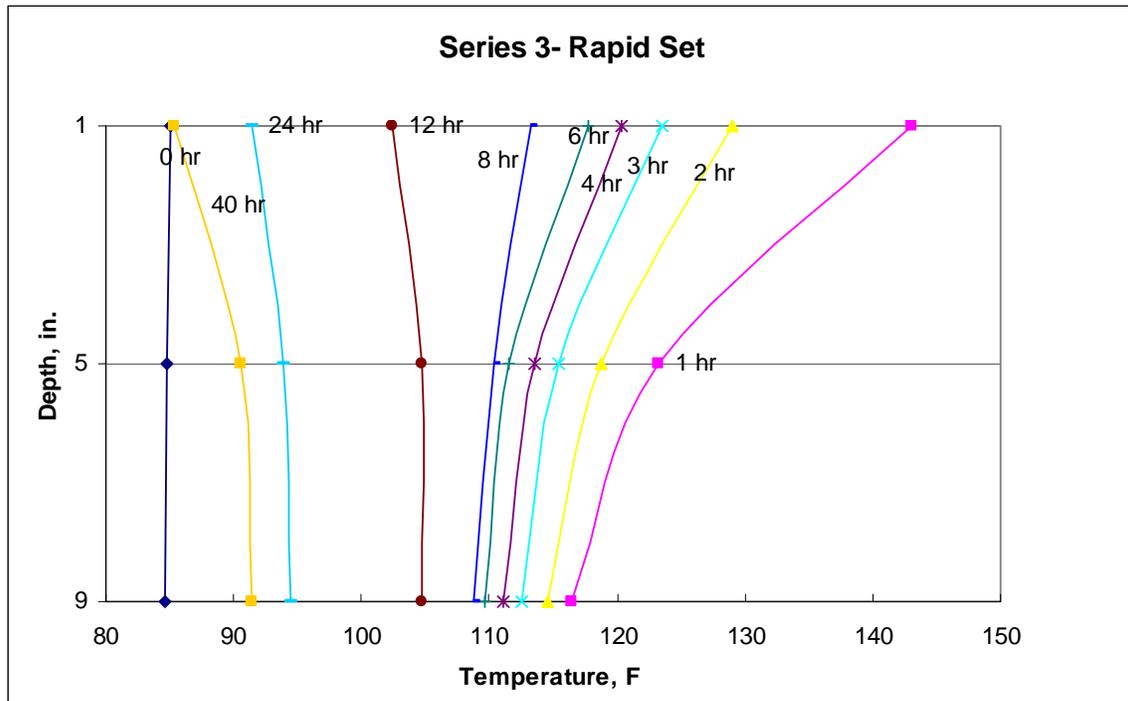
Figure 164. Series 3. Rapid Set-temperature with depth.

In comparing the maximum temperatures for Rapid Set for the three series, the temperature did not vary significantly, but the cure time decreased as the cap thickness increased. This would be expected as the volume of material increased which would result in achieving hydration in

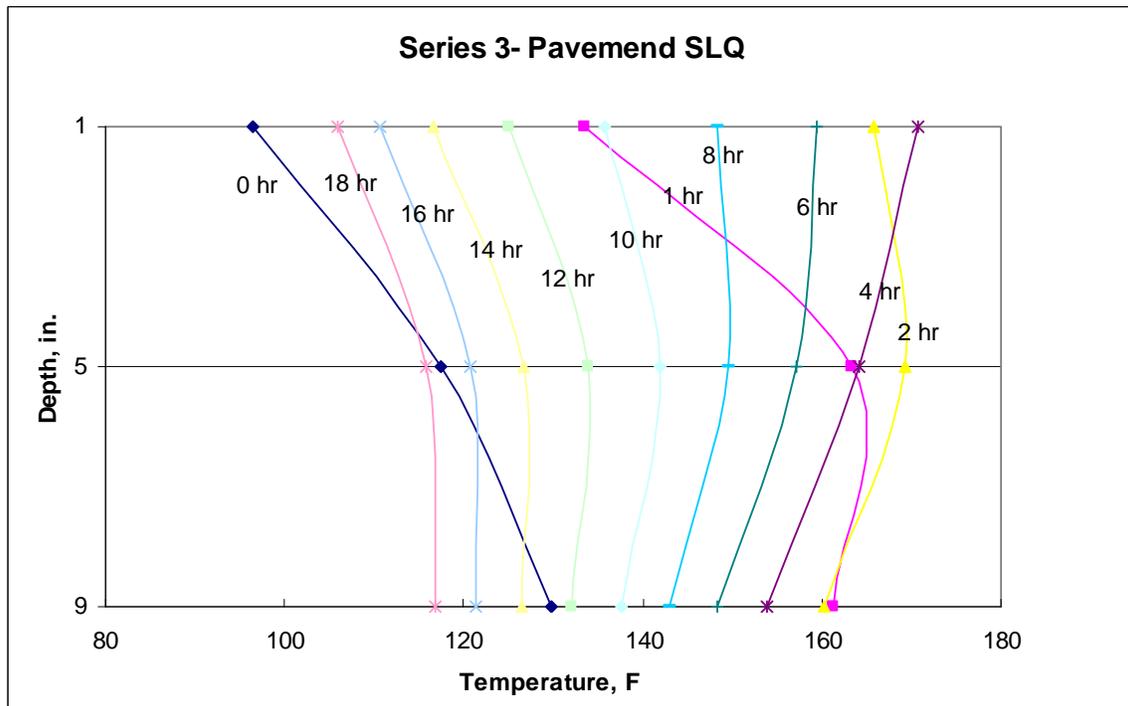
Figure 165. Series 3. Pavemend SLQ-temperature with depth.

shorter times due to the volume involved. This was not the same for Pavemend SLQ whose value did not vary significantly for maximum temperature, but the cure time at maximum temperatures increased for Series 2 and 3. The set times for the Rapid Set were very short, and the material had to be placed in smaller volumes in multiple batches. ThoRoc 10-61 had the greatest drop in cure time at maximum temperature. Because the material was placed in a few batches at a greater volume in Series 3, the heat was generated at a faster rate. A summary of the maximum temperatures reached in each cap, location of the sensor, and cure time are included in Table 31.
