FIGHTING VEHICLES RESEARCH AND DEVELOPMENT ESTABLISHMENT

REPORT NO: FT 2239

DEVELOPMENT TRIALS 'A' VEHICLES REPORT

MINE DAMAGED TRACK

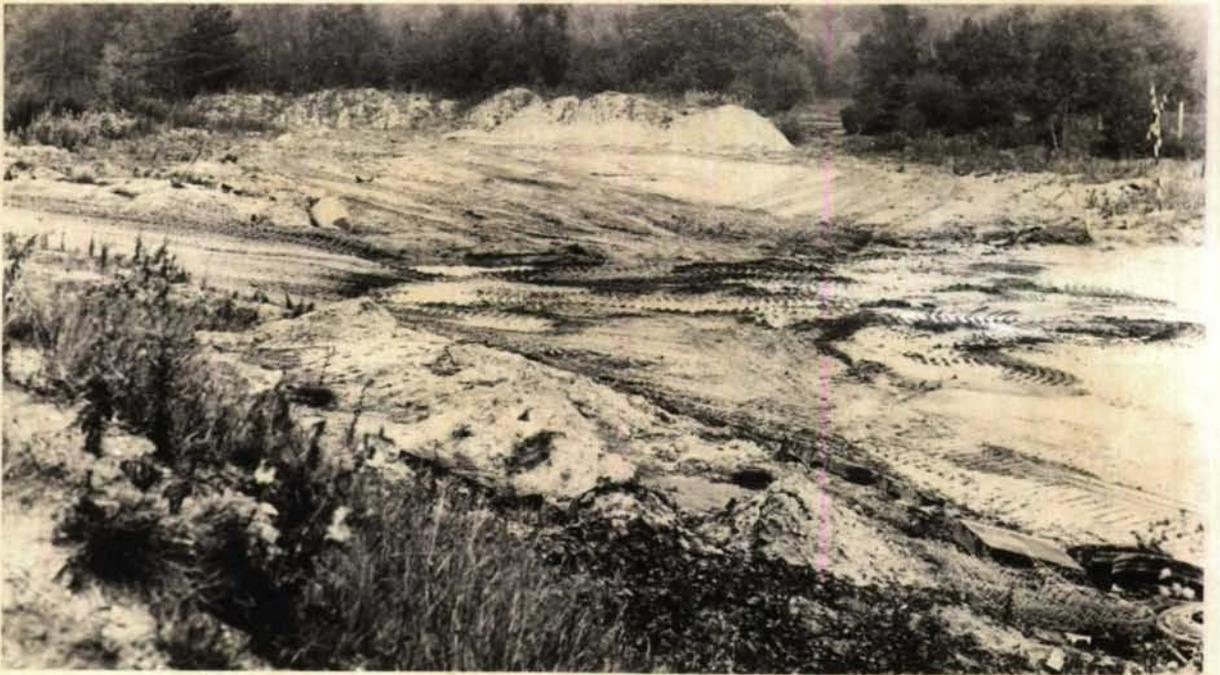
FIG. 4

5.2 After fitting a section the vehicle was moved to give the track one complete traverse. This was done to confirm that the damaged portions would pass over the suspension components. The short cross country course shown in Figs. 4, 5, and 6 was then used, the vehicle was accelerated through the gears along the straight, slowed down for a steered turn and then returned to the starting point. A skid turn on concrete completed the test circuit which brought the vehicle into position for the next section of track to be fitted.

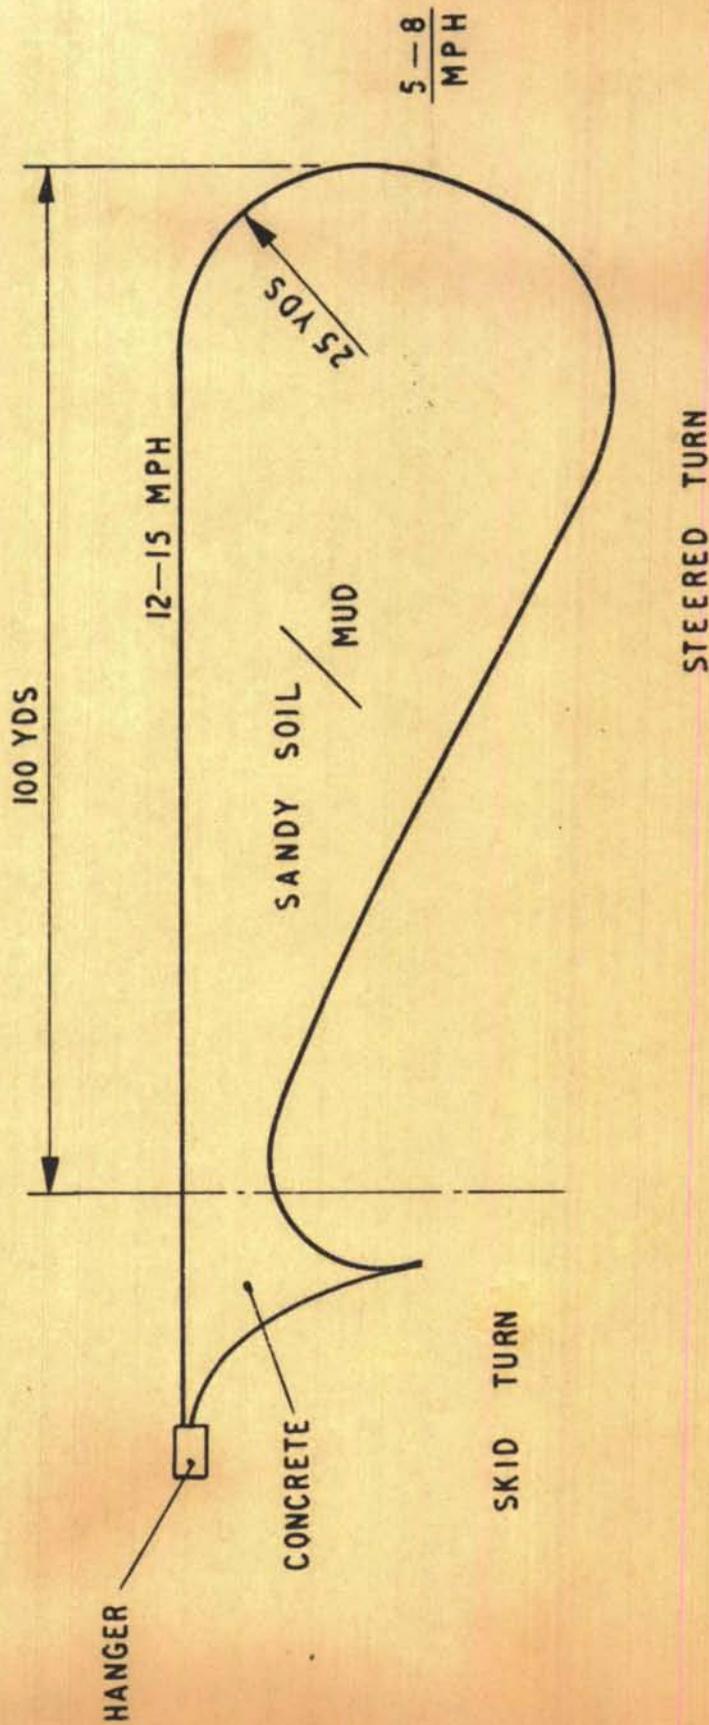
- 2.4 The running course shown in Fig.6 was arbitrarily chosen as being typical of the type of cross country over which the vehicle was likely to encounter a mine field. After attack, if not immediately disabled, the vehicle would have to move, unaided, to a cleared area to enable the crew to carry out repairs. The length of the course was considered adequate for this purpose and if the damaged track prevented this movement the attack was considered a 'kill'. This trial satisfactorily demonstrated the ability of light track to continue running after sustaining considerable mine damage.

TEST COURSE AT LONG VALLEY USED TO TRY OUT MINE DAMAGED TRACKS
