Lipari Landfill Piping Network Corrosion Condition Assessment and Service Life Prediction Analysis

Charles P. Marsh, Thomas A. Carlson, Robert A. Weber,
Carl A. Feickert, and Peter B. Stynoski

December 2008

Final report

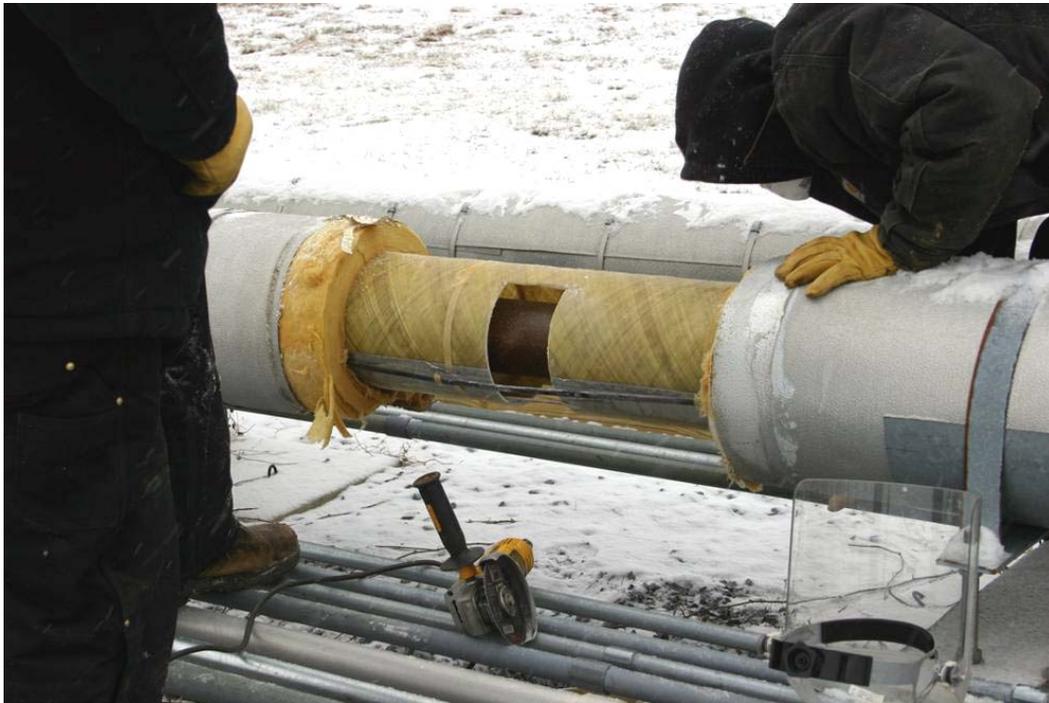
Figure 3. View of the pipe to be ultrasonically tested showing trace wire used to prevent pipe from freezing.

As a continuation of the initial condition assessment, thickness measurements were taken by ultrasonic methods for an additional 15 months beginning on April 9, 2007 and ending on July 26, 2008. The purpose was to estimate the current corrosion rates within the pipes. The test plan for this long term series of thickness measurements on the three headers included the same inspection points that were used for the initial condition assessment. These points would be exposed approximately every 2 weeks for 8 months and measured at the top and bottom locations with ultrasonic thickness measurement techniques. After the first 8 months, the readings were then taken approximately once per month for another 7 months. The data was recorded on a series of spreadsheets developed specifically for this work. Figure 3 shows the pipe ready to be ultrasonically tested. After each ultrasound test, the pipe's fiberglass shell was taped in place and the fiberglass insulation was replaced. Finally, the aluminum weather shield was put in place and bands attached until the next reading was taken.

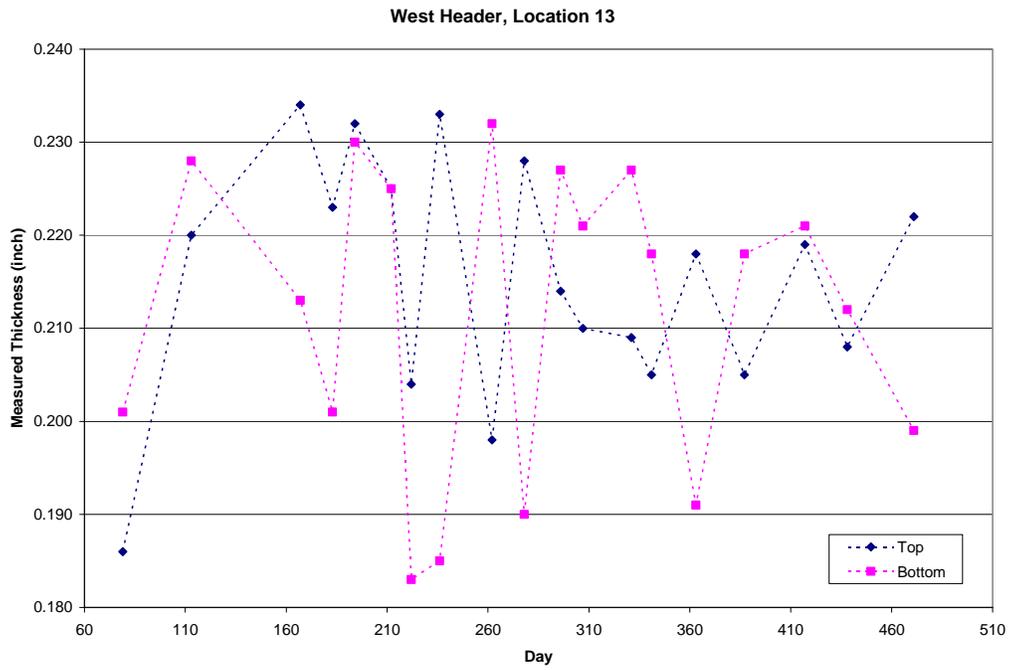
Figure 7. Thickness measurements for the west header taken at location 13.

After reviewing the thickness measurements made on the carrier pipe for 15 months (Appendix B, Tables B1 through B23), it was obvious that the data had a large amount of scatter. The thickness values for individual measurement locations were plotted versus time. Selected examples are shown in Figure 7, Figure 8, and Figure 9.

As mentioned, sequential time measurements at any one of the particular top or bottom locations have failed to display a systematic temporal trend, in fact quite to the contrary, as previously shown in Figure 7, Figure 8, and Figure 9. It was then considered to treat an entire date's collection of all header pipe measurements as two "samples," with data from the top and bottom treated separately.

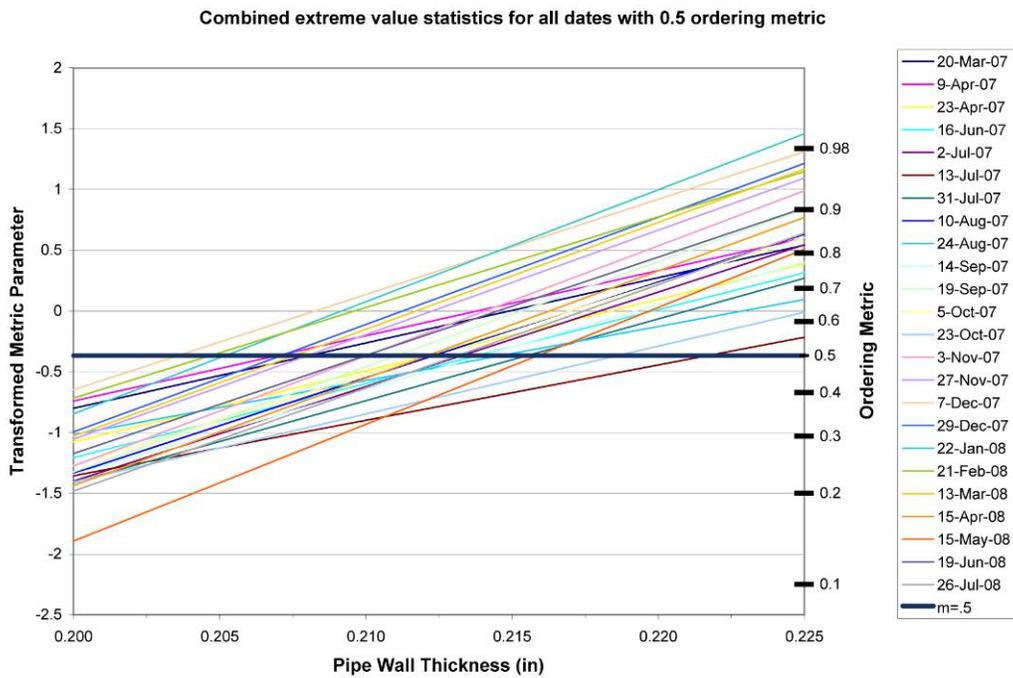
Figure 13. Compilation of extreme-value statistics for all top thickness measurements for all dates measurements were taken.

Figure 12 represents data from December 29, 2007 for the top of all three carrier pipes, and is a particularly good representation of an extreme-value distribution for the data collected, following the procedures described by Gumbel (1958). The compilation of the extreme-value statistical analysis for all the measurement dates for the top headers is displayed in Figure 13.

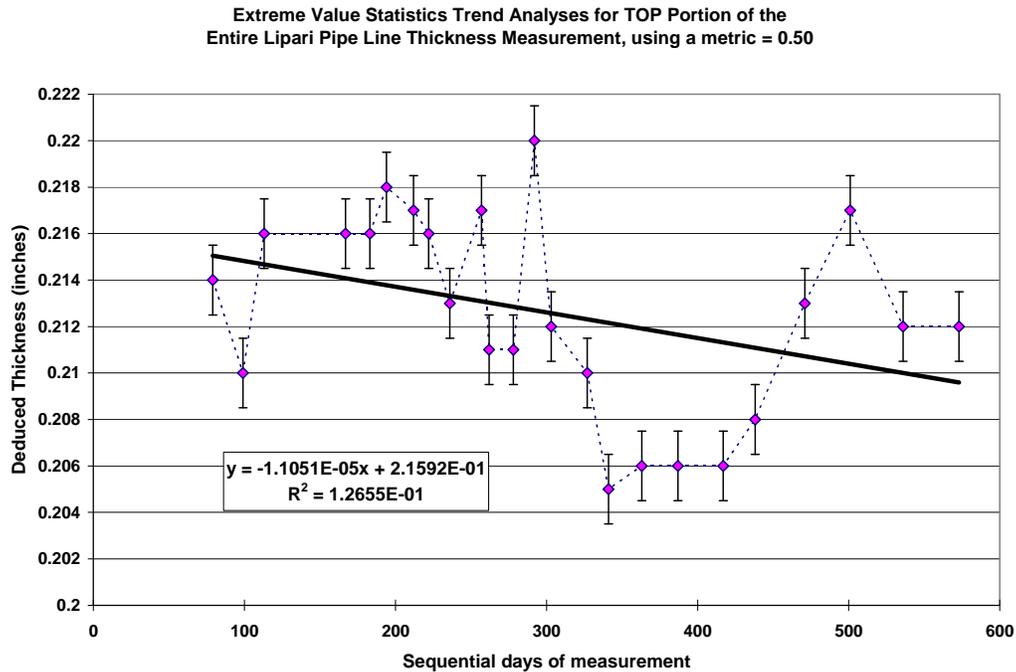
Figure 14. EVS trend for all top ultrasonic thickness measurements for the duration of the assessment period using a metric of 0.50.

Choosing a middle metric parameter of 0.5, a collection of associated thicknesses was obtained and plotted in Figure 14. The scatter in Figure 14 is a measure of the characteristic global scatter found in the individual site location and time-sequenced measurements.

The random scatter in this actual data is substantial. Even so, the statistical method extracts a systematic thinning of the original 0.237 in. thick steel carrier pipe. Using the analytic equation derived from the least squares fit of the data in Figure 14, a characteristic corrosion rate for the top of all pipes was calculated to be 4.03 mpy. Using the analytic equation derived from the least squares fit of the data in Figure 15, a characteristic corrosion rate for the bottom of all pipes was calculated to be 2.63 mpy.

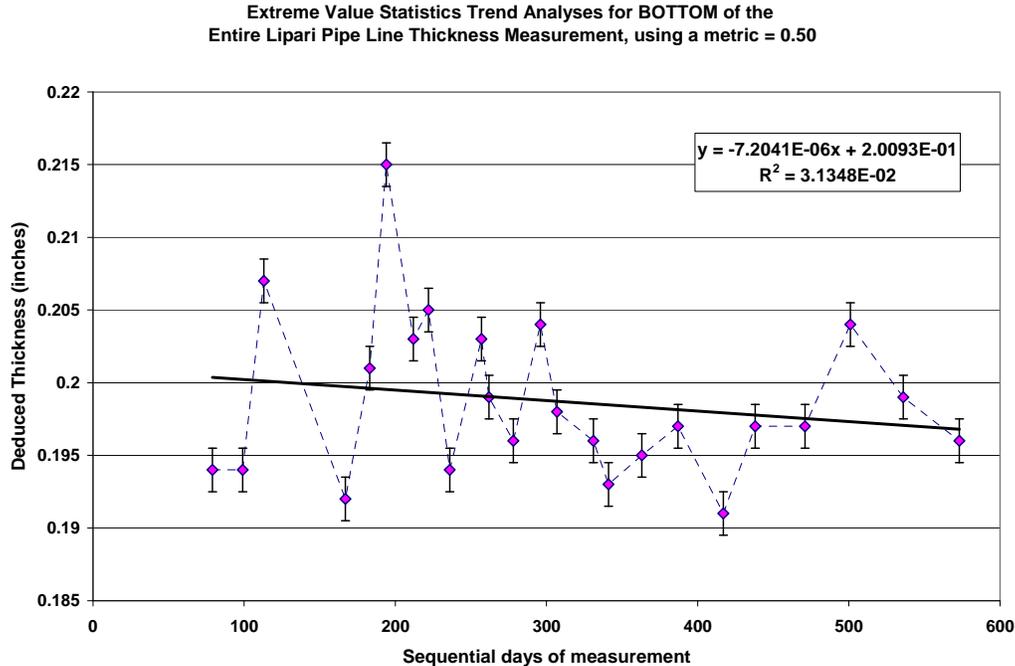
Figure 15. EVS trend for all bottom ultrasonic thickness measurements for the duration of the assessment period using a metric of 0.50.

An EVS analysis was also performed for the bottom thickness data. The resulting trend is shown in Figure 15.

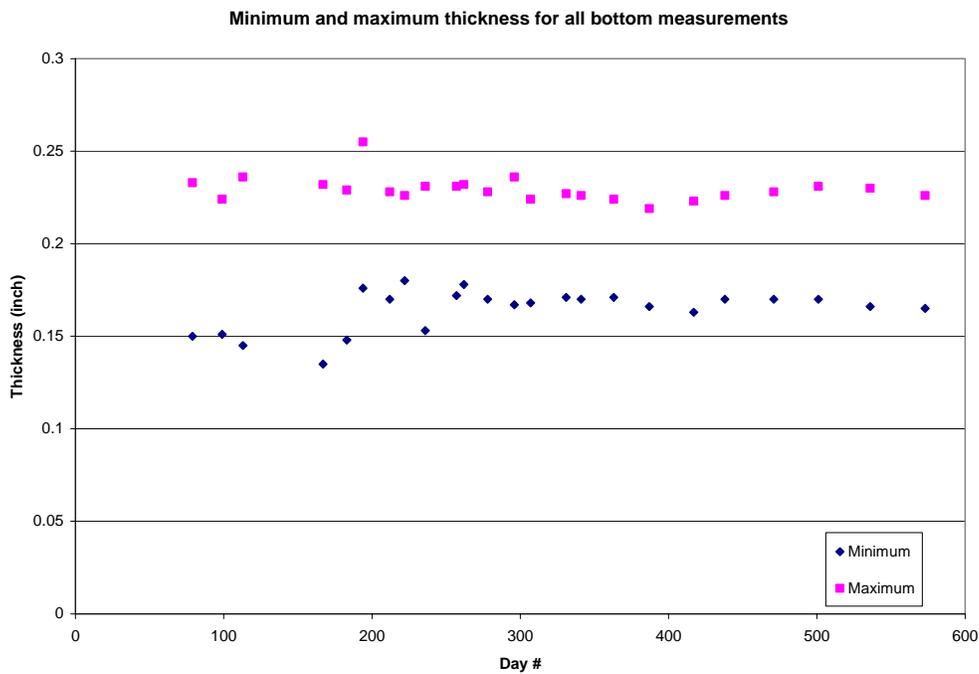
Figure 16. Maximum and minimum ultrasonic thickness readings for all the bottom measurements.

These figures show no meaningful temporal trend over the 15-month measurement period. A simple average of the minimum and maximum values was calculated to determine the corrosion rate during the previous 14 years of service using a method similar to that described in sections 3.1 and 3.2.3.2. Average thickness values of 0.197 and 0.203 in. were calculated from those readings and assigned as the current average bottom and top thicknesses, respectively. Then corrosion rates were calculated for the bottom and top based on an initial pipe thickness of 0.237 in. The resulting corrosion rate was 2.86 mpy for the bottom and 2.43 mpy for the top. These results were similar to the rate obtained using the extreme-value method for the bottom of the pipes, but they were lower for the top.

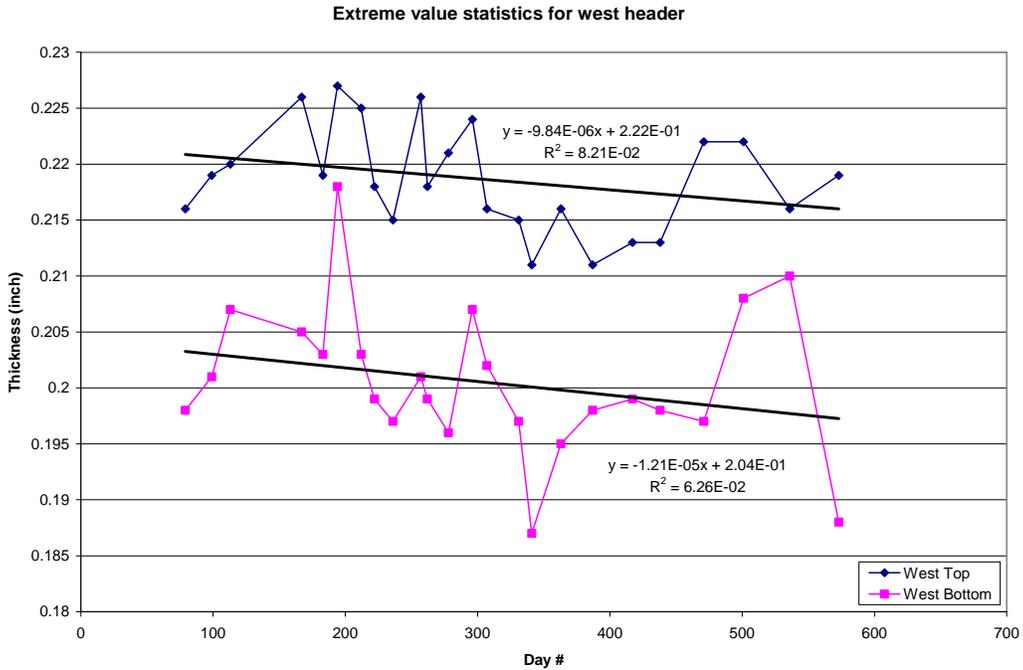
Figure 18. Extreme-value statistics for top and bottom of the west header.

Qualitatively, these trends look very similar to those presented in Figure 4, Figure 5, and Figure 6 in section 3.2.3.1. For purposes of consistency, corrosion rates were calculated only from those trends that showed a decreasing thickness. The corrosion rates for the top and bottom of the west header were 3.59 and 4.42 mpy, respectively. The corrosion rate for the top of the central header was 5.66 mpy. These corrosion rates are similar to those in Table 2 and are consistent with the other corrosion rates found using the EVS method.

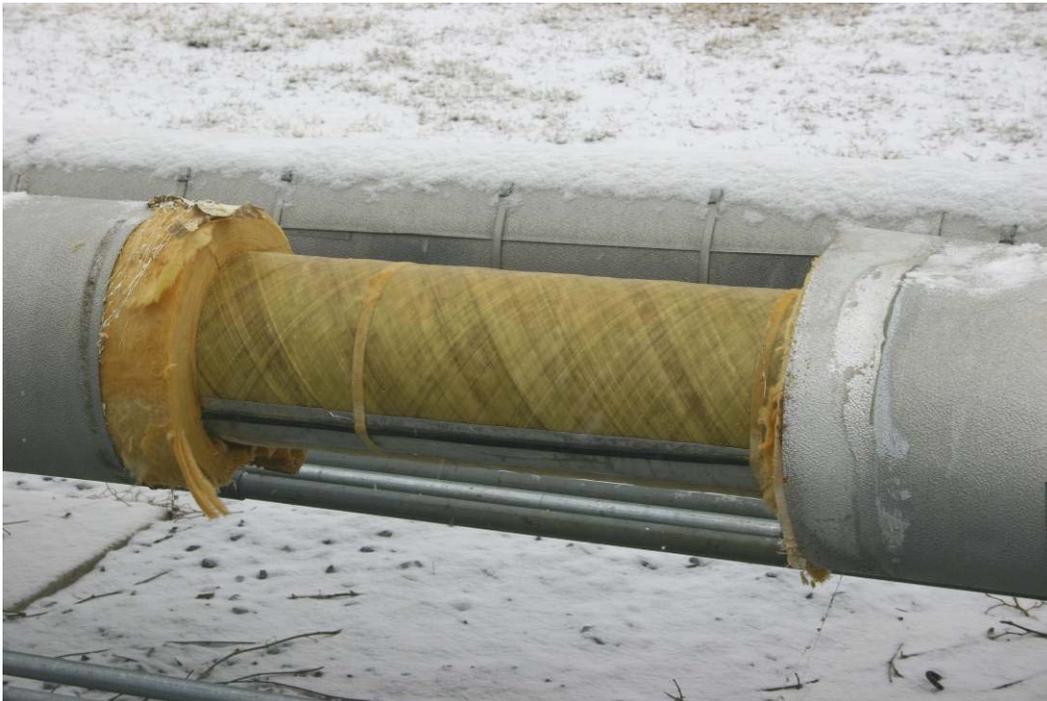
Figure C7. View of west header with aluminum weather shield and fiberglass insulation removed, revealing the fiberglass containment pipe.
