ERDC/CERL TR-07-23

Corrosion-Resistant Materials for Water and Wastewater Treatment Plants at Fort Bragg

Final Report on Project AR-F-319 for FY05

June 2007

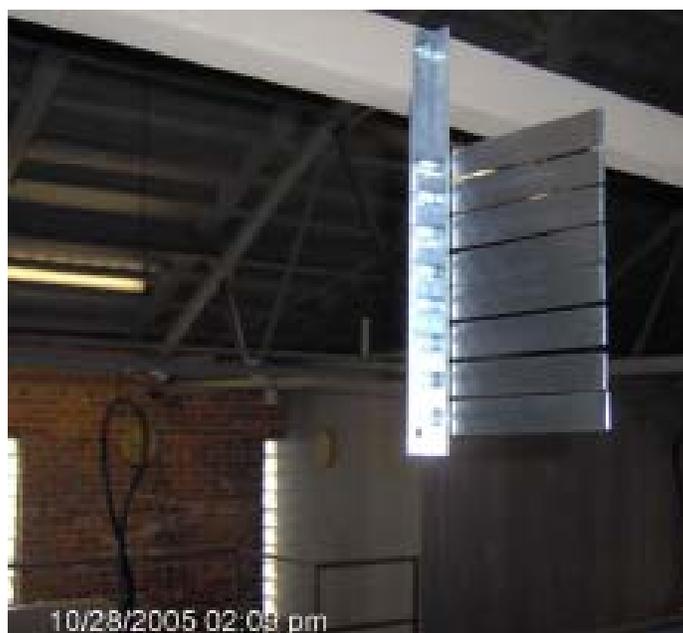
Figure 13a. Above water weight loss coupon at WTP.

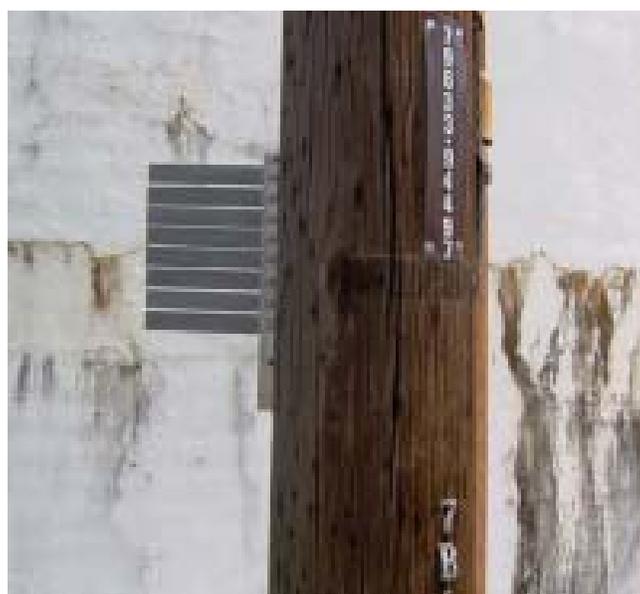
Figure 13b. Atmospheric weight loss coupons at WTP.

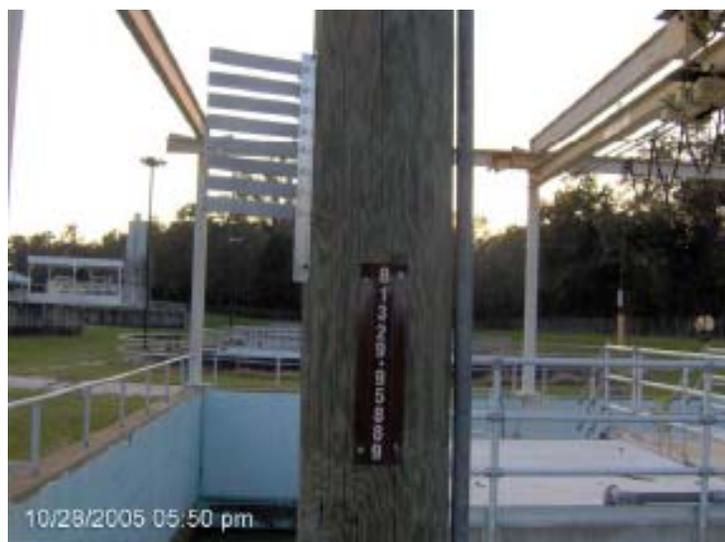
Figure 13c. Atmospheric weight loss coupons at WWTP.

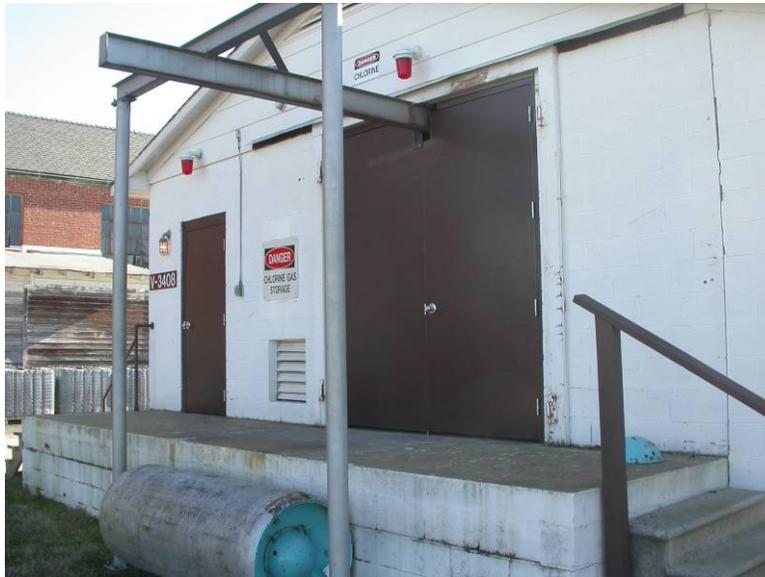
The loading doors at the opposite end of the building are shown in Figures 6 and 7.

Figure 6. Doors on the opposite end of the building from those shown in Figure 5.

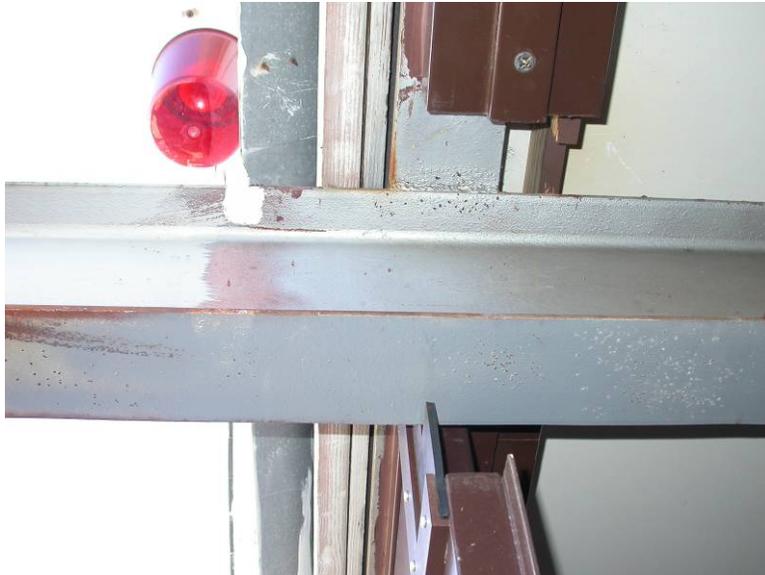
system. The carbon steel overhead rail for this system was not replaced, although it was repainted at the time the new doors were installed.

Figure 8. Overhead track used for moving cylinders into the room shown in Figure 6.

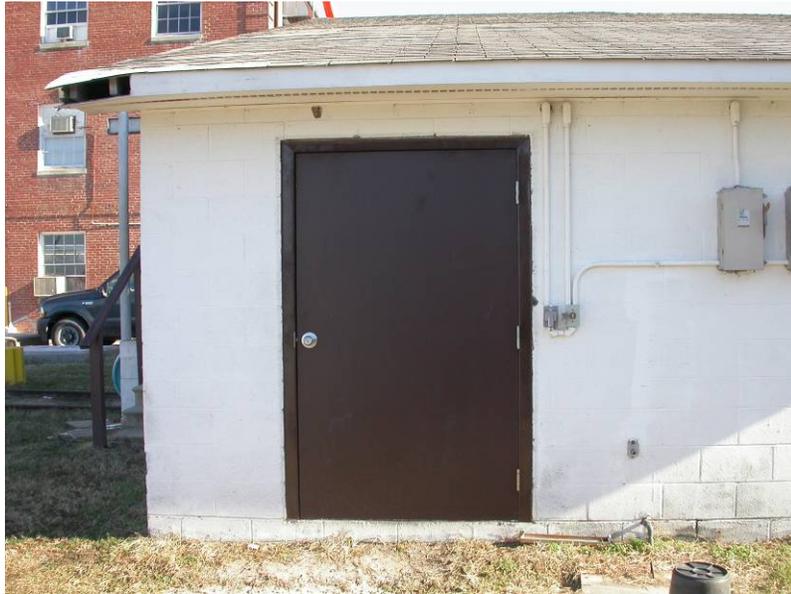
Some of the chemicals shown in the room discussed in Figures 6–11 are mixed and used in the room behind the door shown in Figure 12. The corrosive acids used in water treatment have etched the concrete floor of this room. The floor etching due to chemical spills is apparent in Figure 13.

Figure 12. Pedestrian door leading to chemical room at water treatment plant at Fort Bragg.

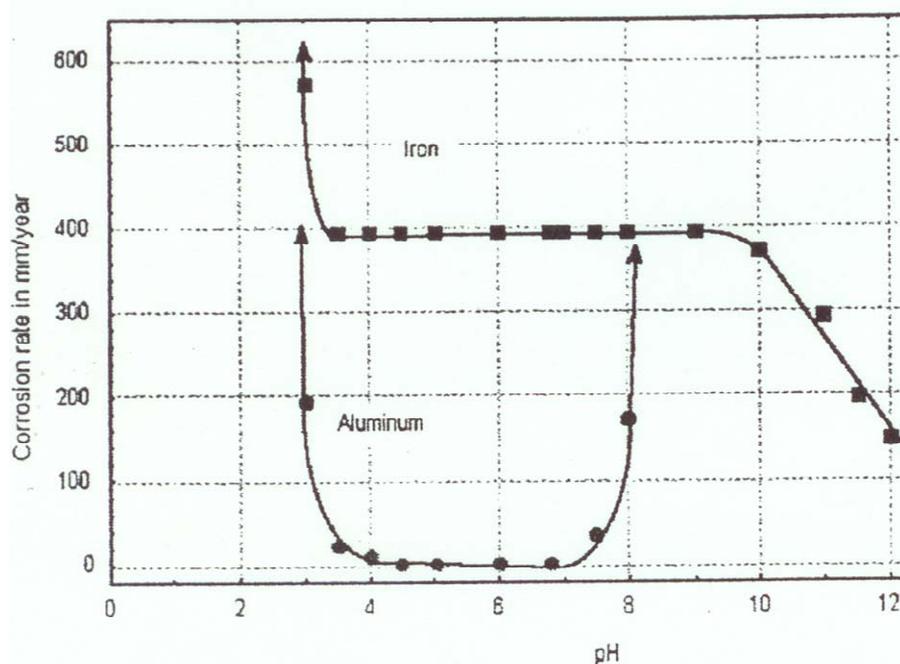
Acids are corrosive to carbon steel and concrete. They are also corrosive to zinc and aluminum, two coating metals frequently specified for retarding corrosion in atmospheric environments. This is emphasized in Figure 15, which shows the relative corrosion rates of aluminum and iron (carbon steel) at varying pH's.

Figure 15. Effect of varying pH of the environment on the corrosion of iron and aluminum.
