# **ANALYSIS OF DEBRIS FROM HELICOPTERS FROM THE FIELD**

**INTERIM REPORT  
TFLRF No. 402**

**U.S. Army TARDEC Fuels and Lubricants Research Facility  
Southwest Research Institute® (SwRI®)  
San Antonio, TX**

**Contract No. DAAE-07-99-C-L053 (WD49)**

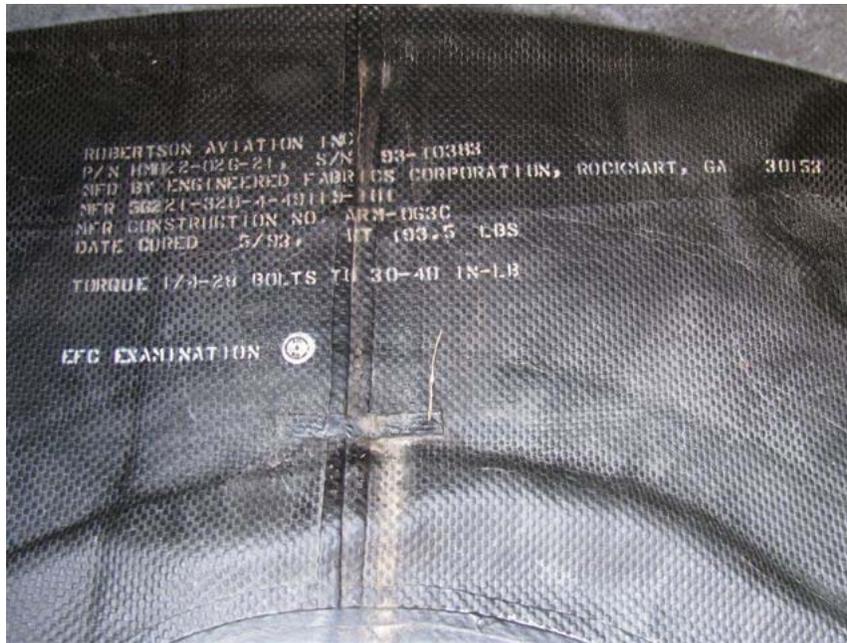
**Figure 30. Helicopter Fuel Bladder**

A fuel sample and part of an internal helicopter fuel bladder were provided to SwRI to determine if the “black” debris in the fuel was the bladder or other contamination. Figures 30 –35 illustrate the bladder and the problems encountered in the field.
