## Reducing Fracture Tendencies in PCBN FSW Tools

ONR Contract Number N00014-09-C-0288

### Base Effort Final Report

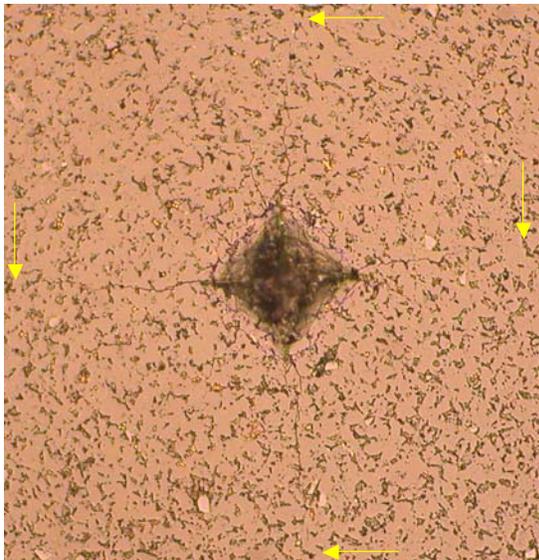
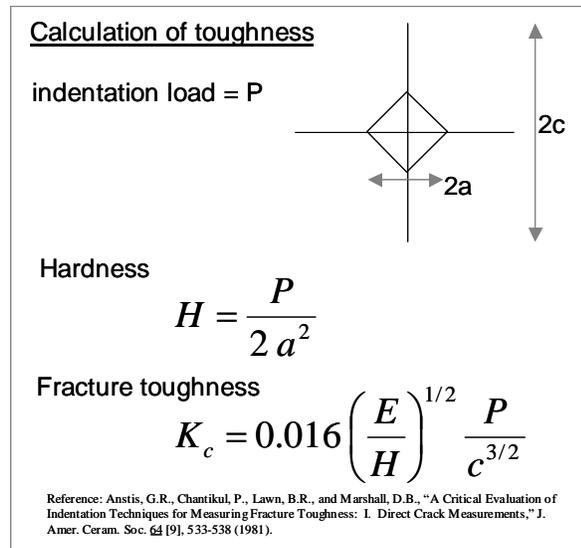
*Fig. 1. Indentation method for measurement of fracture toughness: (a) Vickers indentation (200N load) in polished surface of polycrystalline cubic BN (MS80). Arrows indicate positions of crack tips, which can be readily located in higher magnification optical micrographs; (b) Schematic of indentation and cracks, with fracture mechanics expression from which the fracture toughness can be evaluated.*

This technique has been developed extensively with ceramic materials, although it has not been applied previously to PCBN materials. Indentations in PCBN at loads smaller than ~50 N generally produce irregular crack patterns because of their high hardness and relatively large grain size. However, at higher loads well developed cracks are produced, as in Fig. 1.

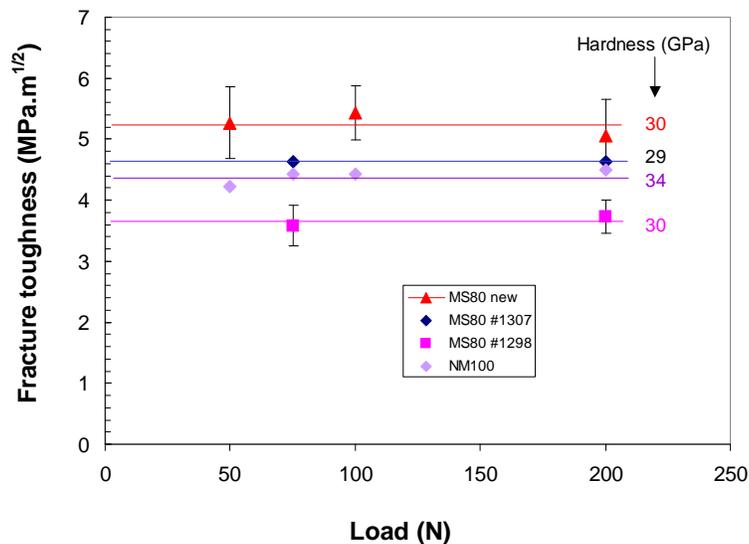
Significant differences are evident in the fracture toughnesses of the three MS80 materials. The highest toughness ( $5.2 \text{ MPa}\cdot\text{m}^{1/2}$ ) is observed in the new material which was also much more difficult to grind and polish than the other two materials. However, the relative ranking for the other two materials is opposite to their relative performance in FSW: the material with lower toughness (#1298) is the one with the longer FSW life. Further measurements will be made to investigate whether this trend is followed in other materials.

The hardness of these materials is expected to scale with the volume fraction of BN and be relatively insensitive to subtle microstructural variations that influence fracture toughness. The measured hardnesses listed in Fig. 2 are consistent with this expectation: the values for the three MS80 materials are indistinguishable (30 GPa) whereas the value for the MN100 material is higher (34 GPa).

Fig. 2. Indentation fracture toughness measurements from several PCBN materials. Error bars indicate standard deviations.

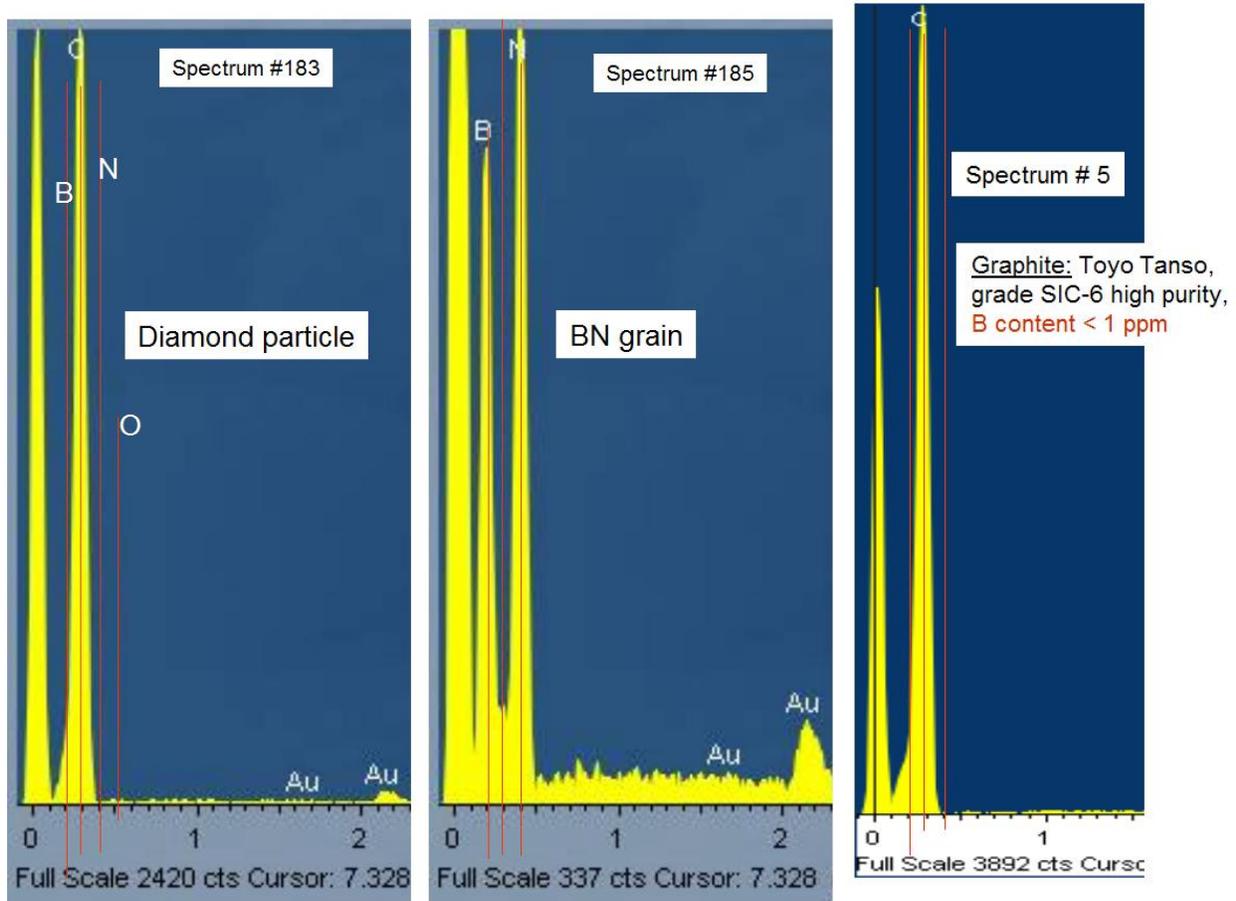
The boron map was at first sight puzzling, with the C grains showing a B signal with intensity slightly higher than the intensity of the B signal from the BN grains. However, this was shown to be an artifact due to finite width of the carbon peak and overlap with the position of the boron peak. EDS spectra from diamond and BN grains are shown in Fig. 6, with positions of B, N, and C peaks marked. The carbon peak from the diamond grain is slightly asymmetric, with intensity at the boron position approximately 10% to 15% of the peak value. The absolute intensity at this position is approximately the same as the absolute intensity of the boron peak from the BN grain, consistent with the EDS map (note the intensity scales for the diamond and BN grains in Fig. 5 differ by a factor of ~8). An EDS spectrum from a high purity graphite standard is shown in for comparison in Fig. 6. The carbon peak has shape and width identical to that from the diamond grain, thus confirming that the asymmetry of the carbon peak is due to an instrument characteristic and not due to overlap with a genuine boron peak.

Fig. 6. Comparison of EDS spectra from diamond and BN grains in new MS80 and high purity graphite standard.

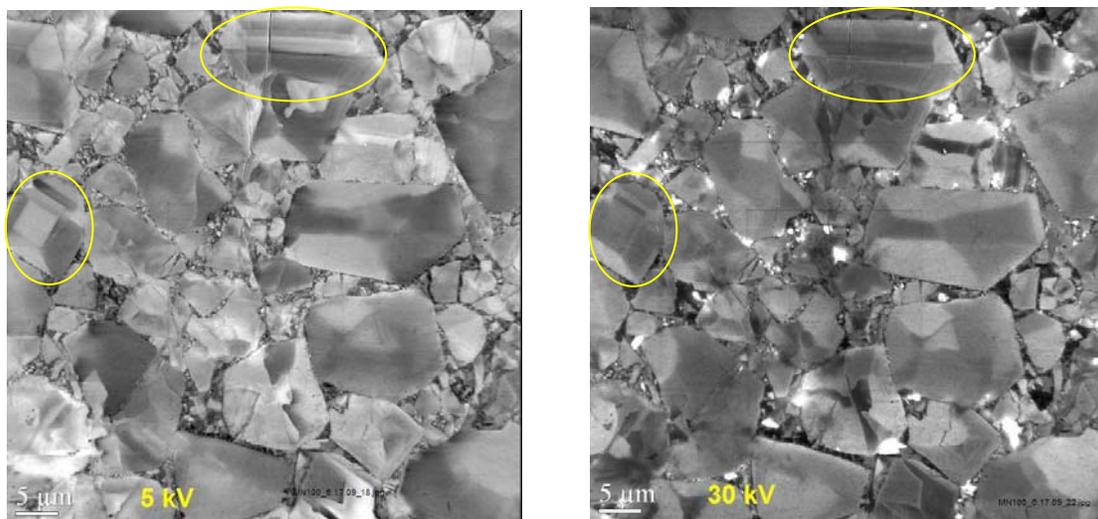
The detailed contrast in images such as Fig. 7b was found to be sensitive to the accelerating voltage, with reversals of contrast occurring within some grains when the voltage was changed (Fig. 8). This and the observation that the contrast within the BN grains disappears when surface is coated with conducting gold suggests that contrast may be associated with charging. (The image contrast also disappears when the surface is coated with carbon (Fig. 9b), thus eliminating the possibility that the contrast is obscured by scattered electrons from the gold coating.)

*Fig. 8. Reversal of contrast in secondary electron images from uncoated surface of MN100 material at two different accelerating voltages: (a) 5 KV; (b) 30 KV.*

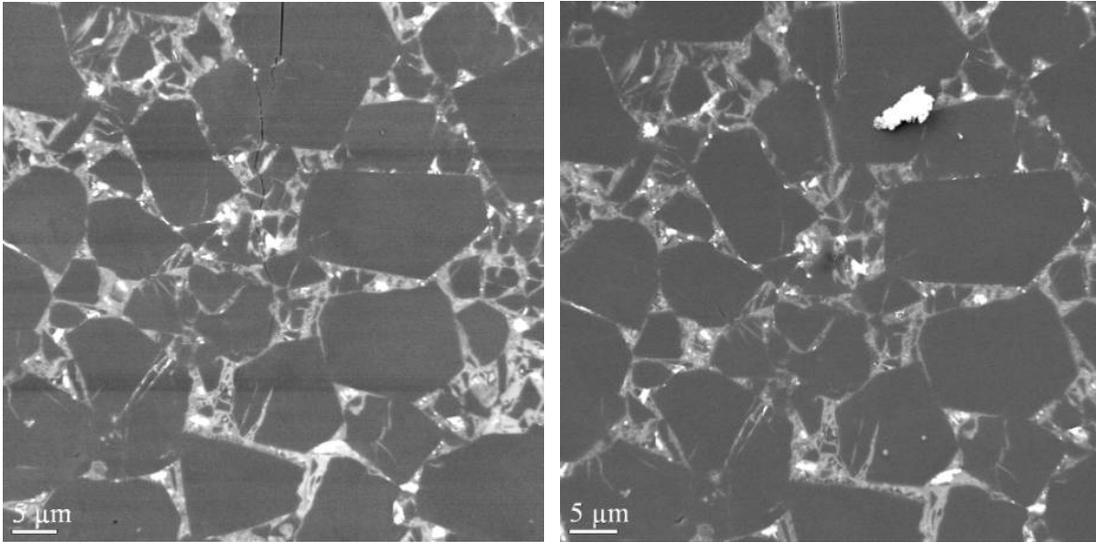
*Fig. 9. Images from area of Fig. 8: (a) backscattered electron image, uncoated surface; (b) secondary electron image after coating the surface with carbon.*

We hypothesize that these contrast features may correspond to internal twins or other deformation structures in BN grains, possibly caused local contact forces due to grain-to-grain contact during high pressure consolidation. Similar contrast features are observed in the MS80 materials, although only a small fraction of grains show internal features (consistent with expectation that, with the higher binder content, less damage occurs in MS80 from neighboring grains being in direct contact during densification).
