INVESTIGATION OF AN EXPLOSIVE

ACCIDENT USING SIMULATION AS A TOOL

J.F. DROLET, G. COUTURE AND R. FARINACCIO

DEFENCE RESEARCH ESTABLISHMENT VALCARTIER
P.O. Box 8800, COURCELETTE
QUEBEC, CANADA, GOA 1R0

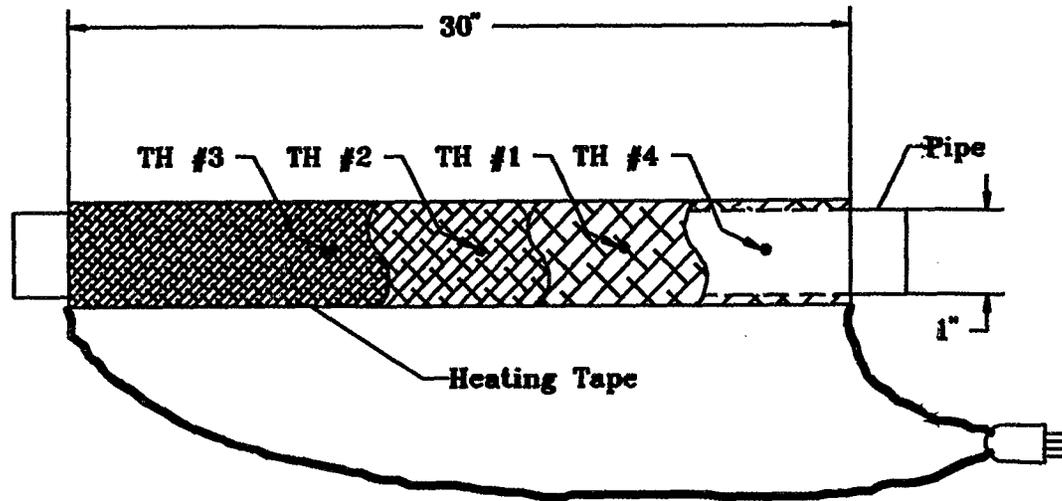
FIGURE 6: First simulation test

A schematic of the simulation test is shown in Fig. 6 and the results appear in Fig. 7. It can be concluded from the results that the number of layers has a strong effect on the temperature of the pipe but in this case, it does not seem to bring it high enough (170°C) to explain the ignition of EXP.

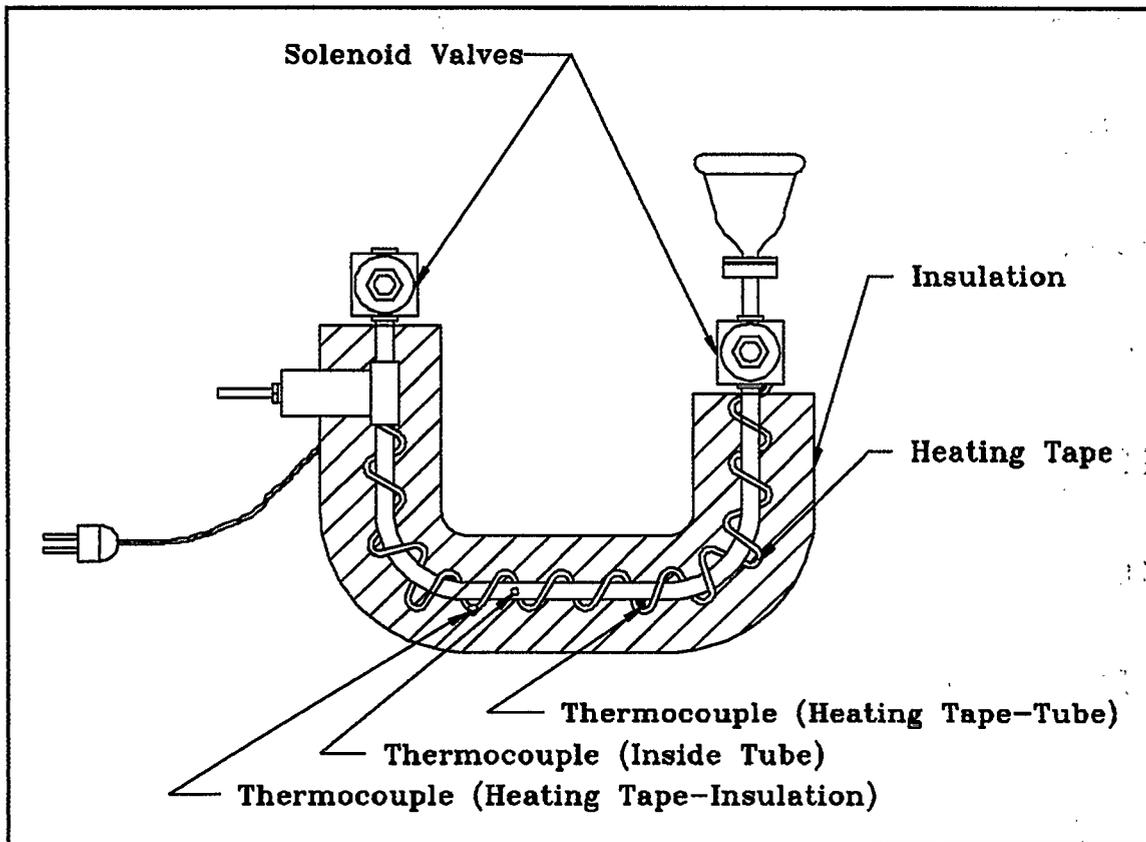
Figure 8: Second simulation of heated pipe.

A closer examination of the conditions that prevailed at the moment of the accident revealed that a short section of the pipe that was heated with heating tape was also insulated.

A second simulation similar to the one just described above but with the addition of insulation over the heating tape (see Fig. 8) was prepared. As shown in Fig. 9, this simulation revealed that the temperature inside the piping could have reached, after equilibrium, a temperature as high as 370°C, a temperature more than sufficient to cause the auto-ignition of EXP (auto-ignition of EXP is $214 \pm 2^\circ\text{C}$).

- 1) installation of a safety valve in the equipment;
- 2) not using heating tape as a source of heat in the presence of energetic materials;
- 3) formation of a team of experts to study the risks associated with new processes or new equipment and make the proper recommendations.
- 4) writing of SOPs even for a one time operation when the level of risk is high.
- 5) operation of equipment by remote control whenever possible.
