**Investigation of Failed Components from a 7-in
High Altitude Research Program (HARP) Cannon**

ARL-TR-5814

November 2011

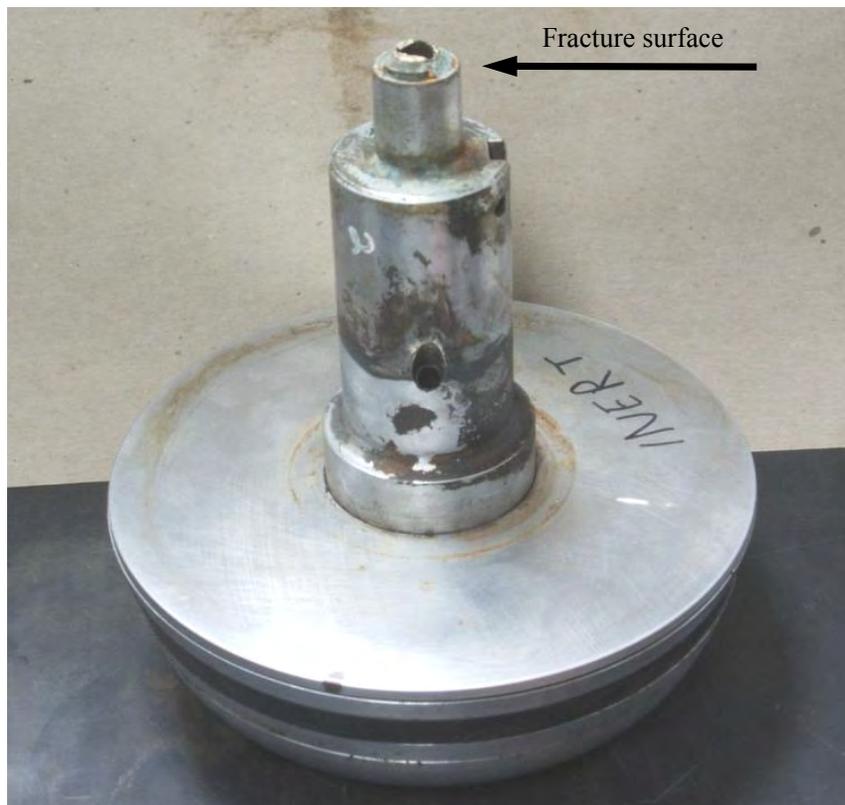
Figure 1. As-received M113A1 breech assembly spindle.

The primary focus of the HARP breech failure was on the spindle, although there were secondary fractures to the assembly. The failed spindle can be observed in figure 1 and compared with the geometry of an intact spindle of similar design in figure 24. The mating fracture half from the failed spindle was never recovered. By contrasting the two figures, it can be discerned that the failure of the spindle occurred very near the end of the turned threads on the spindle.

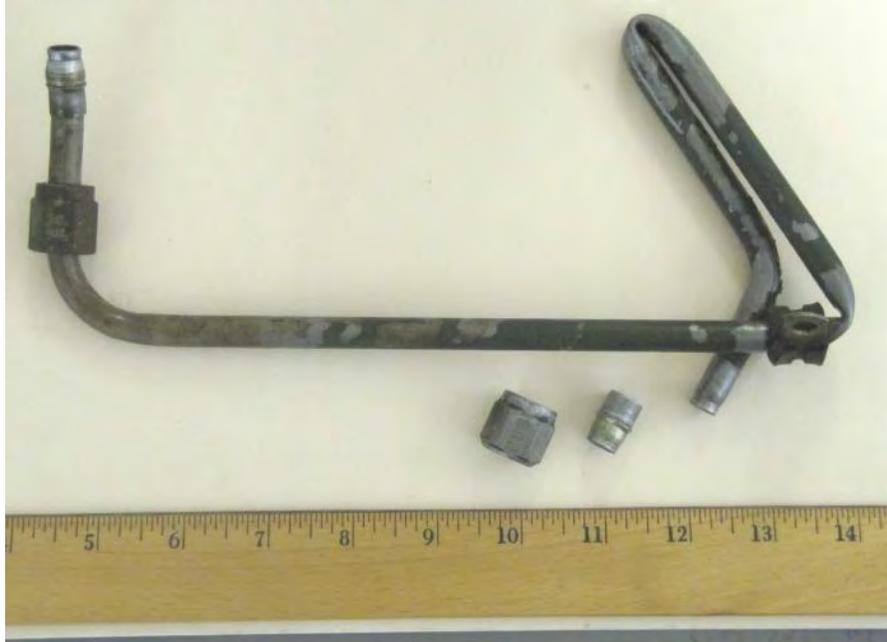
Figure 2. As-received M174 recoil unit replenisher/recuperator tube.

The external surfaces of the M174 recoil unit tube were photographed and examined for defects and/or witness marks from impact, installation, or corrosion. This component was removed from the M174 recoil unit by removing the locking nut on the fixed end of the tube. The other end was visibly bent (figure 2) and the joint failed at the nut-stud/coupling interface as observed during the initial inspection after the event. The locking nut remained on its respective coupling with the ferrule after the failure. Since there were no visible metal fracture surfaces, the failed joint design and surfaces were examined. There were no observable impact marks on the tube, which would have caused the tube to become dislodged from its mount. The nut and ferrule removed from the failed end of the tube are shown in figures 3 and 4.

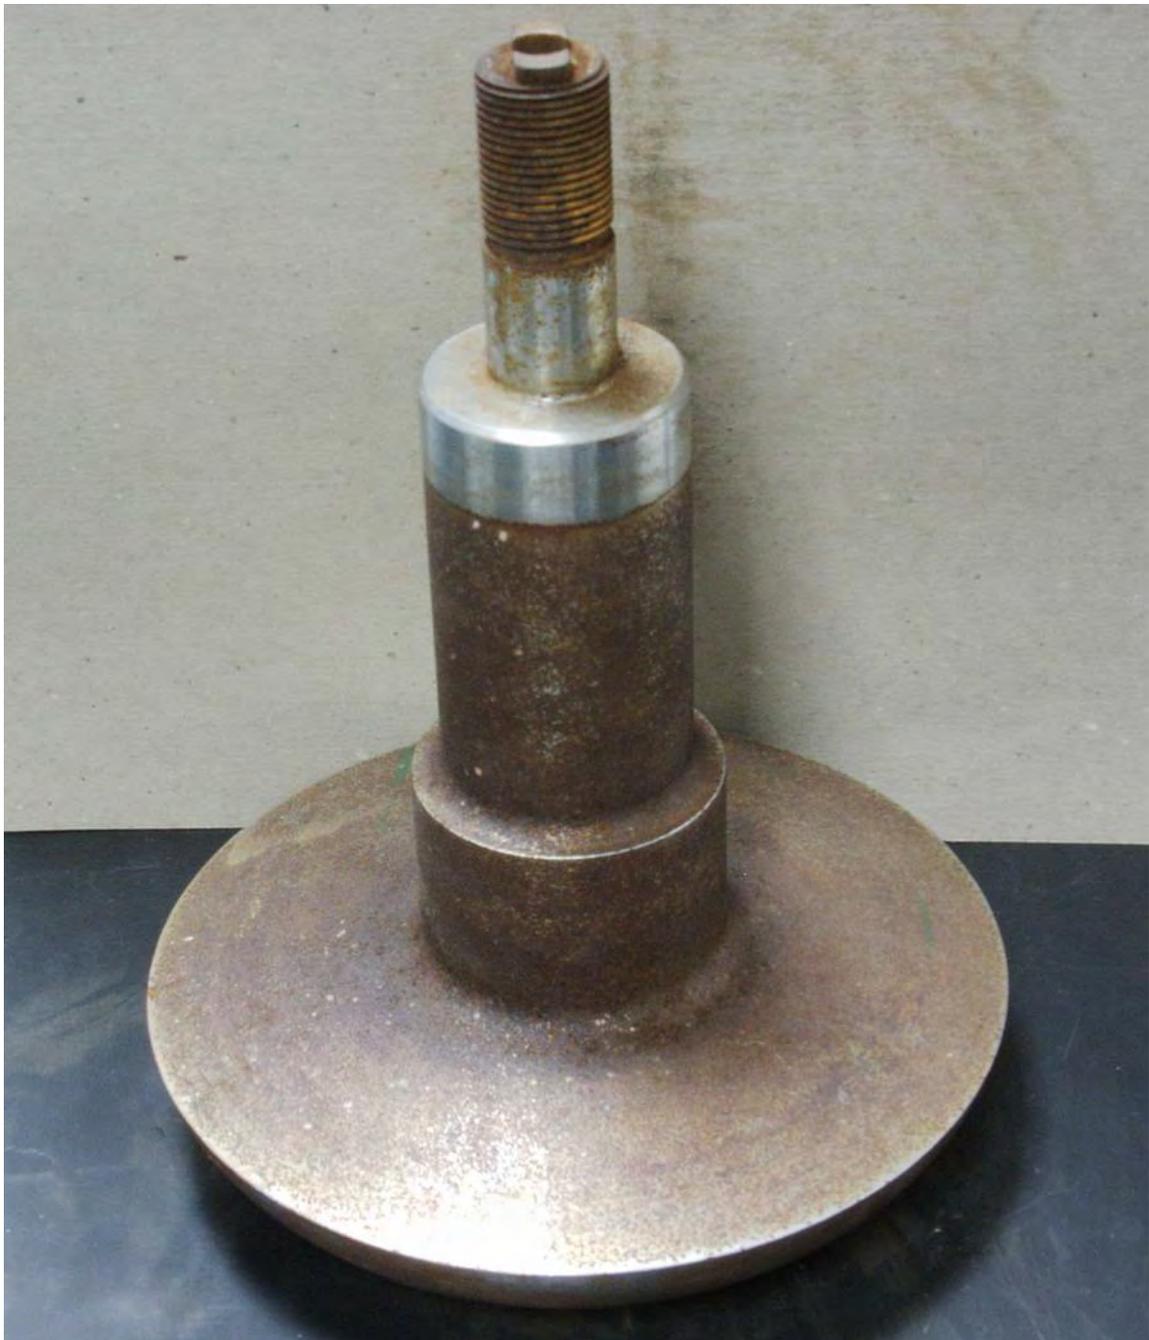
Figure 24. Geometry of an intact spindle, similar to the failed component.

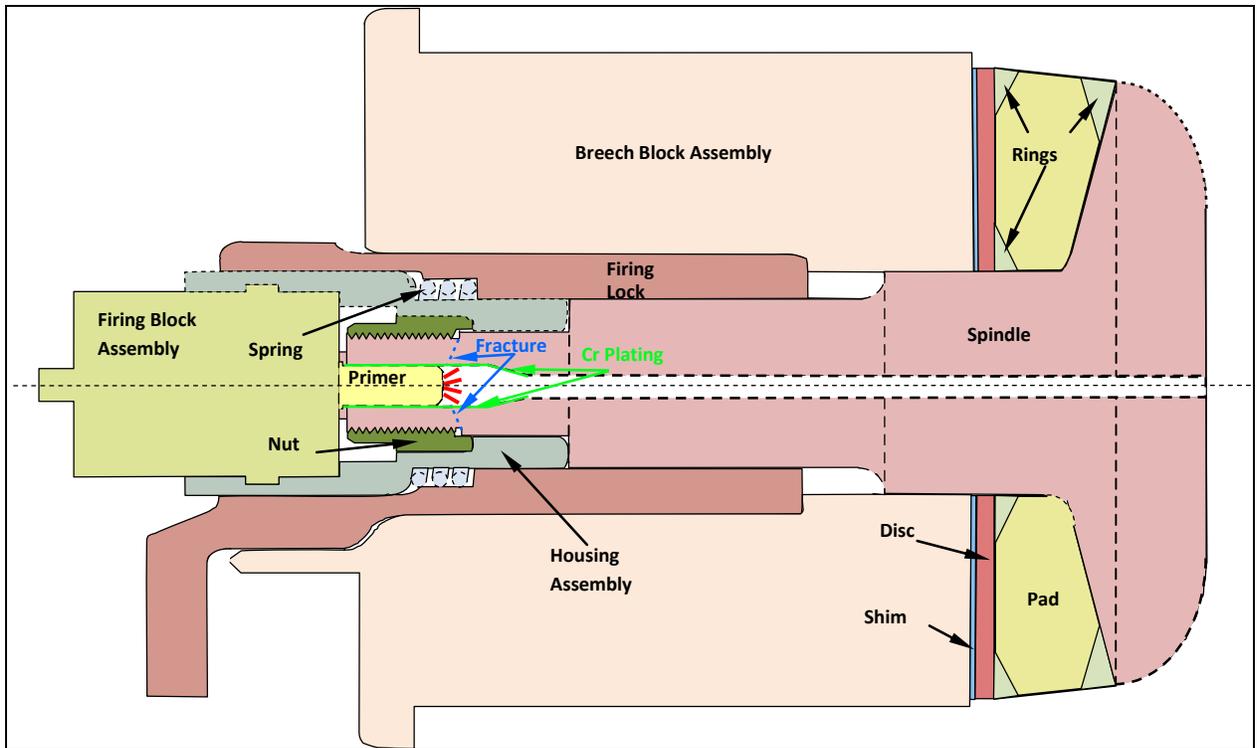
Coincidentally, this area is near the exit of the Mk-15 primer cartridge when fitted and locked into the interior bore of the spindle. This relationship can be observed via the simplified schematic in figure 25. From a design perspective, it is likely less than optimum that the exit from the primer charge is located upstream and adjacent to the machined step for the threads. A side-by-side comparison between the failed spindle and an intact example can be viewed in figure 26.

Figure 25. Simplified schematic showing the primer/spindle thread proximity.
