*Monitoring Completed Navigation Projects Program*

## **Kaumalapau Harbor, Hawaii, Breakwater Repair**

Final report

Under MCNP Work Unit Kaumalapau Harbor, Hawaii, Breakwater Repair

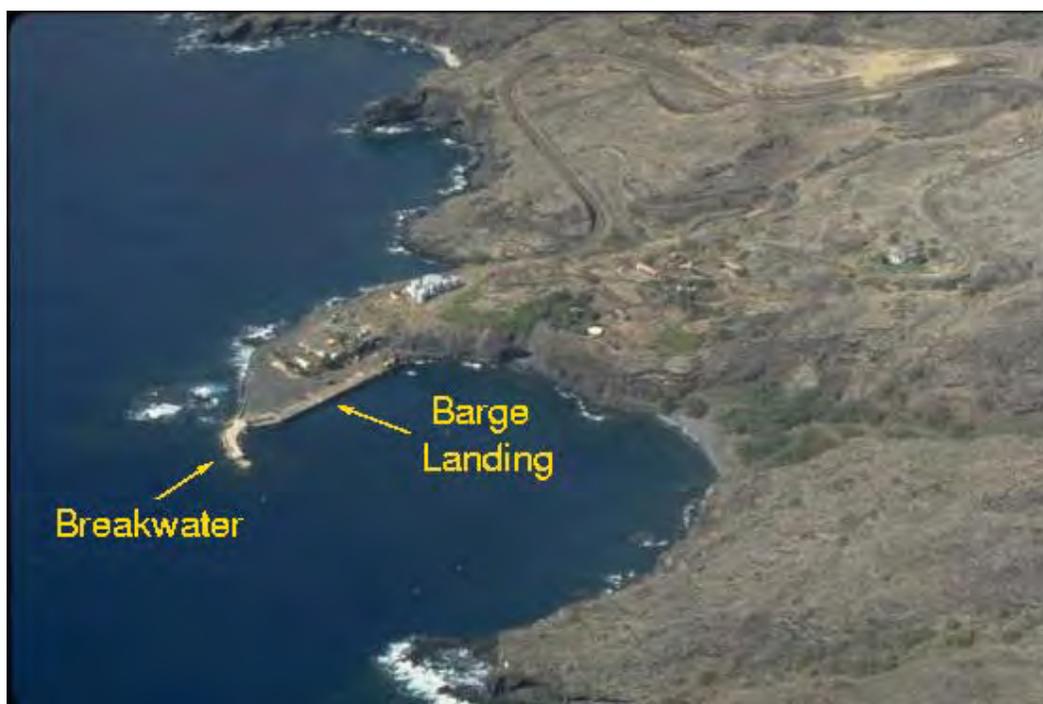
Figure 1.2. Kaumalapau Harbor barge landing and breakwater prior to 2007 repair.

The original breakwater structure may have been an “engineered” design, or it may have simply been a rubble mound constructed of a random mix of available stone. Even if it was an engineered structure, it would not have met the criteria required by modern breakwater design practice, nor would sufficient information regarding oceanographic design conditions have been available to the designer. The breakwater suffered extensive damage over the years, and has been repaired numerous times. A severe “Kona” storm resulting from a low-pressure front southwest of Hawaii damaged the breakwater significantly in January 1980, and Hurricane Iwa caused further damage in 1982.

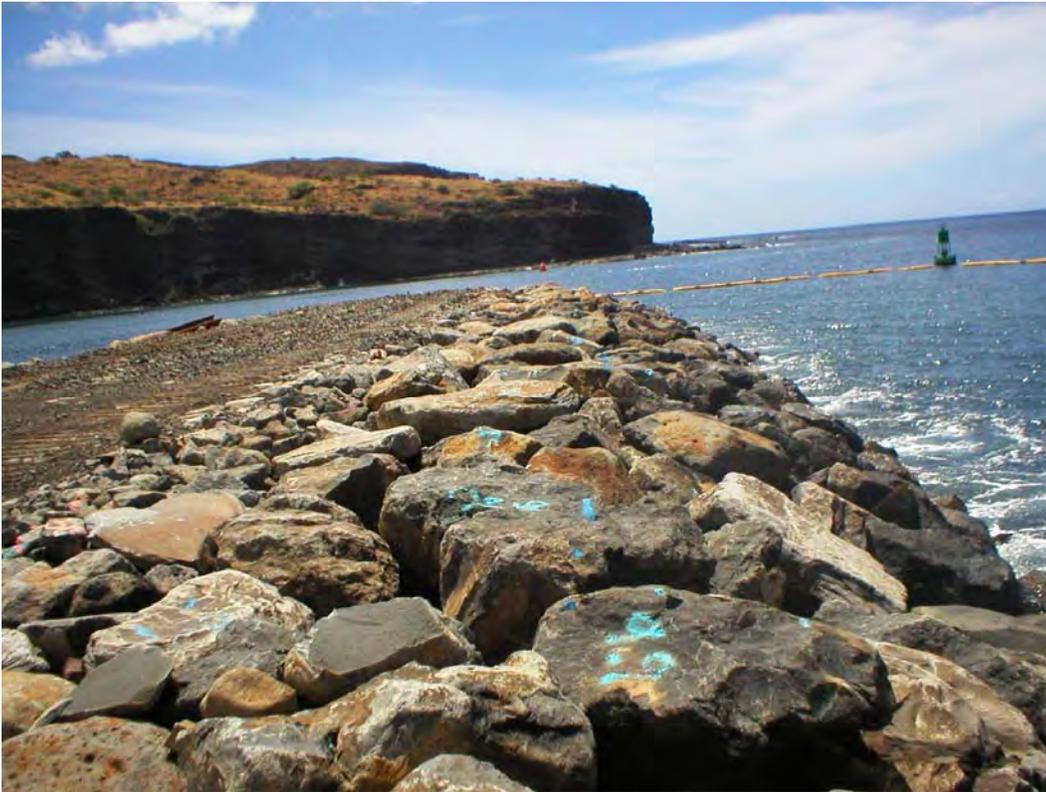
Figure 2.1. Breakwater underlayer prior to placement of Core-Loc armor layer.

The existing rubble mound was excavated and shaped to form the core of the new breakwater. Excavated material was used as core material for the breakwater head, and as stone for a harbor side toe berm. Underlayer stone weighing 2.5 to 4.5 tons was salvaged from the existing structure to the maximum extent possible, and necessary supplemental stone was barged to the project site from the Island of Molokai (Figure 2.1).

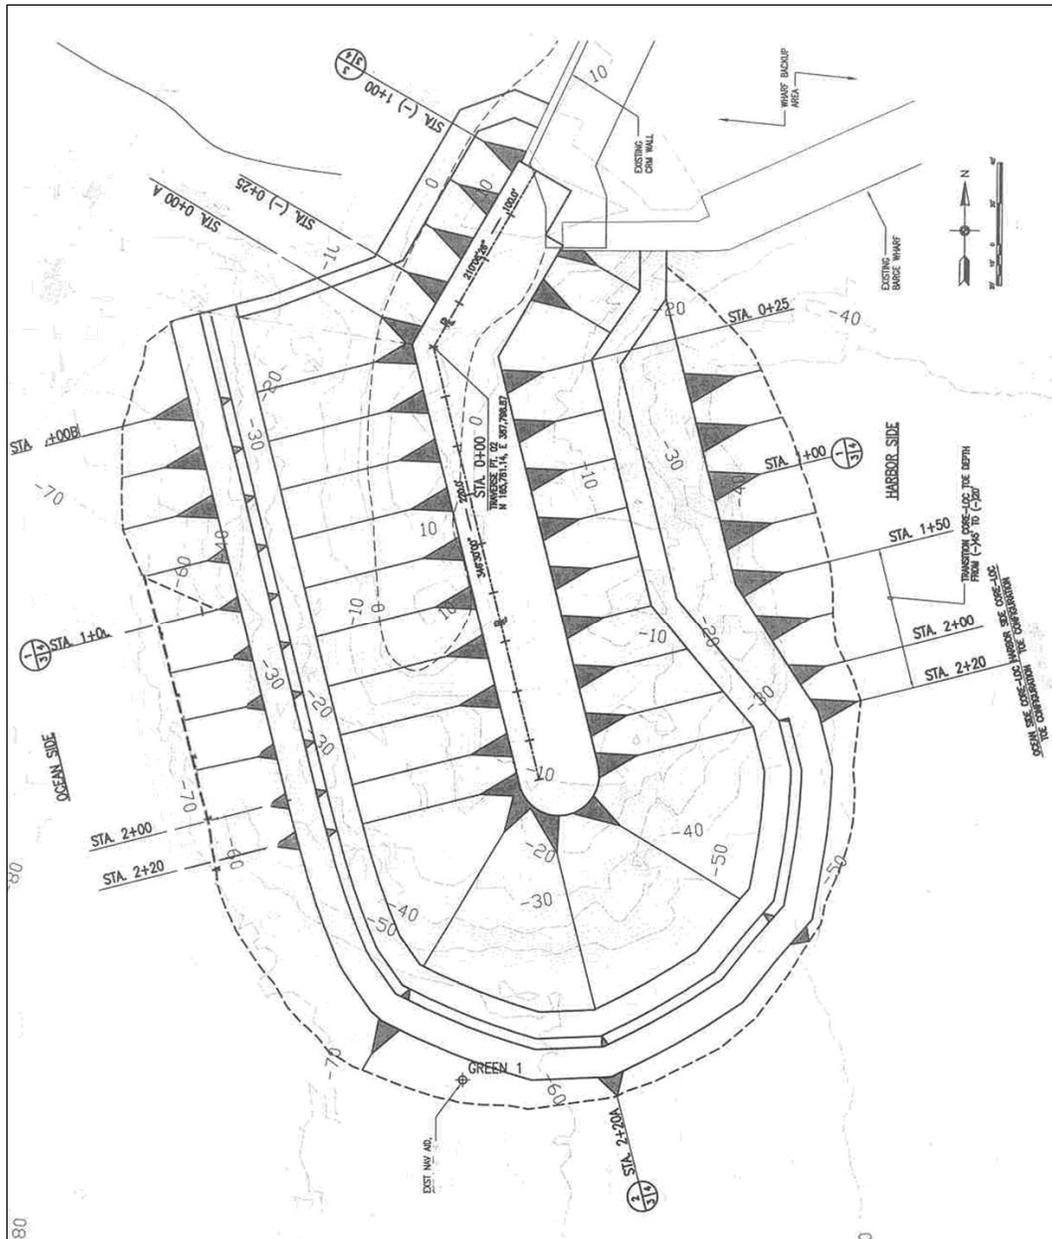
Figure 2.2. Kaumalapai Harbor breakwater rehabilitation plan (U.S. Army Engineer District, Honolulu 2003).

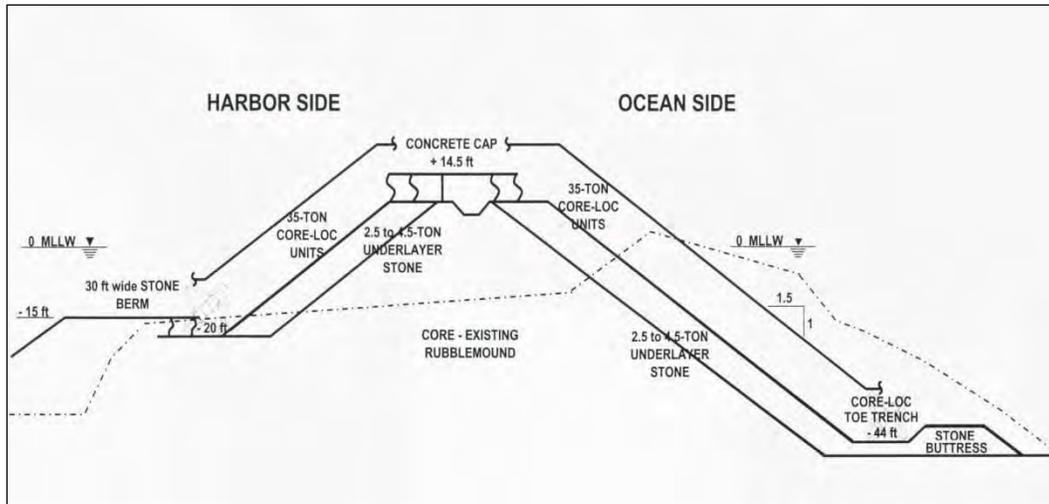
Figure 2.3. Typical Kaumalapau Harbor breakwater cross-section, Sta. 0+00 to Sta. 2+20 (Sullivan and Werren 2003).

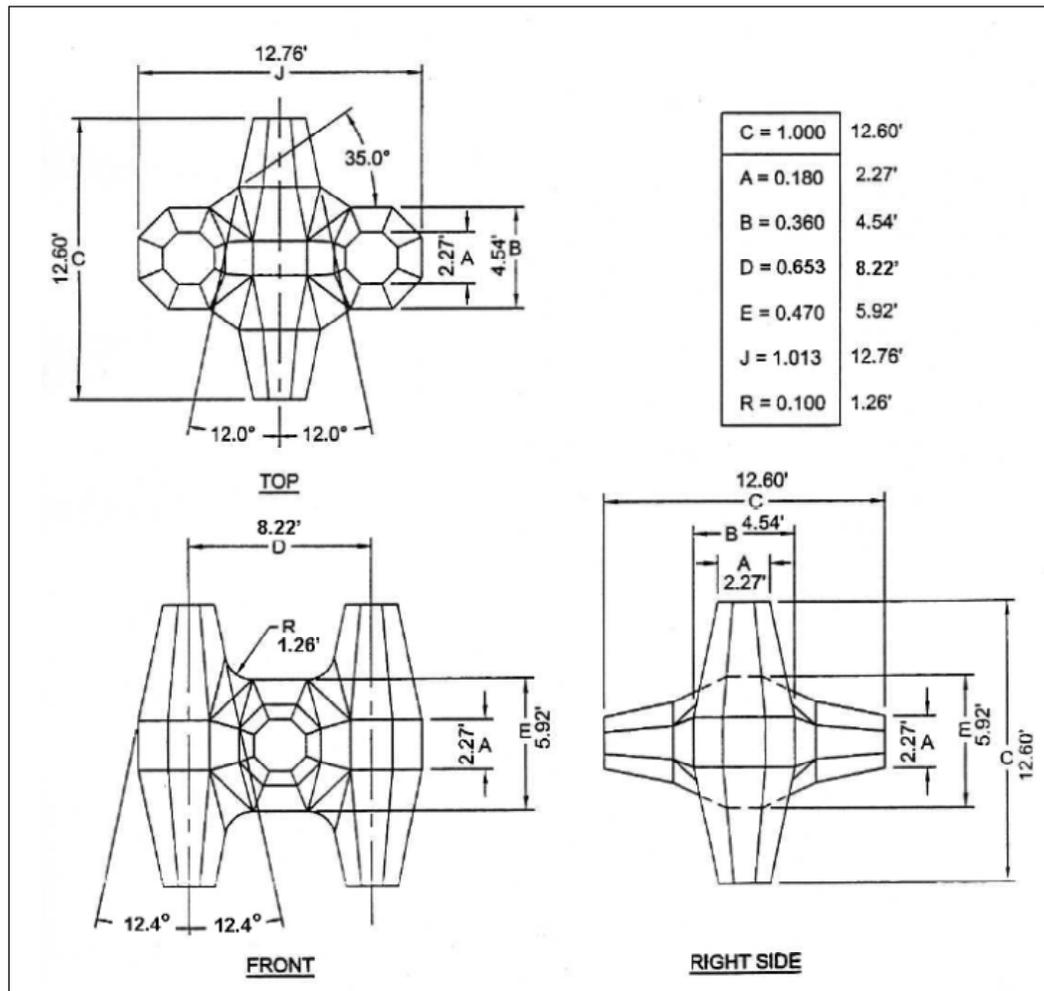
Figure 3.1. Core-Loc II unit shape and dimensions used on Kaumalapau Harbor breakwater rehabilitation.

No hydraulic model tests were done to determine the performance of the Core-Loc II, and the assumption was made that hydraulic stability performance would be similar to the Core-Loc I. Thus, the hydraulic stability performance would be similar at the same total weight (35 tons); and therefore, the “C” dimension was adjusted to obtain the 35 ton weight with the new unit. The “C” dimension changed from 12.9 ft for the Core-Loc I to 12.6 ft for the Core-Loc II. This increased the packing density coefficient from  $\phi = 0.57$  to 0.62. The final design Core-Loc II and dimensions are shown in Figure 3.1.

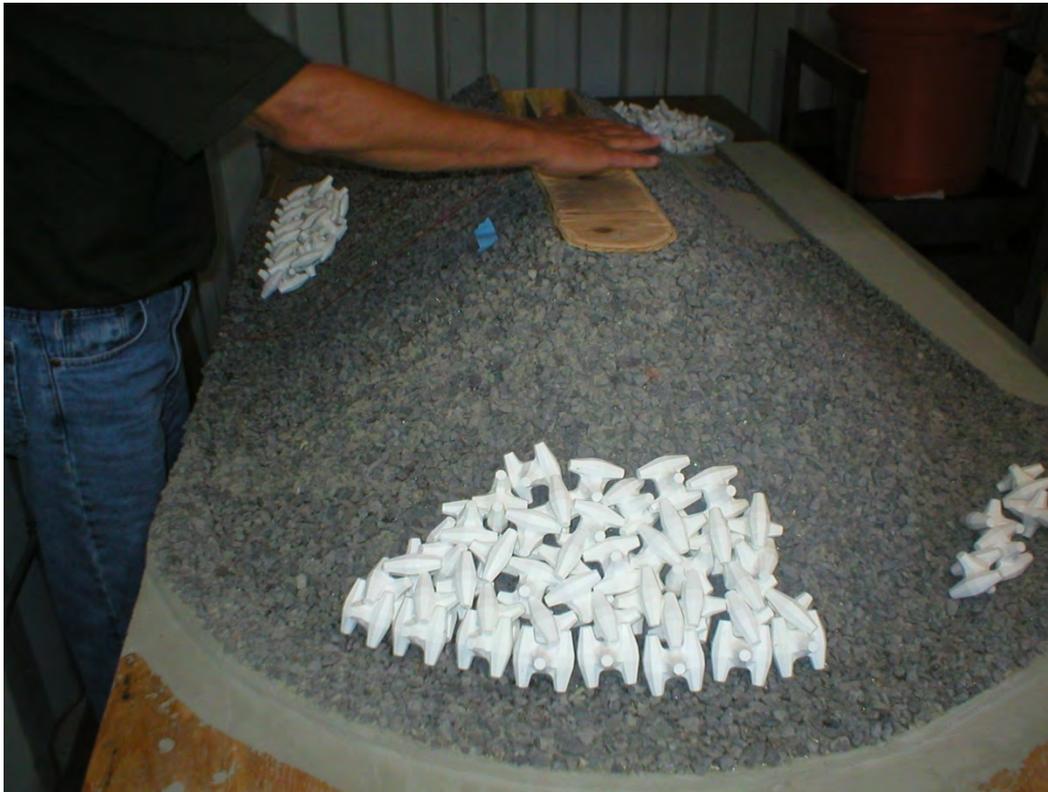
Figure 3.2. Contractor scale-model of Kaumalapau Harbor breakwater and Core-Loc armor units.

units on the scaled breakwater structure (Figure 3.2). As placement of the units proceeded from the lower elevations to higher elevations on the structure, fewer and fewer units would be needed in a row. Hence, around the head of the structure, adjusted placement was necessary to get the correct number of units on the structure at the prescribed packing density. A total of 817 scale-size Core-Loc units were required for the model, the same number as ultimately placed on the breakwater.

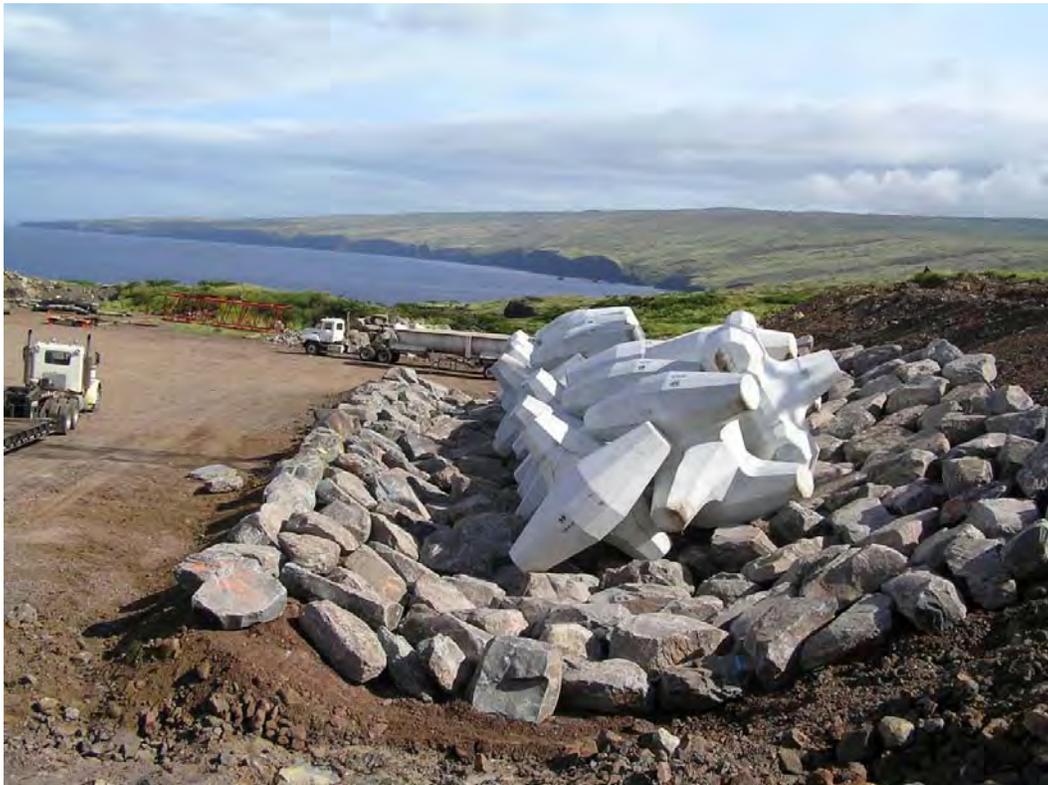
Figure 3.3. Test section constructed on land showing approximation of actual toe trench, and non-random “cannon” orientation (lower row) and “straddled” orientation (upper row) of structure toe Core-Loc armor units.

The specifications for Core-Loc placement also included requirements for building a test section of the Core-Loc placement on land. Constructing with 35-ton armor units is not easy, and errors in prototype construction can be costly and time consuming. Thus, a test section of the Core-Loc placement on land was required prior to starting work on the actual breakwater (Figure 3.3). This gave the contractor a chance to practice slinging units and an understanding of unit attitude variation to facilitate interlocking, and practice adhering to a precise placement plan prior to placing units underwater.

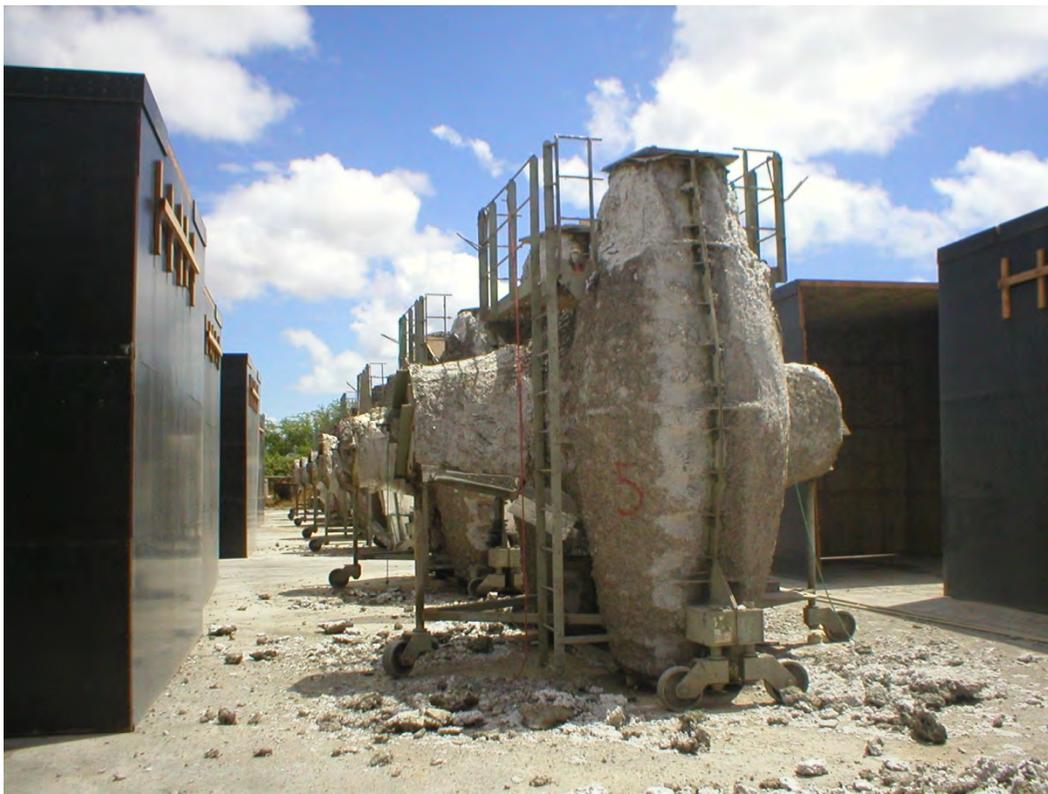
Figure 3.4. Insulated formwork for casting 35-ton Core-Loc armor units.

suitability of the forms for their intended purpose of casting 35-ton Core-Loc units (Figure 3.4). The specification stated that forms shall not be removed from the Core-Loc within 24 and 72 hr after casting for non-supporting and supporting forms, respectively. A provision was made to permit earlier removal of the forms provided that a structural analysis of concrete strength was made to show that the concrete in the forms had compressive and flexural strength sufficiently higher than the minimum required for form removal. The Kaunalapau contractor did not elect to remove any forms early.

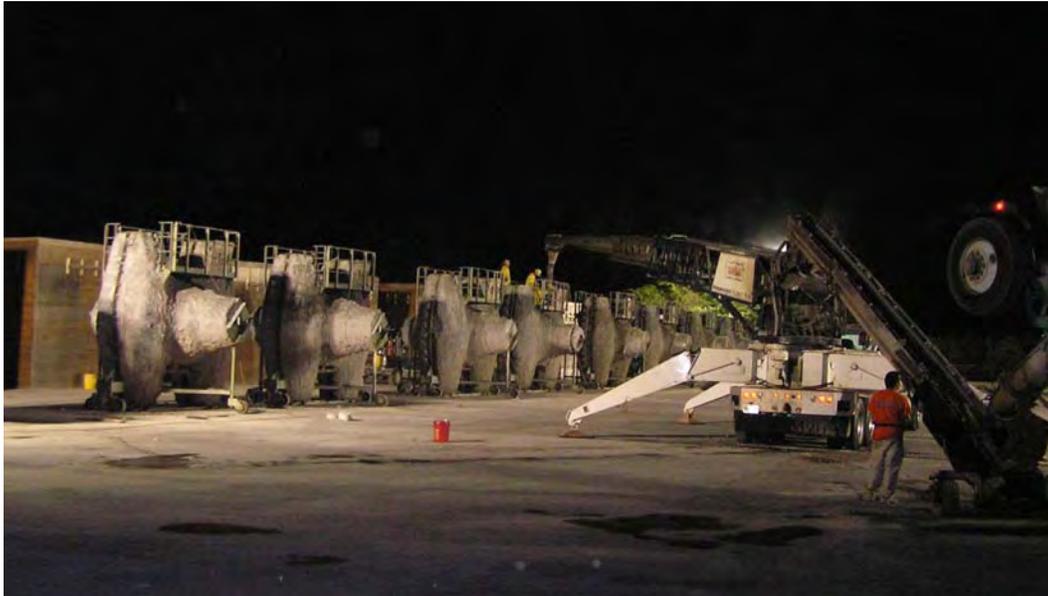
Figure 3.5. Casting concrete Core-Loc armor units at night for better temperature control.

in accordance with ASTM C 1116, Type III, synthetic reinforced concrete, with 7.5 pounds (lb) of structural fibers per cubic yard (cu yd) of concrete (forta fiber or equal). The concrete-placing temperature was not permitted to exceed 85°F, which basically necessitated that the contractor cast the Core-Loc at night (Figure 3.5).

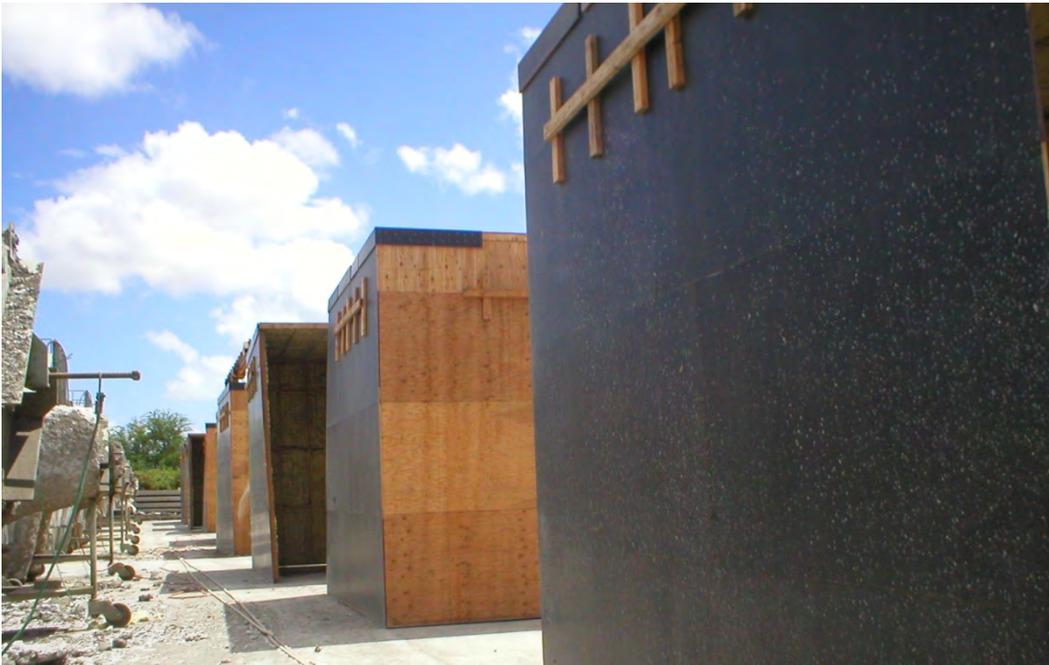
Figure 3.6. Insulated plywood curing boxes encasing the Core-Loc concrete forms to maintain contract temperature specifications limits.

In addition, to meet the concrete curing temperature requirements, the contractor used a significant amount of water in the form of ice in the mix. The concrete mix resulted in a concrete unit weight of 150 lb per cubic foot (cu ft). These stringent temperature requirements necessitated that the Core-Loc concrete forms be encased in insulated plywood curing boxes to ensure that the actual temperatures during curing did not deviate beyond the contract specification limits (Figure 3.6).

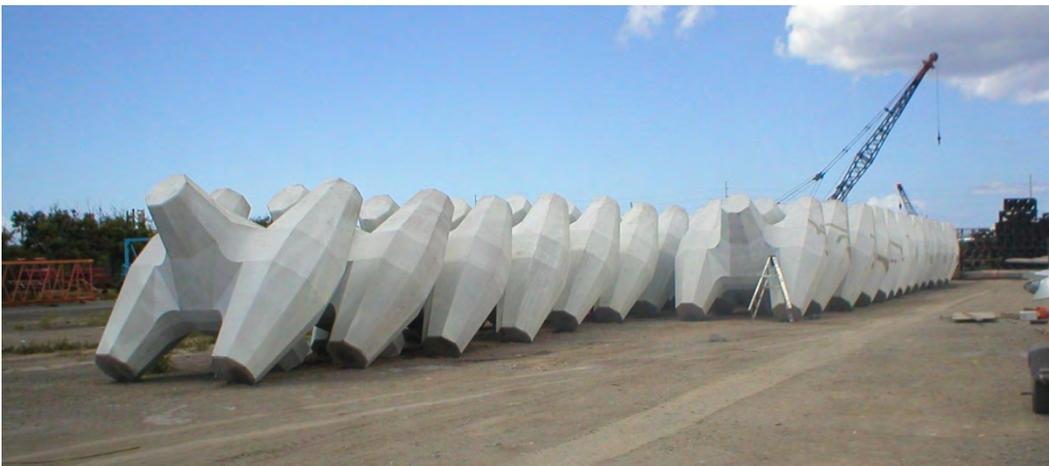
Figure 3-7 shows a portion of the Core-Loc armor units after removal from the forms at the Island of Oahu casting yard, and prior to transport by barge to Kaumalapau Harbor breakwater construction site on the Island of Lanai.

Figure 3.7. Core-Loc armor units awaiting transport to Island of Lanai.

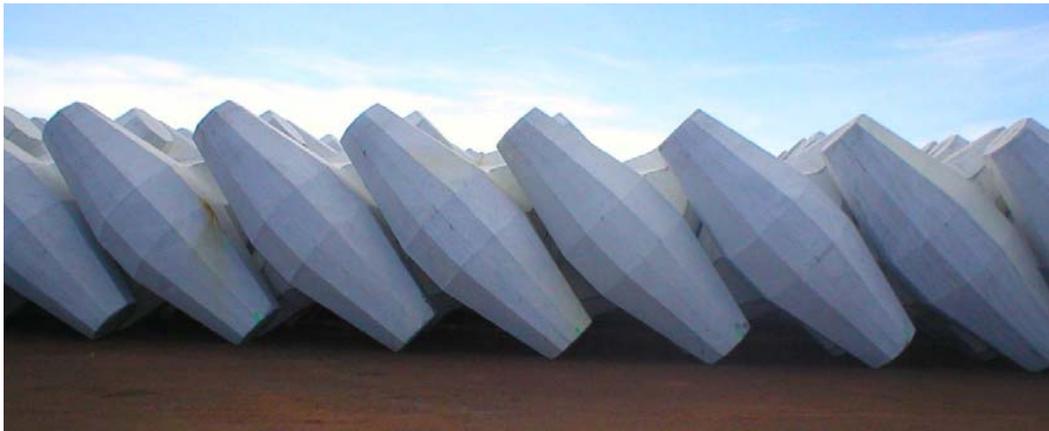
Figure 4.1. Core-Loc units at the storage yard on Island of Lanai, awaiting transport to Kamalapai Harbor breakwater construction site.

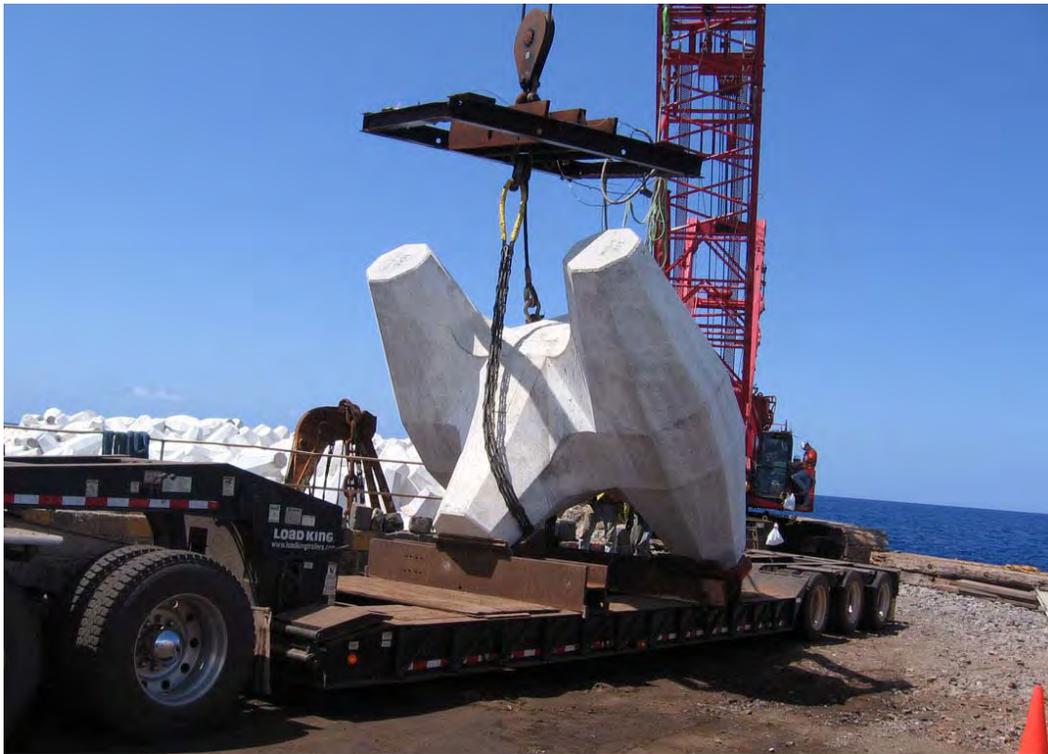
Figure 4.2. Core-Loc unit rigged for offloading at the breakwater construction site after being transported from the storage yard (Sea Engineering, Inc. and Group 70 International 2008).

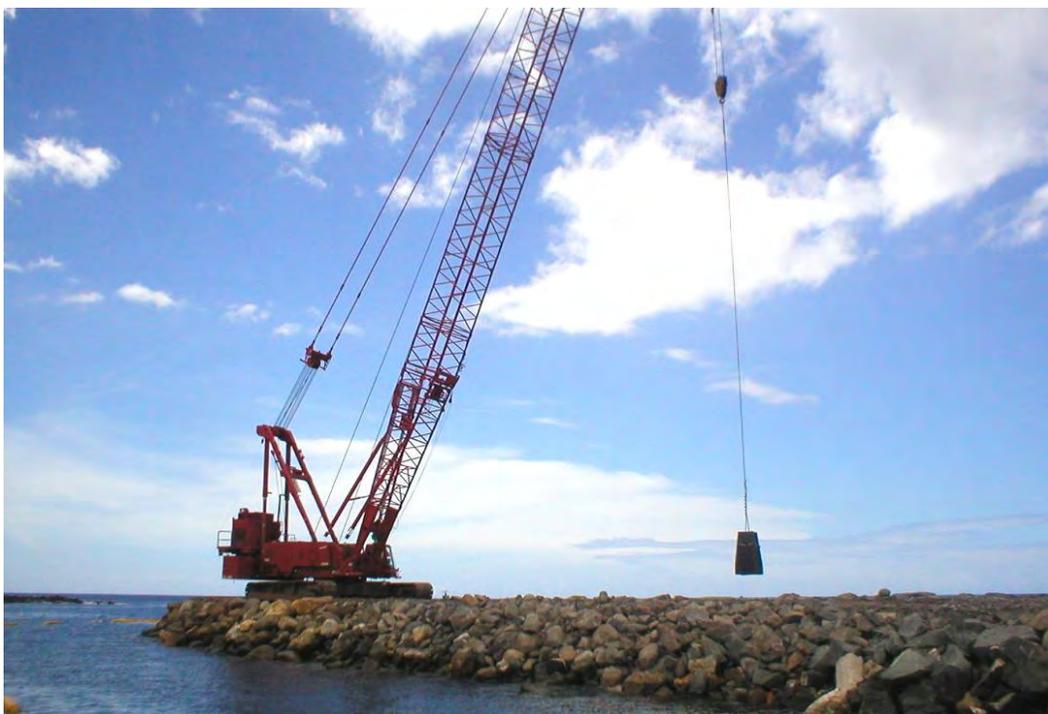
Figure 4.3. Manitowoc 2250 crane, primary equipment used to rehabilitate the breakwater.

On-site construction was accomplished primarily by one piece of heavy equipment, a Manitowoc 2250 crane that was used to shape the existing rubble mound to form the core, place all the stone, and place the Core-Loc units (Figure 4.3). Ancillary equipment included a smaller Manitowoc 999 crane for handling of the Core-Loc units on the barge, and lowboy trailers used for moving Core-Loc units to and from the inland stockpile area. Any necessary supplemental underlayer stone for forming the core of the breakwater was obtained from a quarry site on the Island of Molokai and barged to Lanai. Suitable stone salvaged from on-site, as approved by the

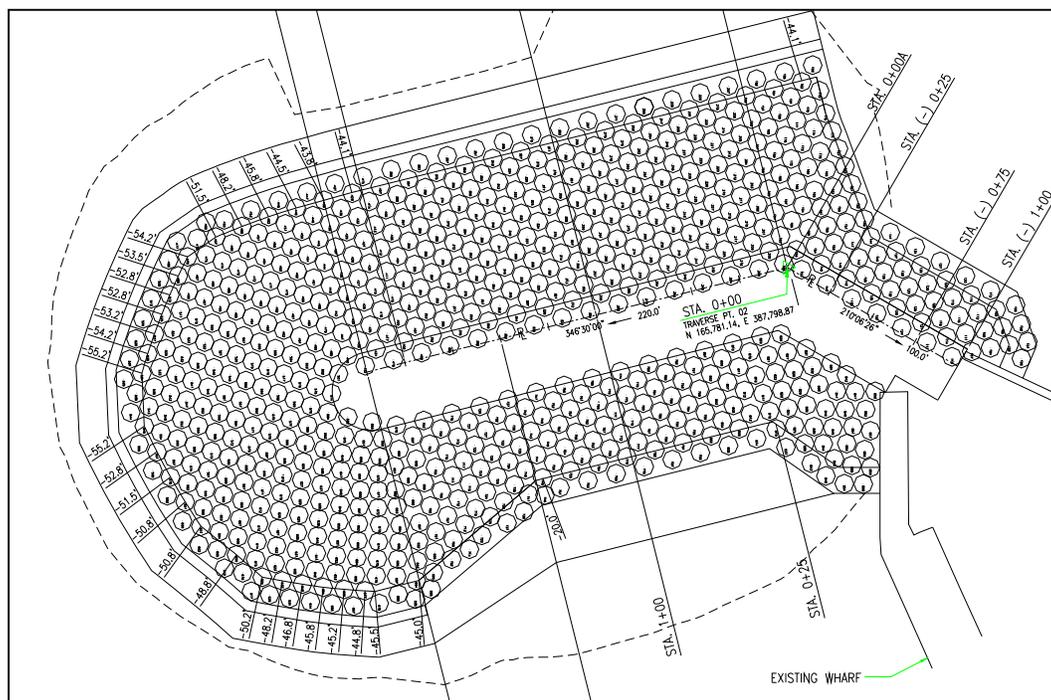
Figure 4.4. GPS horizontal coordinates of each Core-Loc unit placed on the breakwater, based on packing density coefficient of  $\phi = 0.62$ .

The packing density specified for the armor units' size and shape required that a placement plan be developed, giving each unit a unique location (Figure 4.4). These locations were based on a horizontal coordinate system that is tied to benchmarks at the project site. The benchmarks are precisely set using a GPS, which incorporates satellites, ground base stations, and hand-held GPS receiving units. To place each Core-Loc in its specified location, a method was developed that included the use of a real-time kinematic GPS mounted at the top of the crane boom used to place the armor units. The substantial weight of the units caused them to hang directly below the GPS unit. This, in combination with position targeting

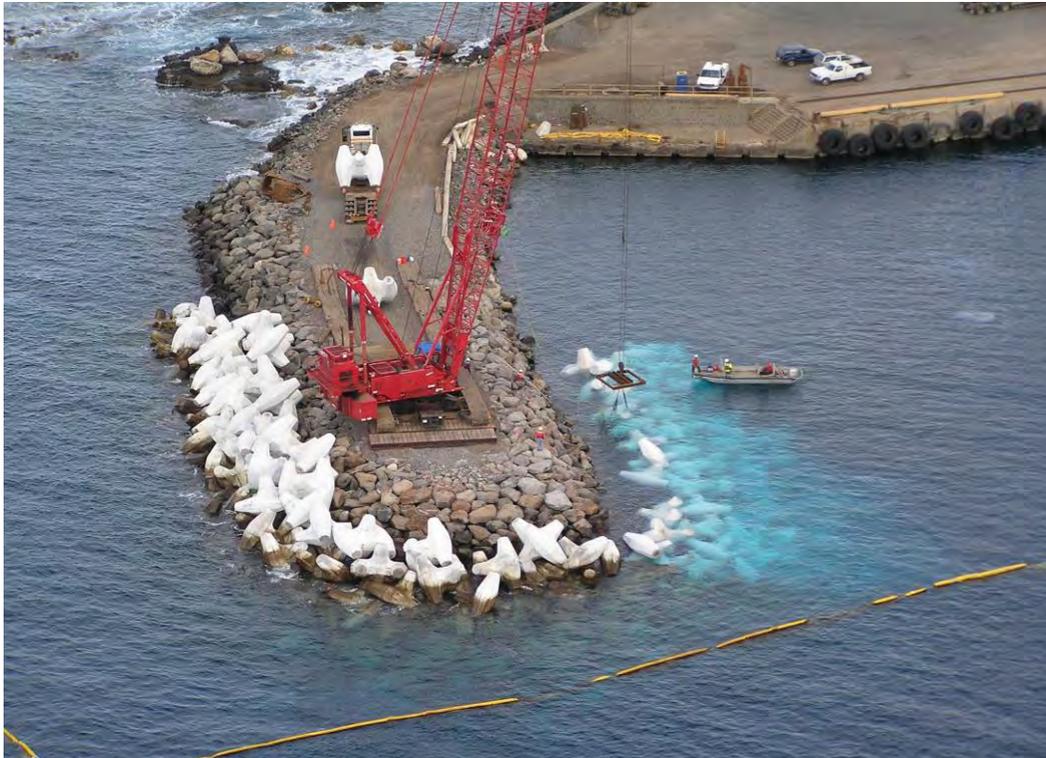
Figure 4.5. GPS placement of Core-Loc armor units on Kaumalapau Harbor breakwater during rehabilitation.

software, allowed the crane operator to place the center of each armor unit in its predetermined location. Although external factors such as wind and waves affect the precision with which the units can be located underwater, the accuracy achieved during the initial placement of armor units was within  $\pm 15$  cm of the target location. Placement of the armor units on the structure is shown in Figure 4.5.

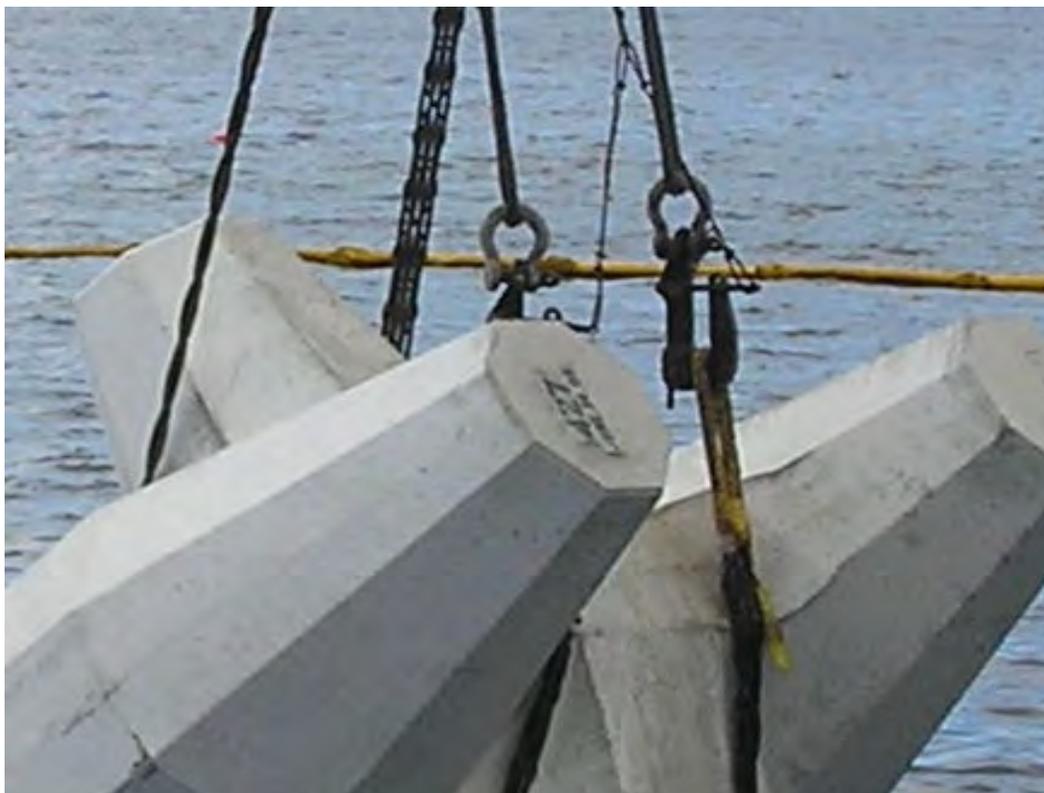
Figure 4.6. Double-sling with quick-release hooks for placing Core-Locs on the breakwater.

The importance of the orientation and interlocking of the armor units when placed required that the handling of the units be highly maneuverable. The use of a double-sling arrangement (Figure 4.6), as well as quick-release hooks on the slings, allowed the crane operator to have more control over each unit's stability during placement, and ensured that once a unit was in the correct position, the slings could be removed easily. The sling had three ways of wrapping around the unit. Thus, six different Core-Loc orientations could be achieved during the lifting operation.

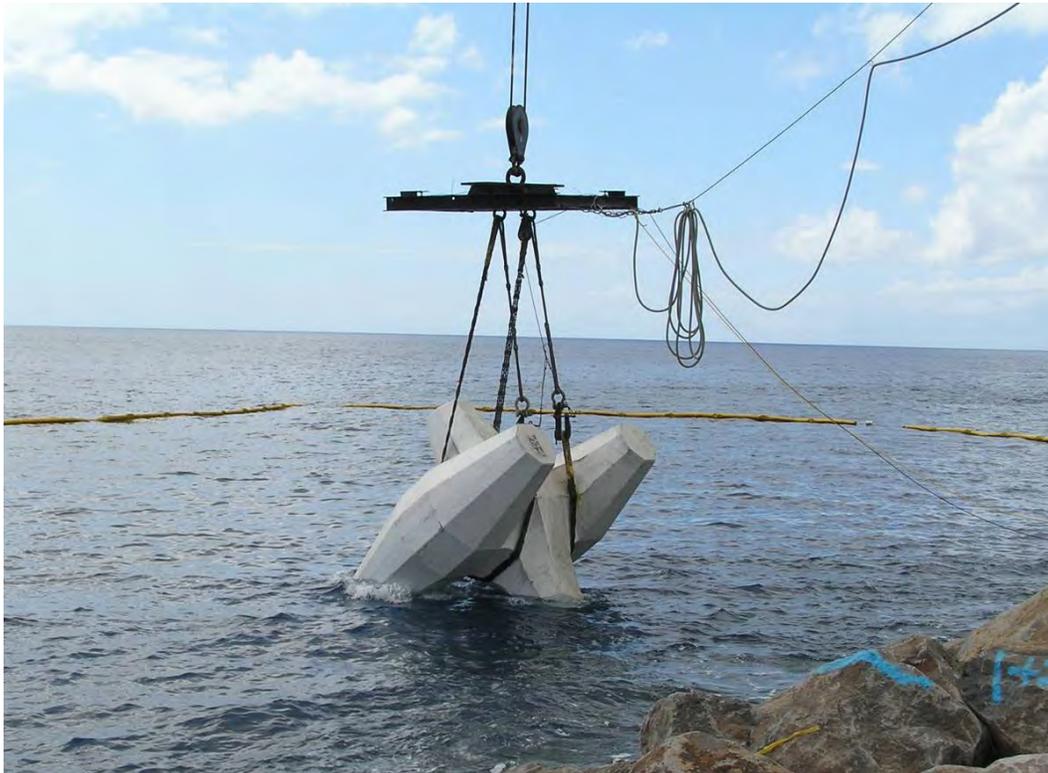
Figure 4.7. Lifting frame with tugger cables attached to double-sling for precise placement of Core-Loc units on the breakwater (Hays, Smith, and Sullivan 2006).

The contractor developed a lifting frame from I-beams for the Core-Loc units to which the sling was attached (Figure 4.7), and for which the rotation could be controlled with tugger winches from the crane. The combination of different unit sling orientations and the ability to rotate the unit permitted a wide range of Core-Loc orientations to be achieved and maintained underwater. For the cannon style toe unit placement, two slings were used to maintain the proper uniform Core-Loc orientation.

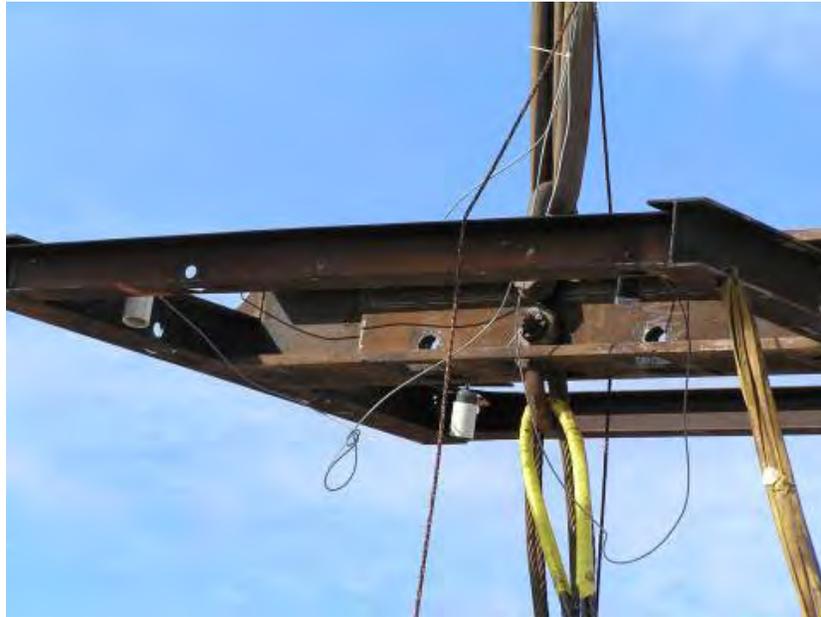
Figure 4.8. Lifting frame with four camera mounts.

The fact that the majority of this structure is underwater added an increased level of difficulty to armor unit placement. To provide the crane operator with a visual aid to orientation of the units, four cameras were placed around the edges of the lifting frame. The real-time video from the cameras was displayed on a 4-way split screen monitor inside the crane, showing the armor unit from four angles. This additional information improved the operator's ability to achieve the required orientation and interlocking of armor units. The lifting frame with the four camera mounts is shown in Figure 4.8, and a view of the split screen monitor in the operator cab is shown in Figure 4.9.

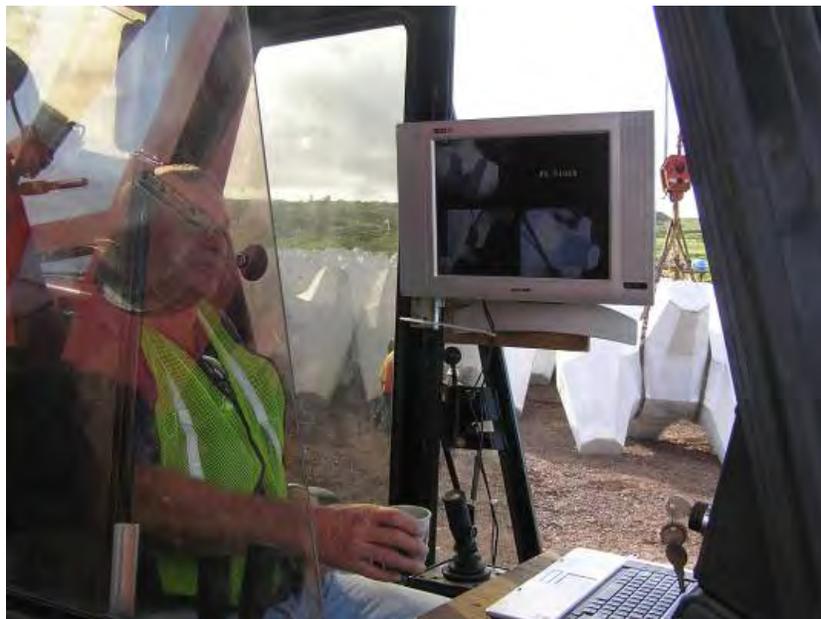
Figure 4.9. 4-way split screen for operator control of orientation and interlocking of armor units.

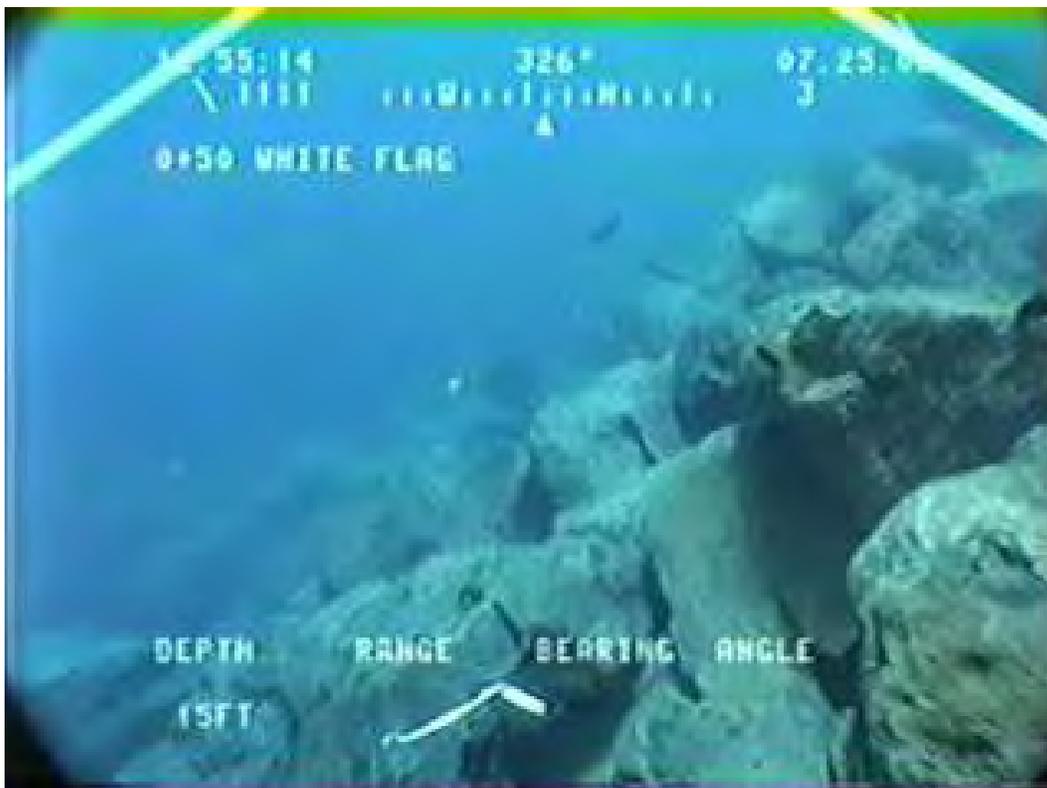
Figure 4.11. Use of ROV for underwater structure inspection of stone underlayer.

An ROV camera similar to that shown in Figure 4.10 provided USACE construction officers with a way to inspect completed stages of underwater breakwater construction, and to verify adherence to specified tolerances. The ROV system can record video for a more detailed examination at a later date (Figure 4.11). However, divers greatly facilitated the underwater Core-Loc placement. It was a challenge to determine compliance with points of contact between adjacent units and the back-slope. Cameras mounted on

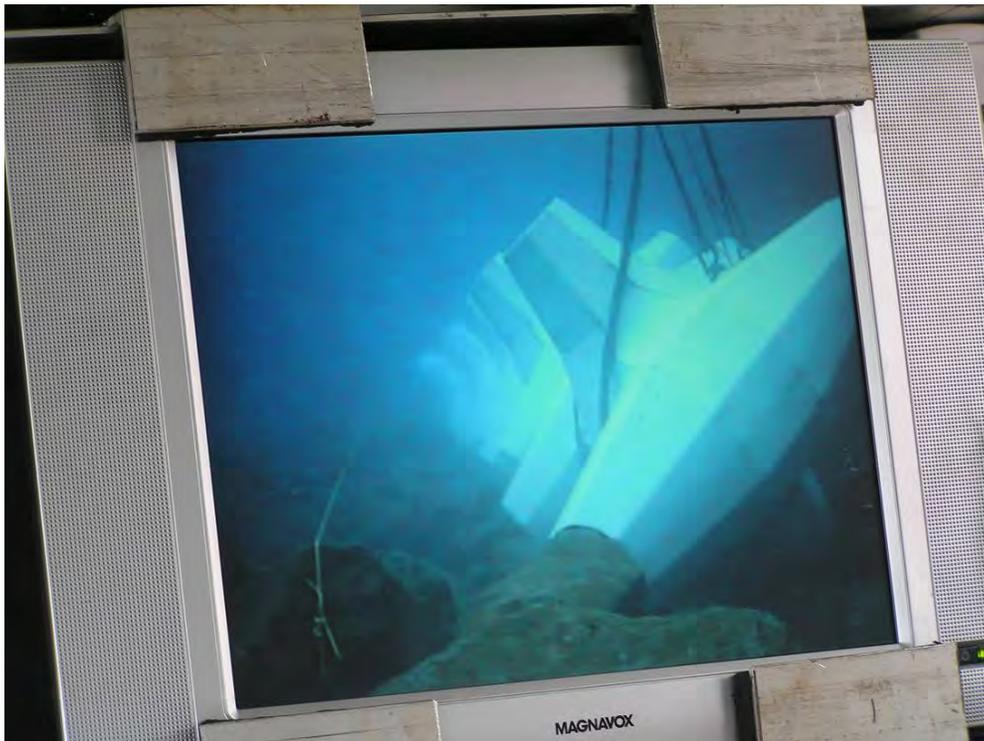
Figure 4.12. Operator view of underwater placement of Core-Loc unit from a diver camera.

A diver with a helmet-mounted camera was used for final verification of correct Core- Loc placement before it was released from the sling (Figure 4.12). The diver was important particularly for placement of the cannon style toe units and the second row above them. The contractor used diver placement and verification assistance for almost all of the below water Core-Loc placement. The remote cameras worked well, and reduced the reliance on divers as well as providing visual observation as the units were being moved into position when it would have been too dangerous for a diver to be up close. However, the mobility of a diver and the ability to see close up was very important to be sure the unit interlocking was optimized and that the required contact between adjacent units and the underlayer stone was maintained for every unit placed.

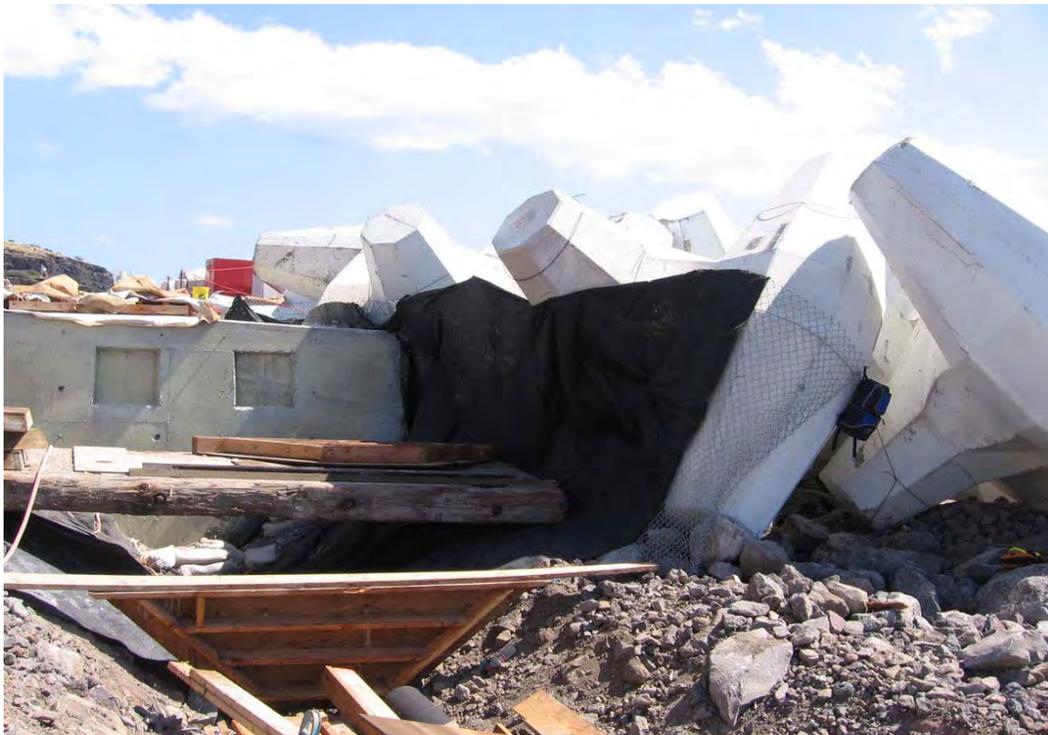
Figure 4.13. Breakwater crest cap segment being prepared, showing 3-ft-deep key trench into core material (Sea Engineering, Inc. and Group 70 International 2008).

The concrete crest cap was constructed in segments, beginning from the breakwater head and proceeding landward. The segments were to be 10 ft long initially; however, the contractor requested approval to pour them in 15-ft lengths to optimize the use of the batch plant production capability. Figure 4.13 shows a crest cap segment being prepared. Note the shear key female halves cast in the end of the previous segment, and the 3-ft-deep key trench excavated into the crest core material. Heavy wire mesh fencing material lined with geotextile filter fabric was used as the flexible formwork around the Core-Loc crest units, and between the crest units and the cap.

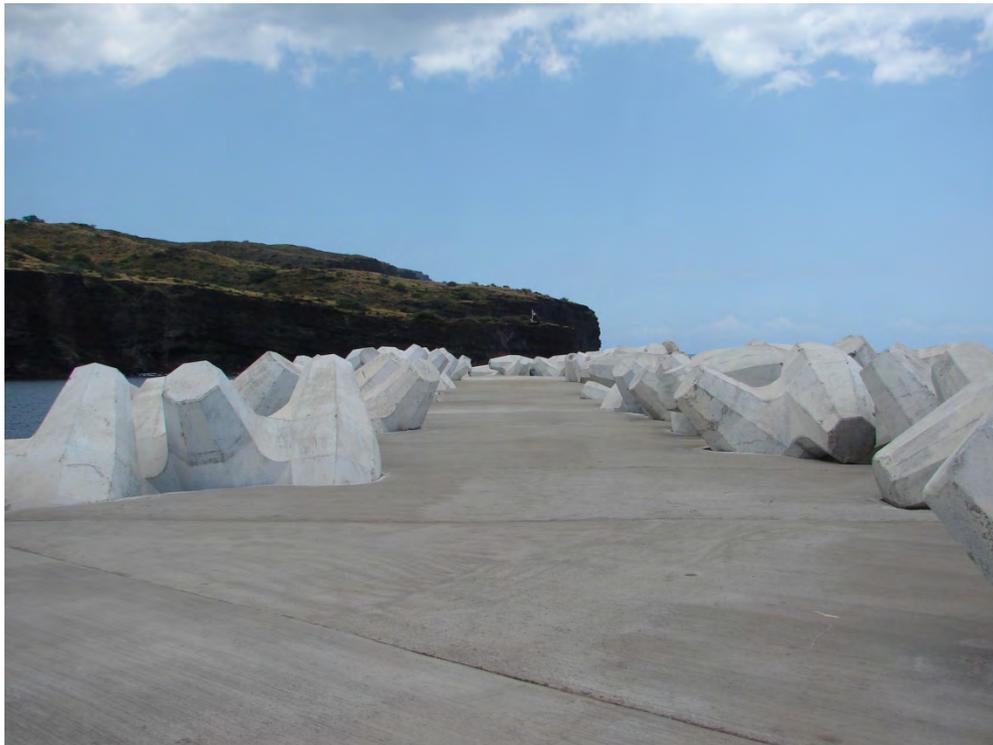
Figure 4.14. Completed breakwater crest cap.

This worked very well as it could be made to conform easily to the varying contours of the Core-Loc units, and it could be made to project into gaps between units. The mesh was held in place by a steel cable system until the concrete cured, and then any mesh and cables projecting above the concrete were cut off. The completed cap is shown in Figure 4.14.

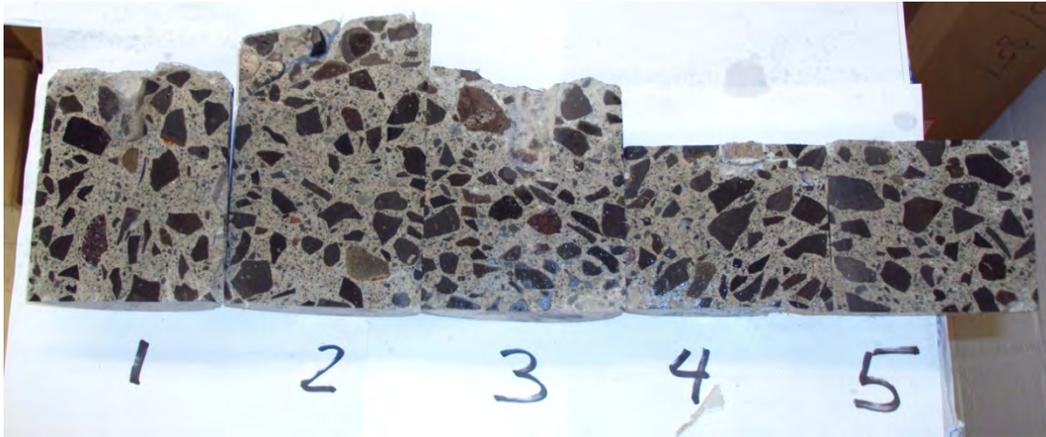
Figure 5.3. Photograph of saw-cut sections of Kaumalapau Core-Loc 4-in.-diam core samples (O'Neil and Haskins 2008).

No concrete segregation, as observed in the Tercia (Azores, Portugal) Core-Loc units, appeared to occur within this specimen according to the in-situ collected data as well as the core specimen data. Visual observation of cut cross-sections from the 4-inch-diameter (in.-diam) collected cores also confirmed consistency from the top to bottom in terms of aggregate distribution (Figure 5.3).
