*Monitoring Completed Navigation Projects Program*

## **Kaumalapau Harbor, Hawaii, Breakwater Repair**

Final report

Under MCNP Work Unit Kaumalapau Harbor, Hawaii, Breakwater Repair

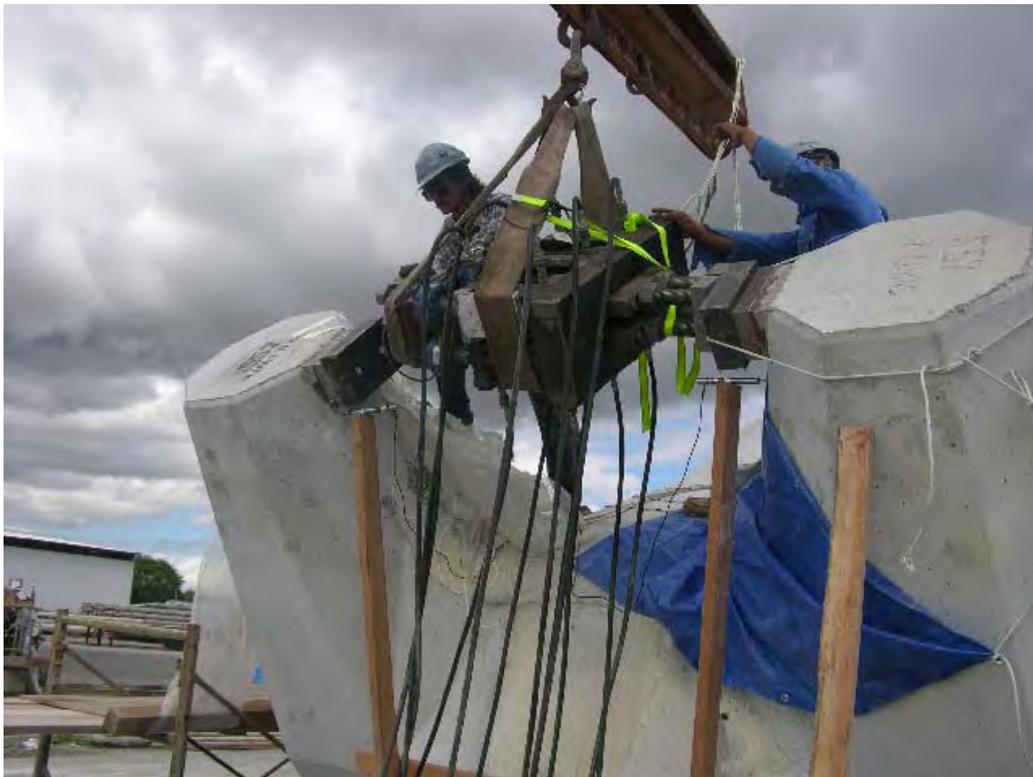
Figure 5.7. Hydraulic ram placed between the Core-Loc legs (O'Neil and Haskins 2008).

The primary purpose of the destructive test was to establish a load that would fail one leg of a Core-Loc. The hydraulic ram was arranged to push from between the two legs and break one of the legs with tension on the inside of the leg and compression on the outside. Figure 5.7 shows the loading assembly being placed between the Core-Loc legs.

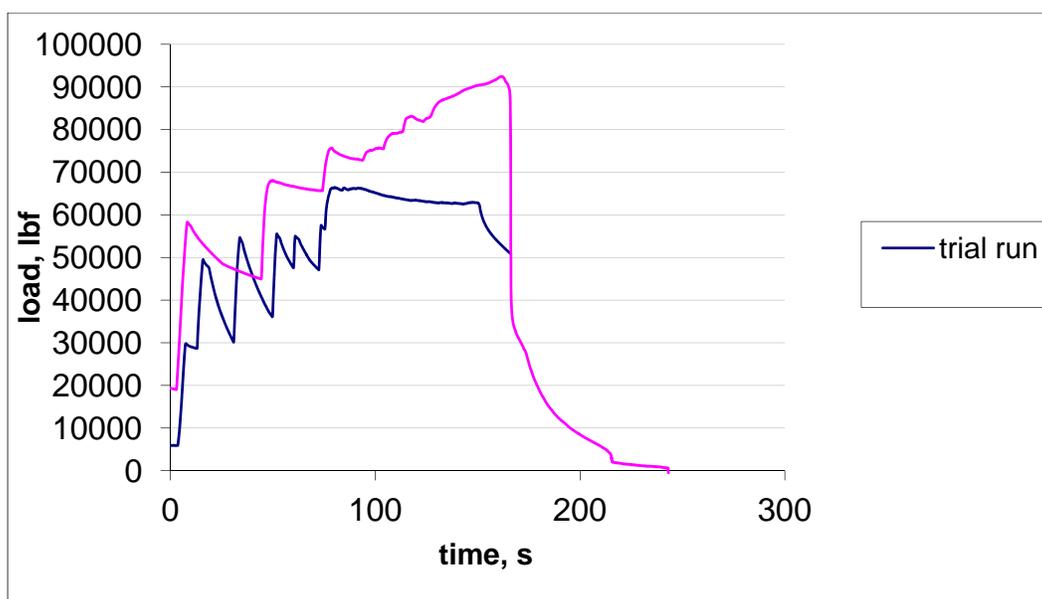
Figure 5.10. Load vs. time plots for the trial and failure runs of the test Core-Loc (O'Neil and Haskins 2008).

The load vs. time results of the trial run and the failure run are presented in Figure 5.10. The stair-step loading methodology that is evident in the figure was the result of limited hydraulic control of the loading mechanism that was available. An average loading rate of 500 lbf per second (lbf/s) was achieved for both the trial and failure runs. The load during the trial run was increased to approximately 67,000 lbf before it was removed. The failure run load was applied until the load cells indicated a major drop in load denoting failure of the leg. The highest recorded load in the failure run was 94,000 lbf.

The 94,000 lbf actual failure load was approximately 42 percent of the 223,600 lbf theoretical failure load. In the theoretical calculations, the tensile stress capacity of the concrete was chosen as the highest test result achieved from an entire month of material flexural tests (925 lbf per square inch (psi)), while the contract required tensile stress was only 700 psi at 28

days. Additionally, in the theoretical calculations, the failure plane was assumed to be an octagonal plane perpendicular to the longitudinal axis of the Core-Loc leg. When the armor unit failed, the orientation of the actual failure plane was at an angle rotated about 35 deg below the plane perpendicular to the longitudinal axis of the leg, thus producing a stretched octagon with a larger moment of inertia ( $I_{xx} = 246,372 \text{ in.}^4$ ), a larger distance to the extreme fiber (24.23 in.), and a larger moment arm.

These differences in geometry and material properties do not fully account for the large difference between the theoretical and actual failure loads. Using the actual failure load, the adjusted moment of inertia, and the distance to the extreme fiber to calculate the tensile capacity of the concrete yields only 436.2 psi (see Appendix A), well below the contract required tensile flexural strength of 700 psi (as determined by ASTM C78). This computation leads to the apparent conclusion that some additional factor was responsible for the lower than anticipated failure load.

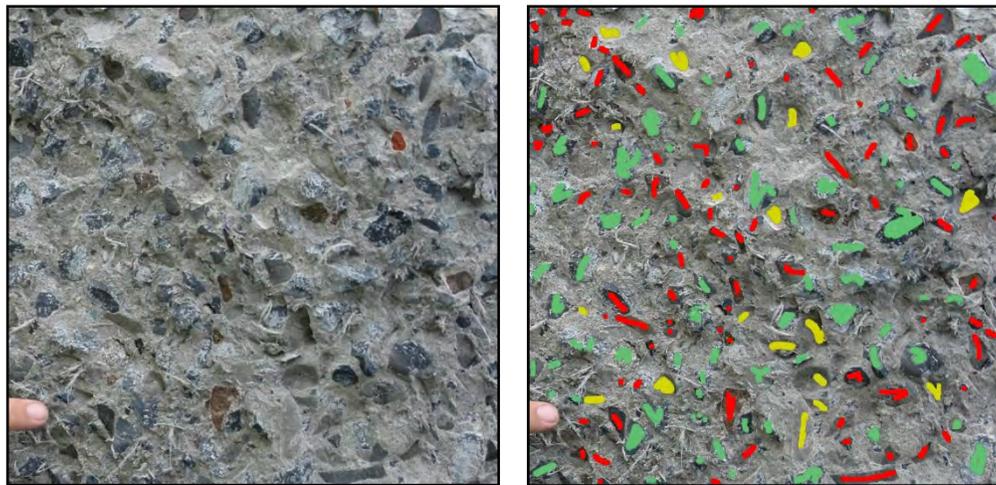
Observation of the failure surface of the Core-Loc revealed that a large percentage of the aggregate was pulled out of the concrete rather than fracturing, indicating a poor bond between the aggregate and cement paste. To roughly quantify this observation, Figures 5.11a and 5.11b show an identical 1-sq ft image of the Core-Loc failure surface. Figure 5.11a is unedited. Figure 5.11b has been enhanced with different colors to indicate whether the aggregate beneath the color was fractured (red), aggregate had pulled out of the cement paste and was showing on the interface (green), or was a cement paste pocket indicating the aggregate had pulled out of the cement paste and was in the other face of the fracture plane (yellow).

This analysis is subjective to a degree, but indicates that in the 1-sq ft area, there are 89 fractured aggregates, 83 aggregates pulled out on this face of the fracture plane, and 19 cement paste pockets indicating aggregates that pulled out on the opposite face. Of the total 191 visible areas of aggregate to paste bond, approximately 53 percent pulled out of the cement paste. This is undesirable because, if the cement paste does not bond well to the aggregate, the aggregate does not contribute to the strength of the concrete. This can have a tremendous effect on the overall strength of the composite because the strong tensile properties of the aggregate are not part of the composite strength. Poor quality concrete paste or dirty aggregate could be responsible for this condition, and are discussed in further detail below.

Figure 5.11. Core-Loc failure fracture face showing details of broken aggregate and locations where aggregate pulled out of the cement paste (O'Neil and Haskins 2008).

With clean aggregate, the bonding process is simple and straight forward, and the hardened cement paste clings tightly to the surface of the aggregate. However, if the aggregate is dirty and contaminated with dust or silt, the cement paste will cover the aggregate, but instead of bonding to the aggregate it will bond to the dirt. This leaves a poor quality interface between the cement paste and aggregate that is weak and easily fractured. When the concrete is put under stress, the strength will be lower because the bond to the aggregate is poor and the aggregate particles will separate from the cement paste more easily.

Another potential cause of a weak interface between cement paste and aggregate is a high water-to-cement ( $w/c$ ) ratio. If the  $w/c$  ratio used in the mixture is greater than approximately 0.42, then there is more water in the mixture than can be combined with the cement to form cement paste. This excess water has a tendency to collect around aggregate particles and dilute

the cement paste in the vicinity of the aggregates surface. This makes the local  $w/c$  ratio of the cement paste near the aggregate higher than the bulk of the cement paste. This, in turn, makes the cement paste around the aggregate weaker and more easily susceptible to failure by the aggregate pulling out of the cement paste. The  $w/c$  ratio required by contract specifications was 0.4.

In the visual analysis of the failure surface of the broken Core-Loc armor unit, it was observed that there were a high percentage of aggregate particles that had debonded from the cement paste and pulled out of one or the other face. This high percentage of debonded aggregate (>53 percent) leads to the possibility that the low tensile stress in the concrete that propagated a failure under a load of 94,000 lbf was partially due to low strength created by aggregate particles not participating in the strength

development of the composite. The cause of this condition is related to the development of a micro-thin layer of poor quality concrete forming at the paste/aggregate interface either from an accumulation of dirt and silt material on the aggregate or the accumulation of excess water on the surface of the aggregate that accompanies high water-to-cement pastes. These conditions cause weak bond strength, frequent pullout of aggregate particles, and ultimately lower strength concrete because the strength of the aggregate cannot contribute to the strength of the composite.

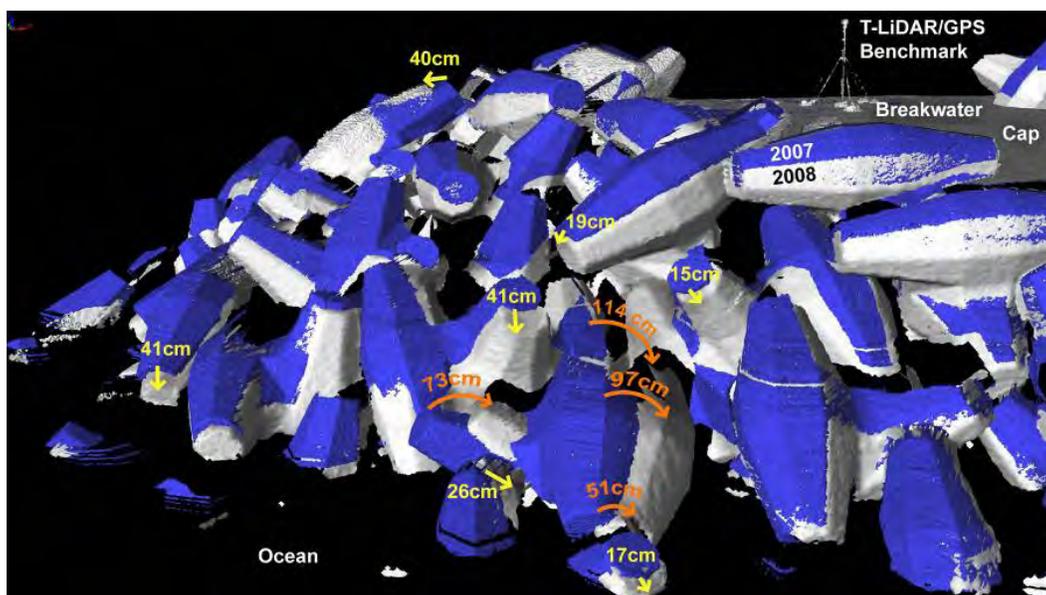
Comparison of these ultra-dense georeferenced positional data (in point cloud form) has enabled the detection of armor unit movement (measured as maximum displacement at any point on an individual unit) as small as 5 cm, and in excess of one meter, as shown by the comparison of 2007 and 2008 point cloud images in Figure 8.5. This figure is an overlay of two point cloud datasets (2007 data in blue, and 2008 data in white), viewed on the ocean side of the breakwater head. The measured maximum displacement of several units, including one armor unit with a maximum landward rotation of 114 cm (44.9 in.), is represented by arrow-arcs in orange for rotational displacement and straight line arrows in yellow for translational displacement.

Figure 8.5. Point cloud data showing measured armor unit displacement from 2007 to 2008.

units has been both rotational and translational, but has been primarily toward the structure (rather than being pulled away or “off” the breakwater) and/or lower in elevation (indicated by displacement arrows shown in Figure 8.5). This appears to indicate that the units are indeed settling and “nesting” into a tighter matrix, rather than being loosened or pulled apart. Secondly, the movement has typically been observed to occur in groups of several adjacent armor units, as shown in locations A (ocean side head), B (ocean side dogleg), and D (harbor side root) of the 2007-2008 change detection map in Figures 8.6 and 8.7. This illustrates the interdependence of each armor unit on those surrounding it and in direct contact with it, whether above, below, or alongside.

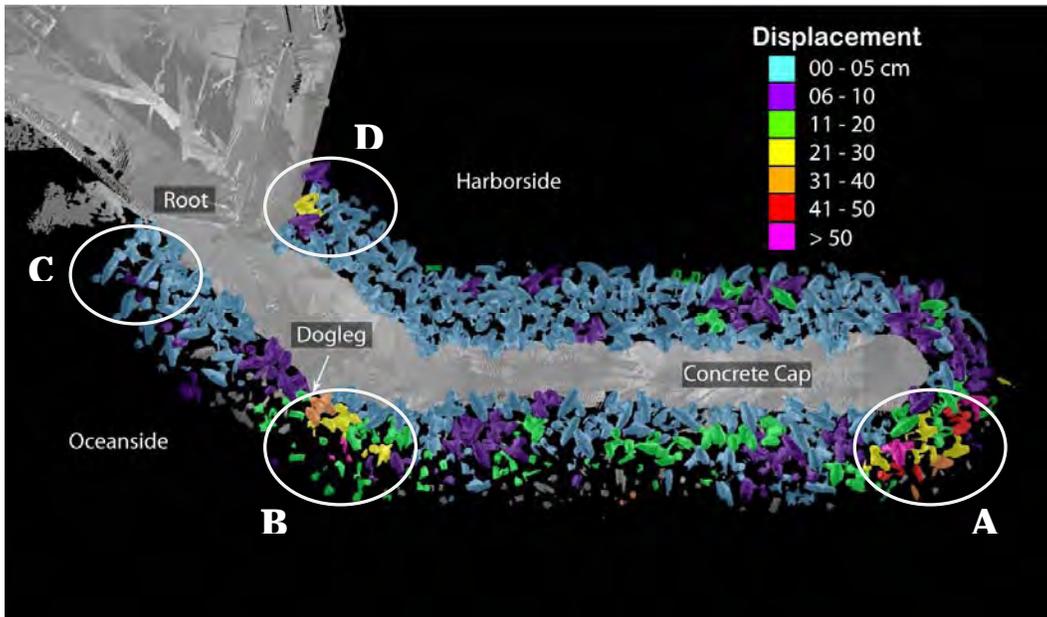
Figure 8.6. Plan view of 2007-2008 T-LiDAR change detection map: A. Ocean side head, B. Ocean side dogleg, C. Ocean side root, D. Harbor side root.

In addition, the change measurements over the 2007 - 2008 time period indicate that the largest movements of individual armor units, on the order of 20 cm to over 1 m (0.7 to 3.3 ft), occur at one of two locations: the ocean side head or ocean side dogleg of the structure (Figure 8.6 and 8.7 at locations A and B). This is also illustrated by the plan view of the change detection map at the breakwater head in Figure 8.8, which shows a dramatic difference in the magnitude of displacement between the harbor side and ocean side of the structure head. This distinction is evidenced by the range of colorization on the left side of the figure in comparison with that on the right side of the figure. The armor unit identified previously in Figure 8.5 that rotated landward a distance of 114 cm (44.9 in.) is called out in this figure. Photos taken at the completion of construction show

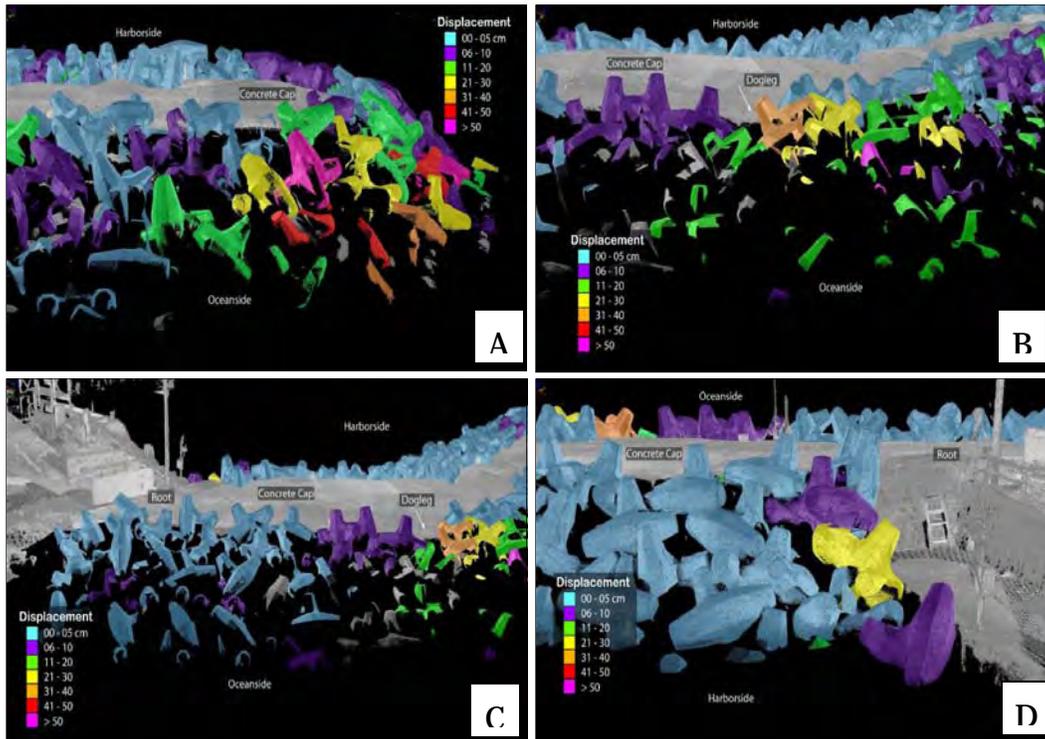
Figure 8.7. Oblique angle views of 2007-2008 T-LiDAR change detection map: A. Ocean side head, B. Ocean side dogleg, C. Ocean side Root, D. Harbor side root.

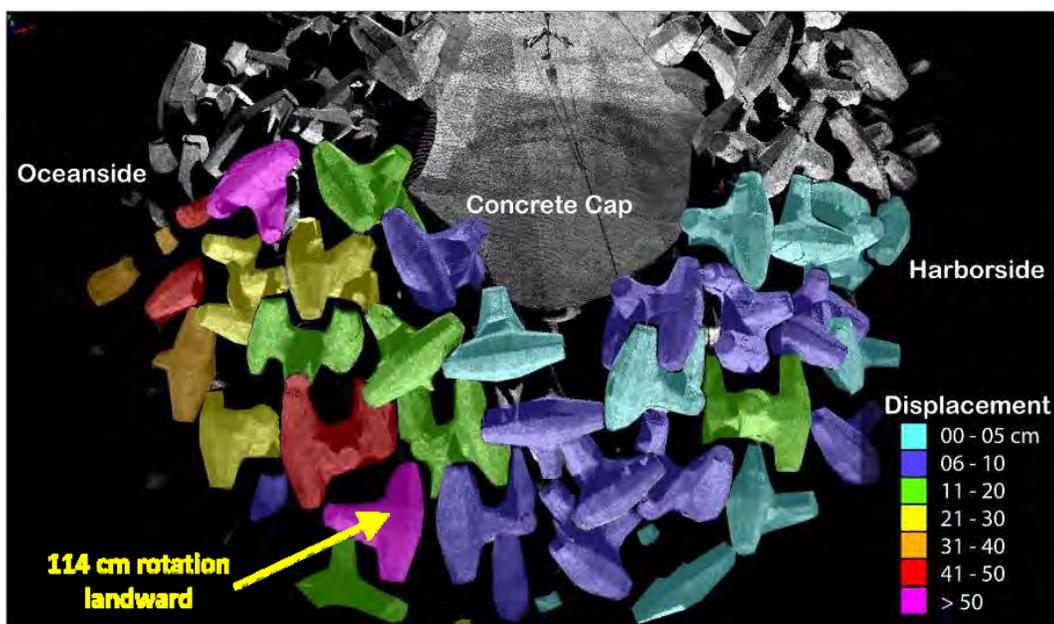
Figure 8.8. Plan view of 2007-2008 T-LIDAR change detection map at breakwater head.

that the armor units in this area were placed such that a void existed between this rotated unit and the unit just landward of it. Movement of 11 to 50 cm (4.3 to 19.7 in.) in the nearby armor units is also evident in Figure 8.8. Since the T-LiDAR laser does not penetrate the water, it is not possible to quantitatively determine whether the motion observed at this location is regionally independent, or was caused by movement below the waterline. However, again referring back to Figure 8.5, portions of two Core-Loc units protruding above the waterline directly below these units moved about 17 cm (6.7 in.) and 26 cm (10.2 in.), respectively. Therefore, it is likely that the larger scale motion observed at the head of the breakwater may relate to nesting of armor units below the water surface.

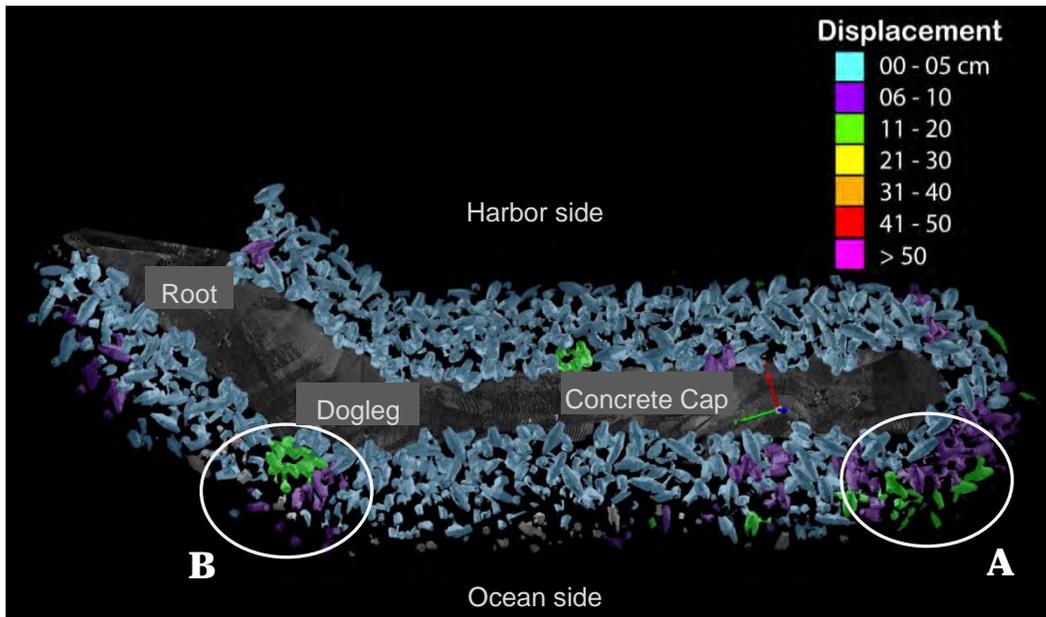
This concentration of armor unit displacement at the ocean side head and dogleg is also evident, though less dramatically so, in change detection maps for the 2008 - 2010 time period (Figure 8.9, locations A and B) as well as in the combined measurements over the entire three-year survey period (shown in Figure 8.10, locations A and B). This phenomenon may be explained by one or more of the following factors:

Figure 8.9. Plan view of 2008-2010 T-LiDAR change detection map: A. Ocean side head, B. Ocean side dogleg.

(Figure 8.9). Side-by-side evaluation of colorized change detection maps for these two time periods clearly shows that the majority of notable armor unit movement (defined here as movement greater than 10 cm (3.9 in.) for an individual unit) occurred within the first year post-construction, with comparatively much less discernable change in armor unit positions occurring between the second and third T-LiDAR surveys in 2008 and

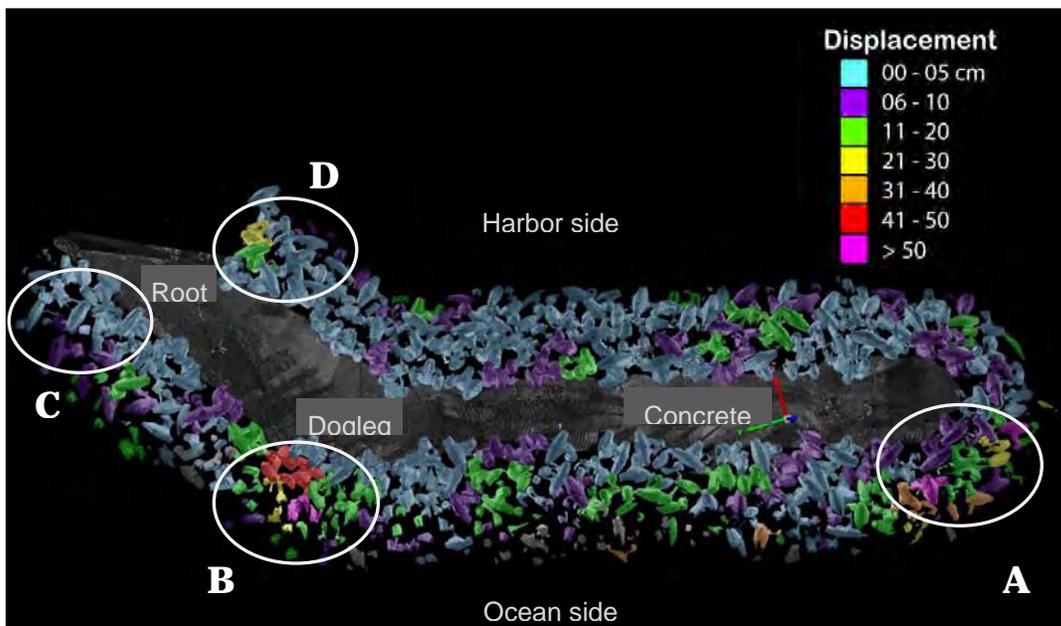
Figure 8.10. Plan view of 2007-2010 T-LiDAR change detection map: A. Ocean side Head, B. Ocean side Dogleg, C. Ocean side Root, D. Harbor side Root

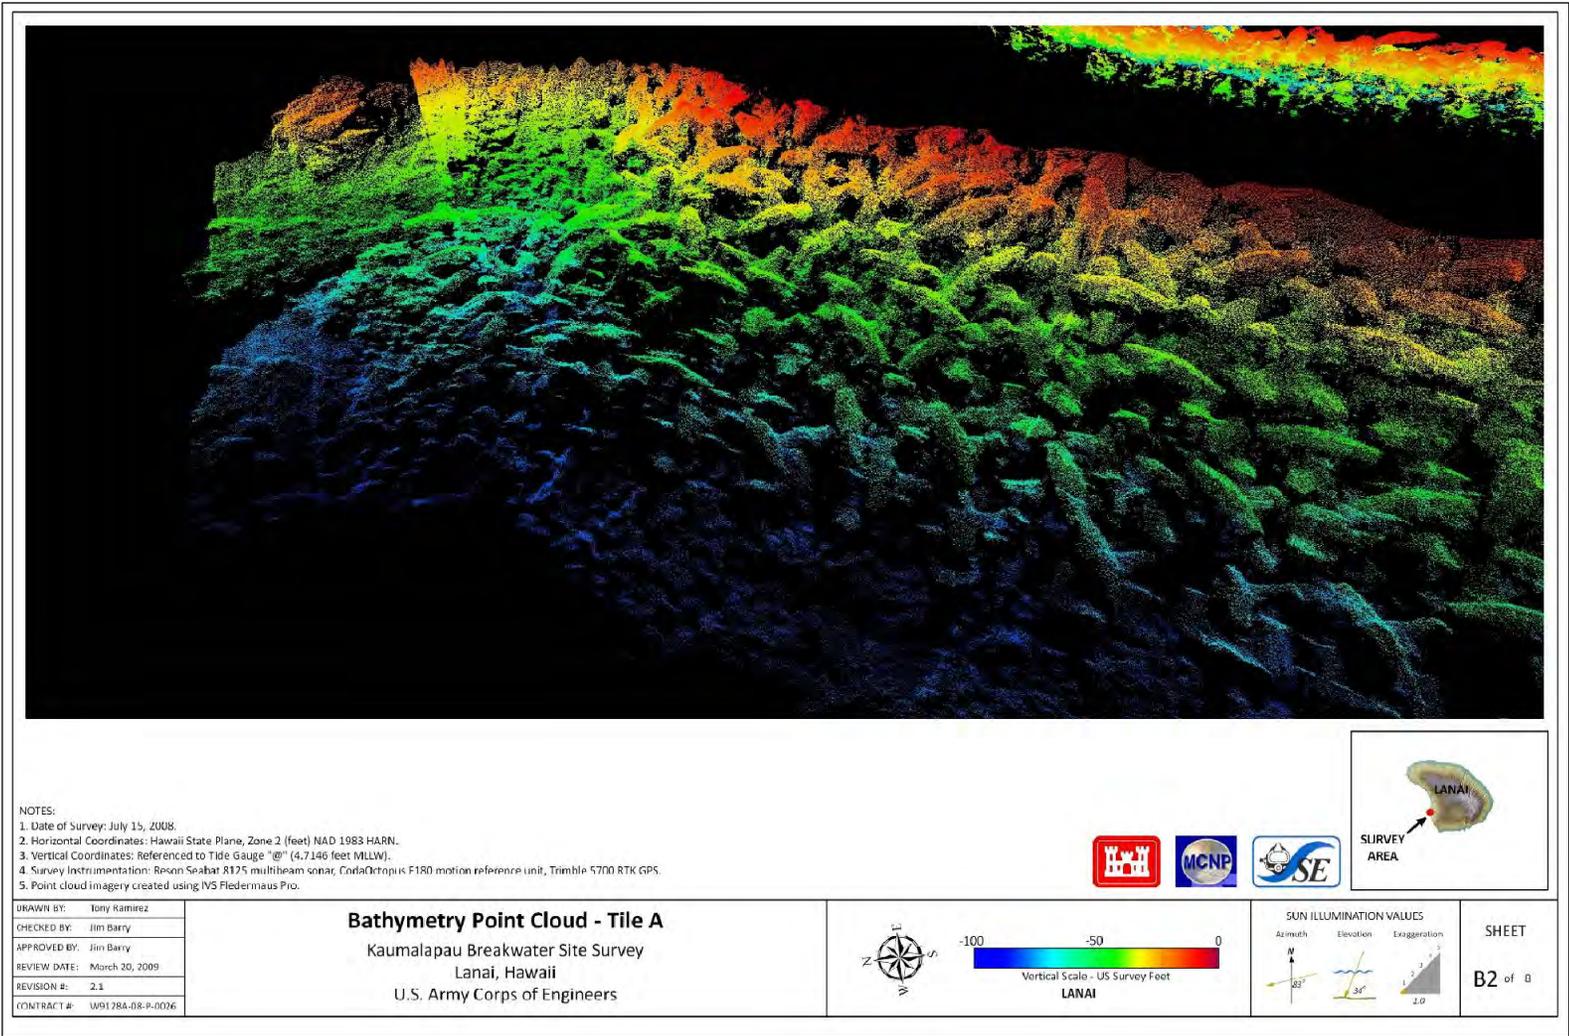
Figure 9.9. Bathymetry point cloud, Section A, Kaumalapau Harbor breakwater (Sea Engineering, Inc. 2009).

Visual analysis of the point cloud images enables the identification of several features of the underwater portion of the structure. Figure 9.9 (Tile A) shows a defined demarcation at the top center of the figure where the ocean side root of the structure ties in to the existing rock outcrop, indicated by an abrupt change in the color scale of the point cloud near the water surface from red to yellow to green. It is also relatively easy to distinguish the difference between the angular Core-Loc units and the armor stones (or other more naturally shaped features such as the rocky seafloor). Figure 9.10 (Tile B) is an almost complete view of the ocean side of the structure from the root to the dogleg. This figure clearly shows the side slope of the structure composed of Core-Loc, and the stone toe buttress (in dark blue). Along the right side of the figure, several of the first row of Core-Locs (placed in the cannon orientation) are easily visible, as well as the interlocking row of Core-Locs placed directly above them also in a specific (but different) orientation. The remainder of the Core-Locs, resting higher on the side slope, clearly are in a more random orientation, as designed.

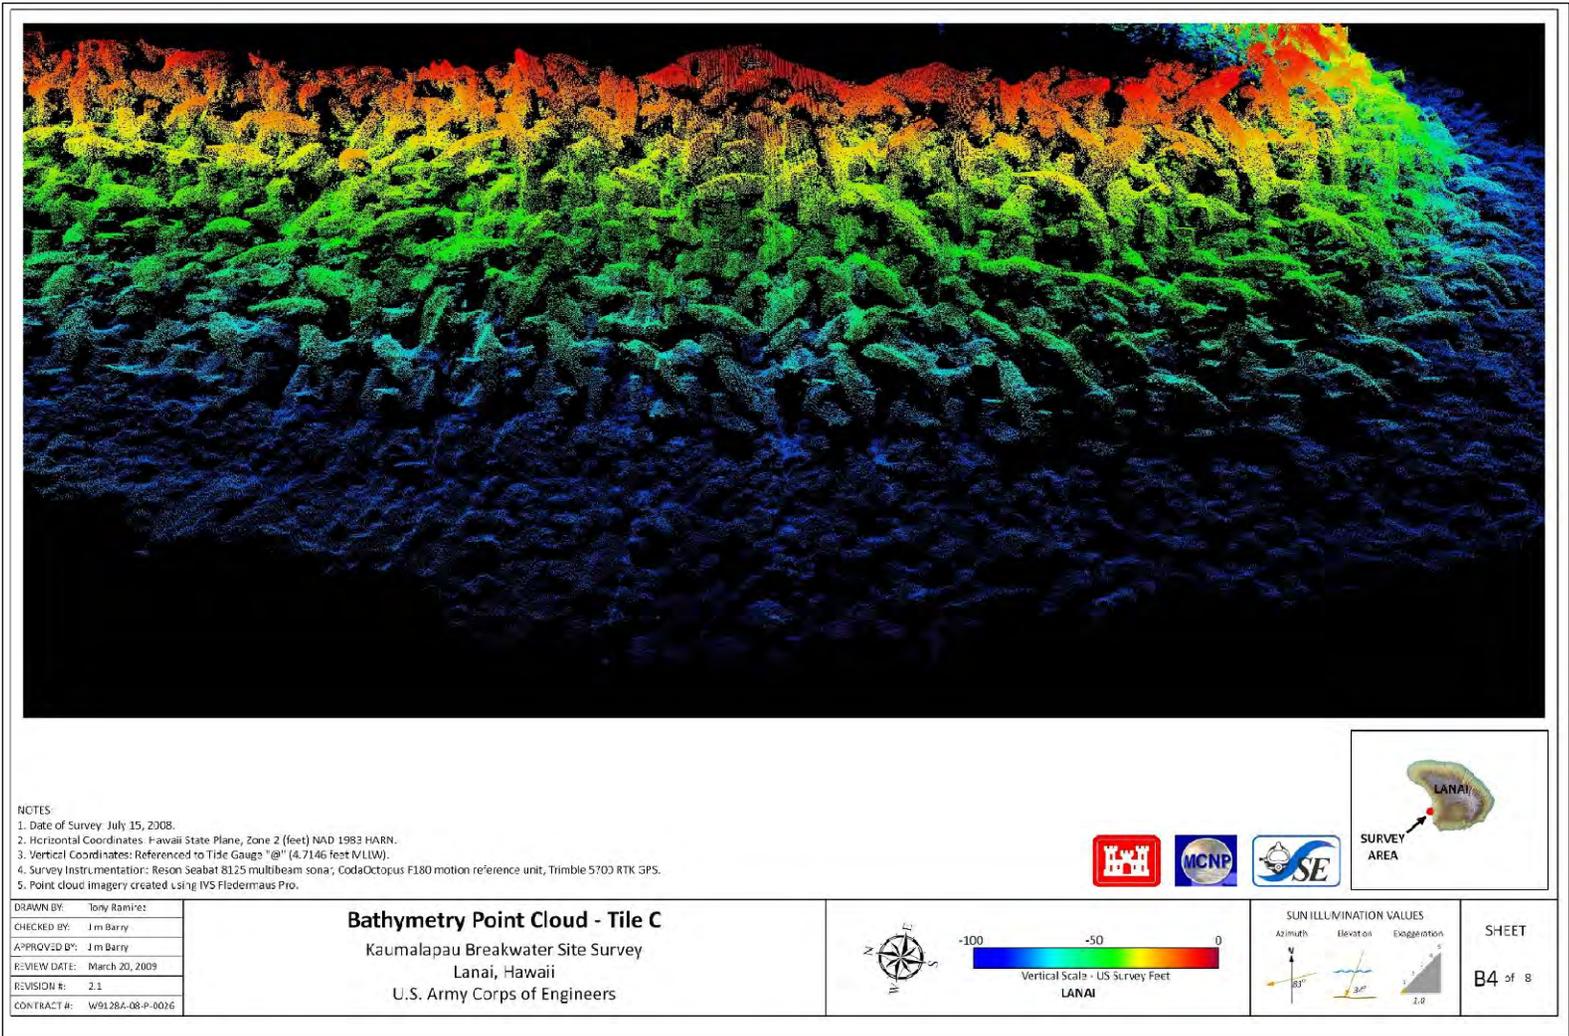
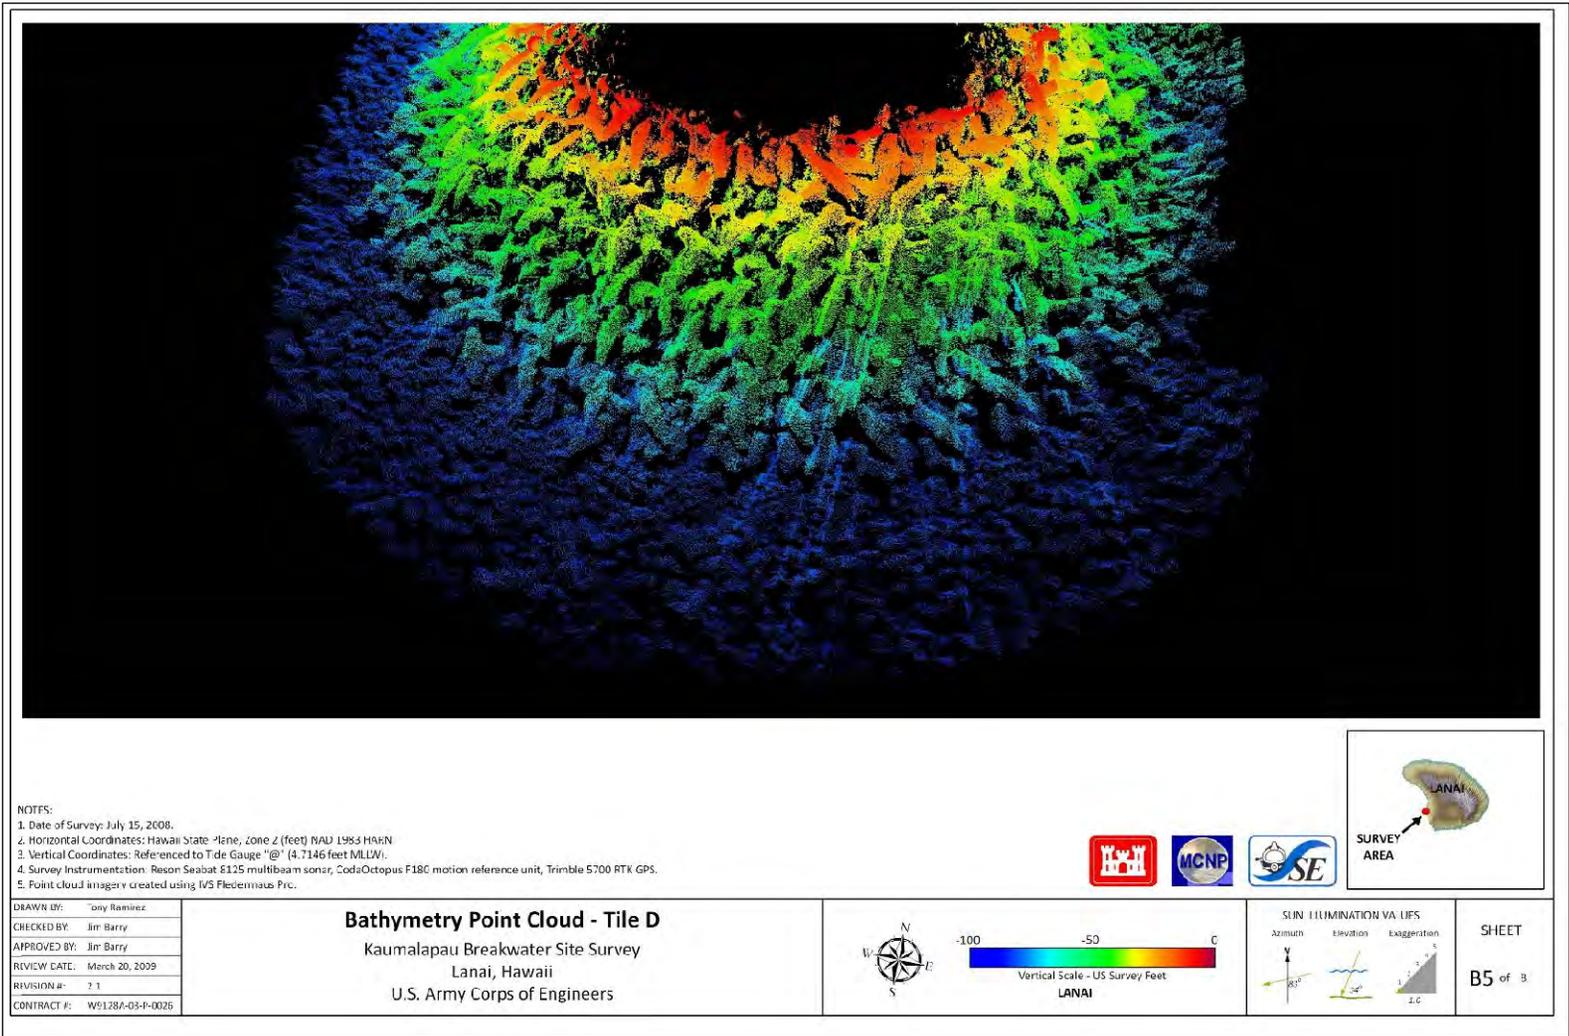
Figures 9.11 (Tile C) and 9.12 (Tile D) show similar representations of the point cloud data from the ocean side dogleg to the ocean side head, and the entire structure head, respectively. Both figures indicate that the structure toe appears to follow a consistent contour along the rock foundation, with no visible deviations or non-interlocked Core-Loc units. Figure 9.13 (Tile E) shows the harbor side head of the structure, as well as the transition to the harbor side toe berm (right half of figure). Examination of the point cloud of the toe berm indicates that there is likely a large gradation in stone size in this area, however, this is consistent with construction specifications allowing for the use of existing stone at the project site to be recovered and reshaped for use in the toe berm (refer to Chapter 2 of this document).

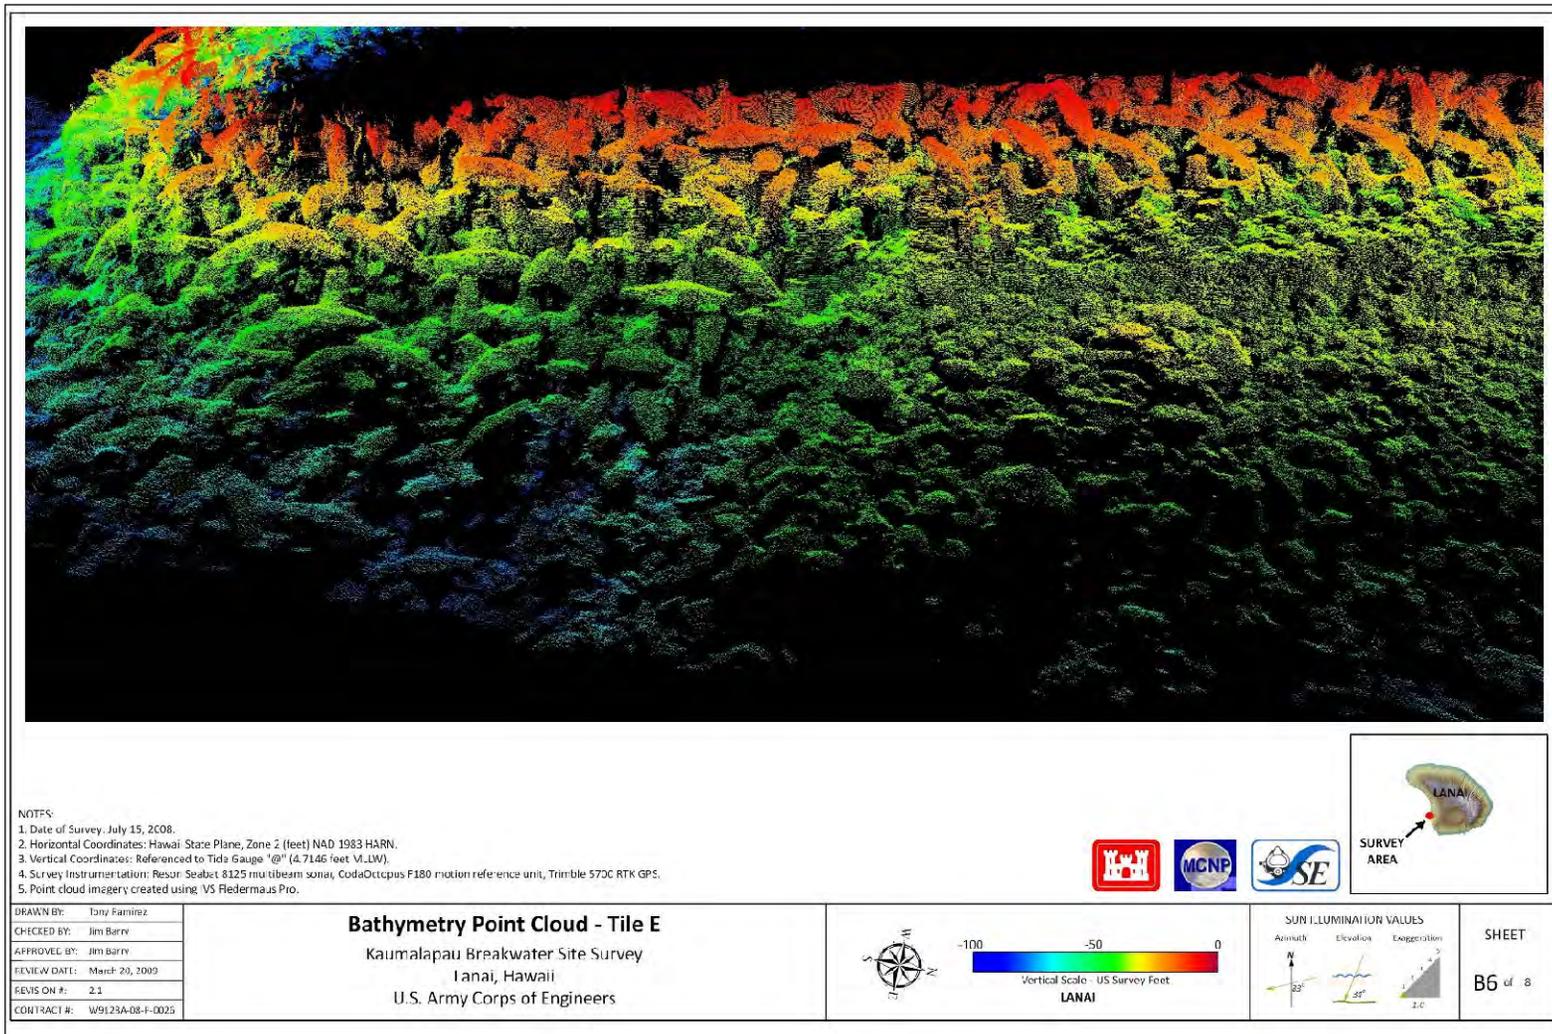
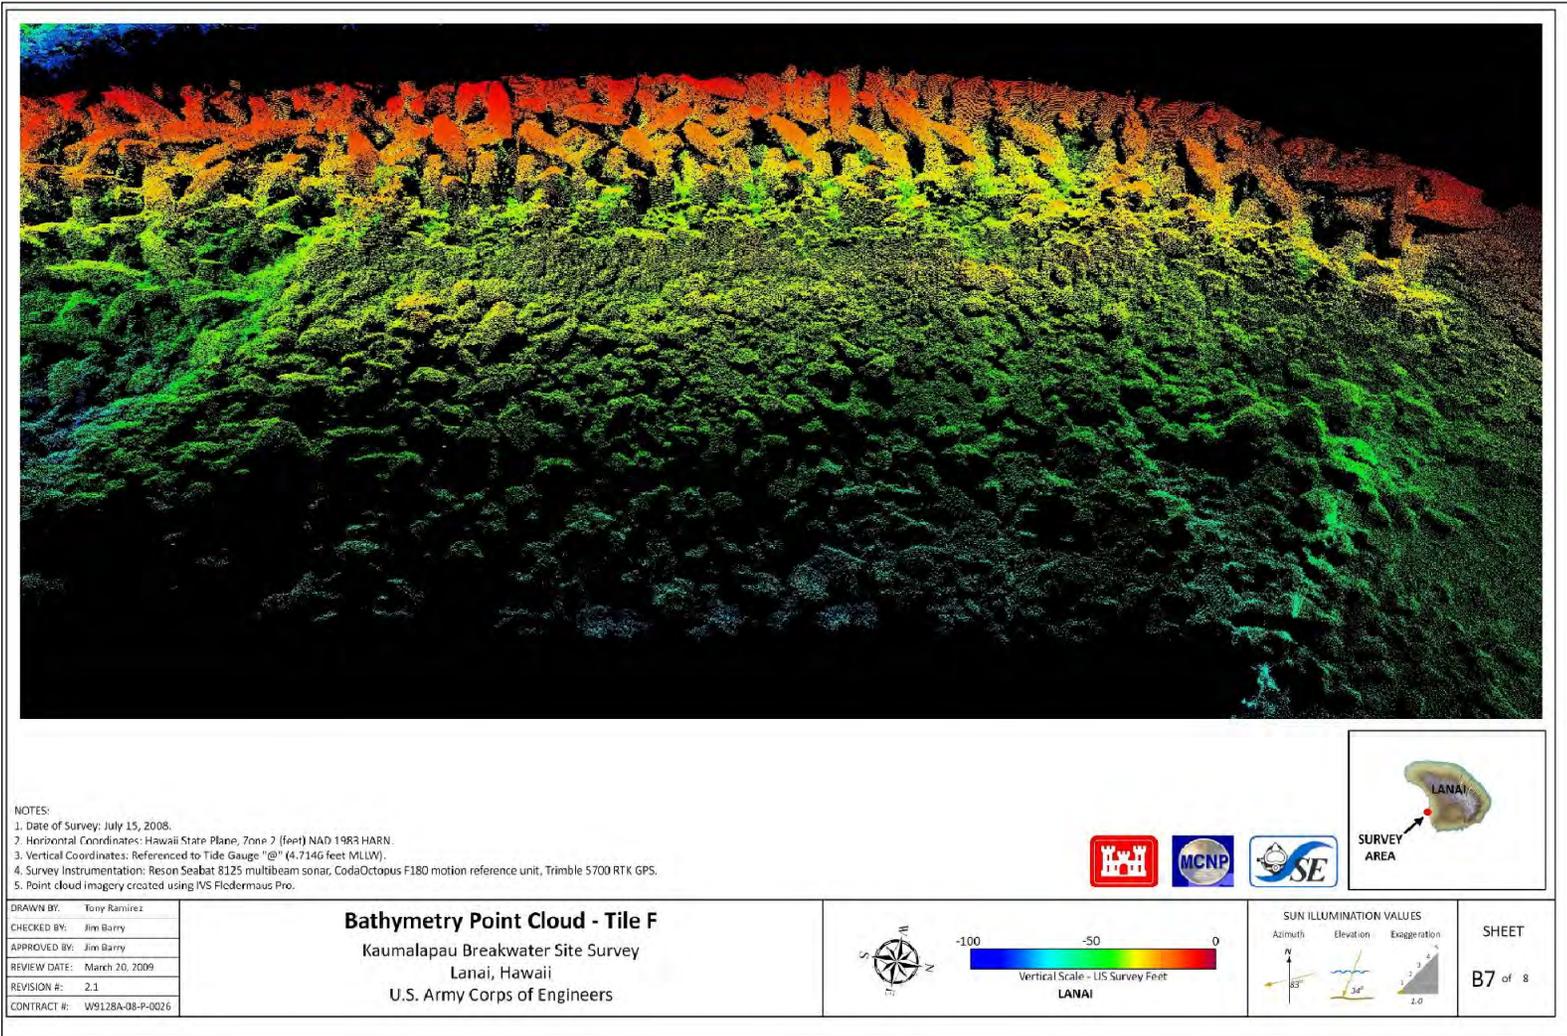
Also visible in Figures 9.13 and 9.14 (Tiles E and F) is what appears to be a steepened slope within the harbor side toe berm (approximately half way down the right side of the image in Figure 9.13 and half way down the majority of the image in Figure 9.14). Reference back to the contour plot of the multibeam survey (Figure 9.3) suggests that this may be due to the change from the relatively flat slope of the wide toe berm at approximately 15 ft below MLLW, to a more steep side slope between the 20-ft and 40-ft contour. It is also possible that the angle of the image may be causing an exaggerated view of this side slope, however, this location should be monitored for changes and/or stability in any future underwater surveys or inspections. Finally, Figure 9.15 (Tile G) shows the location where the harbor side root ties into the existing barge pier, as well as the underwater portion of the sheet pile bulkhead of the barge pier.

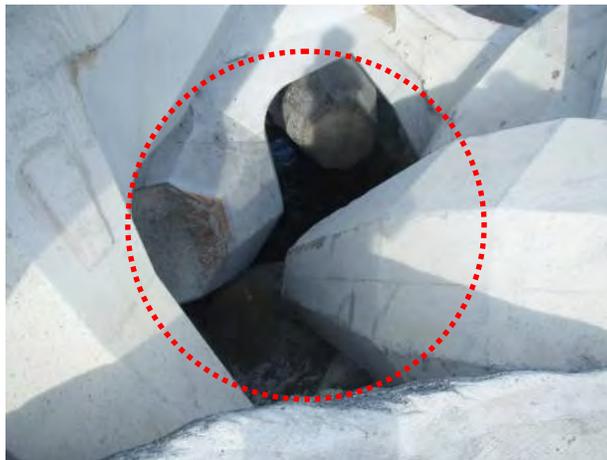
Voids between armor units were observed in several locations, including Station -1+00 along the root of the structure on the ocean side (shown in Figure 10.2) and on the harbor side trunk at Station 1+58 (shown in Figure 10.3). In many cases, these voids exposed underlayer stones, which is undesirable because the stones may be exposed to greater wave attack and possibly become mobilized during very large wave events. If the void between armor units is larger than the armor stone diameter, the mobilized armor stone could potentially be pulled out of the structure through the void.

Figure 10.2. Void in armor layer on ocean side root at Station -1+00 with armor stone and water surface visible through void. (2007 photo)

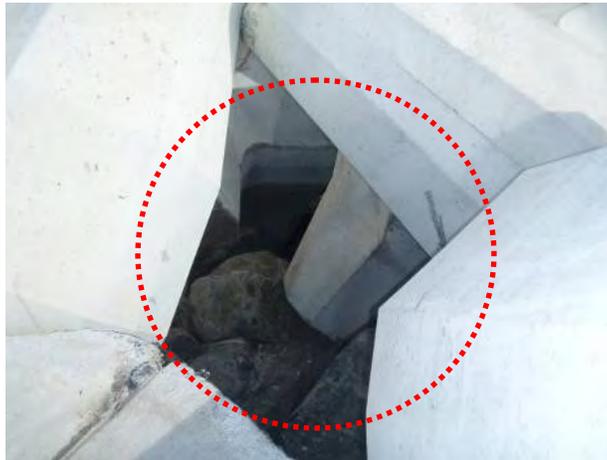
Figure 10.3. Void in armor layer on harbor side trunk at Station 1+59 with armor stone exposed. (2007 photo)

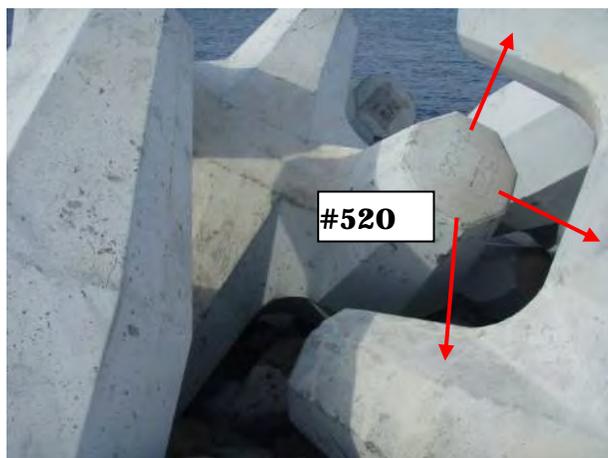
Figure 10.5. Poor contact between unit #520 and adjacent armor units at Station 1+36 on ocean side trunk (2007 photo). Unit #520 has moved 5.9 in. (15 cm) toward head from 2007-2010 (T-LiDAR).

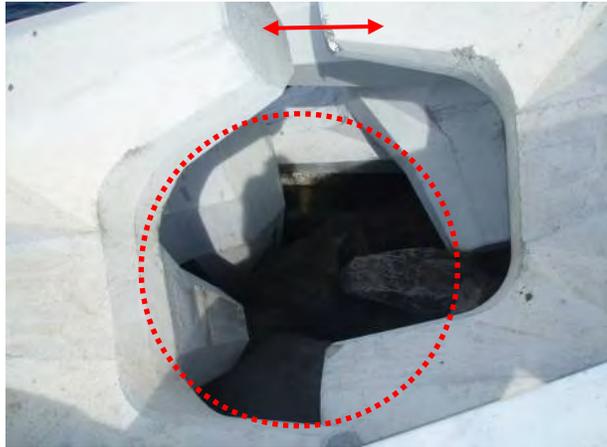
Figure 10.6. Limited contact between armor units placed end-to-end on ocean side trunk near crest at Station 1+82. Void with underlayer exposed. (2007 photo)

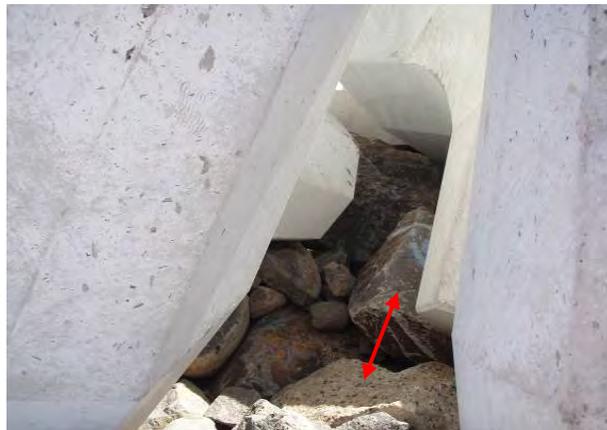
Figure 10.7. Limited contact between armor unit leg and underlayer stone on harbor side trunk at Station 1+26. Void in armor layer with underlayer exposed. (2010 photo)

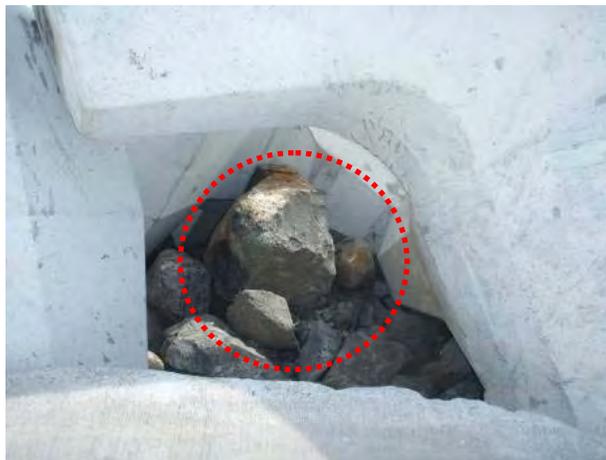
Figure 10.10. Undersize underlayer stone on harbor side trunk at Station 1+51, estimated to be ~0.8- to 2.5-ft diam. (2007 photo)

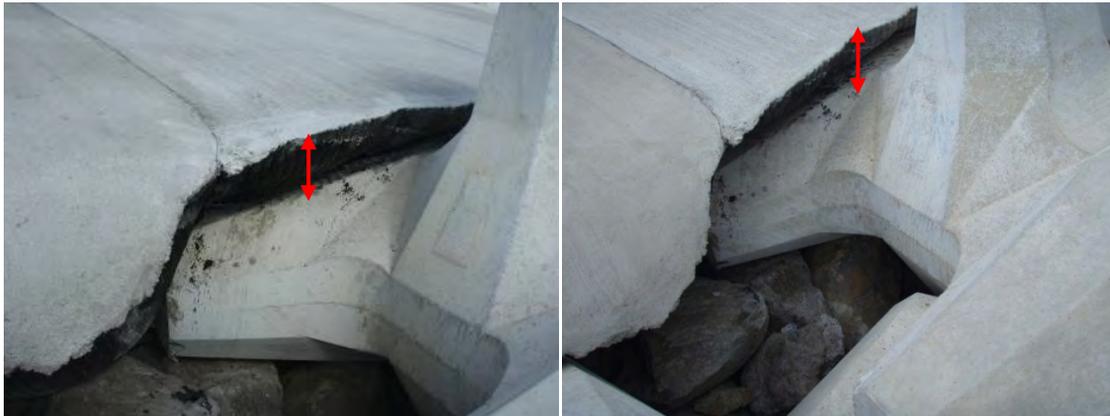
Inspections also noted areas along the breakwater where the side of concrete cap was exposed (i.e., not protected by armor units). Some areas were also noted where the edge of the concrete cap was thin in comparison to the rest of the cap. These areas could be of potential concern due to their greater exposure to wave impact and potential for damage. Photos of these areas are shown in Figure 10.10 through 10.11.

Figure 10.12. Concrete cap is thin and overhangs armor unit along ocean side trunk at Station -0+36. Apparent movement of armor unit between 2007 (left) and 2009 (right).

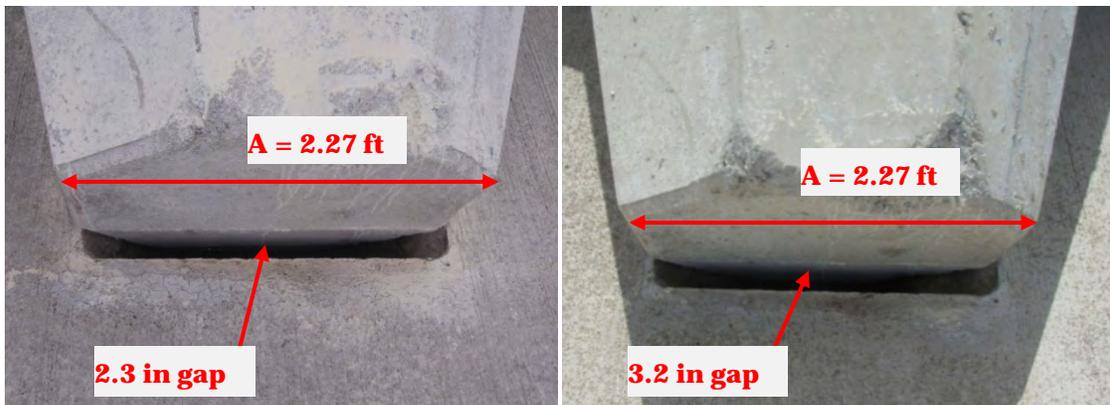
Figure 10.14. Gap created between armor unit and concrete cap on ocean side trunk at Station 0+55. Measured gap was 2.3 in. in 2008 (left) and 3.2 in. in 2009 (right).

from the concrete cap. Since the cap was poured following the placement of the armor layer (using a wire mesh overlaid with geotextile fabric to contain the concrete around the edges of the cap as it flowed into place), it was initially in contact with the armor units at the crest of the structure. Since completion of construction, the gravitational settlement of the armor units at the crest has caused them to pull away from the edge of the concrete cap. The gaps created by this occurrence are relatively small, usually on the order of 6 in. or less. At this scale, the separation of the armor units from the cap is not likely to affect the function or stability of either; however it is important to monitor these areas to keep track of the scale of movement over time. If the gap between the armor units and the cap becomes very large, the cap could become more exposed to damage from wave action. Photos of gaps observed are shown in Figures 10.14 and 10.15.

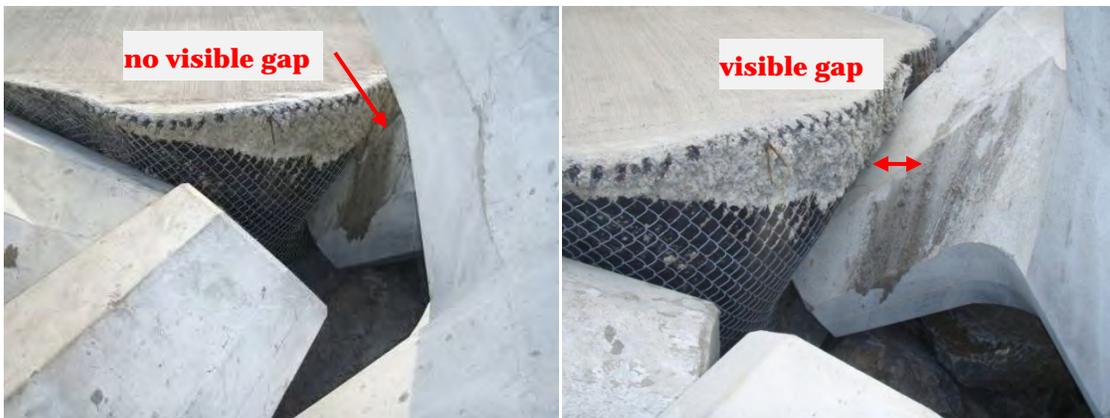
Figure 10.15. Exposed edge of concrete cap with apparent pulling away of armor unit between 2007 (left) and 2009 (right) on ocean side trunk at Station -0+14.

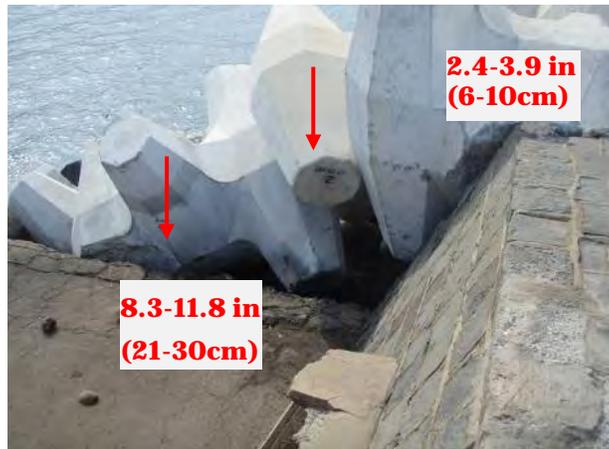
As previously noted, six armor units that were broken (either the nose or a leg detached) during construction were set aside and later used to aid in construction of the tieback along the harbor side root of the structure. It was determined that, because this area was expected to have the least amount of wave impact, use of the partial armor units in this location would not adversely affect the stability of the armor layer. In addition, placing the partial units in this area solved a logistical issue – the fully-intact armor units would not fit securely against the existing wall and face of the barge pier, and the partial units were arranged to do so. This area was monitored closely during inspection to determine whether the partial units had settled, and whether any settlement had affected the adjacent armor units or the integrity of the harbor side tieback. The results of inspection (shown in Figures 10.16 through 10.19), as well as the results of T-LiDAR surveys presented in Chapter 8, indicate that there has been movement of the units in this location, on the order of 4.3 to 11.8 in. (11 to 30 cm) between 2007 and 2010.

Figure 10.16. 2007 photo of harbor side tieback at Station -0+75. T-LiDAR measured settlement between 2007-2008 indicated for two armor units.
