*Monitoring Completed Navigation Projects Program*

## **Kaumalapau Harbor, Hawaii, Breakwater Repair**

Final report

Under MCNP Work Unit Kaumalapau Harbor, Hawaii, Breakwater Repair

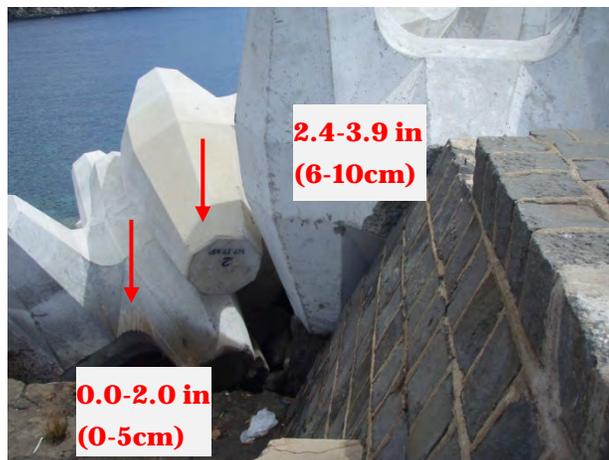
Figure 10.18. 2009 photo of harbor side tieback at Station -0+75. T-LiDAR measured settlement between 2008-2010 indicated for two armor units.

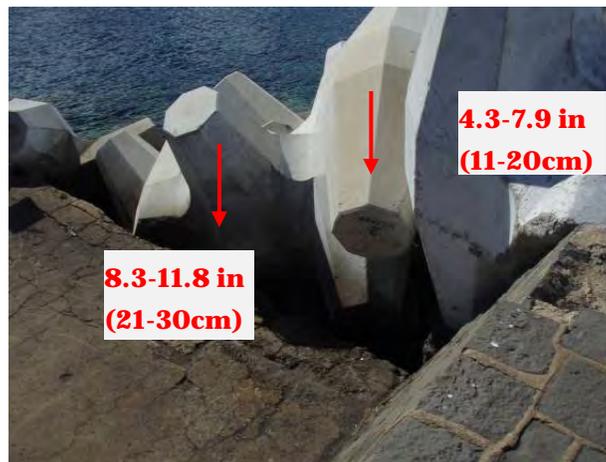
Figure 10.19. 2010 photo of harbor side tieback at Station -0+75. T-LiDAR measured settlement between 2007-2010 indicated for two armor units.

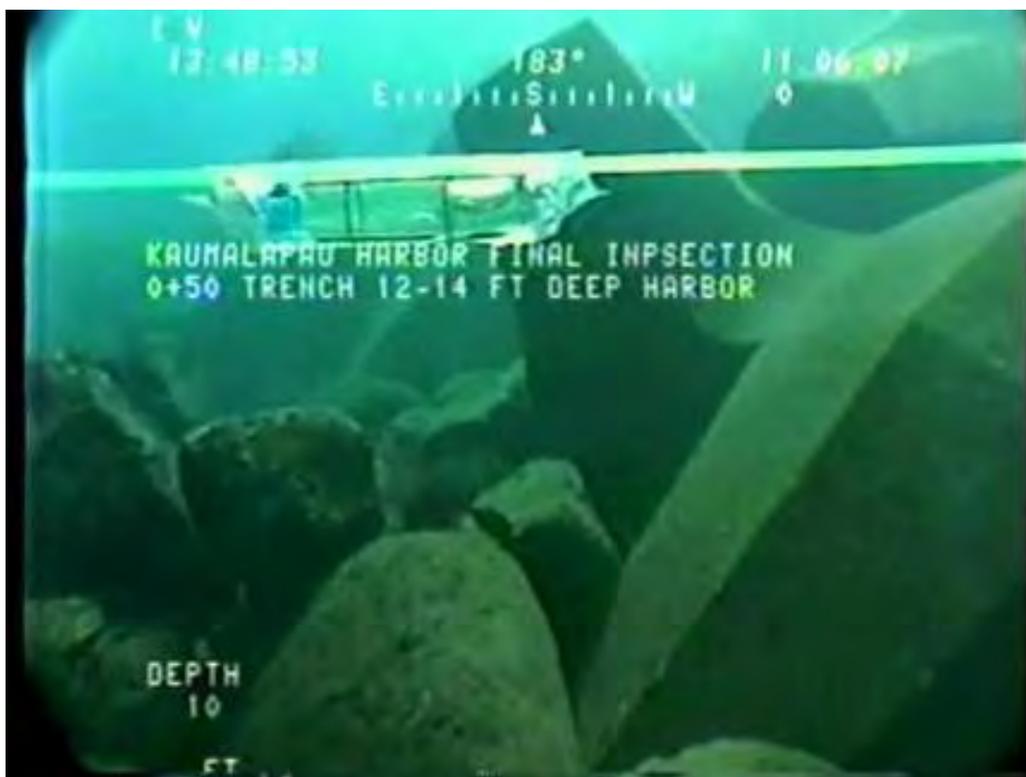
Figure 10.23. Harbor side trunk at approximate Station 0+50. Toe armor units in "cannon" orientation at 12- to 14-ft depth and varied size of toe berm armor stone.

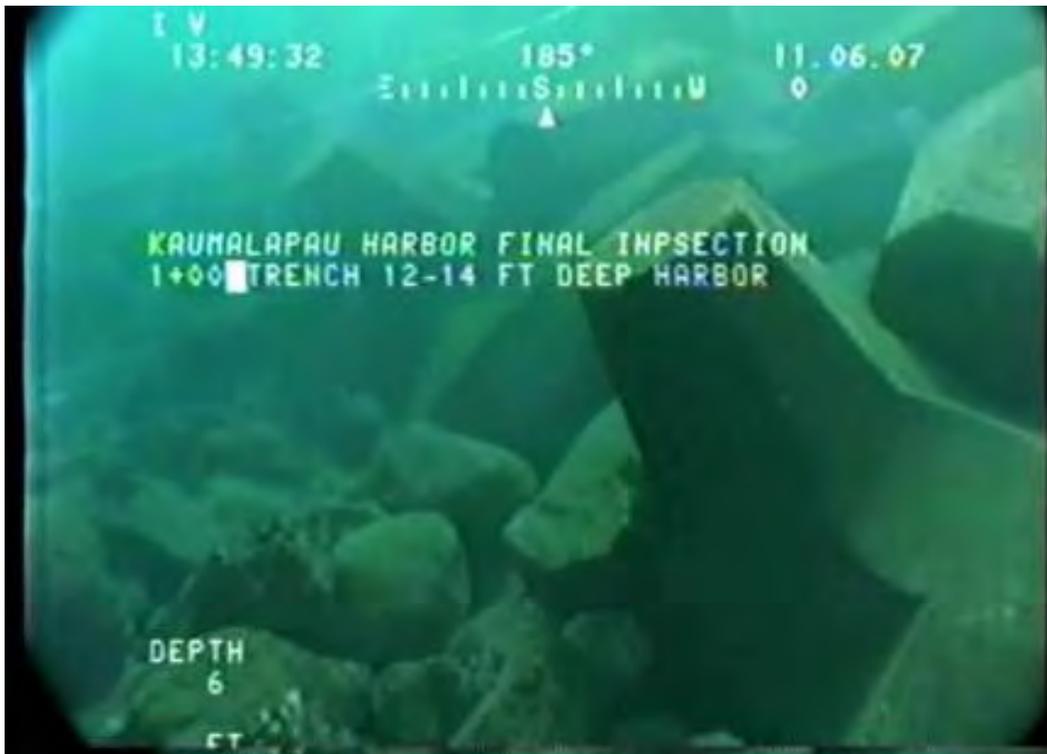
Figure 10.24. Harbor side trunk at approximate Station 1+00. Multiple toe armor units in “cannon” position but in slightly varying orientation and variable size stone toe berm.

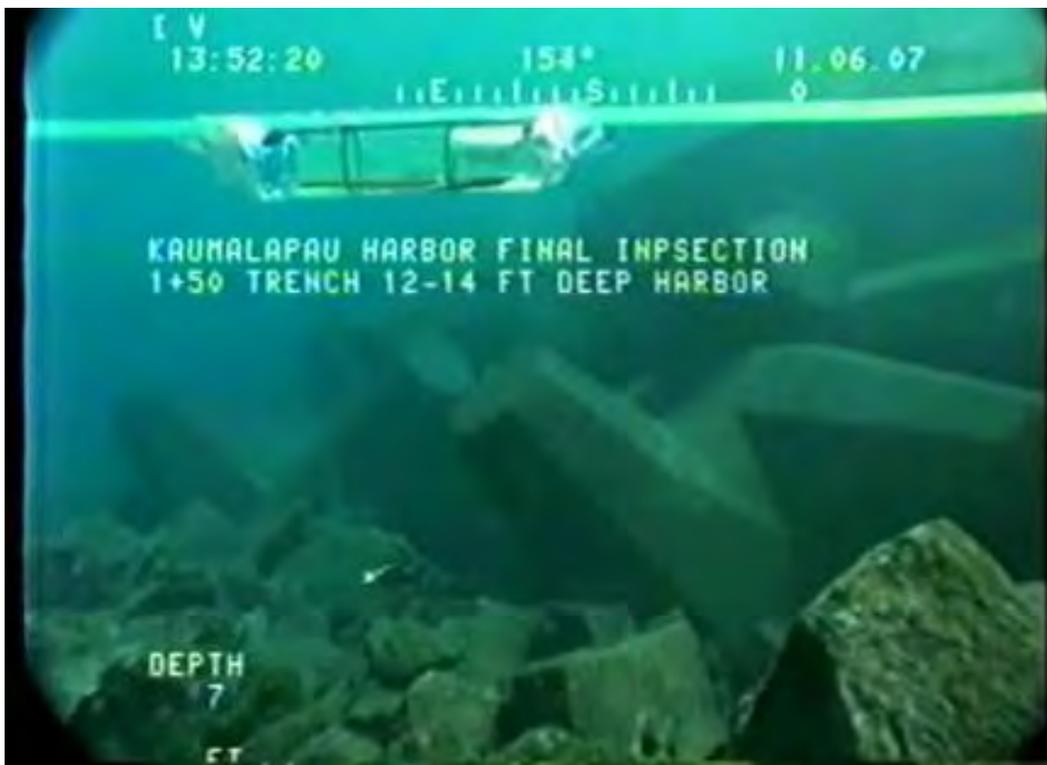
Figure 10.25. Harbor side trunk at approximately Station 1+50. Second row of tow armor units and stone toe berm with variable rock sizes are visible. Toe units are well seated into toe berm.

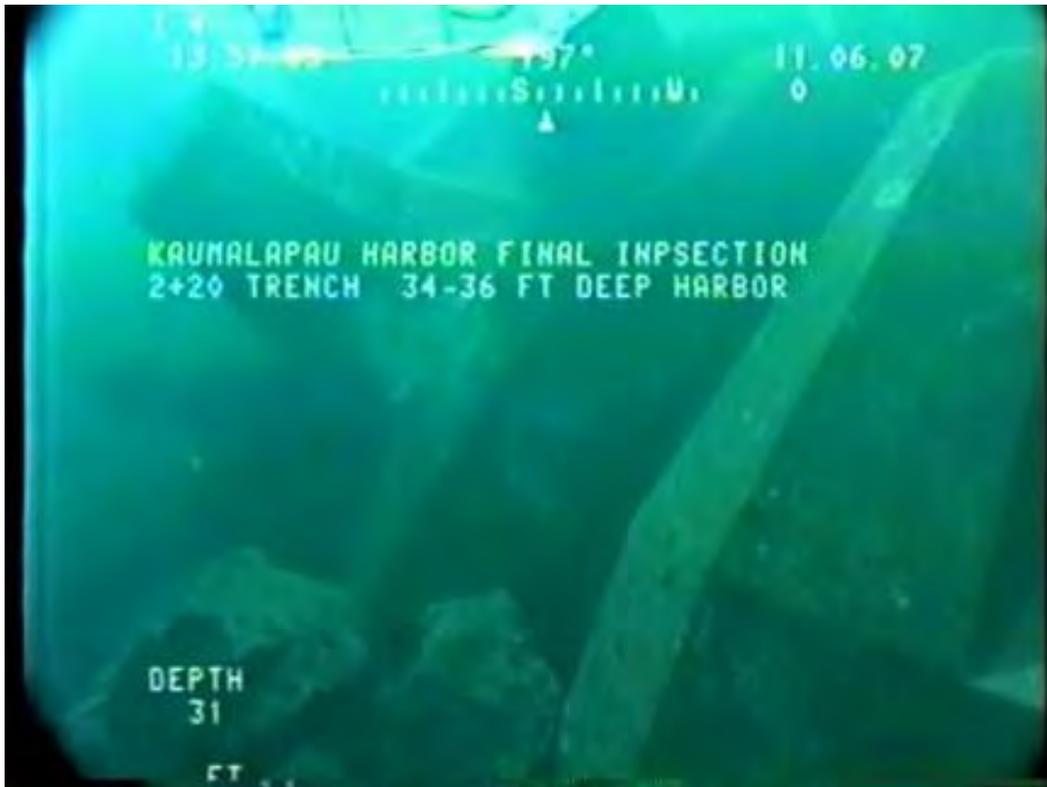
Figure 10.26. Harbor side head at approximately Station 2+20. Toe units in “cannon” orientation are visible at approximately 31-ft depth.

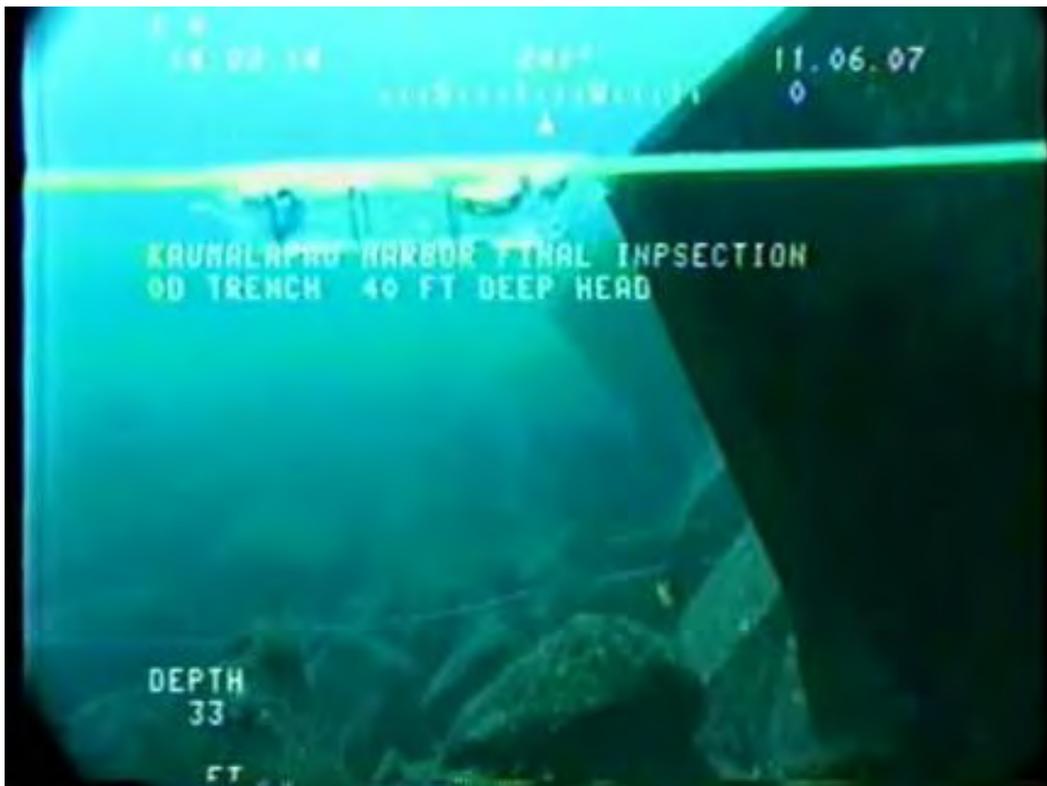
Figure 10.27. Breakwater head. Two well-entrenched toe units visible in “cannon” orientation.

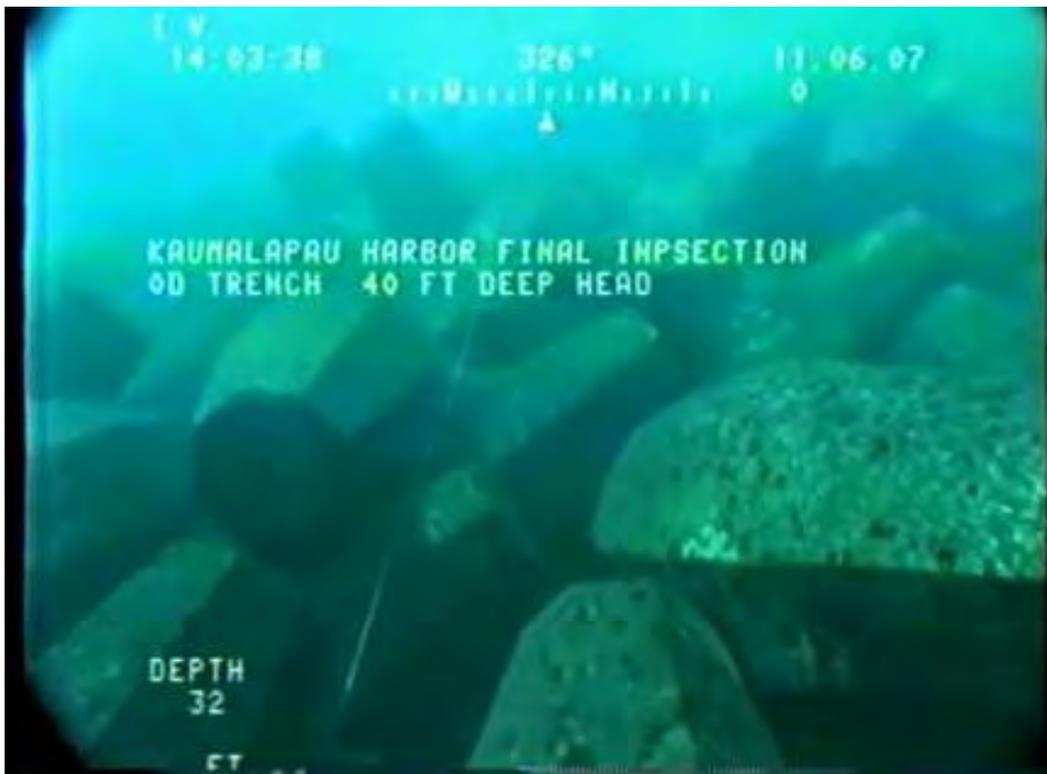
Figure 10.28. Ocean side of breakwater head. Side slope of breakwater shown with armor units well interlocked.

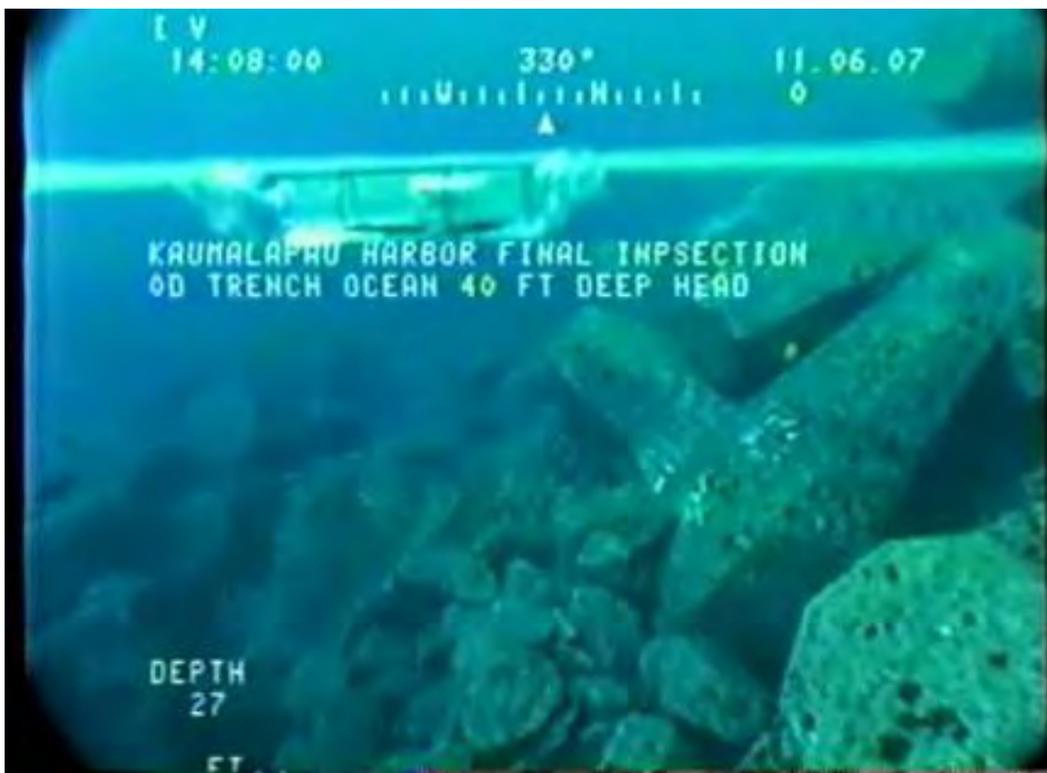
Figure 10.29. Ocean side head at approximately Station 2+20. Toe units in "cannon" orientation and ocean side toe trench/stone buttress with varied sized of stone are visible.

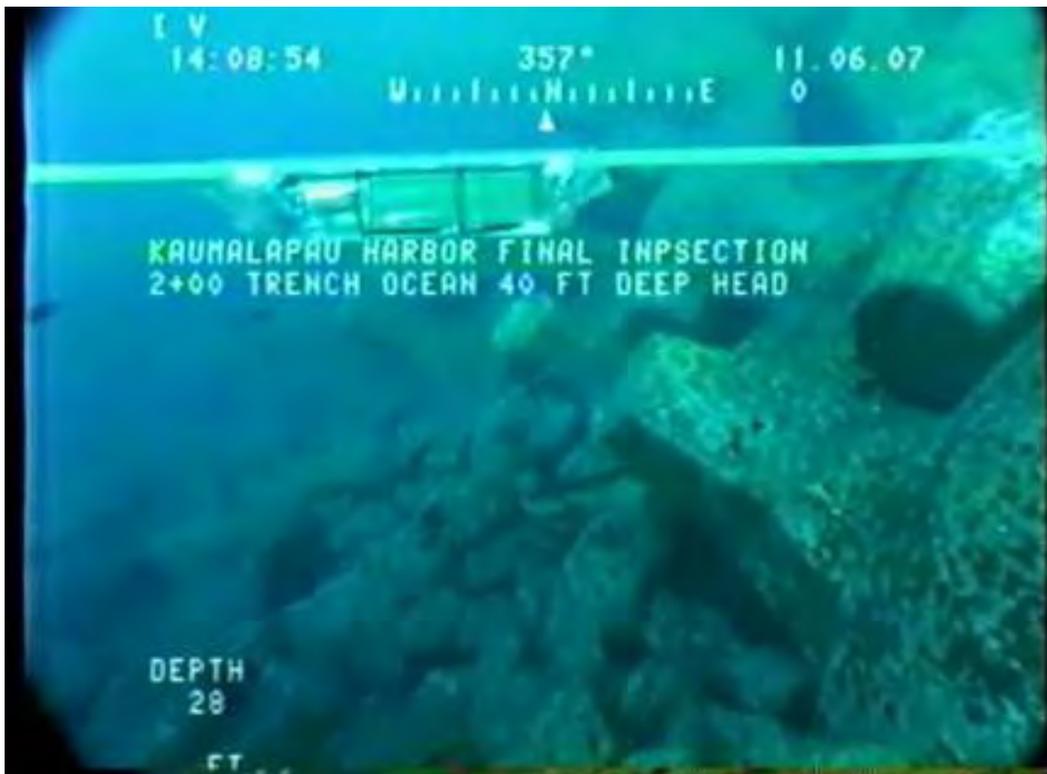
Figure 10.30. Ocean side trunk at approximately Station 2+00. Toe armor units and second row of armor units visible. Slope of toe trench/stone buttress appears somewhat steep.

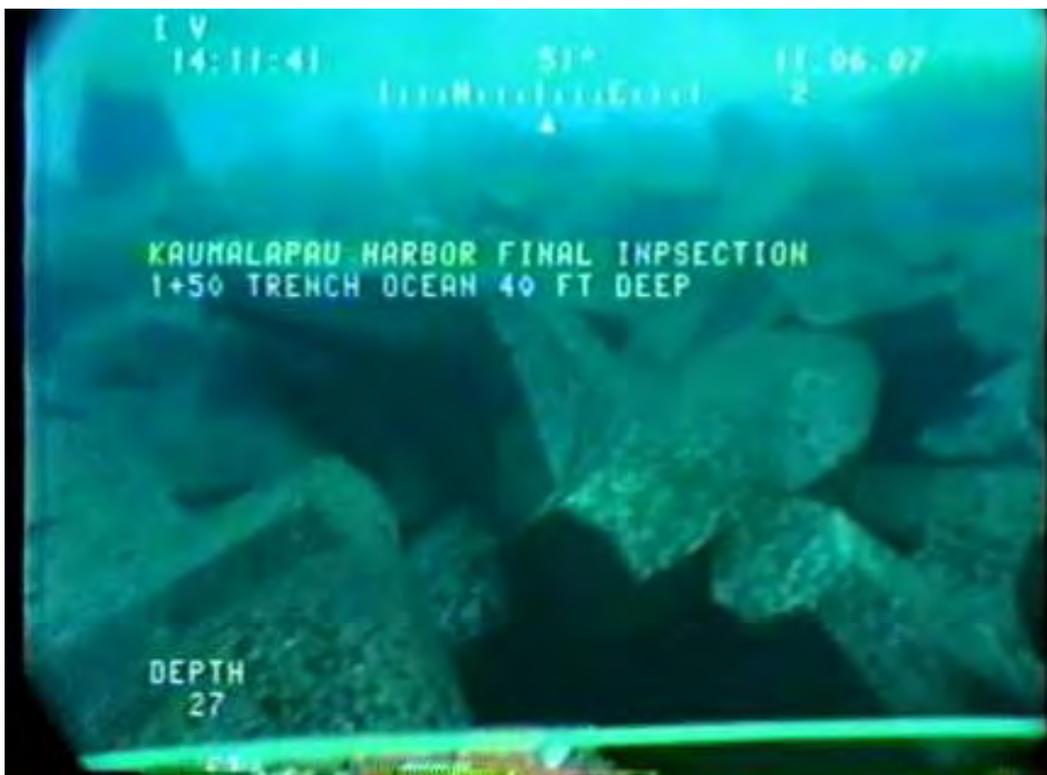
Figure 10.31. Ocean side trunk at approximately Station 1+50. Armor units appear well interlocked along breakwater side slope.

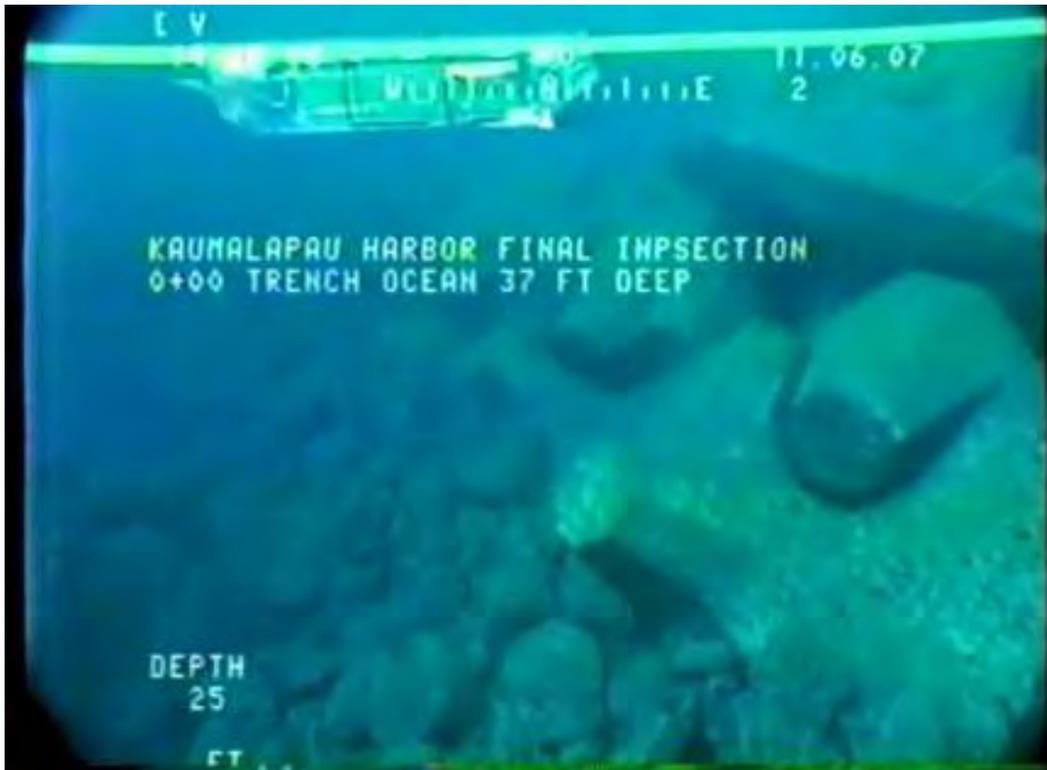
Figure 10.34. Ocean side trunk at approximately Station 0+00. Several toe units and interlocked units in the row above are visible at approximately 25-ft depth.

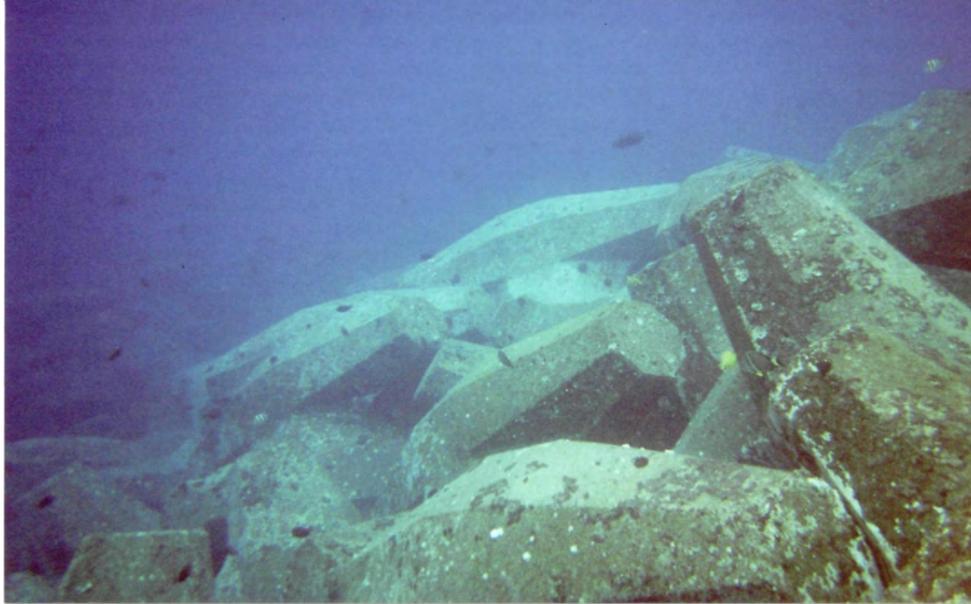
The following Figures 10.36 through 10.39 are photos of the underwater portion of the structure from August 2009, obtained by a private individual. The photos, in addition to the photographer's observations, indicated that there were no visible broken armor units, and that the armor layer still appeared to be well interlocked at that time. No location information is available for these photos.

Figure 10.36. Photo of underwater structure side slope. (Photo by Orville T. Magoon, August 2009).

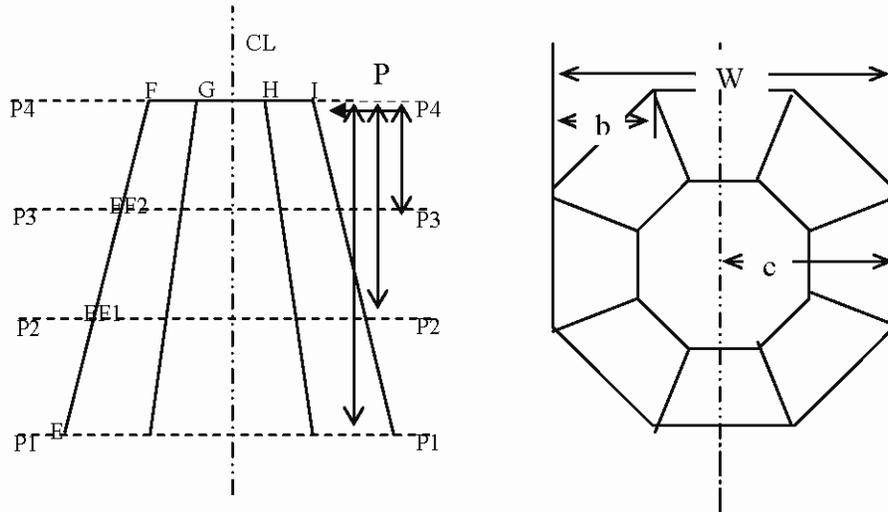
## Structural load calculations for failure load to break a Core-Loc™ Leg

Failure sections were examined at P1-P1, P2-P2, and P3-P3. Load P was applied at P4-P4.

The analysis shows that the smallest breaking load is 223600 lbf acting on the cross section P1-P1. Note if  $\sigma$  is smaller, then the breaking load will decrease.

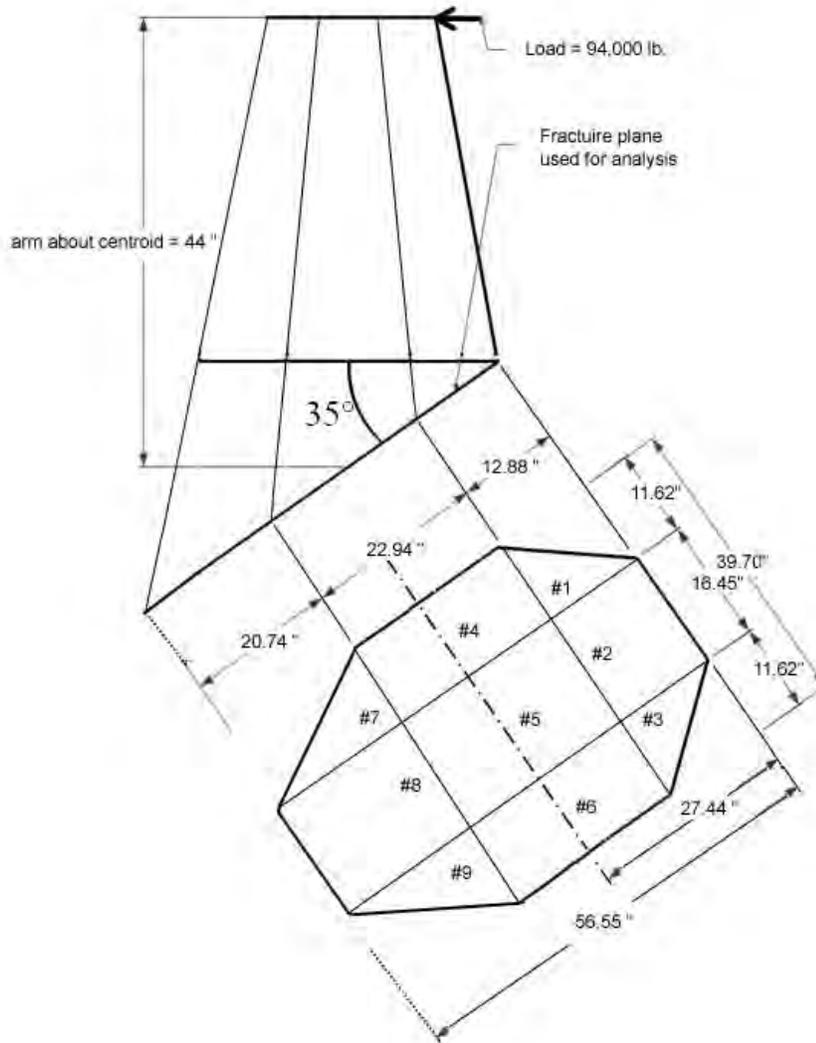
The fracture surface produces an elongated octagon like the picture above. The center of the area is 27.44 in. from the upper end of the fracture surface. The Moment of Inertia of elongated octagon can be determined by dividing the shape into nine rectangles and triangles and applying the parallel axis theorem to each of the sub-shapes. This is shown in the table below. The parallel axis theorem is;

$$\sigma_t = \frac{M c_t}{I} = \frac{(94,000)(44)(27.44)}{393,662} = 288.3 \text{ psi}$$
