ESTCP Cost and Performance Report

(WP-200620)

Cold Spray for Repair of Magnesium Components

November 2011

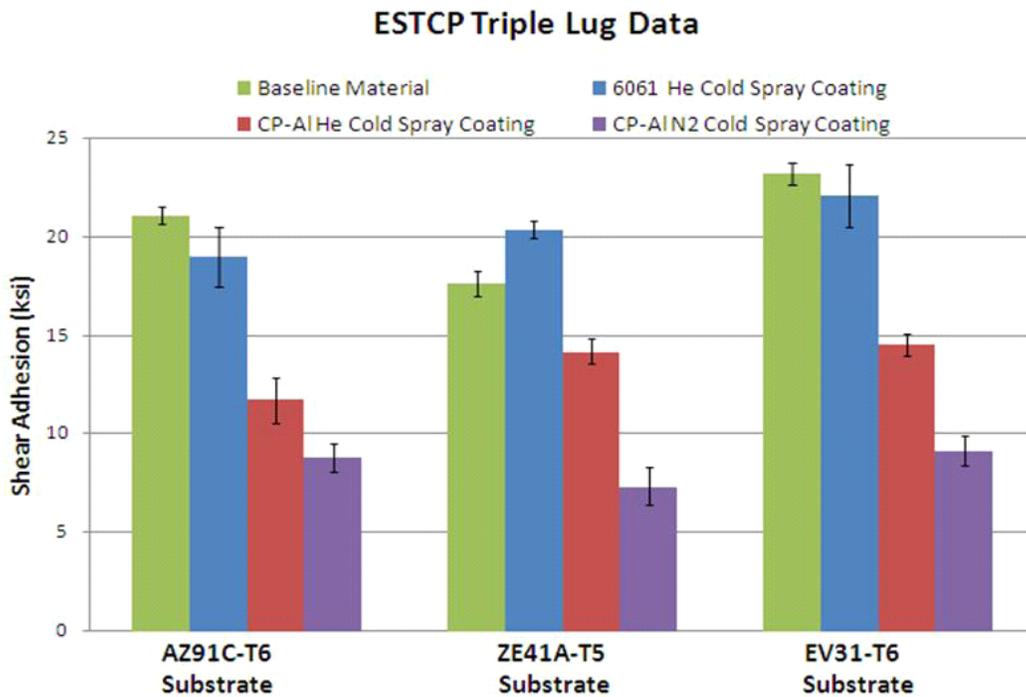
Figure 7. Triple lug shear adhesion data.

All JTP laboratory tests were completed with the optimized coating parameters. All the coating systems exceed adhesion strength of 8000 PSI. The Triple Lug Shear test results are graphed in Figure 7. All the coating and substrate combinations tested achieved the 8.0 ksi minimum adhesion except for the CP-Al N₂ coating on ZE41A-T5 (Table 10). This coating had an average adhesion of 7.4 ksi. It is suggested that component specific adhesion requirements first be identified before implementing a repair of ZE41A-T5 with CP-Al N₂. It should be noted, however, that a shear adhesion value of 7.4 ksi represents a fairly robust coating-substrate bond.

All the 6061 He coatings showed very high adhesion on the Mg alloys. The average adhesive strength of the 6061 He coating on ZE41A-T5 actually exceeded the average strength of the base line ZE41A-T5 samples. Correspondingly, seven of the 12 6061 lugs on the ZE41A-T5 broke off by fracturing material well beneath the coating-substrate interface. This is a positive indication that structural repair could be possible with the 6061 He coating since the weakest point is no longer at the coating interface. All other coating lugs failed by shearing cleanly off at the substrate interface.

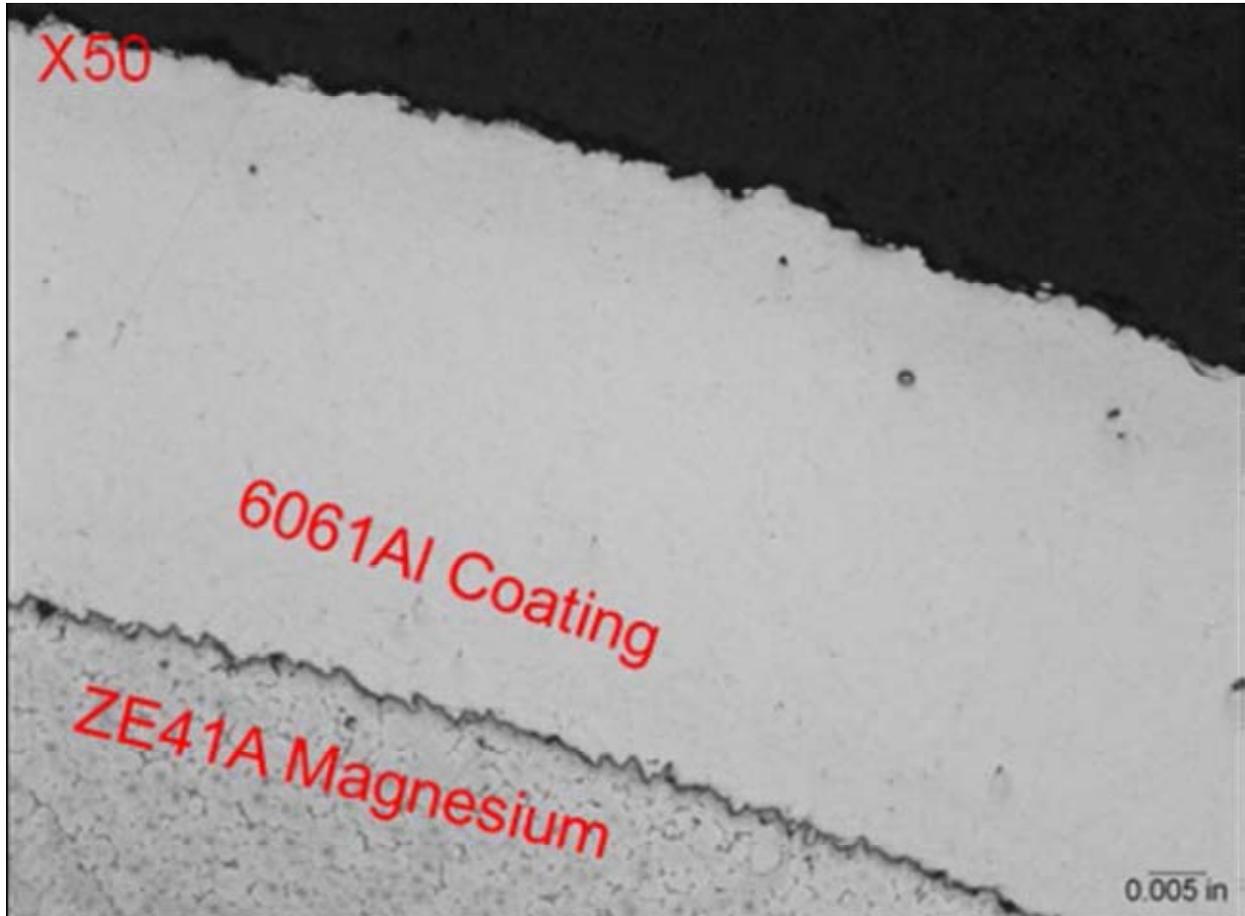
Figure 9. Optical micrograph showing a 6061 He coating on a ZE41A-T5 rod.
(Micrograph courtesy of SAC)

The results from the machining evaluation rod study are qualitative. Feedback from SAC as well as ARL’s own machinist indicated the 6061 coating was much easier to machine than either CP-Al or HP-Al. This is attributed primarily to the hardness of the coatings. The micrograph in Figure 9 shows a 6061 He coating on a ZE41A-T5 rod.

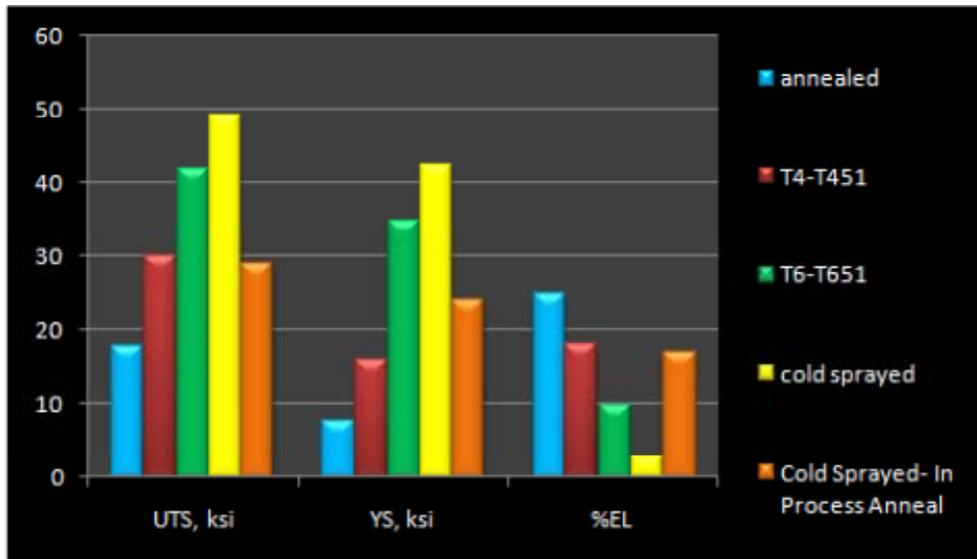
Figure 10. UTS, YS, and percent elongation at failure for as deposited 6061 He Cold Spray (yellow), in-process annealed 6061 He Cold Spray (orange) versus wrought 6061.

The 6061 He micro-tensile testing showed that this coating system has very high strength in the as-Cold Sprayed condition (Figure 10). The YS and the UTS of the Cold Spray deposit actually exceed the properties of wrought 6061-T6 [11]. The primary strengthening mechanism is most likely work hardening since the elongation at failure (%EL) is only 3%. However, 3%EL is in line with cast Mg alloys [10-11]. The %EL increased to approximately 17% after the in process annealing. The YS and UTS dropped to values typical of wrought 6061 with T4 tempering. Both the as-deposited and in-process annealed data indicate that there is potential for structurally repairing these Mg alloys with this Cold Spray coating.

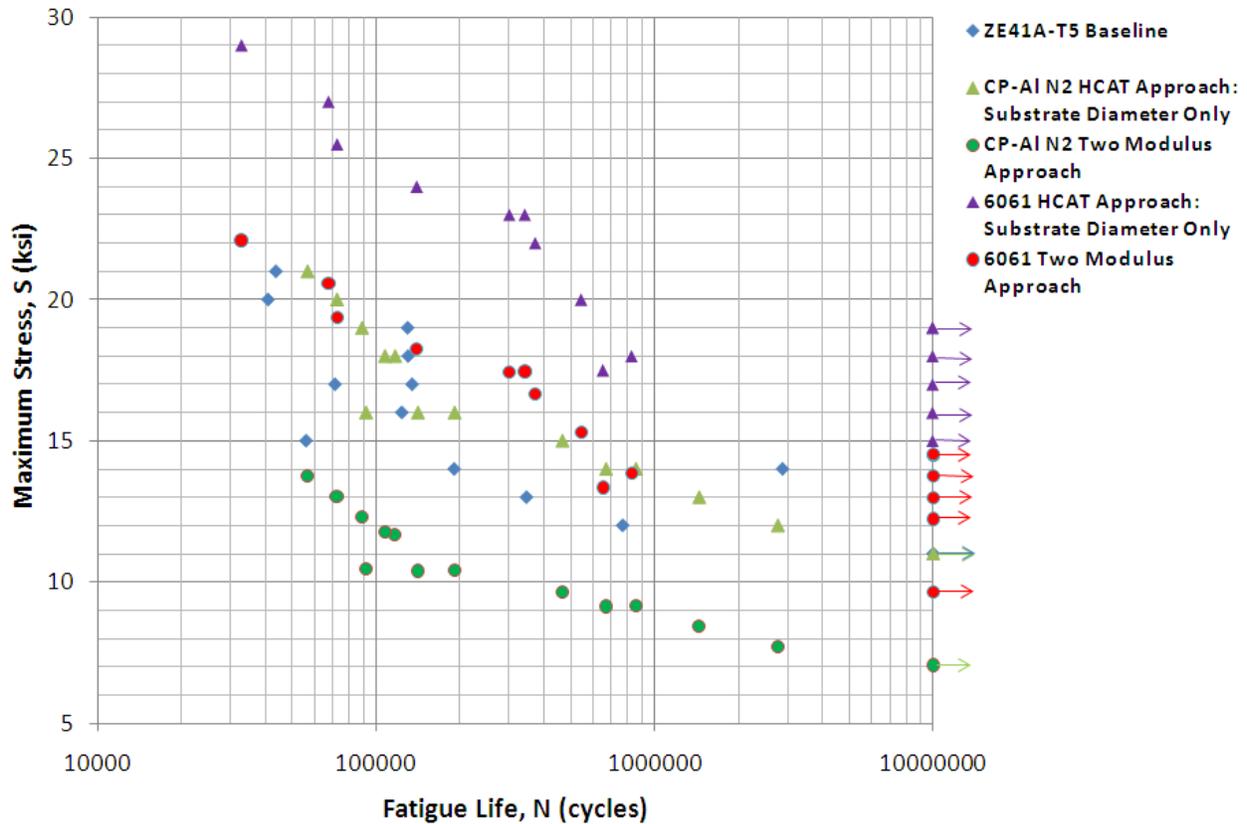
Figure 11. S-N plots for 6061 He and CP-Al N₂ Cold Spray Coatings on ZE41A-T5.

There was a significant difference in the rotating beam fatigue performance for samples coated with CP-Al N₂ versus the 6061 He. The stress to number of cycles to failure (S-N) plot for the coatings on ZE41A-T5 is provided in Figure 11. It should be noted that not all specimens failed exactly in the gage. Failure location as well as the cycles, stresses, and gage thickness for all data points for all alloy and substrate combination are provided in the Final Report.

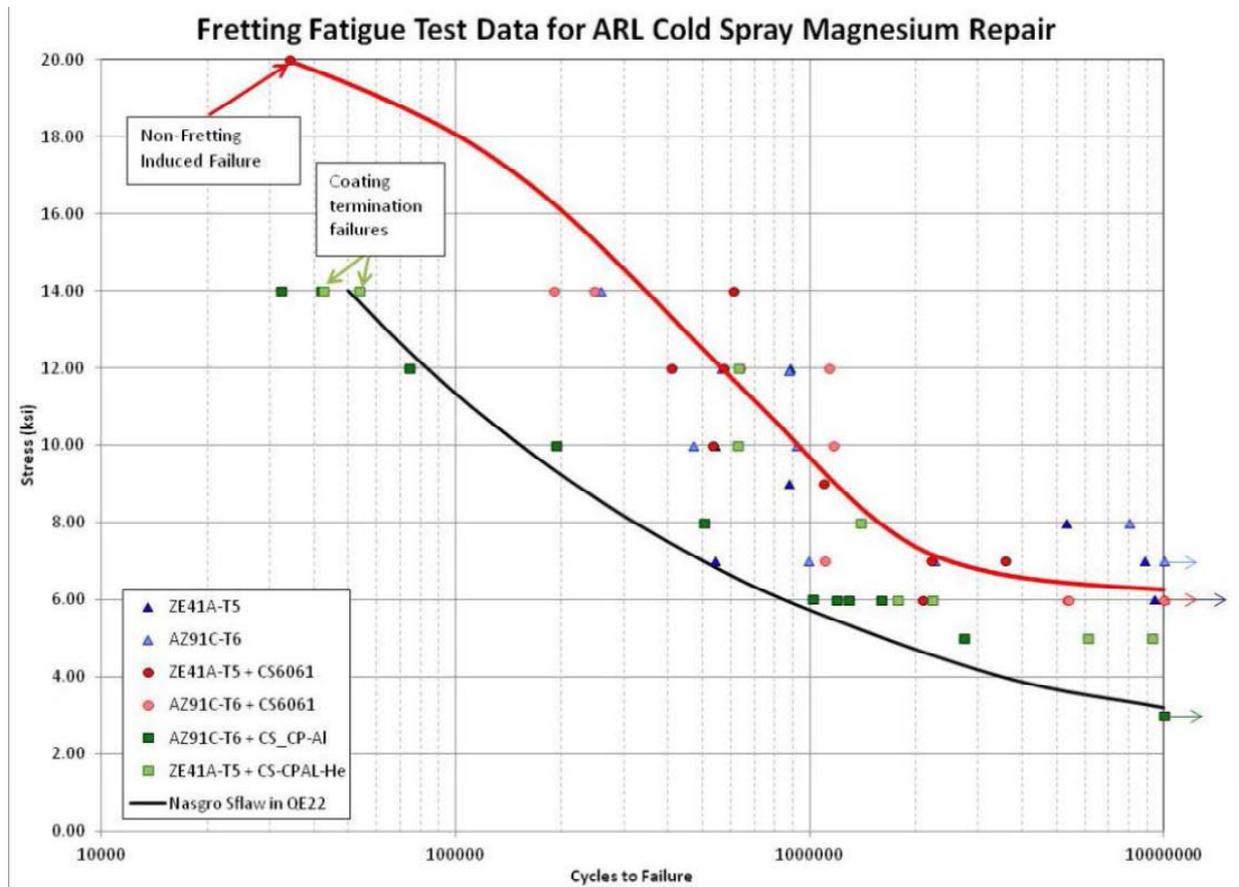
Figure 12. S-N plot for fretting fatigue.

A plot of the fretting fatigue results are provided as Figure 12. The 6061 He coating on the ZE41A-T5 caused a very slight debit. The CP-Al He coating caused no noticeable debit in performance. The CP-Al N₂ sample, on the other hand, caused a significant debit to the fretting resistance. A curve for the CP-Al N₂ is shown in black on Figure 12. UTRC cited low ductility of the CP-Al N₂ system as one of the primary reasons for poor fretting performance. Therefore, CP-Al N₂ coatings should not be used in contact scenarios where fretting could be an issue. The slight debit observed for the 6061 coating is also attributed to the low ductility of the coatings.
