TECHNICAL REPORT REMR-CS-16

REPAIR OF DAM INTAKE STRUCTURES AND  
CONDUITS. CASE HISTORIES

Roy L. Campbell, Sr., Dennis L. Bean

January 1988

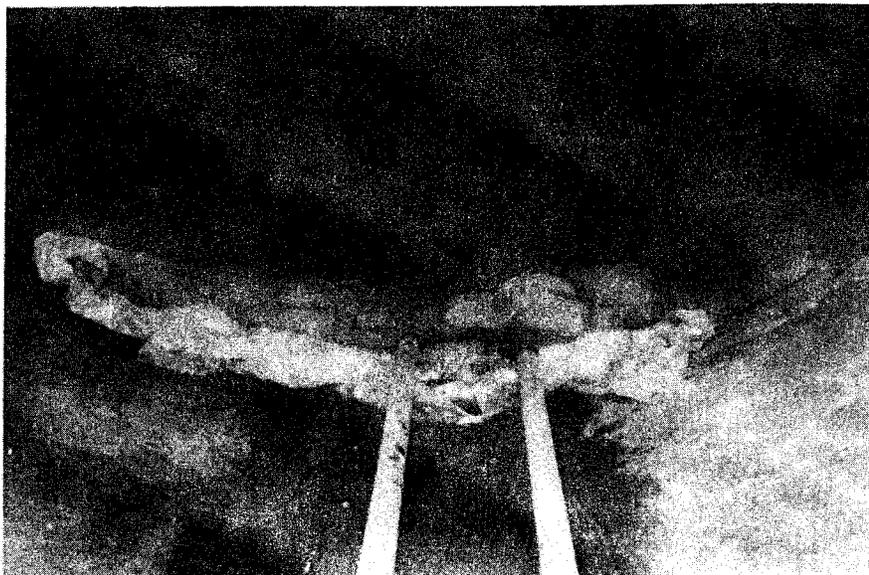
18. 1977. Remedial grouting (USAED, Vicksburg 1979) was performed by the Vicksburg District personnel in June 1977 at joints and cracks of monoliths 1 through 9. After closure of the control structures gates, drilling and grouting equipment were placed in the conduit. A 2-ft-high sandbag dike was constructed across the transition section (Figure 3) and two 3-in.-diameter drain pipes extended from there to near the end of the conduit to pass water leaking from around the gates through the repair area.

Figure 3. Sandbag dike and drain pipes, Arkabutla Dam, 1977

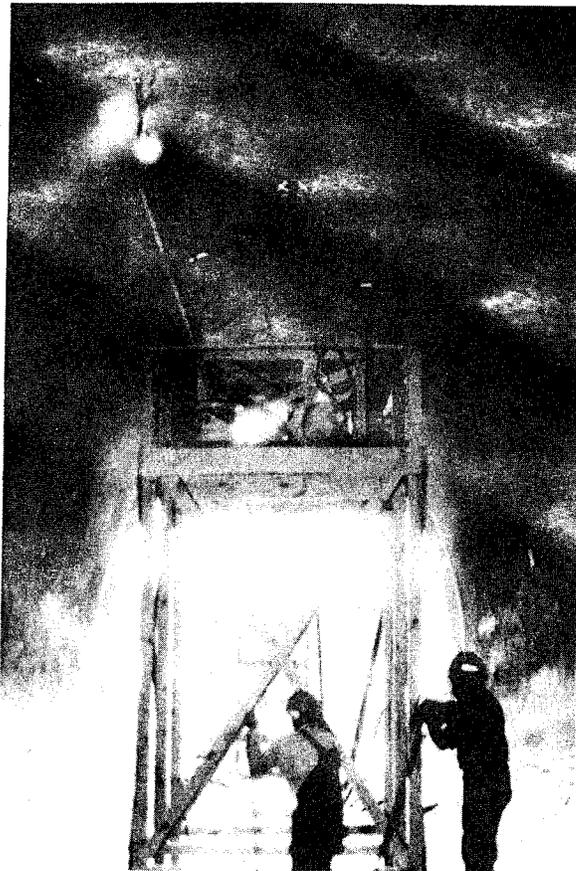
20. An exploratory hole was drilled in the crown at monolith joint 12/13 mainly to check the area near the bottom of the sinkhole that developed in the embankment close to the downstream end of the conduit in 1974. An air-powered rotary drill equipped with a 2-1/2-in.-diameter, thin-wall diamond bit was used to drill 2 ft into the joint. The drill was mounted and braced between the top of a wooden scaffold and the top of the conduit (Figure 5). When the waterstop was penetrated, no water was encountered. A 2-in. inside diameter, 20-in.-long, pipe coupling and nipple with a flared end were grouted in place.

Figure 5. Drilling exploratory hole in conduit crown, Arkabutla Dam, 1977

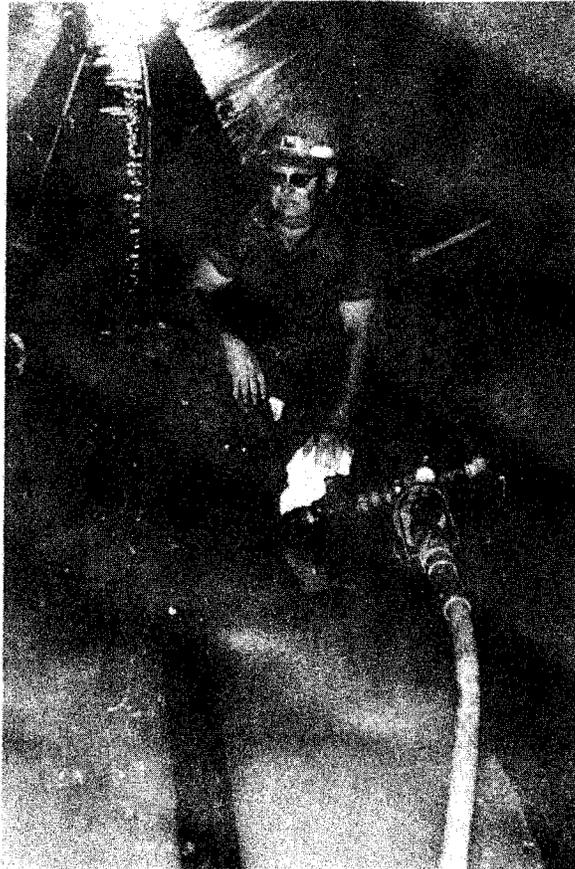
Figure 6. Control valve, Arkabutla Dam, 1977

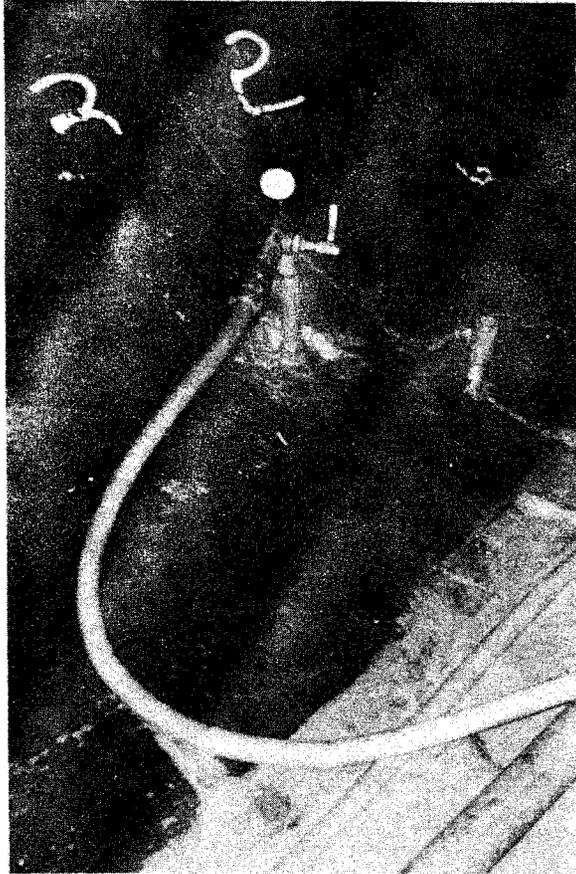
Figure 7. Pressure gauge and cutoff valve, Arkabutla Dam, 1977

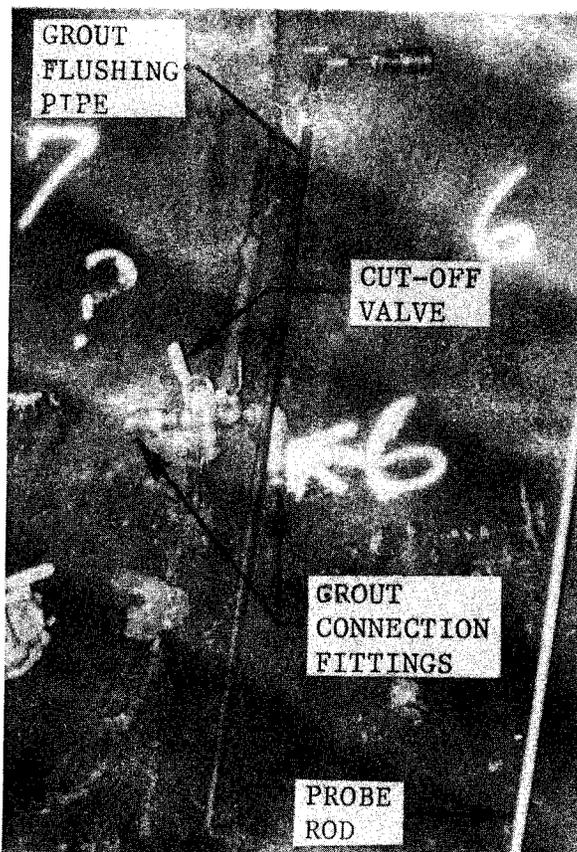
23. Immediately prior to grouting any port having back pressure, the cut-off valve was opened and a 1/2-in. inside diameter, 6-ft-long, flushing pipe inserted (Figure 9). Grout was jetted through the pipe into the hole to

Figure 9. Grout hole with cutoff valve, Arkabutla Dam, 1977

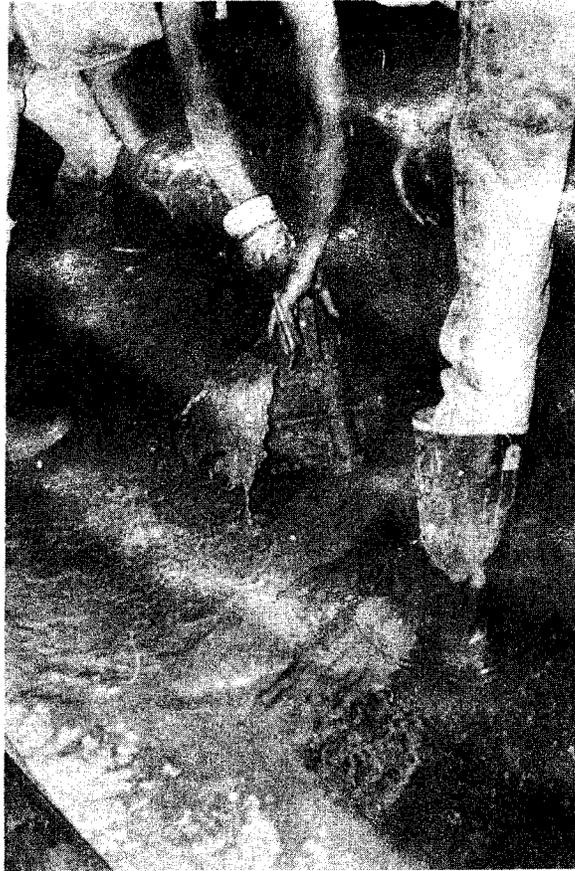
remove foundation sands that had filled the port (Figure 10). After the port was cleared, the pipe was quickly removed and the valve closed. When the regular grout connection was made, the hole was unobstructed and could freely pass grout to adjacent voids.

Figure 10. Flushing of grout hole, Arkabutla Dam, 1977

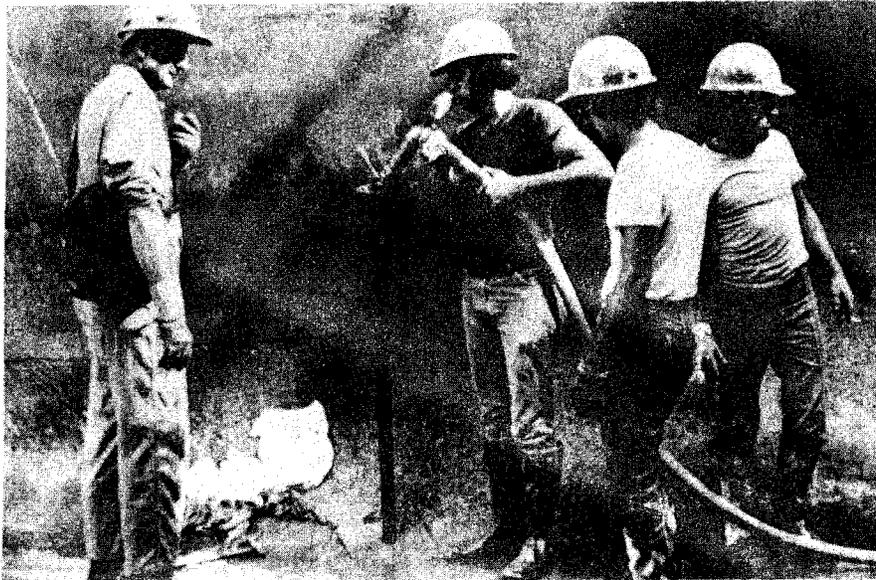
24. At the end of the grouting day, all grouted holes were inspected. Water dripping from a hole when the valve was slightly opened indicated grout had not sealed the leak. A 4-ft-tall standpipe was connected to the hole and filled with 1:1 grout (Figure 11). If water was observed dripping from the top of the standpipe the next day, adjacent ports were cleaned out, jetted with water, and then pressure grouted with a 1:1 mix.

Figure 11. Grouting using standpipe, Arkabutla Dam, 1977

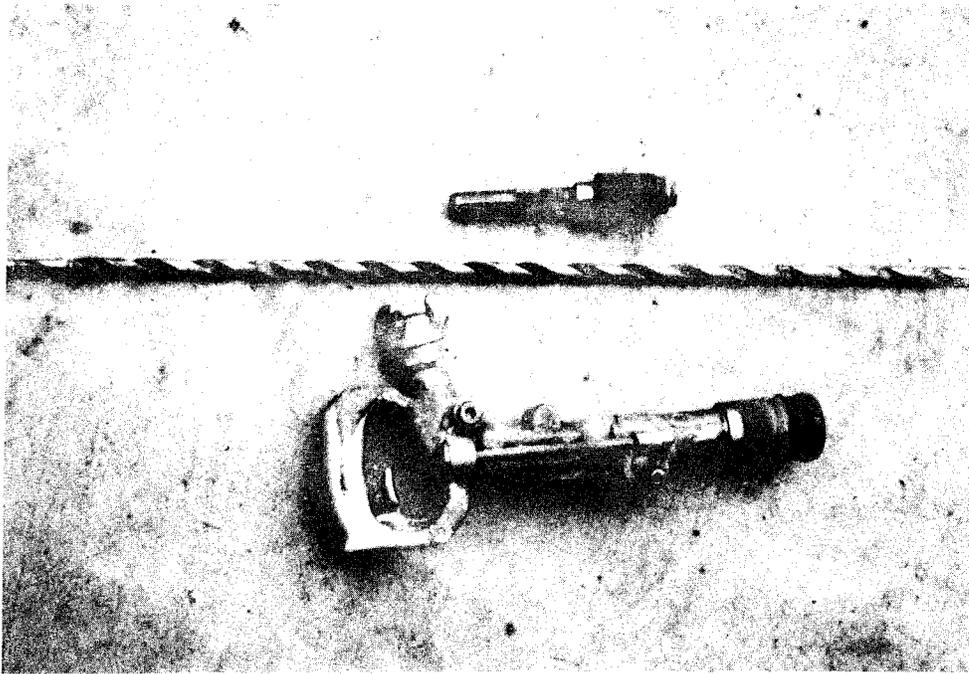
Five hundred and fifty feet of hose was used to supply air to monolith joint 20/21 where the drilling was started. Two Chicago pneumatic rotary hammer drills, model number 9A, were used to drill the grout holes. The grout holes were 5/8 in. in diameter and were drilled using 18 and 36-in.-long masonry bits that were carbide tipped and had SDS (SR) series shanks (Figure 14).

Figure 14. Rotary hammer drill, adapter, and bit, Blakely Mountain Dam, 1986

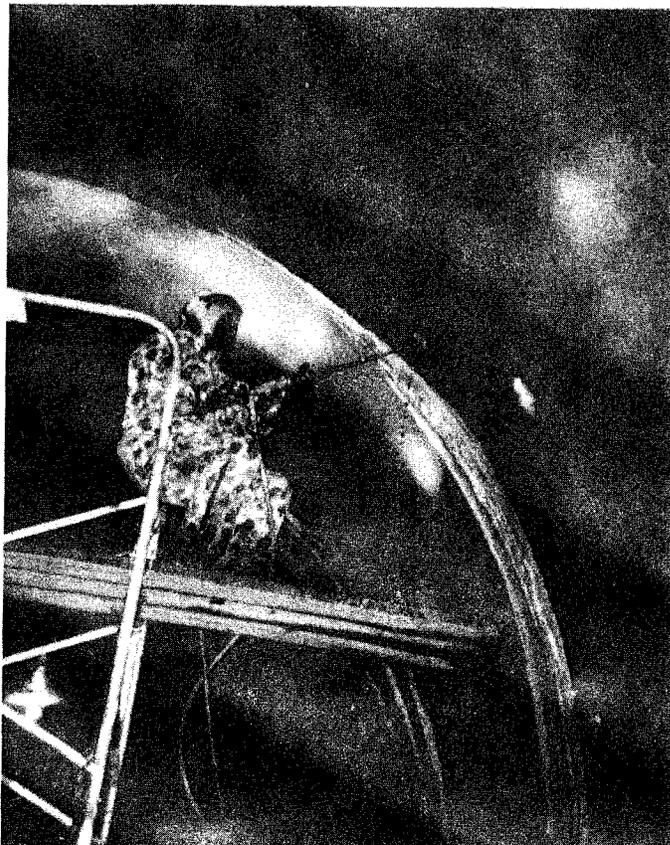
73. Holes to be drilled were measured from the center of crown along the tunnel circumference and marked. Drilling of the grout holes (Figure 15) was started on 30 January 1986 at monolith joint 20/21. The joint was weeping at two locations, 9.5 ft right of the centerline of the crown and 5 ft left of the centerline of the crown looking downstream. Five holes were located as follows: 5 ft right (weeping), 7.5 ft right (flowed), 7.5 ft left (flowed), 5 ft left (weeping), and 2.5 ft left (flowed). These grout holes were drilled at a 40- to 45-deg angle to the concrete surface and slanted toward the joint with the holes starting 12 to 16 in. downstream of the joint. The purpose for this was to intercept the joint behind the water stop so that the surface of the joint would not have to be sealed to retain the chemical grout. To drill a 30-in.-deep hole required 45 min to 1 hr. This length of time was required frequent withdrawal of the bit to assist in the removal of the cuttings and the additional effort required to puncture the water stop. Bits were not vented to blow cuttings out of the hole.

Figure 15. Drilling of grout hole, Blakely Mountain Dam, 1986

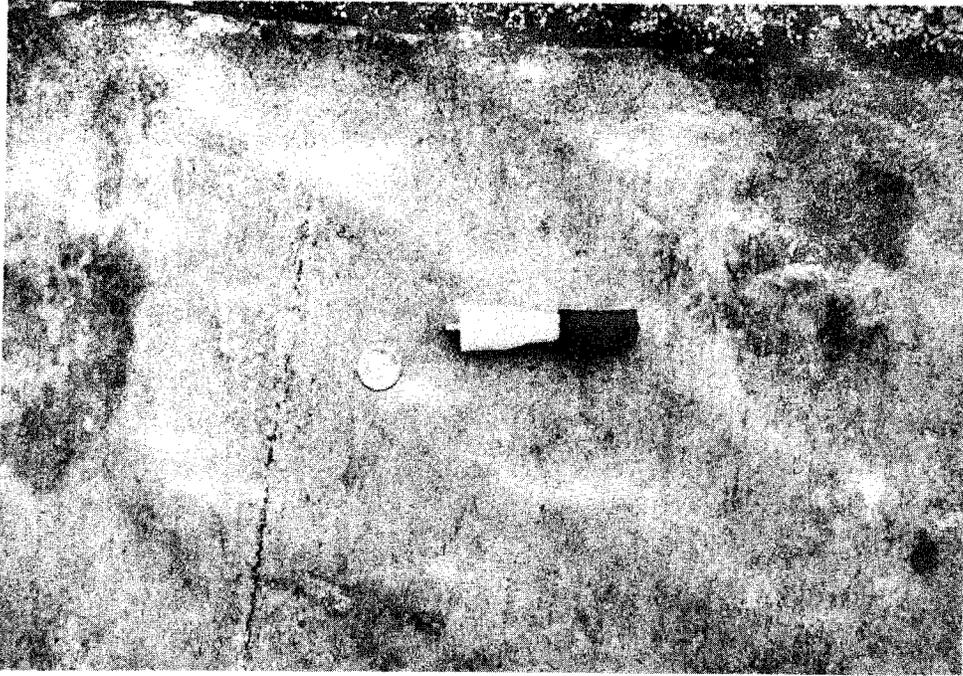
Figure 16. Injection packer, Blakely Mountain Dam, 1986

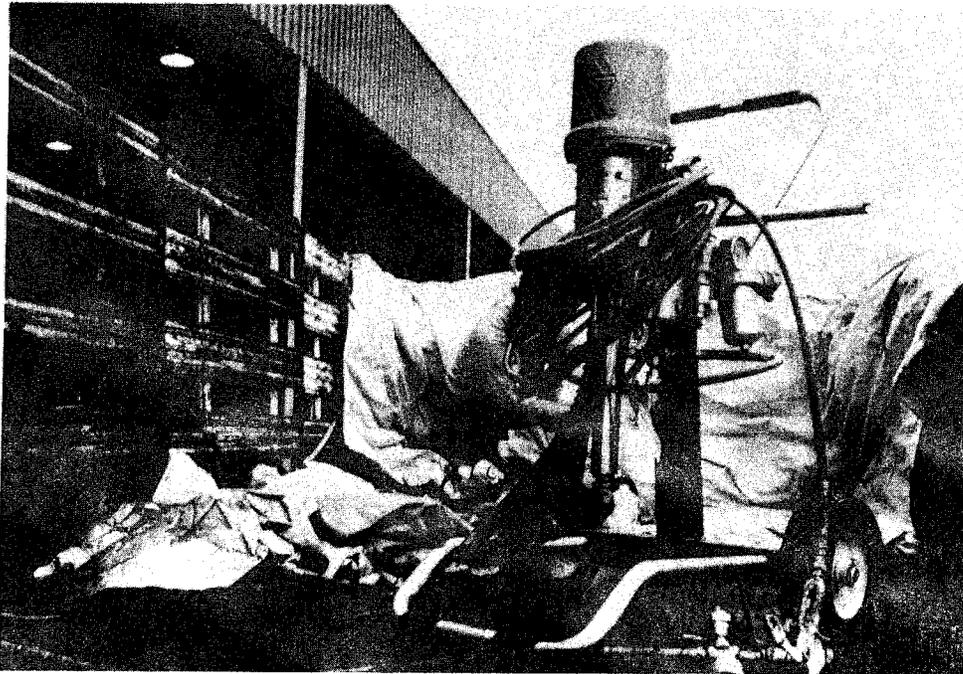
Figure 17. Grout pump, Blakely Mountain Dam, 1986

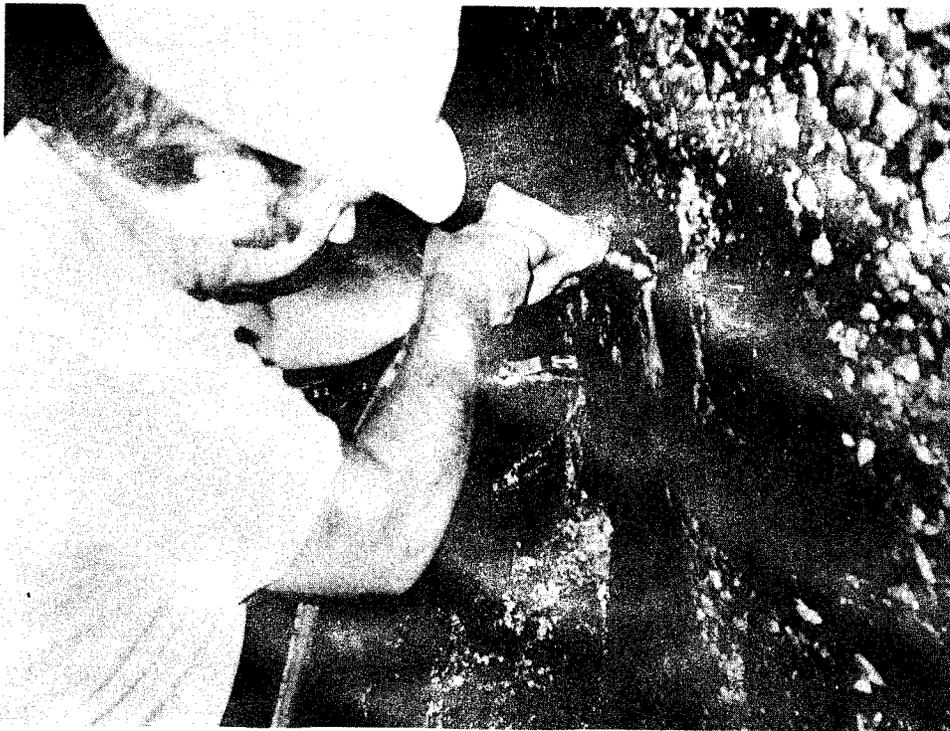
98. Three, 3/4-in.-diameter holes were drilled to reduce or relieve water pressures during the sealing of injection ports. These holes (Figure 21) were drilled to the depth of the waterstop (approximately 6 in.), but not penetrating it. Port tubings were inserted near full depth of each of the five holes to provide a longer flow path, thereby, increasing the time in which the grout had to set before exiting the concrete. Oakum was packed into cracks and holes around ports until the majority of leakage was flowing through ports (Figure 22). This process had to be done in a persistent manner, since pressure increased as each small quantity of flow was shut off by the packing of the oakum. At times one closure would cause a previously sealed area to seep again. After the packing of the oakum was completed, valves were closed to check effectiveness of packing (Figure 23). Preco Plug

Figure 21. Drilling of injection port using pneumatic drill, Buckhorn Lake Dam, August 1986

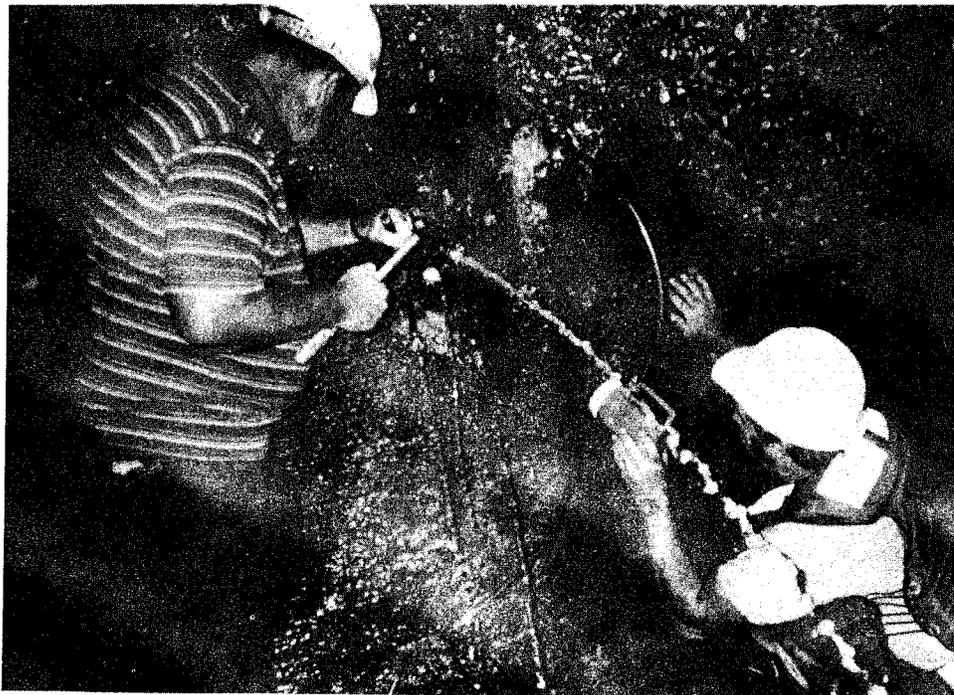
Figure 22. Packing oakum around injection ports, Buckhorn Lake Dam, August 1986

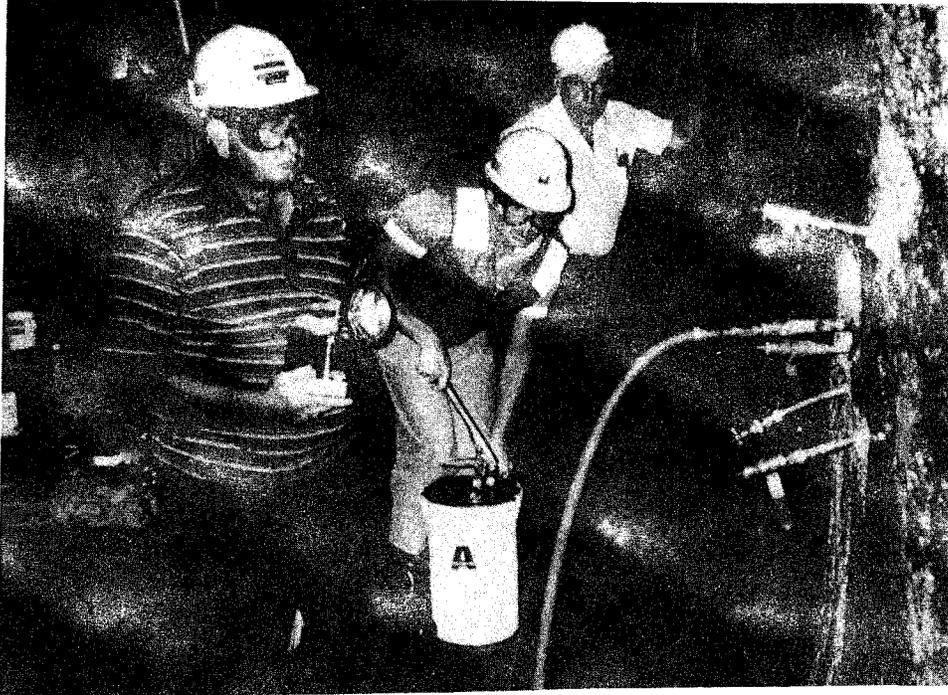
99. After the Preco Plug had set for about 20 min, 2-1/2 gal of TACSS-020 NF was mixed with 5 percent of C-852 accelerator. With the other four valves closed, grout was pumped through the open valve of the port occupying the nondrilled hole (Figure 24). There were a number of small seeps that existed prior to the start of the grouting operation. After 2 to 3 min of pumping these seeps stopped with grout solidifying on the interior wall at some of the seep locations. After all of the approximately 2-1/2 gal of grout had been pumped, the port valve was closed to allow time for grout to react and solidify. Another 2-1/2 gal of grout was prepared and the pump connected to the single port downstream of the joint. The pumping of grout into the port was initiated, but no grout was taken. With valves closed and hose removed, the previously injected grout was allowed to gel for an additional 30 min. Ports were then cut off slightly below the wall surface and projecting oakum removed. Preco Plug was mixed and spread over the work area to form a protective seal (Figure 25).

Figure 24. Injection of TACSS-020 NF mix into port occupying nondrilled hole, Buckhorn Lake Dam, August 1986

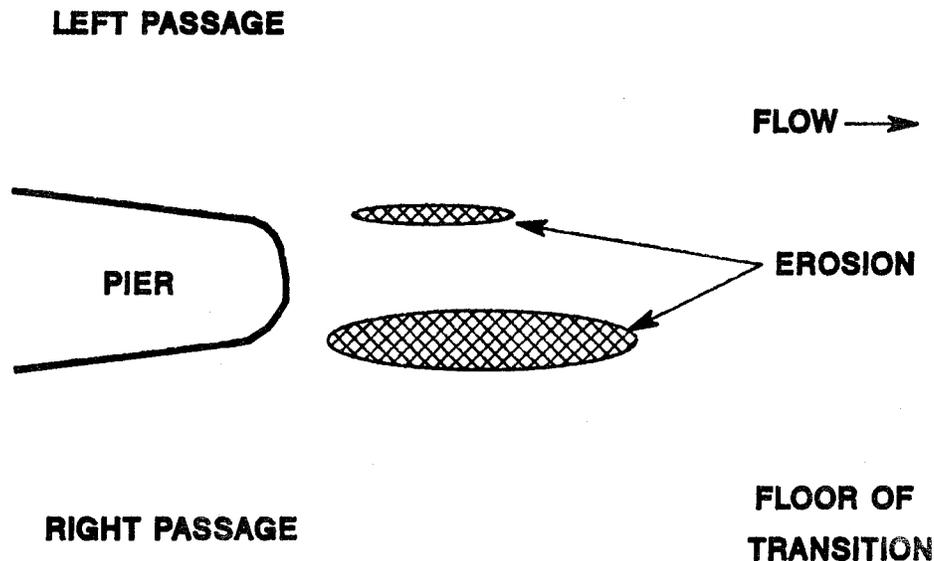
nose of the pier partition that separates the two passages. One area was located to the right of the pier nose and was eroded 2 to 3 in. deep with a length of 2 ft. The other area was located to the left of the pier and was eroded to a depth of 2 to 3 in. with a length of about 1 ft. A sketch of erosion damage in the transition is presented in Figure 28.

Figure 28. Sketch of abrasion damage in floor of transition, Cave Run Dam, 1982

104. 1982. Cavitation-erosion-damaged concrete in the right gate passage of the outlet works was repaired in November 1982 by district personnel using SikaTop 122, a two-component, prepackaged, acrylic mortar, manufactured by Sika Corporation of Lyndhurst, New Jersey\*. The repair was terminated after the mortar failed to set. Inspection of the product containers revealed that no expiration dates were present. It was suspected that the shelf life for the mortar used had been exceeded and, therefore, was the cause of the product's failure to set. The Sika Corporation agreed to replace the undated material. It should be noted that all employees involved complained of minor headaches caused by product fumes and lack of ventilation.

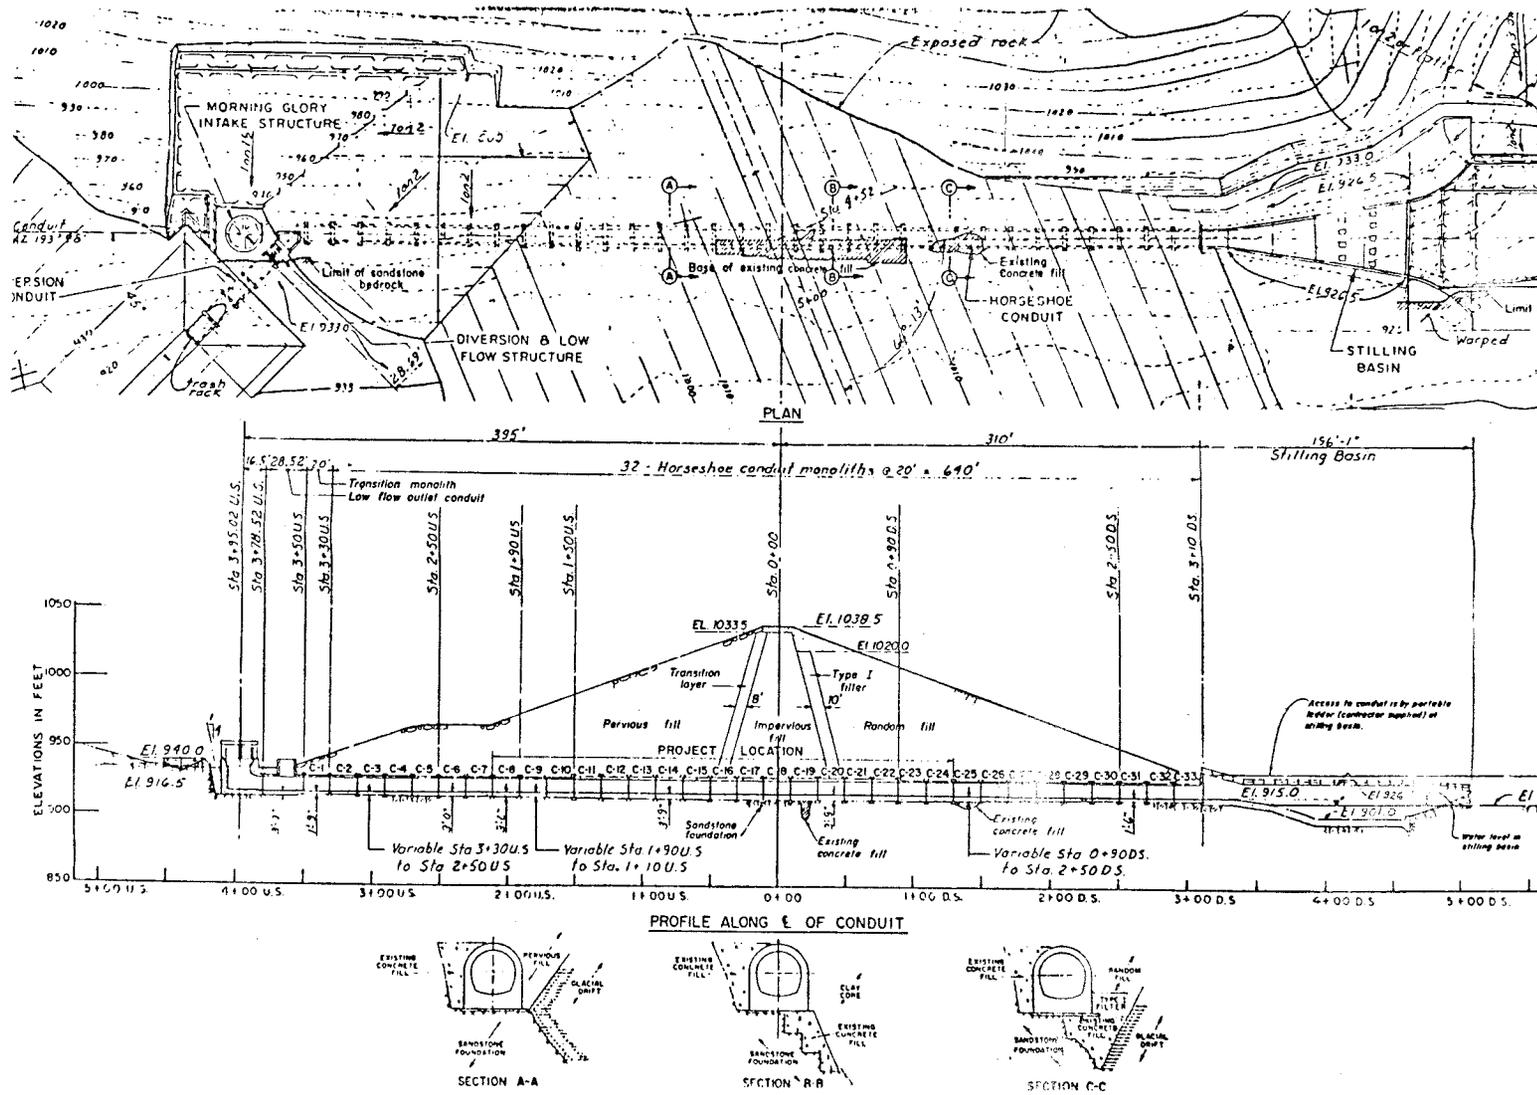
114. The outlet works (Figure 29) includes a morning glory intake, diversion and low-flow conduit and intake, horseshoe conduit, and a stilling basin at the horseshoe conduit outlet. The morning glory intake is a reinforced concrete gravity structure with an ogee crest section and trash rack at the inlet. The diversion and low flow conduit is 80 ft long with a trash rack at its inlet and a reinforced concrete gated intake structure at its outlet into the horseshoe conduit. The horseshoe conduit has a 9.75-ft equivalent diameter and consists of thirty-two 20-ft-long reinforced concrete monoliths. The thickness of the horseshoe and floor portions of conduit varies between 1.5 and 2 ft and 1.5 and 3.75 ft, respectively. The stilling basin walls and slab were designed as an integral U-shaped reinforced concrete structure.

Figure 29. Eau Galle Dam outlet works

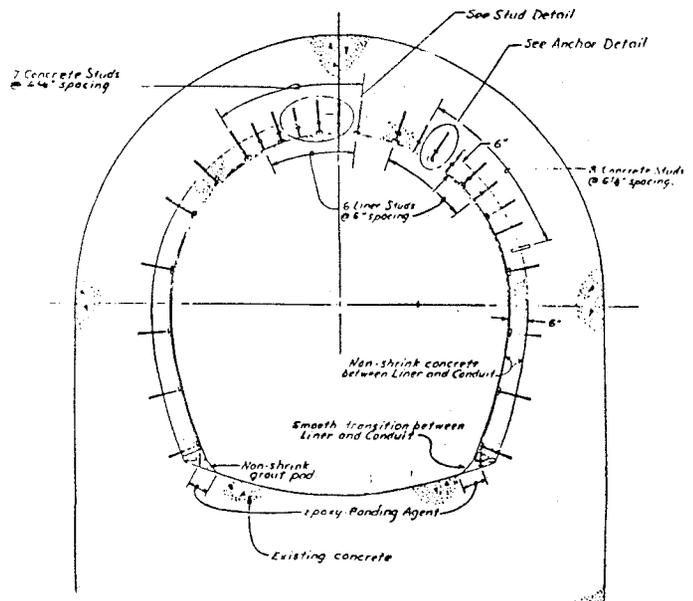
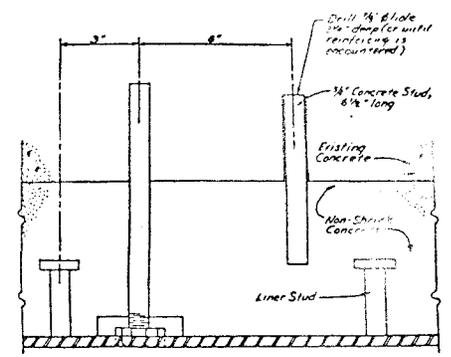
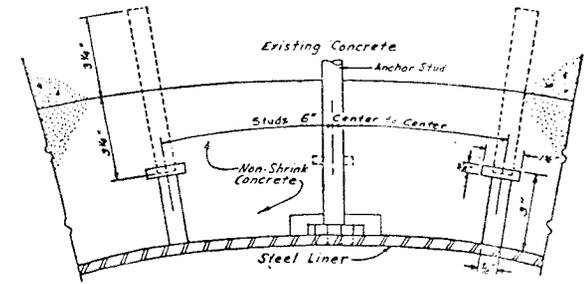
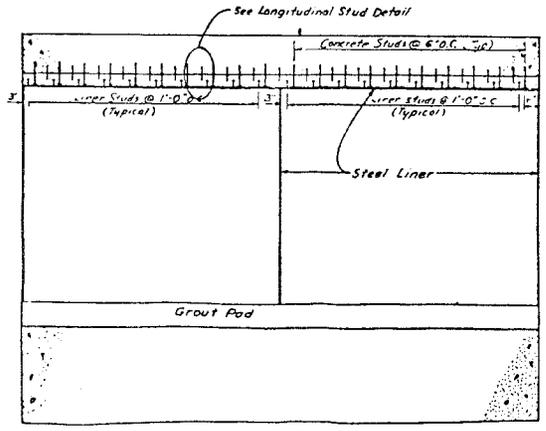
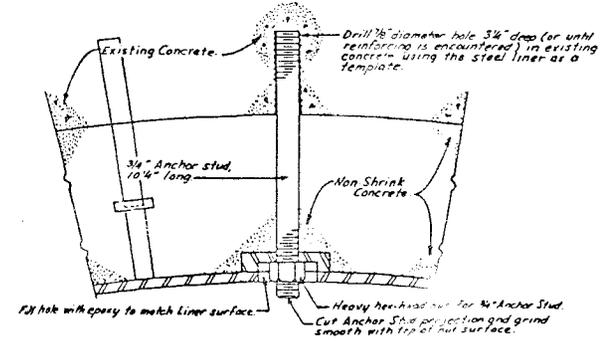
Figure 31. Anchor details for steel liner and nonshrink concrete fill, Eau Gallie Dam

120. The composite liner (Figure 31) consisted of a 3/8-in.-thick steel-plate liner and a 5-5/8-in.-thick layer of nonshrink concrete pumped between the steel and the existing concrete. Steel studs 3/4 in. in diameter (Figure 31) were used to tie the existing concrete, nonshrink concrete, and steel plate together to form a composite structure. The end sections of the repair, monoliths 8 and 24 (Figure 32), consisted of a tapered composite liner of nonshrink concrete and epoxy grout abutted at its end with an epoxy grout liner. The tapered composite liner was integrated with the existing concrete by a ring of dowels located in the nonshrink concrete 2 ft from the joint at the end of the concrete-steel liner and by epoxy bonding agent at the interface.

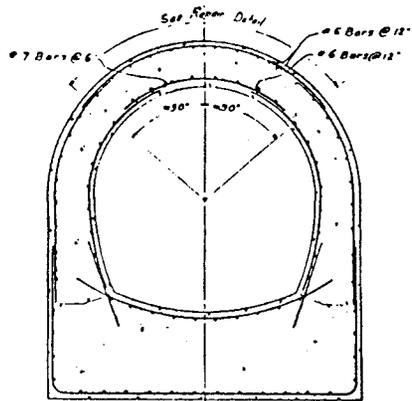
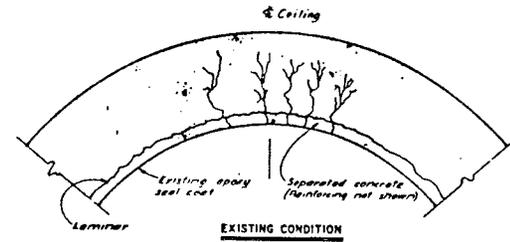
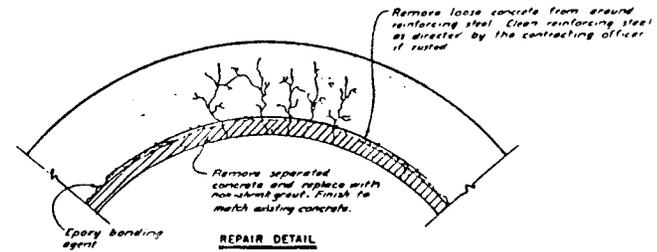
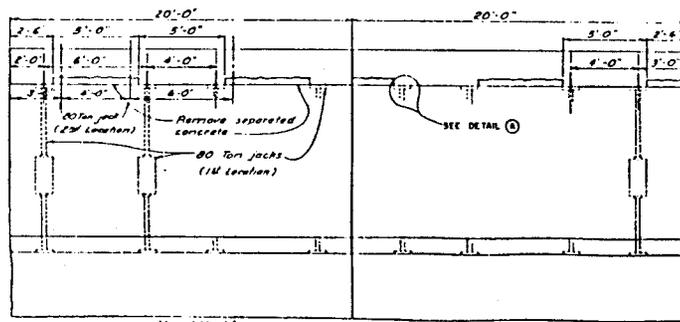
Figure 33. Details of removal and replacement concrete in crown of conduit, Eau Galle Dam

122. In a few of the monoliths containing the most severely delaminated concrete, the damaged concrete in the crown of the conduit was removed and

replaced with a nonshrink grout prior to installation of the steel liner (Figure 33). The work was performed in reaches of 5 ft and required 80-ton jacks at the ends of each reach to support the ceiling during the repair. The specifications for the nonshrink grout required aluminum powder as expansive agent, No. 4 maximum size aggregate, Type III portland cement, and minimum compressive strength of 4,200 psi.

Remove 5' separated concrete between & jack spacing. Replace grout as shown in repair detail and wait 5 days before removing jacks. Jacks may be placed on repaired sections after grout has cured 3 days.

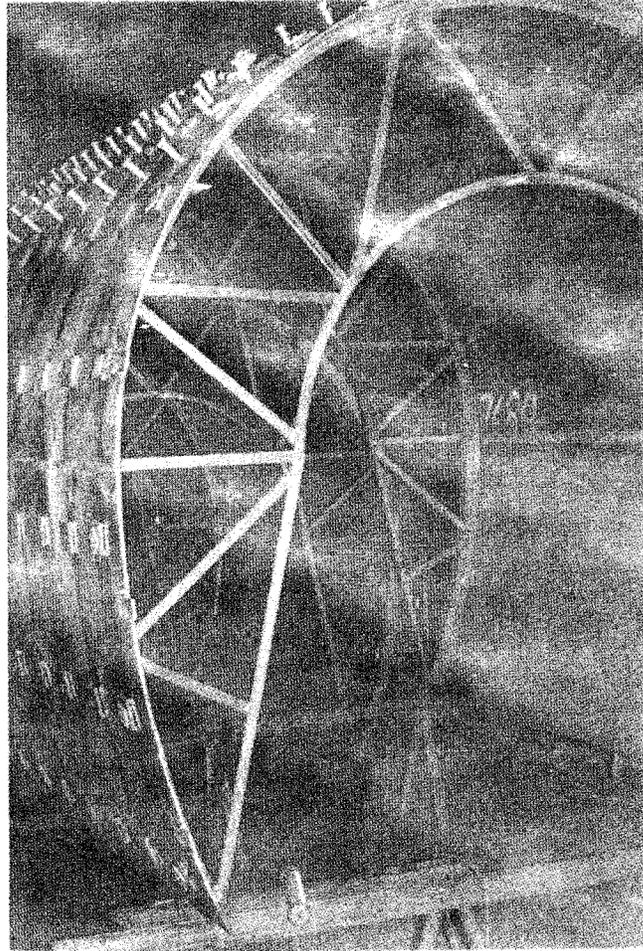
Figure 34. Steel plate liner, Eau Galle Dam

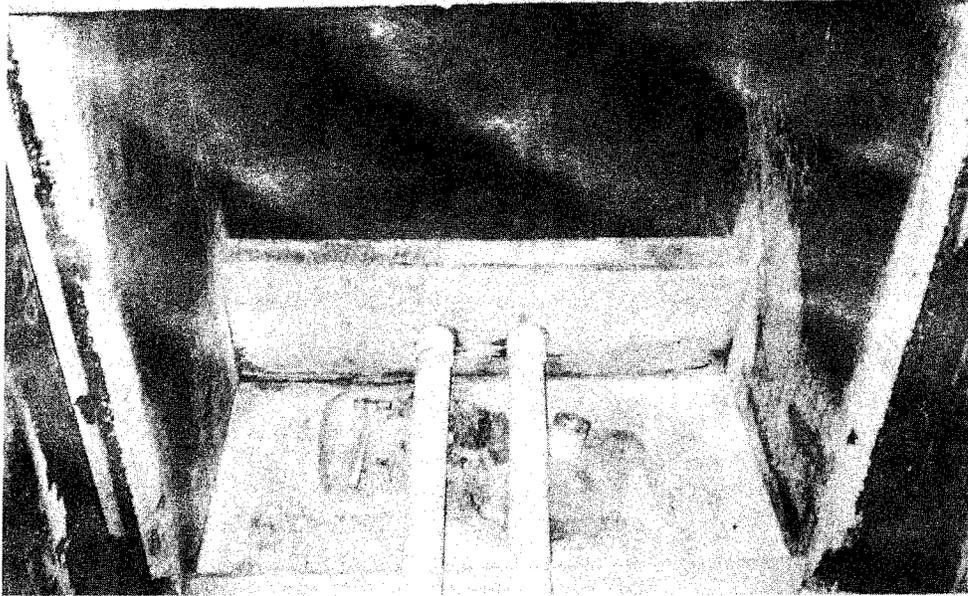
145. Cofferdams (Figure 36) were constructed by project personnel upstream and downstream of the work area with two 3-in. PVC pipes between them to keep the water leaking past the emergency gate from entering the work area. One airbag was installed at the upstream coffer dam to prevent water that was spraying from around the emergency gate from entering the repair area (Figure 37).

Figure 36. Cofferdam, Isabella Dam, December 1983

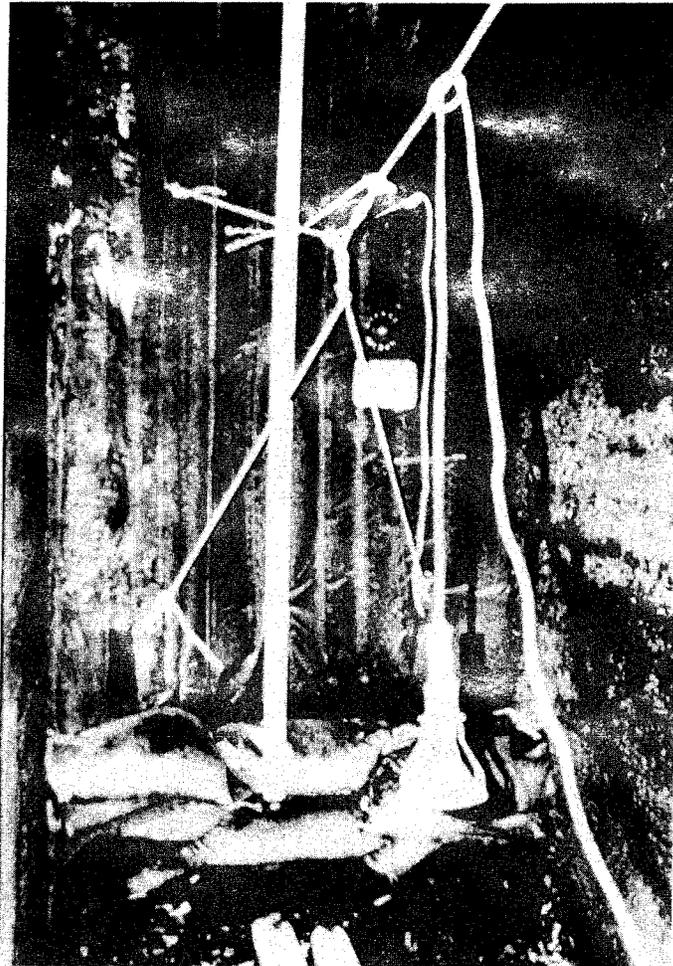
Figure 37. Airbag, Isabella Dam, December 1983

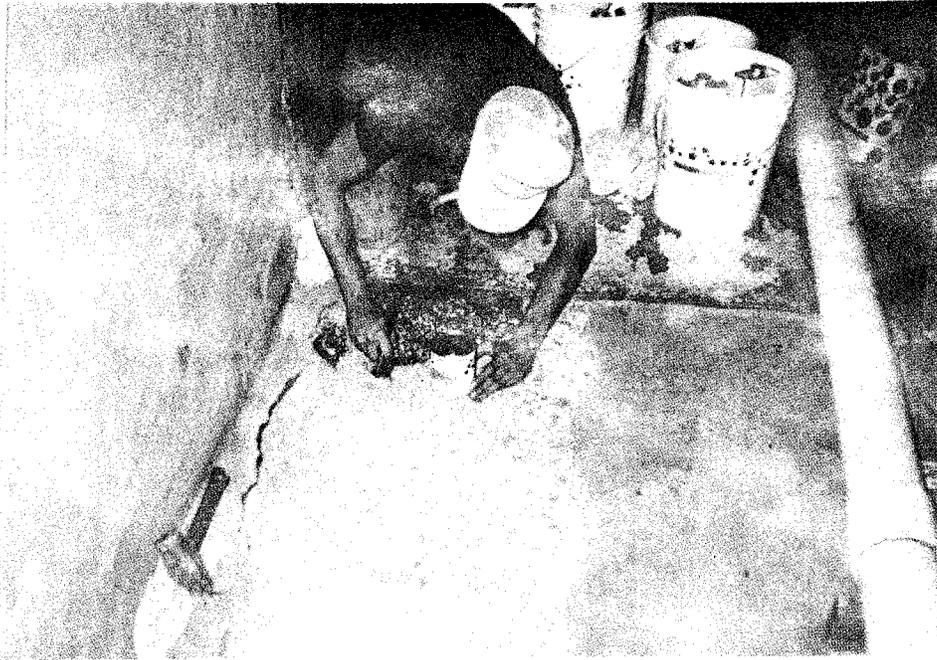
148. The large holes in the concrete at the invert and base of the wall were conditioned with Belzona Molecular Magma Conditioner (Figure 38). The

Figure 38. Applying surface conditioner, Isabella Dam, December 1983

application was done with brushes having half the length of their bristles cut away to increase brush stiffness. Belzona Molecular Magma Fill, a bulk filler material, was mixed and placed into the holes until they were within 1/8 to 1/4 in. of being level with the floor.

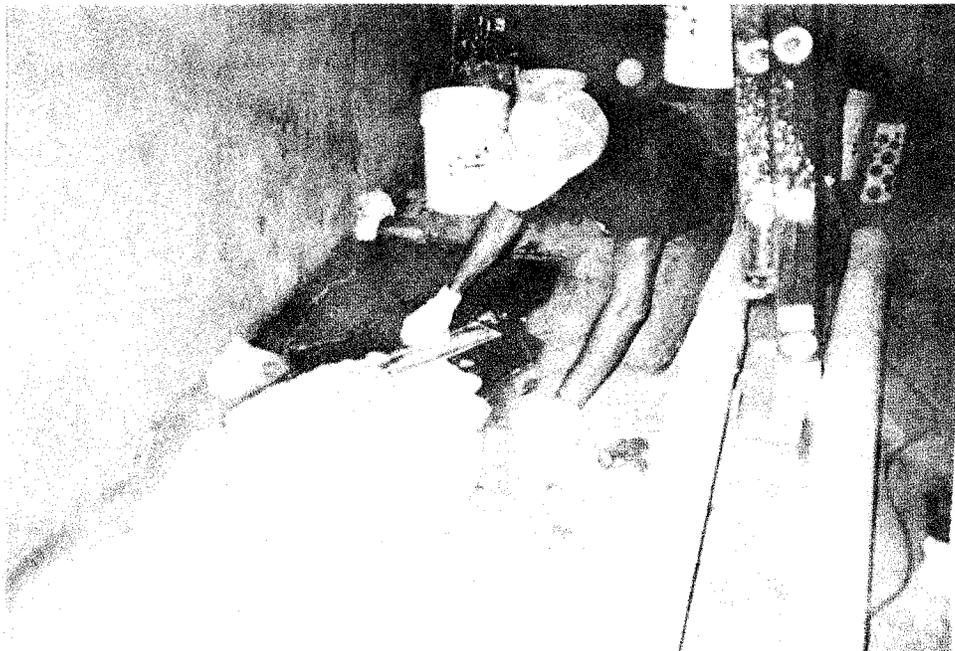
149. The vertical surfaces required shuttering. Wooden boards wrapped in polyethylene sheeting were used because the Magma Fill would not bond to the sheeting when it cured. The Magma Fill was allowed to cure for several hours until it hardened. The polyethylene covered boards were removed and uneven areas of the fill on the vertical surfaces were ground flush to the wall. Belzona Molecular Magma Conditioner was applied to the Magma Fill surfaces with stiff bristled brushes. Magma Quartz was applied over the coated surfaces (Figure 39) using conventional concrete trowels to a thickness of 1/8 to 1/4 in. When the application was completed, it was allowed to cure for a

Figure 39. Applying and finishing surface layer, Isabella Dam, December 1983

minimum of 8 hr before anyone walked over the finished surfaces. Warm air being blown into the gate chamber helped accelerate the cure.

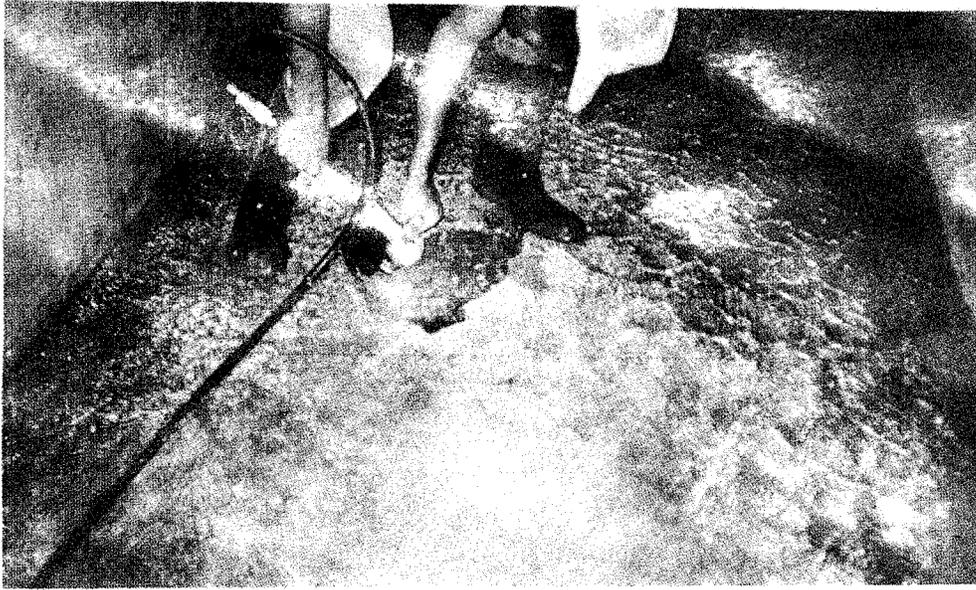
162. A small area of damage (12 by 12 in., 1/4 in. deep) in the concrete at the invert of chamber 2 was repaired underwater using Belzona Underwater Metal. The surface to be repaired was ground using an air grinder (Figure 41). The repair material was placed in the area and worked level with the invert surface (Figure 42).

Figure 41. Underwater grinding, Isabella Dam, September 1984

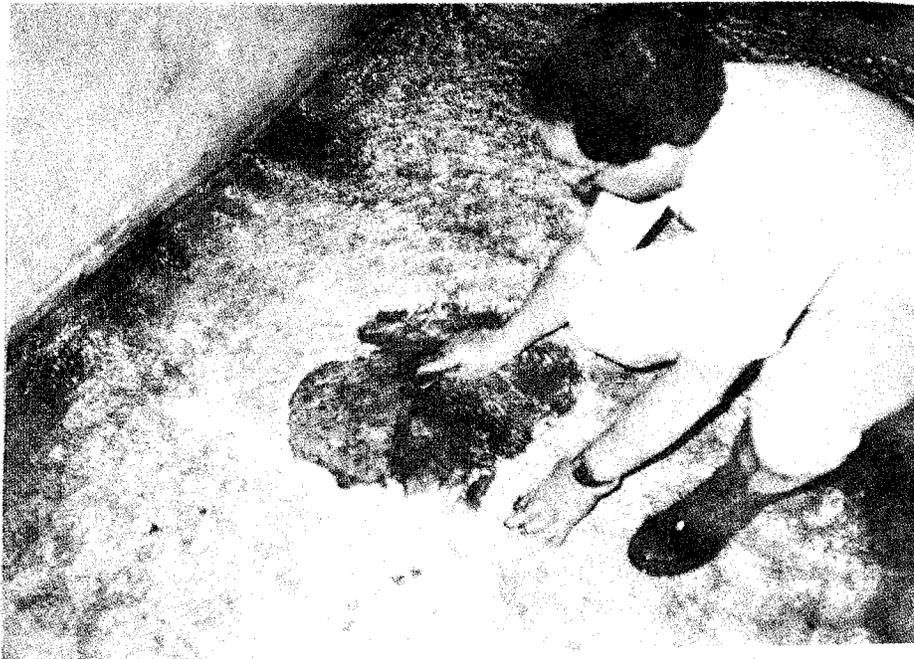
Figure 42. Underwater finishing, Isabella Dam, September 1984

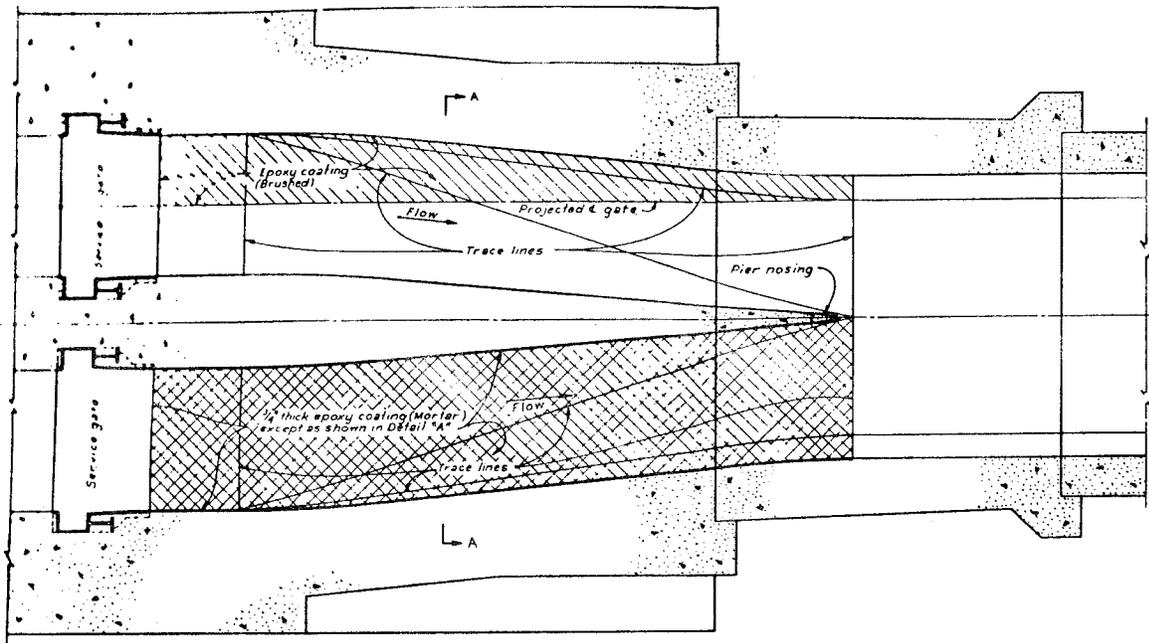
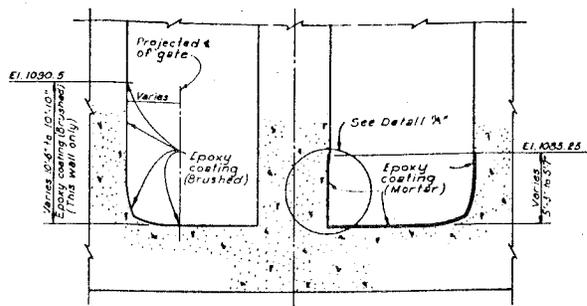
Figure 43. Locations of applied coatings, Milford Dam

174. In the left gate passage, the brush-on epoxy was applied to the wall and floor left of the passage centerline (Figure 43). The epoxy was not applied to the right half of the passage to provide a base from which the effectiveness of the coating could be evaluated.

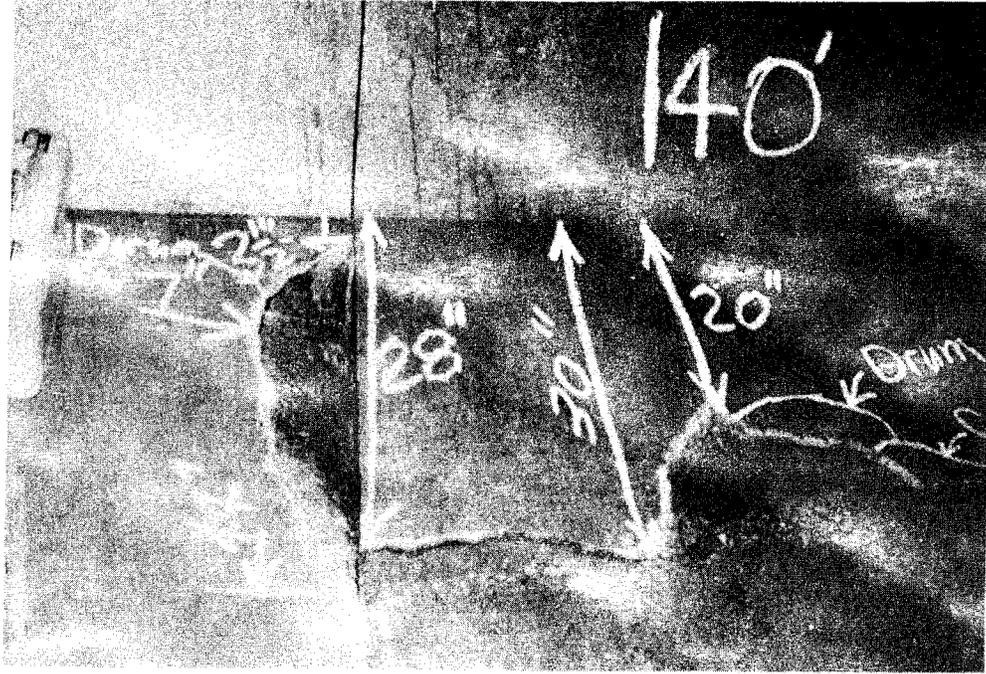
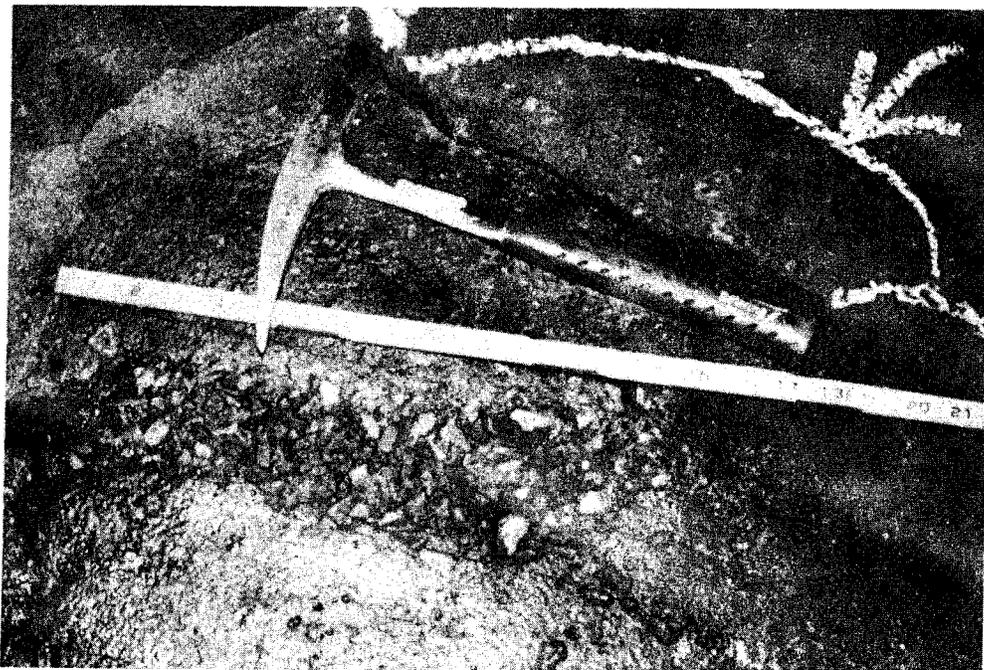
Figure 44. Mortar loss, Milford Dam

189. In 1974, approximately 80 percent of the 3/4-in.-thick epoxy mortar in the invert was missing with delamination evident in some of the areas where the mortar remained. The area of loss was primarily between the service gate steel liner and the construction joint between the tower and first conduit monolith (Figure 44). The epoxy mortar on the walls was intact and appeared sound (no drumming was detected when tapped with a hammer). It was suspected that the loss of epoxy mortar was the result of strains caused by differences in thermal expansion between the epoxy mortar and concrete and strains caused by cavitation forces produced by the high discharges that occurred in the spring of 1973.

a. Downstream end of passage

b. Closeup
