TECHNICAL REPORT REMR-CS-16

REPAIR OF DAM INTAKE STRUCTURES AND  
CONDUITS. CASE HISTORIES

Roy L. Campbell, Sr., Dennis L. Bean

January 1988

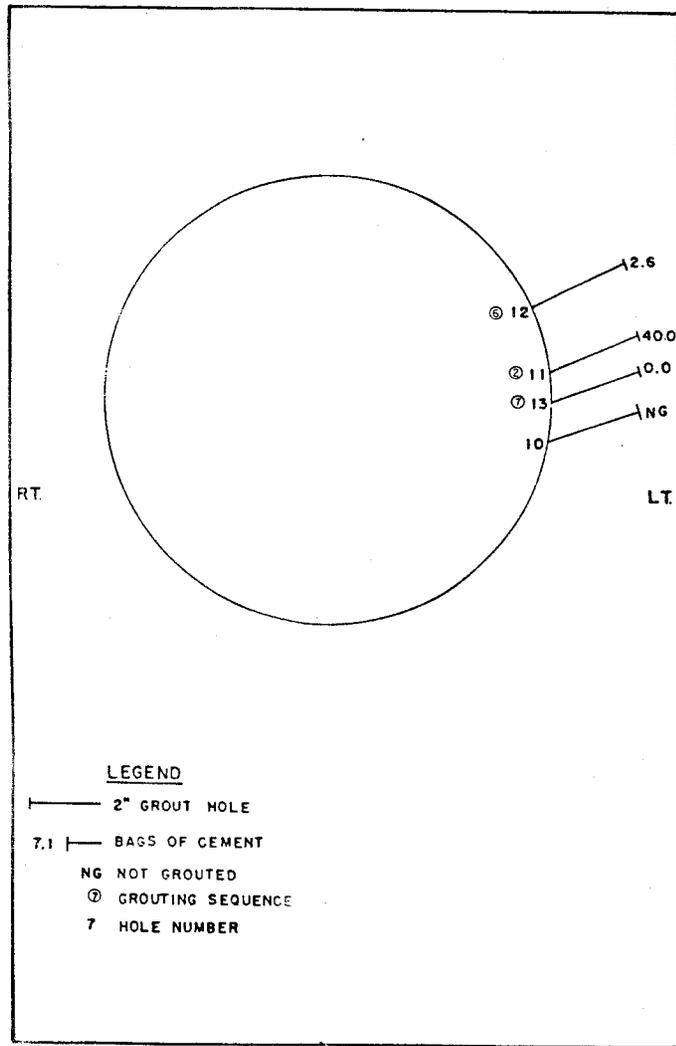
206. Four holes were drilled near the left spring line at monolith joint 2/3; three of the holes were grouted with 42.6 sacks of cement or 55.25 cu ft of grout. Nine holes were drilled around the joint 8/9, with the majority drilled on the upstream side; four of the holes were grouted with 90.7 sacks of cement or 119.85 cu ft of grout. Figures 48 and 49 show drill hole locations, grout takes, and grouting sequence for joints 2/3 and 8/9.

Figure 48. Details of grouting for joint 2/3, Pine Creek Dam, 1976

209. 1976. Remedial grouting (USAED, Tulsa 1976) using a portland-cement (Type II) grout was performed in July 1976 by district personnel to stop continuing leakage at monolith joints 2/3 and 8/9 and new leakage at joints 5/6, 12/13, and 13/14. Approximately eight holes were drilled around the periphery of each joint using air drills and 1-7/8-in.-diameter diamond bits. If contact was made with the leaking joint before the conduit wall was penetrated, drilling was stopped and the hole grouted. Usually several holes were drilled before grouting began. Prior to grouting, all holes were pressure tested using the maximum grouting pressure. Holes that would not take water were not grouted. The grout was injected through a packer set in the top of the hole. Mixtures with a water-cement ratio ranging from 4:1 and 0.75:1 by volume were used. The majority of the holes were grouted with a 1:1 mixture. Grouting pressures ranged from 15 to 30 psi. To prevent grout leakage, the joints were caulked with lead wool. All holes were backfilled or packed with cement. A total of 127.8 sacks of cement or 250.5 cu ft of grout were used in grouting the leaks. The total cost of the repair was estimated to be \$25,000.

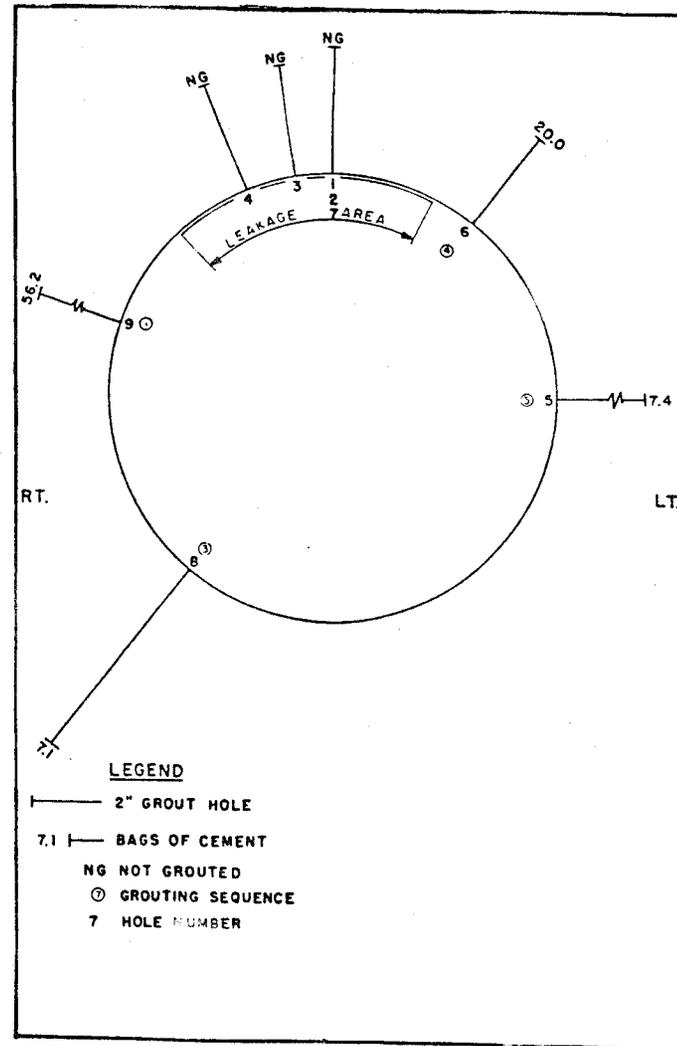
Figure 49. Details of grouting for joint 8/9, Pine Creek Dam, 1976

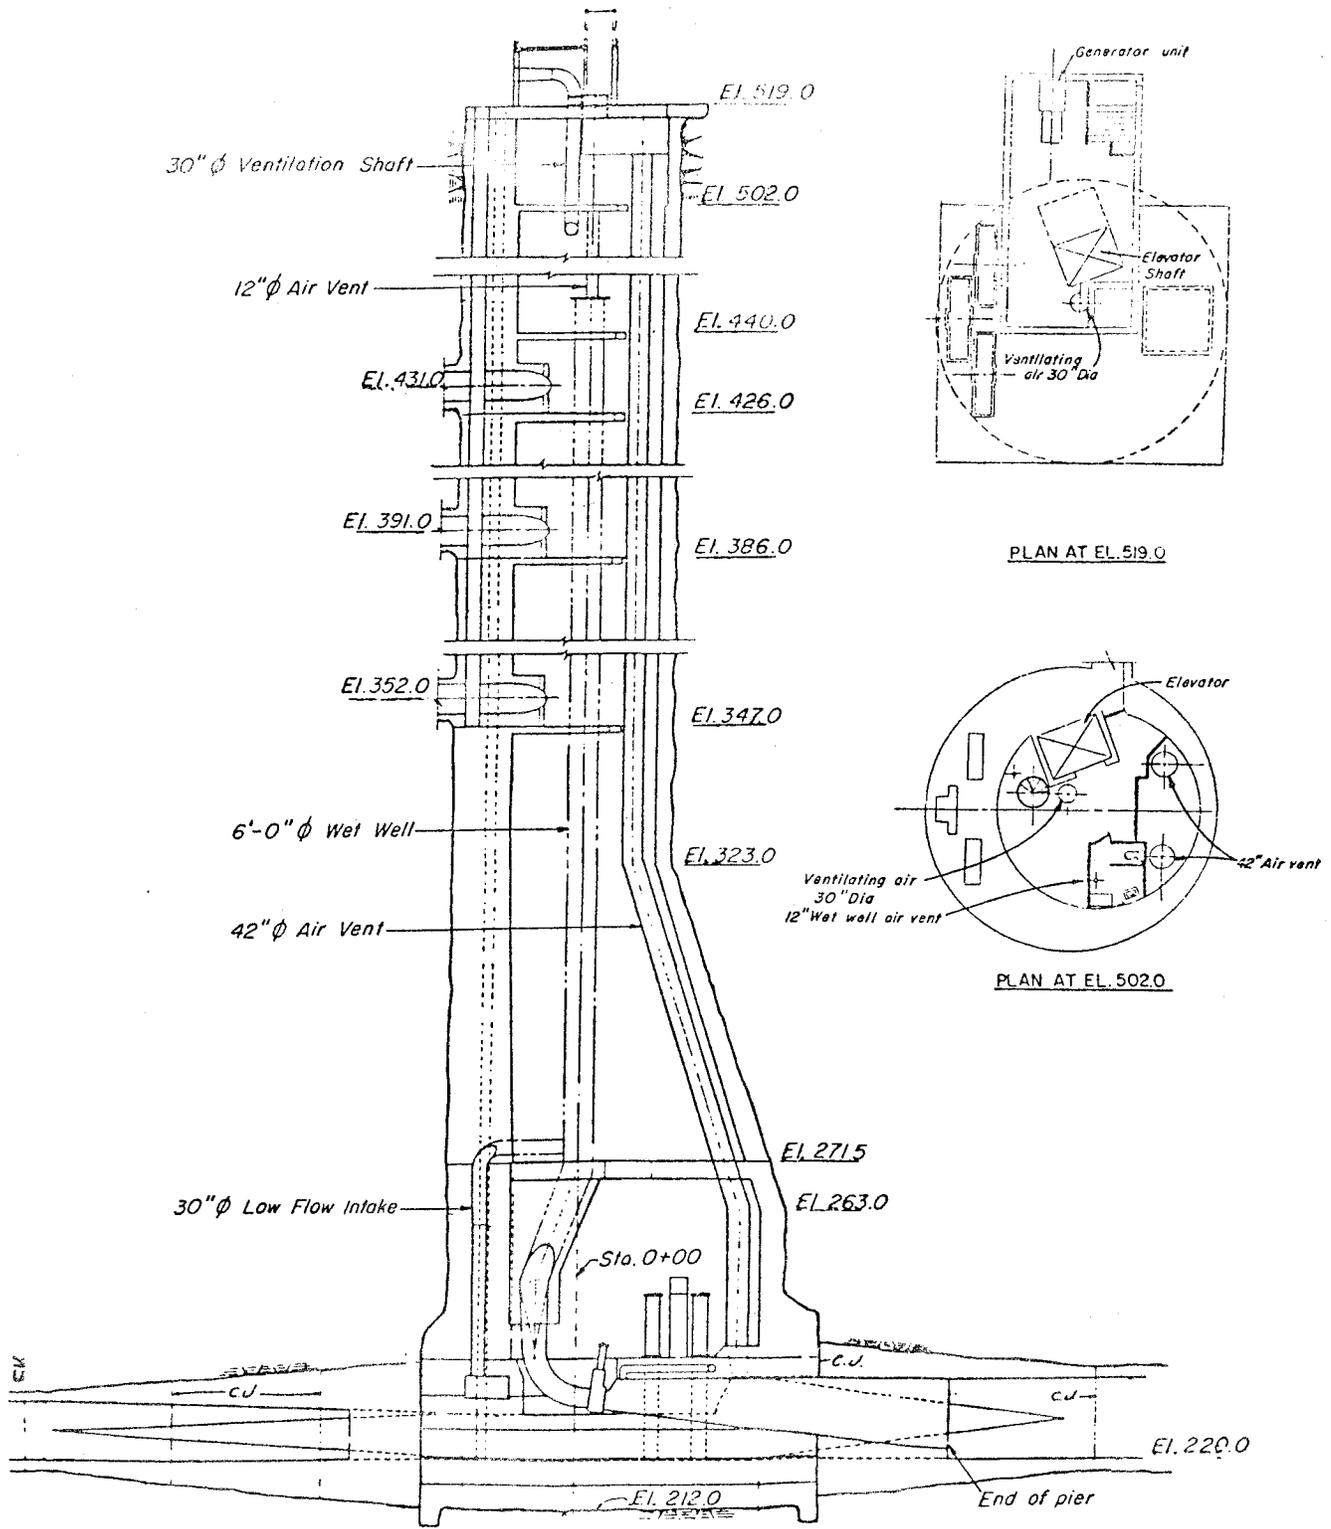
Figure 51. Centerline elevation view of intake control structure, Warm Springs Dam

213. Leakage from horizontal construction joints and vertical cracks in the wall of the intake control structure was noted during the first periodic inspection in November of 1982. Groundwater was the leakage source since the embankment of the dam had just been completed and no water had been impounded. The extent of the leakage at the joints was highly variable, ranging from very slight, isolated flows covering 0.5 ft to 3 ft of the joint to much heavier flows wetting virtually the entire joint circumference. Many of the vertical cracks were essentially continuous across horizontal construction joints and extended over 100 ft in length. At the lower levels substantial portions of the interior surface were continuously wet and at many locations covered with mineral deposits and efflorescence. The floors at these levels were ponding water.

214. The leakage posed no threat to the structures safety, but was threatening the structure's ability to perform as designed. The leakage was resulting in significant reductions in the reliability and performance of the electrical systems and increased corrosion of the operating machinery and appurtenances.
