US Army Corps  
of Engineers

TECHNICAL REPORT REMR-CS-4

## REPAIR OF WATERSTOP FAILURES: CASE HISTORIES

James E. McDonald

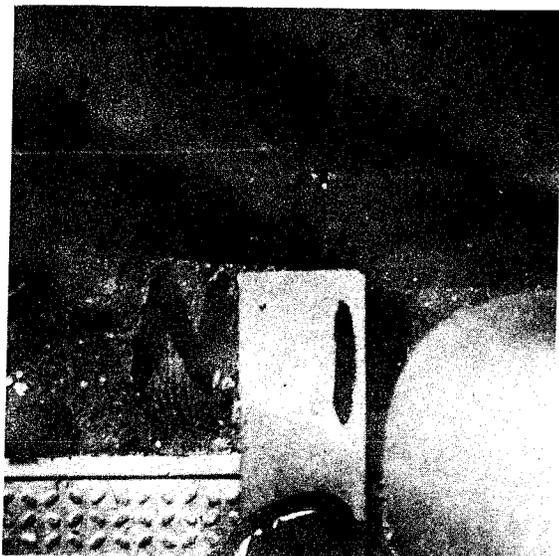
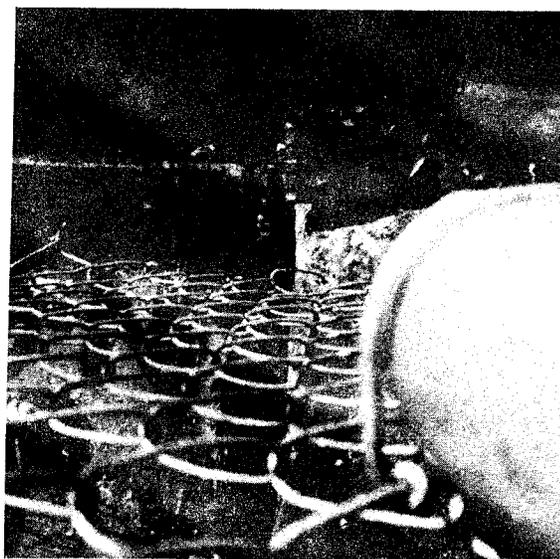
17. The joints between lock chamber monoliths and those between approach monoliths appeared to be in good condition with no unusual openings or offsets when inspected in 1973. However, joints between the gate bay monoliths and adjacent monoliths showed visual evidence of considerable movement (Figures 3 and 4). Also, there were indications that considerable water passed through the joints between the west gate bay monolith and adjacent chamber monoliths during the recent high water (Figure 5). Gate bay joint movements as measured in October 1973 are shown in Figures 6 and 7. No joint repairs were considered necessary at the time; however, repairs during the next scheduled dewatering in 1978 were anticipated.

Figure 3. Movement between east gate bay monolith and adjacent monoliths as viewed from top of lock wall, November 1973, Algiers Lock

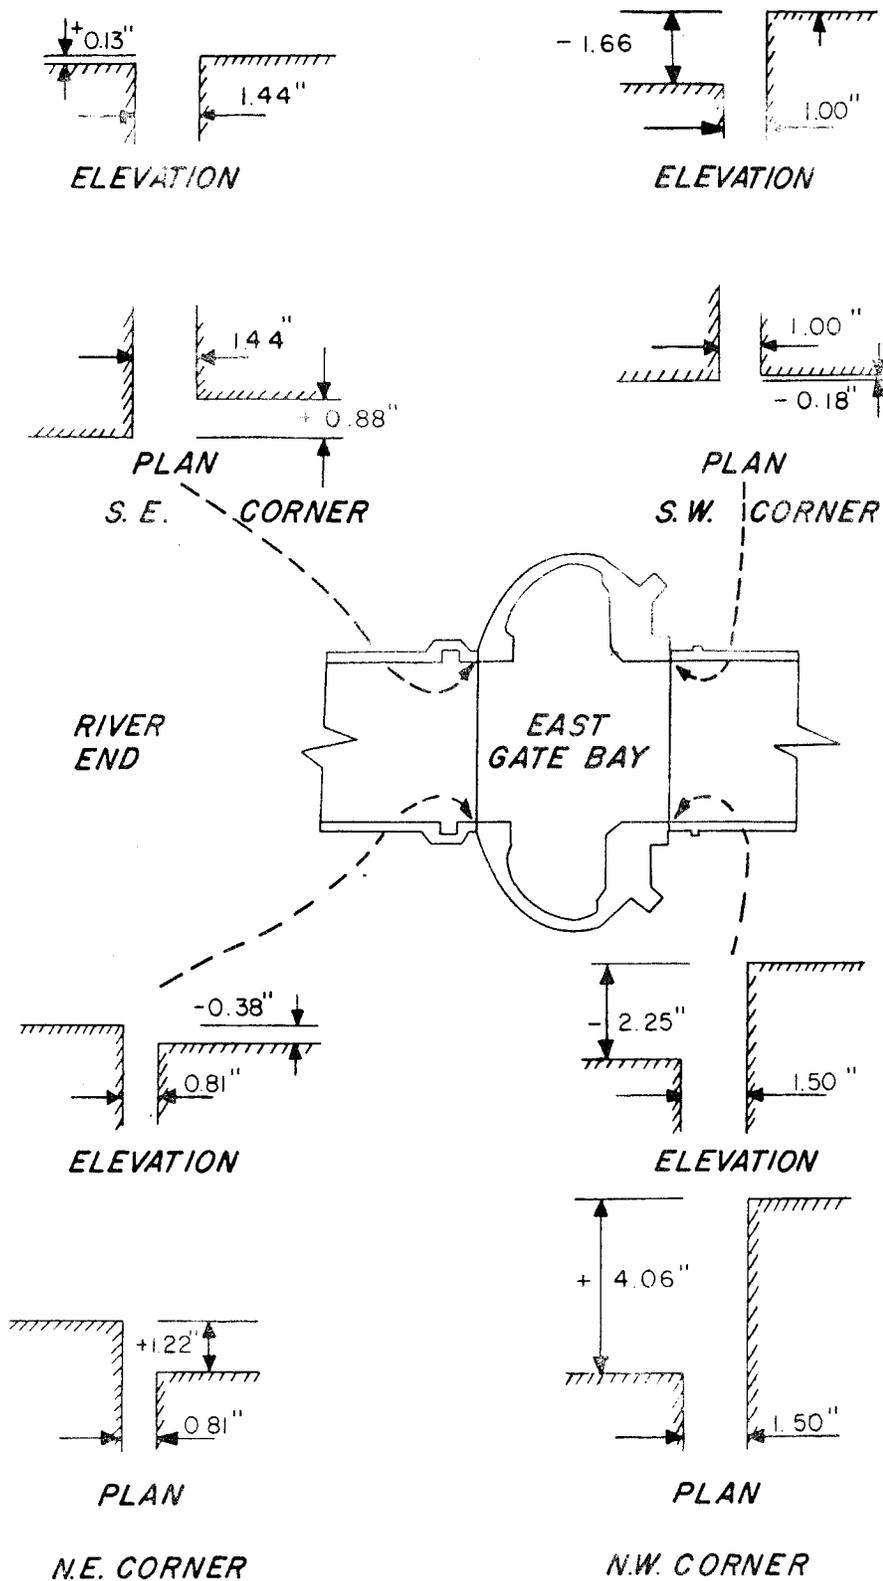
Figure 6. East gate bay joint movements, October 1973, Algiers Lock

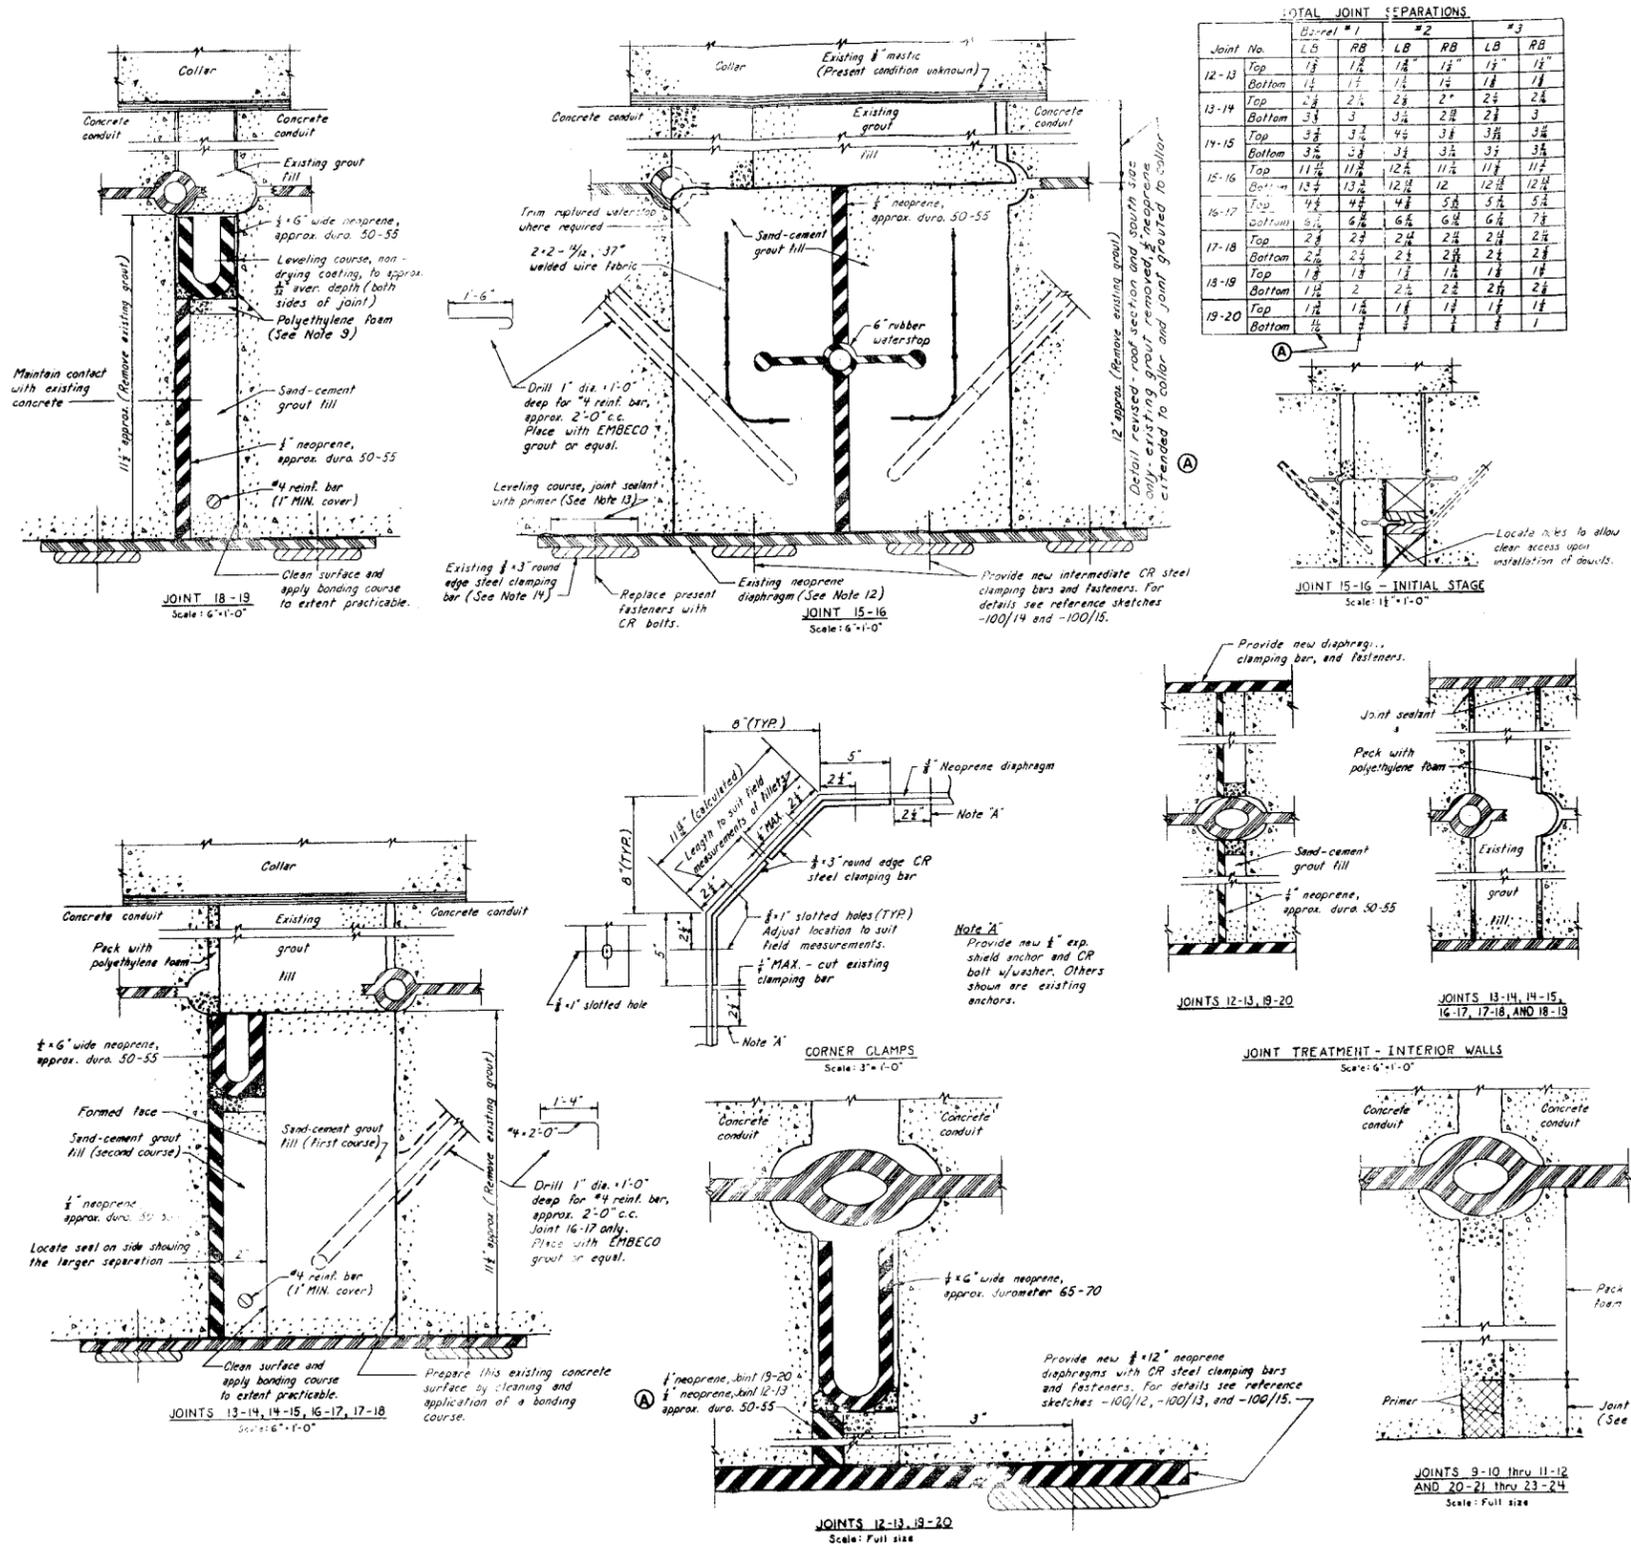
Figure 13. Repair details, Kirwan Dam

settled about 4.1 ft and elongated 1.89 ft. This resulted in the opening of a number of joints with a maximum joint opening of 12-3/4 in. Major repairs were required on eight joints and seven joints required minor remedial measures to repair ruptured waterstops and reseal the joints. This work was accomplished by the Operations and Maintenance (O&M) Branch.

27. Several repair techniques were used depending on the width of the joint opening. Details of the various repair techniques including material specifications are shown in Figure 13. A new 6-in. rubber waterstop was installed in the joint (15/16) with the maximum opening. Where joint openings were in the range of 1 to 7 in., a 1/2- by 6-in. neoprene seal element shaped in a "U" configuration was placed in the joint as a replacement waterstop. Following placement of polyethylene packing at the convex fold of the seal element, the joint was filled with a sanded cement grout. A 3/8- by 12-in. neoprene diaphragm was then anchored across the joints. Those joints with smaller openings were typically repaired with caulking sealant.

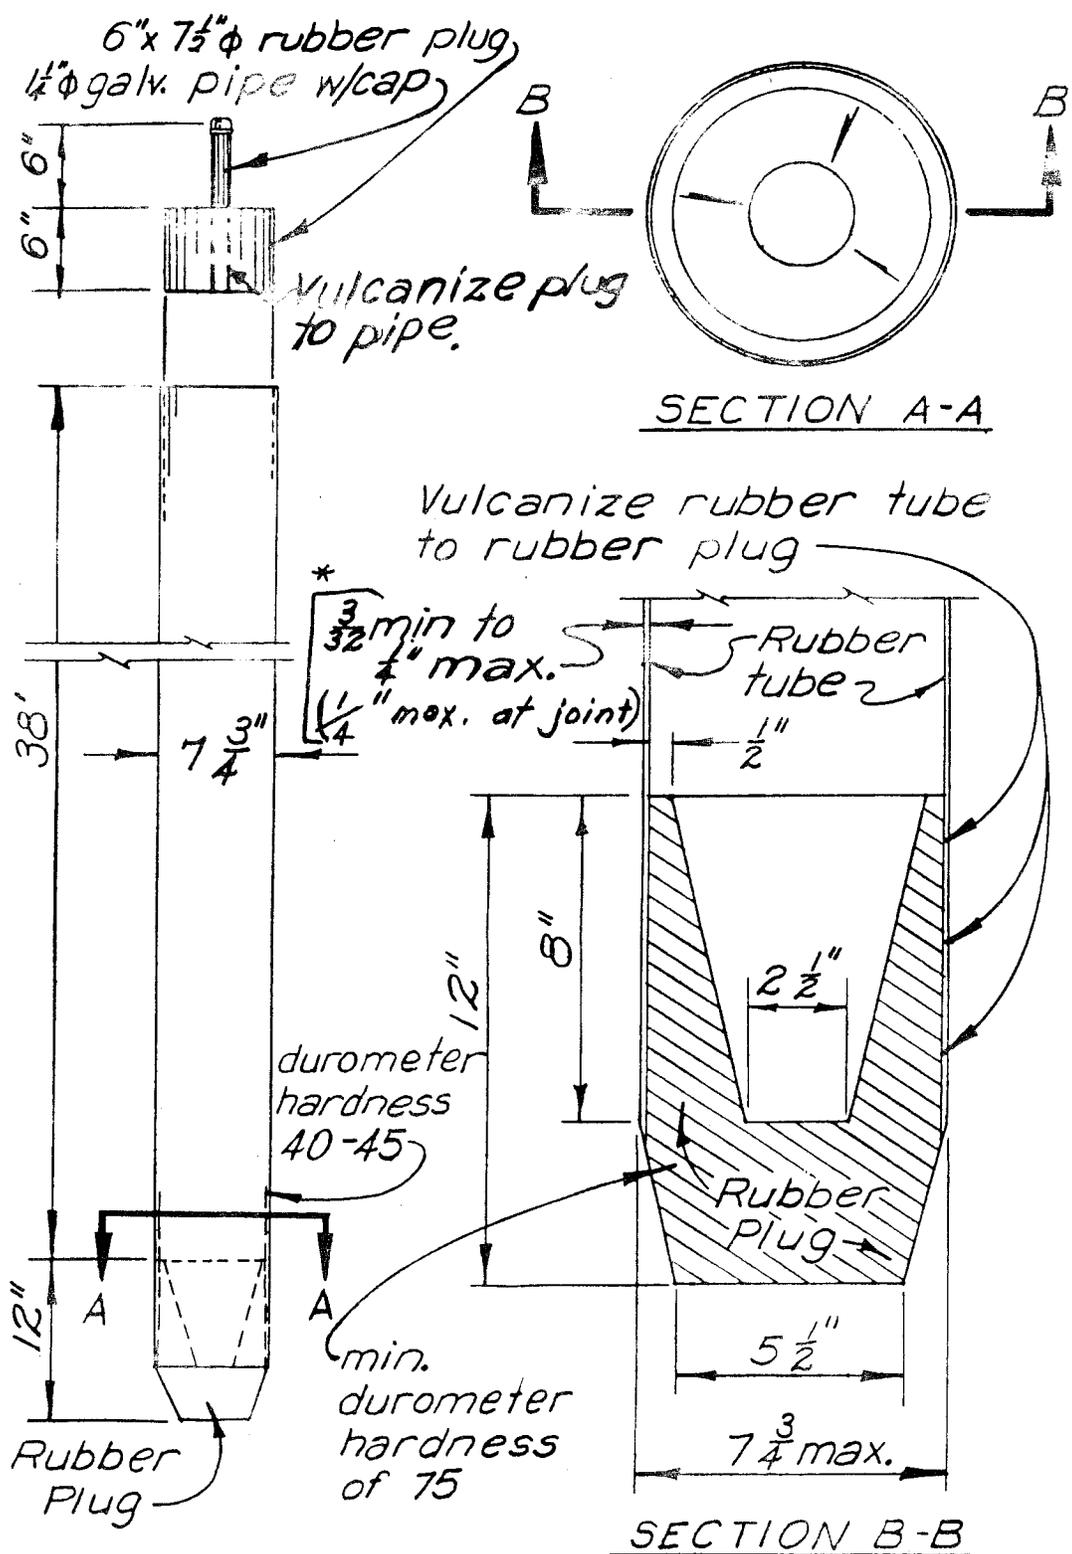
Figure 25. Waterstop detail, Lock and Dam No. 3, Arkansas River

76. During the fall and winter of 1970 the cooler weather caused the concrete training walls to contract. The foam rubber tubes previously installed as waterstops in the training wall joints had lost their resiliency by crushing and did not expand to fill the holes. Leakage was observed at the joint between the dam and the first upstream training wall monolith. Piezometers with tips near the joints began to indicate higher water levels. This trend continued throughout the winter.

74. A visit was made to several rubber specialty companies in the Houston, Texas, area in search of one that could manufacture tubes 40 ft in length and of sufficient diameter to fill the existing core holes. It was found that rubber tubing of the specific size and length required was not available as a standard item, but such tubing could be manufactured by at least two companies in Houston. Murray Rubber Company could manufacture the tubes by joining two 20-ft sections of ethylene-propylene-diene-monomer (EPDM) synthetic rubber formed and cured on a steel mandrel. The tubes would be 7-3/4-in. outside diameter with 1/8-in. wall thickness. The wall thickness at the joint would be greater than 1/8 in. and less than 3/16 in. The joint would be as strong as the other section of the tubing. The rubber for manufacture of the tubes would have a Young's modulus of approximately 500 psi and a durometer hardness of 40-45. The EPDM polymer was recommended because of its resistance to deterioration due to weather, water, and temperature. Details of the tube are shown in Figure 25.

75. A search was also conducted for a fluid to be placed in the tube that was heavy enough to press the rubber tube against the circumference of the hole with sufficient pressure to prevent seepage. This fluid also had to remain in a liquid state permanently. A fluid which met these requirements and would not affect the rubber tubing was obtained from Baroid Division, National Lead Company. The fluid is commonly used as ship ballast, remains permanently liquid, and could be obtained with the desired specific gravity.

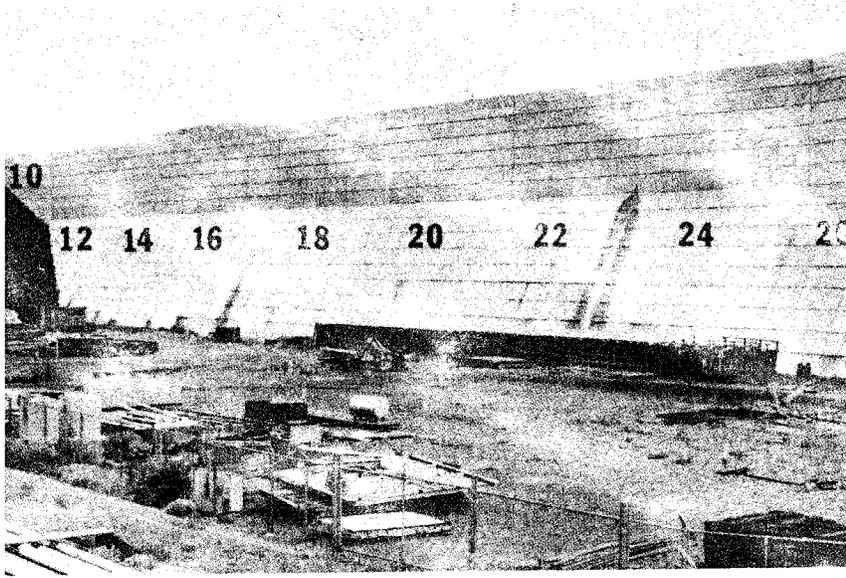
a. Overall view

84. In October 1972, leakage was noted at monolith joints 10/12, 12/14, 16/18, 22/24, 24/26, and 28/30 for the landside lock wall and at 21/23, 23/25, 25/27, and 27/29 for the riverside wall. All except monolith joints 10/12, 12/14, and 22/24 had been repaired in May 1971. Leakage from the landside lock wall with the lock full of water is shown in Figure 28. Leakage apparently entered the landward backfill and some subsidence was reported.

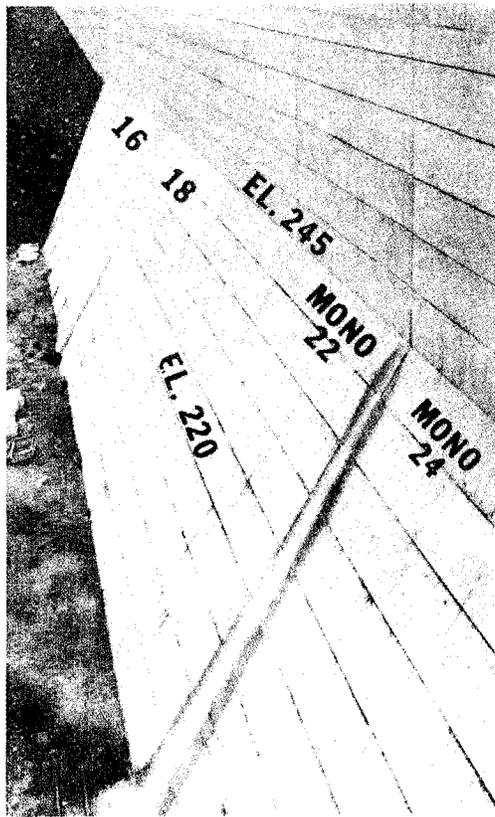
b. Closeup of monolith joint 22/24

Figure 28. Landside lockwall leakage, John Day Lock, October 1972

Leakage from monoliths 16/18 and 22/24 appeared on the surface of the back side of the wall at elevations 220 and 245 ft, respectively. Measured deflections in excess of 1/2 in. were reported for individual lock monoliths (Figure 29).

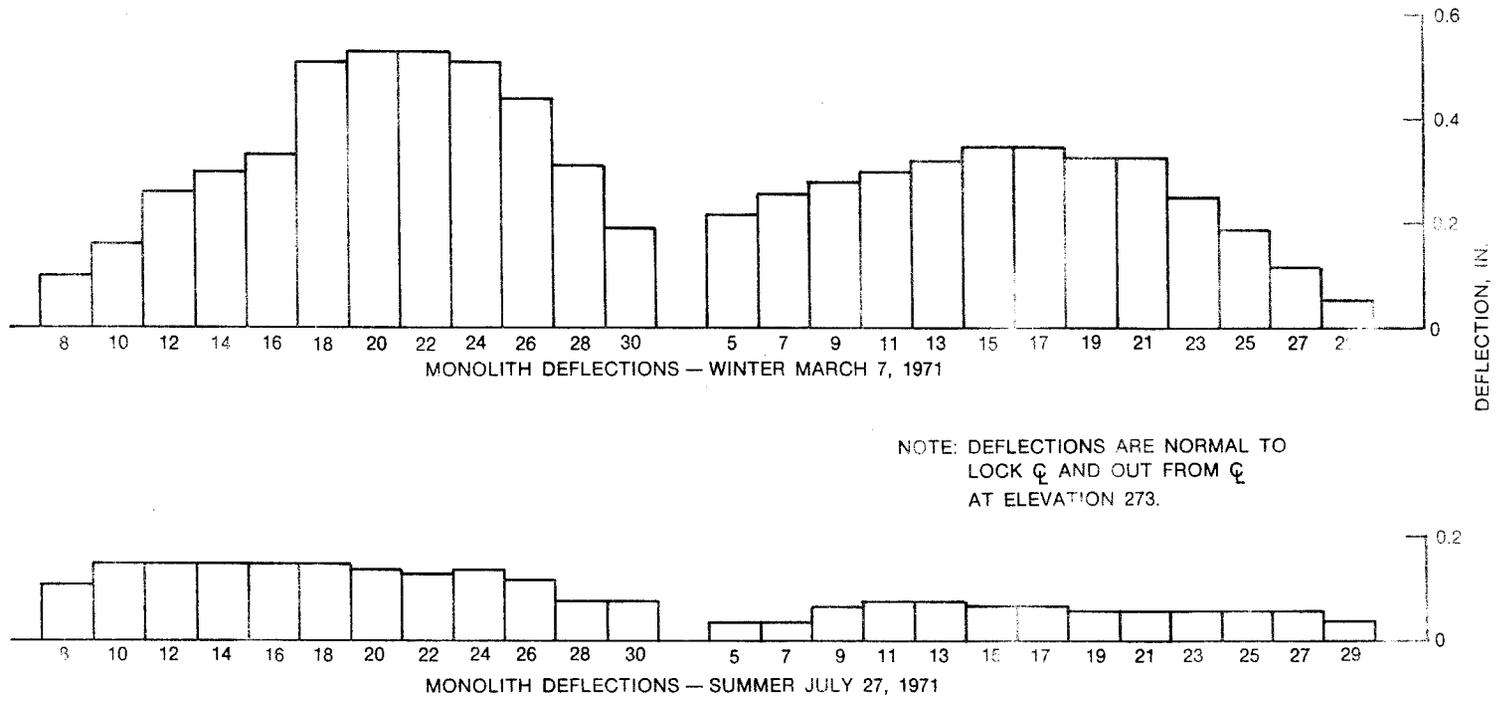
Figure 29. Monolith deflections due to lockage water loading, John Day Lock

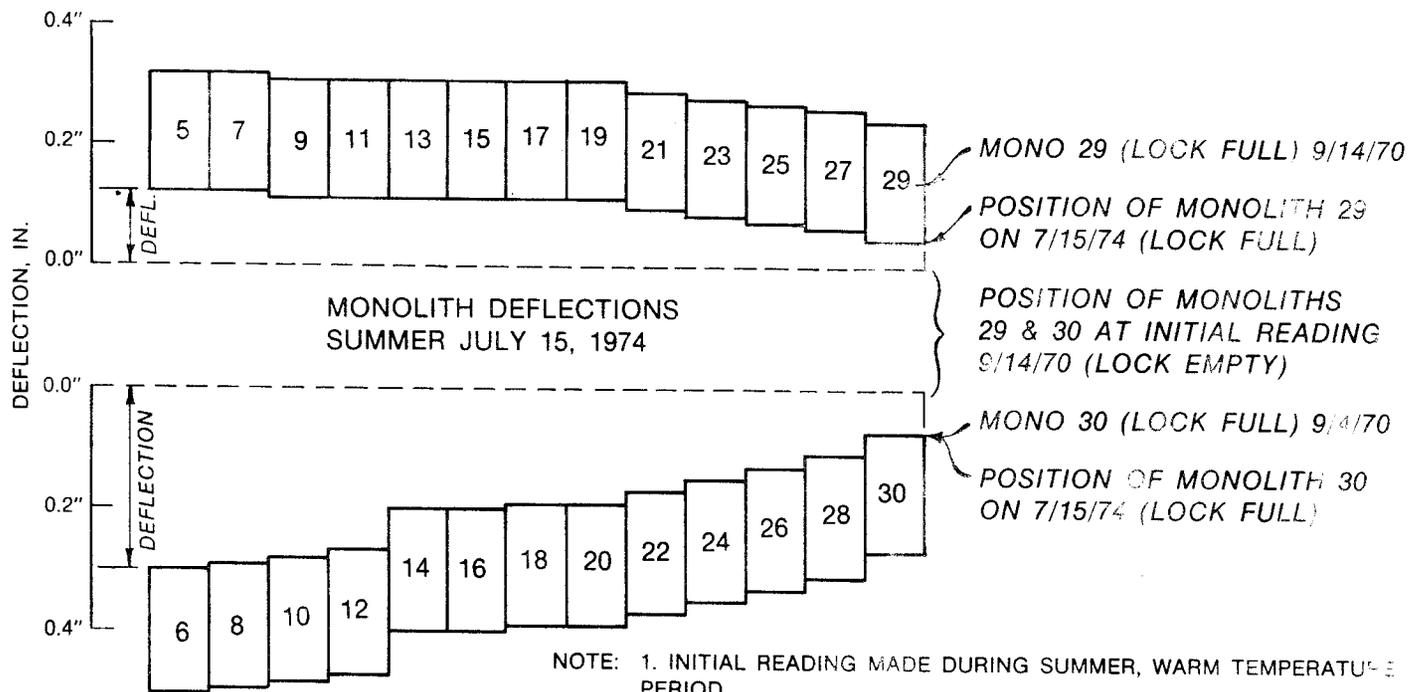
Figure 30. Lock monolith deflections, summer conditions, John Day Lock

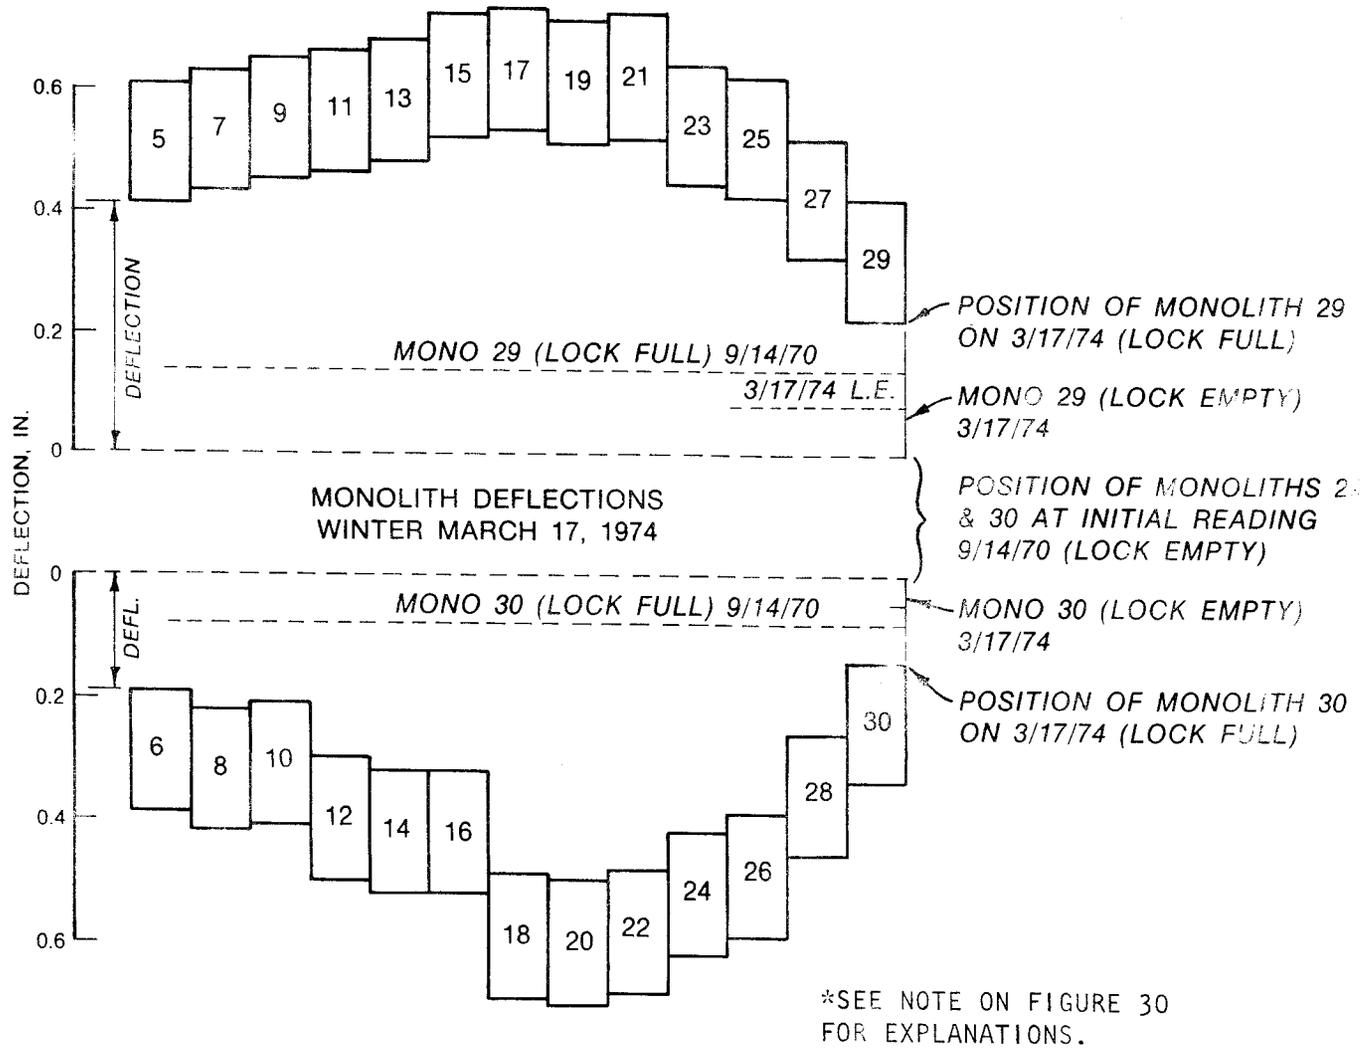
Figure 31. Lock monolith deflections, winter conditions, John Day Lock

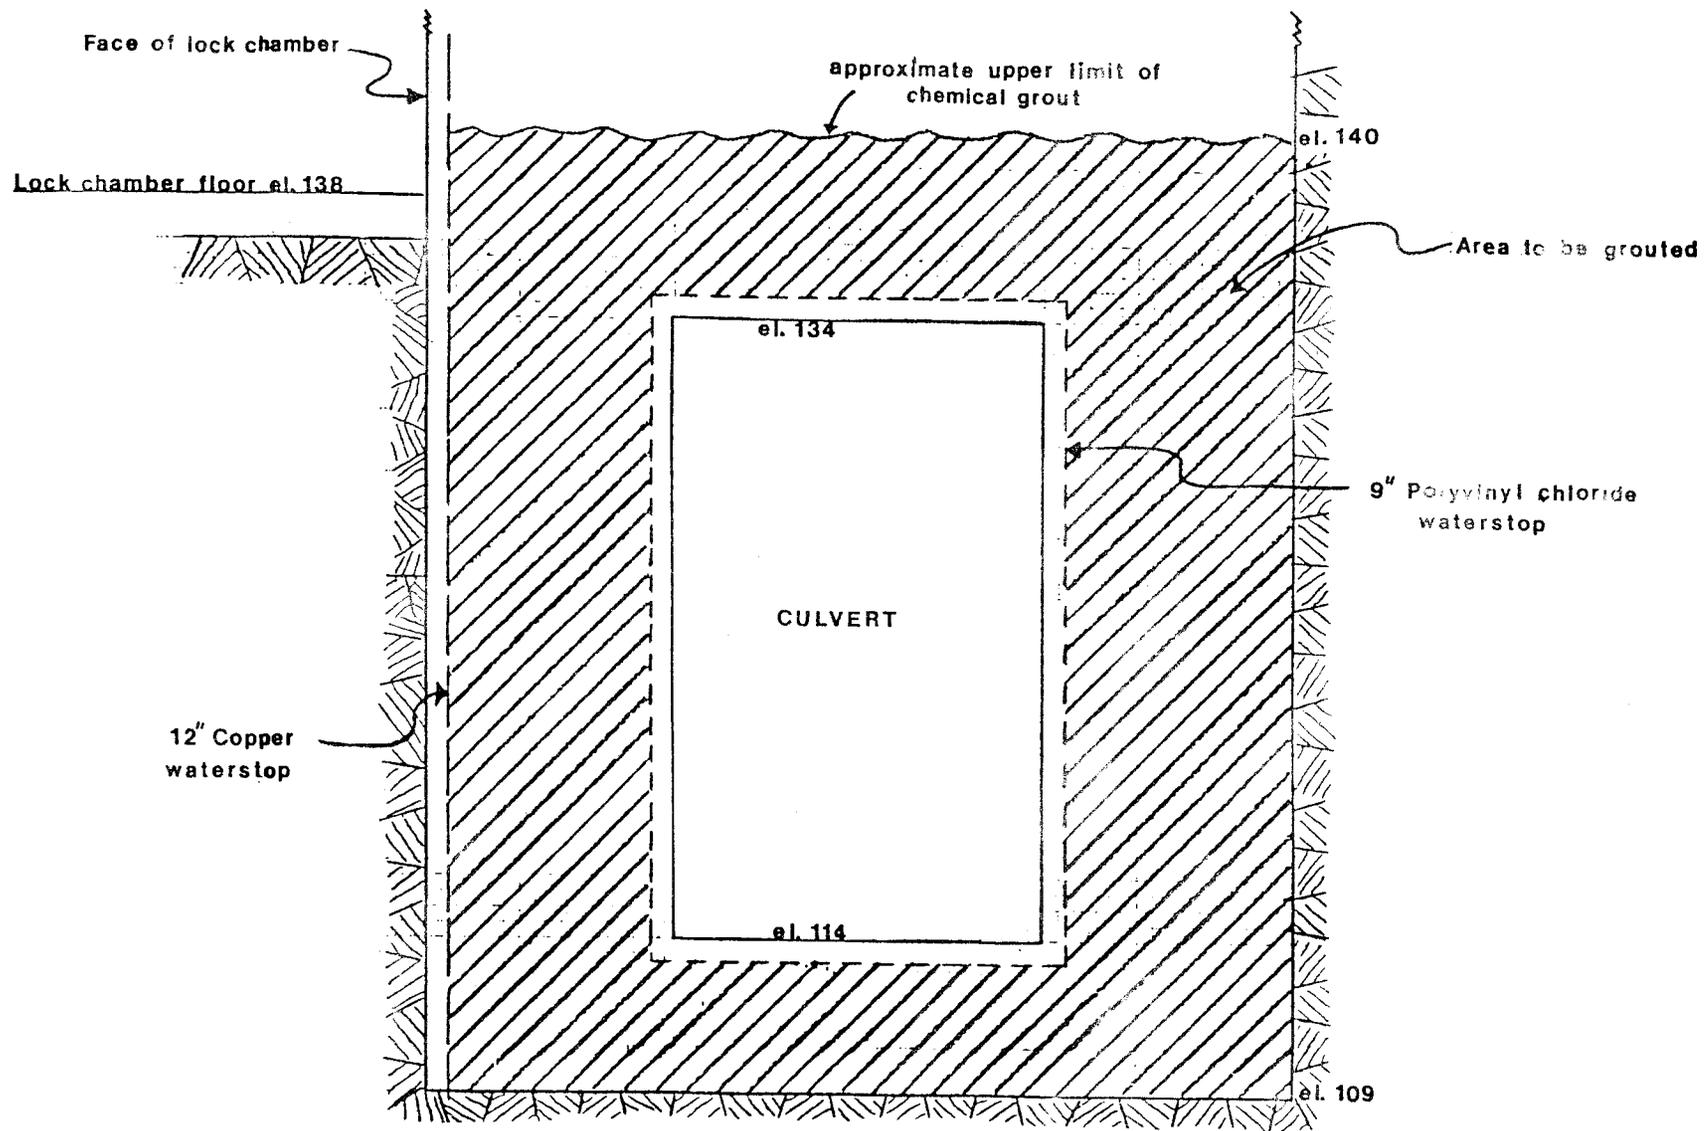
92. Monolith joints 28/30, 18/20, 16/18, 14/16, 12/14, and 10/12 in the north (landside) emptying and filling culvert (Figure 32) were repaired in 1982 using chemical grout. Also, a crack in the ceiling of monolith 10 between joint 10/12 and the bulkhead slot was chemically grouted.

Figure 32. Detail of culvert area to be grouted, John Day Lock

93. EX-size drill holes were evenly spaced around the culvert approximately 1 ft from the joint. Holes were drilled from inside the culvert at an angle of 65 degrees to intersect the joint behind the existing waterstop. All drilling was done by the Government.

94. 3M Company's hydrophilic polyurethane gel (CR-250) was specified for the repair. The polymer grout was mixed at a ratio of 1 gal polymer to 7.75 gal of water. An accelerator (CR-251) and a shrinkage control agent (CR-252) were added to the fluid grout. Also, diatomaceous earth (Celite 209) was added in the amount of 6 percent by weight of the fluid grout. Uncoiled oakum saturated in hydrophilic polyurethane foam (CR-202) was used on joints 10/12 and 28/30 to control the flow prior to injections of the CR-250 grout.

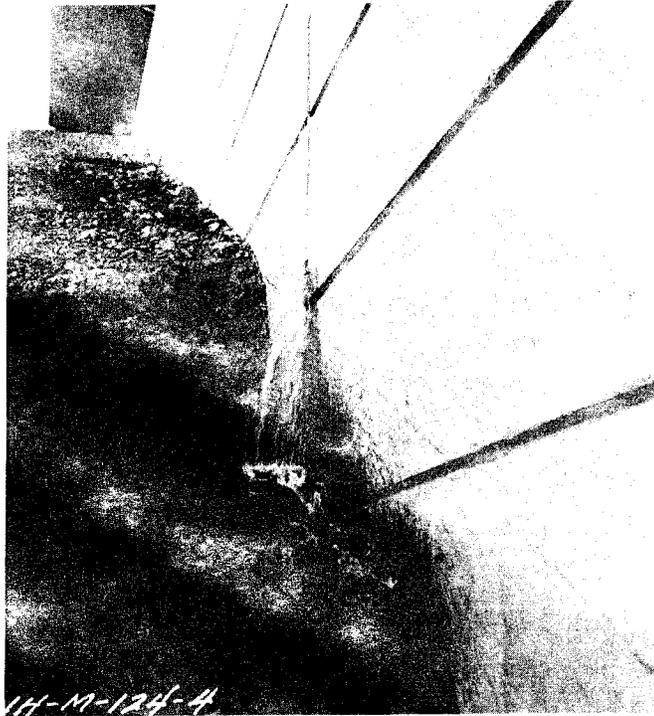
101. Leakage through monolith joint 32/34 was reported during a September 1969 inspection (Figure 37). This joint had been repaired in the spring of 1969 by drilling a 6-in.-diameter vertical hole along the joint and filling it with sand-bentonite mixture. The failure of this repair was attributed in part to the inability to properly place the mixture. Another repair attempt in the spring of 1970 tried placing the sand-bentonite mixture into elongated bags inserted into the drill hole.

Figure 37. Monolith joint 32/34 leakage,  
Ice Harbor Lock, 1969

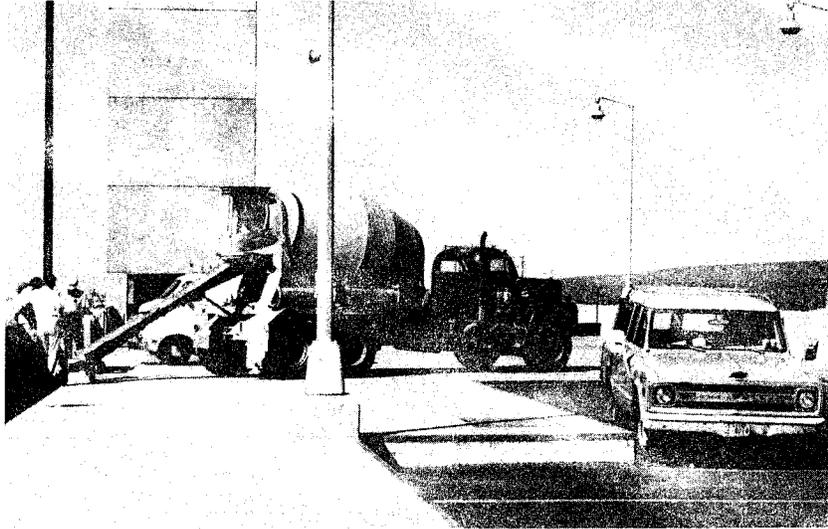
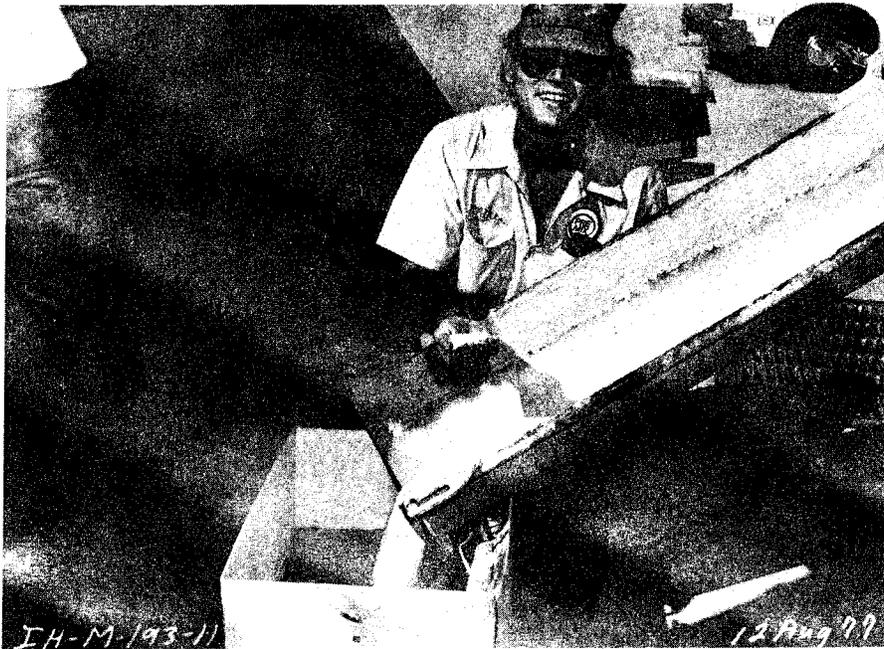
Figure 39. Discharging hydrophobic sand into drill hole, Ice Harbor Lock

111. The drill hole was filled on 12 August 1977 by discharging the hydrophobic sand directly from the transit mixer into the hole (Figure 39). Approximately 35 cu ft of hydrophobic sand was used. Excess sand was stored at the lock. By 17 August, the sand had settled about 5 ft and the hole was refilled. The sand appeared to settle about 1/4 in. with each lockage (Figure 40). On 24 August, the sand was about 5 in. below the surface and the hole refilled. On 2 September, the sand was down about 9 in. and the hole was again refilled. During October 1977, a 6-in.-diameter hole 118 ft deep was drilled 7 ft from the lock face to be used as an observation well to check the effectiveness of the material as a waterstop. On 29 November, the sand was down about 15 ft in the test hole. When the lock was filled, the water in the observation well rose almost as fast as the water in the lock. When the lock was full, the water was within 15 ft of the deck. The water was also running over the top of the sand in the test hole. The water was running fast enough to be clearly heard and seen flowing through the joint looking down both holes from the deck. Since that time, sand has continued to be washed out of the test hole through the joint into the observation hole.

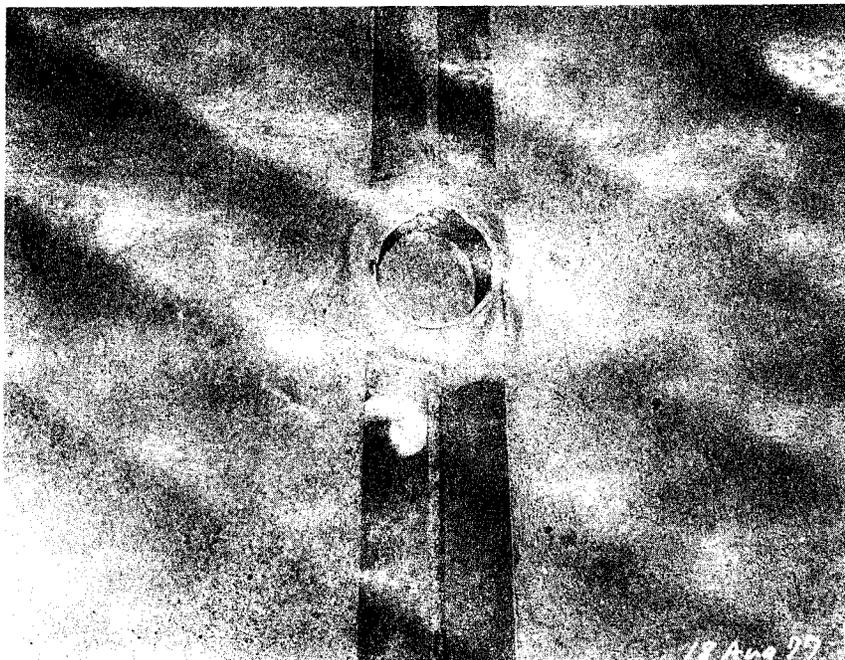
Figure 40. Settlement of hydrophobic sand in drill hole after three lockages, Ice Harbor Lock

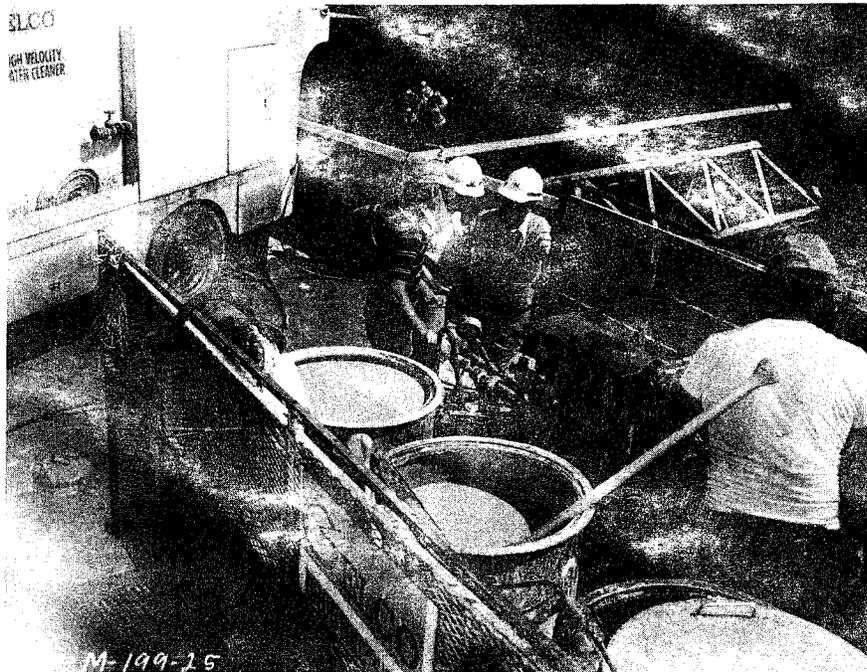
Figure 41. Mixing and pumping equipment for acrylamide grouting, Ice Harbor Lock

114. The drill hole was grouted on 17 August 1977. The packer was inserted into the hole to about 150 ft below the surface. Two separate solutions of grout materials were mixed (Figure 41) and then pumped separately through two hoses (Figure 42) which were connected to a mixing nozzle suspended below the packer. The grout was pumped in 10-ft stages. This necessitated stopping grout injection while the packer was being moved and then resuming pumping. The top 30 ft of the grout was diluted by water in the hole. This material was removed from the hole using a high-velocity water cleaner and the section of the hole was regrouted. Grouting was accomplished while the lock water was at tailwater level. A view of the completed repair is shown in Figure 43.

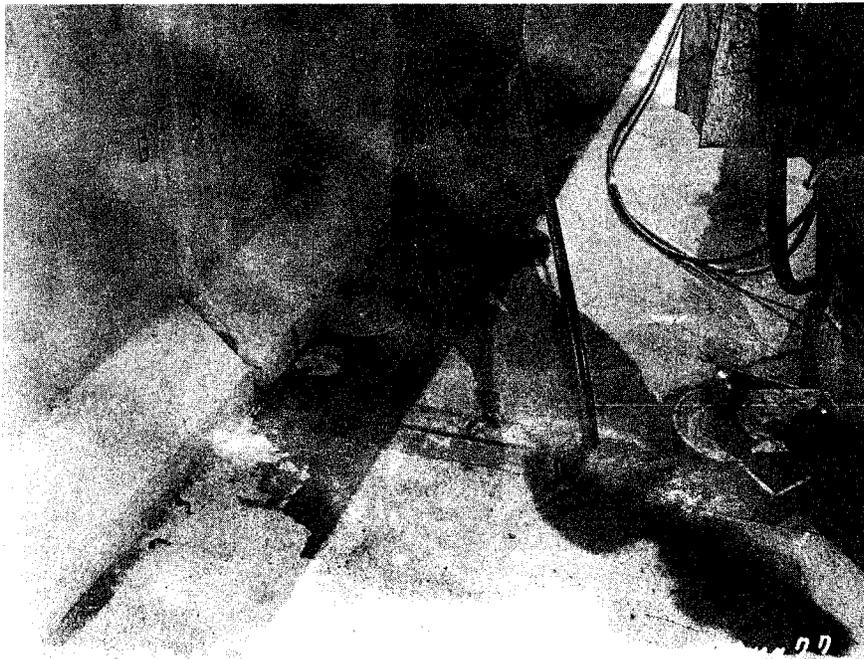
Figure 42. Double injection lines used to pump both acrylamide grout solutions to the bottom of drill hole, Ice Harbor Lock

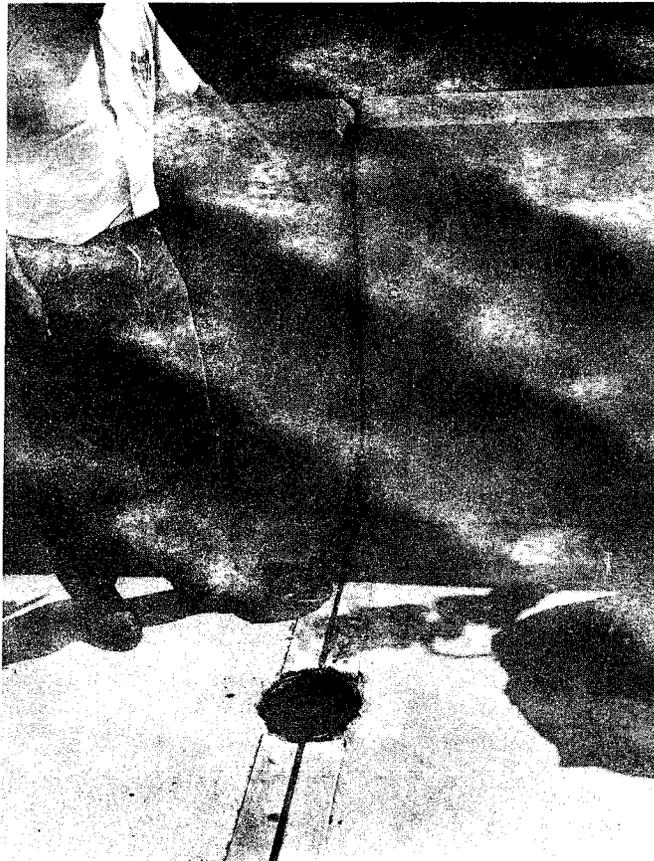
Figure 43. Drill hole filled with acrylamide grout, Ice Harbor Lock

115. The grout still looked good when inspected on 2 September. An observation hole was drilled 4 ft landward of test hole in October 1977. On 29 November 1977, the water level was measured at 95 ft below deck with the lock filled. The water level was below the end of a 100-ft tape before the lock was filled; depth to tailwater was about 108 ft. The AM-9 was still in the test hole to within an inch of the top.

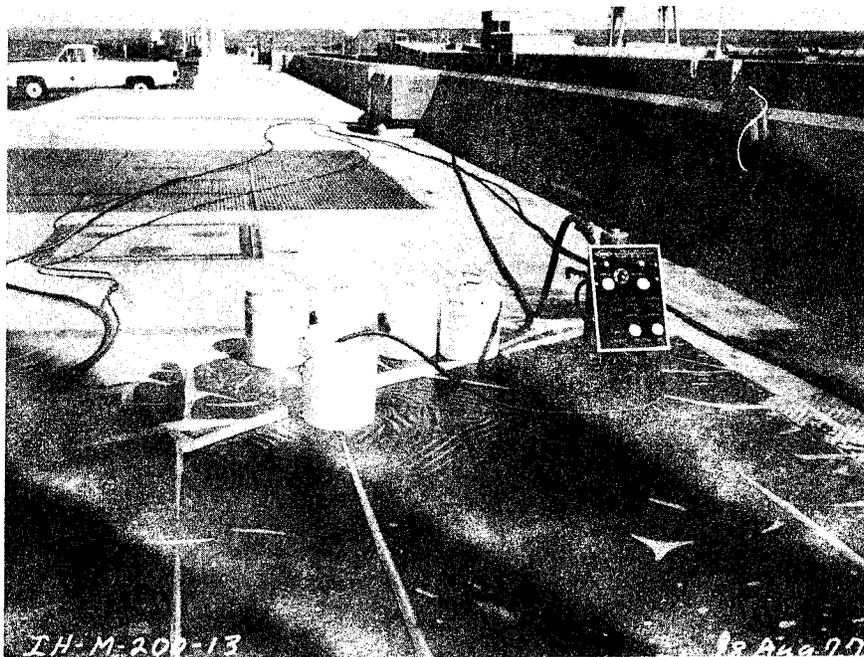
Figure 44. Polyurethane grout installation with proportioning pump, Ice Harbor Lock

118. The drill hole was grouted on 18 August 1977 (Figure 44). A 6-in. packer built for this test would not fit into the 6-in. drill hole, so a shorter aluminum sewer grouting nozzle was used. The grouting was started at the bottom of the 120-ft hole and was being raised in stages when a boat lockage through the navigation lock raised the water surface in the hole very quickly. This caused the grout to flow around the packer through the joint and set above the packer. The packer was stuck in the hole about 60 ft from the surface with about 15 ft of the material above the packer. The retrieval equipment would not raise the packer, so the 3/8-in. steel cable and the rubber hoses attached to the packer from the hole and the 3/8-in. cable broke.

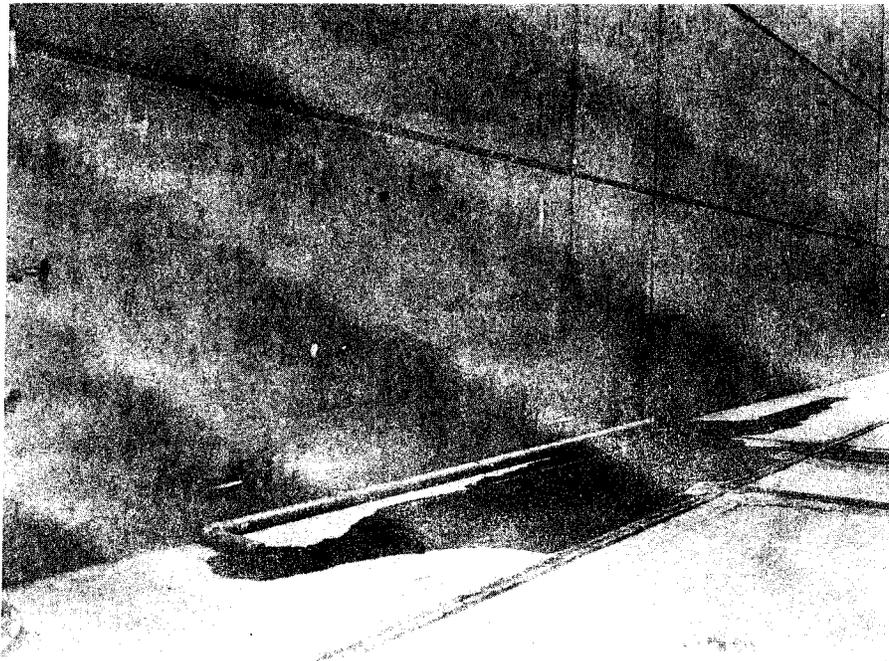
125. Leakage of varying intensities was reported between monolith joints of the different bays in the powerhouse. As would be expected, the amount of leakage varies with the seasons. Garden-type hoses are used at the joints in the powerhouse interior to help divert leakage and control it from flowing onto the generator floor. Joint 1/2 leaks every winter, joint 2/3 has leakage that runs through the hose fairly regularly, and joint 4/5 started leaking when the additional powerhouse units were watered up. Leakage at the outside transformer deck is substantial and is contained in metal troughs and pipes (Figure 47). It was noted that if the pipes were to freeze or if the leakage increased considerably during the winter, a problem of ice buildup and possible flooding of the transformer deck could occur.

Figure 47. Trough and piping to help contain monolith joint leakage in powerhouse, Ice Harbor Dam

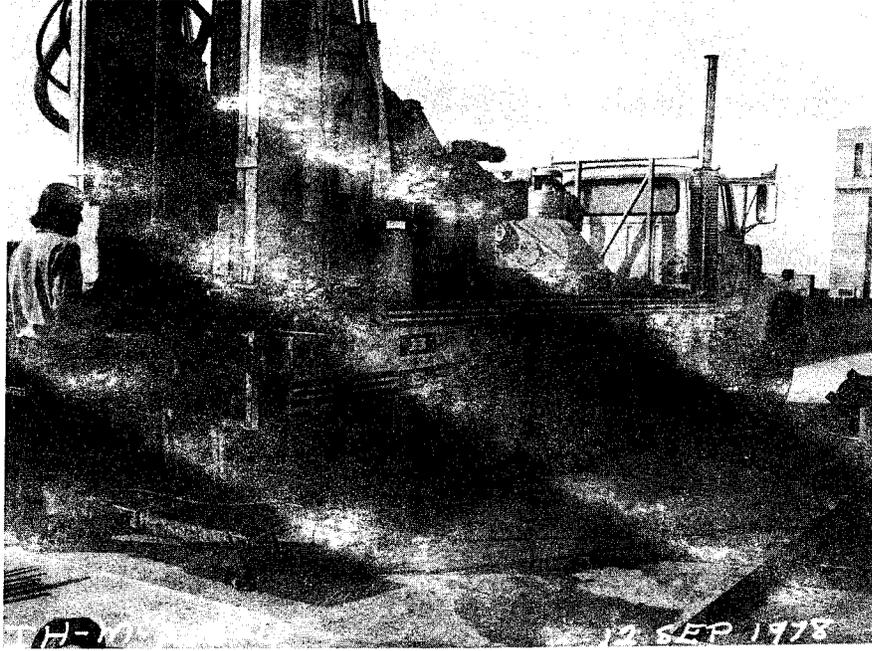
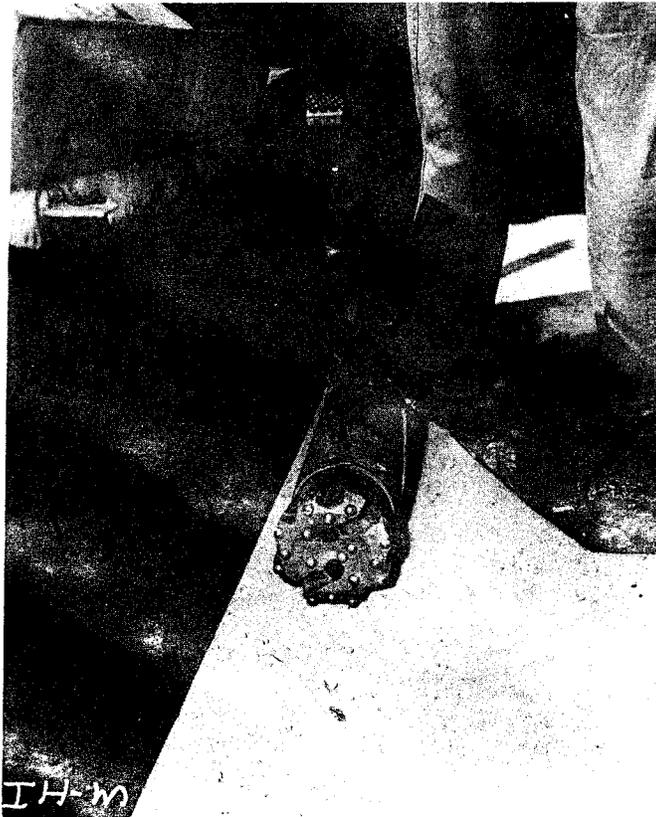
Figure 49. Equipment used to drill holes along monolith joints for remedial waterstops, Ice Harbor Lock

into bedrock (Figure 49). The drill holes were filled with an impermeable flexible chemical grout. Greatly decreased flow of water into the landside fill from the navigation lock joints was attributed to the waterstop repair. Visible contraction joints showed no sign of leakage when inspected in November 1980. Lock monolith displacements, as measured by extensometers, remained unchanged from the previous inspection in 1977.

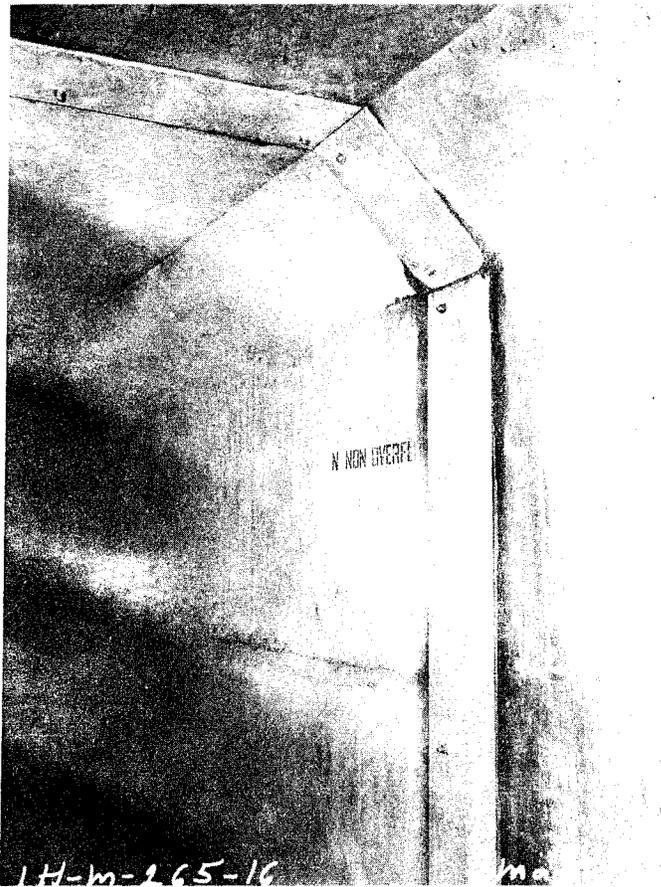
Figure 50. Steel backup plate installed at nonoverflow monolith joint 1/2, Ice Harbor Dam

128. Major leakage into the north nonoverflow dam was eliminated by the 1978 installation of chemical grout vertical waterstops similar to those installed in the navigation lock. Backup plates that were installed during the grouting operation are to be replaced in the next repair contract. The plates, which are bolted along one side in one monolith (Figure 50), were bolted so tightly against the neoprene pad behind the plate that the plate was sprung, eliminating any possibility of sealing the joint from water leakage and grout extrusion. It was suggested that the steady water seepage into the
