US Army Corps  
of Engineers

TECHNICAL REPORT REMR-CS-4

## REPAIR OF WATERSTOP FAILURES: CASE HISTORIES

James E. McDonald

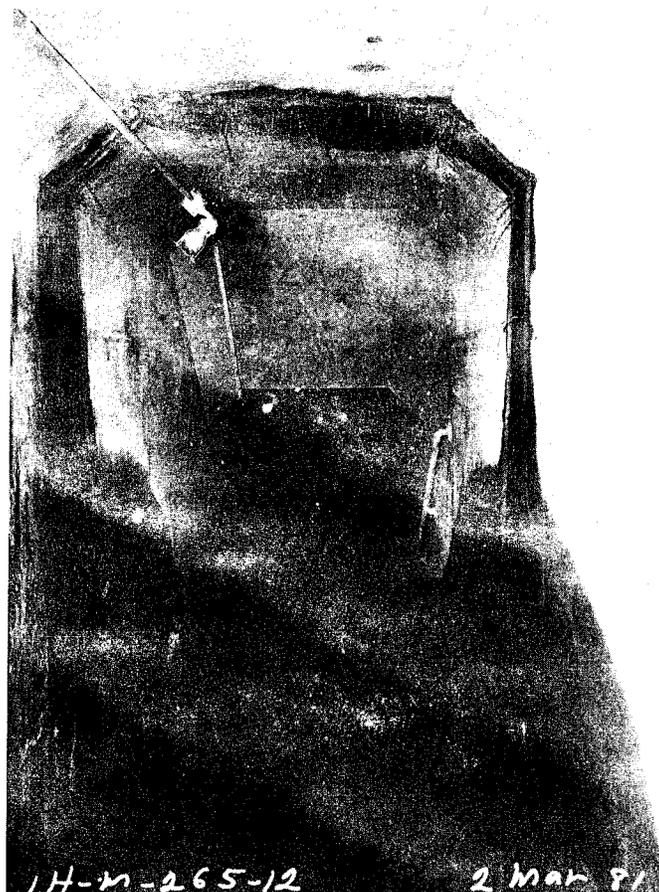
129. The crack in monolith 8 of the south nonoverflow was previously investigated with drill holes. The crack extends through the dam from the upstream face to the downstream face. An array of EX-holes was drilled from the elevation 355 ft drainage gallery to intersect the crack at a point 5 ft from the upstream face on 10-ft vertical centers. These holes were to intercept the water leaking into the crack and channel it away. The flows proved to be so great that the holes and crack were chemically grouted using AM-9 as part of the 1978 grouting contract. The leakage was stopped but a year later

the crack began leaking again. Leakage in March 1981 was as shown in Figure 51.

Figure 51. Monolith 8 crack as viewed from the drainage gallery, Ice Harbor Dam

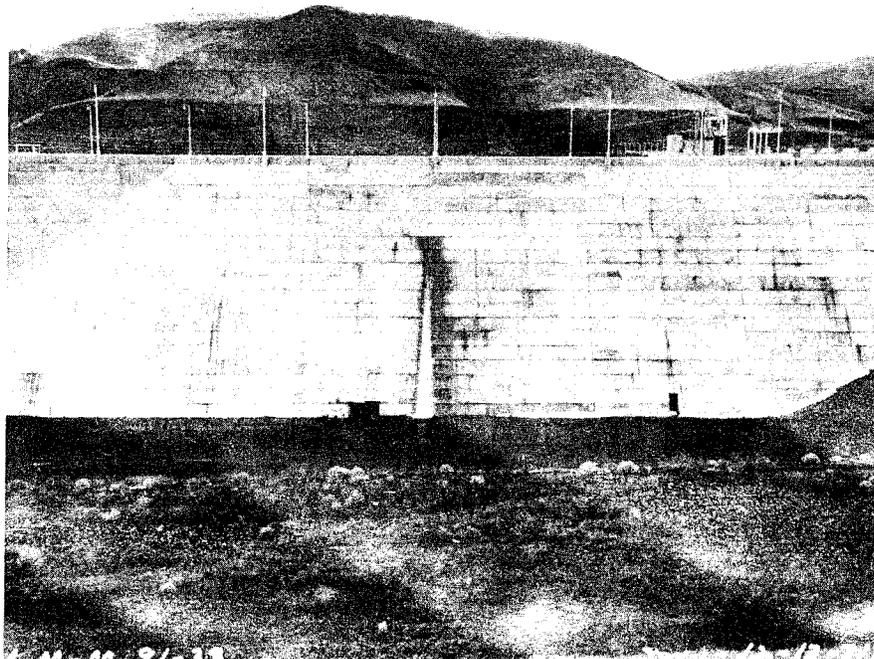
manufactured by Sika Corporation, to form a temporary membrane over areas of deteriorated concrete adjacent to the joint. In September 1971, it was reported that the epoxy showed signs of deterioration and also that the concrete deterioration appeared progressive, as evidenced by increased flows through joints 26/28, 25/27, and 18/20 (Figure 55).

Figure 55. Leakage through joint 18/20 with full lock  
chamber, Lower Monumental Lock, December 1971

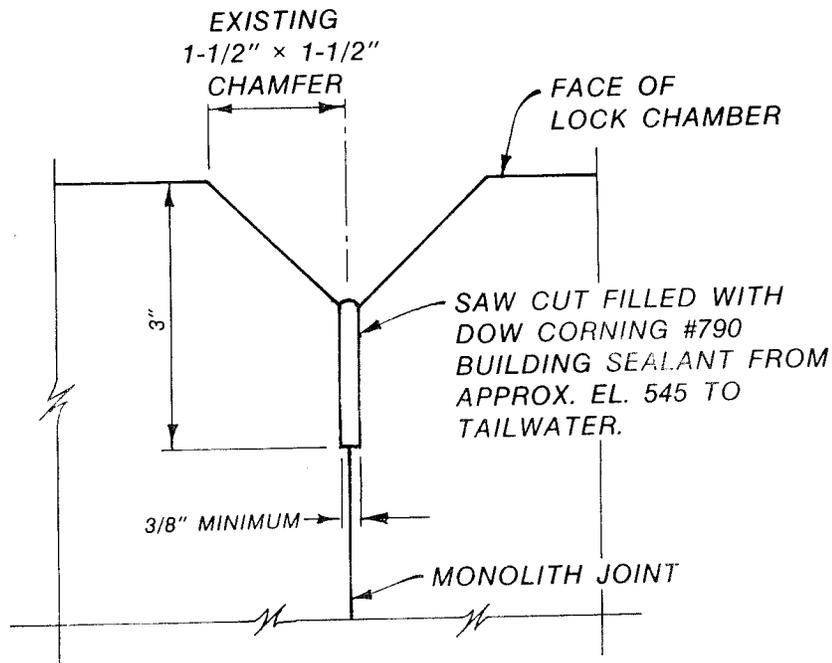
Figure 56. Caulked joint repairs, Lower Monumental Lock

significantly in the past and was repaired by District personnel in March 1975. A groove 3/8 in. wide and 1-1/2 in. deep was sawed along the joint and filled with Dow Corning 790 building sealant (Figure 56). The sealant was applied during a period when the lock was out of operation for approximately 24 hr. Cost of the repair was approximately \$2,000. The sealant was tightly bonded and totally filled the sawed groove which was inspected during the December 1976 condition survey. However, there was some leakage through the joint from elevation 470 ft to the ground. Since the sealant was only applied down to the existing tailwater elevation, the leakage may have been coming through the joint below this level. Regardless of the reason, the leakage was much less than occurred prior to installing the sealant.

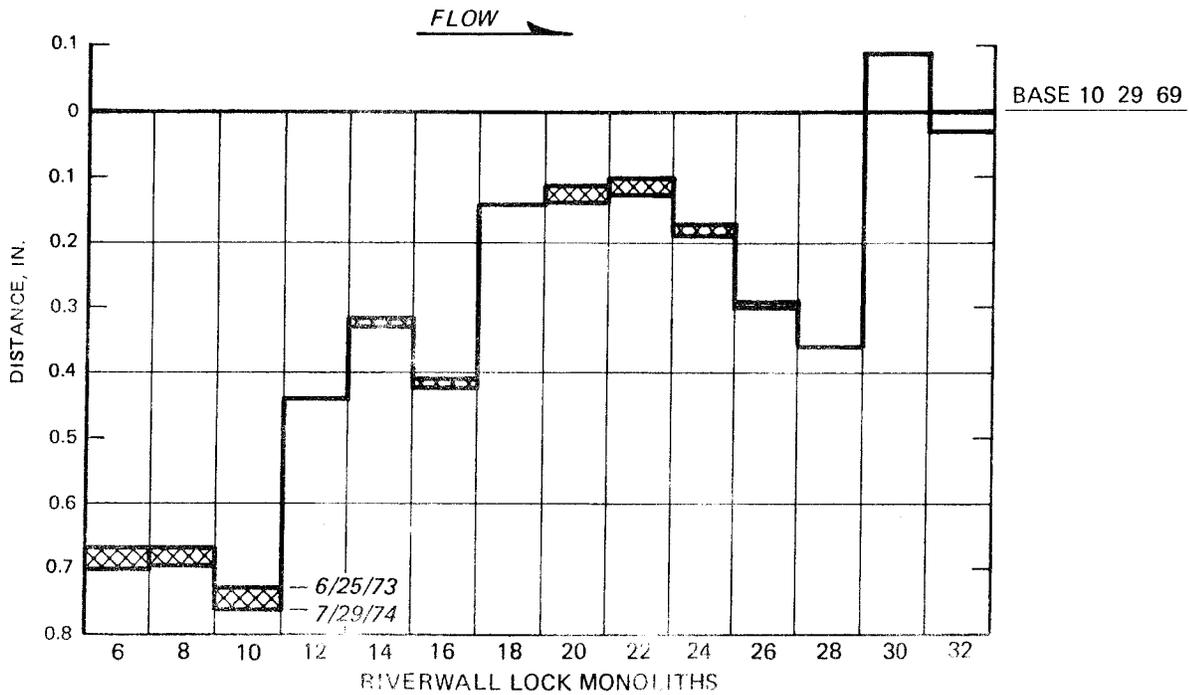
147. Subsequent deflection measurements indicated continued outward tilting of the riverside lock monoliths. Maximum permanent deflections, measured by extensometers, of more than 0.7 in. (Figure 61) were reported in 1974. Displacements were attributed to compression of the relatively weak flow breccia stratum underlying the wall buttresses. The largest relative displacements occurred at monolith joints 4/6, 10/12, 16/18, and 28/30

Figure 61. Permanent deflections measured with lock chamber empty, Little Goose Lock

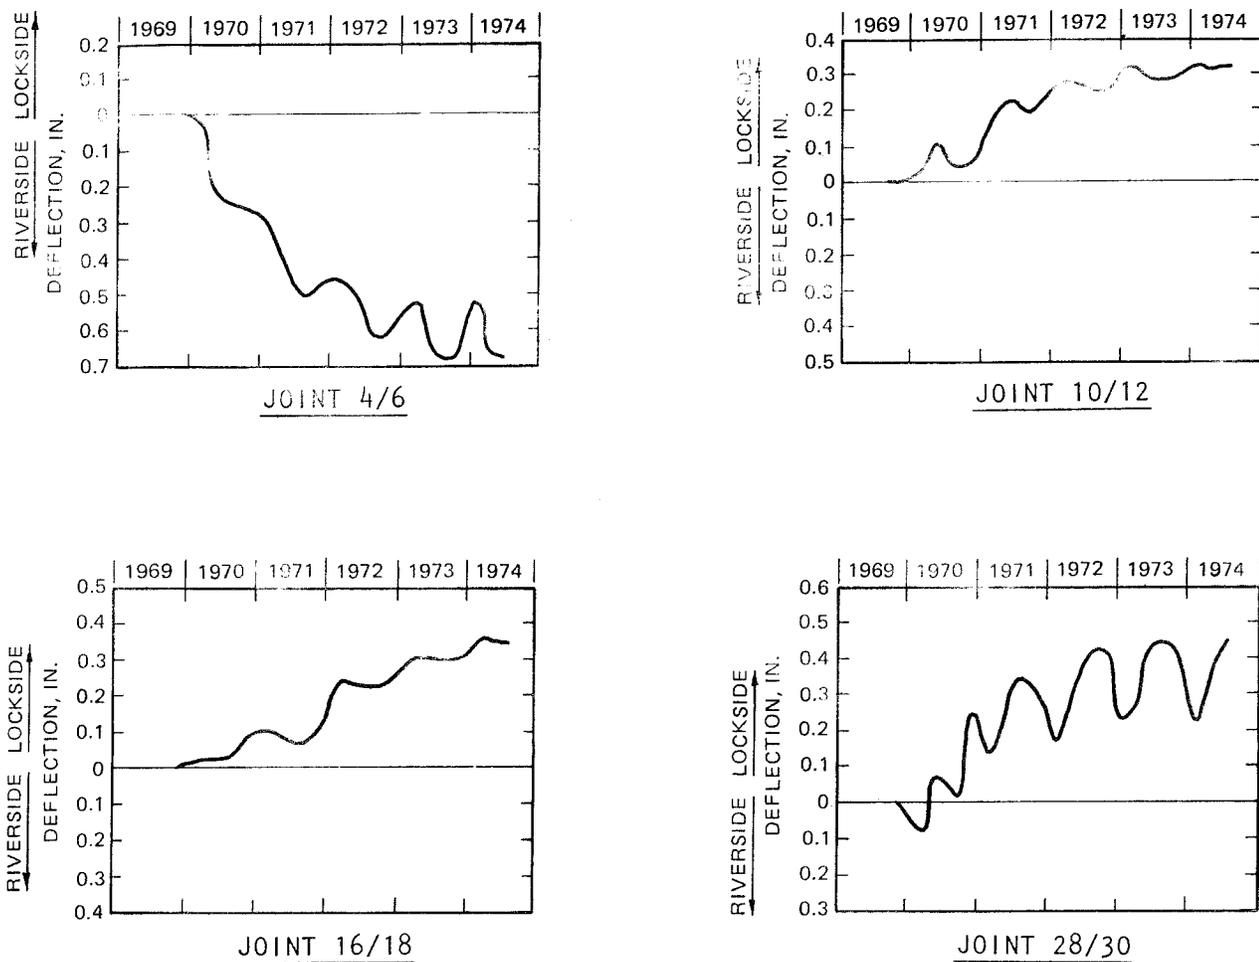
(Figure 62). Total failure of the waterstop at monolith joint 4/6 was reported as a result of the relative displacement between the adjacent monoliths. When the lock was filled, water leaked through the joint and spilled three deep into the parking area near monolith 6 (Figure 63). Most of the other monolith joints exhibited varying rates of leakage.

Figure 62. Maximum relative displacements of lock monoliths, Little Goose Lock

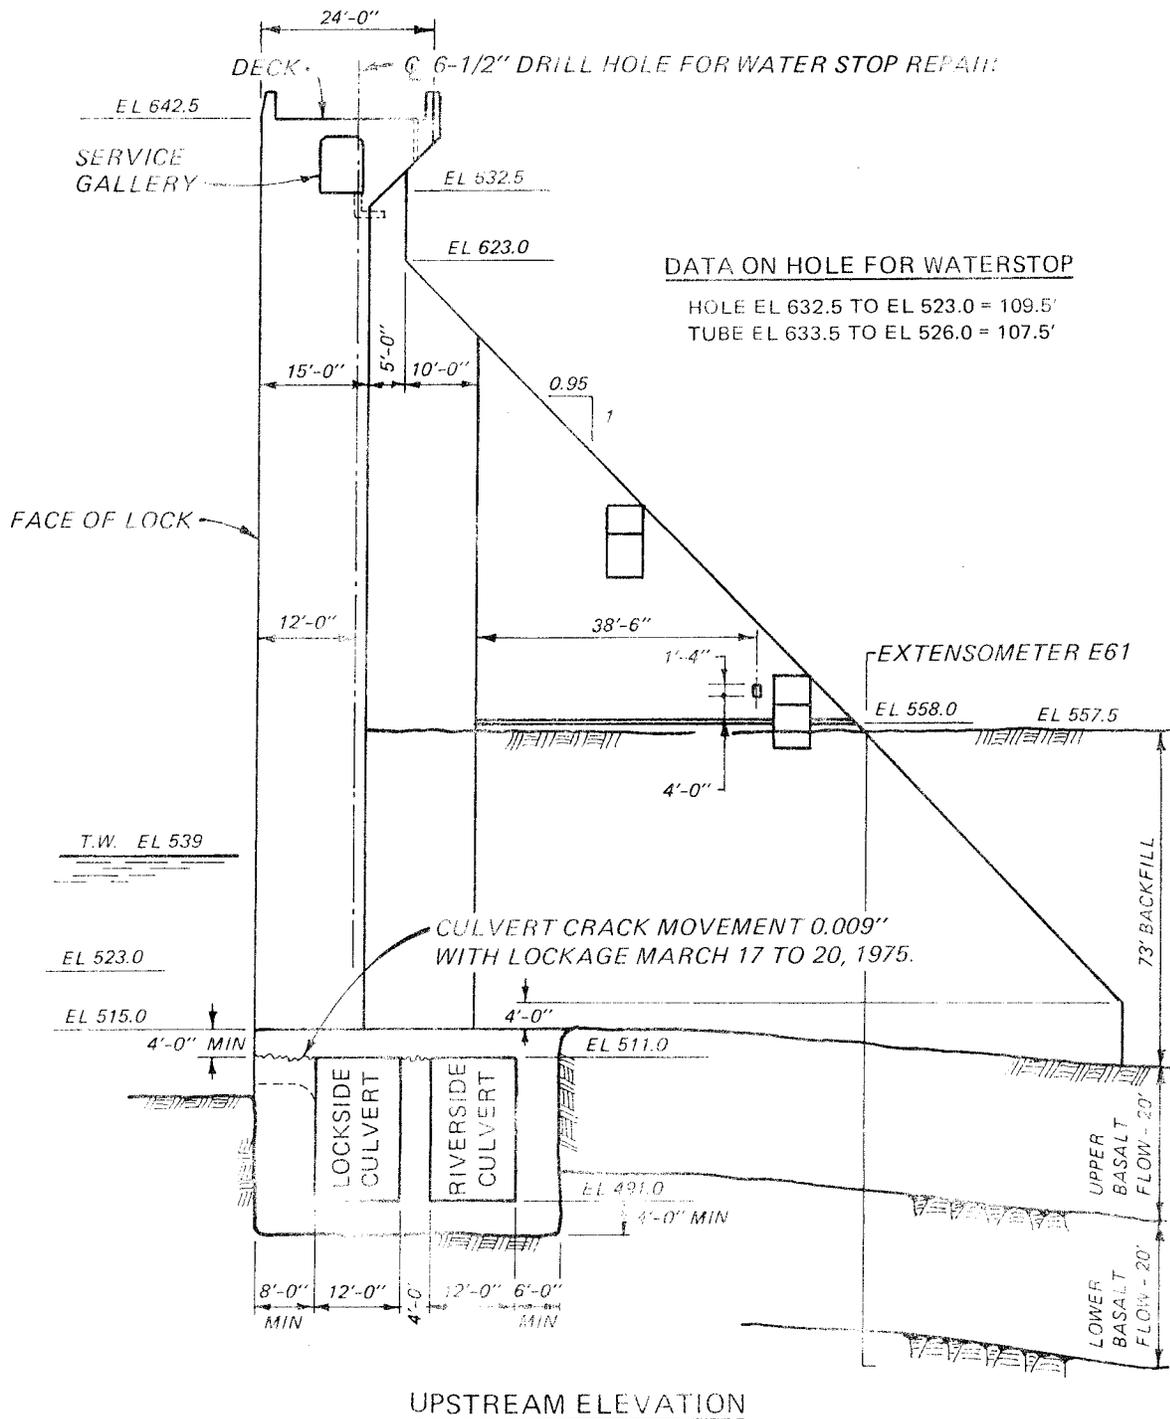
Figure 64. Location of arial waterstop repair, Little Goose Lock

hose was 51 psi; however, the hose had lateral support so the pressure was not critical. The slurry was partially effective but did not result in a maintenance free and positive waterstop. An alternate procedure for providing an effective waterstop would be to remove the plastic tube and fill the drill hole with an elastic material. In effect, this would be a 6.5-in.-diameter cast-in-place waterstop. It was decided to try this technique at Ice Harbor Lock using four different fillers in holes along four joints as previously described.

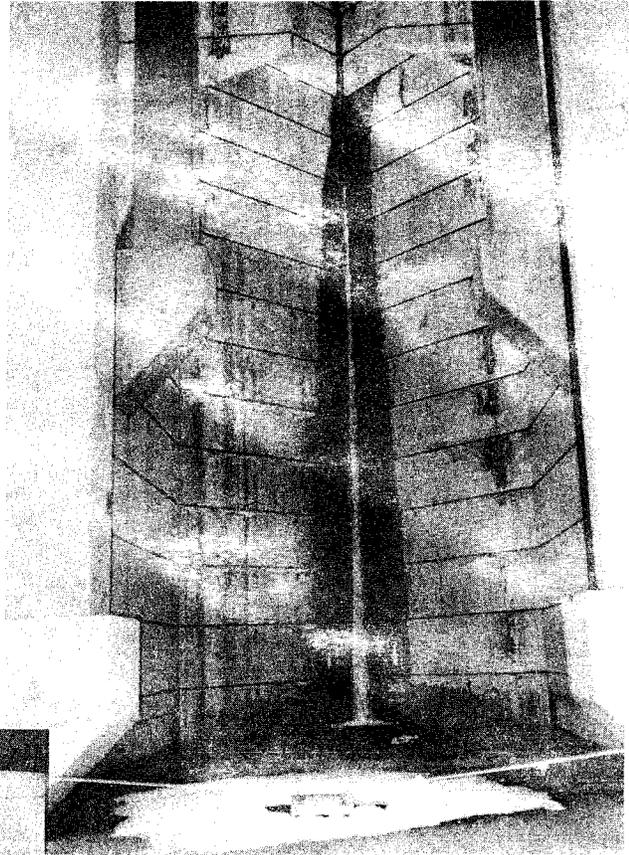
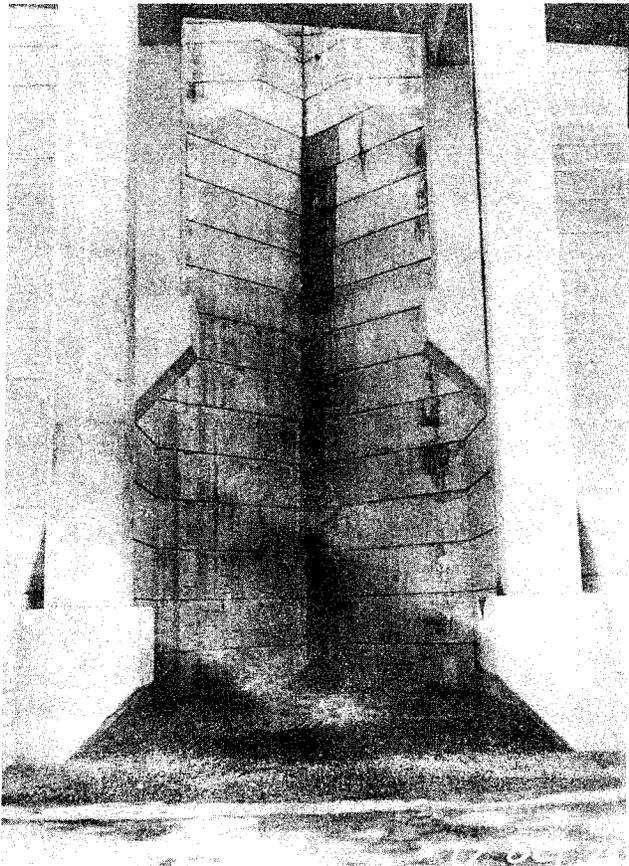
Figure 65. Monolith joint 10/12 leakage before and after repair, Little Goose Lock

152. Based on the Ice Harbor and Little Goose trial repairs, the drill hole with elastic filler method was selected to reestablish monolith joint waterstops at Little Goose Lock. Repairs were accomplished under contract in 1978 by drilling a 6-in.-diameter vertical hole along the joints from the deck to about 5 ft into bedrock and then filling the holes with AM-9 chemical grout to create a cast-in-place waterstop. This repair stopped an estimated 95 percent of the leakage. Leakage at selected joints before and after repair is shown in Figures 65 and 66.

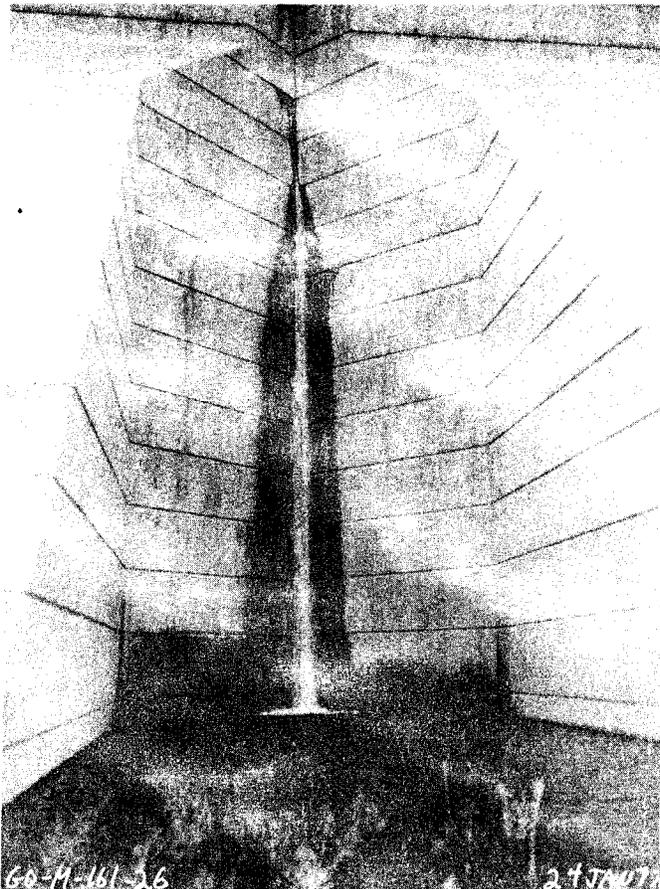
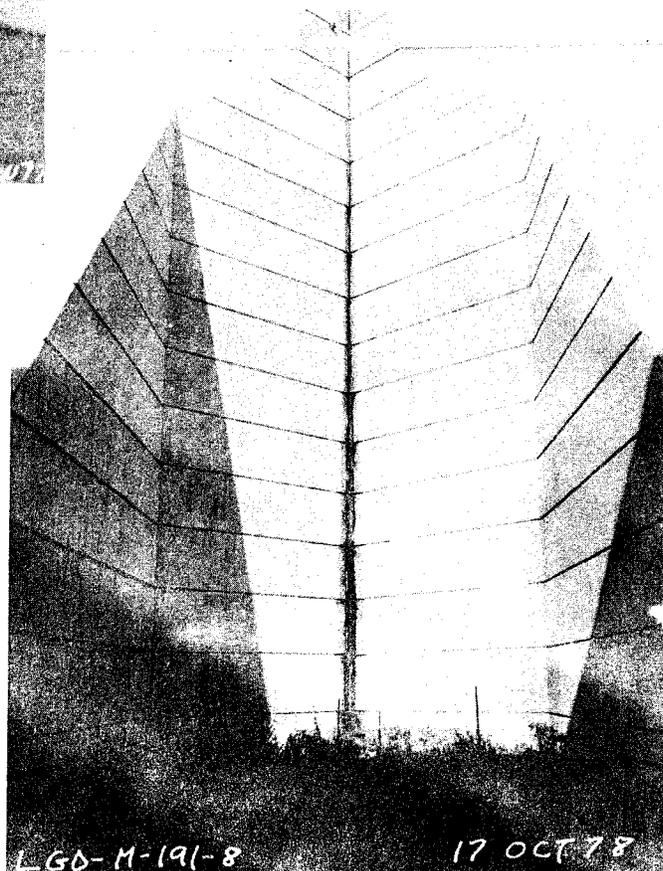
Figure 66. Monolith joint 11/13 leakage before and after repair, Little Goose Lock

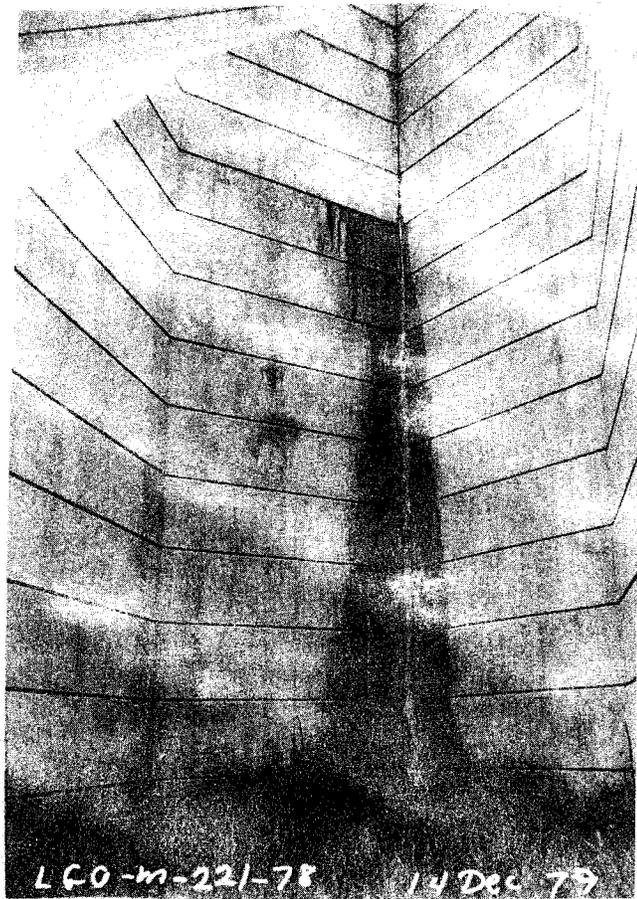
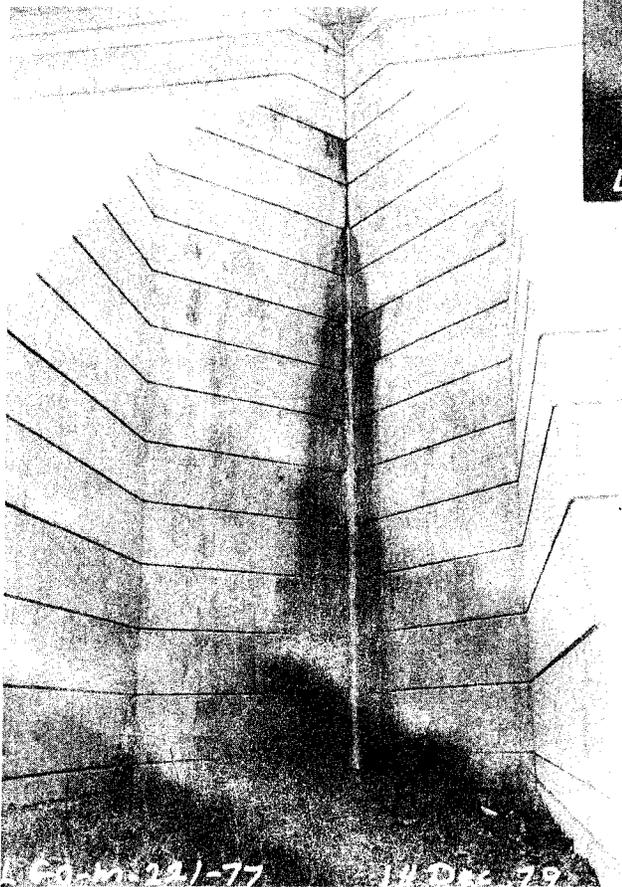
153. Based on an inspection in August 1979, it was reported that several monolith joints exhibited small amounts of leakage (Figure 67) and would probably require regrouting in the future. It was suggested that one of the advantages of this repair system is that regrouting could be done easily and economically by an experienced chemical grouting crew. Other observations reported during this inspection included:

Figure 67. Monolith joint leakage, Little Goose Lock, December 1979

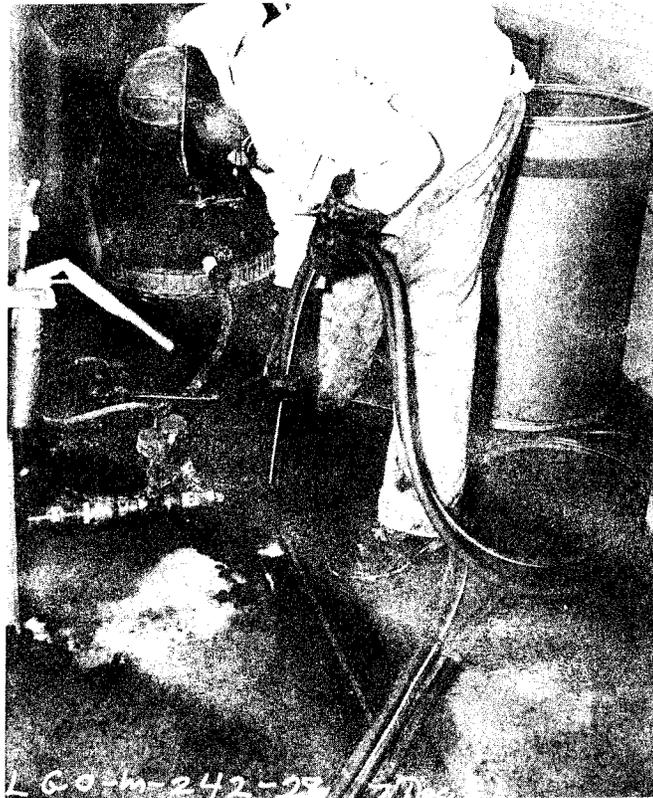
Figure 69. Acrylamide grouting operations, Little Goose Lock

157. Drill holes along monolith joints 15/17, 22/24, and 24/26 were flushed and filled with approximately 300, 350, and 250 gal of acrylamide grout, respectively. Photographs of the grouting operation are shown in Figure 69. At one point, the grout line stuck in the monolith joint 24/26 hole

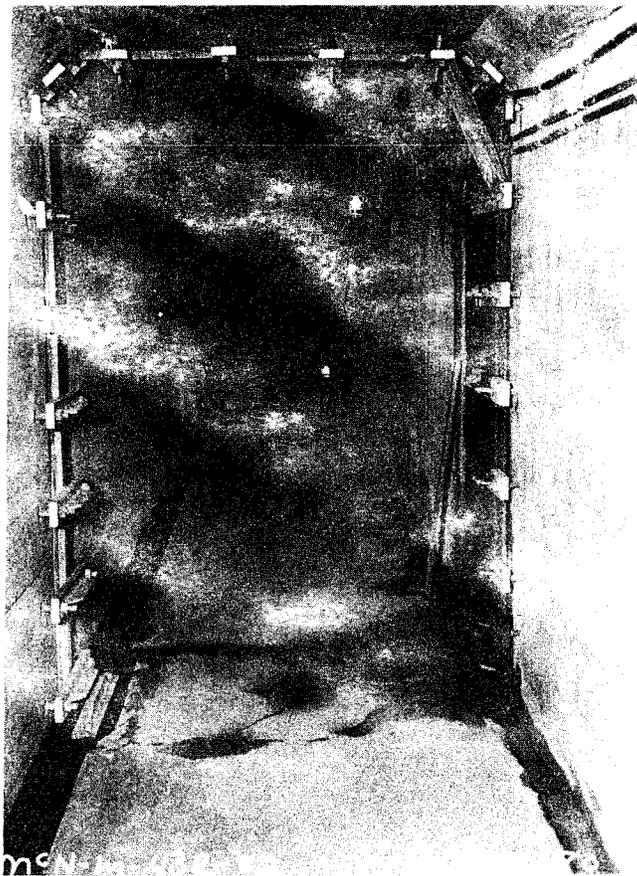
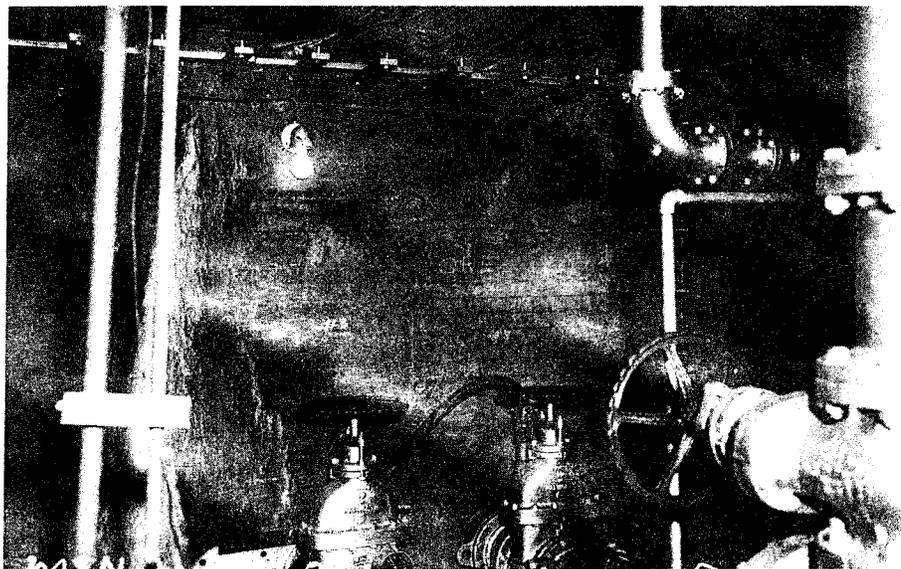
170. Leakage in the cross-over gallery at the construction joint between the lock's upstream sill block and the north overflow dam was again reported in October 1974. Progressive waterstop failures in the lock drainage and grouting galleries resulted in excessive leakage at the upstream sill. In 1978, leakage flooded the pump room damaging equipment to an extent that much of it required replacement. A surface-type gasket held in place by compressed steel bars bolted to the gallery walls (Figure 74) was used to control the leakage.

Figure 74. Surface-type waterstops, McNary Lock, 1980

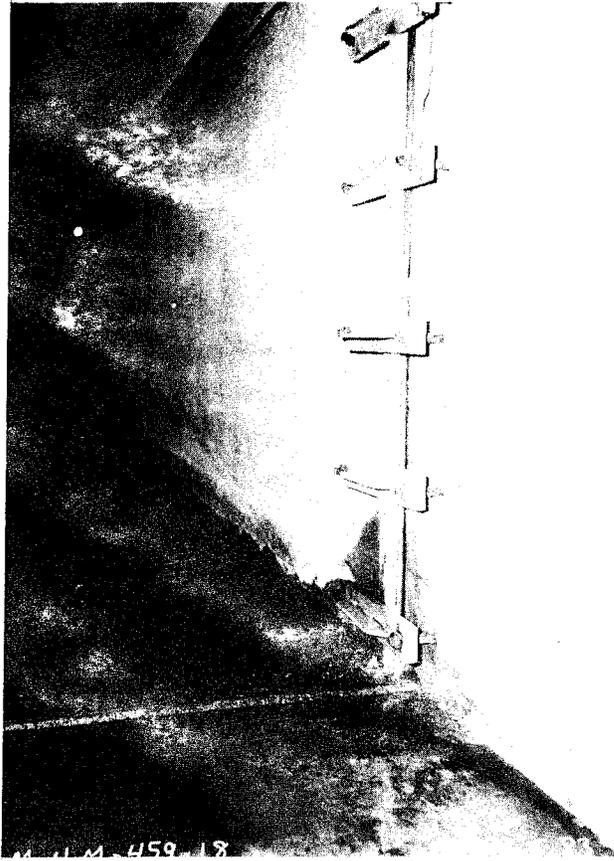
172. Joint leakage remained essentially unchanged at the next periodic inspection in 1983. A surface-type waterstop installed in the cross-over gallery at the joint between the downstream sill block and lock monolith 38 (Figure 75) continues to provide an adequate seal against leakage.

Figure 75. Surface-type waterstop, McNary Lock, 1983

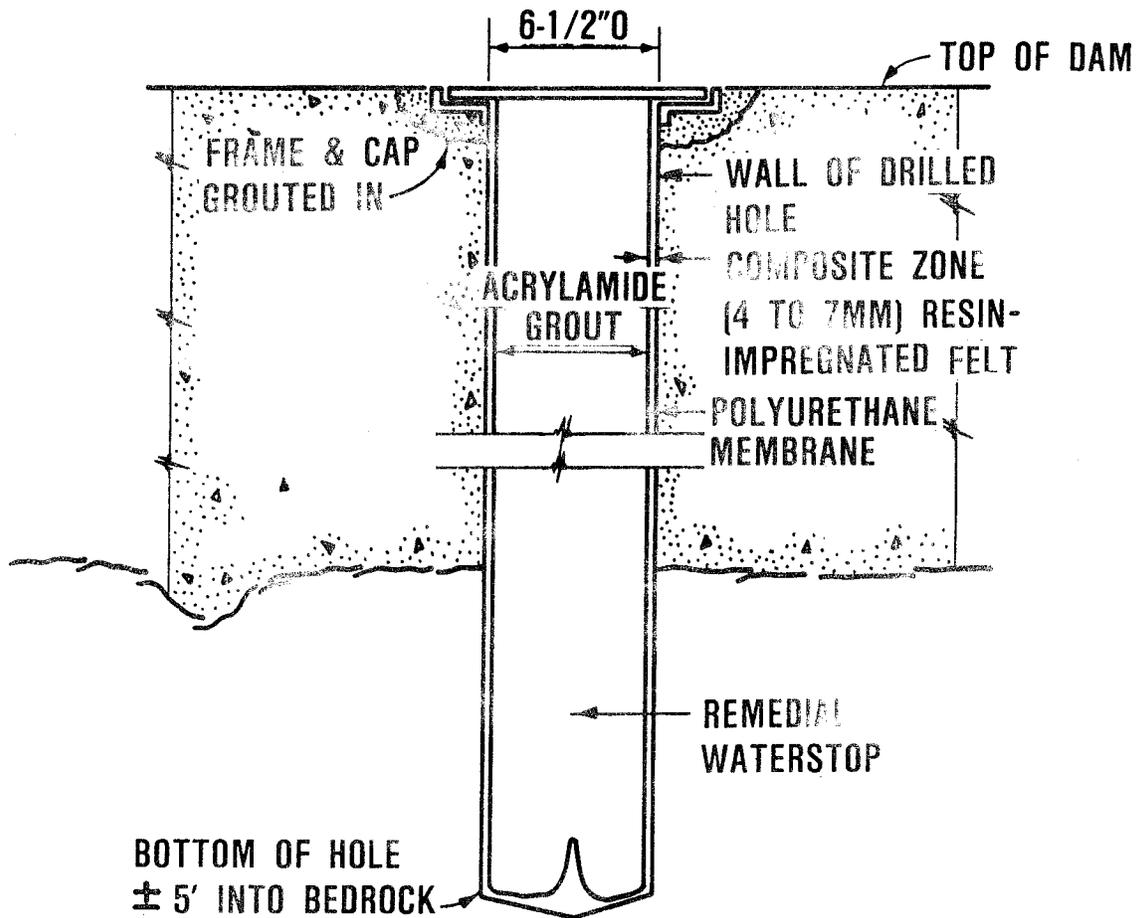
Figure 105. Completed remedial waterstop, Pine Flat Dam

202. On 15 March 1985, each liner tube was cut approximately 8 in. down inside each hole to allow replacement of existing cast iron cap frames (Figure 105). The resin-impregnated felt which was removed had small pieces of concrete adhering to its surface indicating good bond. The cap frames were

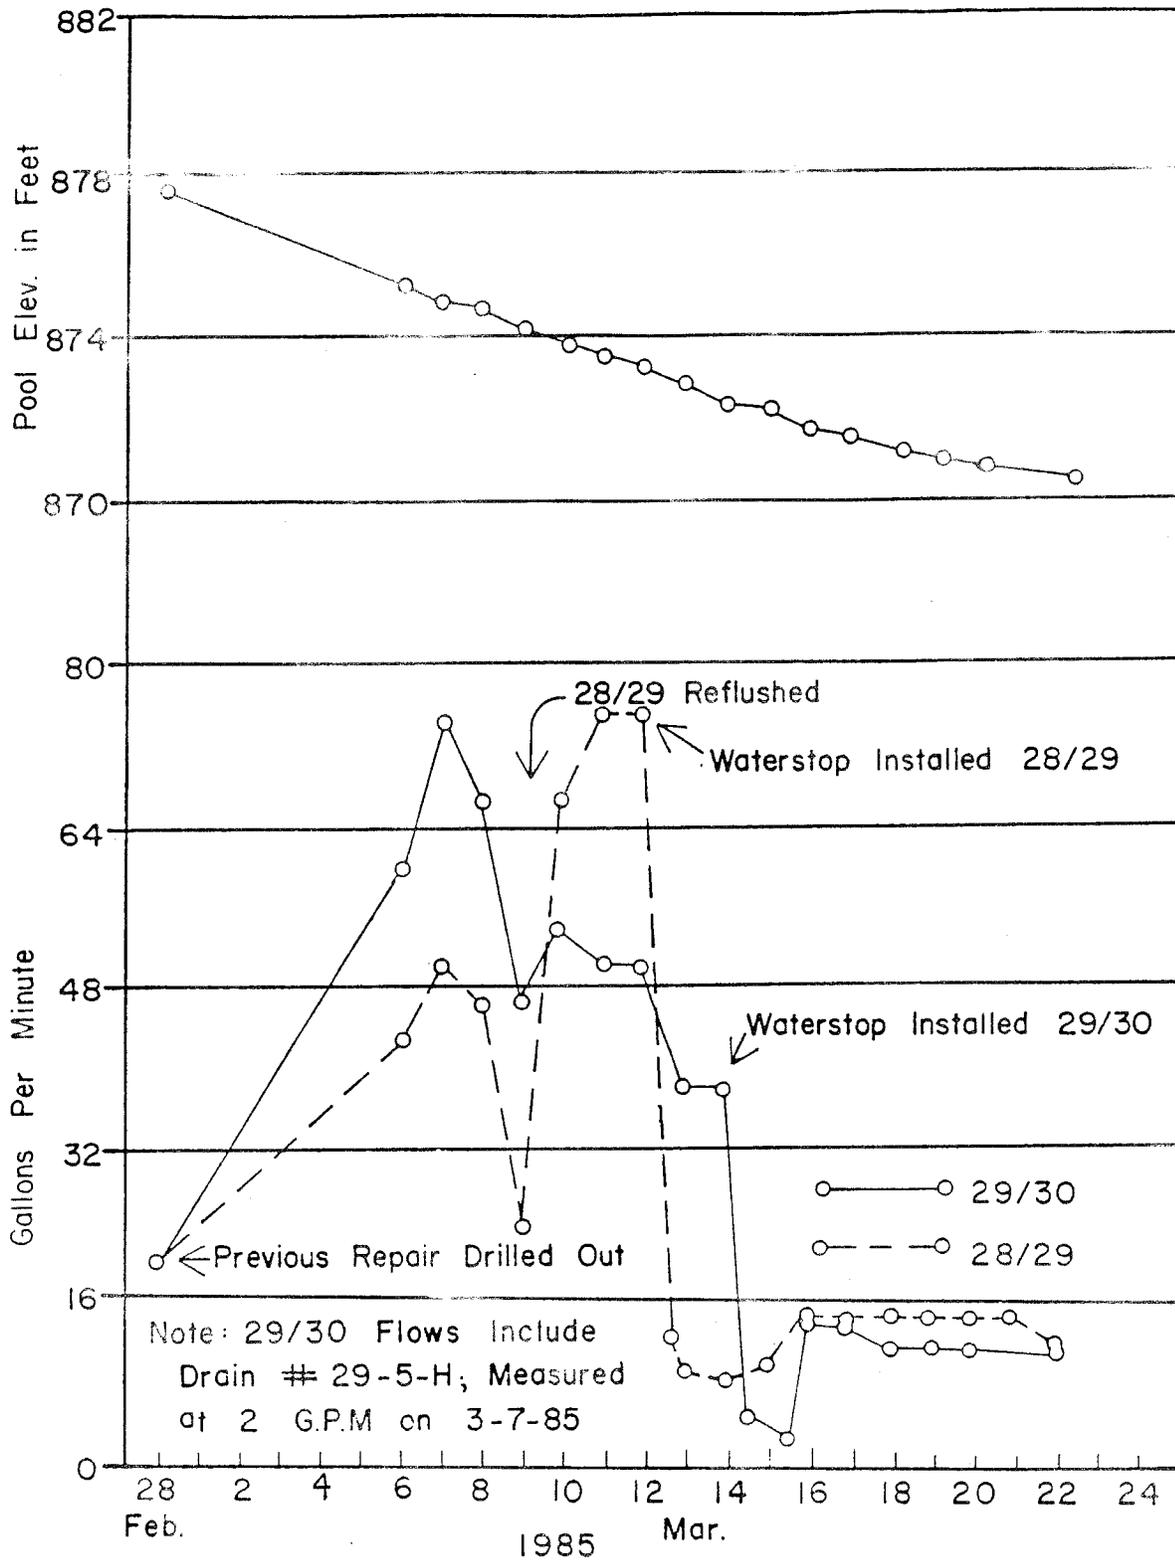
204. Historically, maximum flow through the three joints totals approximately 800 gal/min with a reservoir pool at elevation 950 ft. The reservoir pool level during the repair project ranged between elevation 880 and 870 ft (Figure 111) with a total flow of approximately 150 gal/min prior to repair. Of this total less than 1 gal/min was contributed by hole 30/31. Following installation of the remedial waterstops, total flow was stabilized at approximately 25 gal/min. As in most structures of this type, it is difficult to isolate leakage through monolith joints from that which is passing through horizontal lift joints. It is not known how much, if any, of the leakage into the drain was a result of openings in the lift joints. Results of this project indicate that the majority of flow has been through the vertical joints, yet it cannot be concluded that all of the flows are from the vertical joints.

206. Flow through joint 29/30 peaked at 75 gal/min on 7 March (Figure 111). On 8 March, the abandoned installation reached a depth of 145 ft (elevation 825 ft) before the tube was removed. The fluorescent dye test performed in May 1984 indicated a zone of leakage between elevations 870 and

850 ft. Independently, the video inspection indicated cross-hole flows at elevations 840 and 815 ft. This indicates that the tube had been installed into the major leakage area before it was removed. Between 8 March (aborted attempt) and 14 March (successful installation), flows through this hole decreased daily with the exception of the upward blip caused by the flushing on 9 March discussed above. This would indicate that beneficial penetrations of the joint by the resin occurred even though the tube was removed. Resin thus forced into the joint would not be removed by the flushing. Such an effect can be expected to improve the quality of the seal obtained and thus its long-term performance. However, only a rise in reservoir pool level will provide conclusive evidence as to the efficiency of these repairs.

Figure III. Joint leakage rates, Pine Flat Dam

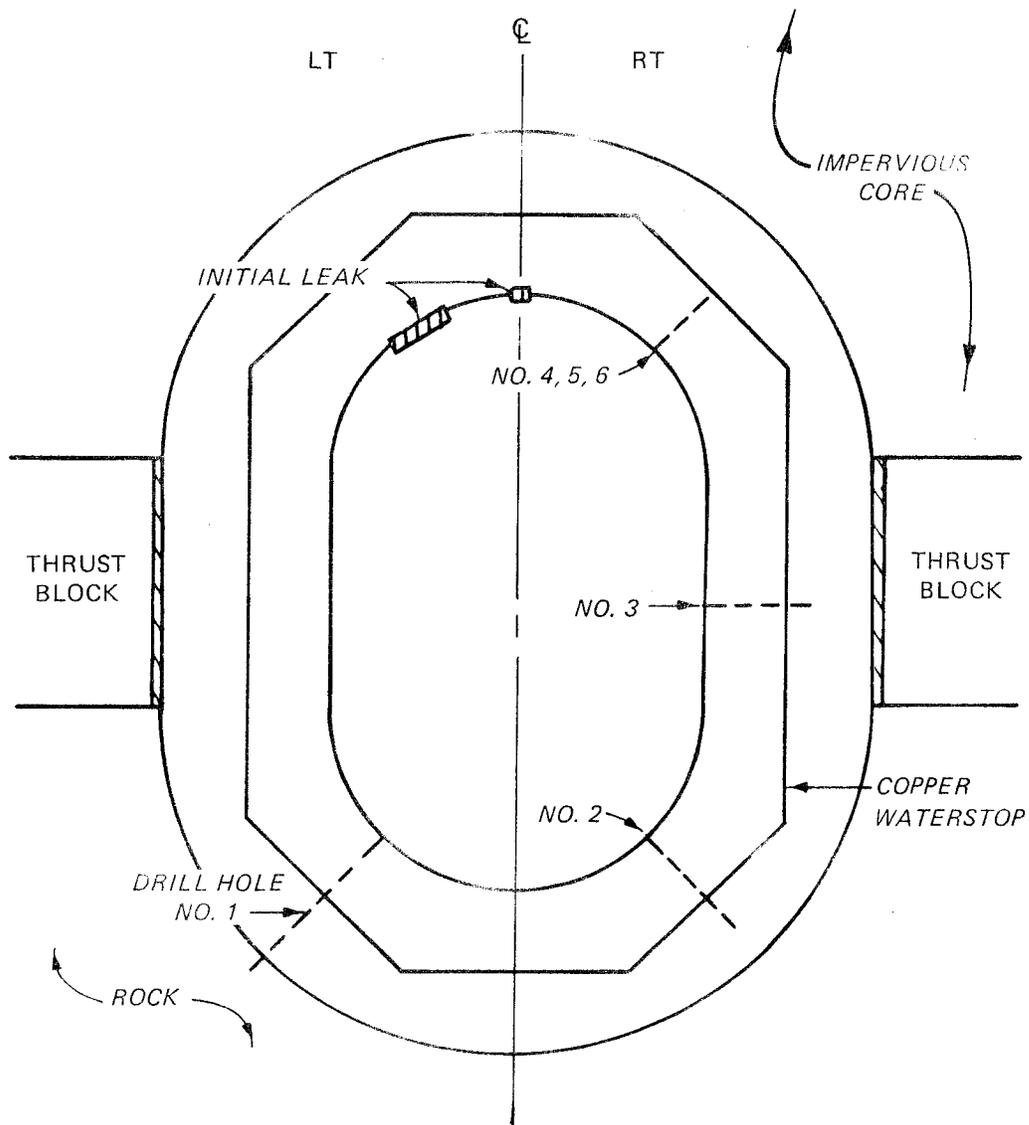
Figure 123. Grout hole locations, Applegate Dam

235. US Army Corps of Engineers crews began mobilizing on Monday, 1 June, and were ready to enter the conduit at the beginning of shift on 3 June. Two holes were drilled, as shown in Figure 123 and 124, and the conduit was made ready for the grouting contractor. Measured flow from the drill holes was 12.5 and 8 gal/min for holes 1 and 2, respectively. Flow through the leak with both drill holes flowing was estimated at 2.5 gal/min.

238. Packers were placed in each of the drill holes. Hole No. 1 was fitted with a quick connector to accept the grout injector, and hole No. 2 was fitted with a valve to control flow. After the injector was connected and pumping commenced, Celite filler which had been added to the water side was transmitted to both the leak and to drill hole No. 2 within seconds, but the grout material did not appear. Pressure at the injector remained low after 3 or 4 min of pumping. CR-851 was added to increase the set time. After several minutes of pumping with pressure at the pump and low pressure at the injector it was discovered that very little grout was being injected and that, because of the high pressures, a coupling had begun to leak. Total loss of grout at the coupling was less than 1 gal. The contractor discovered that the 250-ft section of hose was too permeable and that the grout was taking on water through the hose and was beginning to set up. Sufficient grout had been pumped into hole No. 1 to partially seal it. The grout hose was removed from the conduit and repaired.

239. Grouting was next attempted at hole No. 2. Very little grout was injected before the pressure began to rise. Injection ceased after pressure at the injector rose to 100 psi with no flow, indicating the hole was plugged

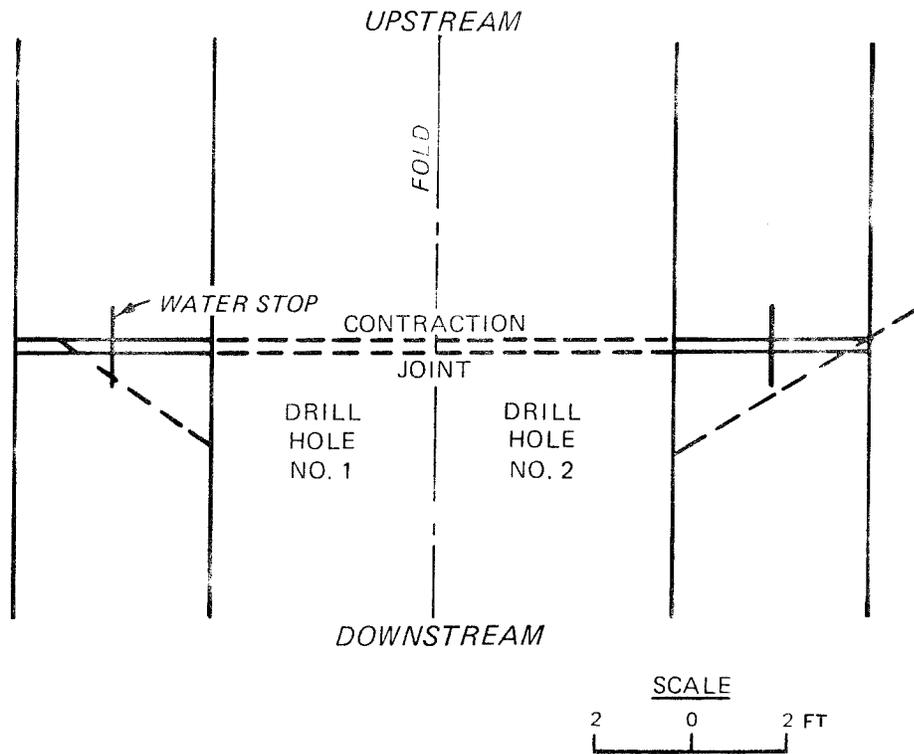
Figure 124. Section through grout holes 1 and 2, Applegate Dam

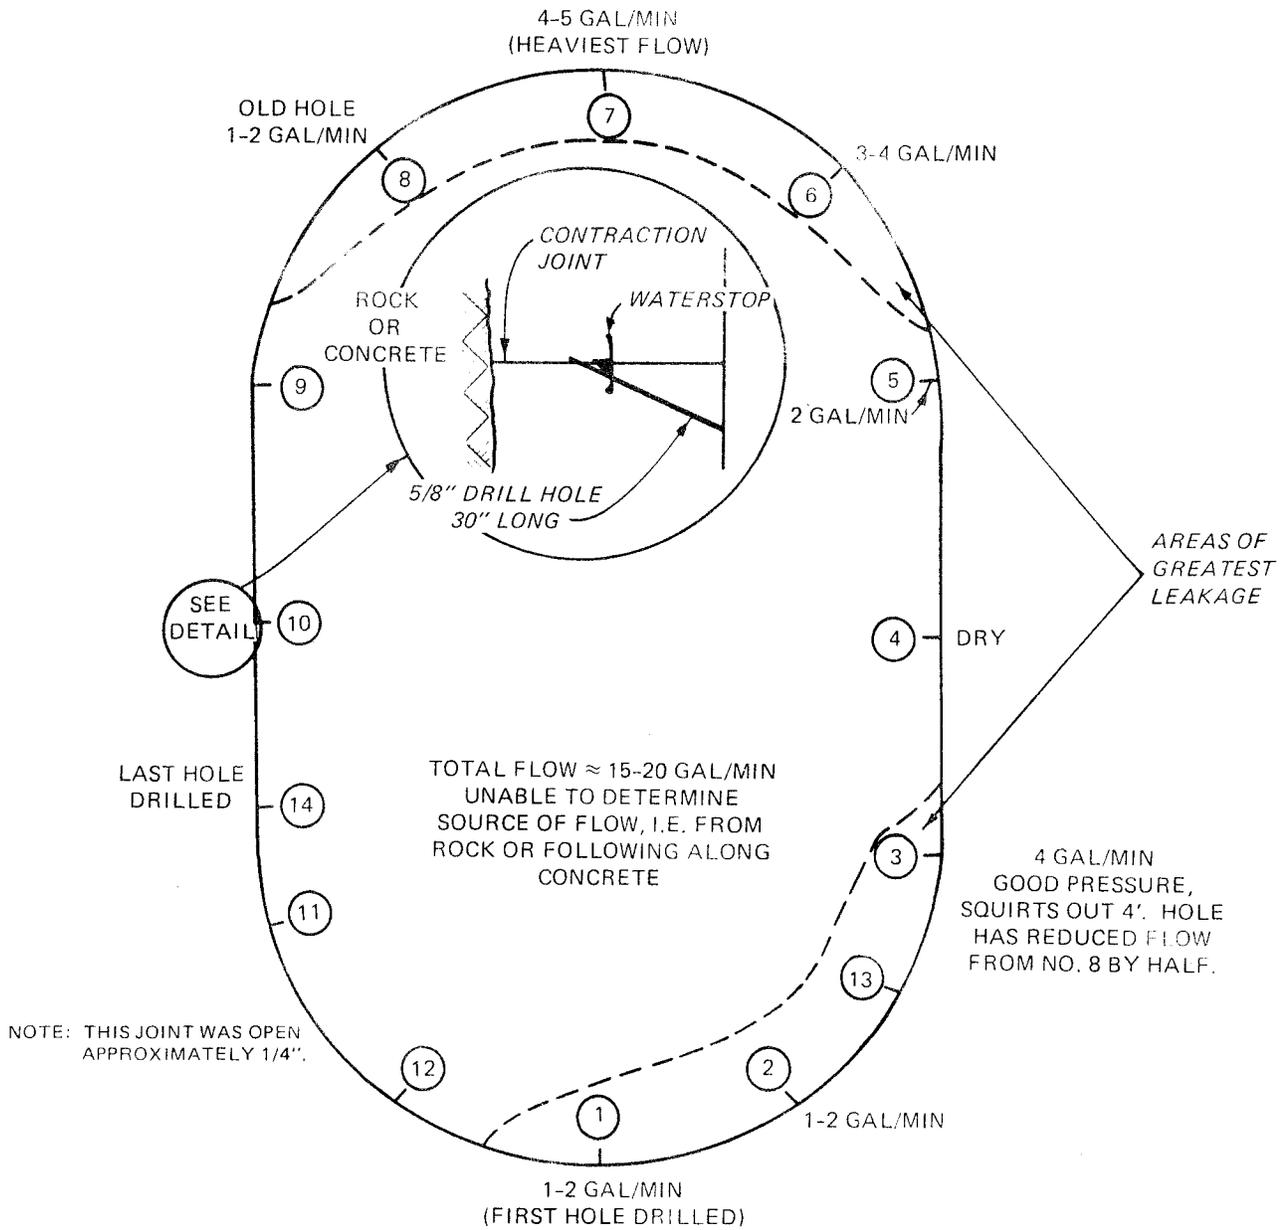
Figure 125. Section at joint 15/16 looking upstream, Applegate Dam

244. A contract was awarded to GELCO Grouting Service, Salem, Oregon, and repairs were begun on 25 July 1984. Fourteen holes were drilled around the perimeter of the conduit to intersect the contraction joint outside of the waterstop (Figure 125). The holes were 5/8-in. diameter and drilled with a Rotohammer drill. Flow through the holes varied from 0 to 5 gal/min, with a total flow of 15-20 gal/min. The system was open, because the contractor was unable to take pressure readings at any of the holes. Also, plugging one hole would cause an increase of flow at other holes.

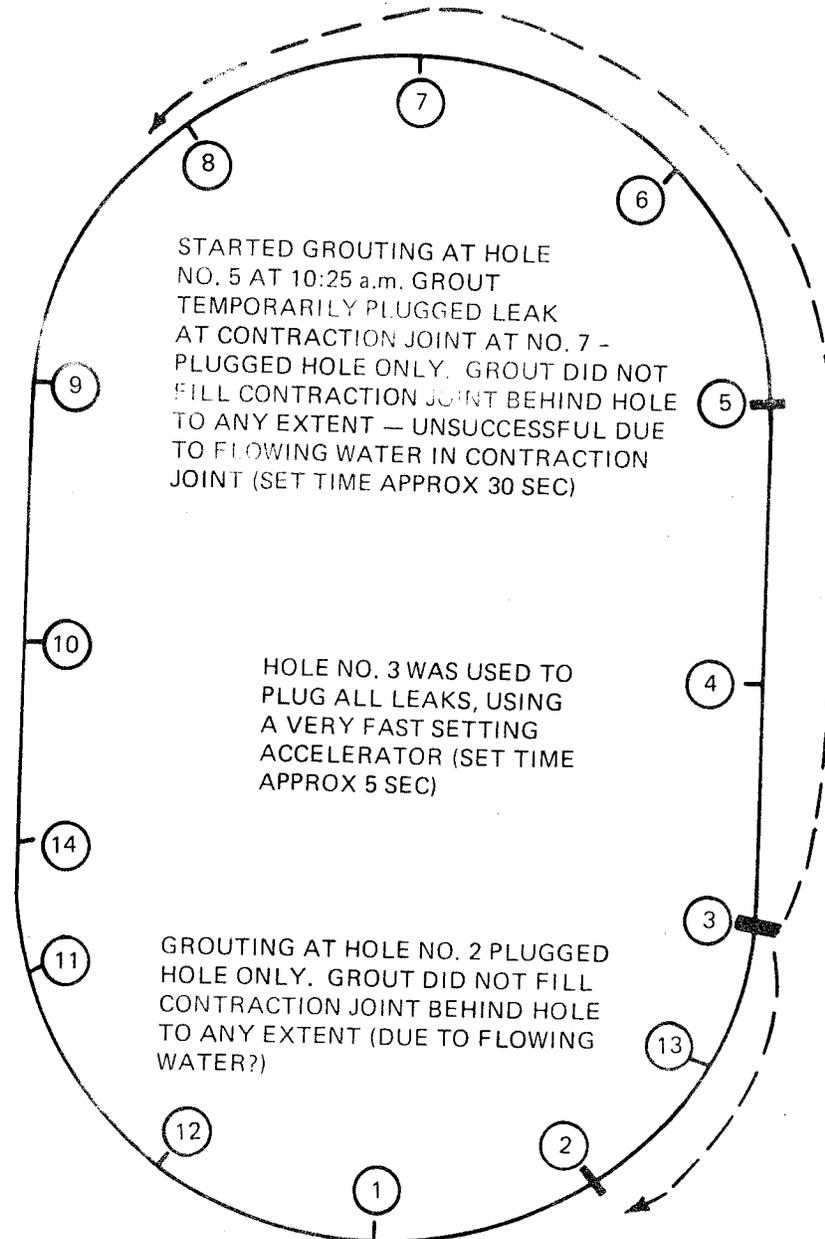
Figure 126. Section at joint 15/16 looking upstream, Applegate Dam

245. Grouting was started on 26 July using a hydrophilic polyurethane gel (CR-250). Grout was pumped into three of the drill holes, starting at hole No. 5 (Figure 126). Grouting at hole No. 5 and 2 apparently plugged those holes but did not fill the joints behind the holes because of flowing water. Hole No. 3 was successfully used to plug all the leaks, because a very fast-setting accelerator was used to shorten the set time of the grout to approximately 5 sec.

246. All holes were redrilled on 27 July. Hole No. 2, 12, 10, and 11 were leaking very small quantities (approximately 0.5 gal/min maximum) of water after redrilling. The grout formula was changed to a setting time of 3 min. Hole No. 2 water pressure was measured at 50 psi when it was the only hole flowing. Hole No. 2 was used for grouting with the slow-setting grout which was pumped at up to 1-1/2 gal/min. Total grout take was 20 gal. Pressure at the pump ranged from 95 to 145 psi at the start of grouting (2:50 p.m.) compared to 110 to 150 psi at completion of grouting (3:15 p.m.). Total grout pressure at the hole was 60 psi. Hole No. 13 and 14 were drilled to confirm
