US Army Corps  
of Engineers

TECHNICAL REPORT REMR-CS-4

## REPAIR OF WATERSTOP FAILURES: CASE HISTORIES

James E. McDonald

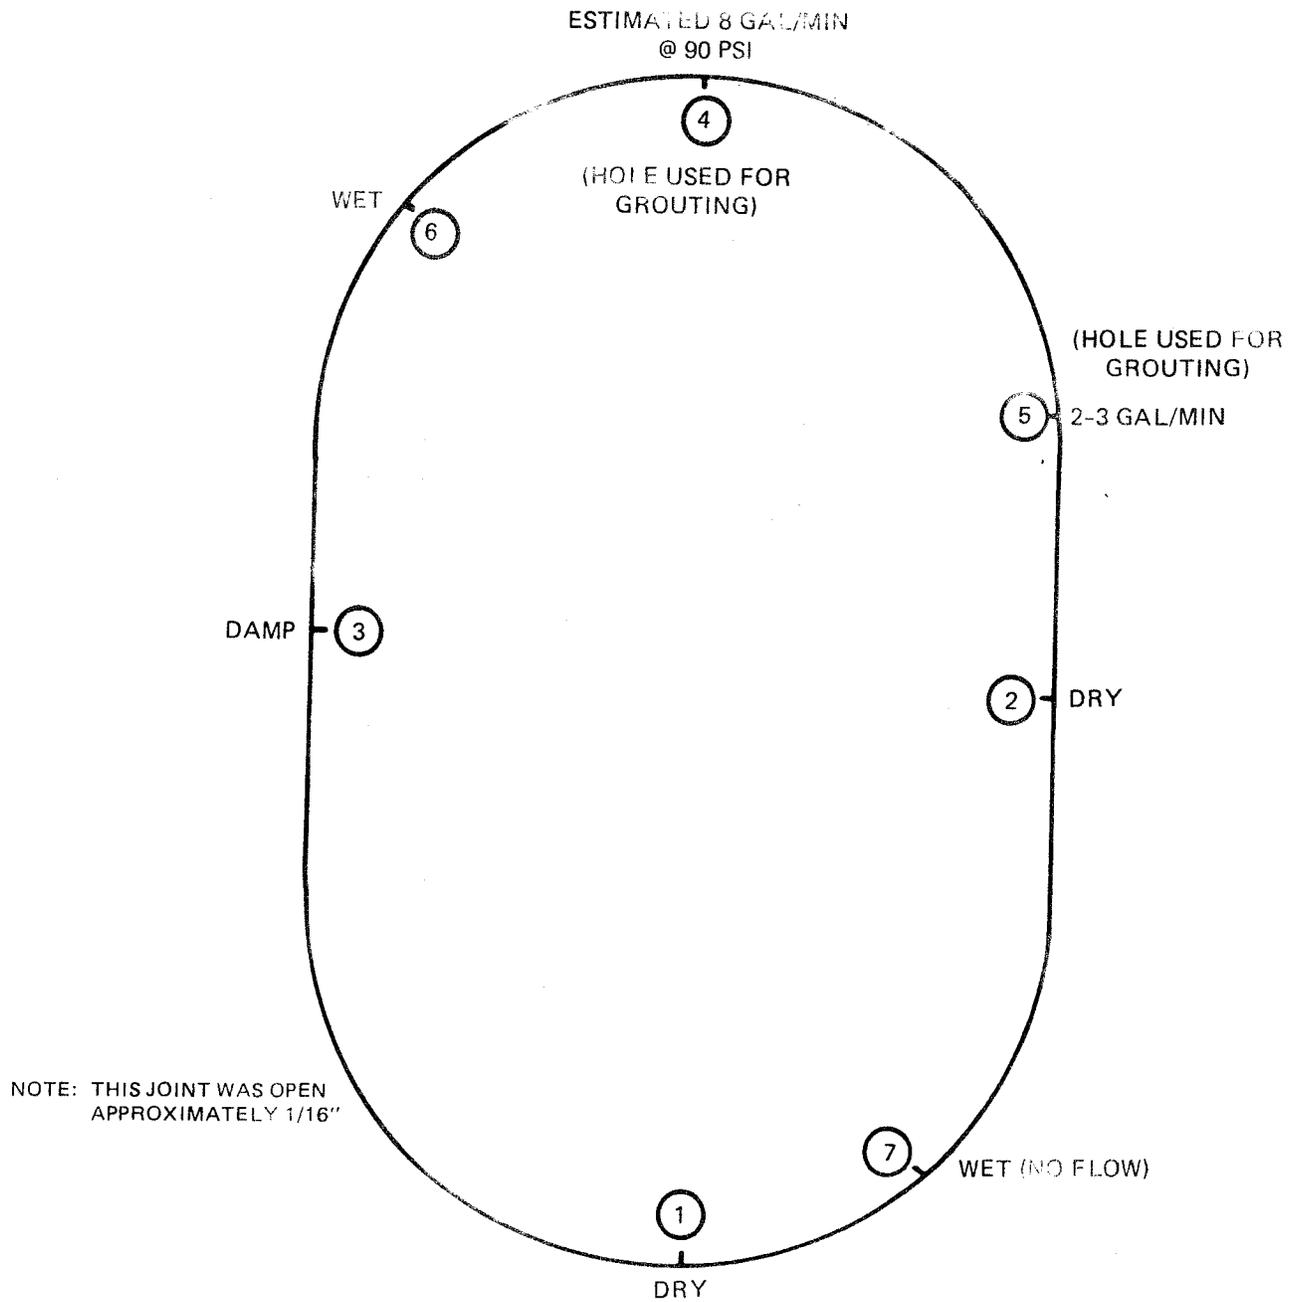
Figure 127. Section at joint 12/13 looking upstream, Applegate Dam

247. On 28 July, seven holes were drilled at joint 12/13 with the 5/8-in.-diameter Rotohammer (Figure 127). Hole No. 4, in the crown, had the largest flow and greatest pressure prior to grouting of any of the drill holes in either joint. Hole No. 4 was grouted first. Pump pressure built up very rapidly and was at 240 psi after 5 minutes when grouting was stopped. The grouting successfully stopped the slight leakage along this joint. Prior to grouting hole No. 5 water pressure was measured at 90 psi. Hole No. 5 took 10 gal of CR 250 grout with no grout pressure buildup. The hole was plugged after 5 min and it was assumed the grout was venting to the gravel fill. An attempt was made to grout the other holes but there was no take in any of them. All holes were backfilled with Preco Plug and the repair was completed at 8:30 p.m. on 28 July.

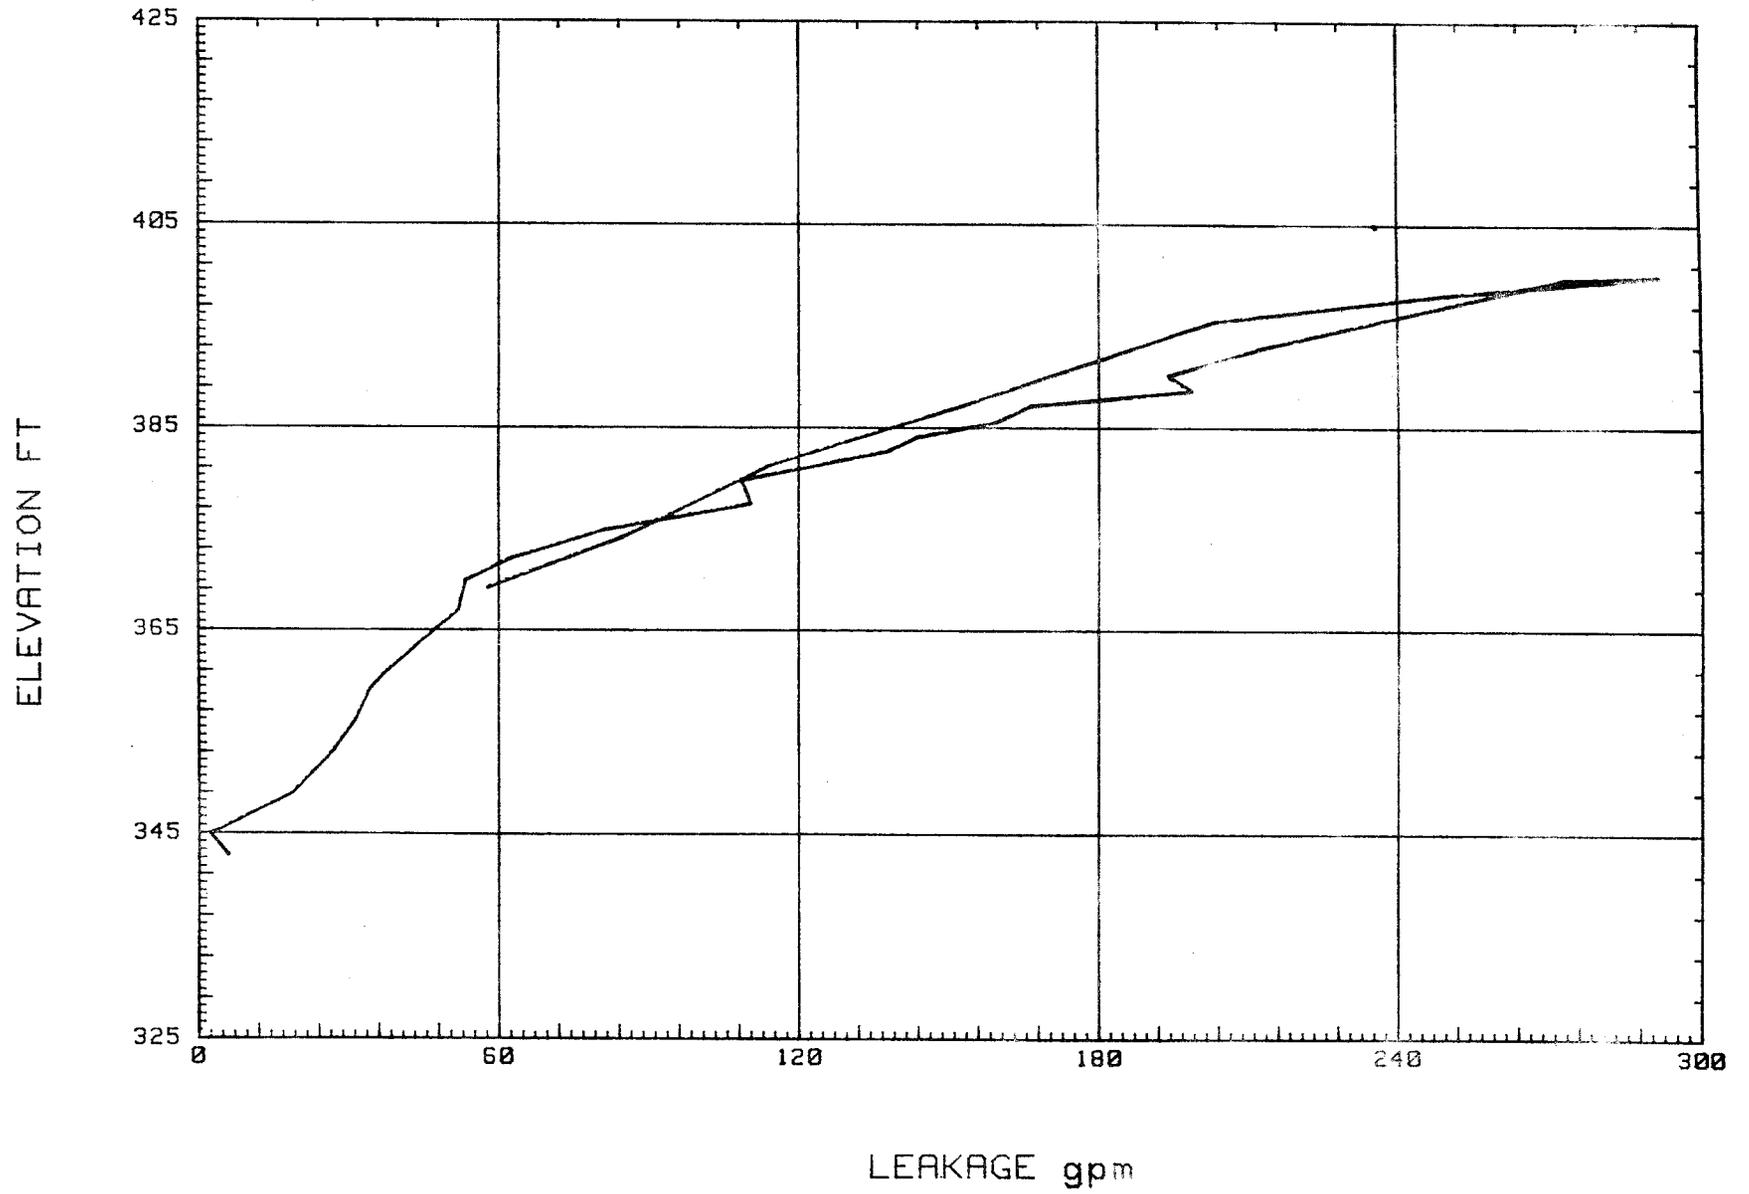
270. After test repairs on the five joints were completed, the pool was again raised to elevation 400 ft to evaluate the effectiveness of the repair. The sluice gates were closed on 6 June 1983 when the lake was at elevation 342.1 ft. As the lake level began to rise, leakage was measured at approximately 5-ft intervals until the lake reached elevation 400 ft on 10 June. The sluices were opened 11 June, and the lake was allowed to fall. The monitoring process continued through 15 June, as the lake stabilized at elevation 360 ft, with results as shown in Figure 136.

Figure 136. Leakage measurements, Richard B. Russell Dam, 6-15 June 1983

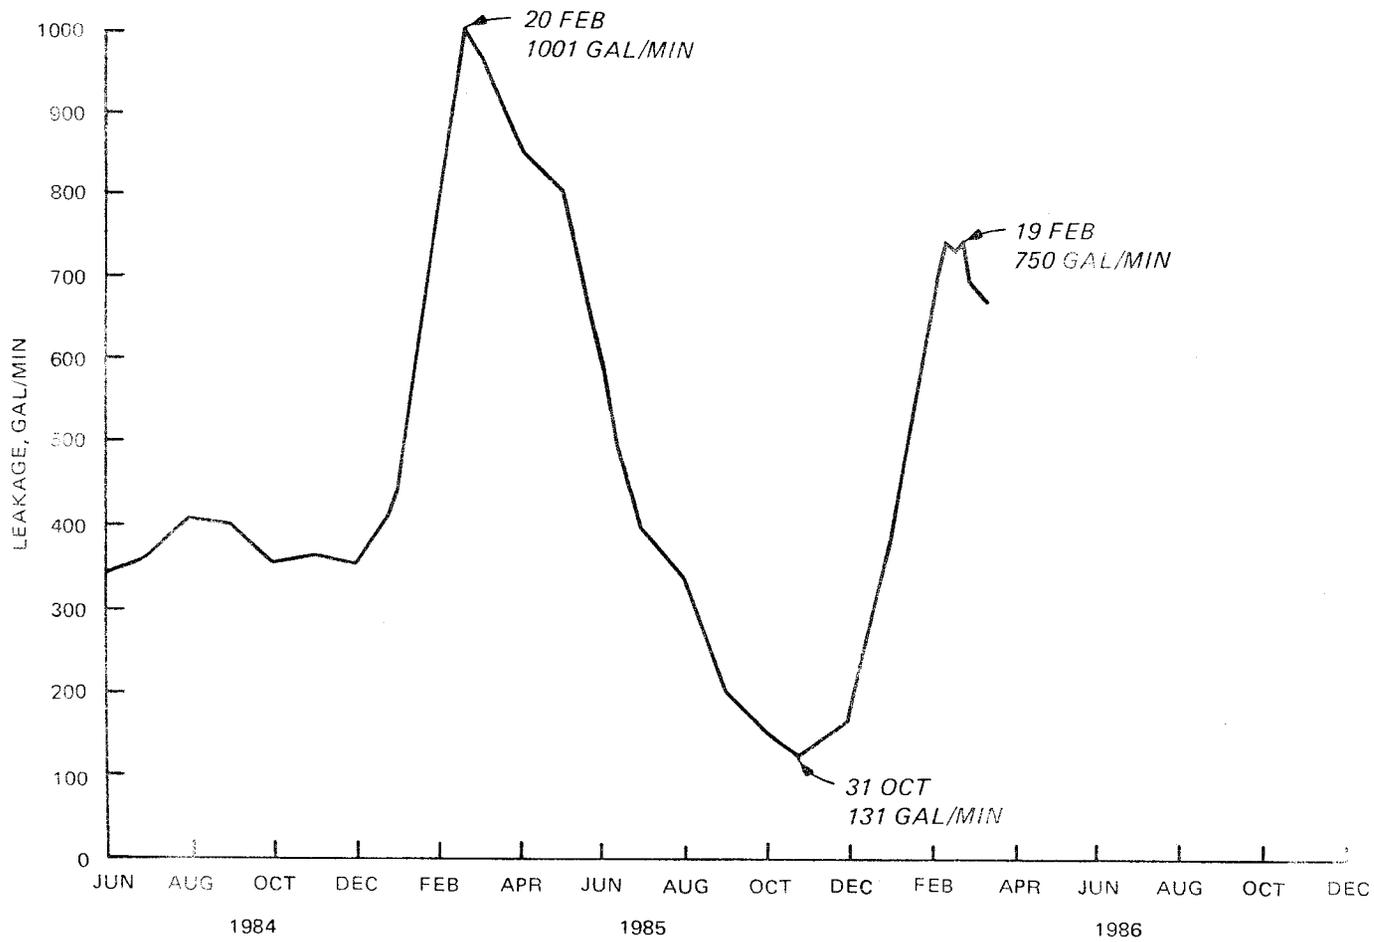
repairs, a maximum leakage of 1,001 gal/min was recorded on February 20, 1985 followed by a steady decline to 131 gal/min on October 31, 1985 (Figure 143). In 1986, the maximum leakage of 750 gal/min was recorded on February 19. Continued measurements and observations are planned through another winter cycle. Based on experience at other dams, it is believed that the formation of calcium carbonate will further reduce the leakage.

Figure 143. Results of leakage measurements, Richard B. Russell Dam

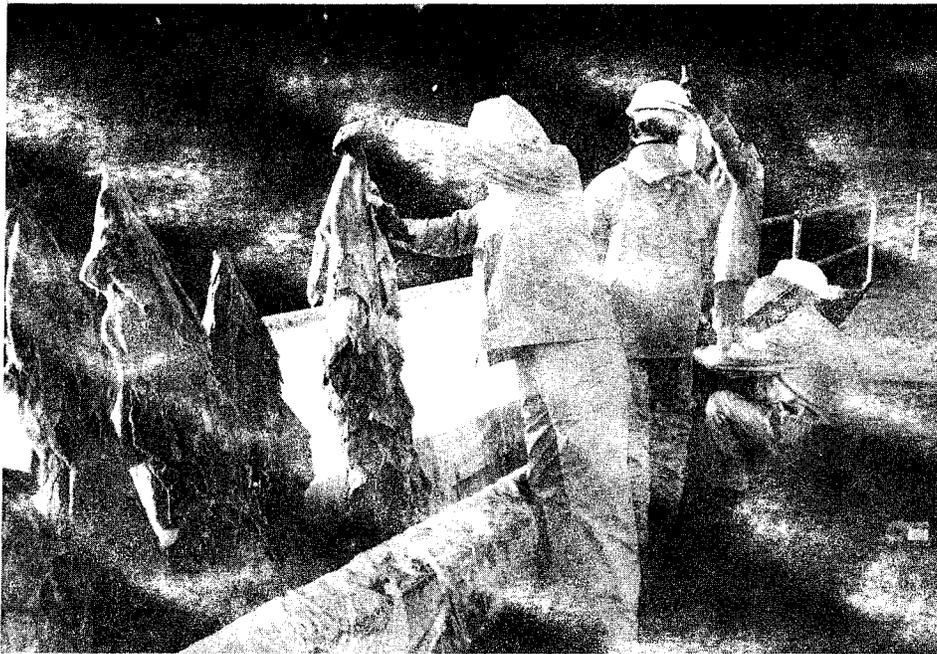
Figure 144. Soaking burlap "Christmas trees" in polyurethane foam grout, Easton Reservoir Dam

287. The grout used was TACSS Flex 44, a polyurethane foam with Environmental Protection Agency (EPA) approval for use around potable water. Because of concerns about the grout being washed through the joint before it set, the grout was not pumped directly into the hole. Burlap was cut into 24-in. squares and attached to a 1-1/2-in.-diameter plastic pipe on approximately 1-in. centers with the pipe through the center of the burlap squares. The pipe sections with the burlap attached were soaked in a long trough filled with the Flex 44 grout (Figure 144). The pipe was removed from the trough and after the excess grout drained off, the pipe was inserted into the hole (Figure 145). The pipe sections were designed to fit together rapidly and lock so the entire 35-ft length of hole could be filled with the burlap and grout

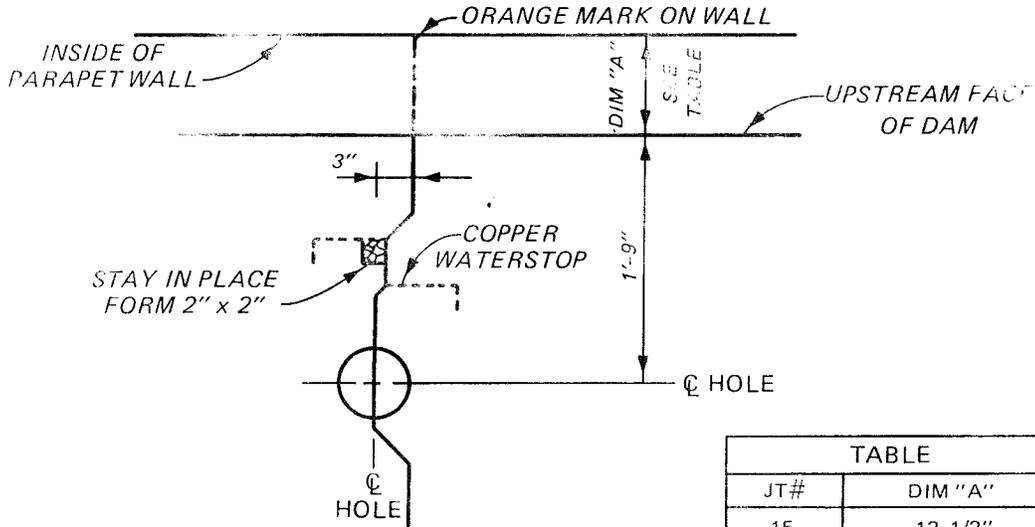
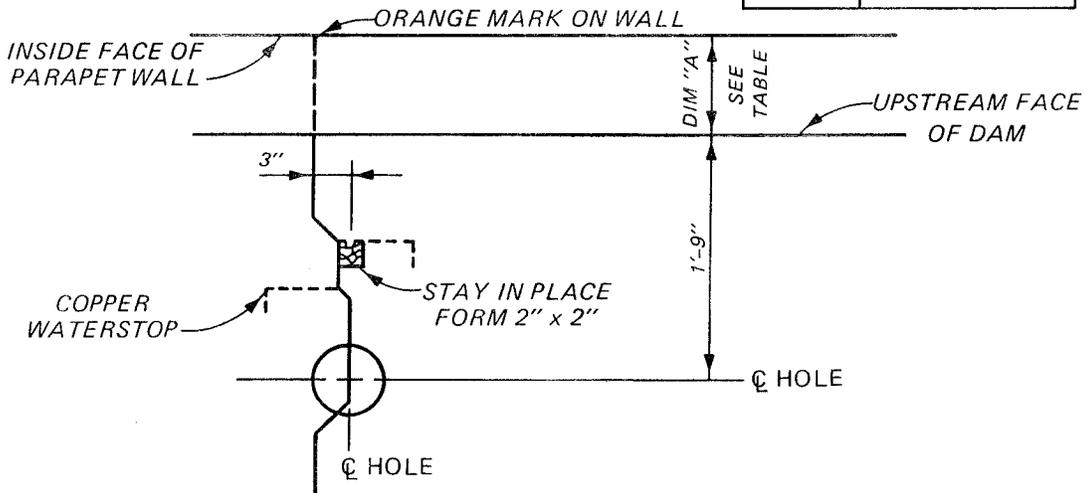
Figure 147. Drill hole locations, Bagnell Dam

293. The apparent wandering of this first hole was attributed to two factors. First, the video showed that the concrete around the waterstop was fragmented and poorly consolidated. Since the theory behind the down-the-hole hammer is that it will follow the weakest plane, it followed the weakened plane along the waterstop. Second, there were several attempts to correct the alignment (away from the waterstop) which may have actually worsened the alignment. The drilling of the first hole was accomplished in 34 hr of drilling; its final depth was 154.8 ft, and it was completed on 14 April 1984.

291. Construction Drilling, Inc. (CDI), the drilling subcontractor, began mobilizing on 3 April 1984. The mobilization took about a day and a half because numerous patches in the roadway had to be planked and bridged over, a requirement of the Missouri State Highway Department. CDI used an Acker track-mounted drilling rig with many modifications specifically for drilling with a down-the-hole hammer. Drilling was accomplished with a 6-in. down-the-hole hammer, a type of rotary/percussion drilling equipment. The head of the hammer pounds as it rotates. At 150 psi, the hammer is operating at approximately 1,000 blows/min. This rate varied as the air pressure at the hammer changed due to depth and frictional losses. In addition to the down-the-hole hammer, a 6-in. core barrel was used to obtain concrete core to verify joint location in the borehole. Drill hole locations are shown in Figure 147.

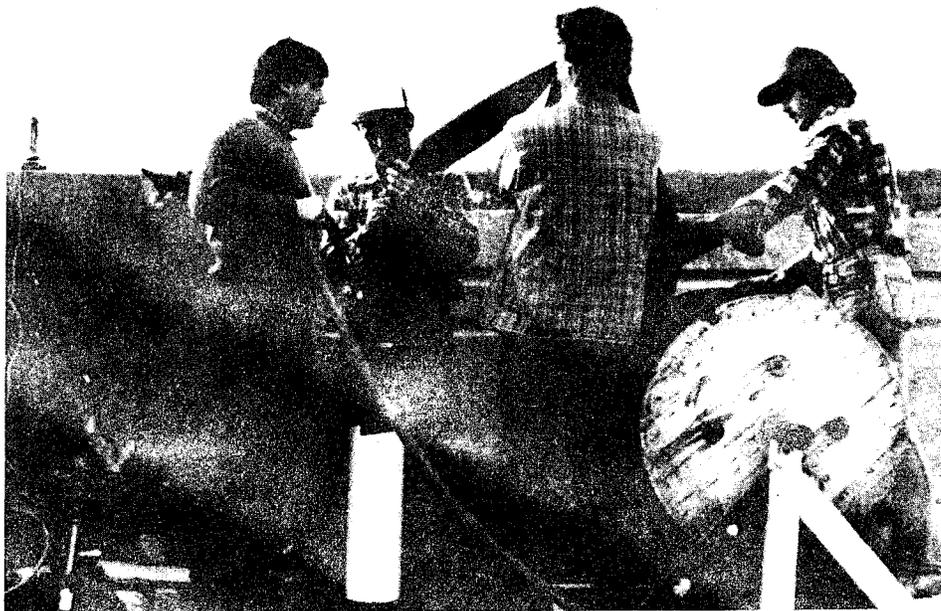
Figure 149. The inversion process underway, Bagnell Dam

302. The intended method of sleeve installation initially was by the inversion process. The inner sleeve was to be delivered inside out to the jobsite. The outer sleeve was to be weighted and lowered into the hole first (Figure 148). Next the inner sleeve was to be attached to a temporary flange at the roadway surface. The inner sleeve would then be inverted down the hole by turning it inside out and filling the annular space with water (Figure 149)

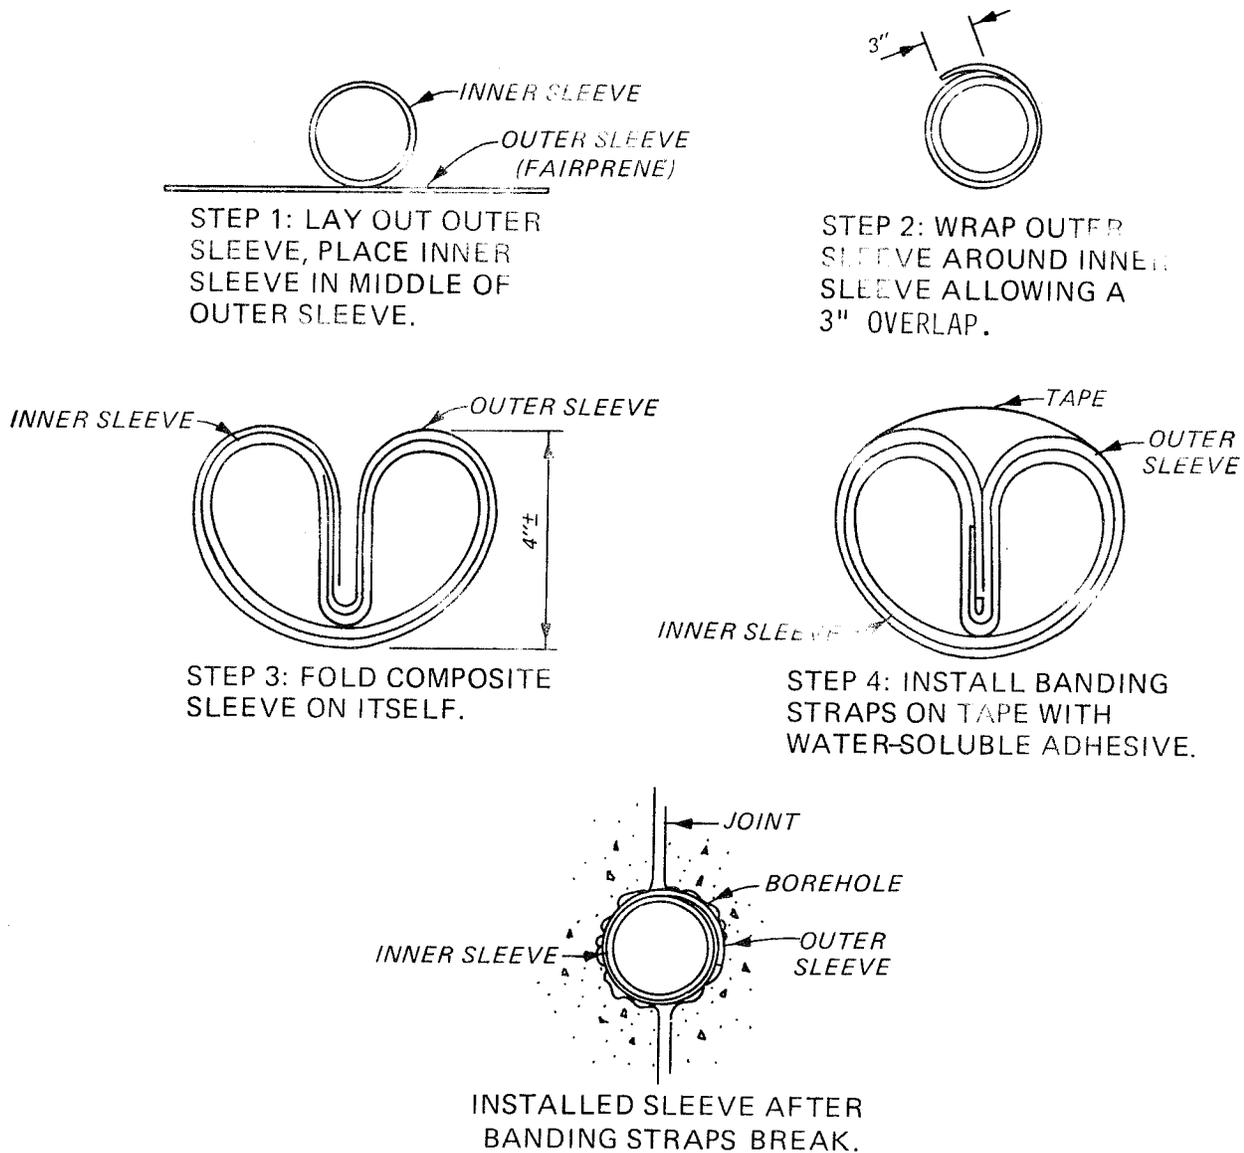
Figure 150. Sleeve installation procedure, Bagnell Dam

304. Subsequent to the failure of the inversion process, an alternate method of installation was employed. This method involved the insertion of both sleeves simultaneously (Figure 150). This was accomplished by weighting one end and lowering the composite sleeve into the hole. This method proved to be fast and effective, and was used in installing all five sleeves. A detailed description of the preparation and installation procedure follows:

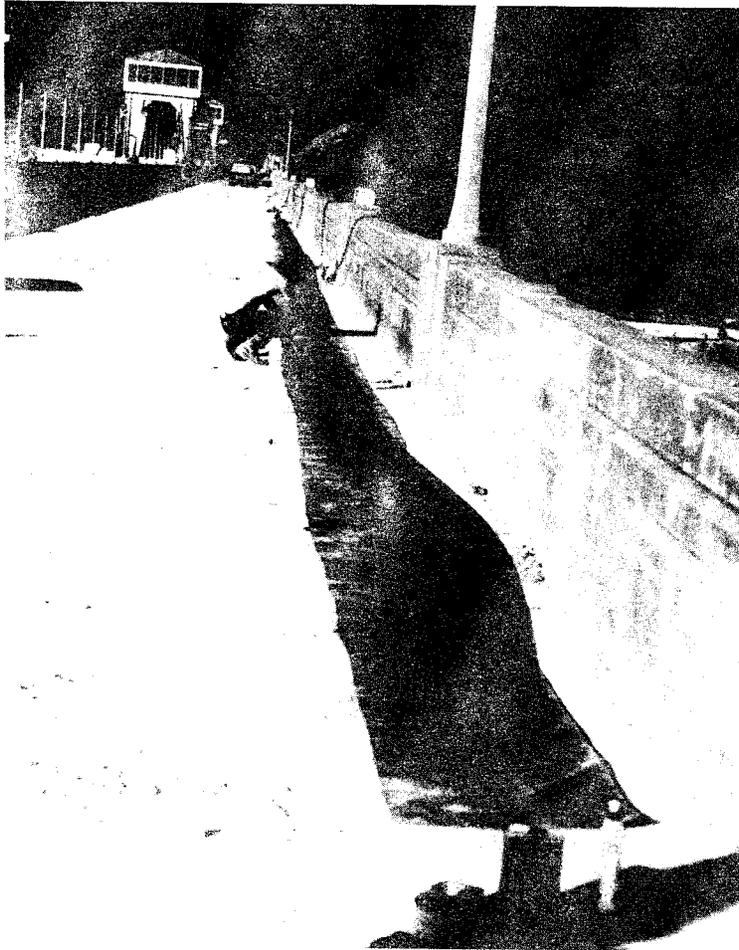
Figure 151. Soap testing the inner sleeve,  
Bagnell Dam

- a. The outer sleeve was rolled out on the roadway deck and cut to the appropriate length. Next, the inner sleeve was placed on the outer sleeve and a packer placed in its open end. Approximately 10 psi of air was then induced into the inner sleeve and it was soap tested for leaks (Figure 151). In the event that any leaks were found, they were repaired by patching with a commercially available tire patch and vulcanizing fluid, a method approved by Rubber Engineer Company.
- b. Once the leak test and any necessary patching was complete, a 10-lb weight was attached to the end of the composite sleeve. The weight consisted of either a piece of 1-1/2-in.-diameter

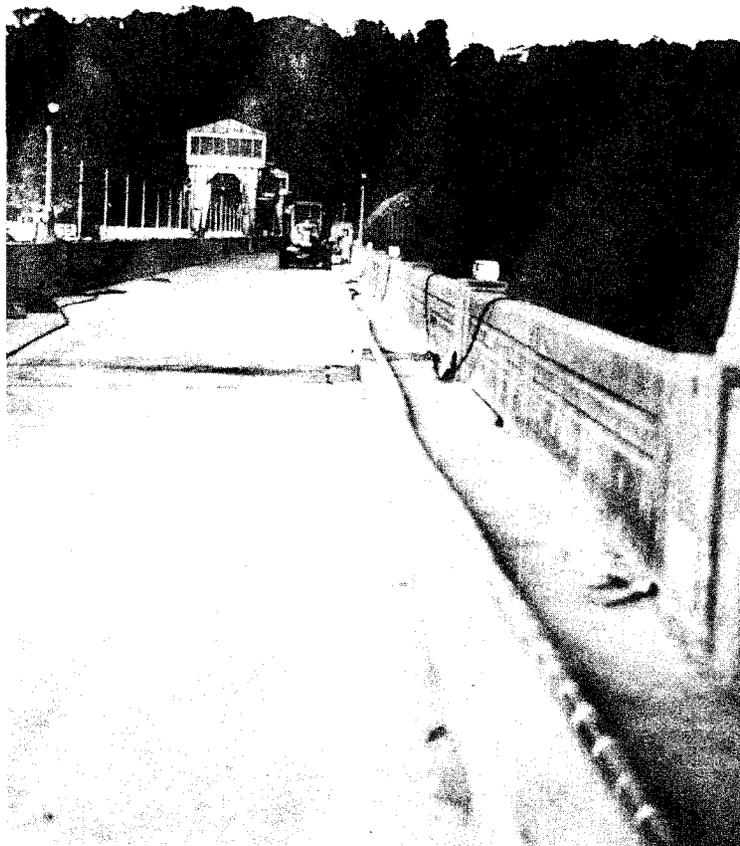
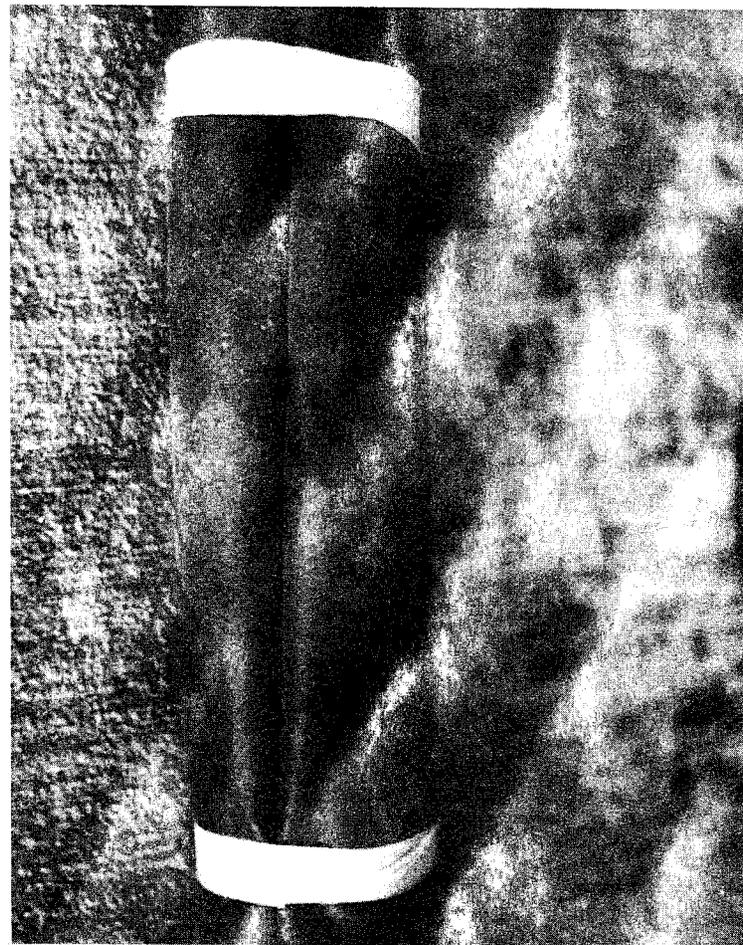
Figure 153. Composite sleeve ready for installation, Bagnell Dam

diameter and secured with masking tape bands spaced at approximately 12 in. on center (Figure 153).

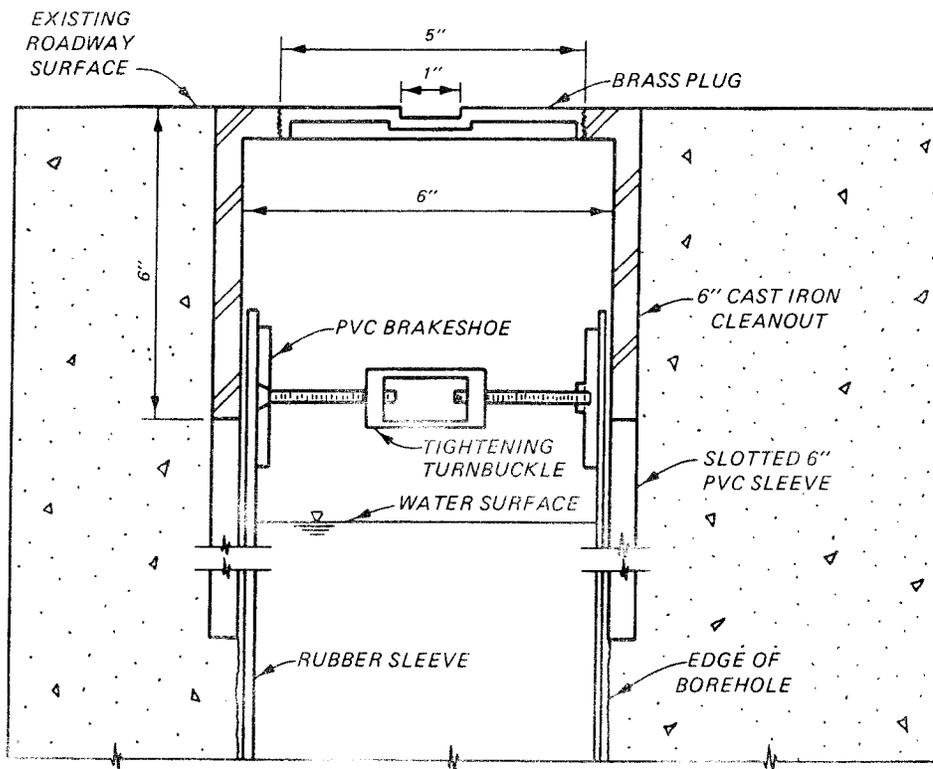
Figure 155. Section through top connection, Bagnell Dam

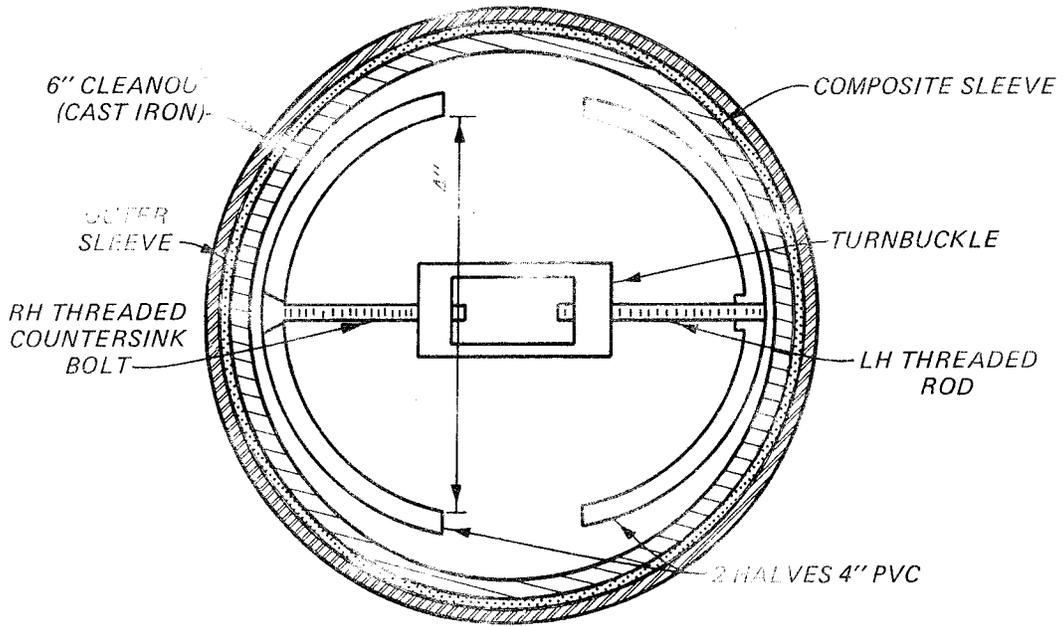
Figure 156. Plan view of top connection, Bagnell Dam

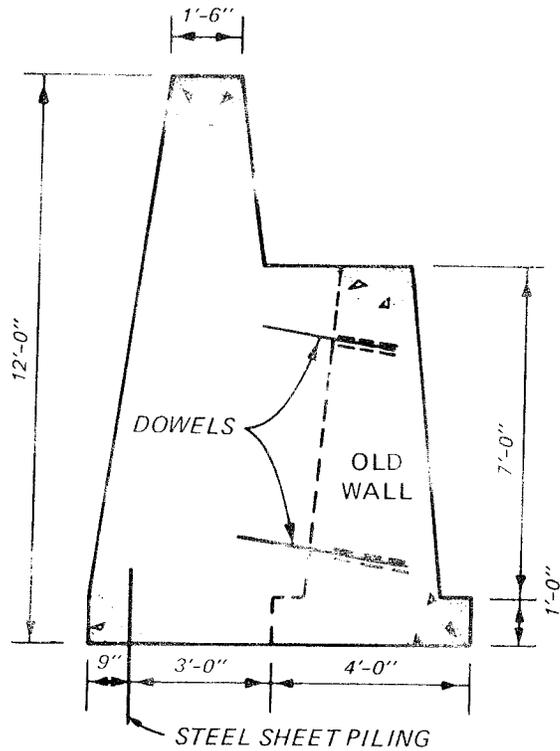
Figure 158. Typical wall section, Caruthersville Floodwall

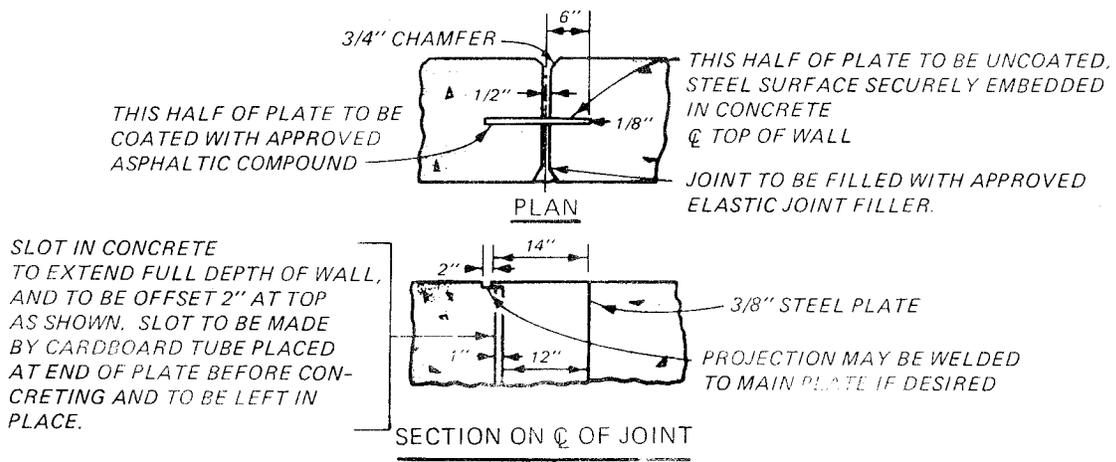
Figure 159. Waterstop detail, Caruthersville Floodwall

310. Concrete cracking and spalling around the monolith joints (Figure 160) was repaired in 1984. Also a new waterstop was installed in 22 of the joints. The center portion of the existing waterstop was removed by drilling a 4-in.-diameter core vertically at the intersection of the steel plate and the joint. A one-piece diamond drill bit 13 ft long was used to core the holes to a depth of 12 ft. The one-piece drill bit was used because the core was divided into four sections by the steel plate and the joint filler and would not stay together in one piece. Also, even if all four pieces of concrete were removed, the drill operators could not free the steel plate until the hole was drilled all the way through the wall. If they had tried to drill deeper after a section of the core was removed, the steel plate probably would have locked up inside the drill bit, causing it to jam. Torque created by such a bit jam could have stripped the threads between the tube sections used to lengthen the drill bit.

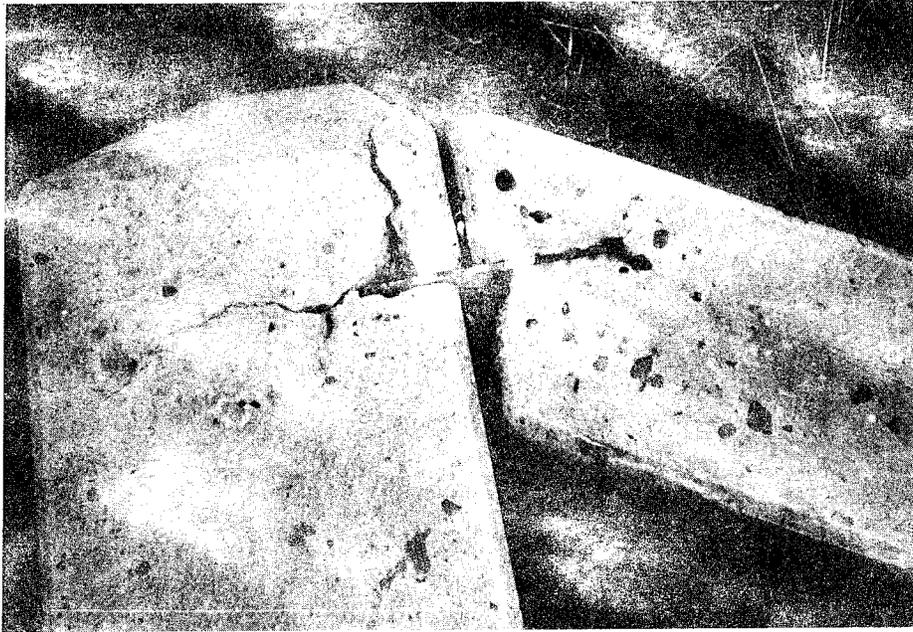
Figure 160. Typical concrete cracking and spalling  
around the steel plate waterstop, Caruthersville  
Floodwall

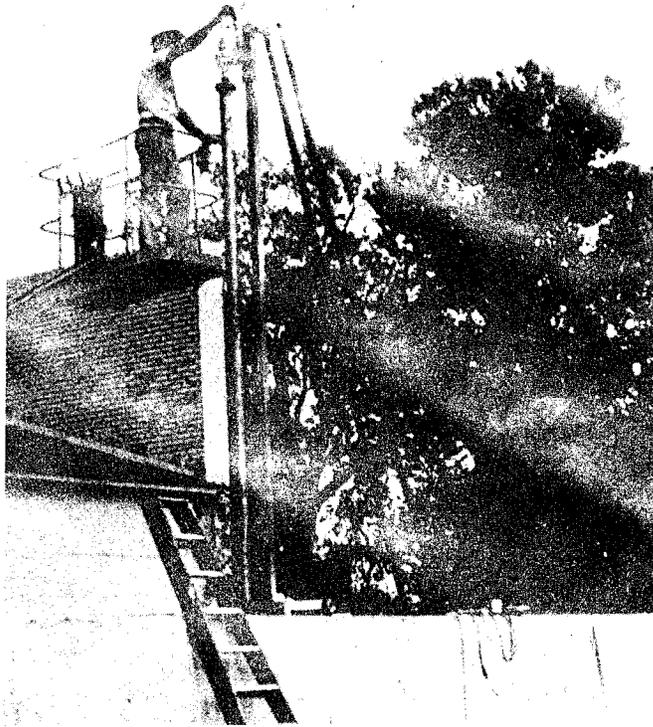
Figure 161. Drilling through existing waterstop, Caruthersville Floodwall

311. The 8-hp air drill was mounted on a 15-ft-high mast that was anchored to the top of the floodwall. Operators had to work from a manlift (Figure 161). Asphalt in the joint filler tended to gum up the drill bit and cause it to jam also. To minimize this, the drillers used a mild soap solution to lubricate the bit. The drill bit still jammed up, however. When this happened, operators had to remove the bit; but when they did this, the concrete and joint filler also often came out. The steel plate remained embedded in the concrete at the bottom of the hole. To keep the plate from flopping around and locking up inside the tube when drilling was resumed, they filled the cored portion of the hole with low-strength grout and then redrilled the entire hole. Because of bit jams, some holes took 7 to 10 days to drill and others took only 1-1/2 days. Dixie Construction Products, Atlanta, Georgia, was the drilling contractor.

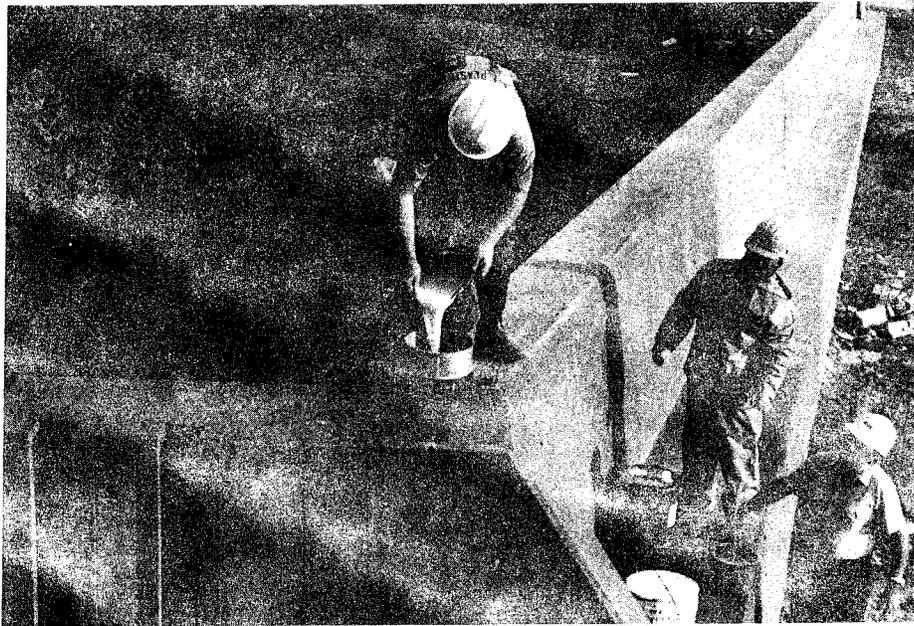
Figure 163. Mixing and placing polyurethane grout, Caruthersville Floodwall

312. After the holes were drilled (Figure 162), they were filled with a flexible grout. FLEX 44, a polyurethane grout distributed by De Neef America, Inc., was used to fill the holes. When FLEX 44 comes in contact with water, it expands and solidifies into a closed-cell flexible sealant. After the grout was mixed by hand with 10 percent water in a bucket, each hole was filled approximately one-third full (Figure 163). The top of the hole was then blocked and through expansion of the grout the remainder of the hole and adjacent joint was filled with the flexible grout.
