1. Report No. NASA TM-X-71867		2. Government Accession No.		3. Recipient Catalog No.	
4. Title and Subtitle OH-58 HELICOPTER TRANSMISSION FAILURE ANALYSIS				5. Report Date

OH-58 HELICOPTER TRANSMISSION FAILURE ANALYSIS

by D. P. Townsend, J. J. Coy, and B. R. Hatvani

Lewis Research Center and
U.S. Army Air Mobility R&D Laboratory

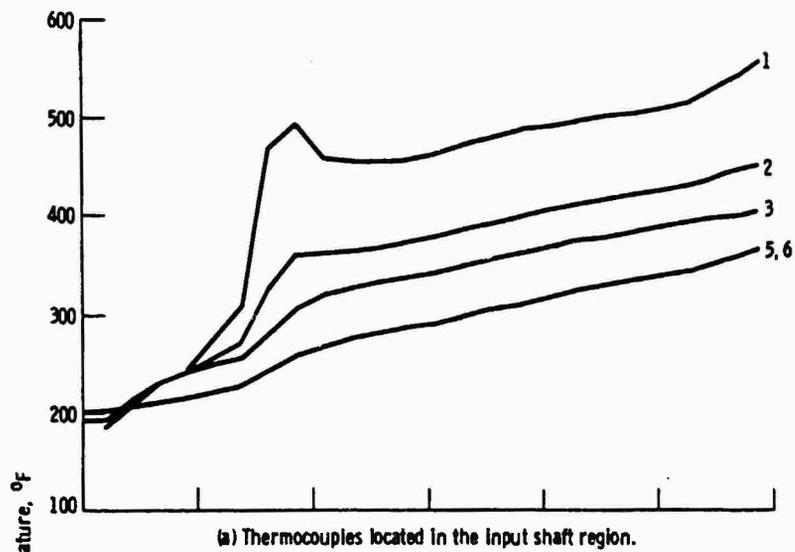
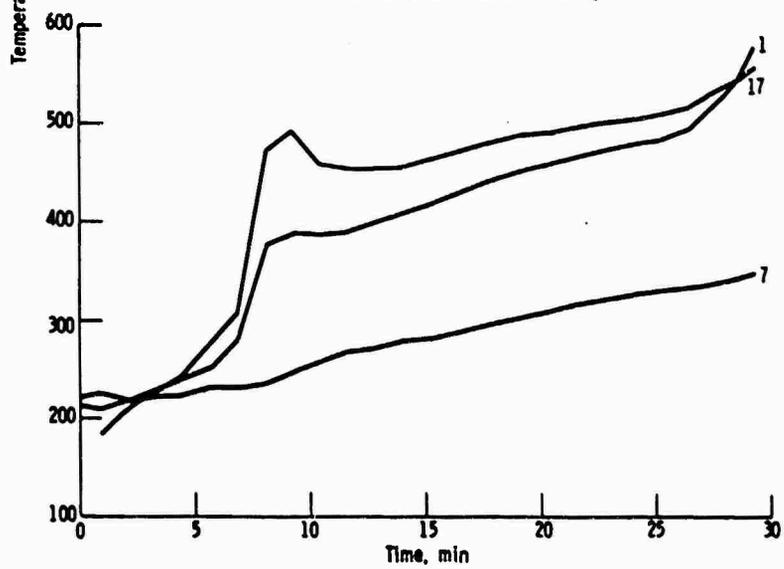
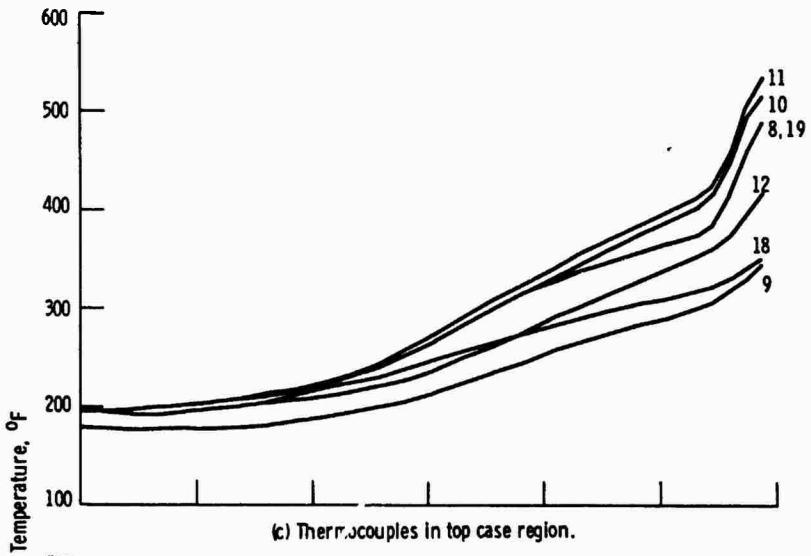
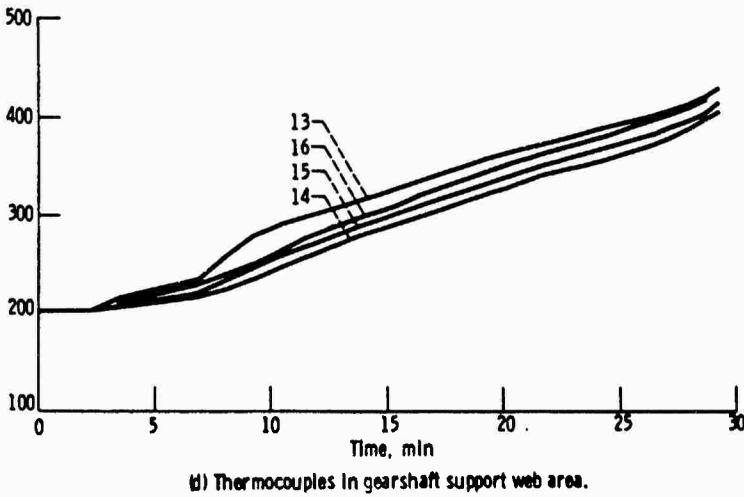
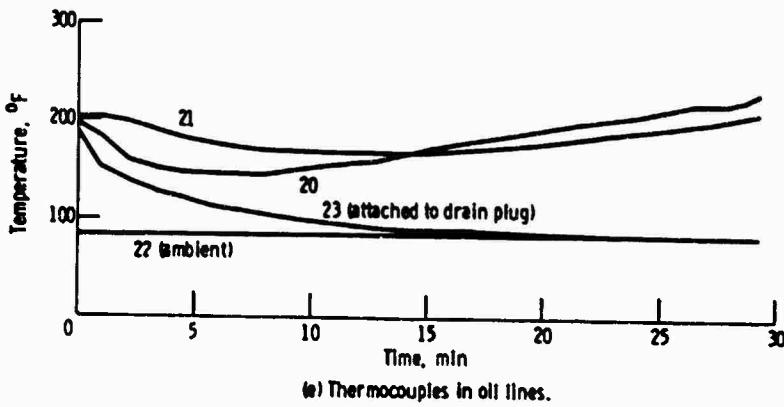
Figure 8(c) shows an increase in temperature in the planet gear area at approximately 13 minutes.

At approximately 27 minutes there is an additional increase in the rate of temperature rise as seen in the planet and (fig. 8(c)), the pinion area (figs. 8(a) and (b)) and to a lesser extent in the bevel gear bearing area (fig. 8(d)). At this point in time the gearbox is approaching complete failure. At these temperatures, the planet gears have very little strength. The lock nut on the planet bearing was being machined by the bevel gear bolt heads (fig. 12). The pinion

Temperatures in the oil system were measured and are shown in figure 8(e). A thermocouple placed near the transmission recorded the ambient temperature of the test cell. It was $84 \pm 1^{\circ}$ F for the duration of the test. The thermocouple attached to the oil drain measured the slow temperature decay to ambient conditions from the time the drain plug was removed. The two thermocouples in the oil line measured the initial reduction in temperature that resulted from the disappearance of hot oil in the lines. The temperature later rose again in response to the heating by conduction from the hot gearbox.

Figure 8. - Temperature as a function of time for survivability test of OH-58 transmission. Input speed, 6200 rpm; output torque, 36 000 in. - lb.

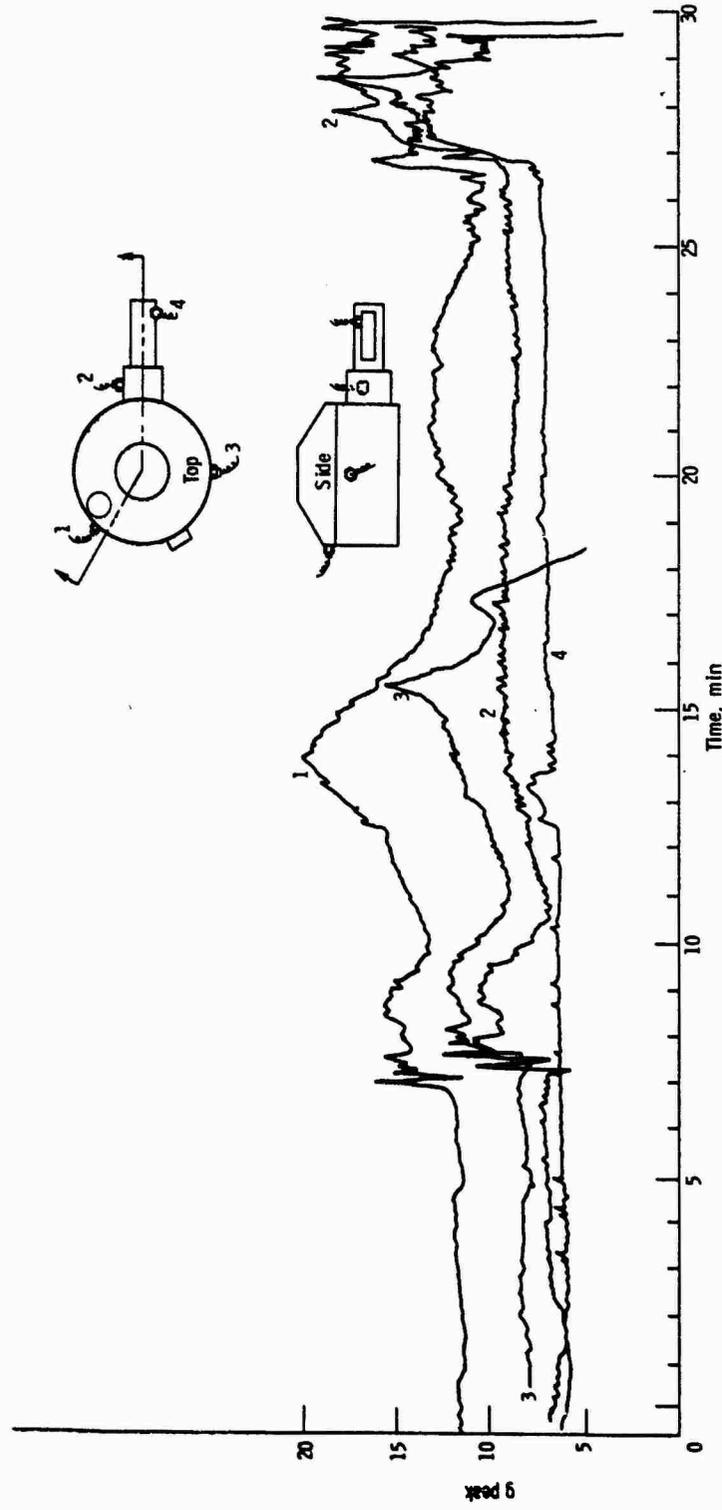
Figure 13 shows the record of the four acceleration peak amplitude levels as a function of elapsed time from the moment the lubricant drain was opened. The respective numbers in the figure indicate the location of the accelerometers, shown in figure 13. The accelerations are plotted on a logarithmic scale. Accelerations were measured (1) in the horizontal direction on the top case in the region of the ring gear, (2) in the horizontal direction on the lower case near the input spiral bevel pinion gear shaft, (3) in the horizontal direction on the bottom case in the plane of the spiral bevel gear, and (4) in the vertical direction on the outboard end of the slipping unit. The acceleration peak levels were lowest on the slipping unit and highest on the top case near the planetary ring gear. It was expected that the highest vibrations would be in the region of the ring gear on the top case. This is because the planet spur gears are the heaviest loaded gears. Also, the spur gears should have higher dynamic loads than the spiral bevel gears.

Figure 13. - Time history of acceleration measured on transmission during survivability test. Input speed, 6200 rpm; output torque, 36 000 in. - lb.

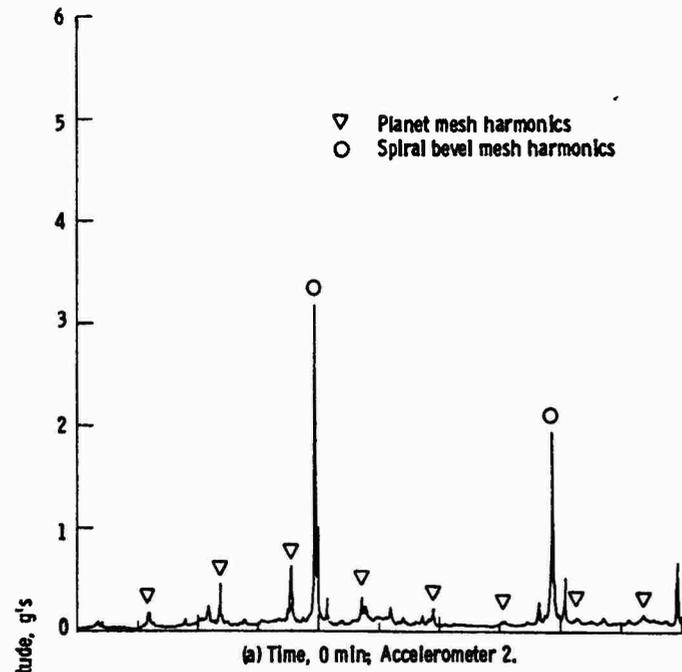
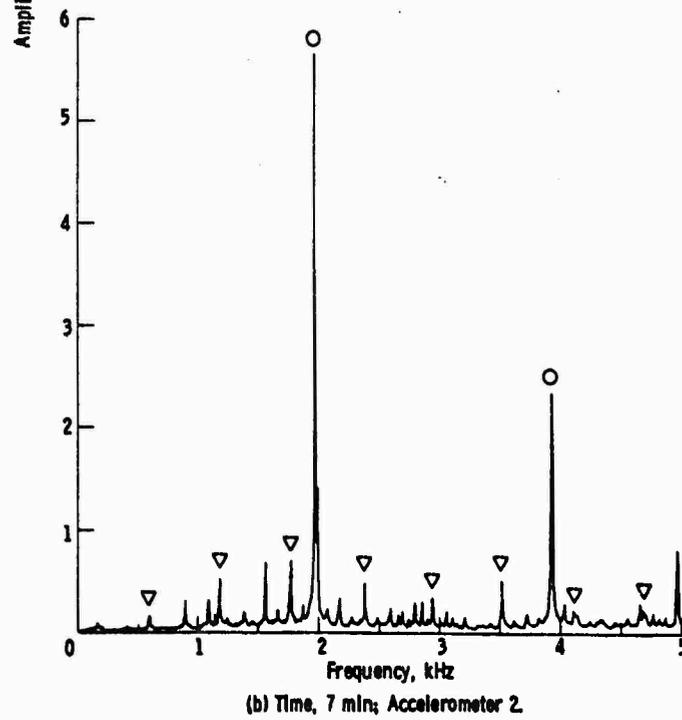
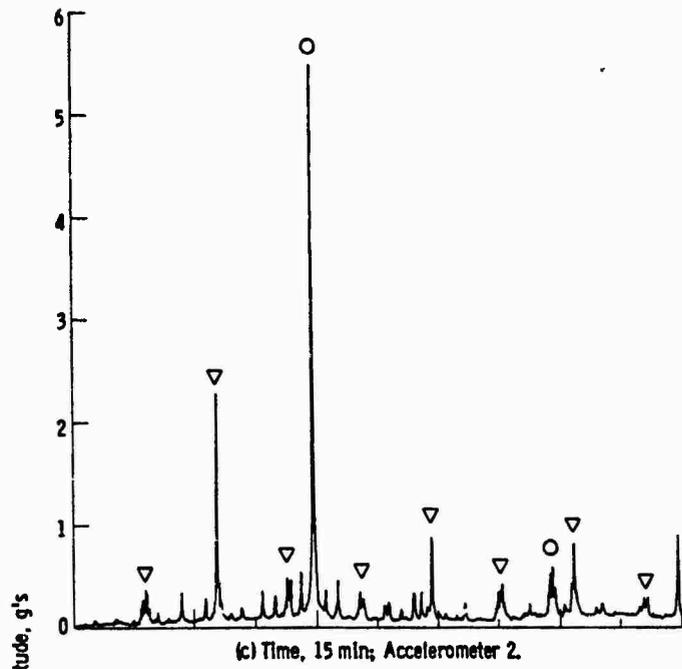
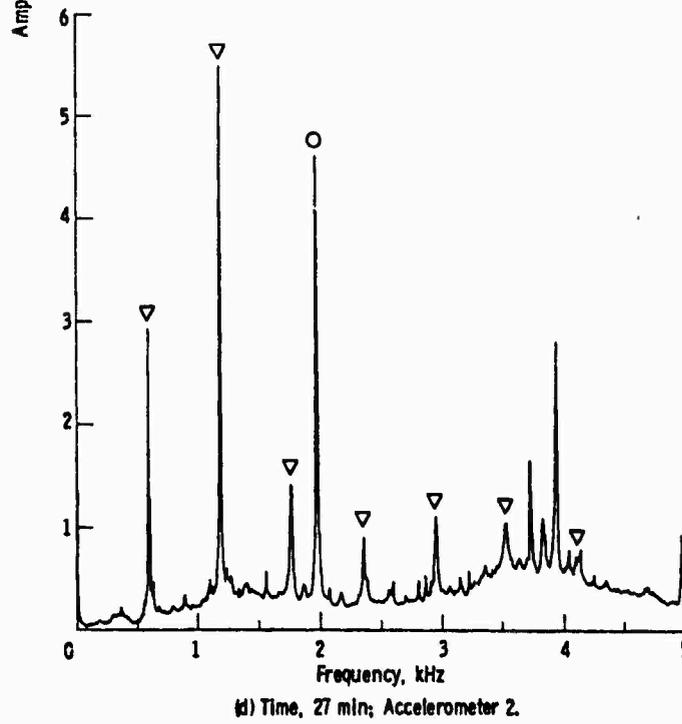
The results of the spectrum analysis are shown in figure 14 for the input pinion location and in figure 15 for the ring gear location. Figures 14(a) and 15(a) show the frequency content of the normal transmission. The next three time periods at which a spectrum plot was obtained were selected in order to show the frequency content of the signal immediately after the several stages of high amplitude vibrations were observed. A comparison of the spectra for these time periods show how the transmission vibration signature changes as the shut-down failure point is approached.

After 7 minutes of operation two classes of change in the transmission signatures are noticed by comparing figures 14(b) and 15(b). The first is an increase in the amplitude of the 888 Hz frequency line. This is the frequency generated if it is assumed that one row of the rollers in the planet bearing has cage debris on it. The pulsating effect that this would have on the input mesh is seen by the presence of upper and lower side band response at 1963 ± 888 Hz. This is caused by the periodic variation in torque when the rollers roll over the cage debris.

component at 1550 Hz was also observed when comparing figure 14 (b) with figure 14 (a). It was speculated that this was a fourth lower side band of the bevel mesh fundamental frequency ($1963 - (4 \times 103)$). The immediate source of this component is unknown.

Figures 14(c), 14(d), 15(c), and 15(d) indicate that two primary changes in the nature of the spectra have occurred. The first is the large increase in the fundamental spur mesh frequency and its harmonics. This indicates that imperfect mesh action is occurring at the sun-planet-ring gear meshes. Secondly, there is a large amount of sideband activity around the spur mesh frequencies. The buildup of sideband amplitudes indicates that the planet bearings were in very poor condition. The increased runout and misalignment of the bearings caused by cage loss and roller skewing is the cause of the modulation. There is also a large level of broadband acceleration that is especially noticeable on figure 14(d). This is caused by the skidding of the badly misaligned rollers in the planet bearing. The amplitudes of acceleration are very low in the 2 to 5 kHz range in figure 15(d). This is attributed to the high temperature (500° F) softening of the cement used to mount the accelerometer.

Figure 14. - Input pinion amplitude spectrum for survivability test. Input speed, 6200 rpm; output torque, 36 000 in.-lb.

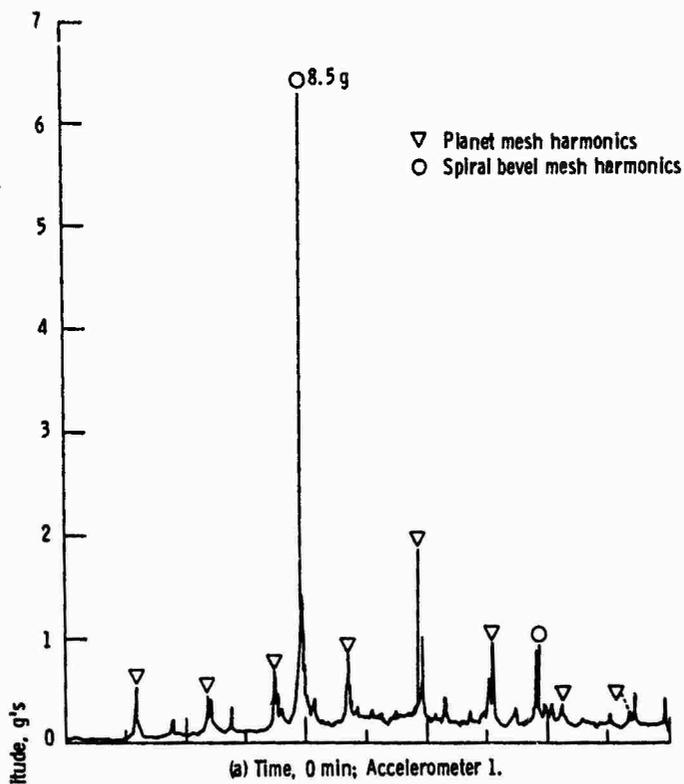
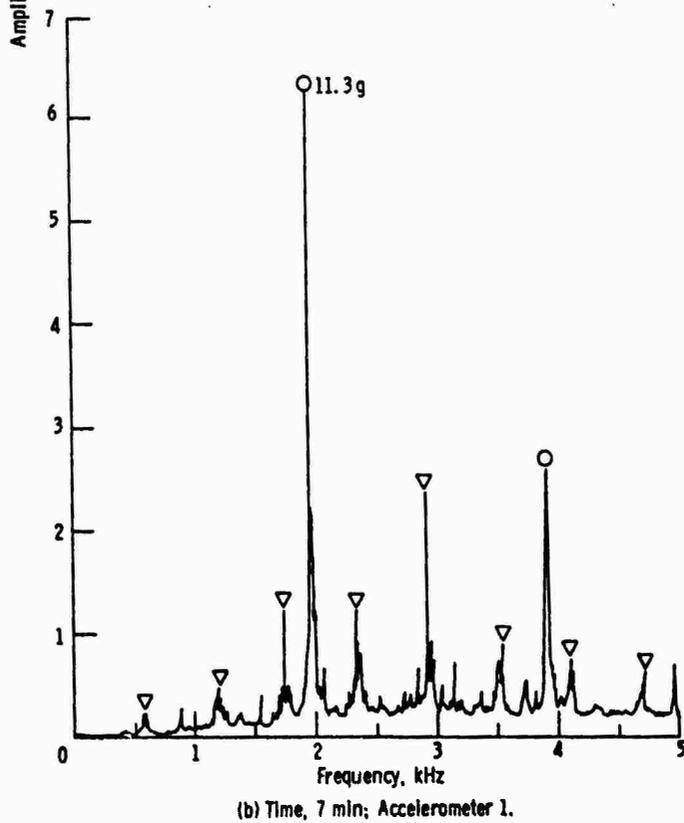
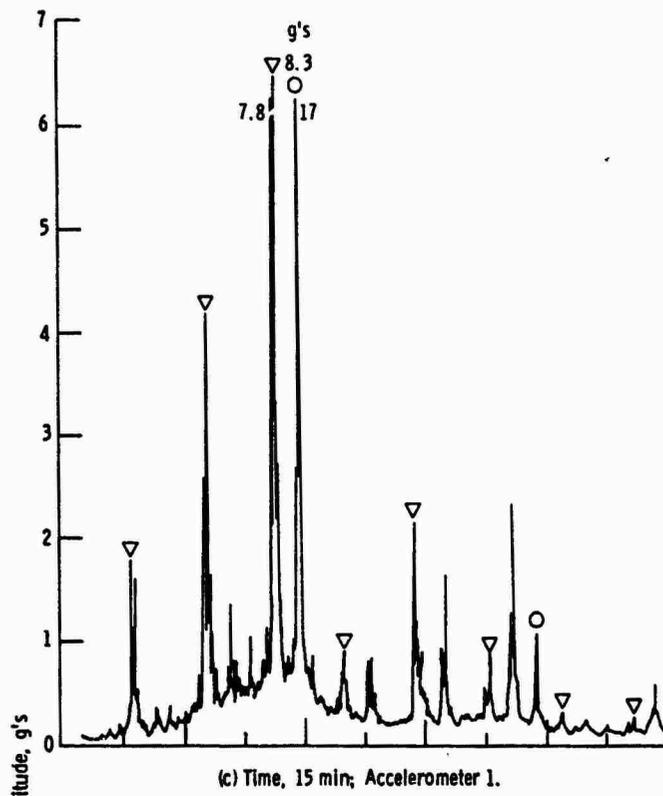
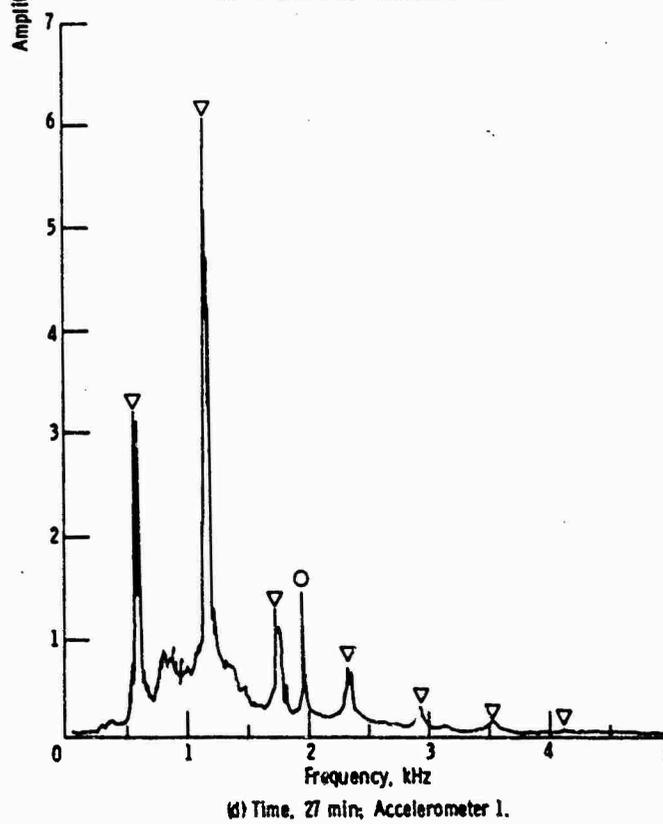
Figure 15. - Ring gear amplitude spectrum for survivability test. Input speed, 6200 rpm; output torque, 36 000 in.-lb.

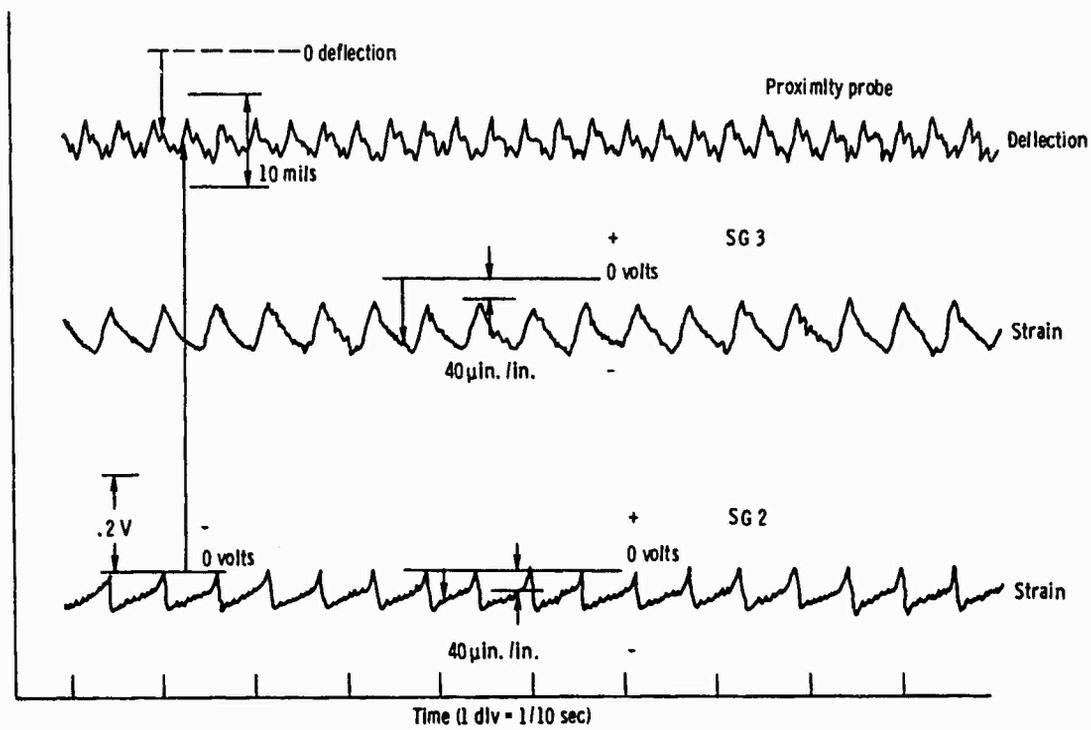
The raw signals from the strain gage amplifiers were recorded on magnetic tape. Figure 16 shows a sample of the time trace of the strain gages. Strong pulsations at the planet pass frequency are clearly present in both of the plots. Also shown in figure 16 is the signal from the proximity probe which measured the deflection of the spiral bevel gear.

Figure 16. - Typical time traces played back from magnetic tape recording of bevel gear deflection and top case strains. Input speed, 6200 rpm; output torque, 56 000 in. - lb; oil-out temperature, 200° F.

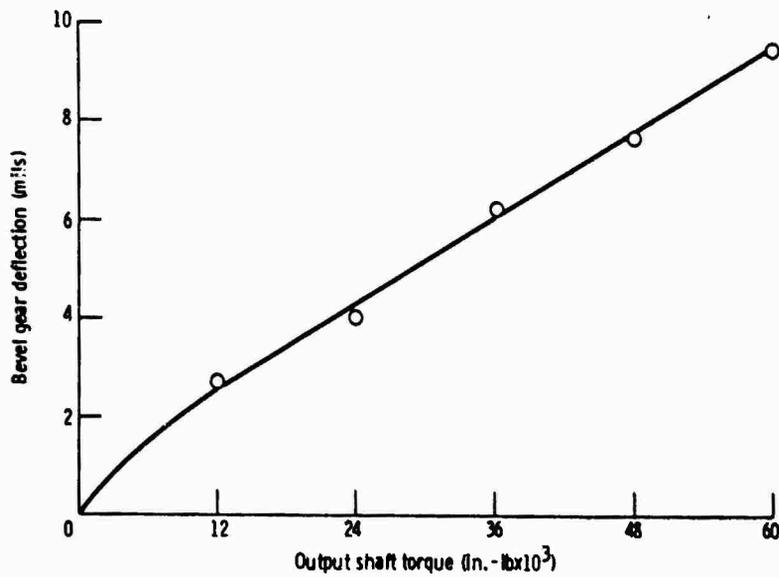
Figure 17 shows the bevel gear deflection as a function of output shaft torque. The deflection is very nearly a linear function of the torque with the spring rate being approximately 6.8×10^6 in.-pound/in. This deflection can cause reduced load capacity and life (ref. 2).

Figure 17. - Bevel gear deflection as a function of output shaft torque. Input speed, 6200 rpm.

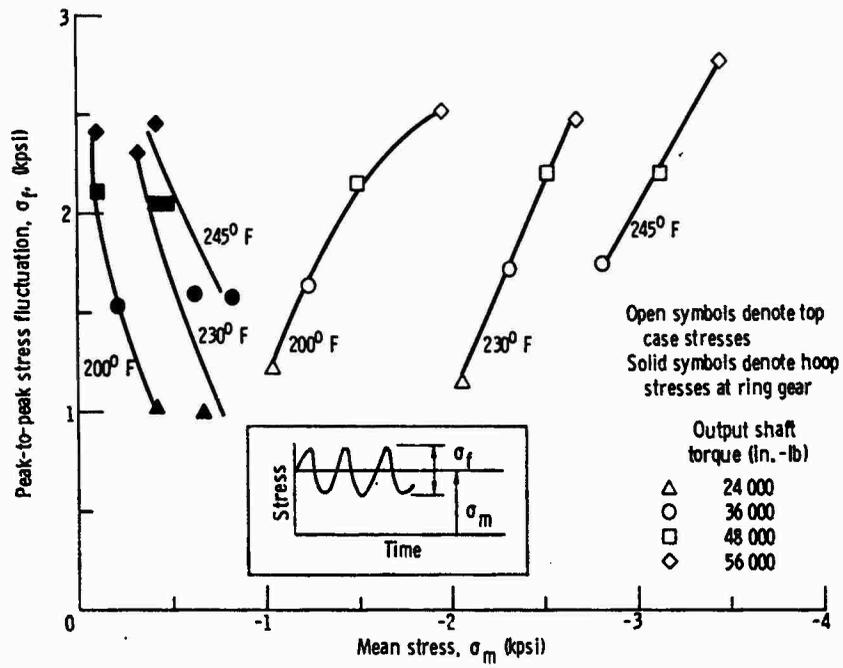
Figure 18 summarizes the stress values that were obtained from the strain gage measurements. The stress results are reported as having a mean value and a peak-to-peak fluctuating value. Under all parametric temperature and torque conditions, the mean stresses on the top case did not exceed 3350 psi compression. The fluctuating peak-to-peak values were less than 2700 psi.

Figure 18. - Variation of measured stresses with output shaft torque for different oil out temperatures. input speed, 6200 rpm; oil-out temperature, 200° F.
