REPORT NO. AML NAM AE 540001

AERONAUTICAL MATERIALS LABORATORY REPORT ON

OPERATION CROSSROADS, TARGET AIRPLANE,
MODEL TEM-3E, SERIAL NO. 69169;
TEST OF

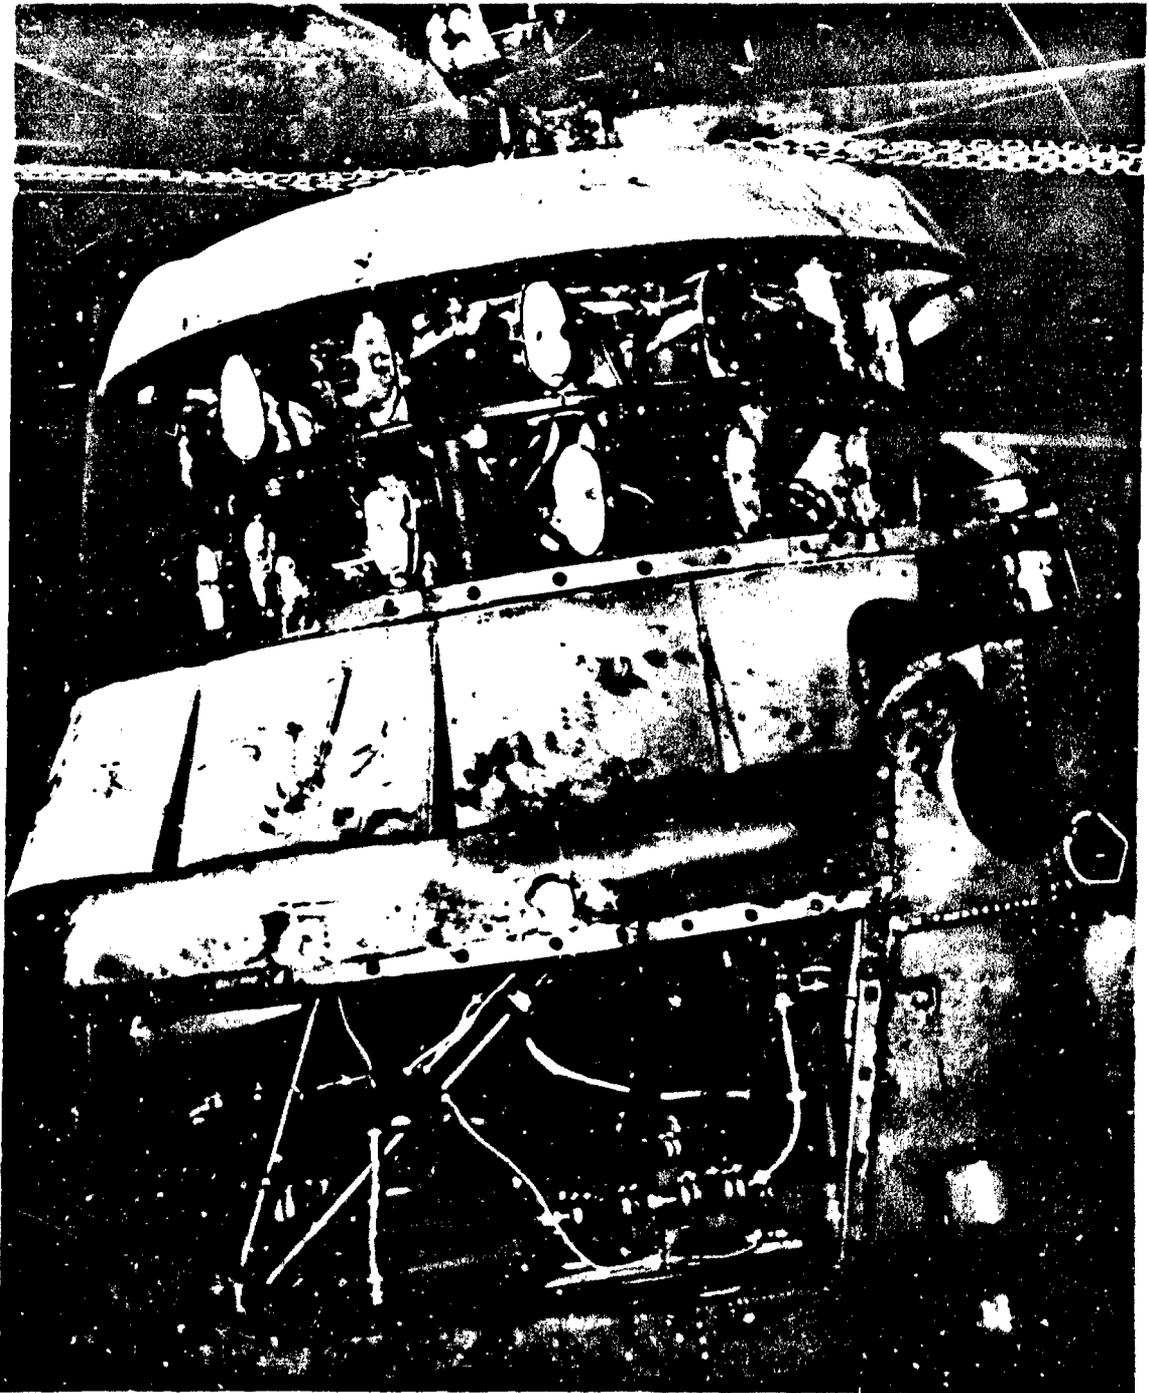
(1) All exposed metal parts (particularly forward of the fire wall) were heavily corroded and rusted; Aluminum parts were coated with a thick layer of gray dust, probably aluminum oxides formed during exposure to the weather and salt atmosphere.

I NP(3)-256082(L)-6-48
TBM-3E TARGET AIRPLANE - ENGINE AND ACCESSORIES
RIGHT SIDE VIEW

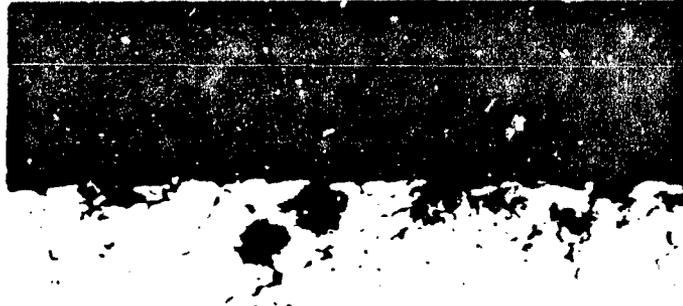
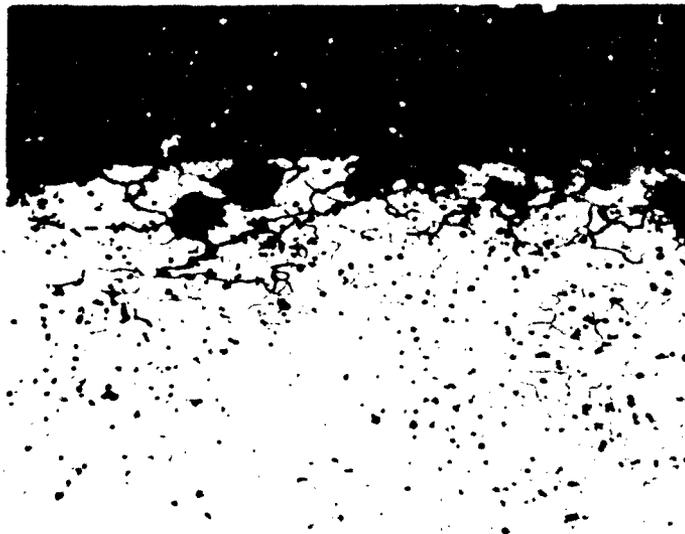
PLATE 3

A. Photomicrographs of specimens subjected to intergranular corrosion tests are shown on Plates 3, 4, 5 and 6. The photomicrographs showed the material to be moderately susceptible to intergranular corrosion.

PHOTOMICROGRAPHS SHOWING RESULTS OF INTERGRANULAR CORROSION STUDIES ON METALS

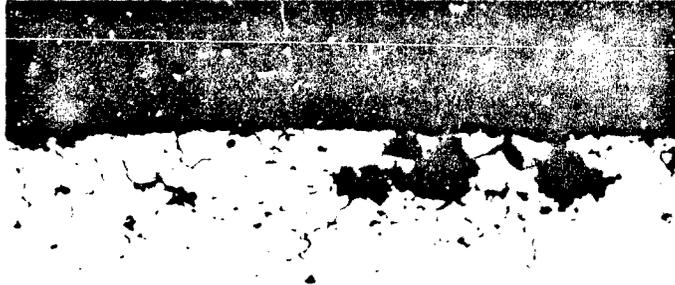
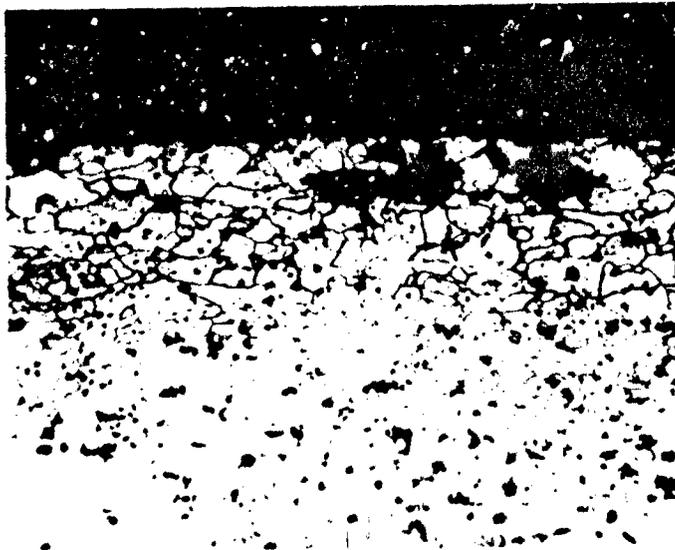
PLATE 4

PHOTOMICROGRAPHS SHOWING RESULTS OF INTERGRANULAR CORROSION STUDIES ON METALS

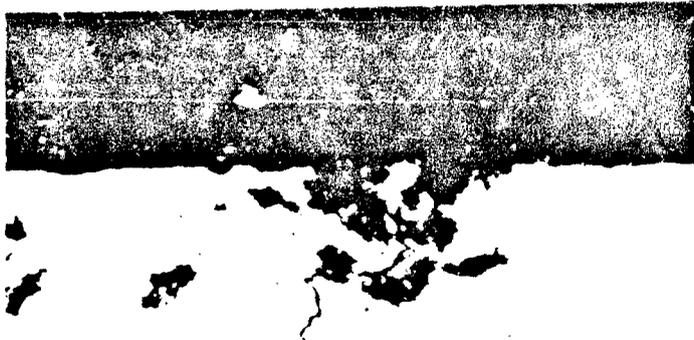
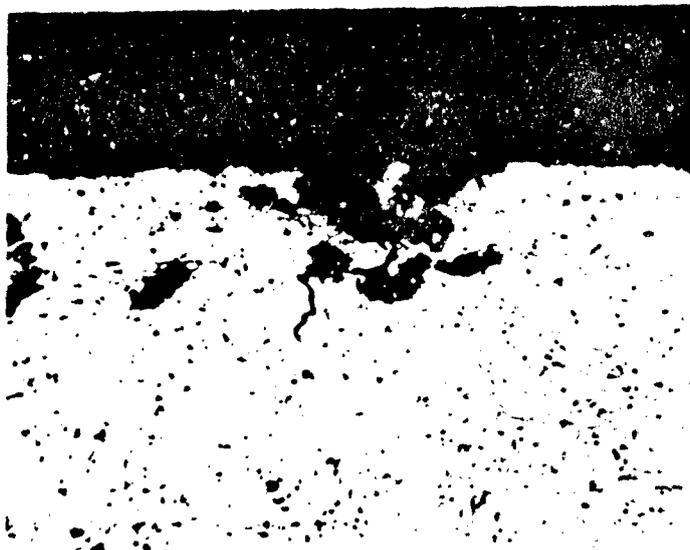
PLATE 5

MICROPHOTOGRAPHS SHOWING RESULTS OF INTERGRANULAR CORROSION STUDIES ON METALS

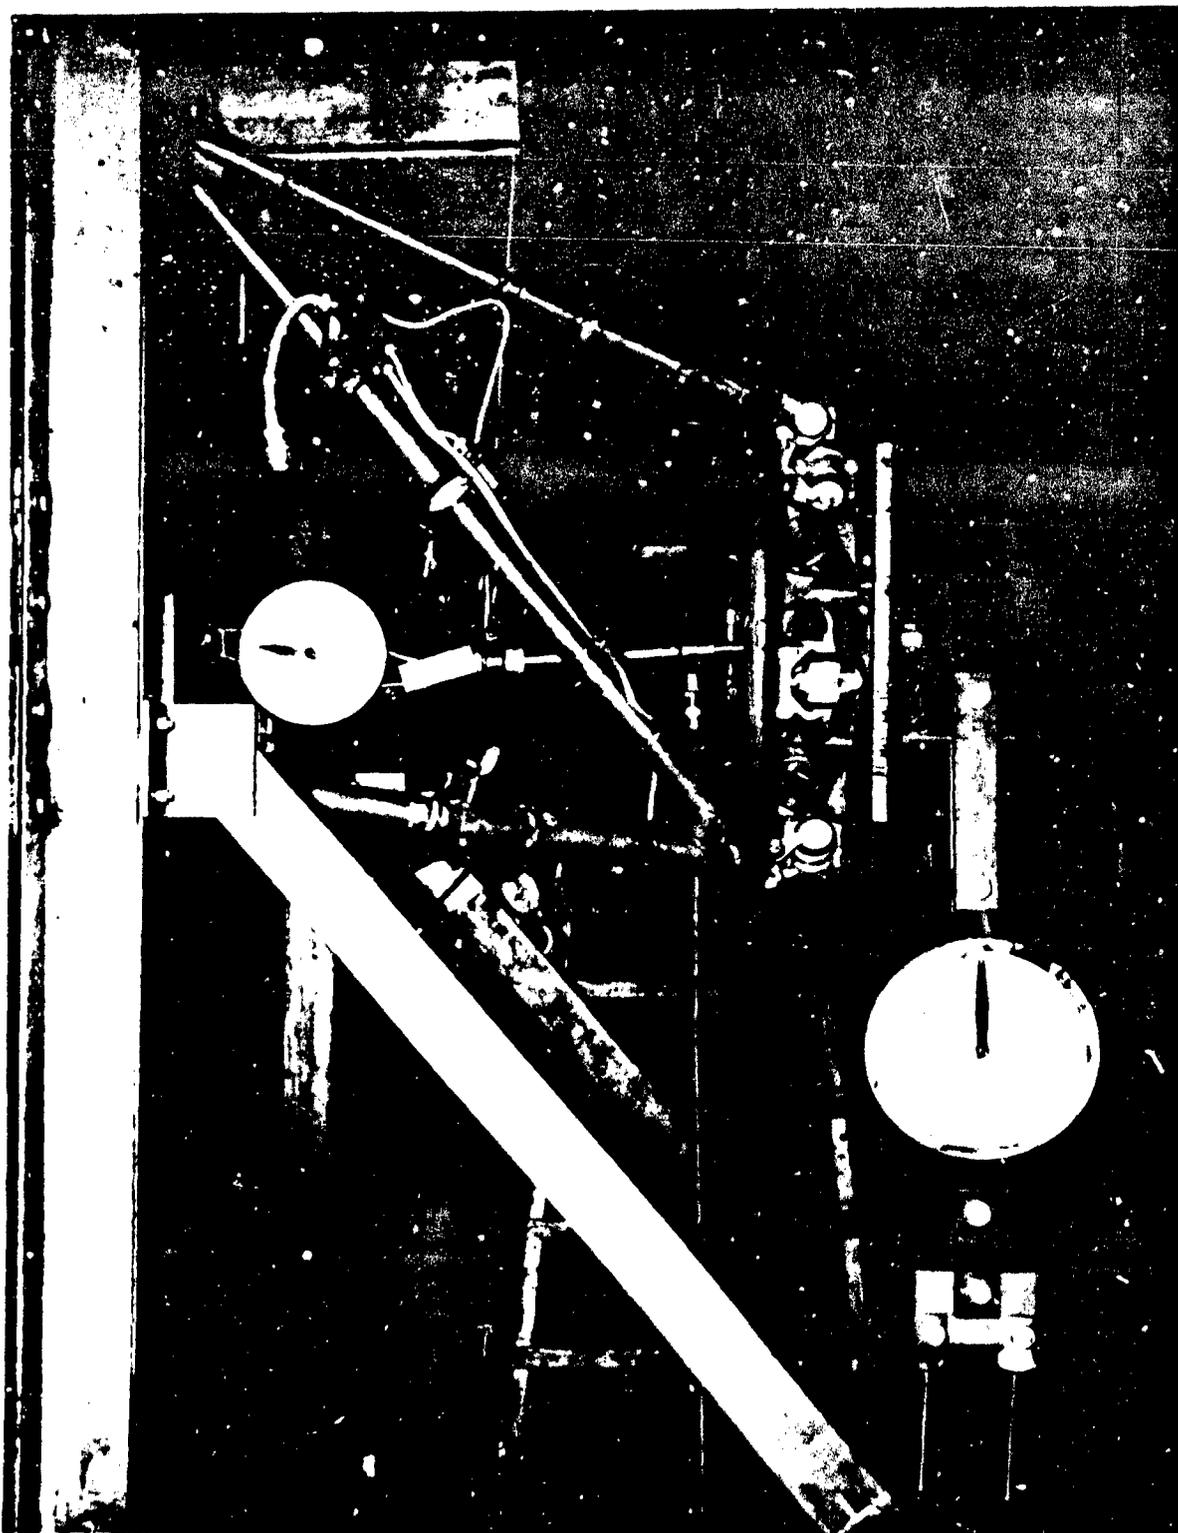
NP(3)-262397(L)-3-48
TBM-3E TARGET AIRPLANE - ENGINE MOUNT TEST SET-UP
SIDE VIEW
0 171!
PLATE I

(1) In the first test, 200% of limit load, as given in Figure 6-1 of ref (c), was applied to the engine mount as shown in Plates 1 and 2. After reaching 200% limit load, all load was removed and the tubes were checked. No permanent bending of the tubes was apparent at this time. The mount was then reloaded to 200% limit load when the lower starboard tube (Tube D) failed in compression as shown in Plate 3. It is to be noted that Tubes B and D are critical in tension and compression, respectively, instead of Tubes E and C as stated on Page 21 of ref (c). For this condition, the contractor's stress analysis (Grumman Report No. 2012, Page 30) shows Tube D to be the critical member with a calculated margin of safety of 6.5%. Q 17

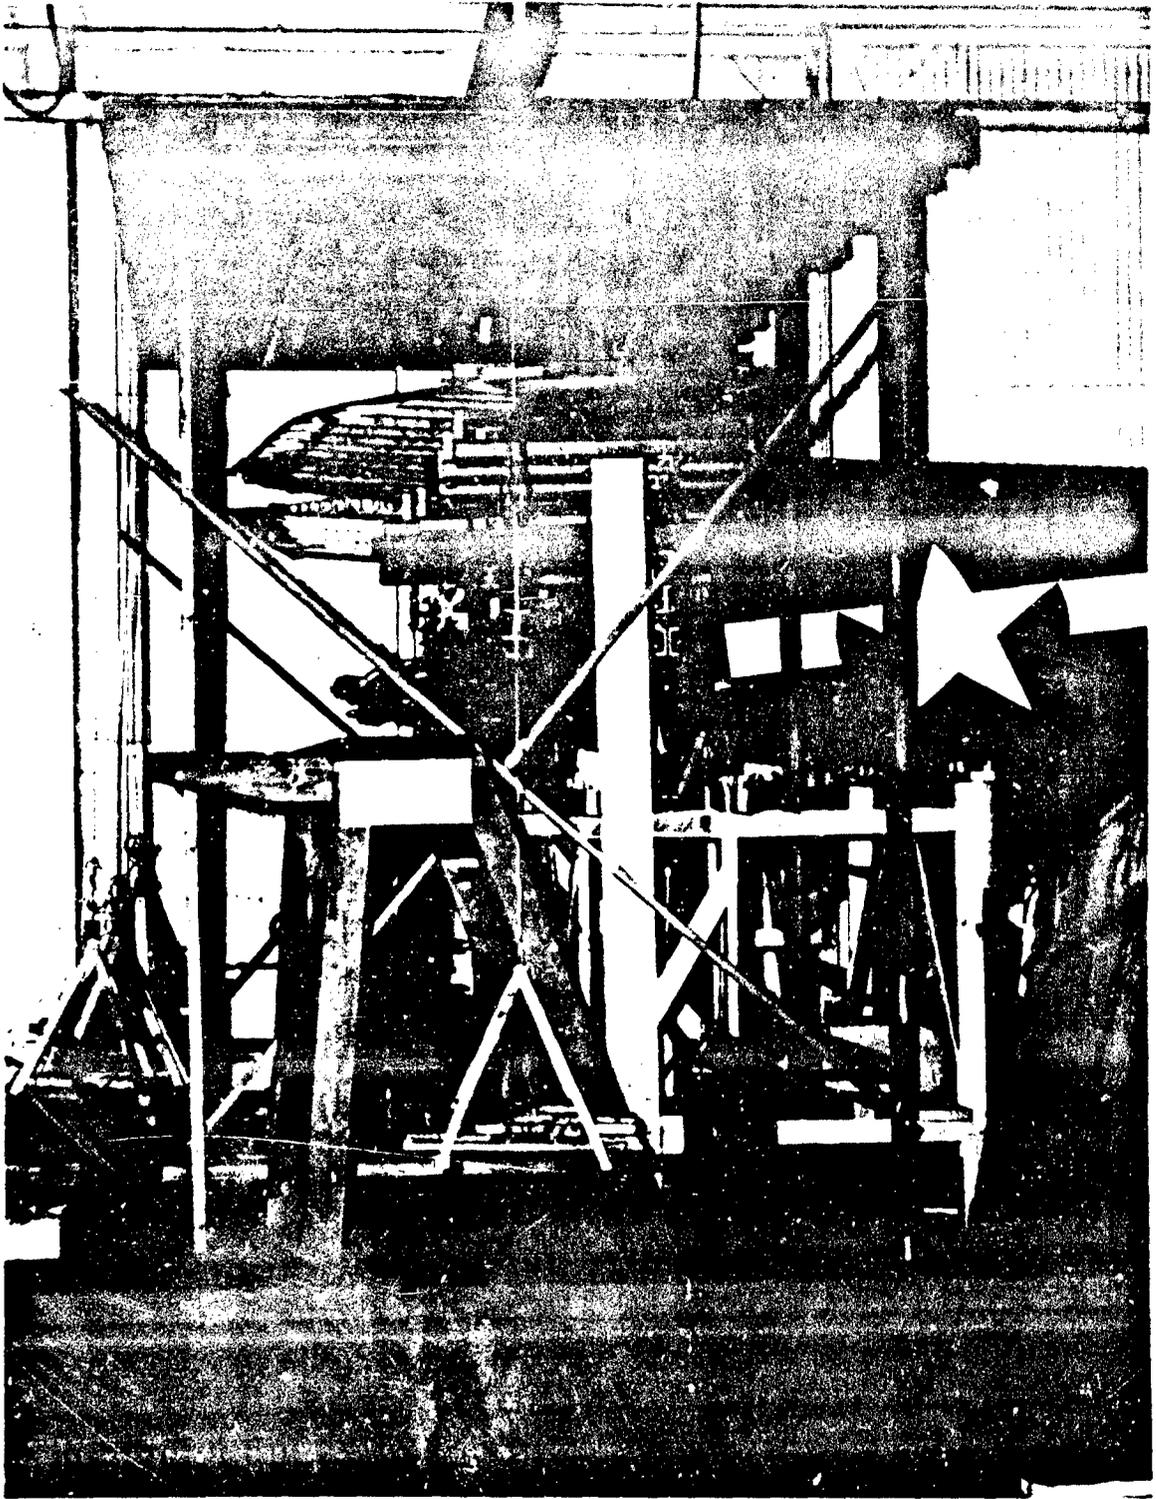
PLATE 4

(b) Horizontal Stabilizer Test - For this test, the fuselage was supported in the region of the stabilizer carry-through structure. Because of excessive blast damage to the port stabilizer, a replacement stabilizer was obtained from TM-3E airplane, BuNo 68074, and was used in the test. The loads shown in Figure 2-1 of ref (c) were applied to the stabilizer by use of formers instead of tension pads as were used in TED No. NAK 2479. Wooden blocks were placed on the ribs of the elevator just aft of the beam and the load was applied to them along the hinge centerline just aft of the beam in the same direction as the stabilizer loads. The test set-up is shown in Plates 4, 5 and 6.

NP(3)-262400(L)-3-48
TBM-3E TARGET AIRPLANE - STABILIZER TEST SET-UP
SIDE VIEW
