NWC TP 5942

F-14A Fire Protection Test Program

by
George E. Moncsko
and
Herman J. Hoffman
Systems Development Department

FEBRUARY 1977

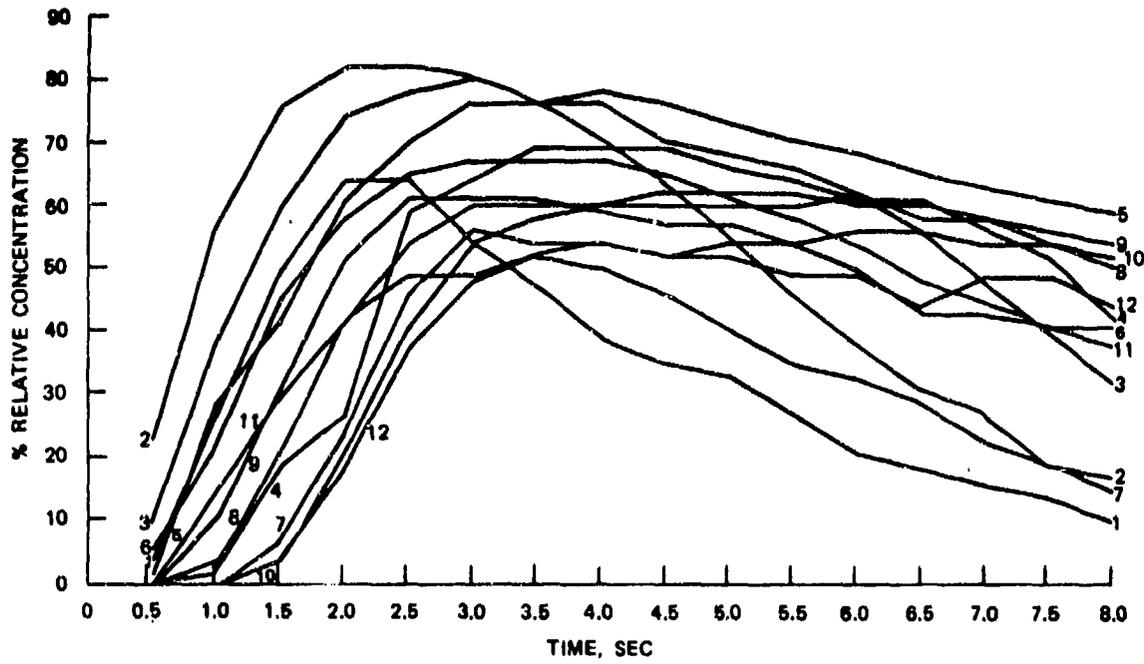
FIGURE 26. Agent Concentration, Nacelle Under Normal Flight Conditions.

In the nacelle under normal flight conditions, where only cooling airflow is provided, the agent concentrations are greatest for the longest duration. As more airflow is introduced and the top deck ruptured, these values decrease as would be expected. Under normal flight conditions the agent concentration was maintained above 15 percent for 5.35 seconds which exceeds the test requirement by 4.85 seconds. The maximum concentration for 0.5 second was 47 percent which exceeded the requirement by 32 percent. As test conditions were changed to introduce fan-case failure airflow and then add the top deck rupture, time duration of agent concentration above 15 percent and maximum concentration percent for 0.5 second was: 3.10 seconds at 26 percent, and 3.30 seconds at 16 percent, respectively. The last condition is the most severe, and the values were still above minimum specification requirements.

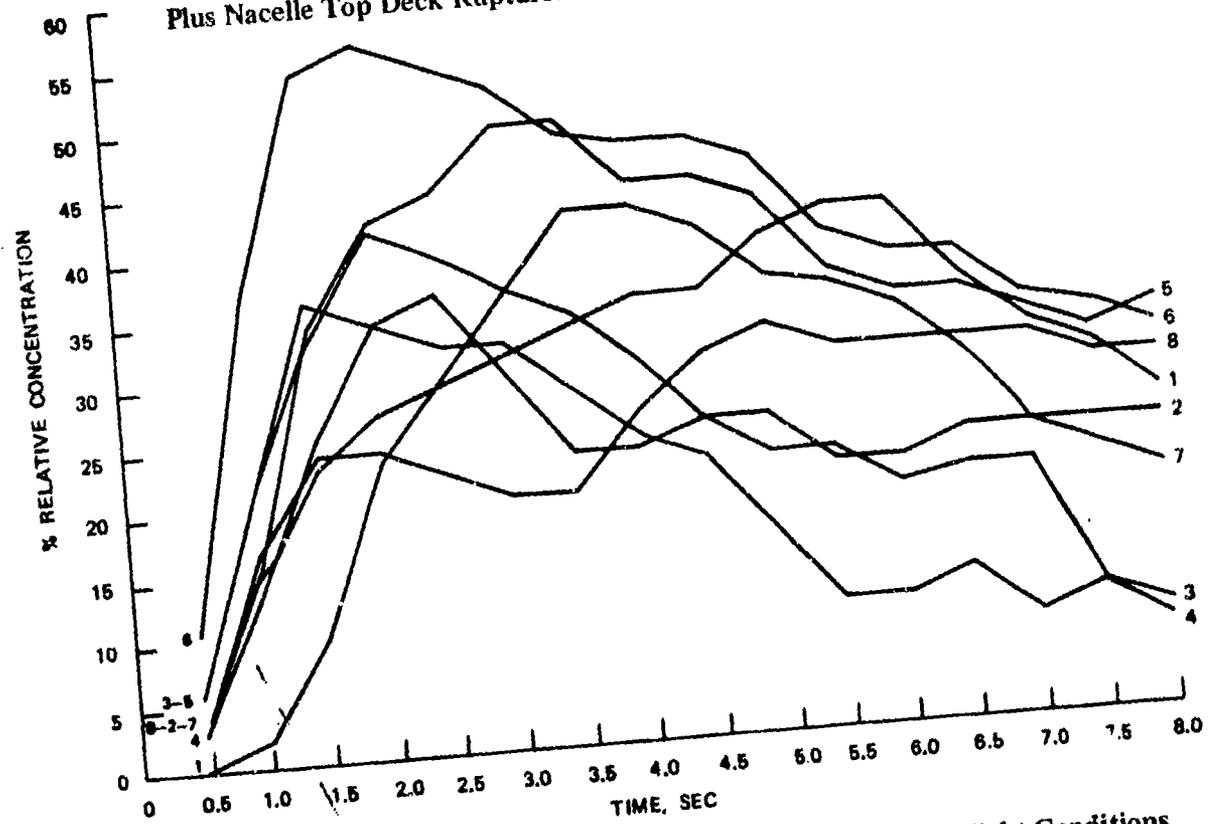
FIGURE 29. Agent Concentration, Accessory Bay Under Normal Flight Conditions.

In the overwing fairing accessory bay, the problem was to get agent into the rear area of the volume. With the discharge nozzle up forward, the aircraft equipment installed in the volume inhibited flow of the agent. The final nozzle design directed the agent forward to deflect off the wing box structure, diffusing around the forward part of the volume, and upward and aft to deflect off the underside of the overwing fairing into the rear portion of the volume. The discharge nozzle design is shown in Figures 30 and 31. This configuration produced a concentration above 15 percent which was maintained for 3.40 seconds, exceeding the time requirement by 2.90 seconds, and a maximum concentration of 23 percent for 0.5 second which exceeded the requirement by 8 percent under a normal flight condition at 250 knots.

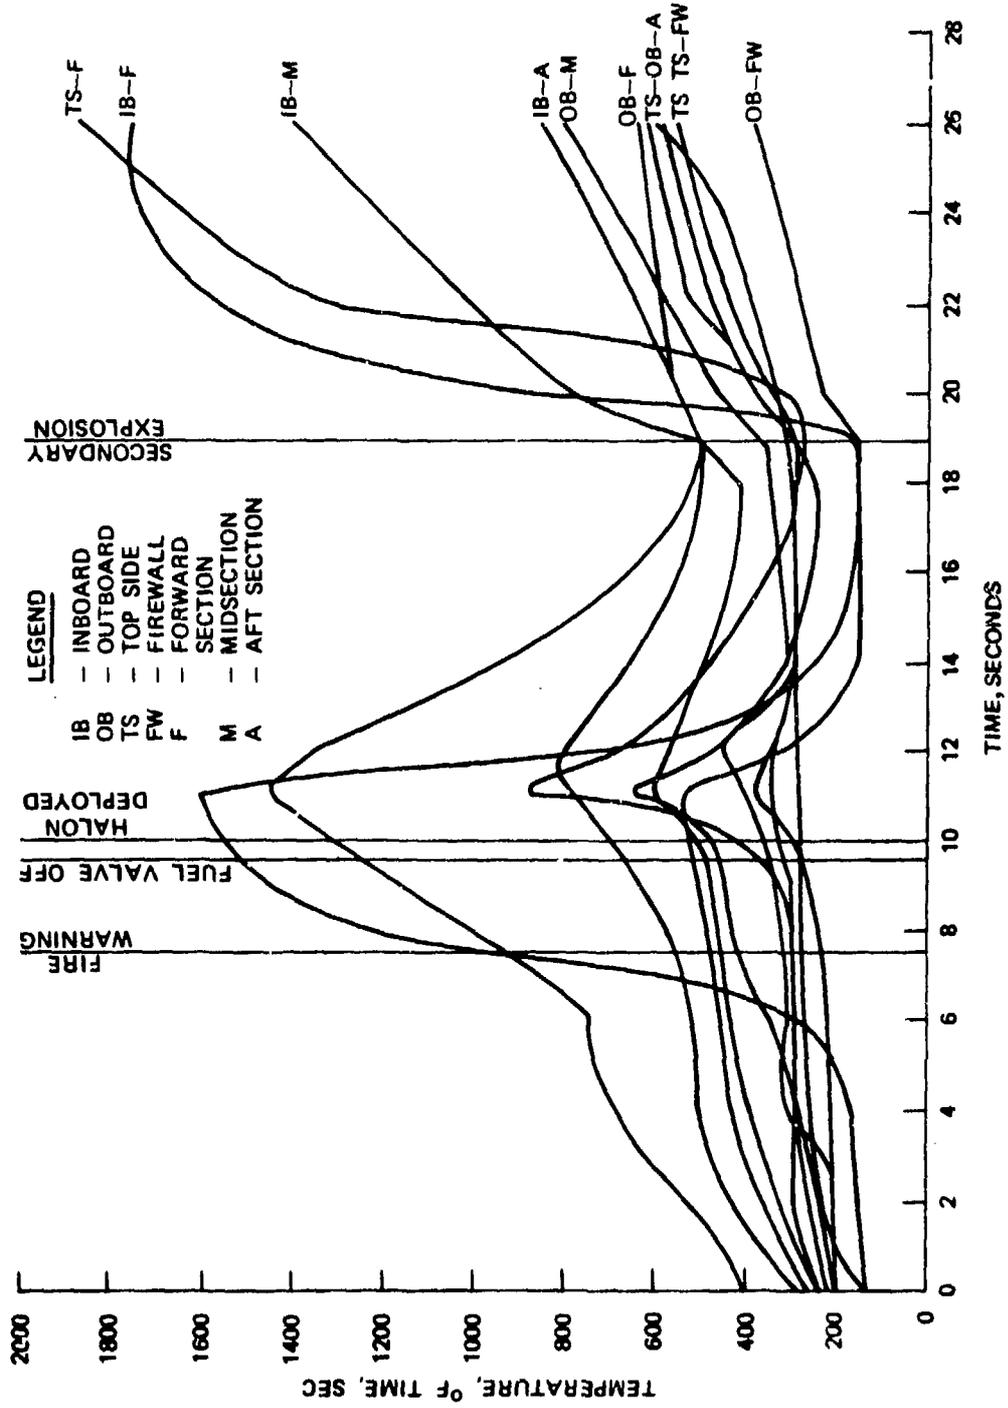
FIGURE 32. Nacelle Temperature Data Plot, Full-Scale Fire Test.

The thermocouple temperature data plots of Figures 32 and 33 show that the on-board fire extinguisher system extinguished the nacelle and overwing fairing fires after the initial 10-second burn. The data plot shows that maximum temperatures were reached approximately 10 seconds after fuel ignition. Correlating the curves with thermocouple position in the test article shows the fire started in the forward nacelle and spread aft in the nacelle, following the airflow circulation from front to rear. At the same time the fuel which was blown through the nacelle top deck rupture by the fan case rupture airflow ignited and burned in the accessory bay. Infrared camera pictures show heat being forced upward along the buttline 10 fire barrier and exiting the overwing fairing as well as being forced out along the outboard (wing pivot) area of the fairing. Temperatures inside the center trough remained approximately ambient. Fire did not cross the center trough fire barrier. The Halon 1301 extinguished the fire in the accessory bay which later reignited (from the test pad residual fire) and was subsequently extinguished by the facility CO₂ system. Concurrent with deployment of the Halon 1301, the temperatures in the nacelle also showed a rapid decrease in temperature indicating the fire had been extinguished.

Analysis of the temperature history in the nacelle shows that the fire started at the failure point then followed the airflow pattern down and aft. It appears that this flow pattern makes just short of one loop

axially about the engine before exiting via the aft nacelle vent. The volume of air was sufficient to cause combustion temperatures to be maximum about 6 feet (2 meters) aft of the failure opening. From this point, aft temperatures drop until reaching exit temperature which, in the initial part of the test, never exceeded 400°F (204°C).

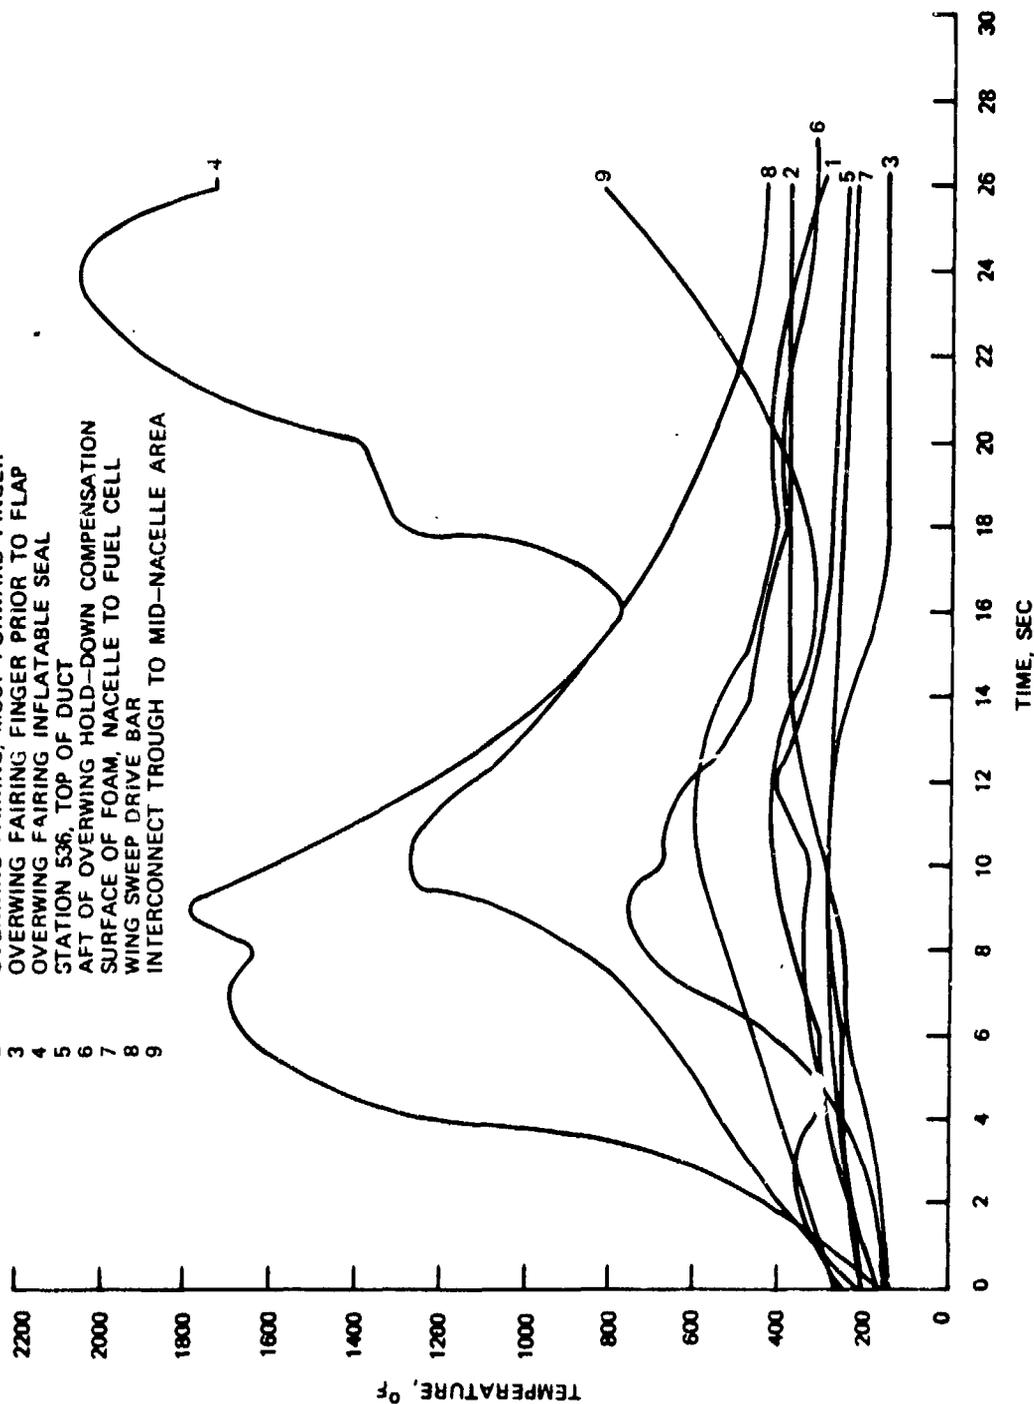
FIGURE 33. Accessory Bay Temperature Data Plot, Full-Scale Fire Test.

Thermocouples in the volume under the overwing fairing show heat penetration first at the aft end then quickly forward from the failure hole past the wing actuator bar and outboard to the wing pivot and the inflatable seal. Temperature of the upper surface of the wing sweep actuator bar reaches 1300°F (700°C) before the extinguishant is deployed. This temperature never increases again during the test. Temperature just forward of the wing pivot reaches just over 600°F (315°C) before the extinguishant released. The sloping deck temperature (top surface of fuel cell 5) never increased much over ambient.

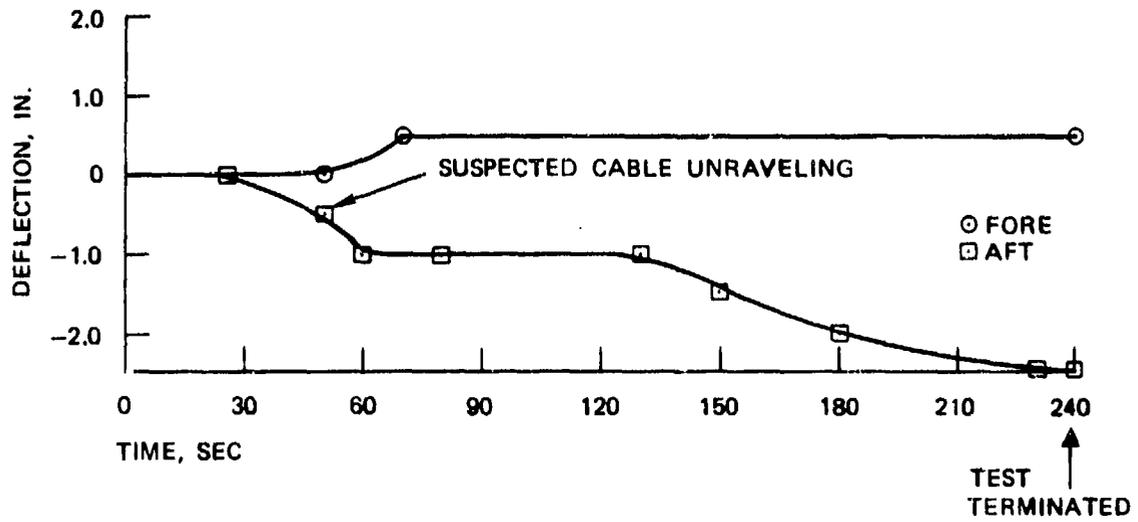
FIGURE 46. Weight Deflection Data Plot, Left Nacelle.

Deflections of the left nacelle test weights are plotted in Figure 46. This plot is derived from the video tape data. Final deflections after the structure cooled down were: fore, 0 inch; aft, - 2.0 inch (-50 mm). The aft weight was observed revolving from 40 to 90 seconds. It is suspected that the 1-inch (25.4-mm) weight drop during this time was due to heat expansion and unraveling of the cable.

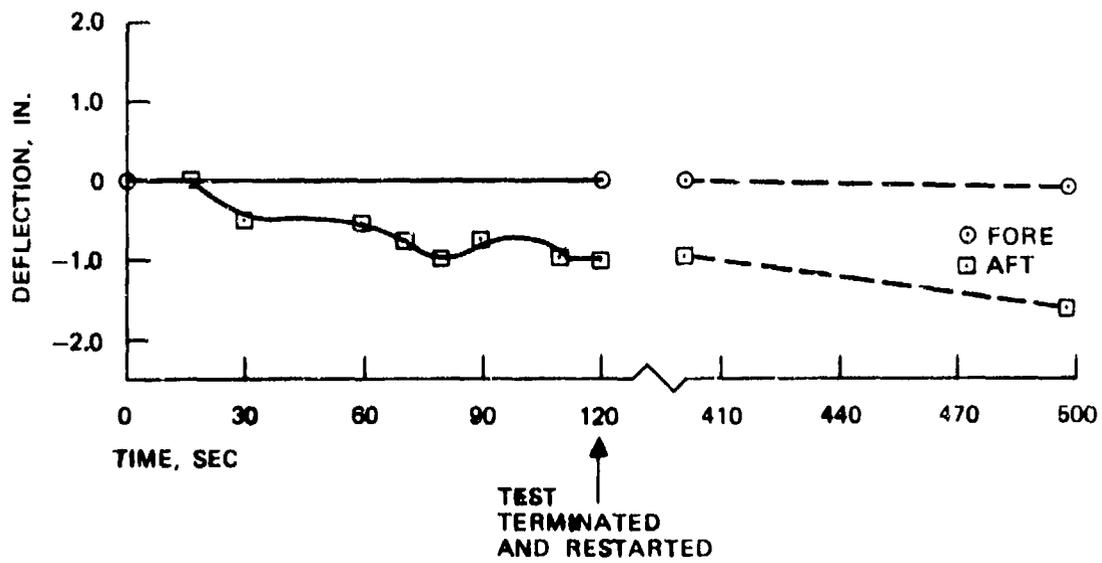
FIGURE 47. Weight Deflection Data Plot, Right Nacelle.

Weight deflections in the right nacelle are plotted in Figure 47. Final deflections after structure cool-down were: fore, 0 inch; aft, 0.56 inch (14.288 mm). The same cable was used for the aft weight in both the left and right nacelle tests. During this burn the cable did not unwind further.

The aft bellcrank assembly was not damaged. However, a deflection of 0.56 inch (14.3 mm) was achieved. This deflection is believed to be caused by the buckling of the aircraft skin and former ribs. The observed oscillation of the aft weight (see Figure 47) could also be caused by the skin buckling. The condition of the aft bellcrank is shown in Figure 48.
