AFML-TR-78-160
Volume I

COST EFFECTIVE REPAIR TECHNIQUES FOR TURBINE AIRFOILS

GENERAL ELECTRIC COMPANY
AIRCRAFT ENGINE GROUP
CINCINNATI, OHIO 45215

NOVEMBER 1978

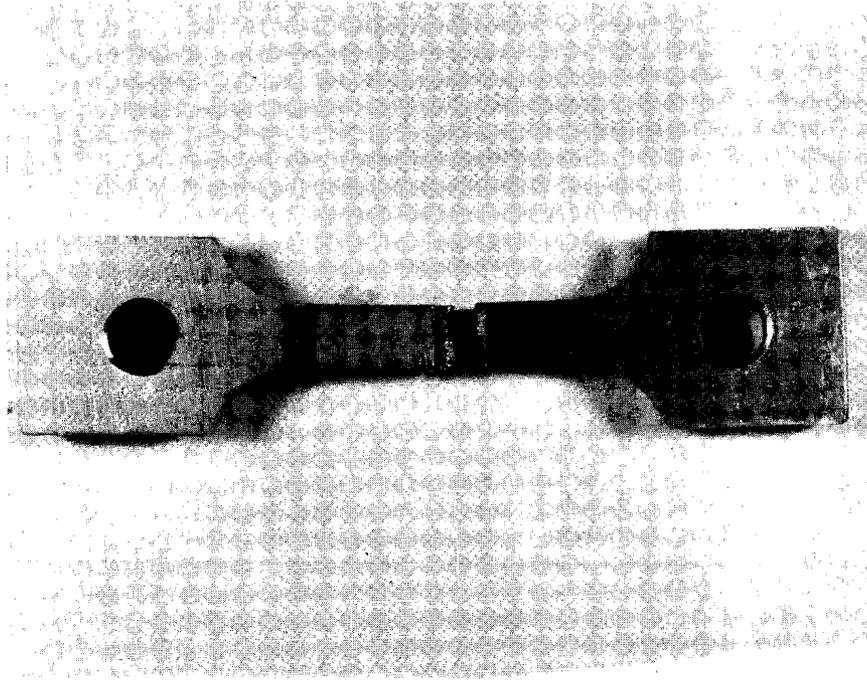
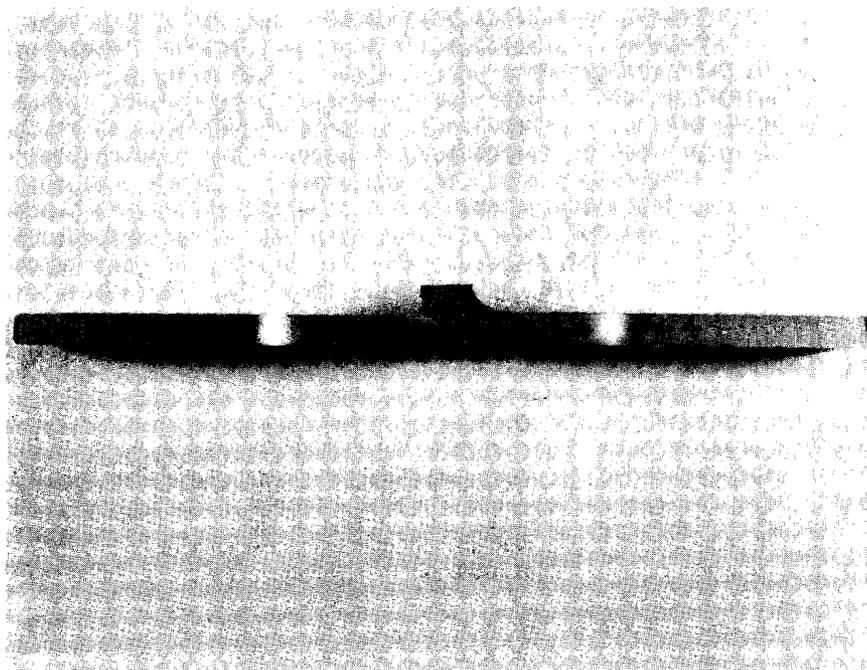
Figure 6. Front and Side View of Tensile Sheer Specimen Showing Typical Failure Location

In all cases the failure occurred in the X-40 base metal at the edge of the overlap fillet radius and a typical failure is shown in Figure 6.

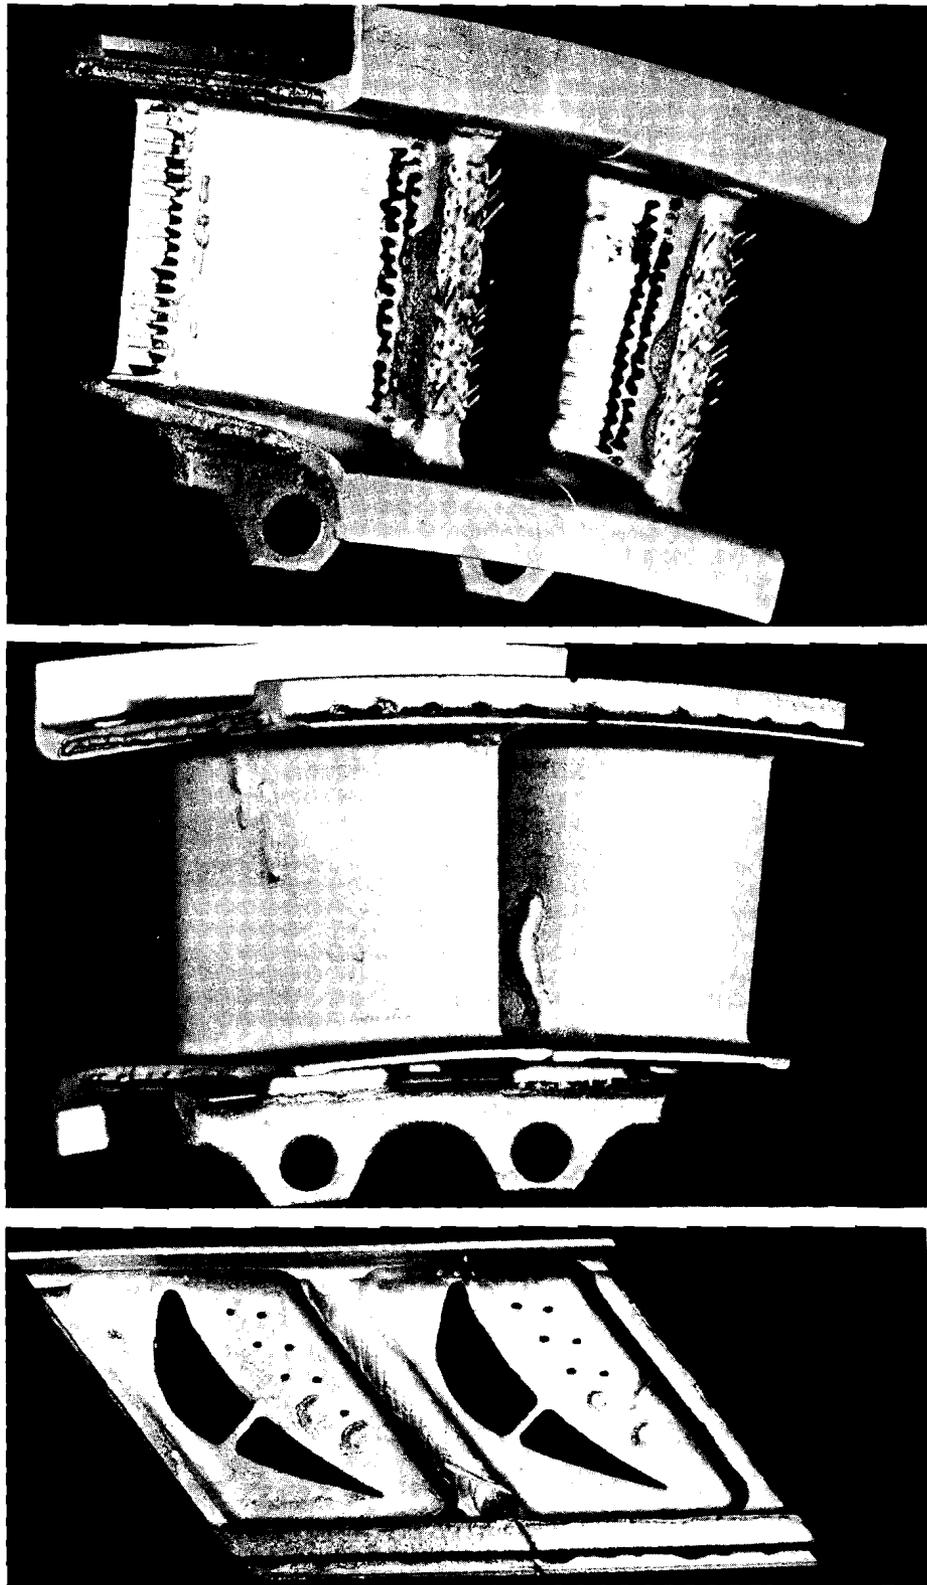
Figure 12. As ADH Repaired Condition of X-40 Engine Run
TF39 Stage 1 HPT Vanes

- TOP VIEW - VANE LEADING EDGE. (NOTE QUARTZ PINS IN LEADING
EDGE COOLING HOLES)
- MIDDLE VIEW - VANE TRAILING EDGE (NOTE FLANGE BUILDUP)
- BOTTOM VIEW - VANE OUTER PLATFORM (NOTE FLANGE BUILDUP)

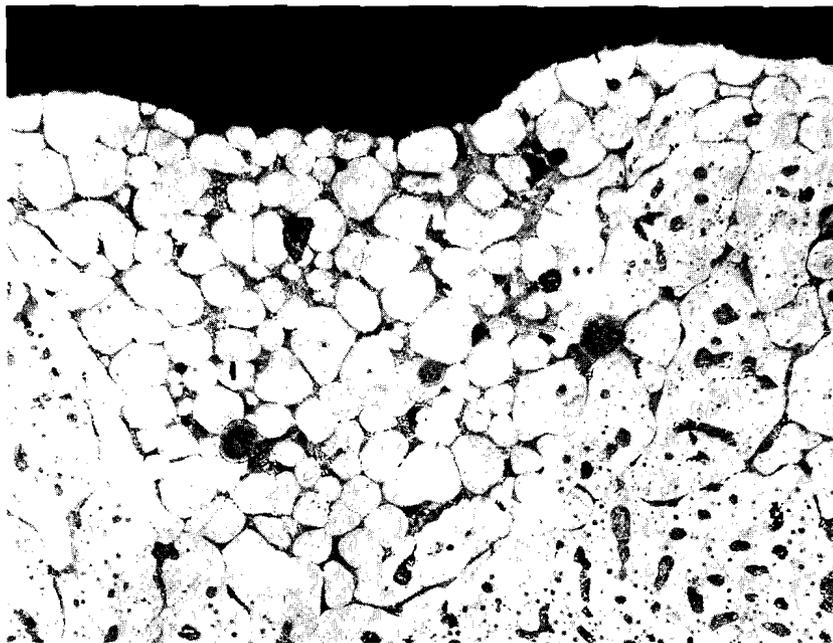
Figure 13. Photomicrograph of ADB Repaired Cracks in X-40 Material

H-33 JOINT IN X-40 MATERIAL

D-15 JOINT IN X-40 MATERIAL

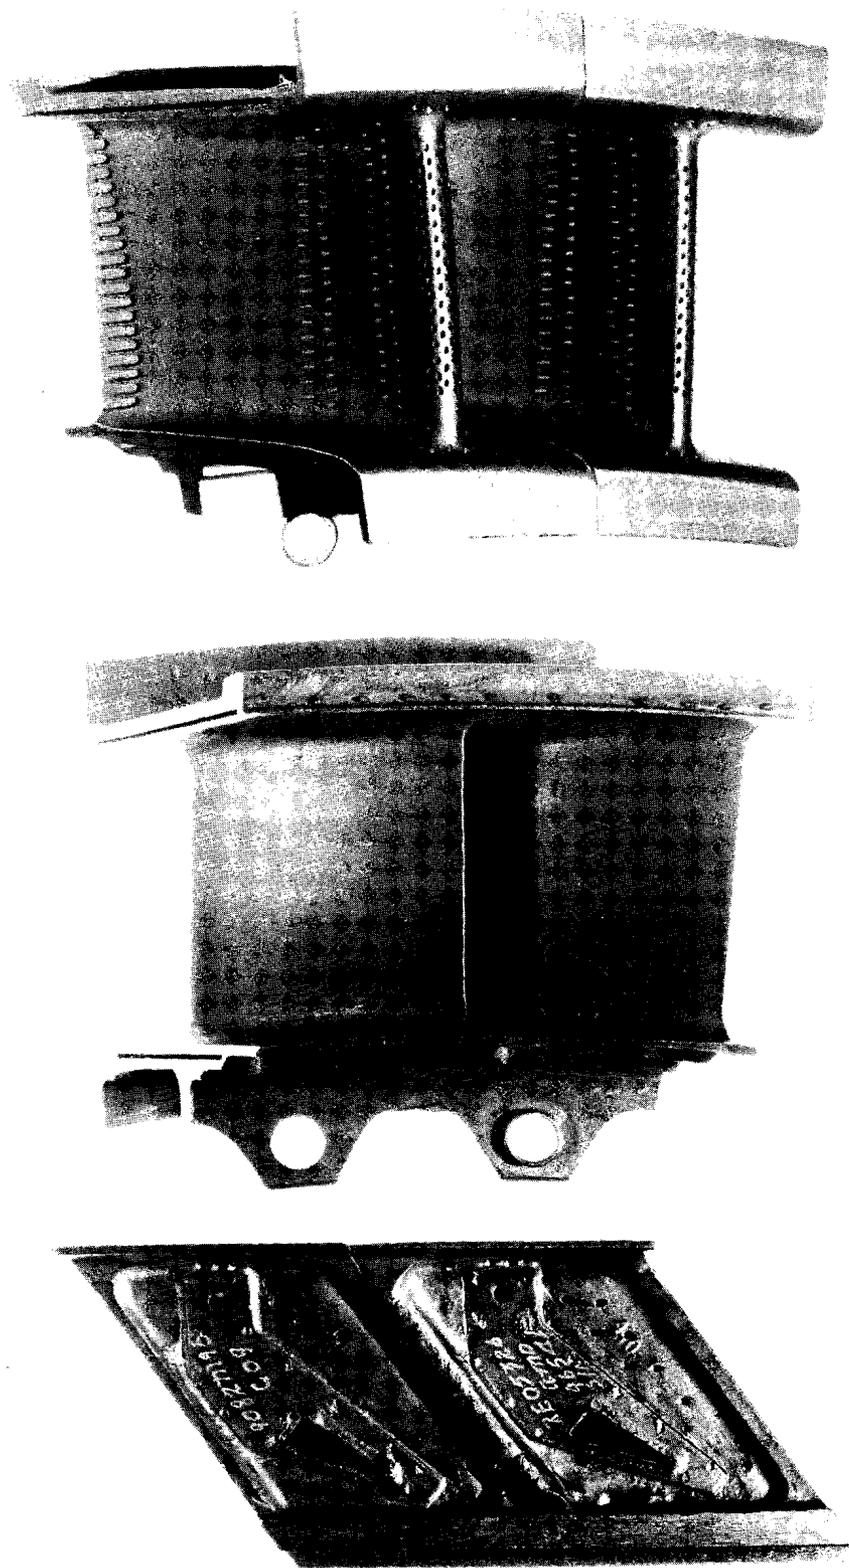
Figure 14. Finished TF39 Stage 1 HPT Vane Repaired by the ADH Process

TOP VIEW - VANE LEADING EDGE
MIDDLE VIEW - VANE TRAILING EDGE
BOTTOM VIEW - VANE OUTER PLATFORM

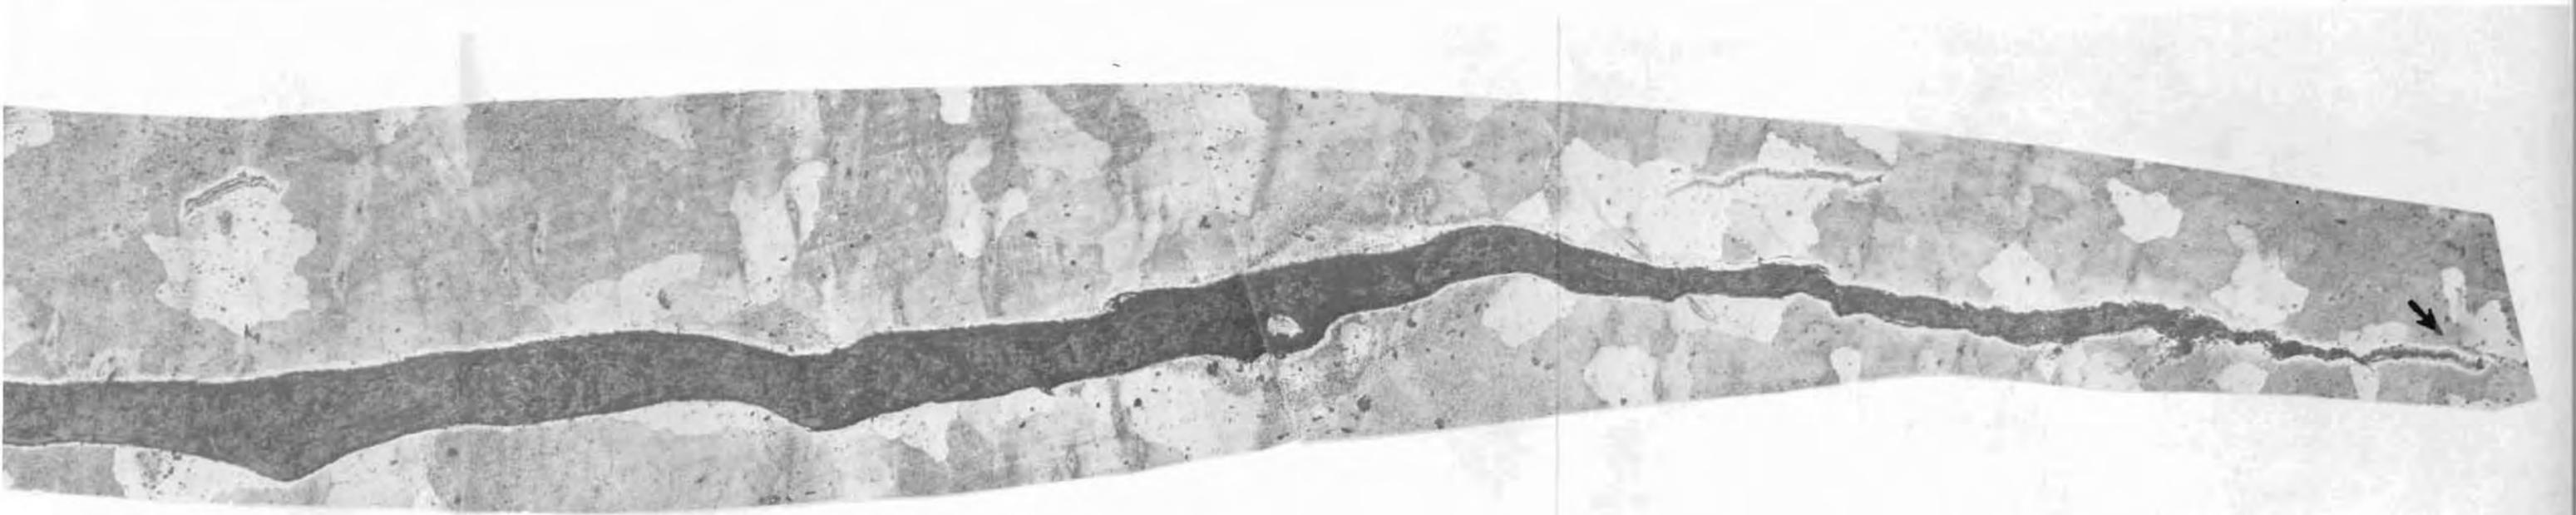
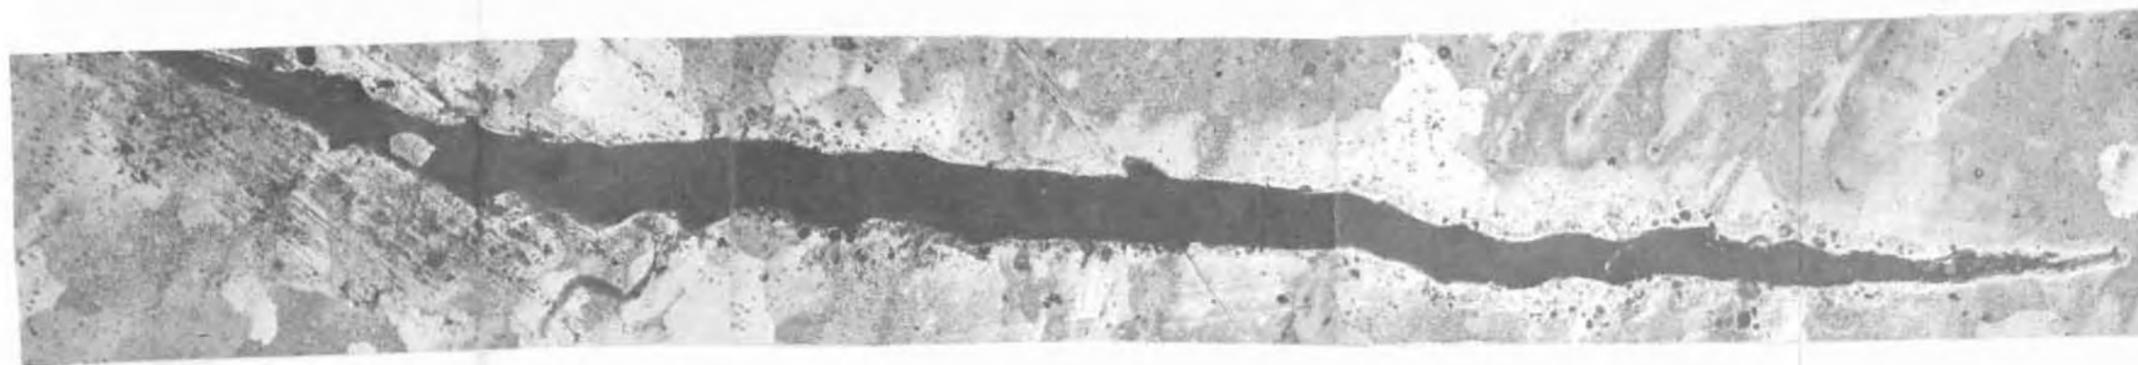
Figure 19. Photomicrograph of Rene' 80 Airfoil Crack After Fluoride Ion Cleaning at 1800°F/1 Hr

On superalloys, oxides are present as complex spinels containing aluminum and titanium. The effect of fluoride ion on real oxides present within cracks is shown in Figure 19. Oxide removal is complete, except for a small amount at the crack tip. These residual defects are considered acceptable by repair design engineering since their size is similar to normal defect limits for vane castings.

Although surface oxides can be removed successfully by the F⁻ cleaning, occasionally the very tight tip of a crack that is less than 0.001 inch in width cannot be totally cleaned of all oxides. This is because the gases are not coming in intimate contact with the metal oxide. This was shown in Figure 19.

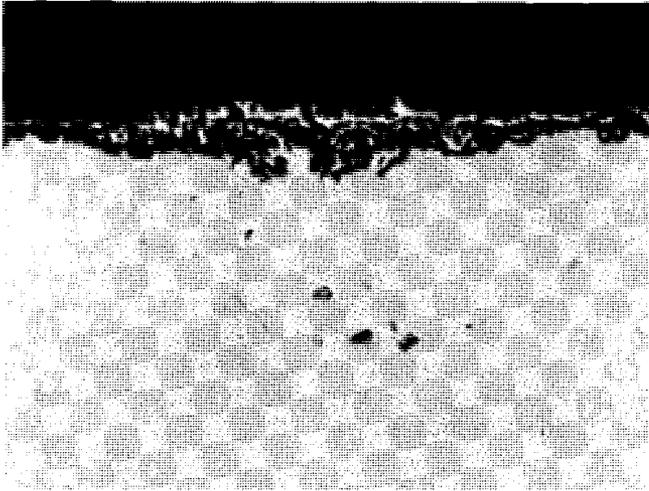
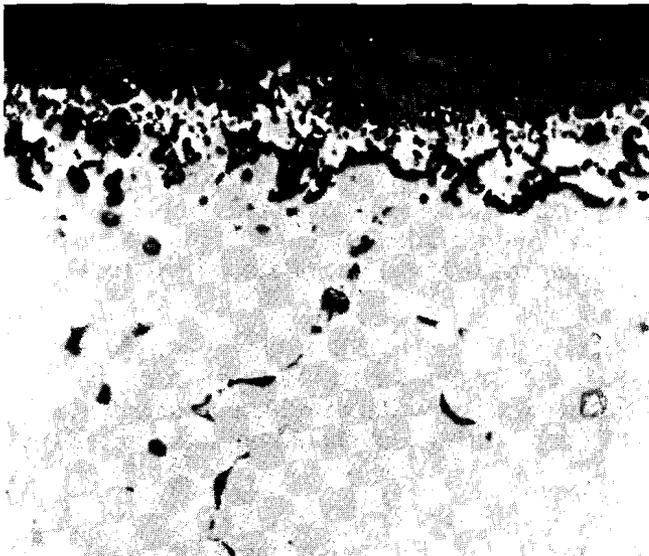
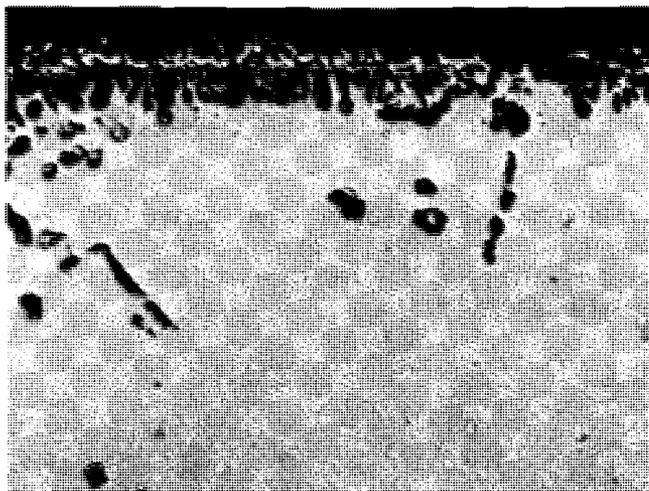
Figure 29. Oxidation Characteristics of Rene' 80

A controlled process evaluation was initiated to study this phenomena. Kirkendall voids were not observed immediately after the F⁻ cleaning portion of the process; however, after both subsequent vacuum clean and/or Codep coating, they were observed. This indicated that a diffusion mechanism became operative during the subsequent thermal exposure and affected a rapid diffusion of substrate elements to the alloy depleted surface leaving the observed Kirkendall voids. The oxidation characteristics of the resulting surfaces are shown in Figure 29 along with the normal oxidation of R80 on a stripped and oxidized component. The depleted alloy layer left by F⁻ cleaning and subsequent oxidation testing resulted in catastrophic oxidation attack. Additional thermal exposure in the vacuum clean cycle allowed more diffusion and thus reduced the amount of oxidation attack.

Stage 2 Vane - CODEP stripped
and oxidized at 2050°F/23 hrs.

Stage 2 Vane - CODEP stripped,
F-cleaned w/CrF₃, and oxidized
at 2050°F/23 hrs.

Stage 2 Vane - CODEP stripped,
F-cleaned w/CrF₃, vacuum cleaned
and oxidized at 2050°F/23 hrs.

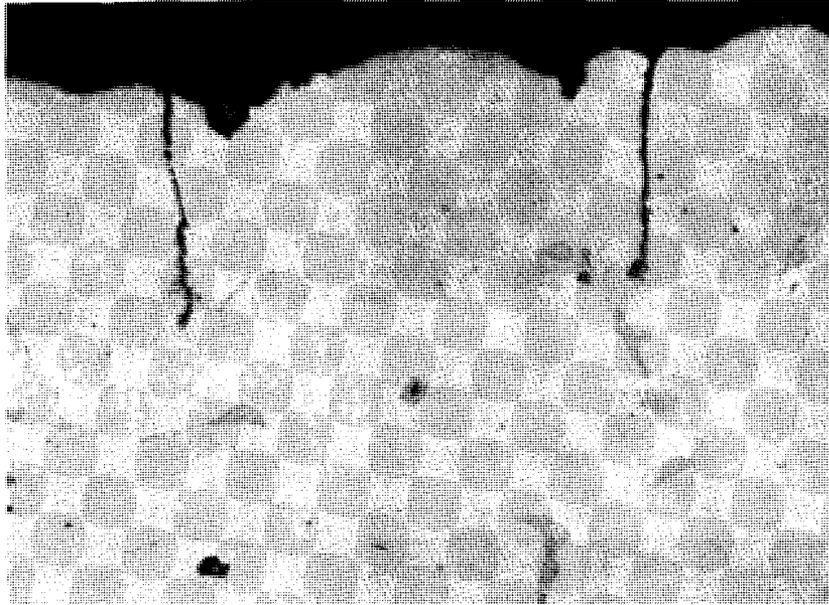
Figure 30. Fluoride Ion Cleaned Vane with .001" Chem Milled from Surface, Codep Coated, and Oxidized at 2050°F/23 Hrs 500x

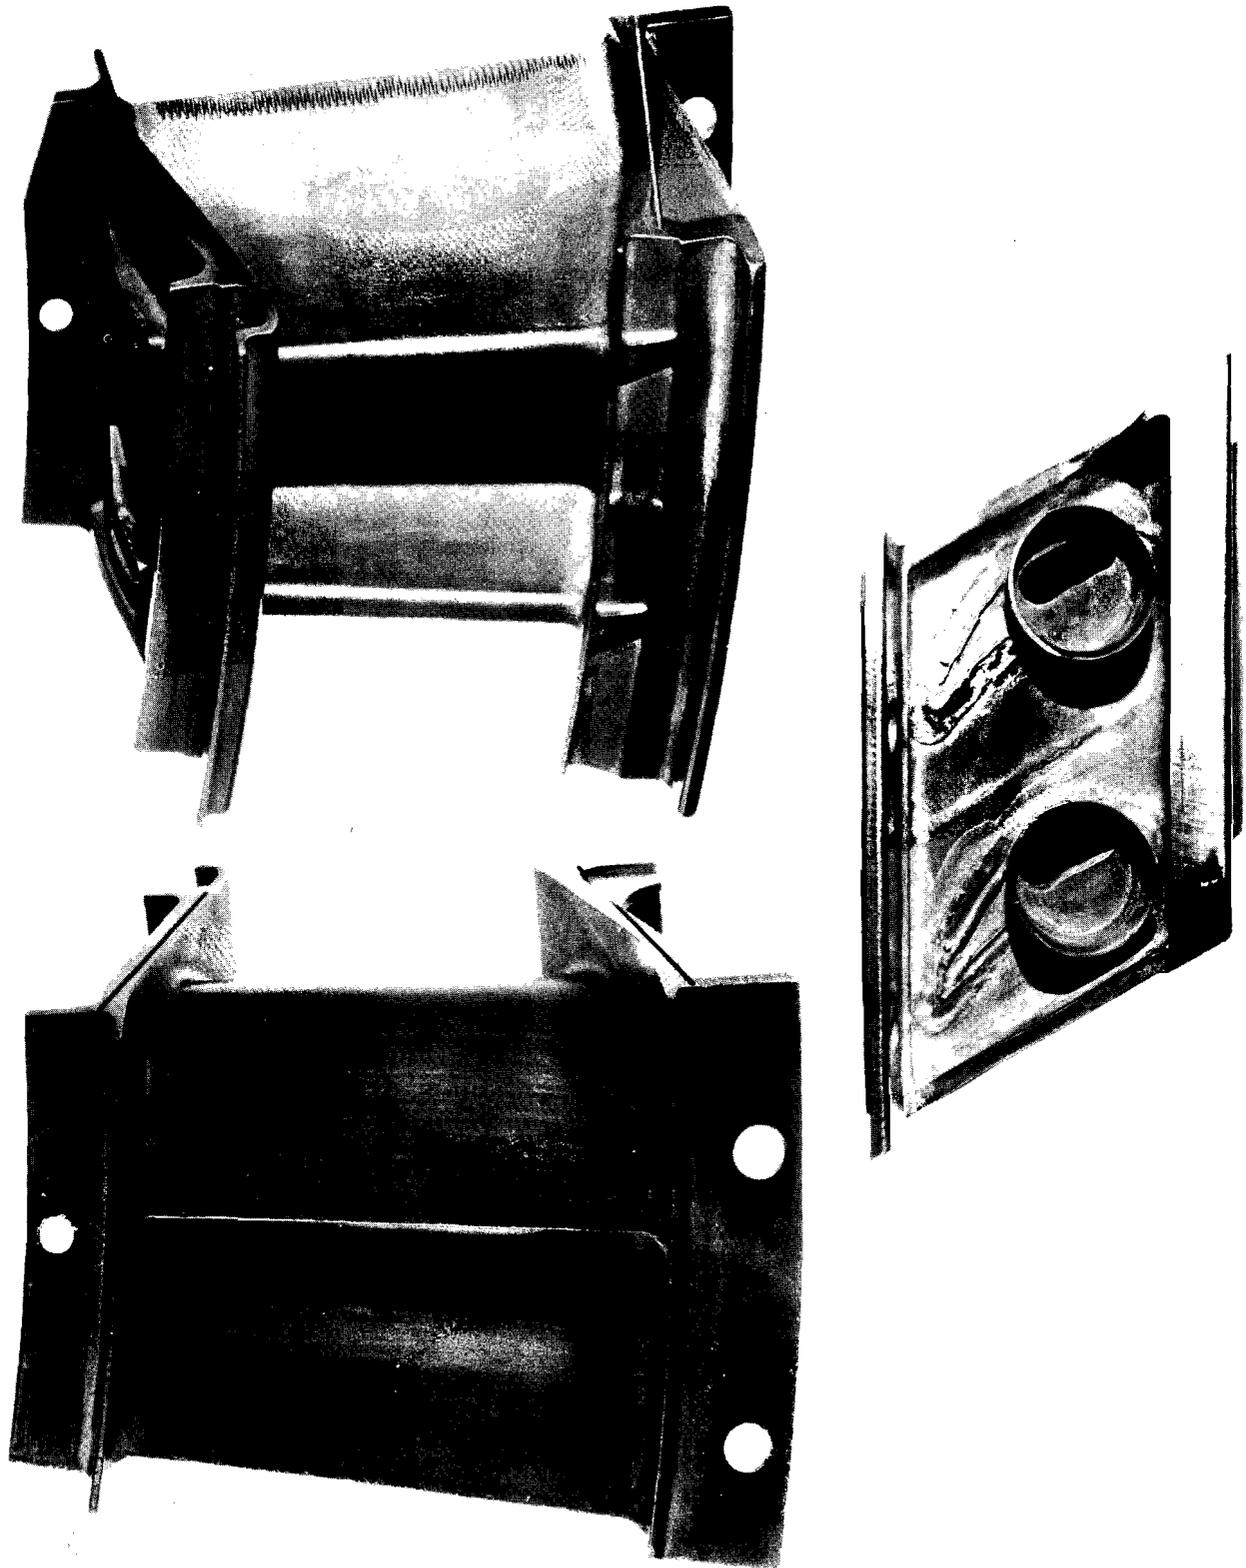
Figure 36. View of Rene' 80 TF39 Stage 2 HPT Vane
After ADH Repair, Codep Coat and Brazing
of Air Cooling Insert

The 40 piece pilot line lot has been completely processed through final inspection with a 100% yield. The ADH repaired stage 2 vanes have been submitted for TF39 engine test and results are expected early in 1979.

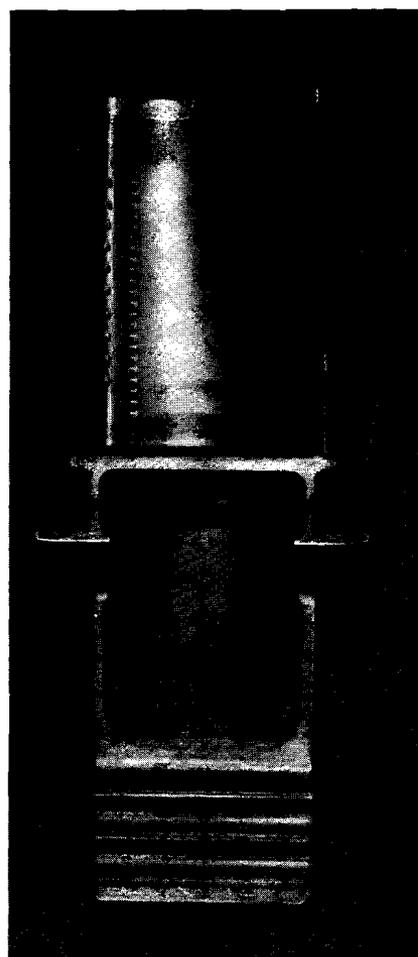
OCCURRENCE
FACTORY \approx 2000 CYCLES

Figure 37. HPTR Stage 1 Blade with Squealer Tip
Cracks Extending Below Tip Cap

MINI-BONDED
SQUEALER TIP

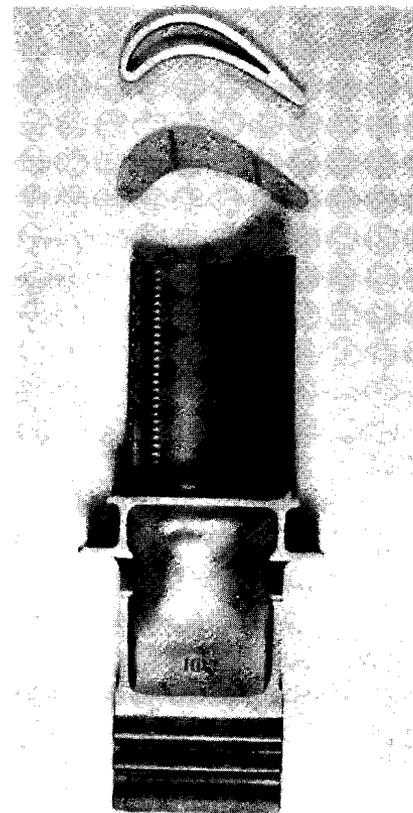
Figure 38. Mini-Bond Tip Replacement Concept on TF39/CF6-6
Stage 1 HPT Blade

The primary goal of this task was to extend the current repairable limits for Rene' 80 blade tip distress. The tip replacement process by mini-bonding was selected as the means by which much serviceable/non-repairable hardware might be salvaged. Excessive tip rub in engine operation generally results in burns and/or cracks resulting at the squealer tip and extending through the tip cap into the airfoil section itself. Figure 37 shows this condition and is illustrative of the potential of a mini-bond repair for replacement of the defective tip and cap. The concept by which the repair was developed is shown in Figure 38. This concept then served as the basis for establishment of the initial repair procedure shown below:

- a. Inspect incoming vane airflow.
- b. Strip Codep coating.
- c. Separate paired blades.
- d. Inspect blades to assess damage and repair needs.
- e. Grind tip for mini-bond repair.
- f. Grit blast clean blade tip area.
- g. Vacuum bright anneal blade to finalize cleaning at 2200°F/2 hours.
- h. Dimensional inspect tip cap height.
- i. Assemble tip cap with presintered D-15 ADB alloy to blade.
- j. Mini-bond tip cap.
- k. Dimensional inspect tip cap height for gap upset and visual inspect for complete bonding.

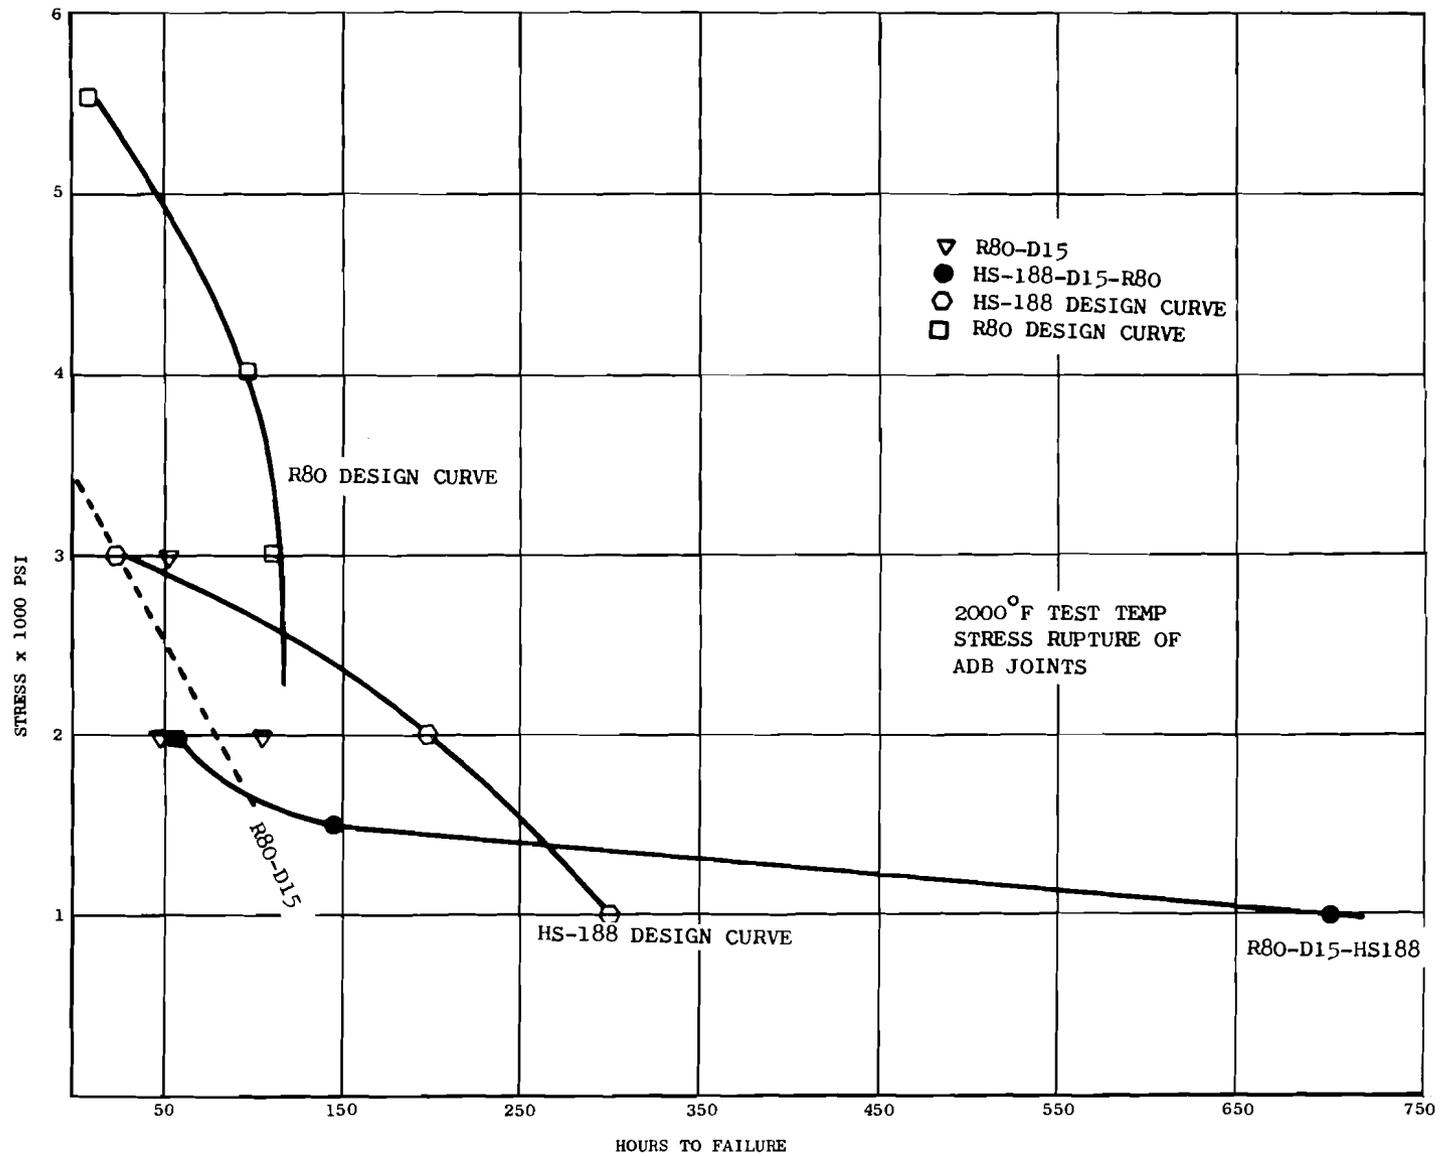
Figure 39. Stress Rupture Test Results of Rene' 80 to Rene' 80 and Rene' 80 to HS-188 ADB Joints at 2000°F

Stress rupture testing of minibonded joints at 2000°F, is shown in Figure 39 and indicates stress rupture values are comparable with the Rene' 80 and HS188 design curves. Although the actual values required for blades cannot be accurately predicted, these values coupled with prior CF6 engine testing of repaired vanes, provide sufficient preliminary data to proceed with TF39 engine testing.

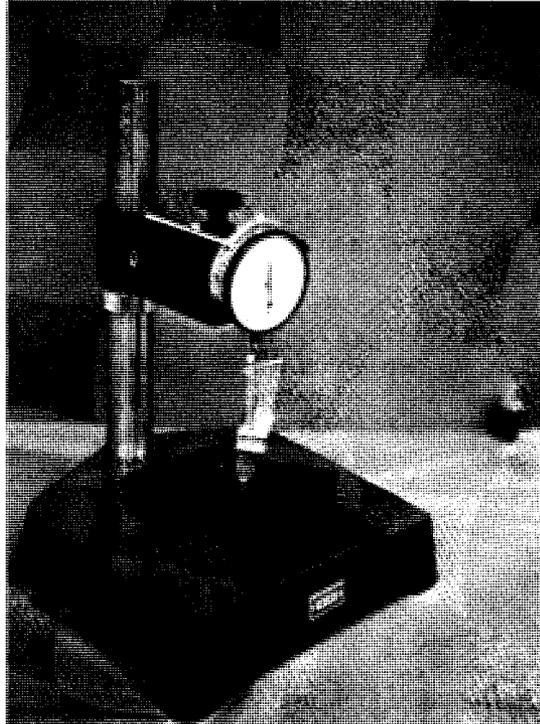
Figure 40. Inspection Fixture Used to Determine
ADB Joint Gap on Mini-Bonded Blade Tips

Evaluation of the fixture shown in Figure 40 used to determine the ADB joint gap on the mini-bonded blade showed that repeatability was not obtainable when a 'standard' blade was subjected to repeated blade height measurements.

Since on the initial run, the bond gap measurements were made using this old fixture configuration, confidence in the accuracy of these measurements is lacking and may account for the high fallout of blades rejected for exceeding the bond gap dimensional limit. To verify the accuracy of the new fixture several blades which had cap to tip bond gaps measured in the fixture using both the old and new configuration were cut to show the cross sections at three measurement points on the joints (see Figure 41) and photomicrographs were made.

Modifications of the fixture were made and resulted in a constant position of each blade in the fixture such that repeatable blade height measurements could be made.

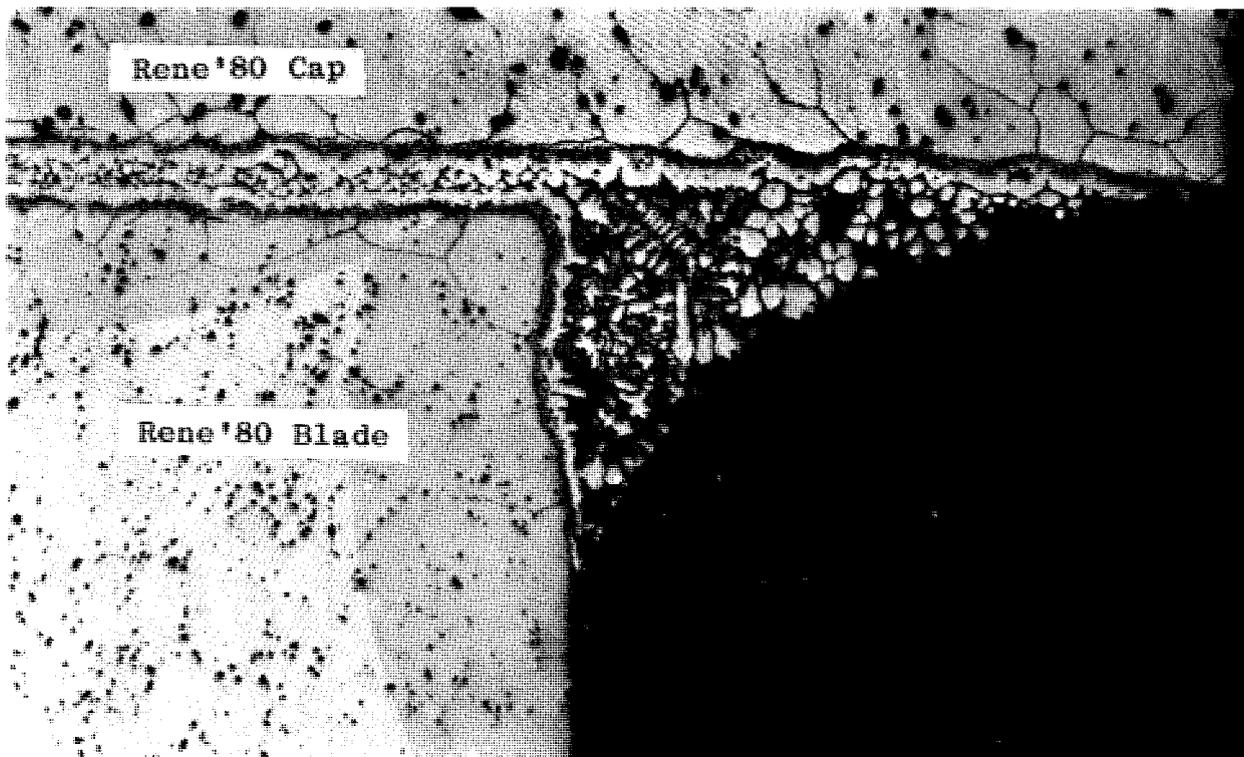
Figure 42. Blade to Cap Joint As-Bonded Prior to a Heat/Diffusion Cycle

Figures 42 and 43 show a typical joint in the as-bonded condition after being run through the diffusion cycle. Bond gap measurements from photomicrographs of the joint are more easily read in the as-bonded condition than after the post diffusion cycle. However, it is useful to see the high quality of the joint after the diffusion cycle has been run. From these photomicrographs the true bond gap can be measured using 100X magnification of these joints. As a result of this comparison it was shown that the new configuration of the fixture accurately measured the true bond gap. Thus, this new fixture configuration shall be used on future blade runs through the pilot line. Unfortunately blades already processed using the original fixture cannot have the bond gap re-measured using this fixture due to the technique involved.
