AL/CF-TR-1994-0056

**A HUMAN FACTORS EVALUATION OF
THE MH-60G PAVE HAWK HELICOPTER COCKPIT (U)**

JANUARY 1994

FINAL REPORT FOR THE PERIOD APRIL 1993 TO JANUARY 1994

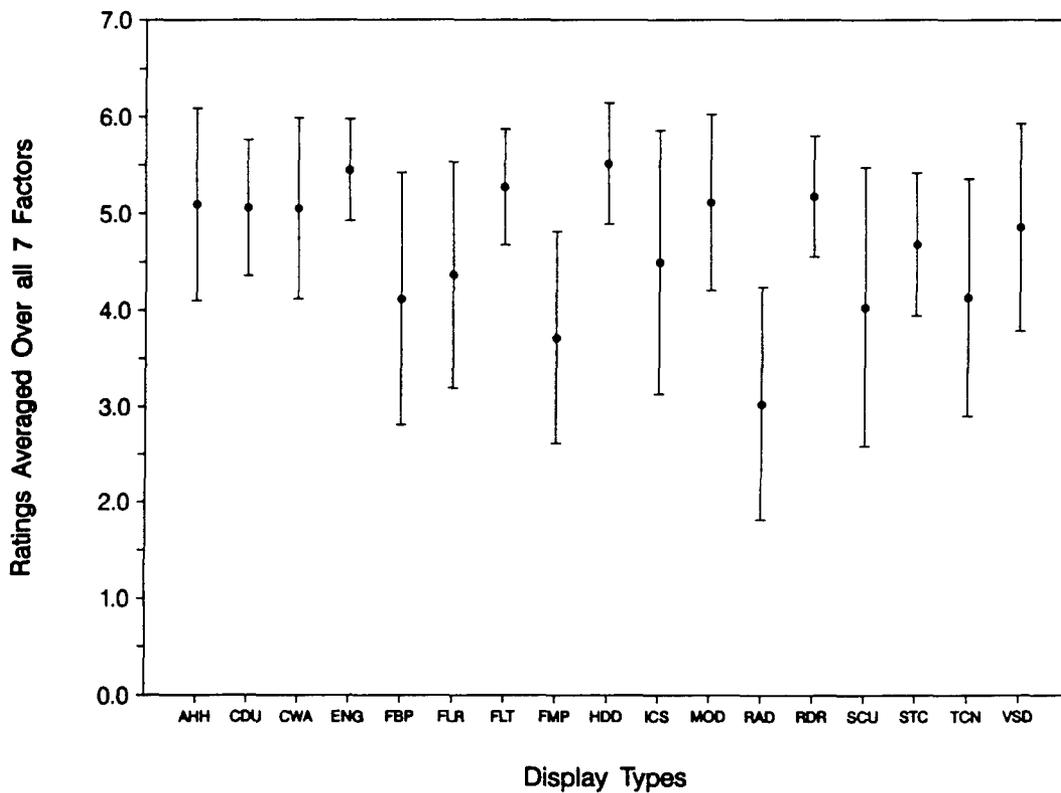
Figure 1. Mean Adequacy Rating for Display Type Averaged Across Display Factor.

The pilots rated some of the Display Types significantly higher than some of the others across all of the Display Factors combined ($P=0.001$). The mean ratings for each Display Type are shown below in Table 2 and are shown graphically in Figure 1. Basically, the Fuel Management Panel and the Radios were rated significantly lower than almost all the other display panels. The SCU, Fuel Boost Pump, TACAN/NAV and FLIR panels were rated as being mildly adequate. The remaining panels were rated as being just under very adequate to close to totally adequate.

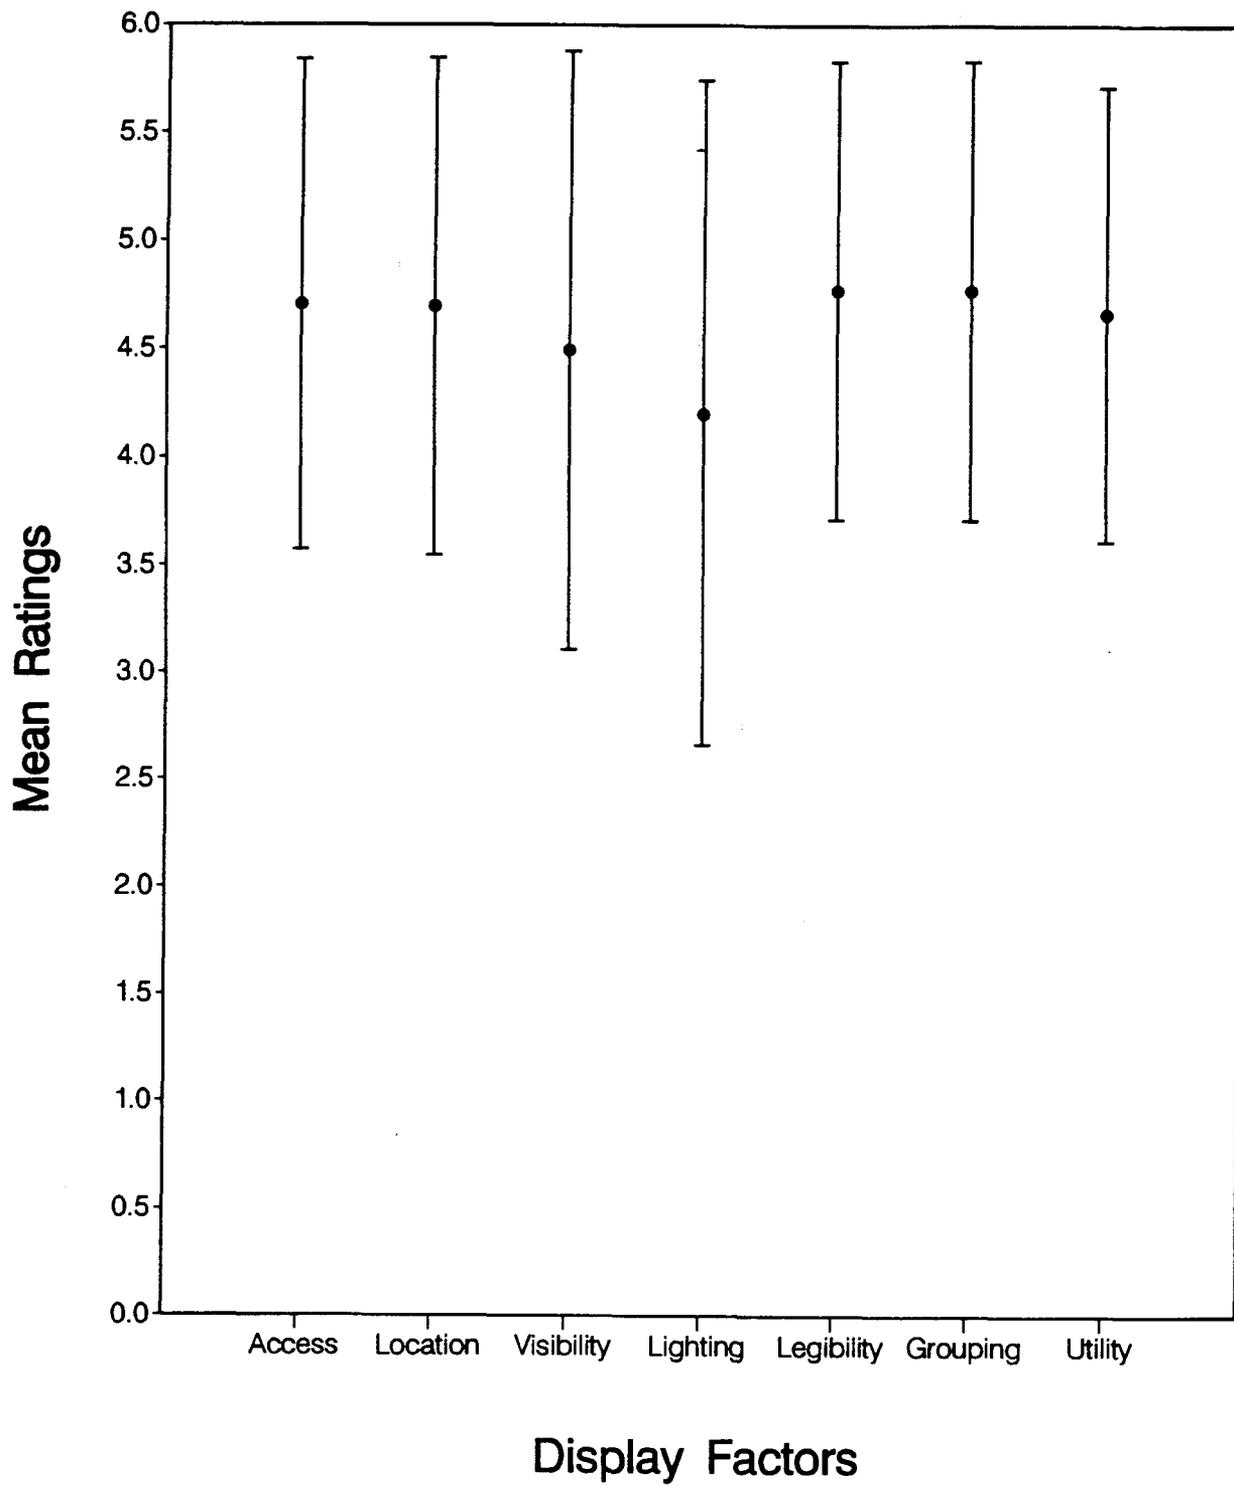
Figure 2. Mean Rating as a Function of Display Factor Averaged Across Display Type

There was a significant effect for the Display Factor variable ($P=0.0049$). The means are shown below in Table 3 and shown graphically in Figure 2. A Tukey post-hoc analysis showed the Lighting factor was significantly lower than all the other Display Factors except Visibility and Utility. No other Display Factors were significantly different from each other. Lighting was consistently rated the lowest across all the display types. The lack of good lighting in the cockpit could be responsible for the low ratings assigned to the Utility and Visibility Factors.

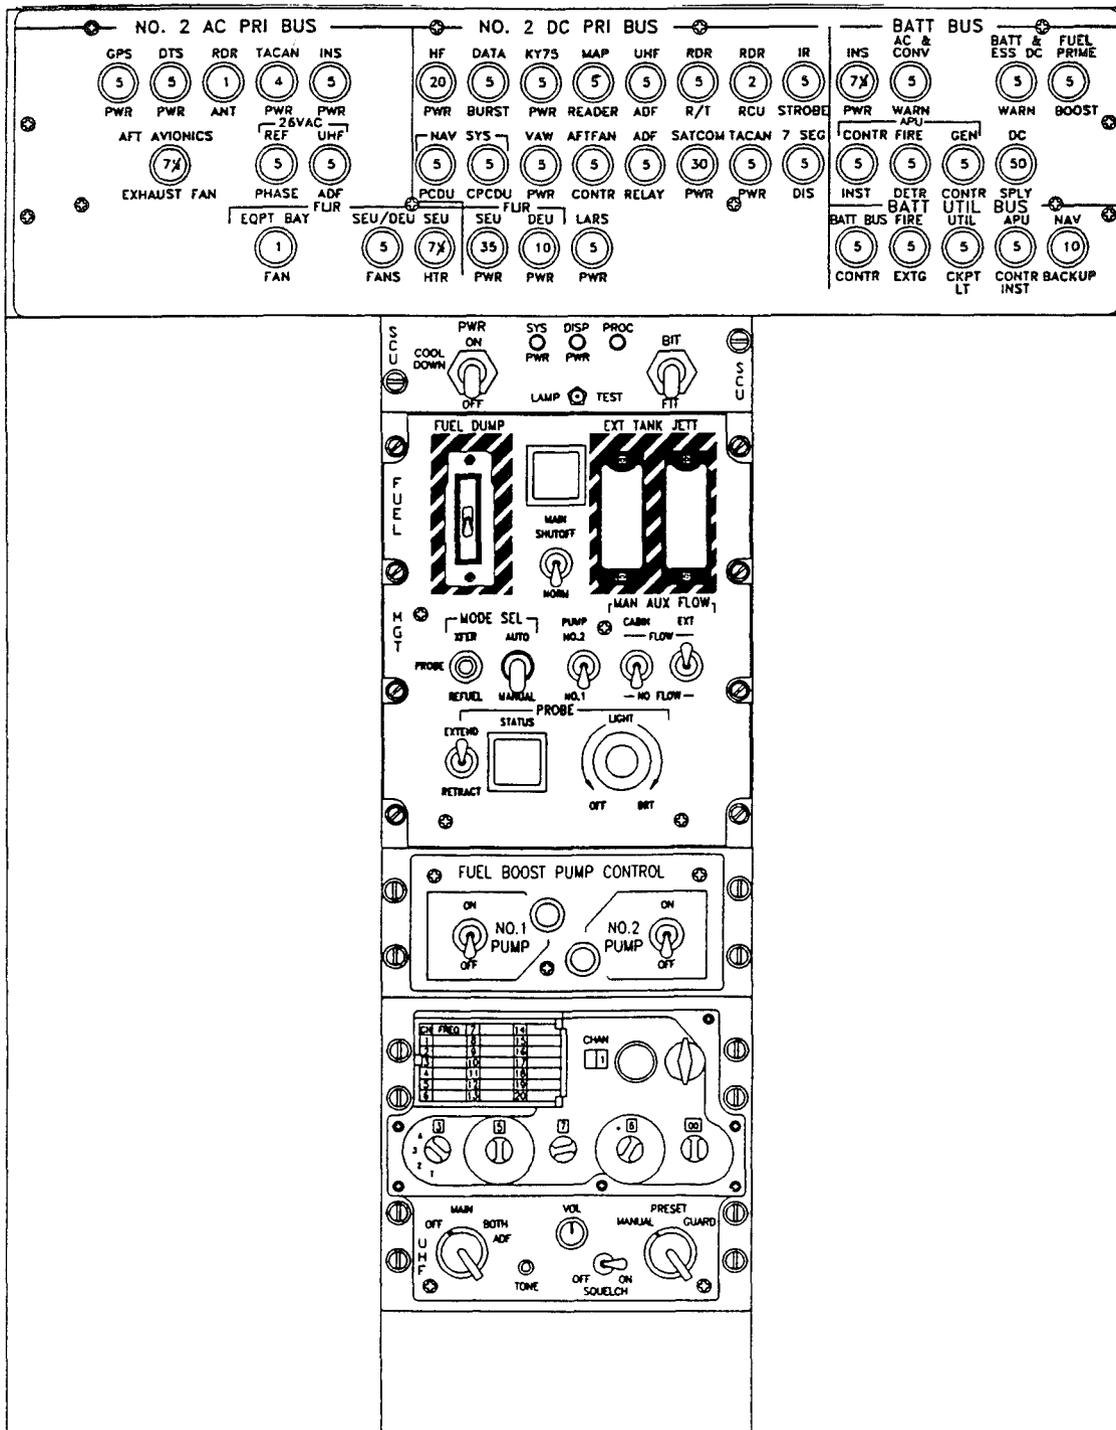
Figure 21. Reconfigured Aft Console with Radios Integrated Through the CDU.

There were several complaints about this panel. The most prevalent complaint concerned the location of the radios. Most pilots reported that the radios were spread out all over the cockpit. Pilots presently have to turn their heads to the back to operate most of the radios, which takes their eyes away from the "outside." This is extremely hazardous when flying low level at night. All the pilots recommended that the radios be integrated into one communication unit. This would not only reduce the difficulty of finding and operating the radios but also create more space on the forward section of the aft console. The integrated communications unit could be placed on the forward section of the aft console. This would leave space on the back portion of the aft console for displays and controls that are not used frequently and/or are not critical to mission completion.

The obvious solution to the problem is to integrate the radios with the CMS-80 and access them through the CDU. Another solution which is in place in the Army MH-47E is to integrate the communications and have a control on the cyclic to select radios with a small display located on the forward console to indicate the selected radio. Integrating the communication systems would not only alleviate the problems associated with radio access, but also free up considerable space on the center and aft consoles. Reconfigured lower and aft consoles with the radios integrated into the CDU are shown in Figures 20 & 21. This reconfiguration would drastically reduce the size of the aft console. The reconfigured aft console would also provide an alternate egress route for pilots and give the flight engineer visual access to controls and displays in the cockpit.
