260-SL-3 MOTOR PROGRAM

VOLUME I: 260-SL-3 Motor Internal Insulation System

FINAL PHASE REPORT

28 April 1967

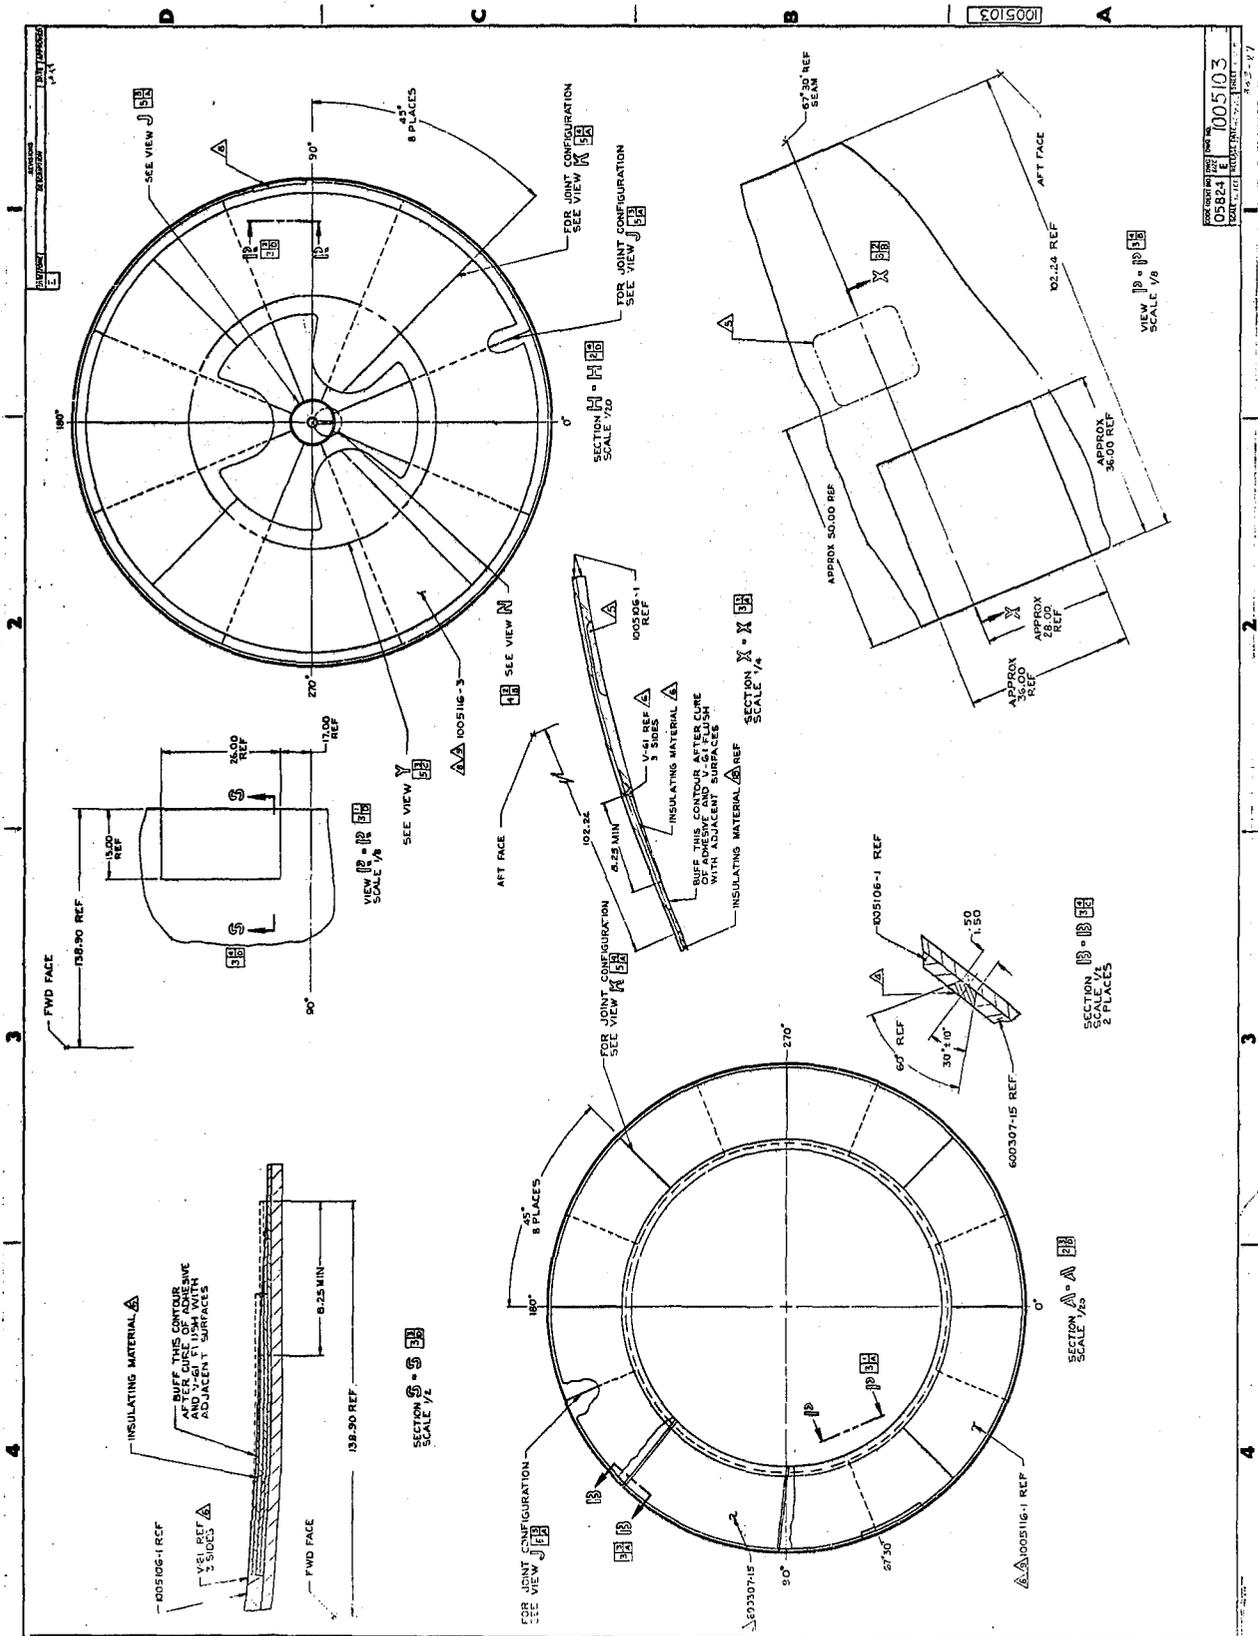
Figure 2

The exposure time is a function of web burning duration, propellant grain configuration, and propellant burning rate. Because the TLR is a function of motor operating pressure and gas velocity, each area of the motor was analysed separately to determine the local conditions to which the rubber was exposed. A summary of the internal chamber insulation design thicknesses is presented in Figure 2.

The determination of aft-head insulation thickness is more complex because of high-velocity gas flow, changes in contour of the exposed surfaces during motor operation, and varying exposure times. The design aft-head insulation thicknesses, summarized in Figure 2, are calculated as follows:

The exposure times at the local area ratios are shown in Figure 2.

The design rubber thickness is calculated as the sum of the thickness required for both nominal and reduced pressure exposure times multiplied by the 2.0 safety factor, shown in Figure 2.

260-SL-3 Motor Chamber Insulation Design Thickness Contour

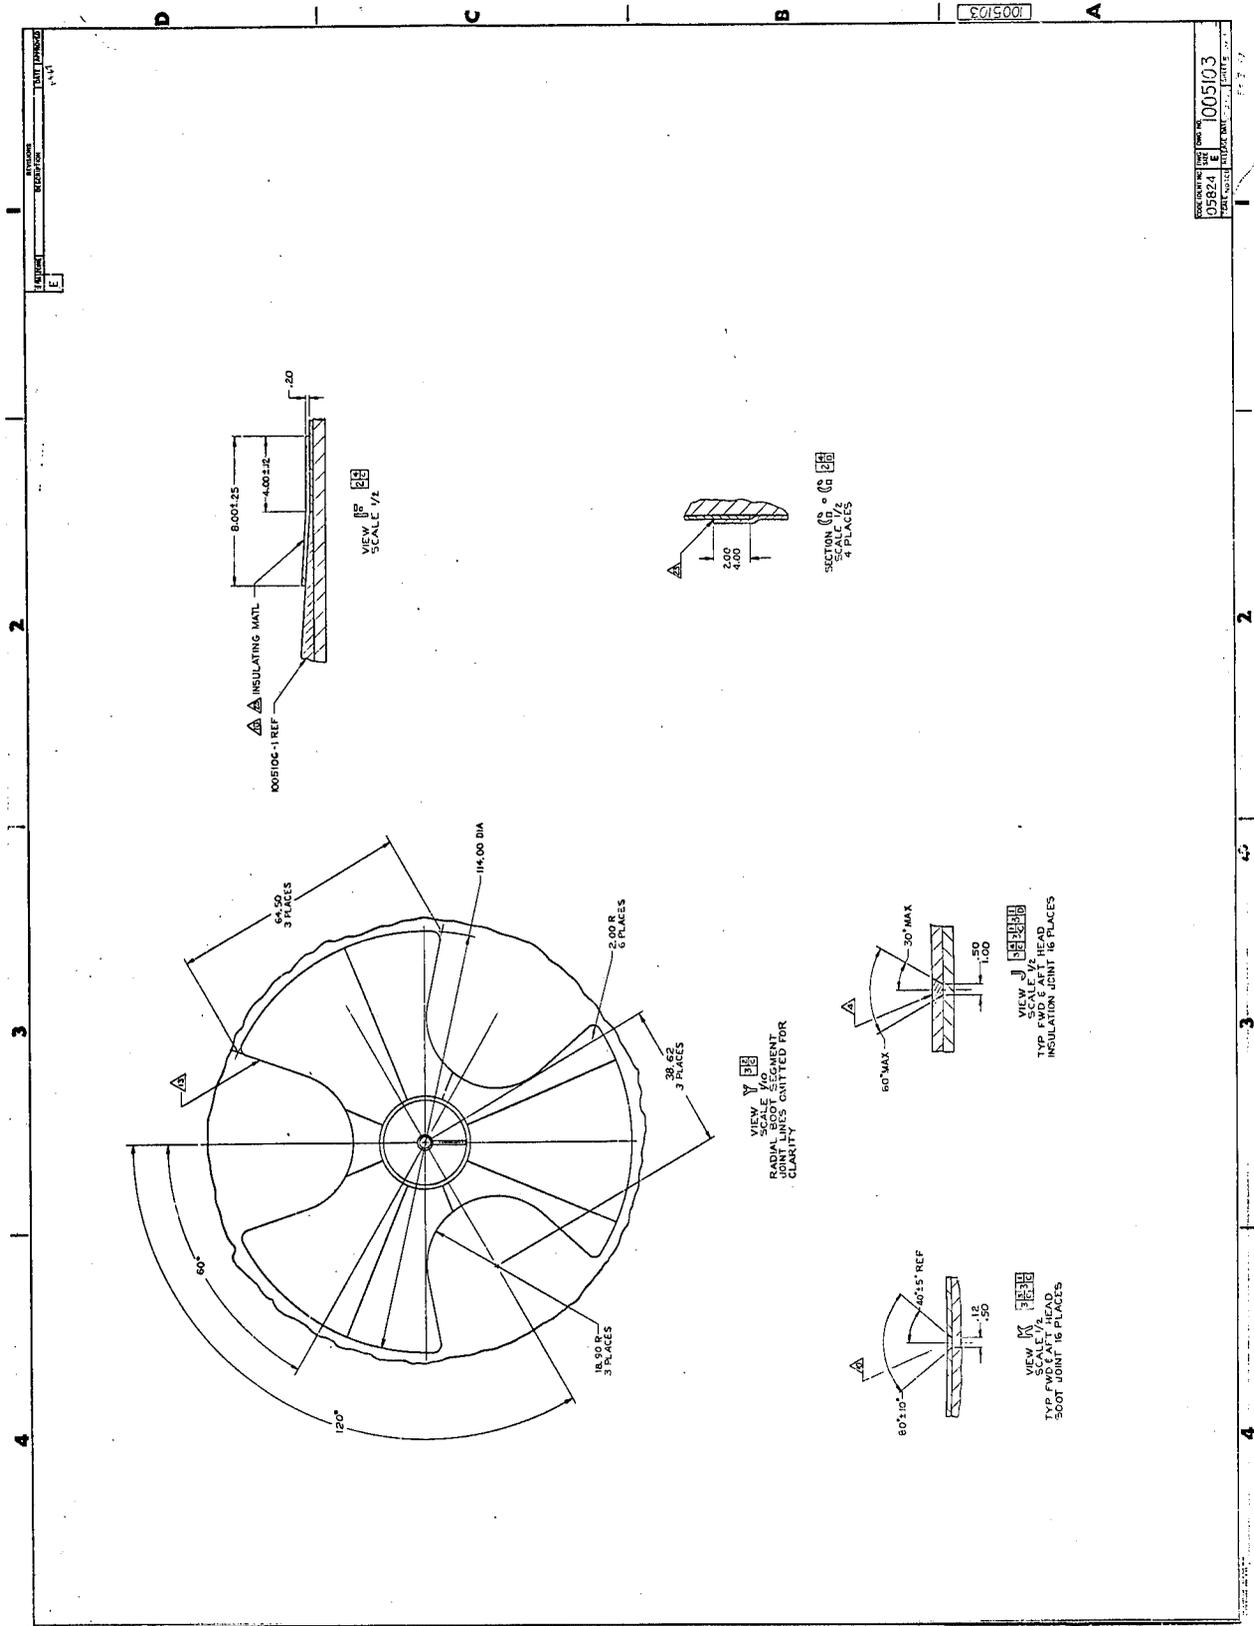
Figure 3, Sheet 5 of 5

The chamber internal-insulation design configuration is shown in Figure 3. The 260-SL-3 motor insulation configuration is similar to that of motor 260-SL-1, which is described in detail in Reference (1).

Installation requirements for the 260-SL-3 motor insulation are included in Figure 3. The operational procedure, Reference (6), was prepared to reflect the installation requirements. Installation of the 260-SL-3 motor insulation components was accomplished by Aerojet personnel at A-DD.

260-SL-3 Insulated Motor Chamber

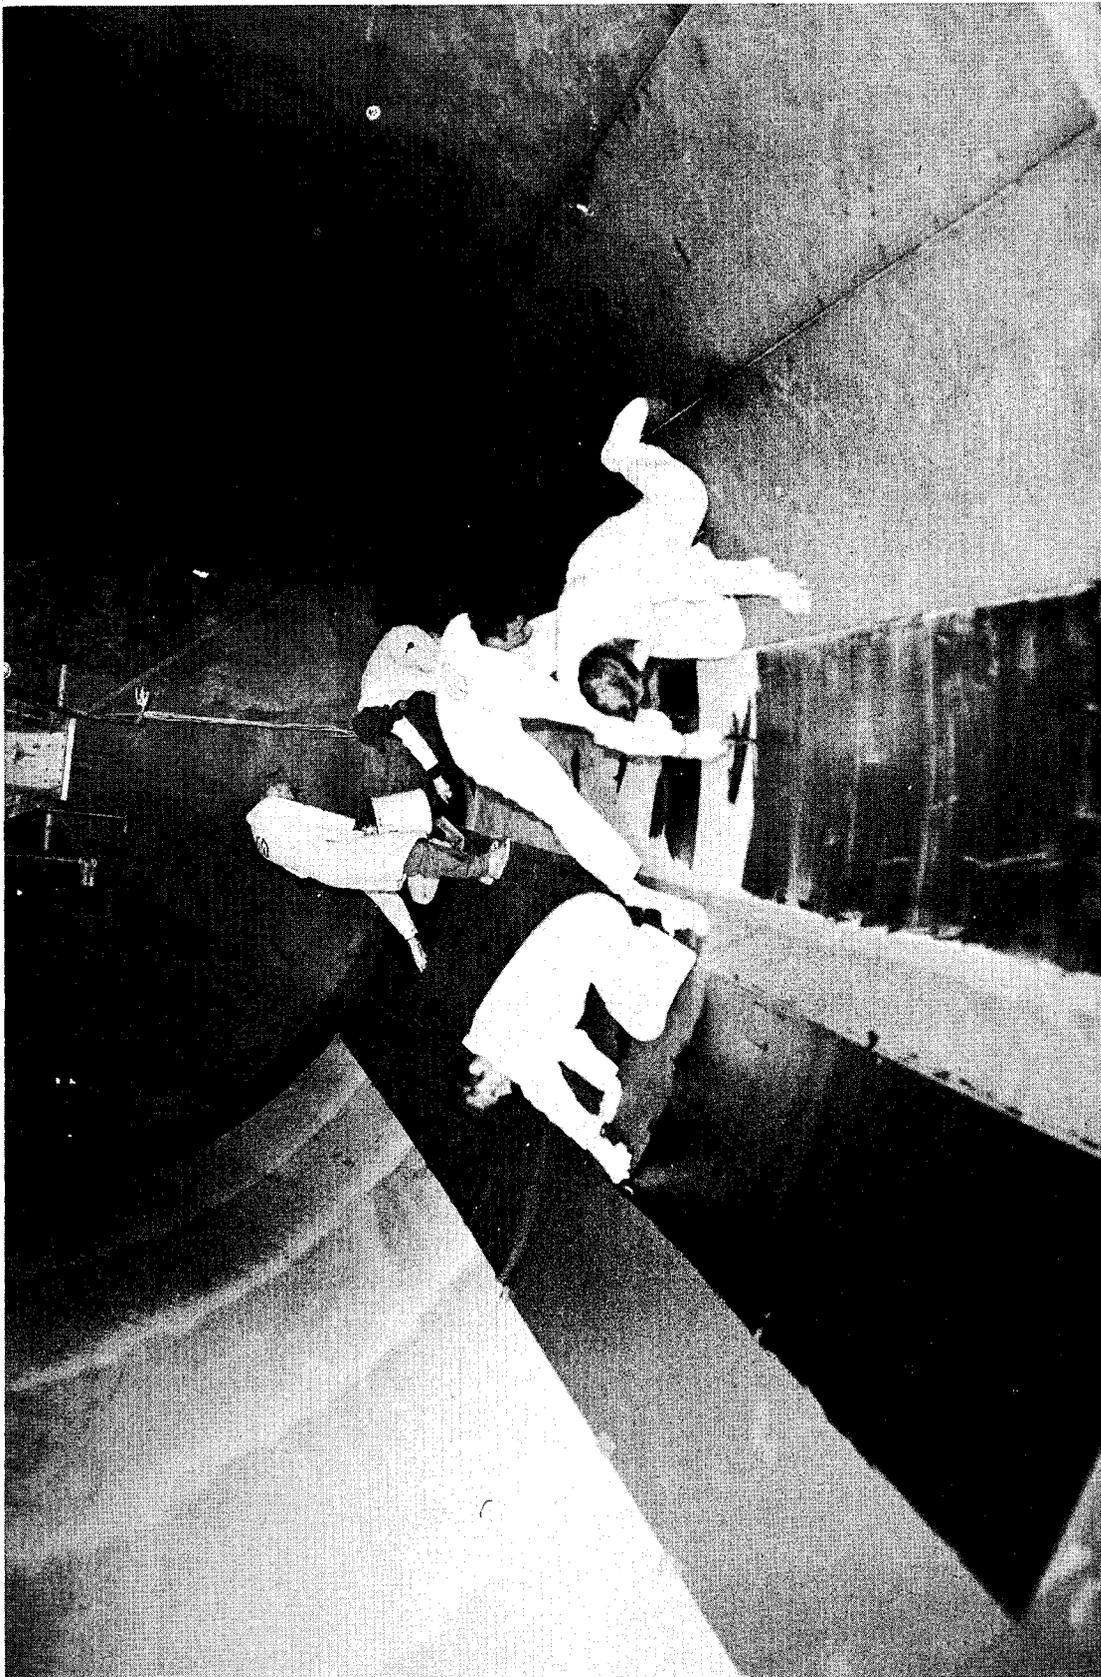
Figure 15

Aft Step-Joint Build-Up with V-61 Potting Insulation

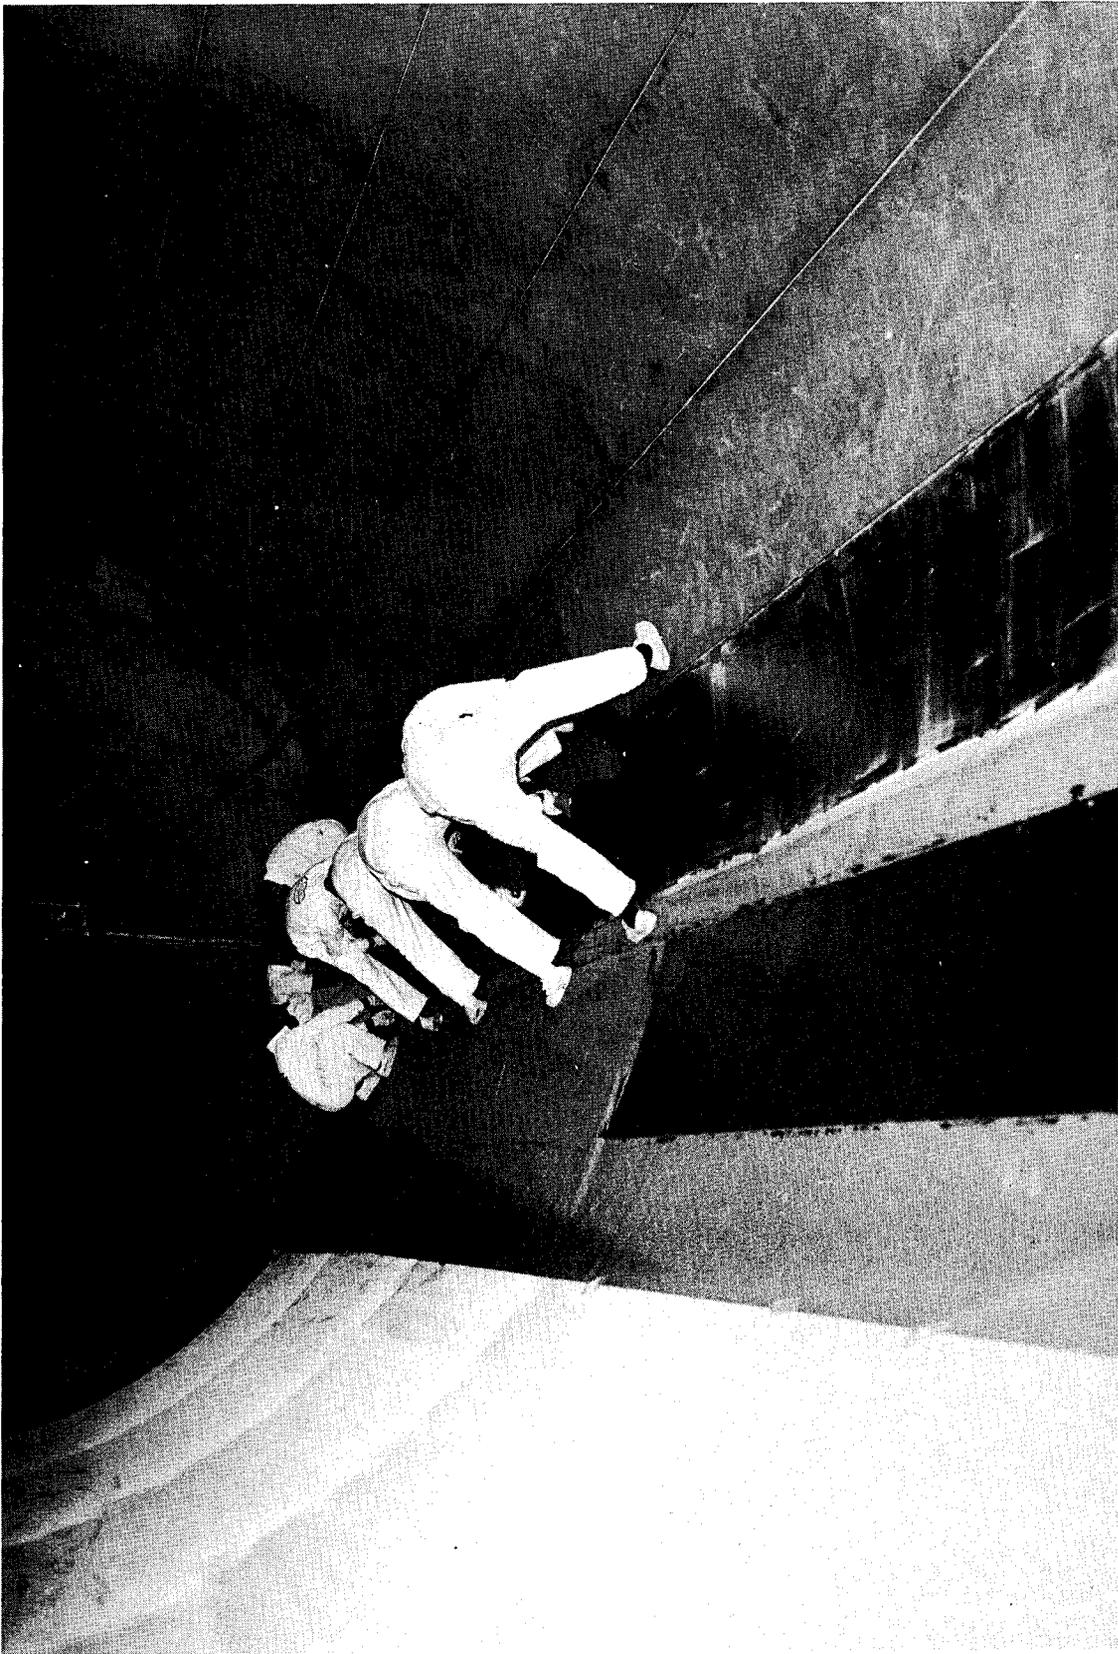
Figure 16

Adhesive Application to Cylindrical Section Rubber Strip

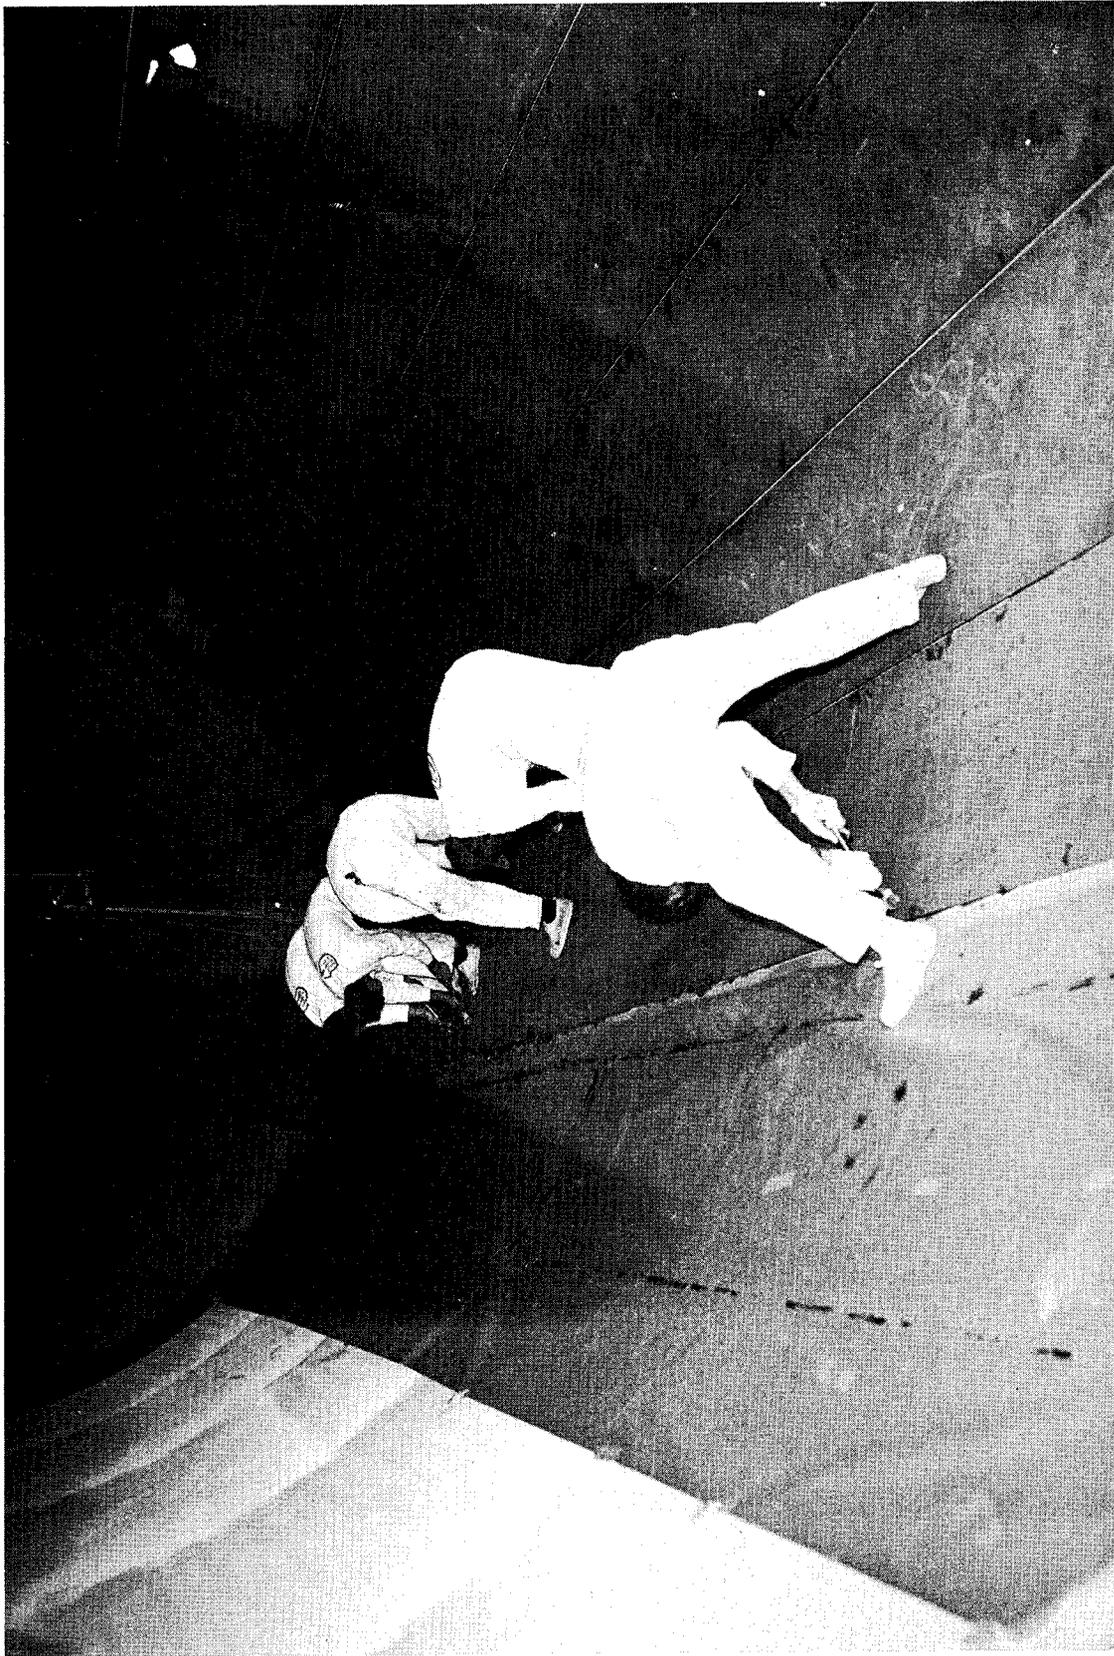
Figure 17

The first strip of the cylindrical-section insulation was aligned by using the longitudinal weld beads in the forward and aft cylindrical courses as an index. When the longitudinal guide line was established, aluminum straight edges were installed to provide a guide edge for installation of the first strip. The rubber strips were moved into the chamber, the skived edges were aligned along the aluminum straight edge, and the strips were trimmed to fit in place. After trimming, the strips were turned over, the epoxy adhesive was applied, and the strips then were installed, as shown in Figures 16 and 17. The strips were pressed into contact with the chamber by 4-in.-wide rollers as shown in Figure 18, while removing entrapped air in the process. Twenty-four full-width longitudinal strips were installed; the final strip was trimmed longitudinally

Installation of Cylindrical Section Rubber Strip
