EFFECT OF DEFECTS ON AIRCRAFT COMPOSITE STRUCTURES

R. A. Garrett

McDonnell Aircraft Company

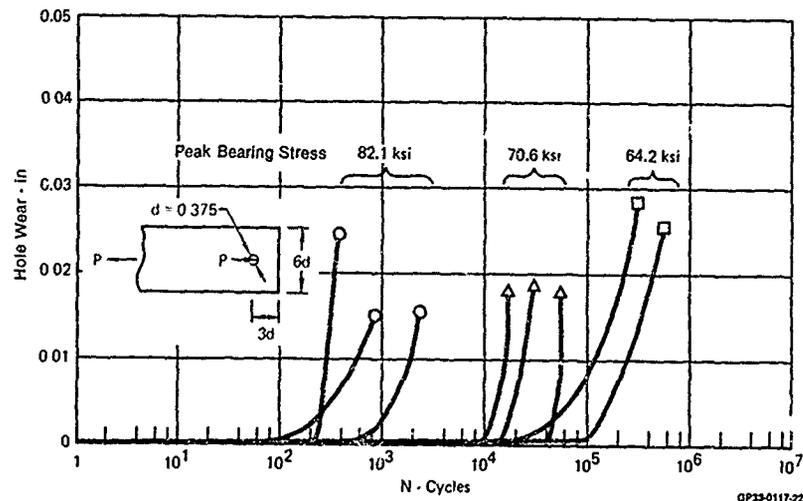
Figure 24. Effect of $R = +0.1$ Loading on Hole Wear
50/40/10 Layup

The spring rates of the test specimens for the 50/40/10 layup were also determined at various times in the constant amplitude fatigue testing to determine correlation with hole wear data. Hole wear data for this layup at RTD, shown in Figure 24 are similar in threshold points and trends to joint spring rate data summarized in Figure 25.

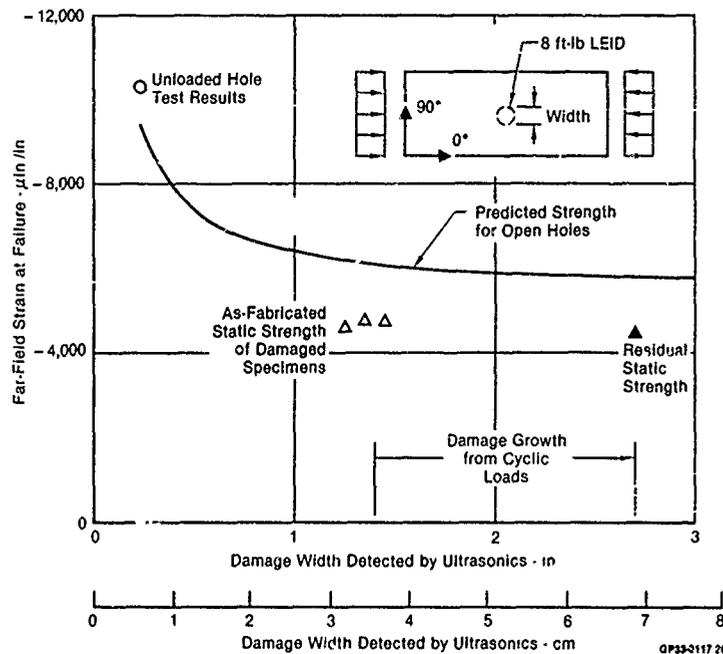
Figure 28. Residual Strength of Specimens with Nonvisible Impact Damage

These test results are summarized in Figure 28 in terms of far-field failure strains as a function of damage sizes detected in ultrasonic inspections. Test results for coupons with a .25-inch diameter hole are also shown in Figure 28. The predicted strengths, presented as a solid line, were determined using the methodology of Reference 1 and the material properties shown in Figure 29. These predictions correlate well with test results for specimens having a .25-inch diameter hole. Predictions for specimens containing impact damage were made for damage modeled as open round holes.

Test results indicate that impact damage produced an effective strain concentration greater in magnitude than a round hole of equivalent size. Strengths predicted for an equivalent hole size were unconservative by approximately 30%, possibly due to local structural instability of delaminate plies within the damaged zone.

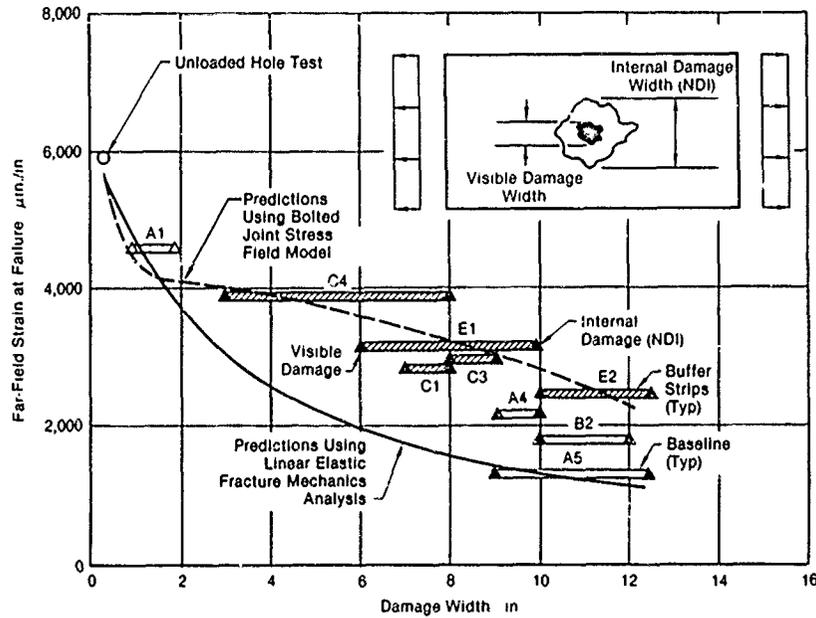
Figure 54. Residual Strength of Ballistically-Damaged Specimens

Residual tensile strengths are presented in Figure 54 as strain-to-failure for corresponding damage sizes. Strain-to-failure was calculated on the basis of the applied load at failure and gross-section properties. The range of damage presented for each specimen covers sizes from the maximum visible damage to the internal damage detected with ultrasonics. Specimens with buffer strips (shaded) exhibited significant improvement in residual strength relative to strength of baseline specimens (unshaded) having similar damage.
