TITLE: Minutes of the Explosives Safety Seminar (22nd) Held in Anaheim,  
California on 26-28 August 1986, Volume 1.

DEBRIS HAZARD AT A ROCKET  
MOTOR TEST CELL FACILITY--  
AN "ACCIDENTAL" STUDY

Patricia Moseley Bowles  
and  
Michael A. Polcyn

Southwest Research Institute  
San Antonio, Texas

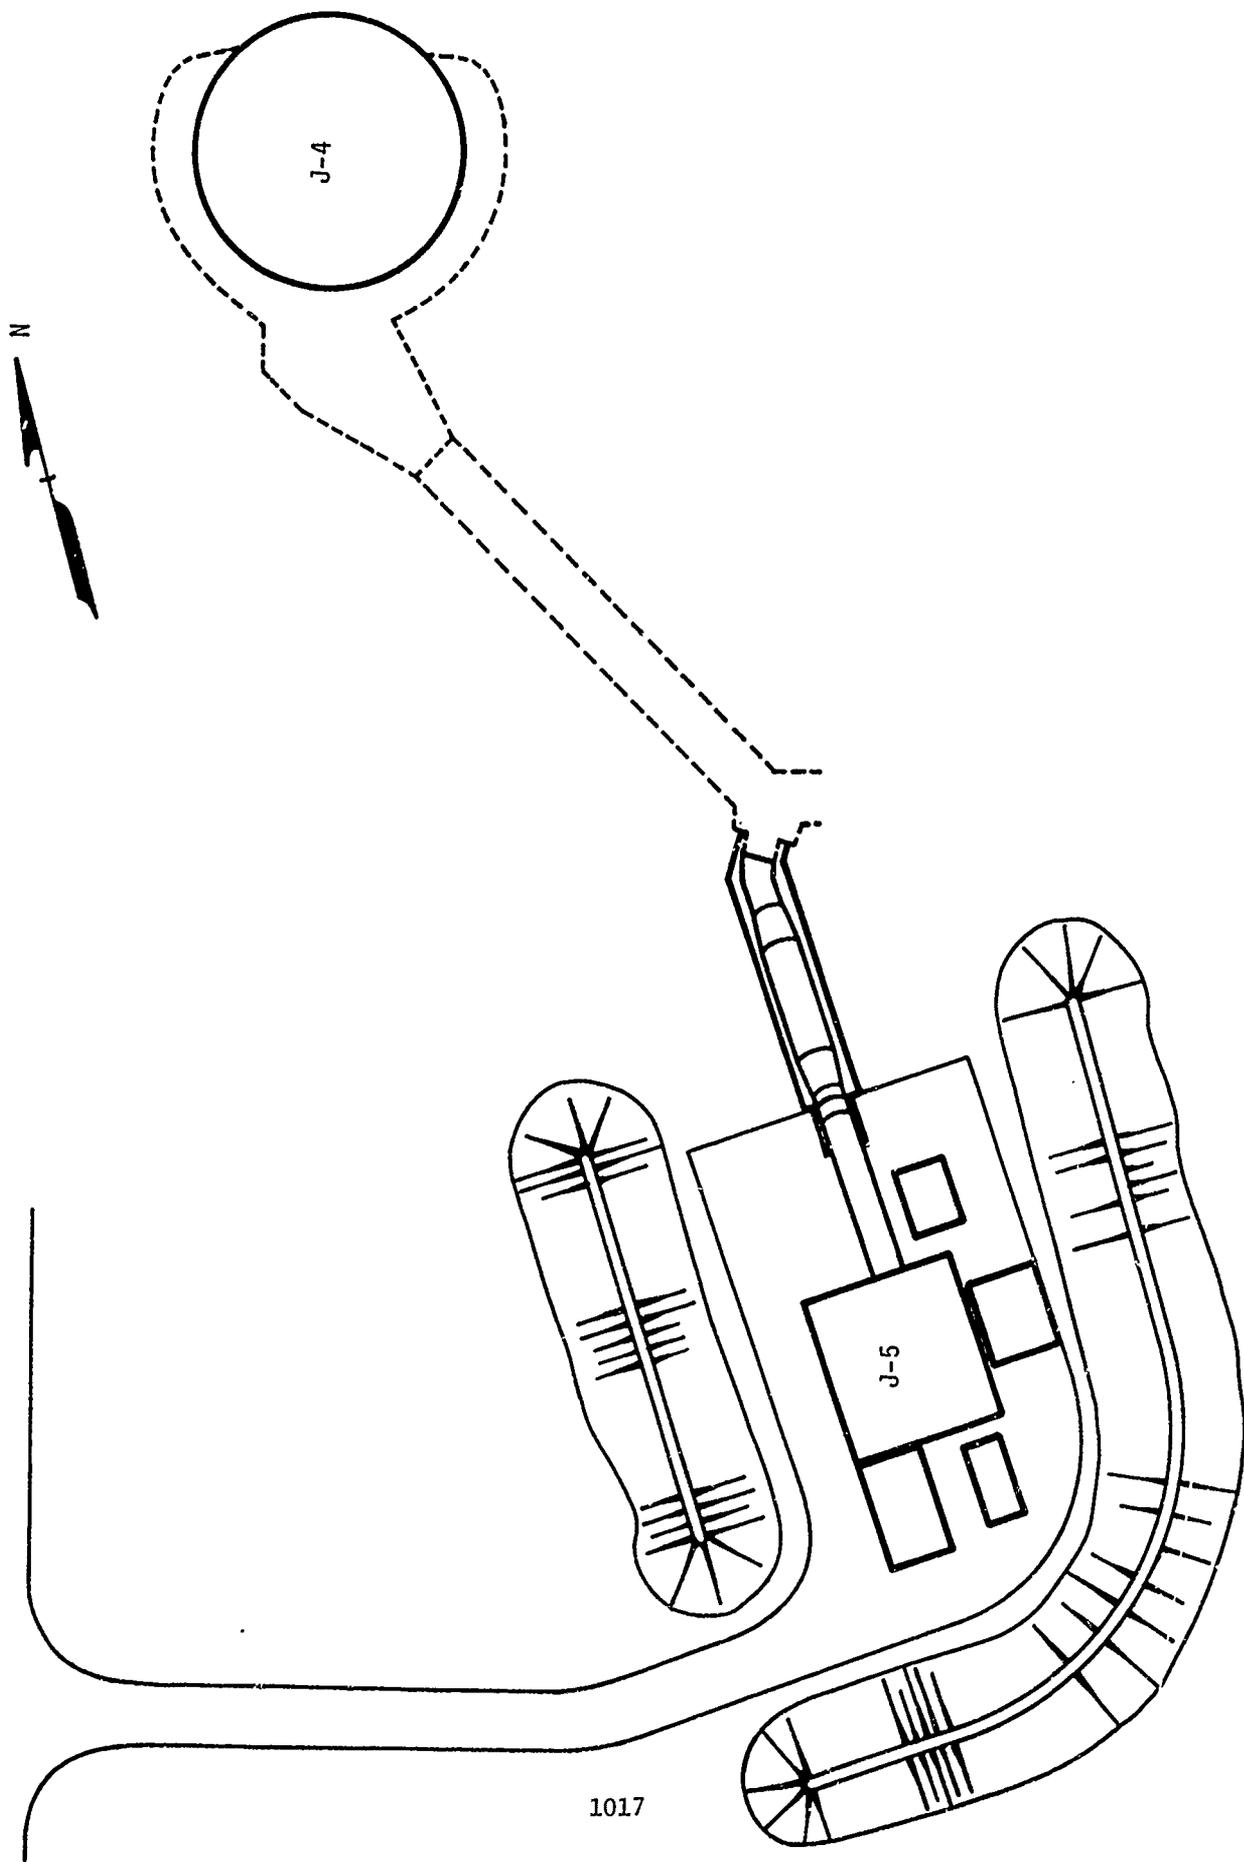
Figure 1. AEDC J-5 Test Facility

Southwest Research Institute (SwRI), as a subcontractor to Lawrence Livermore National Laboratory (LLNL), has been consulting Arnold Engineering Development Center (AEDC) on potential debris distribution problems at the J-5 and proposed J-6 rocket test facilities. The J-5 test facility at AEDC, shown in Figure 1, is the only large national facility for testing solid propellant rocket motors at simulated flight-altitude conditions. However, some motors currently in need of altitude testing and future motors to be tested exceed the test capability of J-5 in nominal thrust and in the amount of propellant contained in the motors. Some of these motors were being tested in J-5 with explosives safety waivers since the location of the facility does not meet quantity-distance criteria required by safety regulations for the type and amount of propellant involved. Safety personnel became concerned with the potential debris hazard which may result from testing motors under safety waivers.

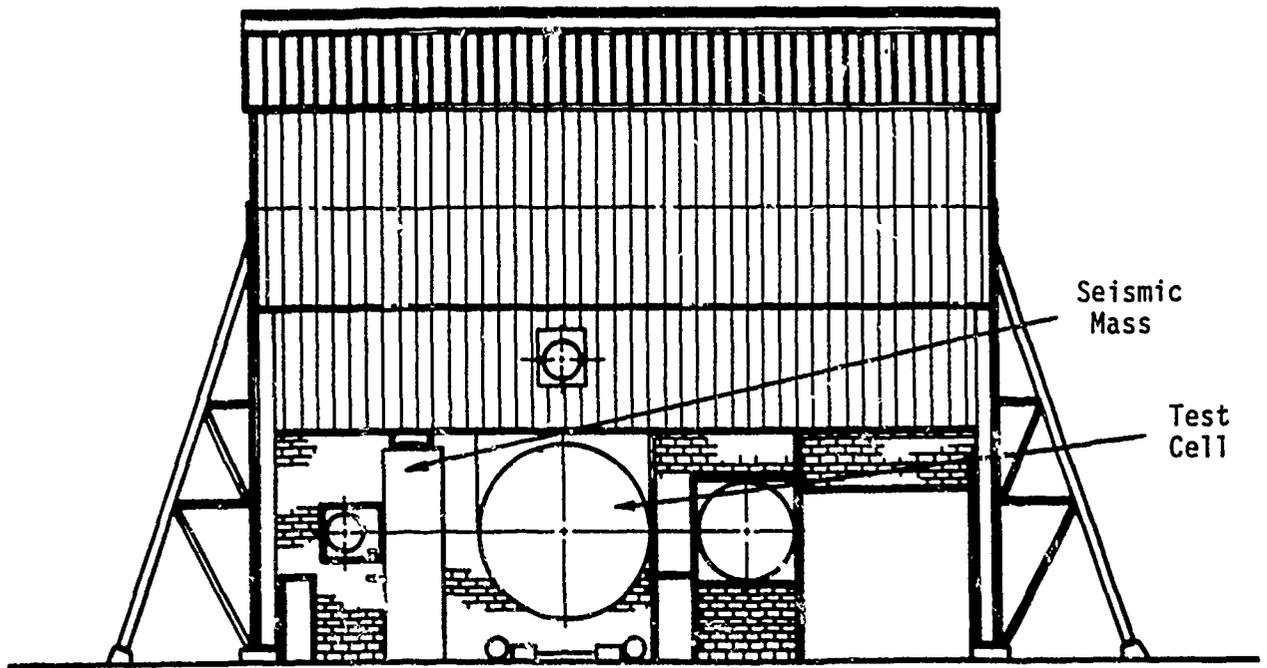
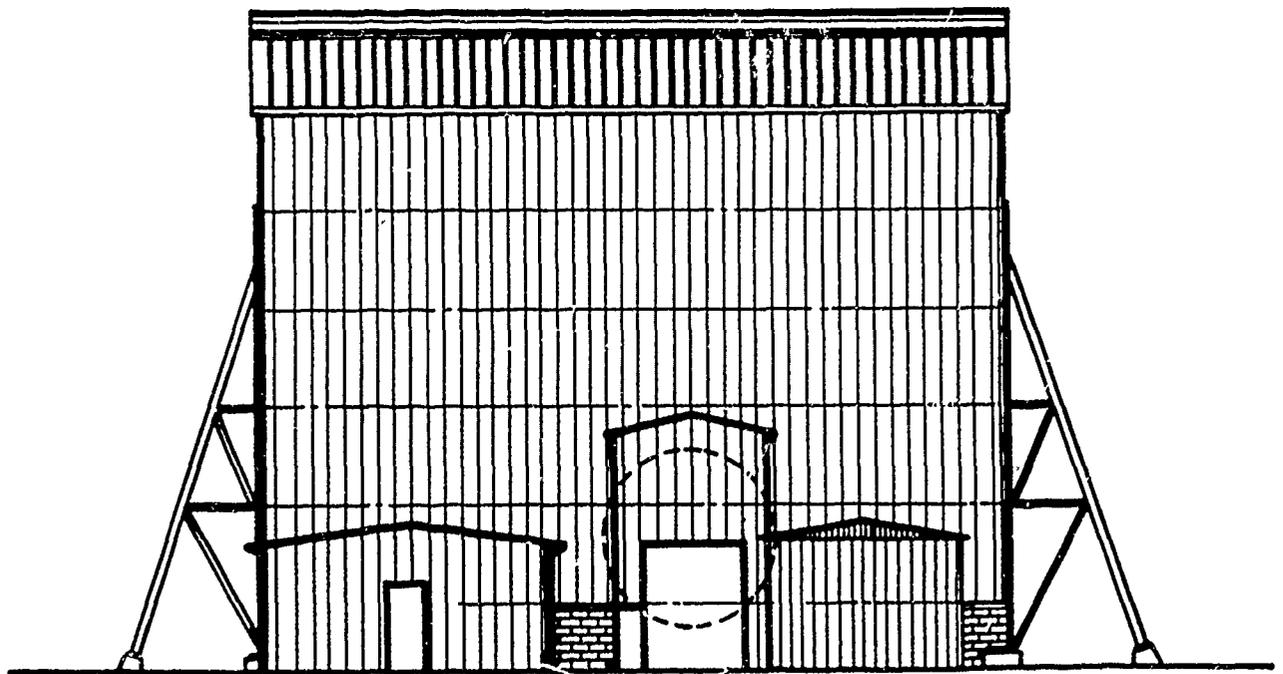
Figure 2. J-5 Facility Elevations

Elevations of the J-5 enclosure building and an expanded detail of the test cell are shown in Figures 2-4. Since the J-5 test cell and enclosure building are similar to the configuration described in Reference 1, debris were expected to be similarly distributed in zones around the enclosure building. The zones which were established for examining hazardous debris densities are shown in Figure 5. Debris densities were estimated in zones 1, 3, 5 and 7 since the number of debris landing in the other zones was assumed to be minimal. Building debris will be dispersed in directions normal to the walls of the enclosure building. The heaviest concentration of motor casing and test cell fragments was predicted in zone 5 because it extends perpendicular to the horizontal axis of the test cell. Approximately 70% of the total fragments and debris will land in zone 5. Although zone 1 extends in the direction opposite of zone 5, fewer casing and cell fragments will land there since a 5 foot thick seismic mass (see Figure 2) supports the test cell on that side. The seismic mass will stop all but high trajectory fragments. About 20% of the total debris will land in zone 1. The remaining 10% of the debris will be distributed in zones 3 and 7, with slightly more debris landing
