FLIGHT SERVICE ENVIRONMENTAL EFFECTS  
ON COMPOSITE MATERIALS AND STRUCTURES

H. Benson Dexter  
NASA Langley Research Center  
Hampton, VA USA 23665-5225

Donald J. Baker  
U.S. Army Aviation Research and Technology Activity (AVSCOM)  
Aerostructures Directorate  
NASA Langley Research Center  
Hampton, VA USA 23665-5225

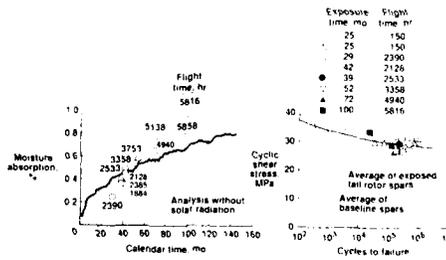
Figure 17. Moisture absorption and strength retention of ASI/6350 Sikorsky S-76 tail rotor spars.

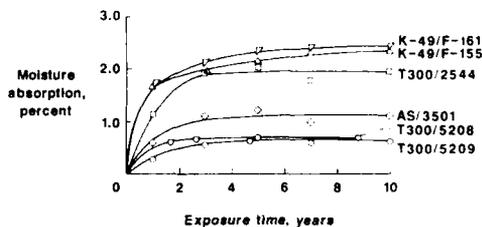
Figure 23. Moisture absorption of unpainted composite materials after worldwide outdoor exposure.

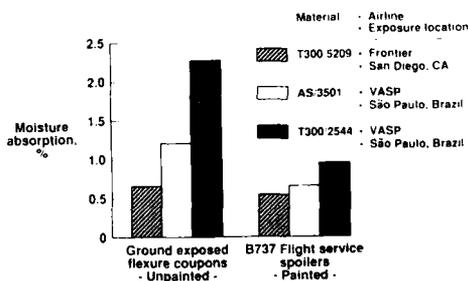
Figure 24. Moisture absorption comparison of graphite/epoxy materials after 10 years of ground and flight exposure.

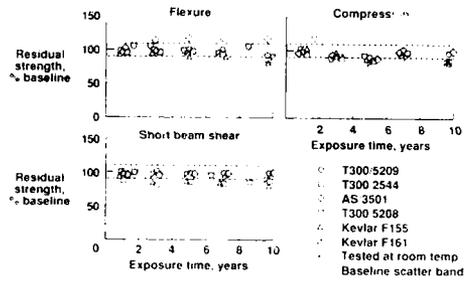
The average room temperature residual strengths (flexure, short beam shear, and compression) of six composite materials for 10 years of outdoor exposure at the six exposure sites discussed previously are plotted in figure 25. The graphite/epoxy coupons were fabricated with 0-degree tape and the Kevlar/epoxy coupons were fabricated with (0/90) fabric. Three-point flexure tests were conducted to assess the effects of outdoor environments on surface fiber strength. The coupons were tested with the exposed surface in compression; in general, however, failure occurred in tension at mid-span of the coupons. After 10 years of exposure, the Kevlar-49/F155 material indicated the largest flexural strength loss, about 20 percent. The T300/2544 material, which had significant surface degradation in the resin, failed at about 13 percent below the average baseline strength. The matrix dominant compression coupons indicated a similar strength loss, 15 to 20 percent, during the 10 year exposure.

Figure 25. Residual strength of unpainted composite materials after worldwide outdoor exposure.

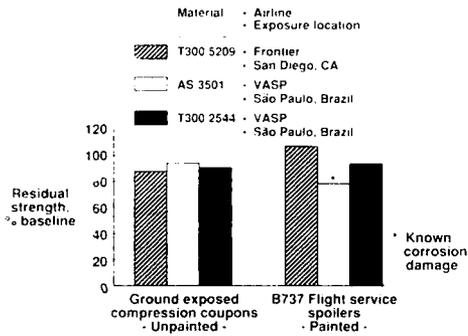
Ten year compression strength data for material coupons are compared with B737 graphite/epoxy spoiler strength data in figure 26. The strength data are for coupons and spoilers with the same exposure conditions that were discussed for the moisture comparison of figure 24. Except for one spoiler with known corrosion damage, the spoilers exhibited residual strengths that were slightly higher than the coupon residual strengths. As discussed previously, the spoiler corrosion damage is a design related problem and could be prevented through design changes. These results indicate excellent strength correlation between ground exposed coupons and flight exposed spoilers.

Figure 26. Strength comparison of graphite/epoxy materials after 10 years of ground and flight exposure.

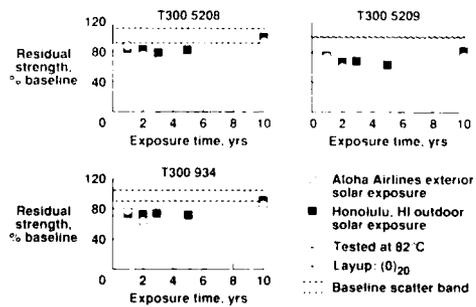
The effects of flight and ground exposure on short beam shear strength of three graphite/epoxy materials is shown in figure 30. The results are for coupons exposed on the upper (solar) surface of B737 flap-track fairing tailcones on Aloha Airlines and for solar exposed material coupons at Honolulu, HI. The coupons were tested at 82°C and are compared to baseline coupons that were also tested at 82°C. An unexplained trend is evident; a significant strength loss after 2 to 3 years of exposure with an increase in strength thereafter. A maximum short beam shear strength loss of 40 percent was evident for the T300/5209 material after 2 years of exposure on Aloha Airlines. However, after 10 years of exposure, strength losses of only 13 to 25 percent occurred. The T300/934 material cures at 177°C, compared to 121°C for the T300/5209 material, however the T300/934 material performed only slightly better in the 82°C test. The coupons exposed at Honolulu, HI performed the same or slightly better than the coupons exposed on the Aloha Airlines aircraft. The results of these tests indicate that the less expensive ground-based tests could be used to assess material performance for future evaluations.

Figure 30. Effect of flight and ground-based exposure on short beam shear strength of painted graphite/epoxy materials.

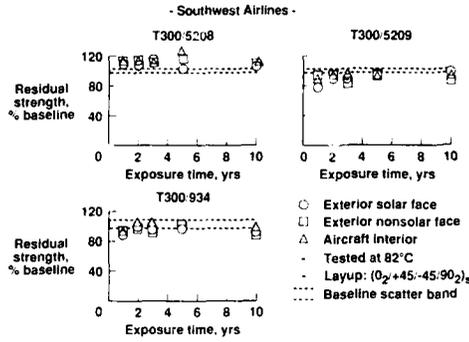
A comparison between interior and exterior aircraft exposure effects on flexure strength of three graphite/epoxy materials is shown in figure 31. The results are for coupons exposed on the upper (solar) surface and lower (nonsolar) surface of B737 flap-track fairing tailcones and in the interior of Southwest Airlines aircraft. The coupons were tested at 82°C and compared to baseline coupons tested at 82°C. A maximum strength reduction of 20 percent occurred for the T300/5209 material exposed on the upper surface of the flap-track fairing tail cone. Considering test data scatter, there is no discernible difference between the effects of solar exterior, nonsolar exterior or aircraft interior exposure.

Figure 31. Effect of interior and exterior aircraft exposure on flexure strength of painted graphite/epoxy materials.

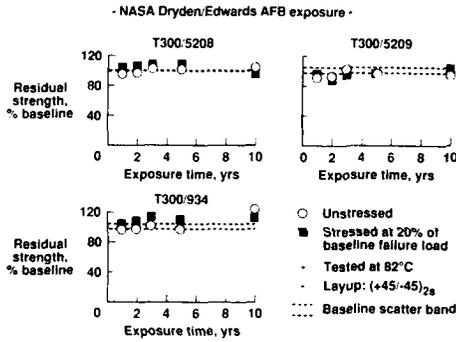
The effects of sustained stress on tensile strength of three graphite/epoxy materials exposed outdoors at the NASA Dryden Research Center in Edwards Air Force Base, CA, are shown in figure 32. The unstressed coupons are compared with coupons that were continuously stressed at 20 percent of the baseline failure stress. The tensile coupons were tested at 82°C. The test results indicate no discernible difference between the stressed and unstressed coupon data. Small variations above and below baseline values are indicated during the 10 year evaluation period. Additional details on the ground and flight exposure program are reported in reference 16.

Figure 32. Effect of sustained stress on tensile strength of painted graphite/epoxy materials after outdoor exposure.

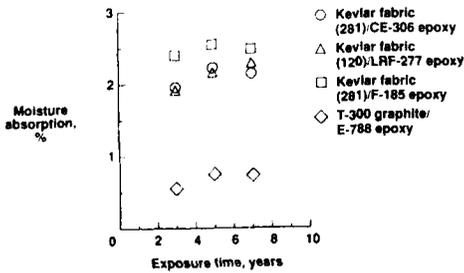
Moisture absorption data for three Kevlar/epoxy fabrics and one graphite/epoxy tape material are shown in figure 33. The painted T300/E-788 graphite/epoxy material absorbed about 0.7 percent moisture, whereas the painted Kevlar/epoxy materials absorbed about 2.5 percent moisture, as expected. The average residual strengths for four Bell 206L composite materials after outdoor exposure at five exposure sites discussed previously are shown in figure 34. In the summer of 1985

Figure 33. Moisture absorption of Bell 206L painted composite materials after outdoor exposure.

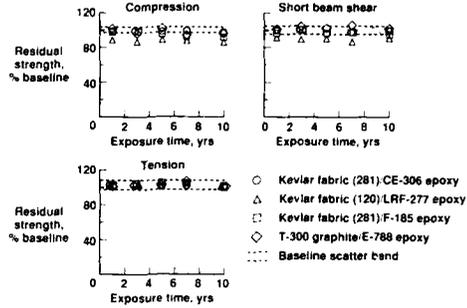
Figure 34. Residual strength of Bell 206L painted composite materials after outdoor exposure.

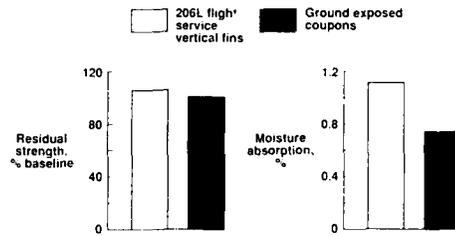
Figure 35 compares strength retention and moisture absorption data for T300/E-788 composite coupons with corresponding data from Bell 206L vertical fins after 5 years of flight service. The vertical fins absorbed about 1.1 percent moisture, whereas the 5 year ground exposed coupons absorbed about 0.7 percent moisture. The fin moisture content includes moisture absorbed by paint, sealer, primer, graphite/epoxy skins, and honeycomb core. Strength retention for compression coupons and vertical fins was near 100 percent. These results indicate that ground-based coupon strength data are representative of strength retention results expected from flight service components. Additional details on the test program and test results are reported in reference 15.

Figure 35. Strength retention and moisture absorption of T300/E-788 after 5 years of ground and flight exposure.

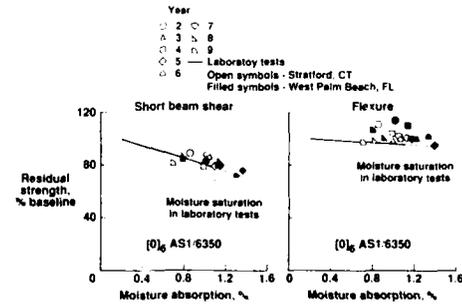
As discussed previously, Sikorsky conducted accelerated laboratory conditioning tests to develop environmental factors that account for anticipated strength reduction as a function of absorbed moisture. These tests were conducted at 87 percent relative humidity and 88°C. To establish a correlation between realtime outdoor exposure and accelerated laboratory exposure, composite panels were exposed for 9 years in outdoor racks located at Stratford, CT and West Palm Beach, FL. Results for 6-ply ASI/6350 short beam shear and flexure coupons machined from the panels are shown in figure 36. Residual strength is plotted as a function of absorbed moisture and the results indicate that the matrix dependent short beam shear strength is affected more than the fiber dependent flexure strength. The accelerated laboratory conditioning tests indicated moisture saturation for the 6-ply laminates at about 1.1 percent. The panels exposed at Stratford, CT absorbed a maximum of 1.13 percent moisture, however, the panels exposed at West Palm Beach, FL absorbed a maximum of 1.40 percent moisture. The results are inconsistent in that the 5 year panels absorbed the most moisture, whereas the 9 year panels absorbed the least amount of moisture. These results are probably affected by local weather conditions at the time of panel removal.

Figure 36. Effect of moisture on the residual strength of Sikorsky S-76 graphite/epoxy laminates.
