- *Title:* Technology Showcase: Integrated Monitoring, Diagnostics and Failure Prevention.
Proceedings of a Joint Conference, Mobile, Alabama, April 22-26, 1996.

PREVENTION OF CRANKCASE EXPLOSIONS IN RECIPROCATING COMPRESSORS

V. A. Cox

Shell Research Ltd
Thornton Research Centre
P.O. Box 1
Chester CH1 3SH
United Kingdom

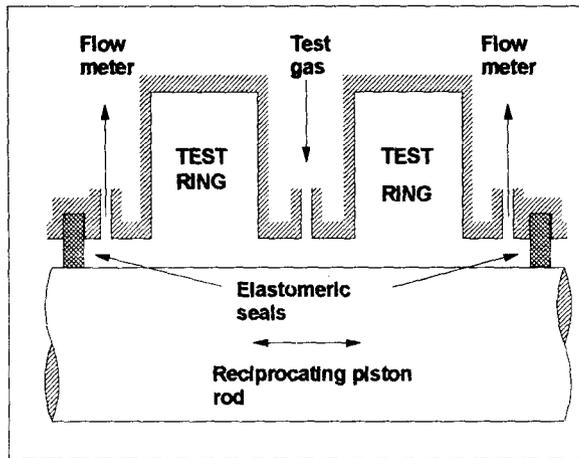
Figure 5. Low pressure seal test rig arrangement

A test rig was constructed for the purpose of measuring typical leakage of gases. The rig, shown in Figure 5, comprised two seal containers mounted back-to-back, with a gas entry port between them. Leakage past the seals was directed to passages equipped with Rotameter flow measurement meters. Elastomeric seals fitted outboard of the containers provided leak-free sealing and were replaced after each test. The piston rod used for this work was of 50 mm diameter and its stroke rate was 300 per minute, identical with that of the compressors.
