AFWAL-TR-81-3096

## **EVALUATION OF SEVERAL BONDING PARAMETERS ON THE RANDOM BENDING FATIGUE LIFE OF ADHESIVELY BONDED ALUMINUM JOINTS**

AUGUST 1981

TECHNICAL REPORT AFWAL-TR-81-3096  
Final Report for Period June 1978 — November 1980

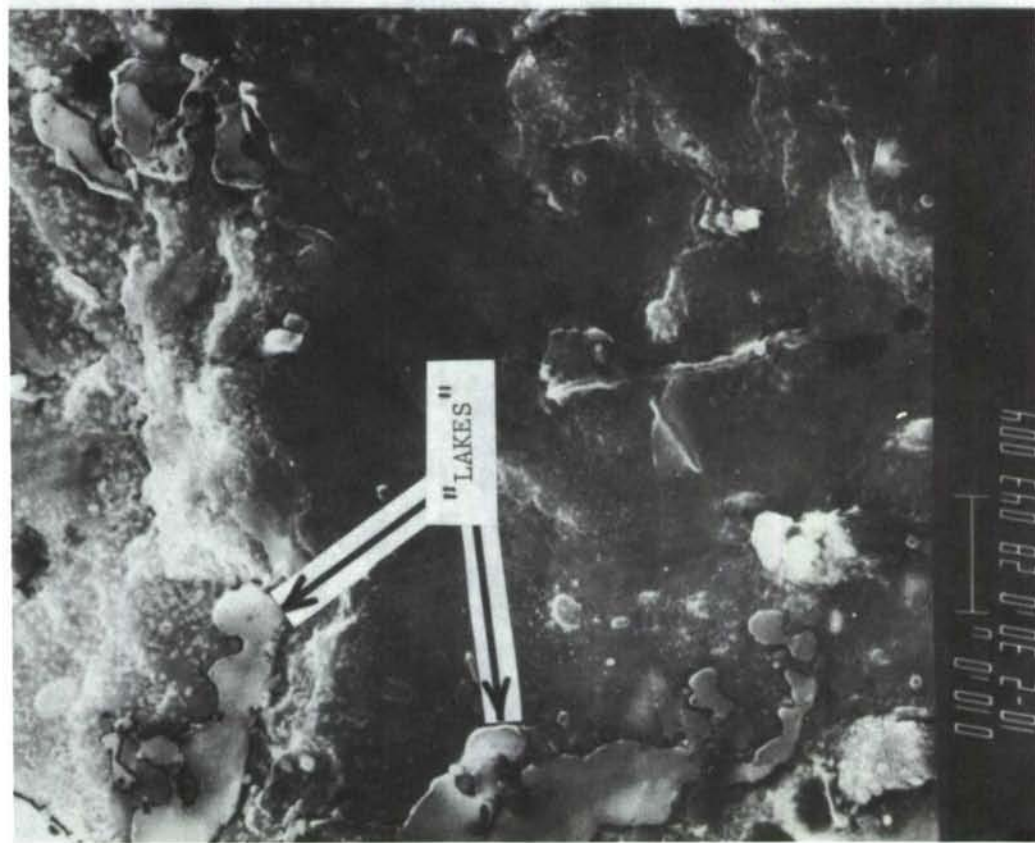
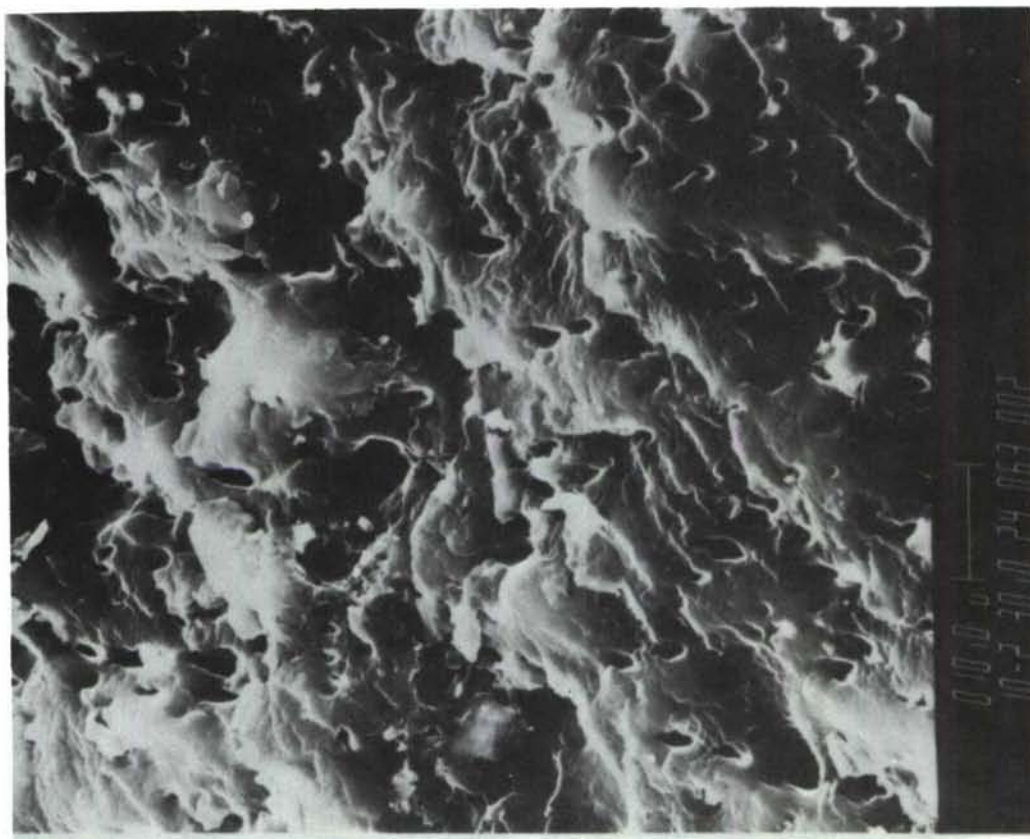
Figure Nr. 29 - Photomicrograph of Fracture Surface (Skin Side), Group E, Specimen Nr. 3

For a specimen from Group E (Specimen Nr. 3, the PABST system except using FPL etch instead of phosphoric acid anodize), the locus of fracture was purely cohesive within the adhesive, but close to the skin side. This is illustrated by Figure 28 for the tee and Figure 29 for the skin, both showing fracture surfaces near the zone of initiation. Figure 28 shows the classical cohesive failure for FM73. Figure 29 also shows cohesive failure, but along a diagonal line from upper left to lower right one can see the adherend surface through a thin layer of adhesive.
