USAAEFA PROJECT NO. 80-07

CLIMATIC LABORATORY SURVEY HUGHES YAH-64 HELICOPTER

FINAL REPORT

MARCH 1982

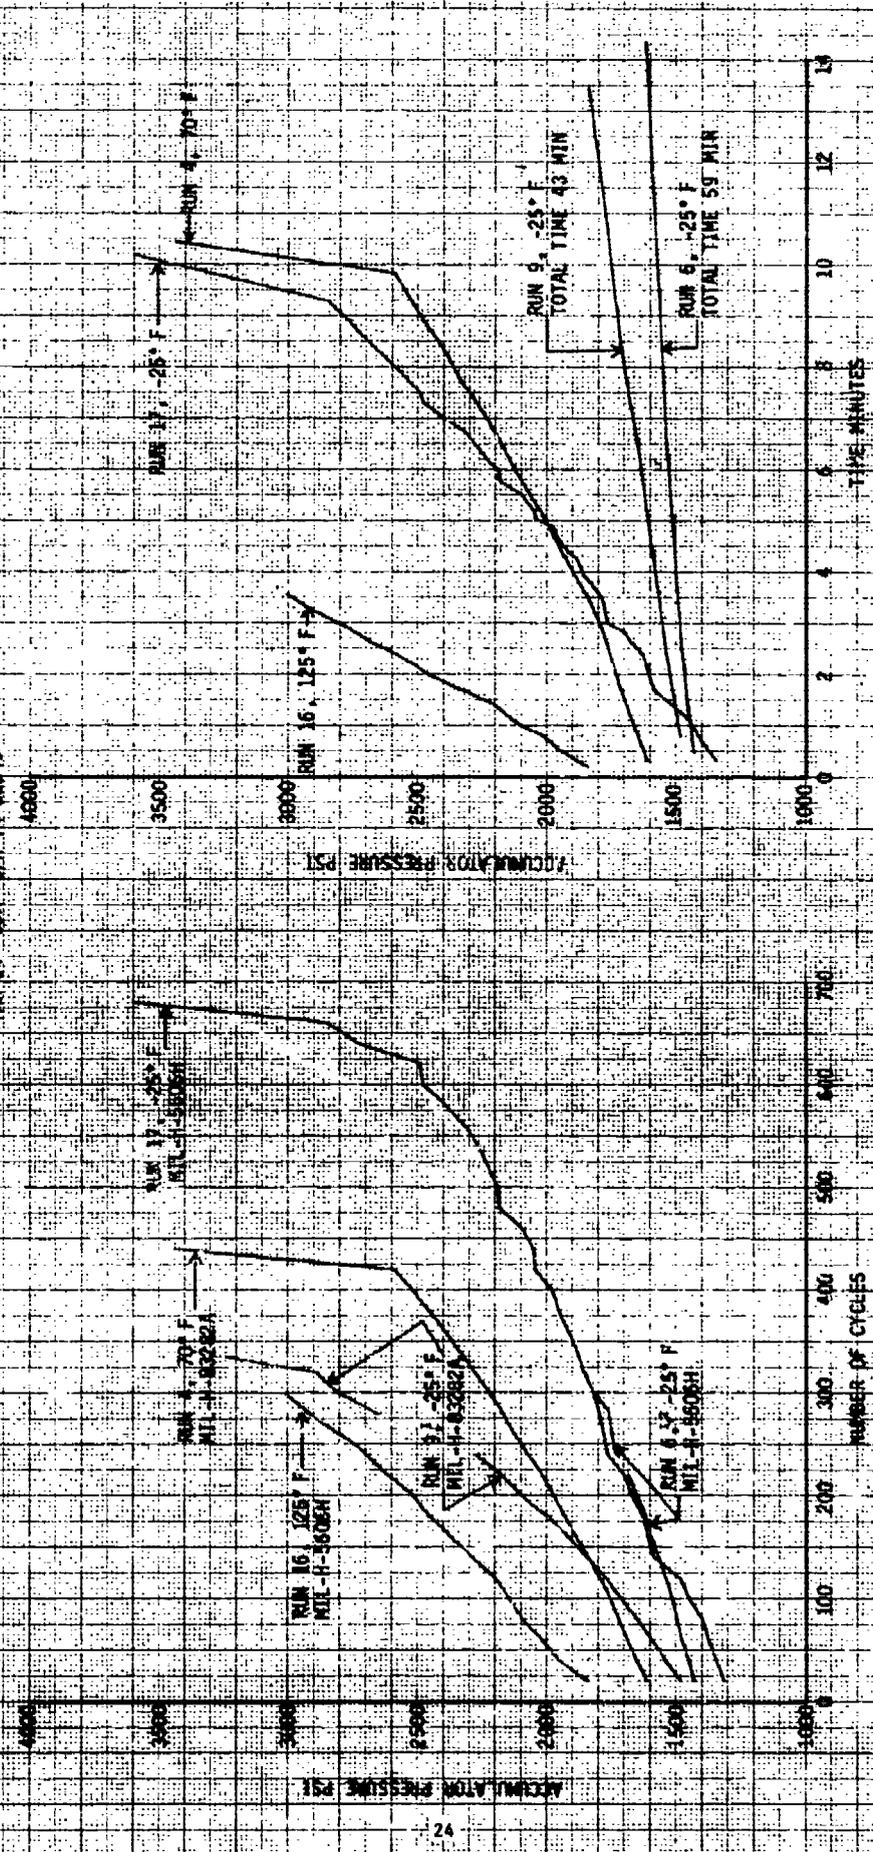
FIGURE 1
UTILITY HYDRAULIC ACCUMULATOR AND HAND PUMP EFFICIENCY
YAN-65 USA S/N 7A-22249

37. The utility hydraulic hand pump was evaluated for efficiency and ease of operation. Fluid was supplied to the pump under pressure from the utility manifold reservoir. Each test was started by depleting the accumulator hydraulic pressure, reading and servicing the nitrogen precharge if necessary, and pressurizing the accumulator with the hand pump. The pump, when serviced with either fluid, operated satisfactorily at 70° and 125°F requiring from 3.5 to 10 minutes and 300 to 460 strokes to pressurize the system to 3000 pounds per square inch (psi). Resistance was encountered throughout the full travel of the stroke and increased the pressure in the accumulator from 3.5 to 4.1 psi per stroke. The pump was less effective at -25°F tests with MIL-H-83282A fluid. It was necessary to allow from 10 to 15 seconds between strokes to fill the pump cylinder to produce a full stroke. Midway through the charging cycle the pump cylinder would not fill and pressure dropped from 4.5 to less than 1 psi increase per stroke. Pressurized air was applied to the utility manifold reservoir through the pressurized air system (PAS) air inlet check valve. The pump then functioned properly to complete the charge cycle. On another occasion, this procedure was used but the pump would not begin to work. Figure 1 shows the number of strokes required to charge the accumulator. A new utility manifold was installed and a second test conducted at -25°F using MIL-H-5606H fluid. The pump charged the accumulator to 3000 psi in 10 minutes averaging 2.4 psi per stroke. There was a reduced efficiency of 32% (an increase of 220 strokes to achieve the same pressure in the same time) compared to the 70°F tests. The pump operation at -50°F with MIL-H-5606H fluid was unsatisfactory. An increase to 30 to 40 seconds between strokes was required to allow the pump cylinder to fill with fluid and less than 50% of the pump handle travel produced any pressure increase.

Further evaluations of the pump at this temperature were terminated and the accumulator charged using an external hydraulic power cart. The inadequate hand pump operations at -25°F with MIL-H-83282A and at -50°F with MIL-H5606H is a deficiency.

g. Paragraph 61d. Hydraulic hand pump problems were traced to a foreign object (chip) which wedged at the piston periphery and caused binding. Since the hydraulic hand pump failure was an isolated type failure, it is not considered a deficiency.

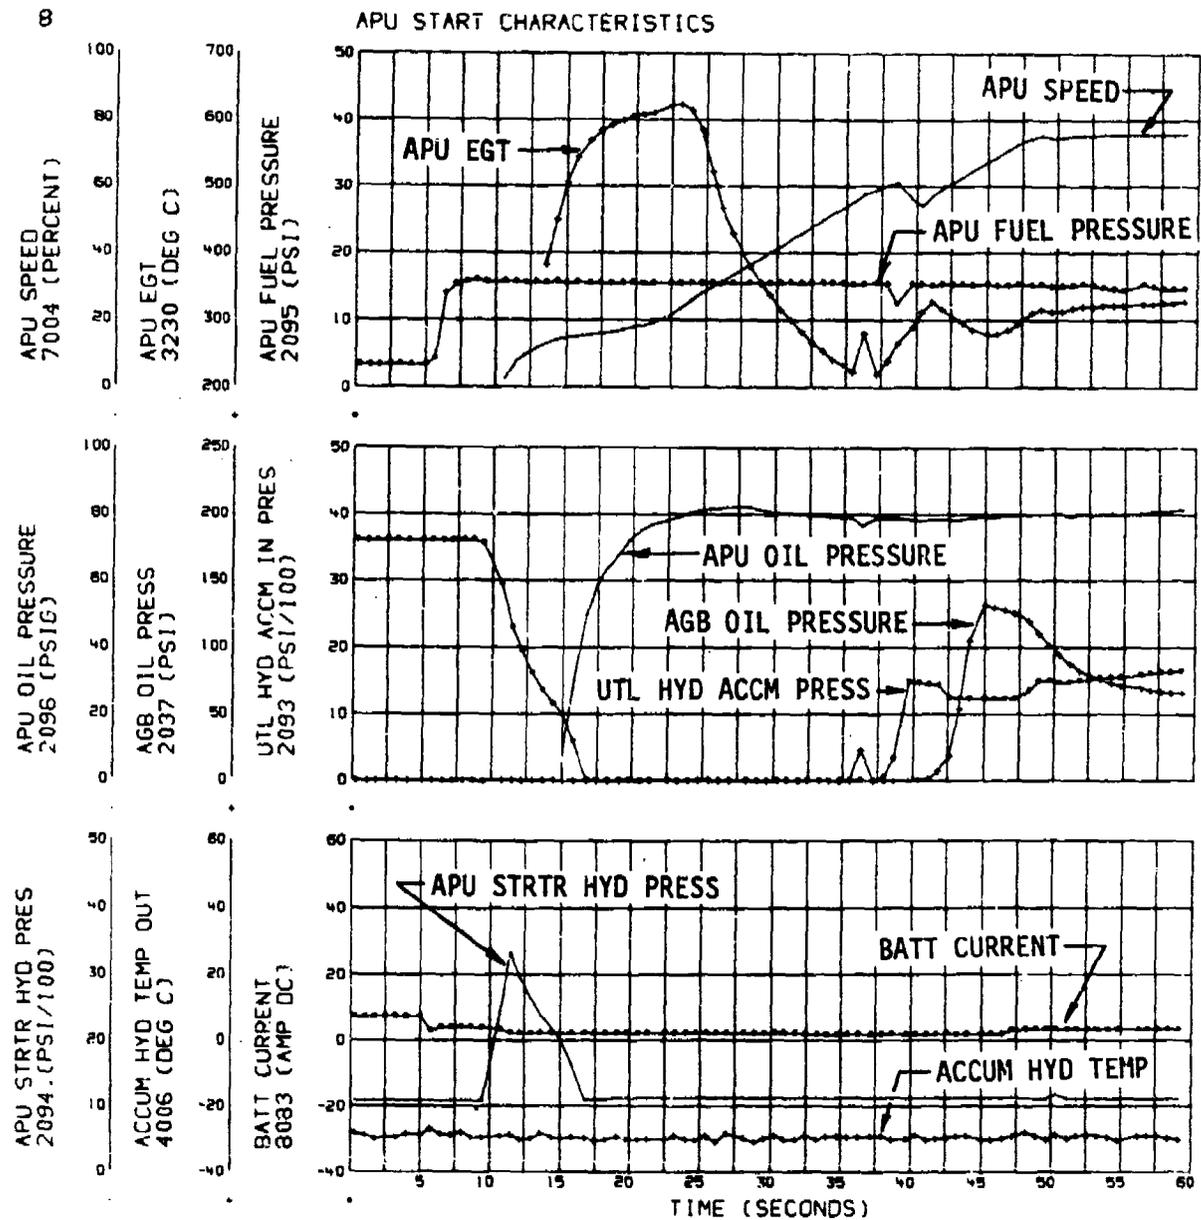
FIGURE 3
APU START CHARACTERISTICS
 APU S/N P113
 YAH-64 USA S/N 74-22249
 CLIMATIC LABORATORY TEMPERATURE -25°F

9. A second -25°F test condition was added to the planned tests primarily to evaluate APU starts with the new clutch installed. Start attempts with the AGB not turning resulted in the APU

starting and accelerating to clutch engagement then decelerating to zero (fig 3, app E). Prior to this second -25°F test, the lubricating oil and hydraulic fluid had been changed to MIL-L-7808H and MIL-H-5606H, respectively.

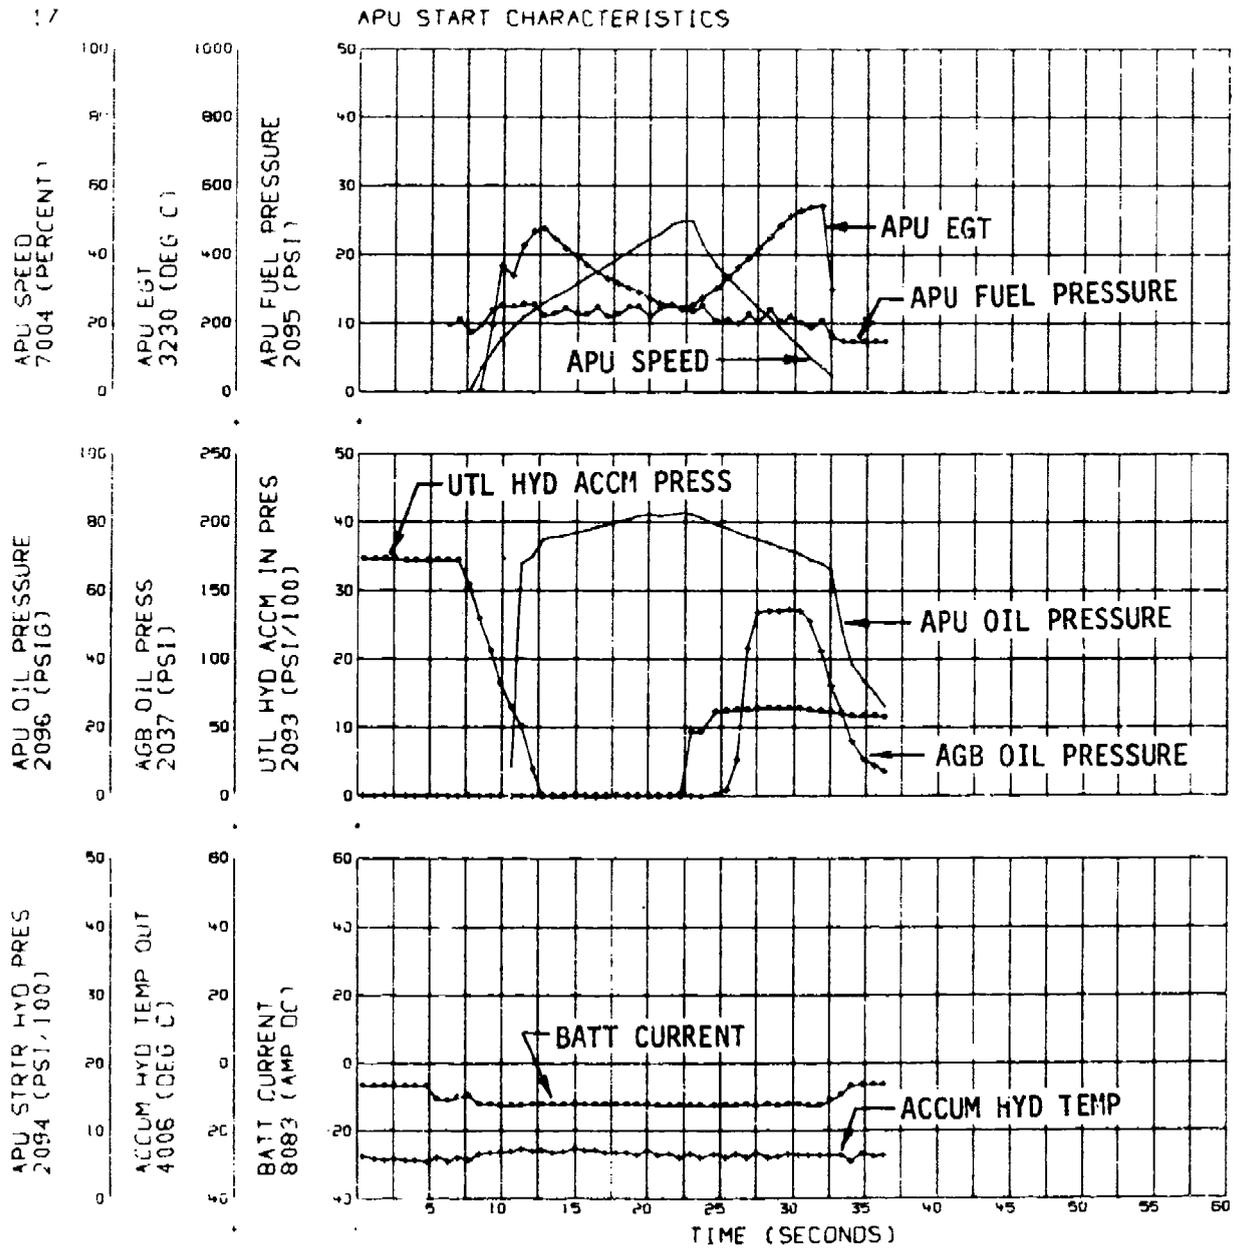
FIGURE 4
APU START CHARACTERISTICS
 APU S/N P113
 YAH-64 USA S/N 74-22249
 CLIMATIC LABORATORY TEMPERATURE -25°F

10. A manual switch was then installed at -25°F to allow engagement of the clutch at 90 percent speed rather than 60. One start attempt was made and the APU and AGB achieved operating speed (fig 4, app E). This switch was a test item and not part of the standard YAH-64 configuration.

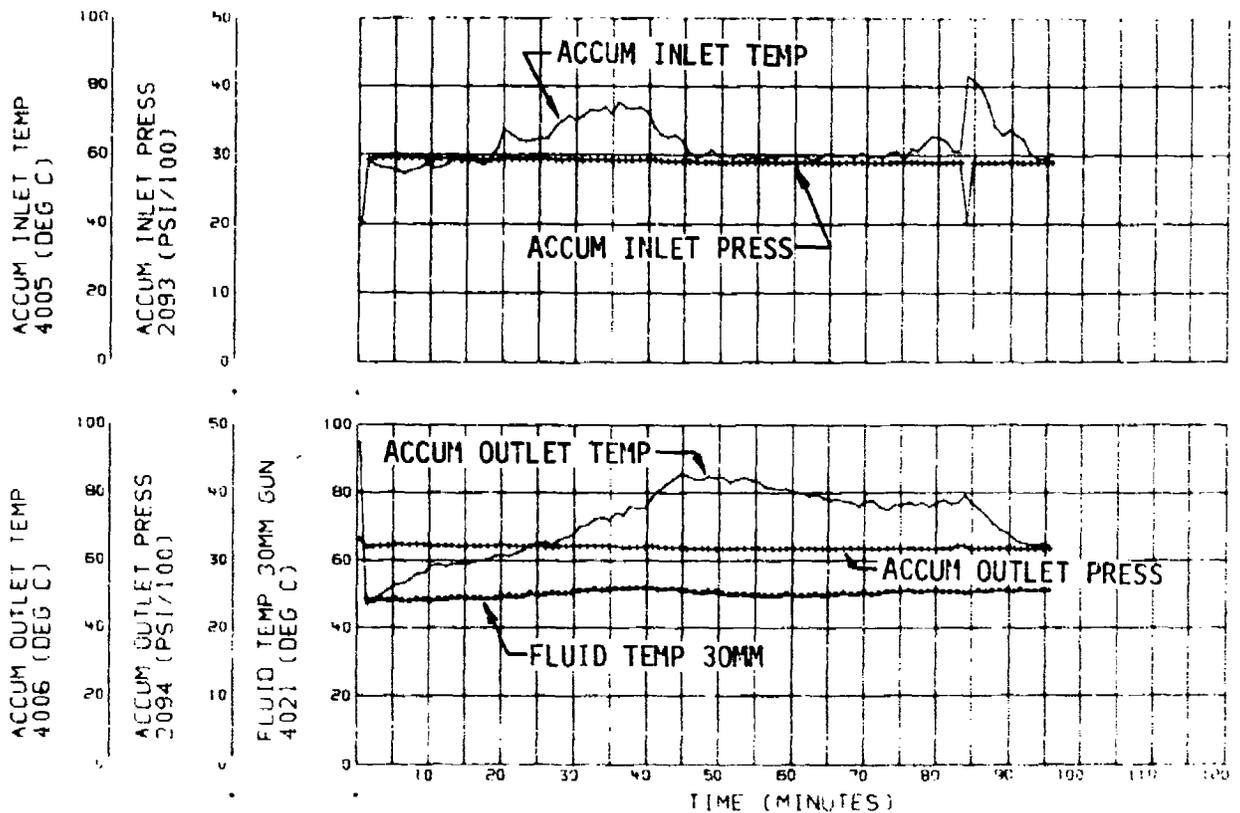
FIGURE 61
UTILITY HYDRAULIC SYSTEM SURVEY - B
YAH-64 USA S/N 74-22249
CLIMATIC LABORATORY TEMPERATURE 125°F

- NOTE:
1. HYDRAULIC SYSTEM SERVICED WITH MIL-H-5606H FLUID
 2. ACCUMULATOR OUTLET PRESSURE INSTRUMENTATION UNRELIABLE

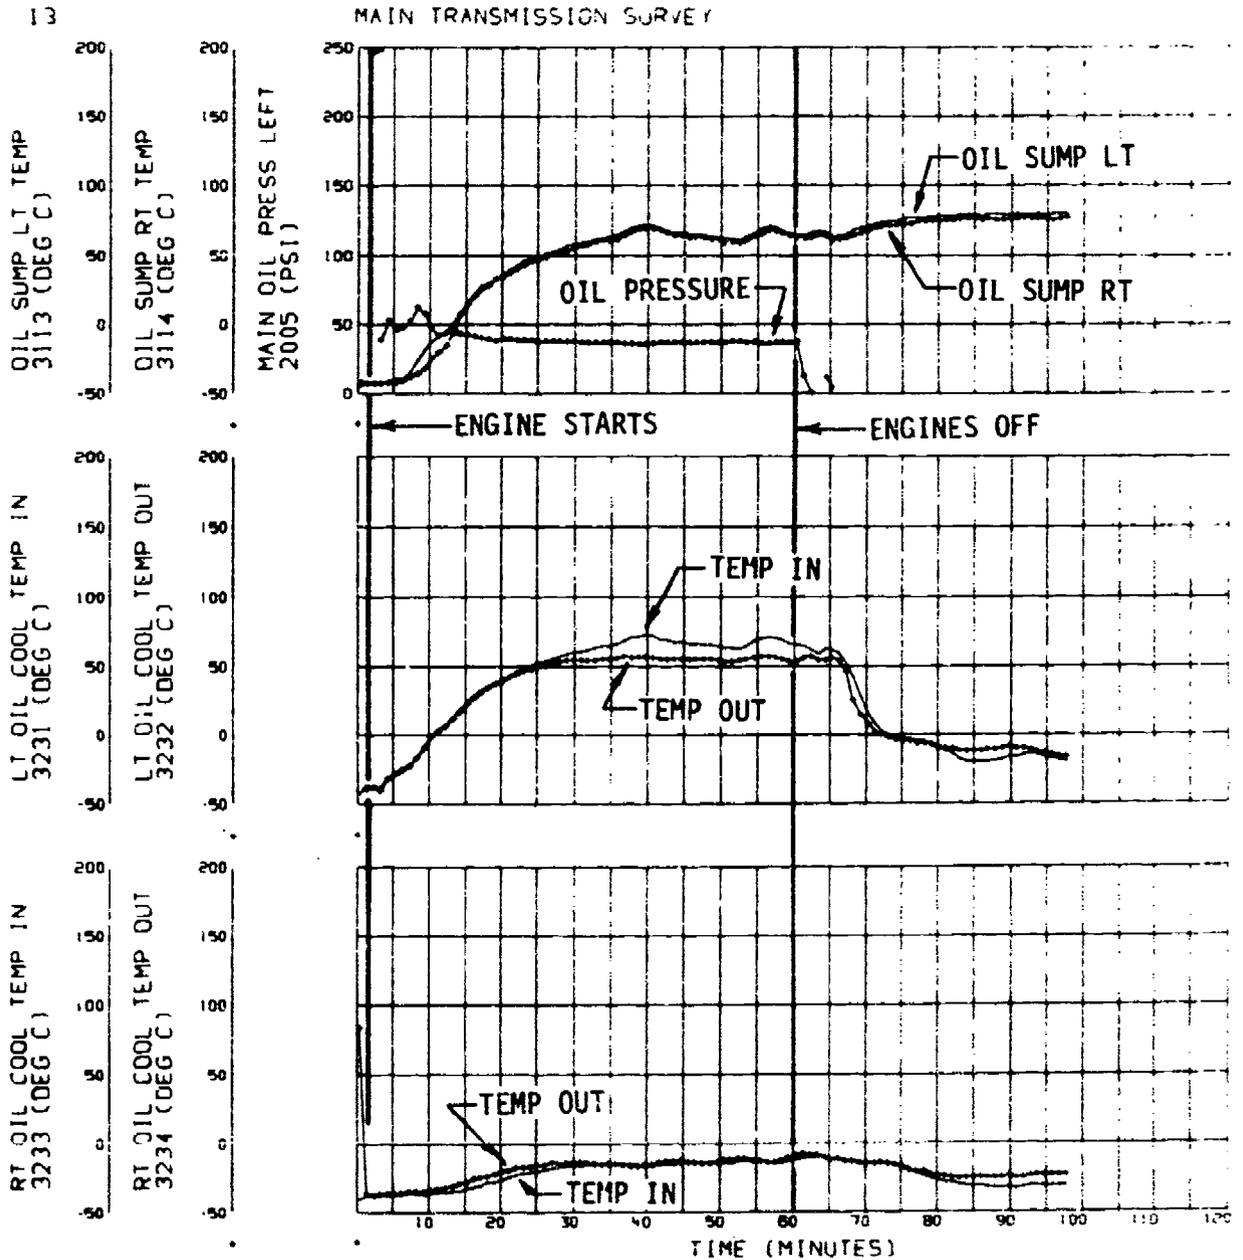
**FIGURE 64
MAIN TRANSMISSION SURVEY**

1. TRANSMISSIONS SERVICED WITH MIL-L-7808H OIL
2. MAIN TRANSMISSION RIGHT-HAND OIL PUMP BROKEN
3. MAIN TRANSMISSION LEFT-HAND PUMP OIL PRESSURE INSTRUMENTATION FAILED 60 MINUTES INTO THE RUN.

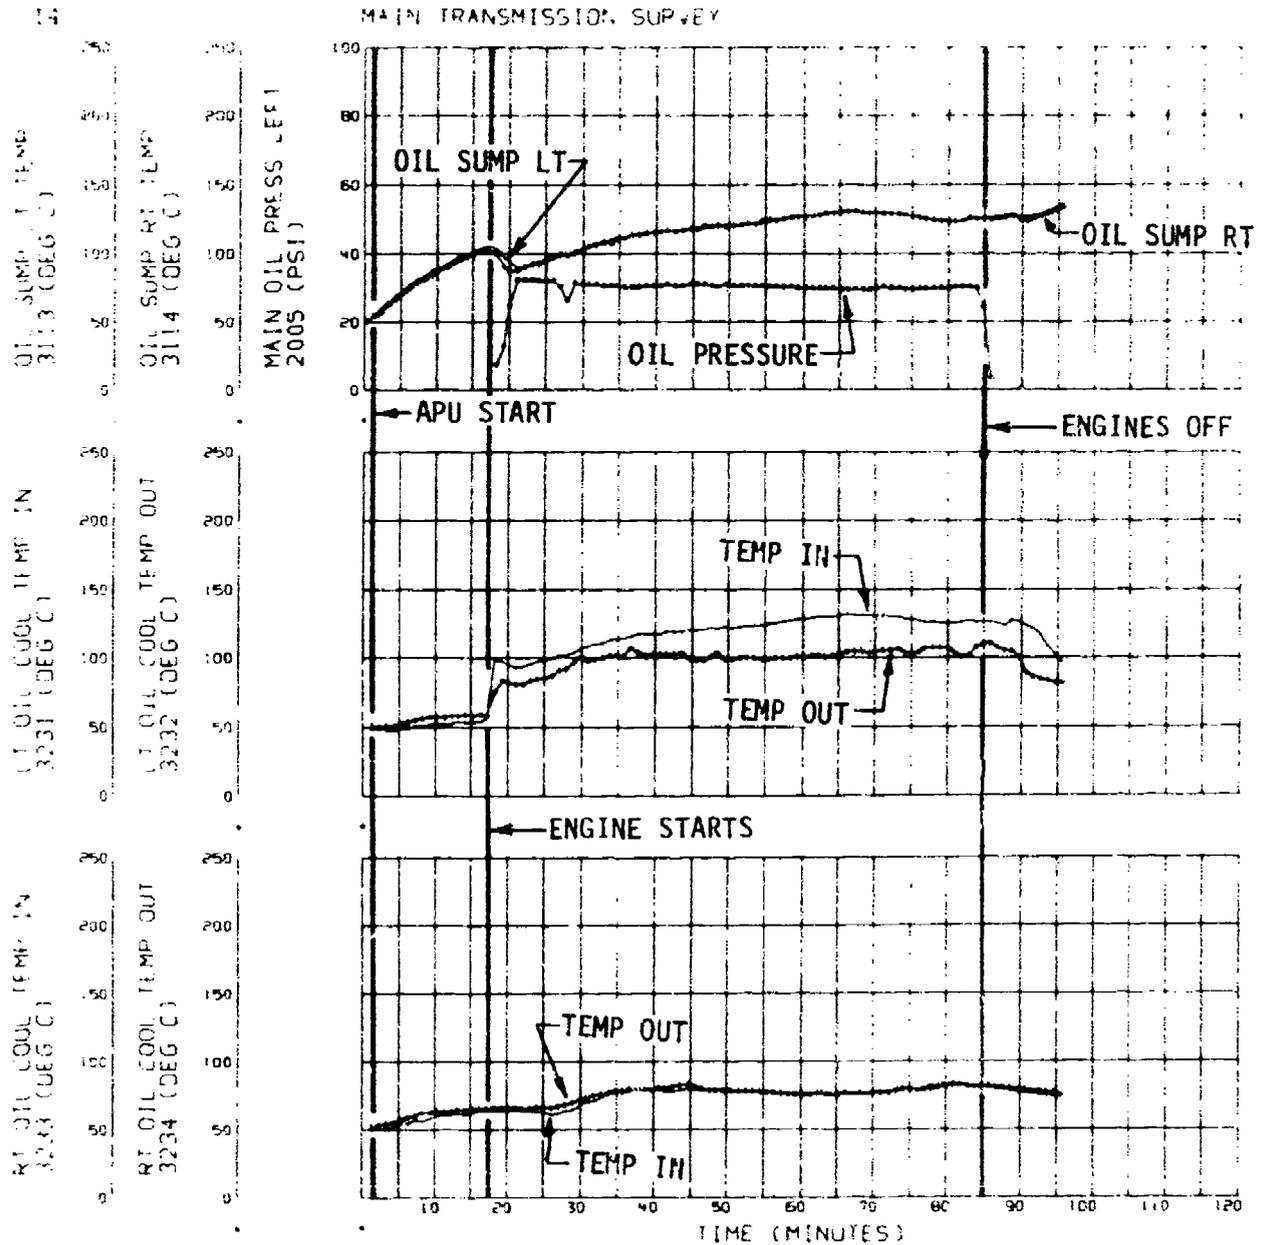
FIGURE 65
MAIN TRANSMISSION SURVEY
YAH-64 USA S/N 74-22249
CLIMATIC LABORATORY TEMPERATURE 125°F

- NOTES:**
1. TRANSMISSIONS SERVICED WITH MIL-L-7808H OIL
 2. RIGHT HAND MAIN TRANSMISSION OIL PUMP FAILED

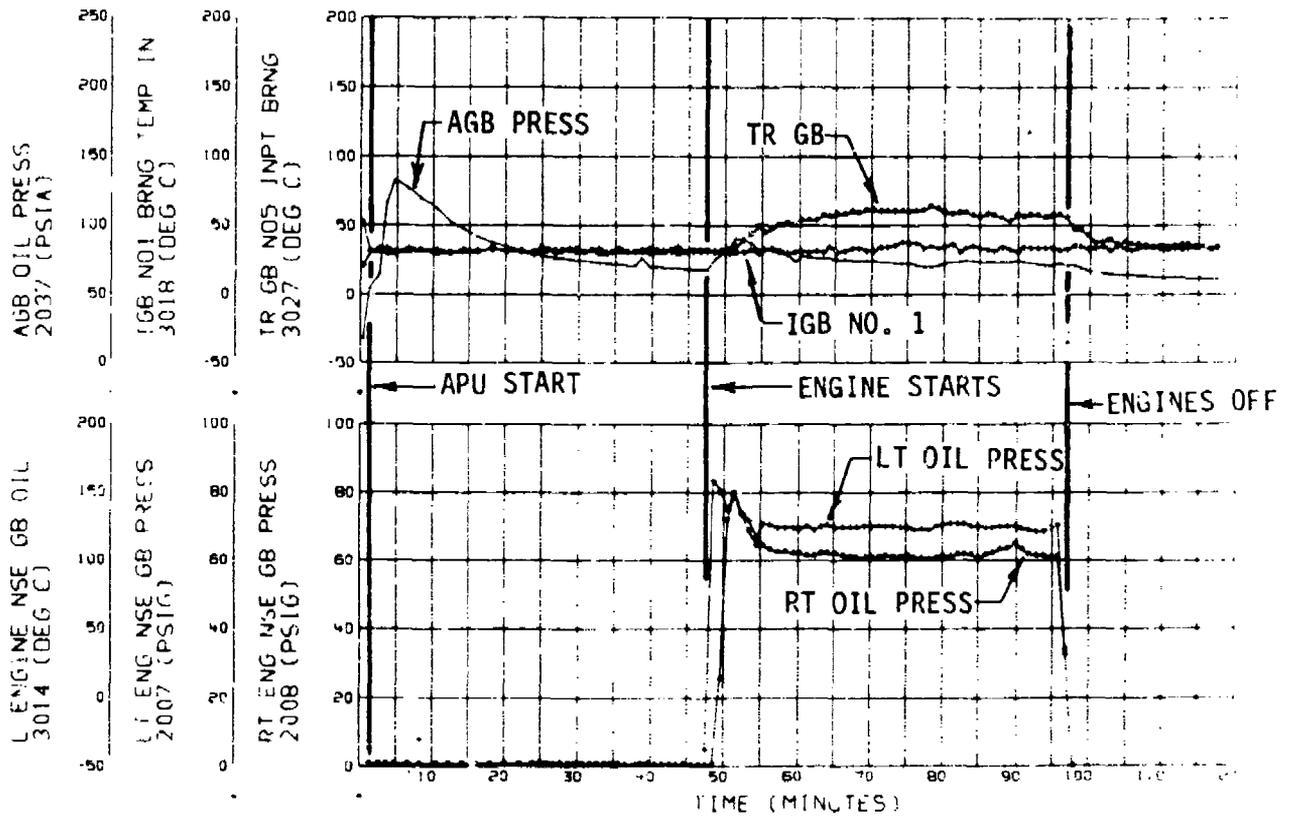
FIGURE 68
 TRANSMISSION SURVEY
 YAH-64 USA S/N 74-22249
 CLIMATIC LABORATORY TEMPERATURE -25°F

- NOTES:
1. TRANSMISSIONS SERVICED WITH MIL-L-23699C OIL
 2. LEFT ENGINE NOSE GEARBOX OIL TEMPERATURE INSTRUMENTATION FAILED

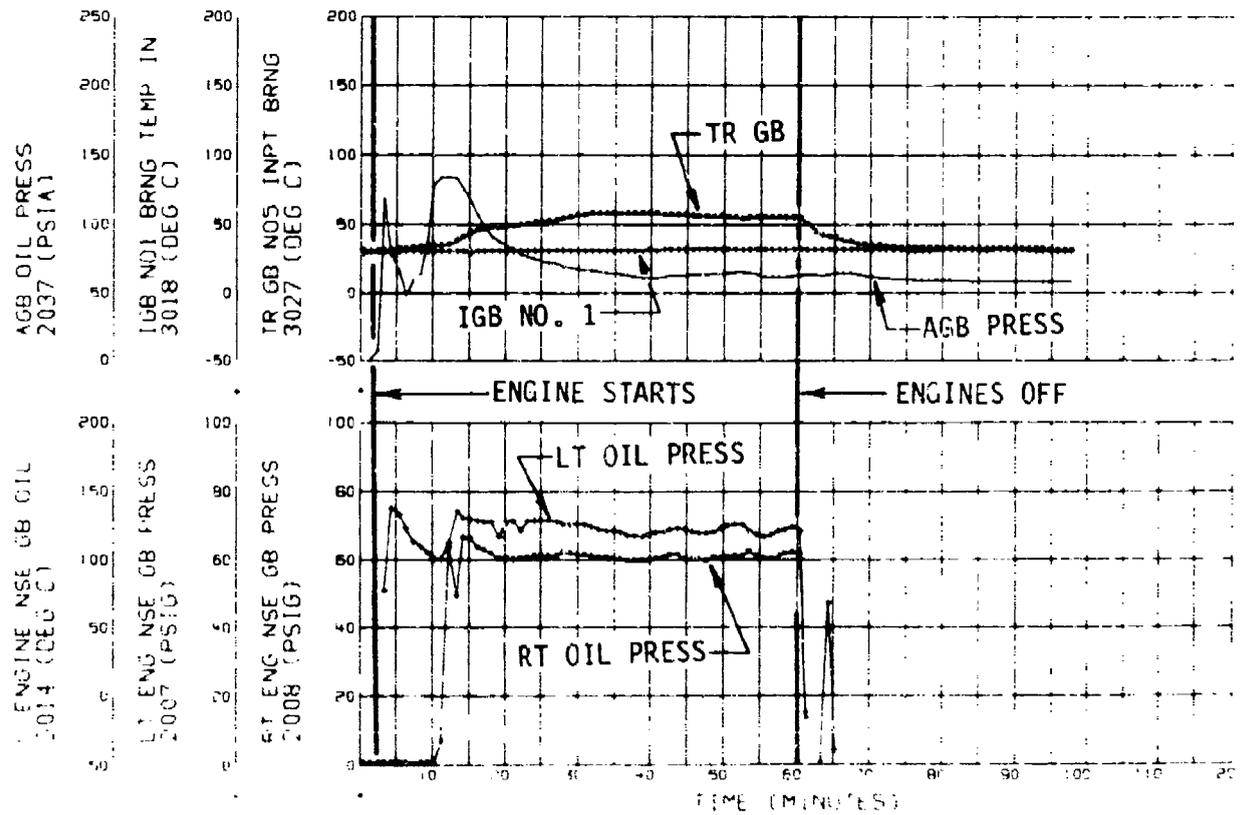
FIGURE 69
TRANSMISSIONS SURVEY
YAH-64 USA S/N 74-22249
CLIMATIC LABORATORY TEMPERATURE -50°F

- NOTES:
1. TRANSMISSIONS SERVICED WITH MIL-L-7808H OIL
 2. LEFT ENGINE NOSE GEARBOX OIL TEMPERATURE INSTRUMENTATION FAILED

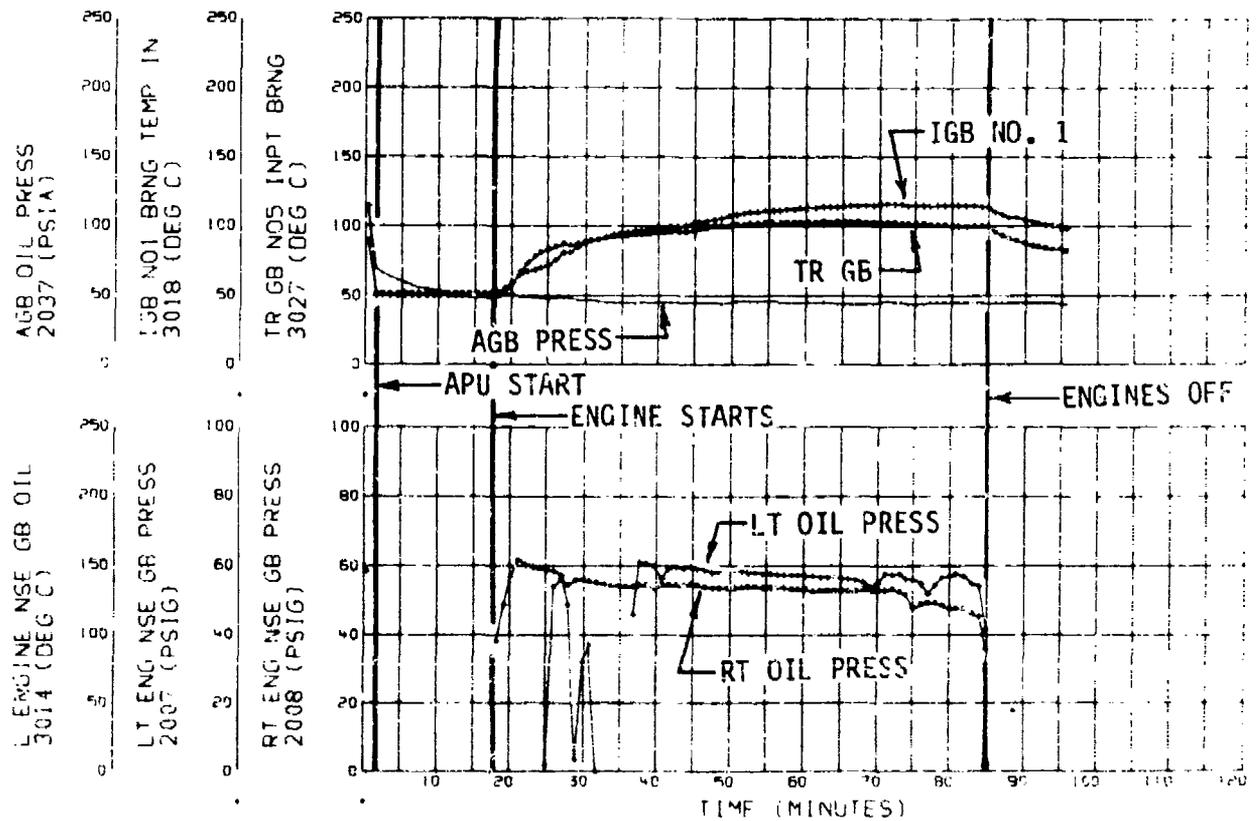
FIGURE 70
TRANSMISSIONS SURVEY
YAH-64 USA S/N 74-22249
CLIMATIC LABORATORY TEMPERATURE 125°F

- NOTES:
1. TRANSMISSIONS SERVICED WITH MIL-L-7808H OIL
 2. LEFT ENGINE NOSE GEARBOX OIL TEMPERATURE INSTRUMENTATION FAILED

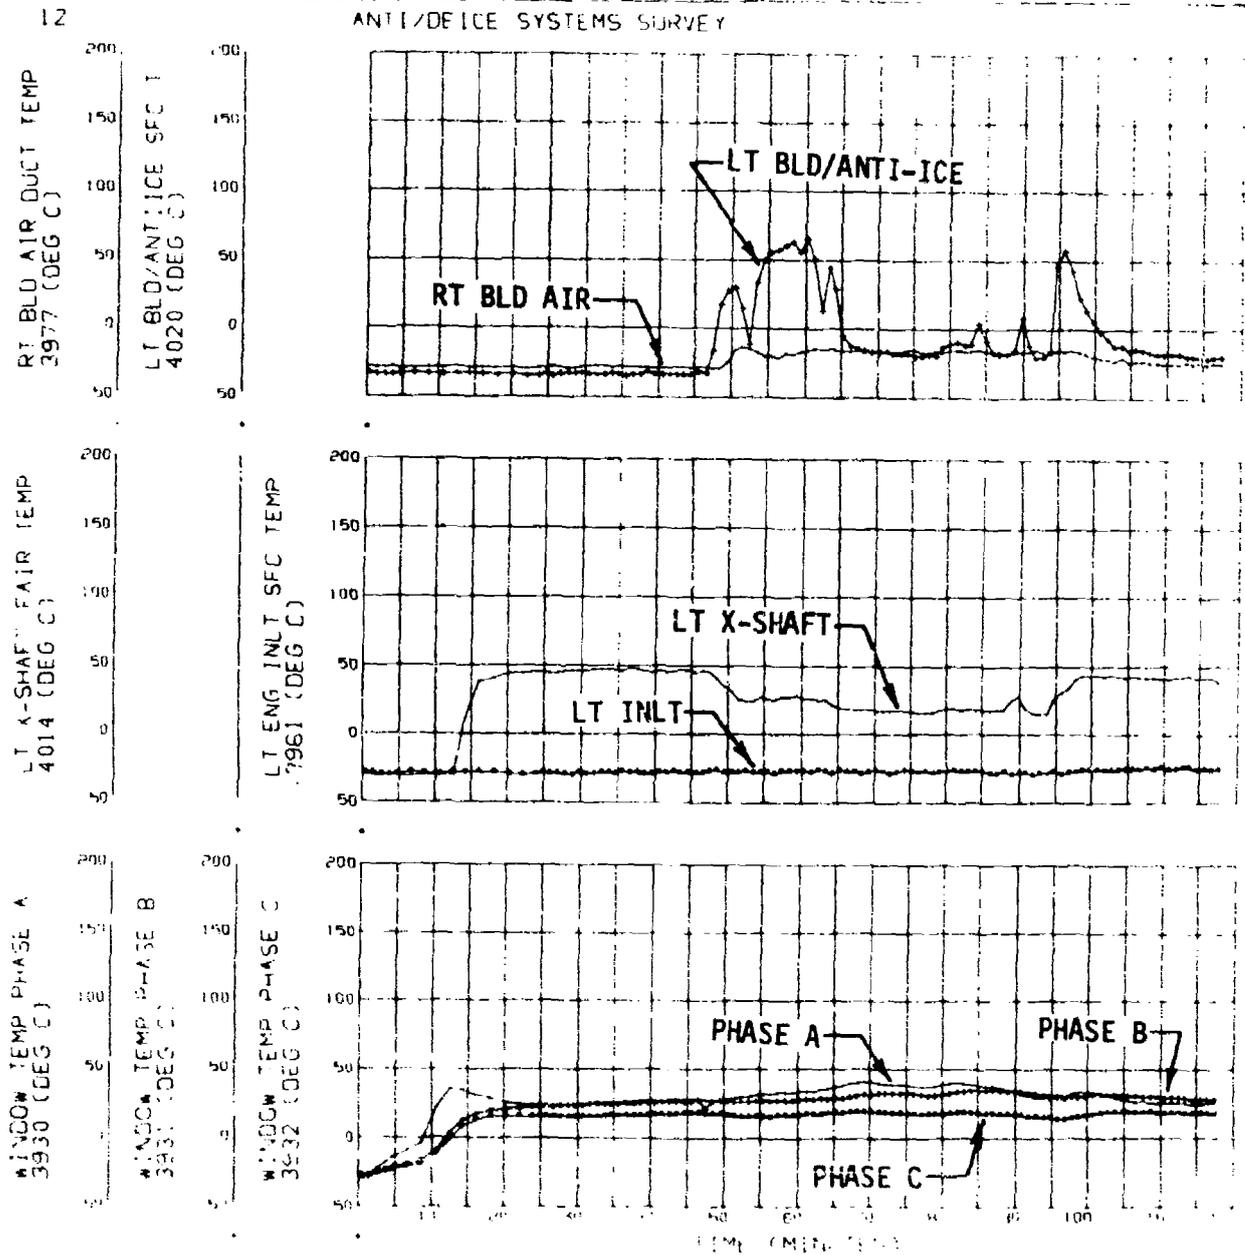
FIGURE 73
ANTI/DE-ICE SYSTEMS SURVEY
YAH-64 USA S/N 74-22249
CLIMATIC LABORATORY TEMPERATURE -50°F

NOTE: LEFT ENGINE CROSS-SHAFT FAIRING INSTRUMENTATION FAILED

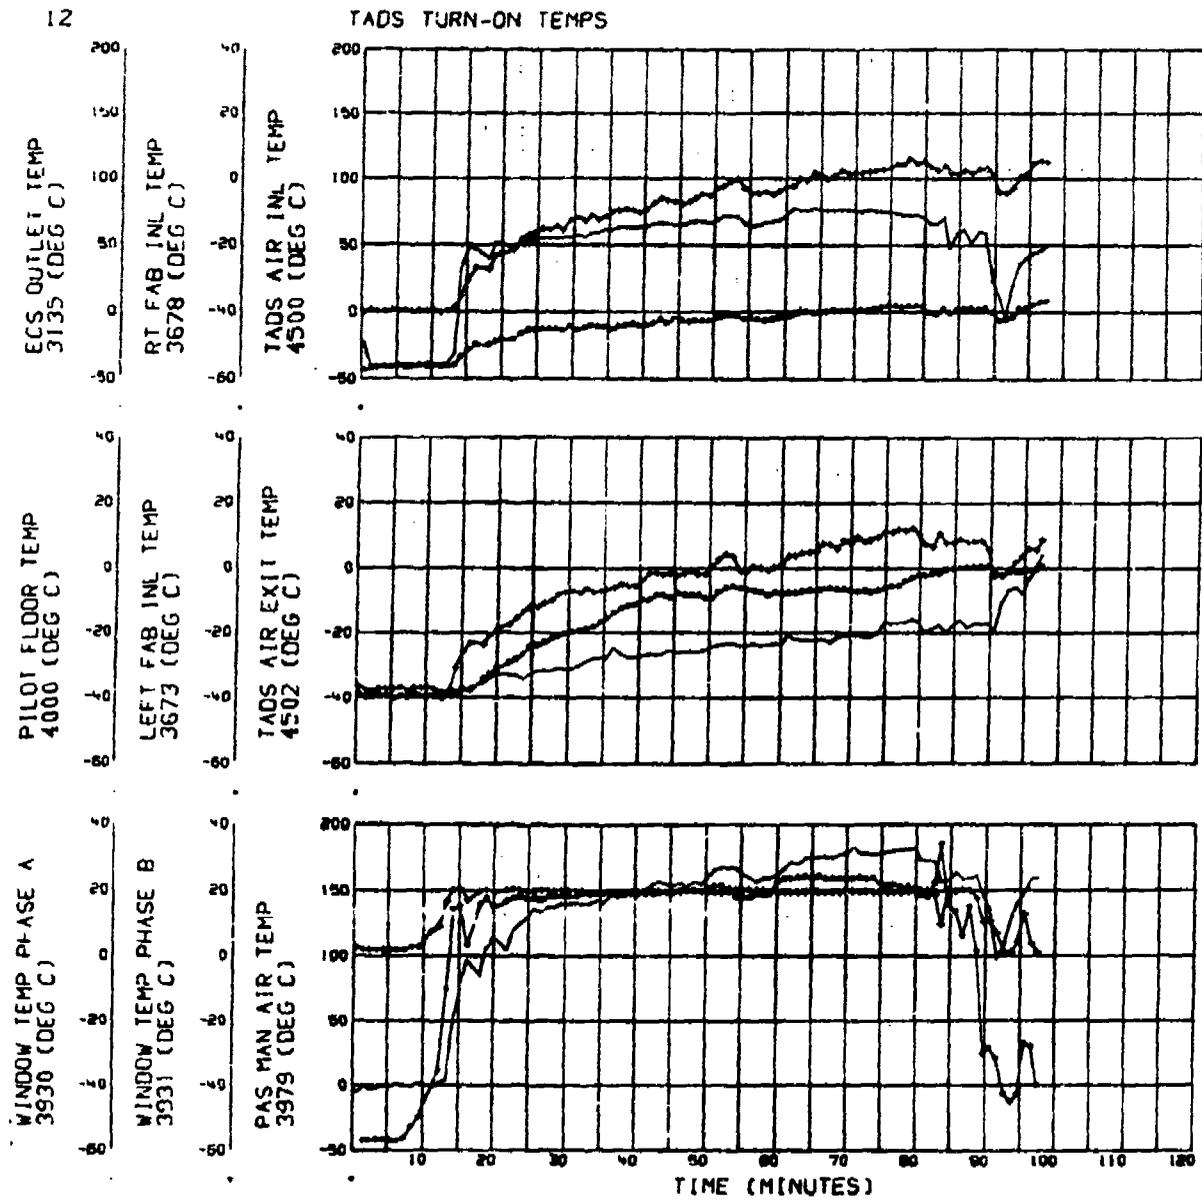
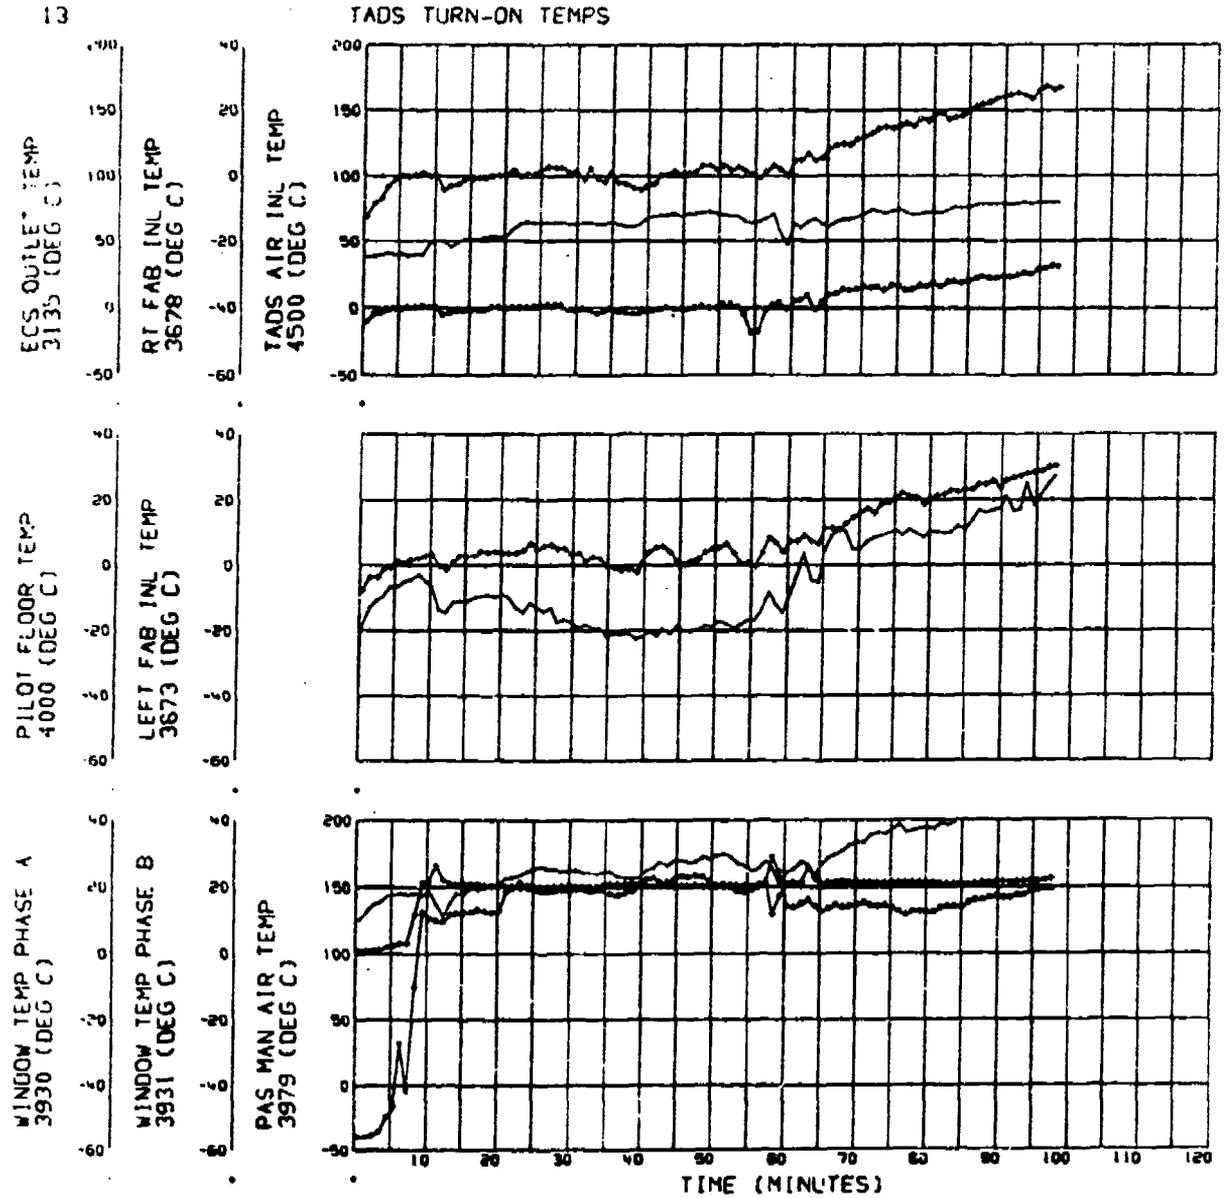
Figure 3-3
 Mission Equipment Air Temperature Survey
 YAH-64 USA SN 74-22249
 Climatic Laboratory Temperature (-50° F)

b. TADS air inlet temperature data is summarized in Incl 3, table 3-3, and also presented in Incl 3, figure 3-3. Two -50°F (-45.6°C) test runs were available for TADS operation: (1) During the first run, the minimum ECS run time was started at a TADS inlet temperature of 0°F (-17.7°C) which allows a minimum run time of 60 minutes prior to turning the TADS on. As the aircraft ENCU continued to provide warmer air, the time lapse precluded using any other minimum run time. After 42 minutes into the test run, the TADS inlet temperature was -4°C. When 60 minutes had been reached, the 40°F temperature had not been provided by the ENCU, the symbol generator had not provided symbology, the aircraft portion of the test had been concluded; therefore, the TADS was not turned on and the test was terminated. (2) The second run was conducted with the fire control computer and symbol generator preheated. After the minimum time had been reached and the TADS was switched out of standby the TADS 28 VDC circuit breaker tripped and the system was turned off and the test was terminated.

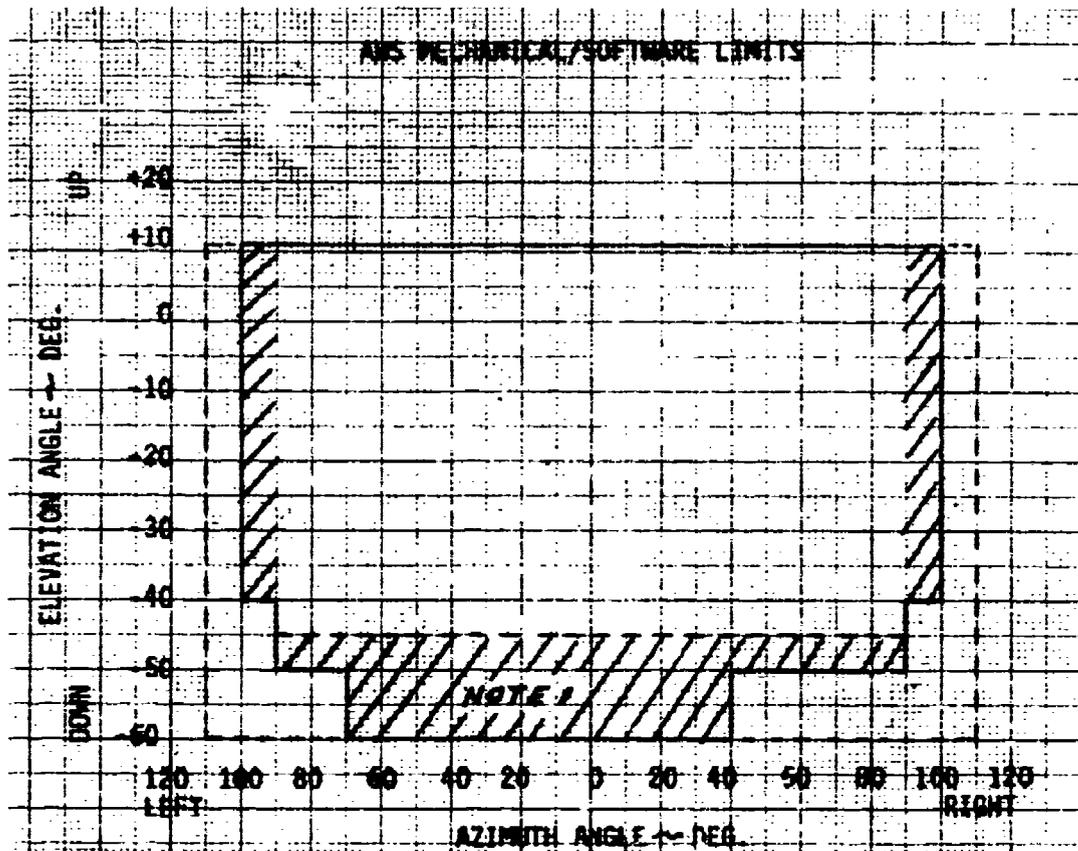
Figure 3-7. AMS Mechanical/Software Limits

7.6.1 The AWS, as installed on the test aircraft, did not include the latest gun/feed system (incl 3, table 3-8) and the latest electrical components (gun control box). During initial presurvey slewing checks, the gun transfer housing and system were broken when the gun was slewed to the limits. This was repaired and care was exercised during the survey to preclude going to the mechanical limits to avoid further breakage. Item 7 of incl 3, table 3-8, indicates an improvement in the latest configuration. Apparently, software programming was not included to preclude such malfunction. Based on this problem, a GUN LIMITS envelope was provided for the survey by the contractor and is presented in figure 3-7.
