**Loss of Pitch Control During Takeoff  
Air Midwest Flight 5481  
Raytheon (Beechcraft) 1900D, N233YV  
Charlotte, North Carolina  
January 8, 2003**

**Aircraft Accident Report**  
**NTSB/AAR-04/01**

# **Aircraft Accident Report**

**Loss of Pitch Control During Takeoff**

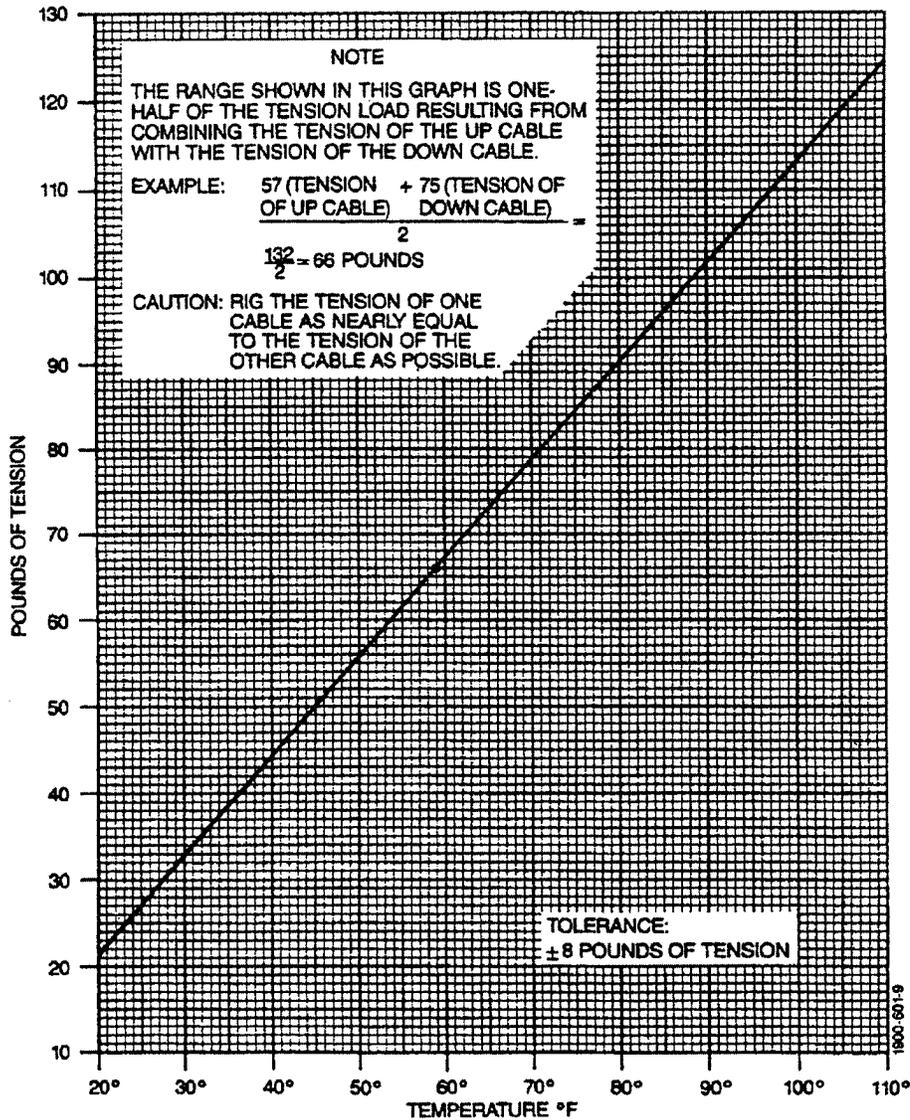
Figure 203 - Elevator Cable Tension Graph

<sup>32</sup> Figure 203 was an elevator cable tension graph included in section 27-30-02 of the Beech 1900D AMM. The graph did not contain instructions on how to take a temperature reading.

- Step q refers the mechanic to the elevator cable tension graph (figure 203) in section 27-30-02 for performing cable tensioning, but no instructions were given regarding whether the airframe, outside air, or cable temperature was to be taken when determining the amount of cable tension; whether the flight compartment cabin temperature gauge or an outside air temperature gauge was to be used in determining the temperature; and what type of device was to be used to measure cable tension.

Regarding the Air Midwest accident, the elevator cable tension graph (figure 203) in the elevator control system rigging procedure did not contain instructions on how to take a temperature reading, which was needed to determine the tension values at which the cables should be set. Regarding the Colgan Air accident, the elevator trim system rigging procedure showed an incorrect illustration of the forward elevator trim cable drum. This error could have resulted in the incorrect installation of the elevator trim cable and elevator tab operation in the direction opposite of that commanded by the trim wheel. Regarding the CommutAir incident, the Beech 1900D AMM did not contain a procedure for replacing a thrust lever detent pin.<sup>152</sup>
