Bore Evacuator Corrosion on the M284 Cannon Tube

Presentation NDIA Joint Armaments Conference,
Exhibition & Firing Demonstration – Modeling & Simulation
16 May 2012

Dr. Elaine Humiston
US Army Benét Laboratories
1 Buffington Street
Watervliet, NY 12189

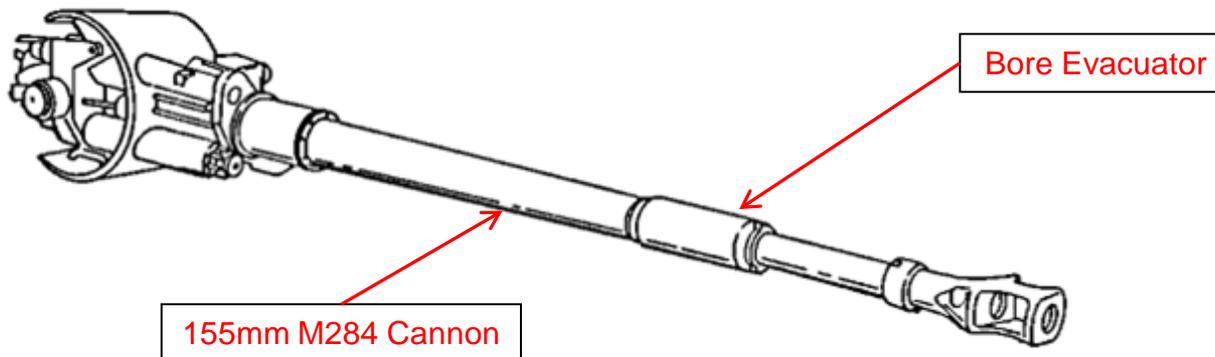
- 155mm M284 Cannon M109A6 Paladin Self-propelled Howitzer
- Paladin Integrated Management (PIM)
 - Modernization program for the vehicle platform
 - Utilizing the same armament as the M109A6
- Issues
 - Overhaul procedures uncovered numerous **gun** tubes with pitting in excess of condemnation criteria in the **bore evacuator** region.

- Issues
 - Evacuator region configuration presented challenges to regular maintenance – not always performed
 - Storage practices have deviated from prescribed procedures resulting in excessive corrosion and pitting of the evacuator region

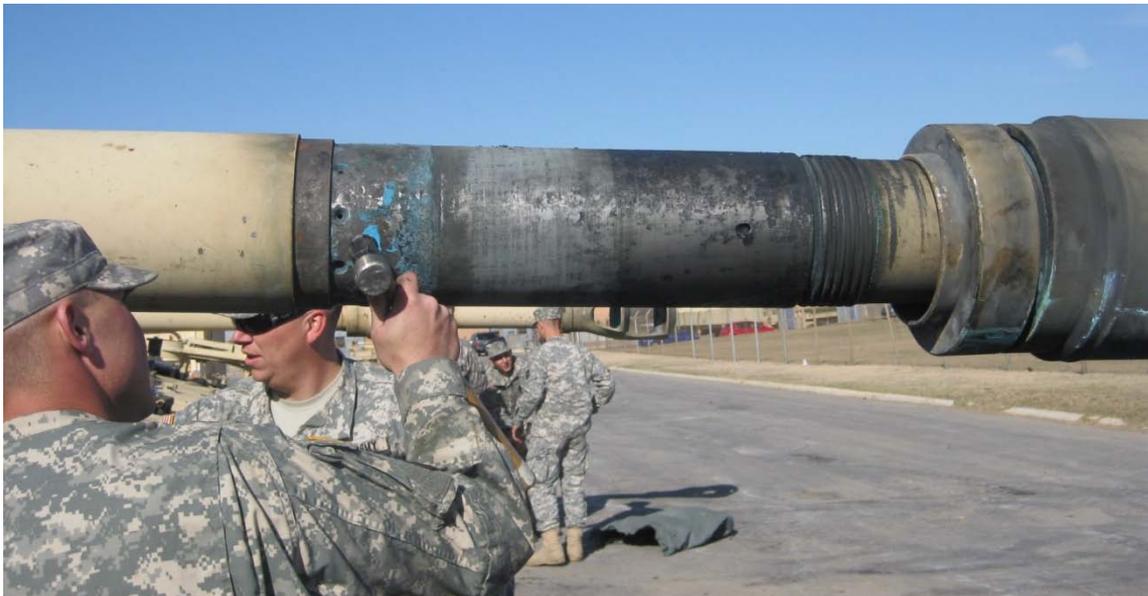
Current Condemnation Criteria 31 December 2006

Tube Area

Evacuator Holes

No pitting allowed

Evacuator Hole
Chamfer

0.010 in. maximum pit depth

Tube Surfaces

0.100 in. maximum pit depth
(bearing and non-bearing
surface)

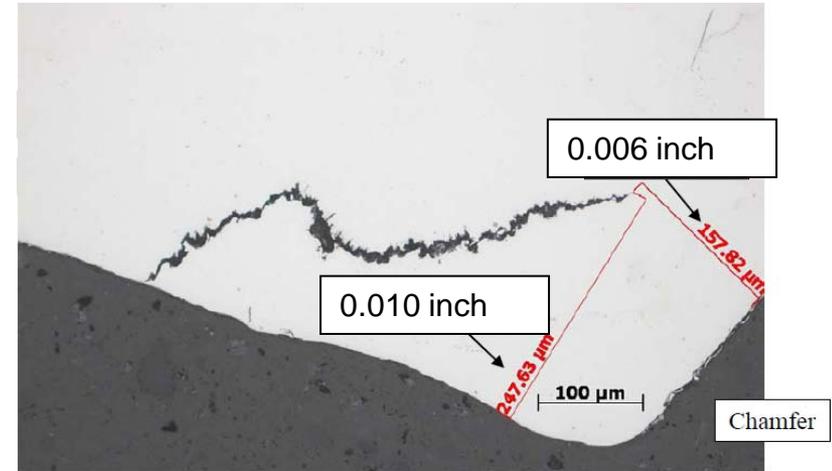
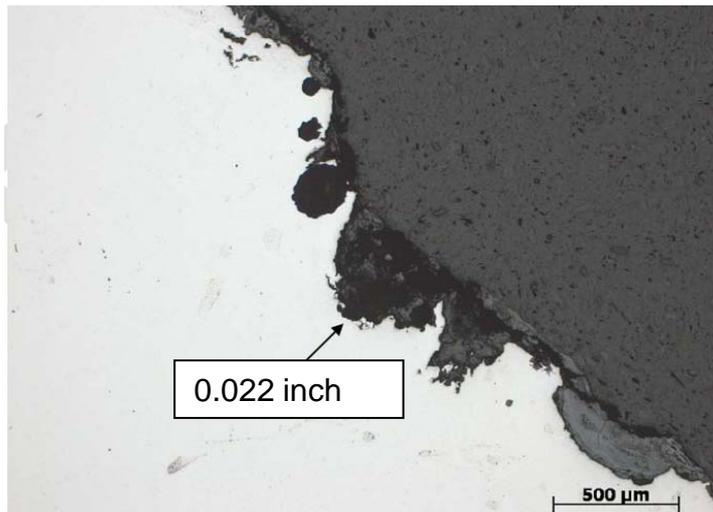
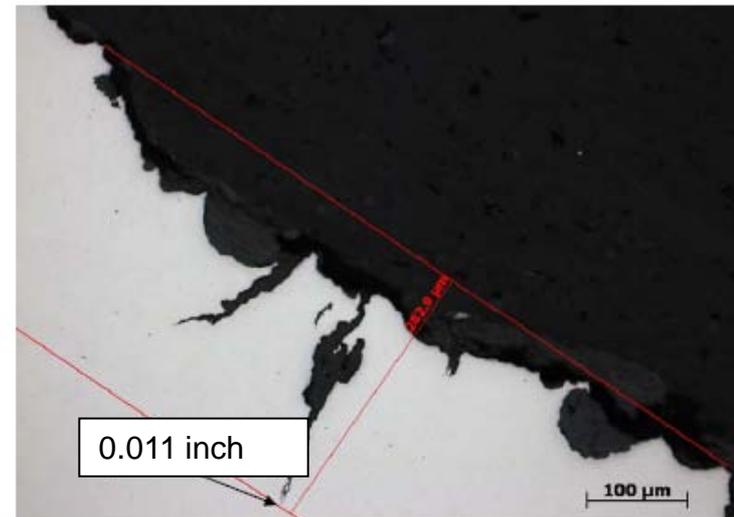
Environmental cracking was found on the order of 0.030 inches primarily in the evacuator holes

- Determination of critical region for propagation of fatigue cracks
 - FEA
 - Fracture analysis
- The critical region identified via FEA matched well with fatigue test specimen fracture surfaces

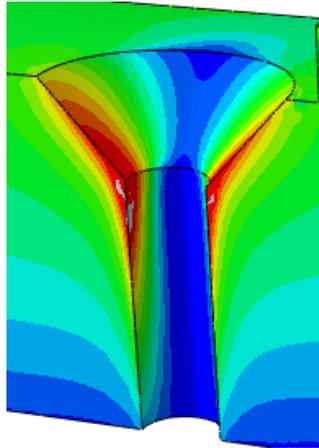
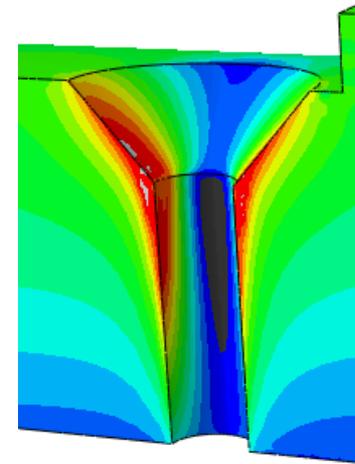
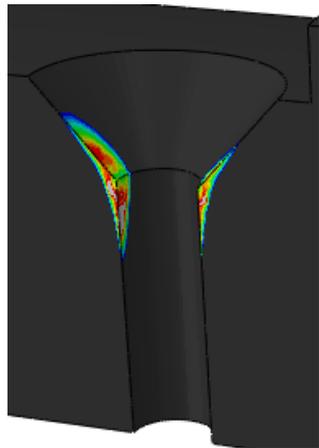
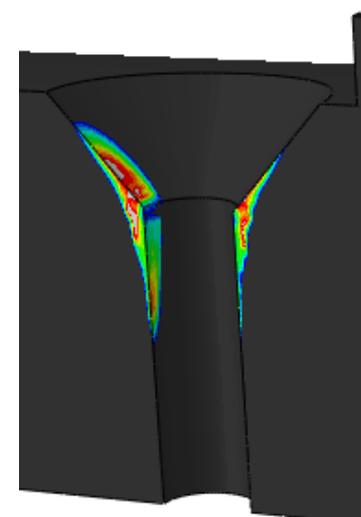
Lower images show yield occurring in the colored areas

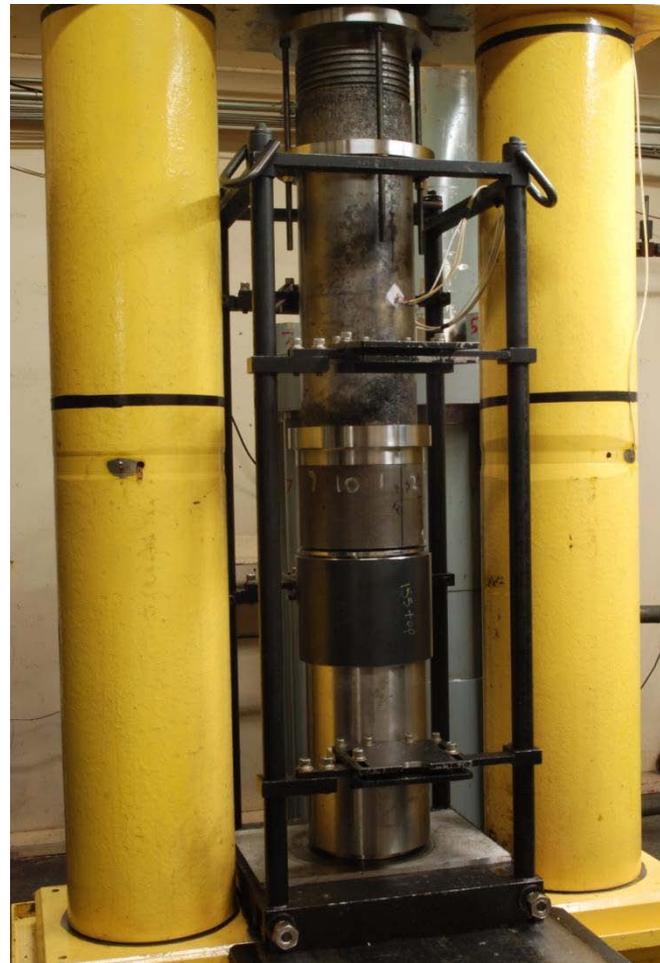
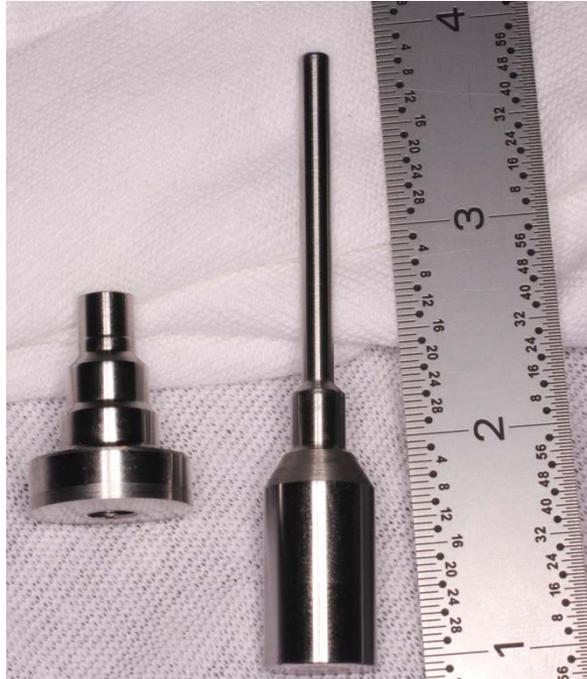
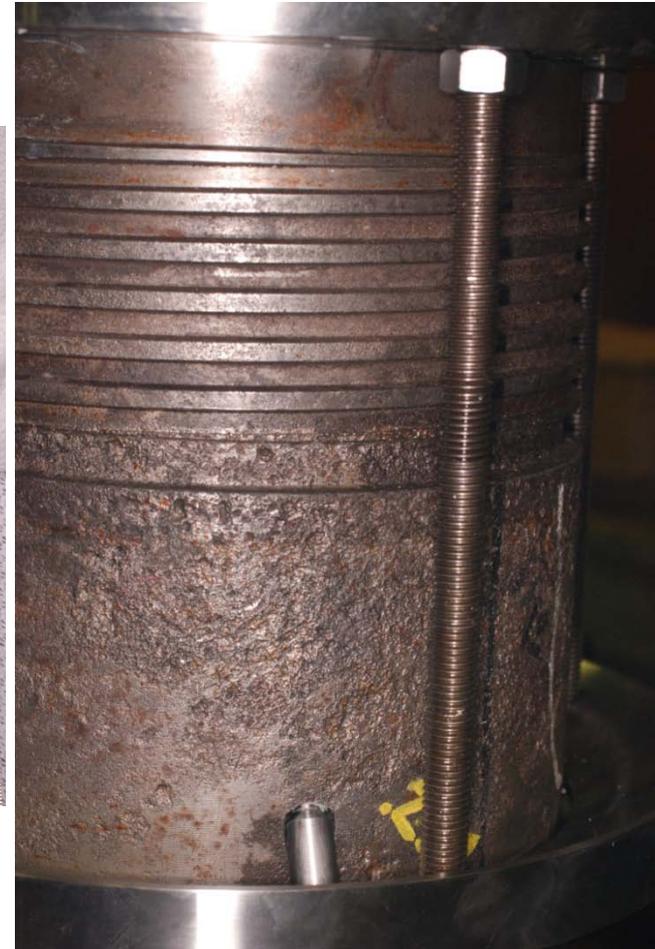
- Findings resulted in a Final Safe Life less than 50% of the original
- Results
 - Tube 1
 - Failure in 30° hole
 - Indications in all 30° holes
 - Tube 2
 - Failure in 30° hole
 - Indications in all 30° and 90° holes
 - 90° holes were not expected to fail (indicate cracking)
