FINAL REPORT

EVALUATION OF SFD-315 MAGNETRON AND SOLID STATE DUPLEXER FOR ASDE-2

FEDERAL AVIATION AGENCY
Systems Research & Development Service
Atlantic City, New Jersey

PROJECT NO. 241-004-01V
REPORT NO. RD-65-122

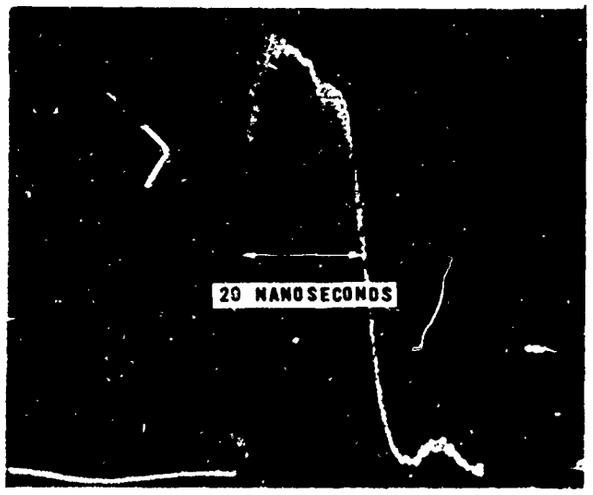
Rise time of the SFD-315 magnetron output pulse was originally observed to be about 10 ns, decay time was more than about 30 ns, and pulse duration at the half power level was more than 40 ns. These values exceeded allowable limits for the ASDE-2 system. Figure 5 shows how the shape of the pulses delivered by the SFD-315 magnetron in Channel B compared with pulses delivered by the BL-M006 magnetron in Channel A.

A number of changes were incorporated by S-F-D Laboratories in the modulator after its installation in the NAFEC ASDE-2; however, the transmitter-pulse duration continued to exceed 40 ns, whereas the radar specification provided that the transmitter pulse should be 20 $\pm$ ns. Some of these changes altered the transmitter pulse but none were successful in producing a pulse comparable to that of Channel A.

BL-MOO6 MAGNETRON IN
CHANNEL A (UNMODIFIED)

SFD-315 MAGNETRON IN
CHANNEL B (AS MODIFIED
BY S-F-D)

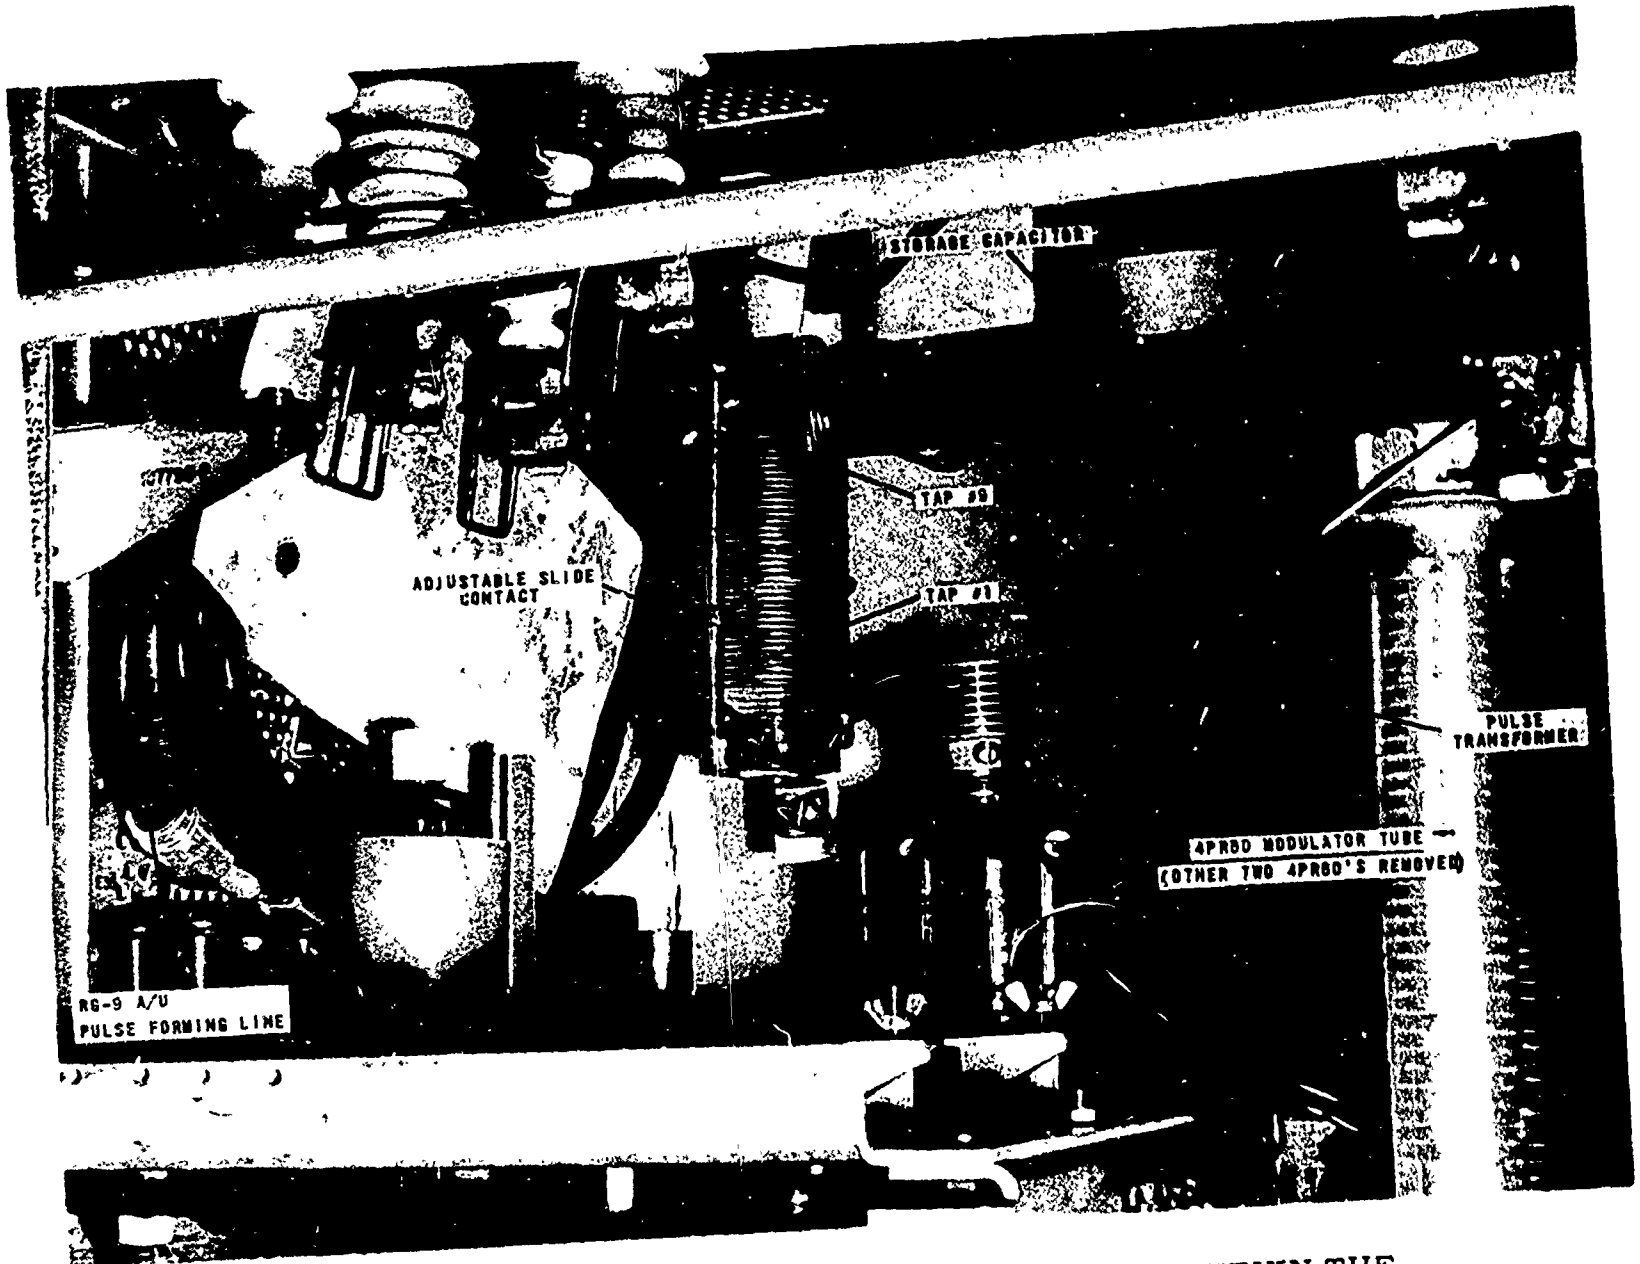
FIG. 6 TAPPED INDUCTOR INSTALLED BY AIL WITHIN THE CHANNEL B MODULATOR

The basic modification proposed by AIL involved replacement of the storage capacitor with a capacitor of lower internal inductance and introduction of a tapped inductor, in series with the new storage capacitor, to transfer and shape the modulator pulse, between the 4PR60 modulator tubes and the SFD-315 magnetron. Figure 6 shows how the tapped inductor was mounted within the modulator.

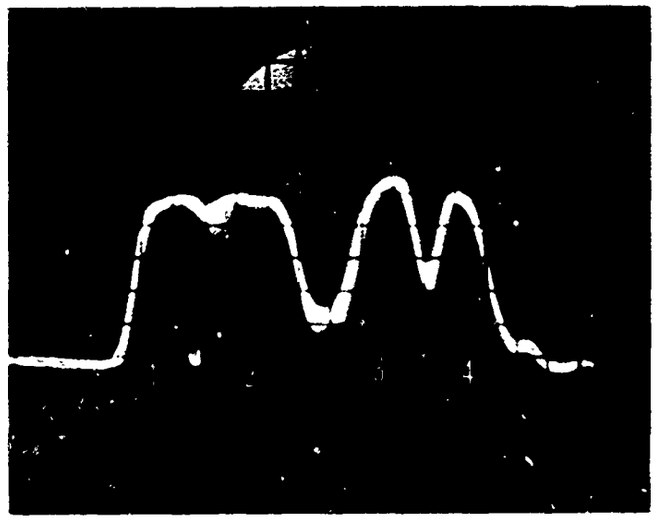
FIG. 9 VIDEO SIGNALS REPRESENTING RADAR ECHOES FROM CORNER REFLECTORS; AVERAGE TRANSMITTER POWER AT 15 WATTS

During the early performance tests, before the Channel B modulator was modified by AIL, it was found that test corner reflectors had to be separated in range by approximately 35 to 40 feet before they could be resolved individually when the SFD-315 magnetron was operating in Channel B. Reflectors 3 and 4 became distinguishable, as shown in Figure 9, on the A-scope once they were separated by 35 feet while reflectors 1 and 2, separated by 20 feet, could not be resolved. The unmodified transmitter, delivering a pulse of 20 ns duration, produced distinguishable signals even though the reflectors were spaced no more than 20 feet apart. Figure 10 reveals representative presentation differences between the BOMAC BL-M006 and SFD-315 when the magnetrons operated at a power level of 12.5 watts.

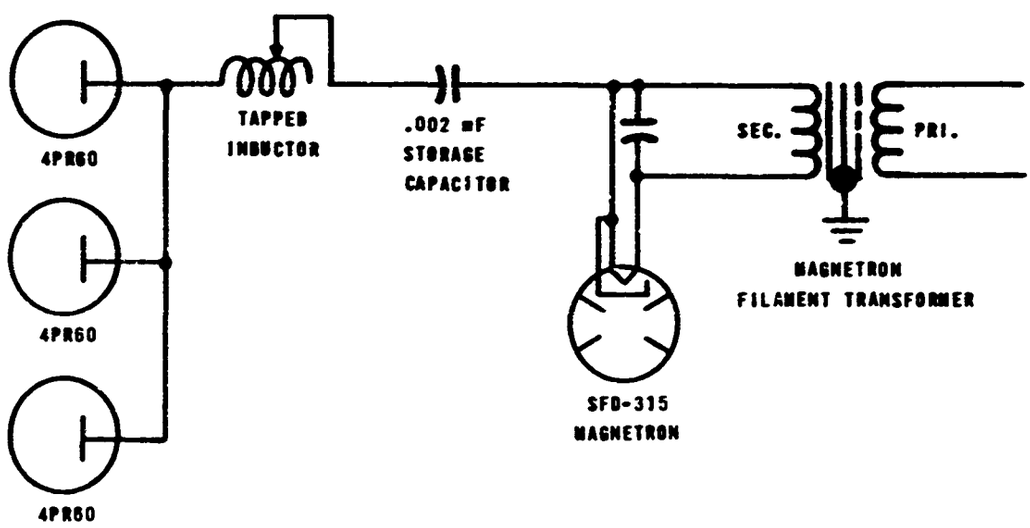
FIG. III-1 Schematic Diagram Showing Location of New Filament Transformer, Energy Storage Capacitor and Tapped Inductor within the Modulator Electrical Circuit.

4. Extension of Pre-Heat Time - A minimum of ten minutes was required to pre-heat the filament of the SFD-315 magnetron prior to the start of RF pulse operation; it took three minutes to pre-heat the filament of the BL-M006 magnetron. Time delay relay K1, which is located behind Transmitter-Receiver Control Panel (FIG. 2), was originally adjusted to accomodate the BL-M006 magnetron. For the NAFEC tests, this relay was readjusted to operate the indicator light after the maximum available time delay of five minutes. An additional five minutes was then allowed before manually energizing the voltage circuits. (A time-delay relay with a ten minute delay would be required as a permanent replacement for K1.) It was also found necessary to reset the filament-voltage control variac in order that pre-heat voltage would equal the operating voltage. A schematic diagram showing the location of the new filament transformer within the electrical circuit, the energy storage capacitor, and the tapped inductor added within modulator, is presented in Figure III-1.
