NOTE ON THE DEVELOPMENT OF A TRAILING-EDGE  
FLAP AS A STALL DETECTOR

REPORT No 75  
September, 1953

Note on the development of a trailing-edge flap  
as a stall-detector.

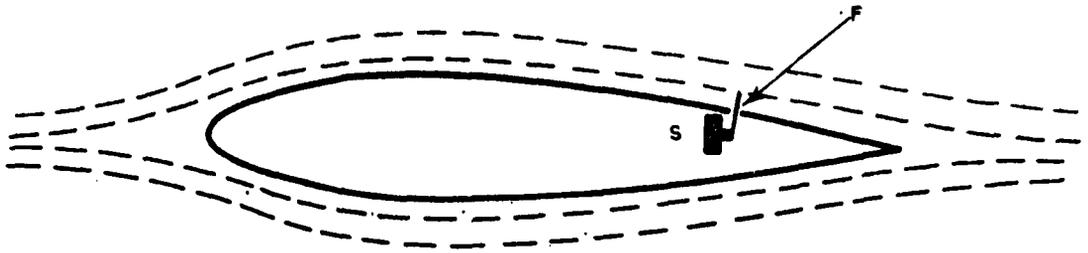
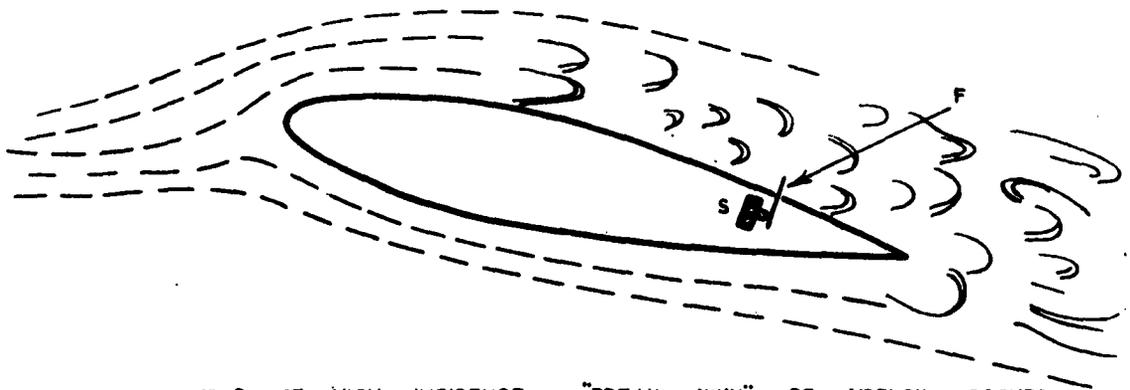
- (a) WING AT LOW INCIDENCE. FLAP "F" IS FORCED BACKWARDS AND DEPRESSES SPRING-LOADED PLUNGER OF MICRO-SWITCH "S", BREAKING CONTINUITY.

- (b) WING AT HIGH INCIDENCE. "BREAK AWAY" OF AIRFLOW OCCURS NEAR TRAILING EDGE, FLAP "F" IS MOVED FORWARD, RELEASING PLUNGER OF SWITCH AND CONTINUITY IS MADE.

PRINCIPLE OF TRAILING-EDGE STALL DETECTOR.

A small metal flap was mounted near the trailing-edge of the wing so that it protruded outside the wing profile normal to the airstream. The flap was free to rotate against the spring-loaded plunger of a "break" micro-switch, i.e. continuity in the switch was broken when the plunger was depressed. The flap was mass-balanced about its axis of rotation. At low angles of incidence the aerodynamic load on the flap pressed it backwards, depressing the plunger of the switch. At incidences near the stall when a break-away occurred near the trailing-edge with a corresponding loss of total head, the aerodynamic loads on the flap were reduced, until, finally, the spring-loaded plunger was released and continuity was completed within the switch. This was connected in series with a suitable stall-indicator. The incidence at which this occurred- the "warning incidence"- could be adjusted either by adjusting the leverage of the plunger about the axis of rotation of the flap or by adjusting the length of flap protruding outside the wing profile. The principle of the stall-detector is illustrated in fig.1, and figs. 3 and 4 show the unit mounted on the Anson and Provost respectively. An obvious criticism of the system described is that the warning circuit was completed when the aircraft was taxiing or at rest, since the aerodynamic loads on the flap were then low (or zero). This defect was eliminated by including an undercarriage micro-switch in the warning circuit, so that the system was not energised when the wheels were on the ground.

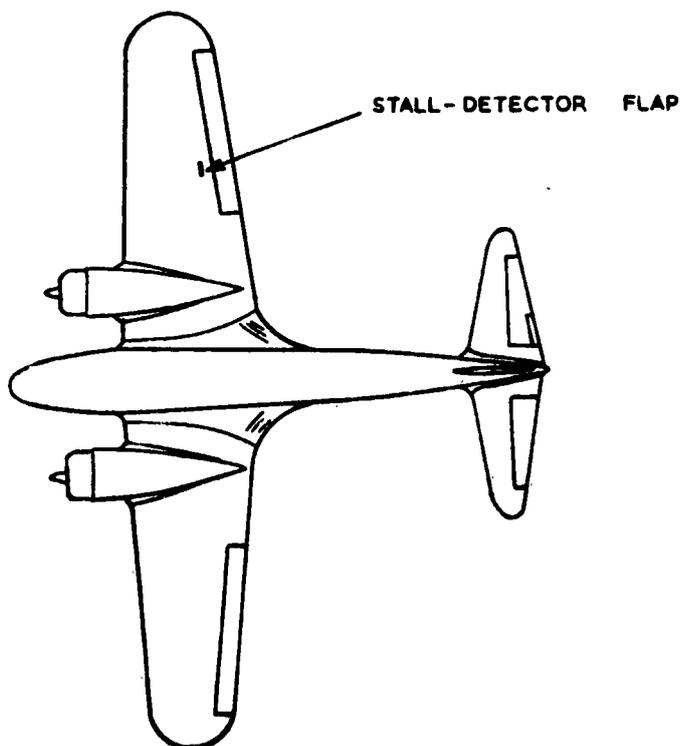
ANSON I.

The stall-detector was fitted to an Anson Mark I in a spanwise position just outboard of the landing flaps and propeller disc where wool tufts indicated a flow breakaway just before the stall. The detector was located at 75% of the local wing chord aft of the leading-edge (fig.3) and was connected in series with the stick-shaker described in ref.1. The effects of adjusting the length of the detector-flap protruding outside the wing profile are illustrated in fig.5 for various configurations of landing flaps and throttle setting. Fig.6 illustrates the similar effects of adjusting the micro-switch plunger in relation to the axis of rotation of the detector

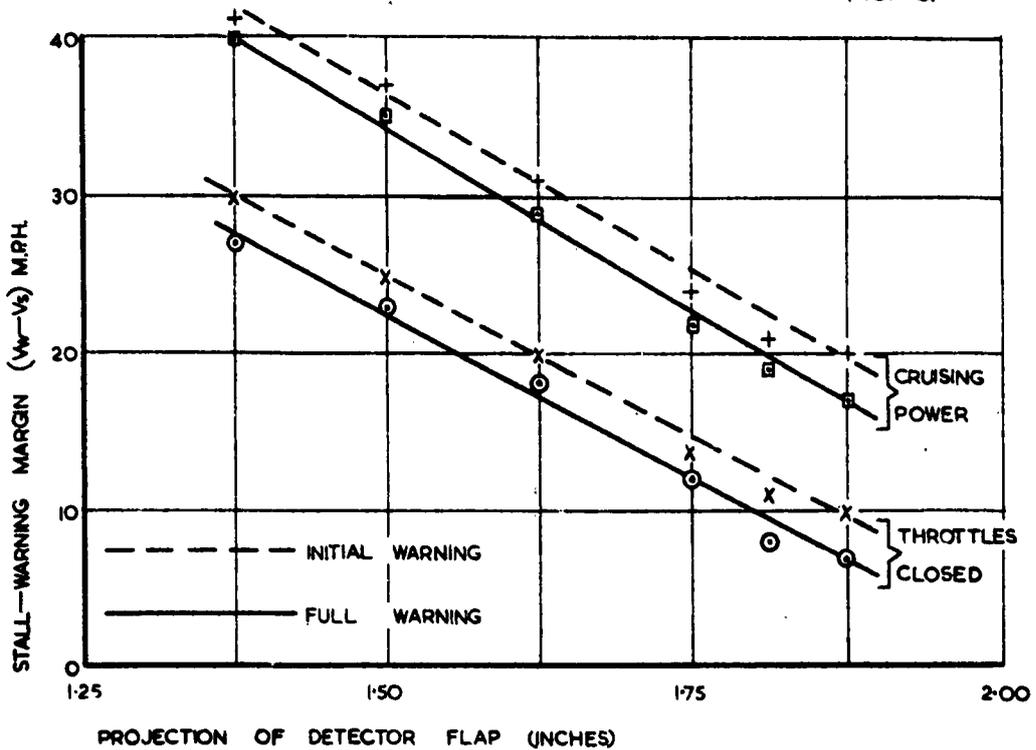
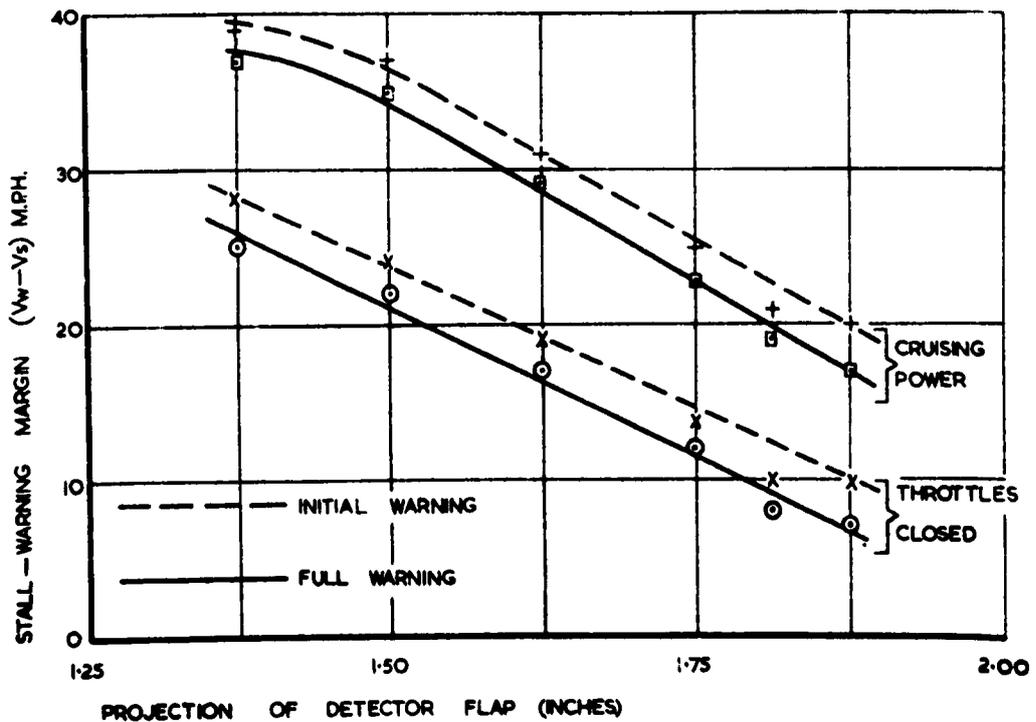
(a) LANDING FLAPS UP

(b) LANDING FLAPS 60° DOWN

EFFECT OF LENGTH OF STRAIGHT DETECTOR FLAP ON STALL-WARNING MARGIN — "ANSON"  
 (MICRO-SWITCH POSITION = 0 I.E. AT DATUM POINT)

flap. Comparing the individual curves of figures 5 and 6 it can be seen that the warning margin (expressed in m.p.h. as excess of warning-speed over stalling-speed) was reasonably independent of landing flap position, but the margin was greater in the case of a powered stall. This was not considered undesirable since the powered stall on the Anson is more violent than the power-off stall and a greater warning margin may be an asset. This particular feature was probably associated with the spanwise location of the detector. The salient point, however, is that for any configuration the margin was adequate without being embarrassingly large.

It is clear from fig.5 and 6 that this type of detector can easily be adjusted to operate over a wide range of speeds. Movement of the micro-switch through 8 mms. relative to the axis of rotation of the flap caused a change in warning speed of about 15 m.p.h. so that it should be possible to adjust warning speed to an accuracy of about 1 m.p.h. Trimming the length of flap may be useful as a preliminary adjustment.

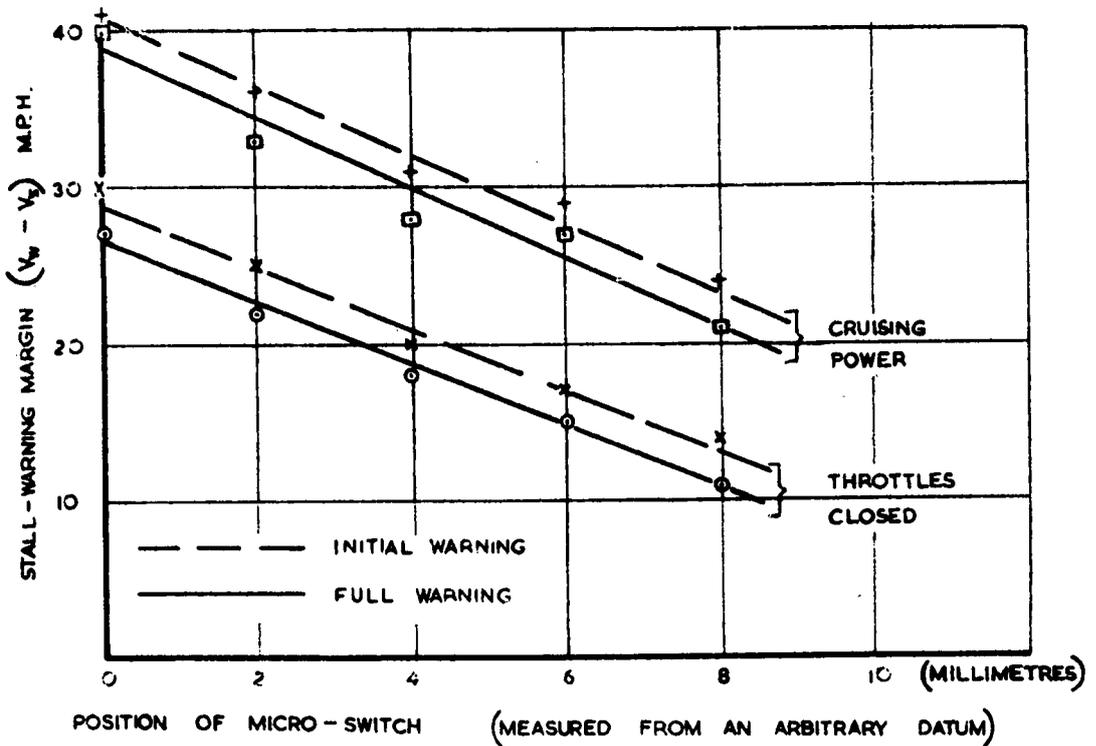
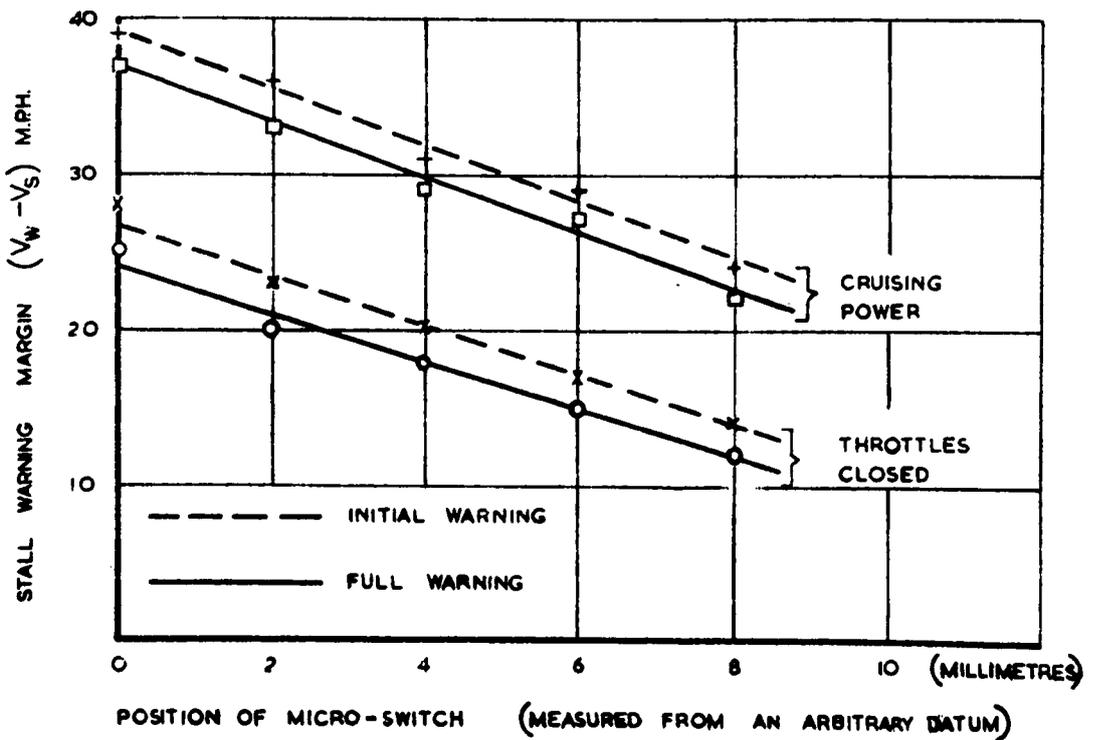
(a) LANDING FLAPS UP

(b) LANDING FLAPS 60° DOWN

EFFECT OF MICRO-SWITCH ADJUSTMENT ON  
STALL-WARNING MARGIN — "ANSON"  
(PROJECTION OF STRAIGHT STALL DETECTOR FLAP =  $1\frac{3}{8}$ ")

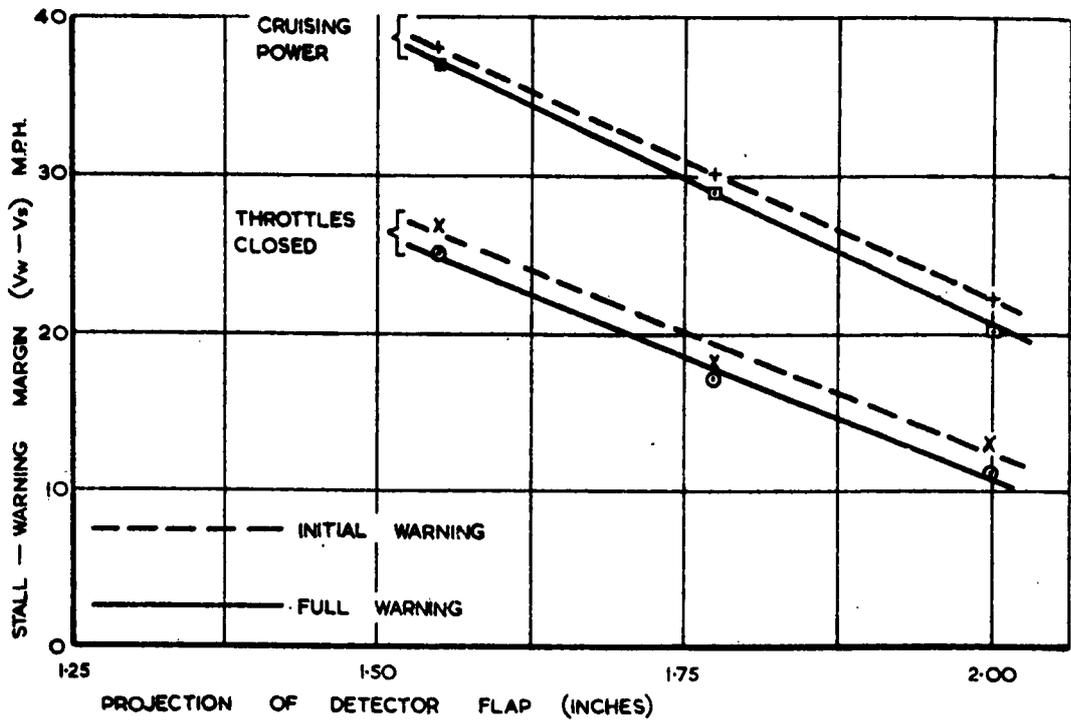
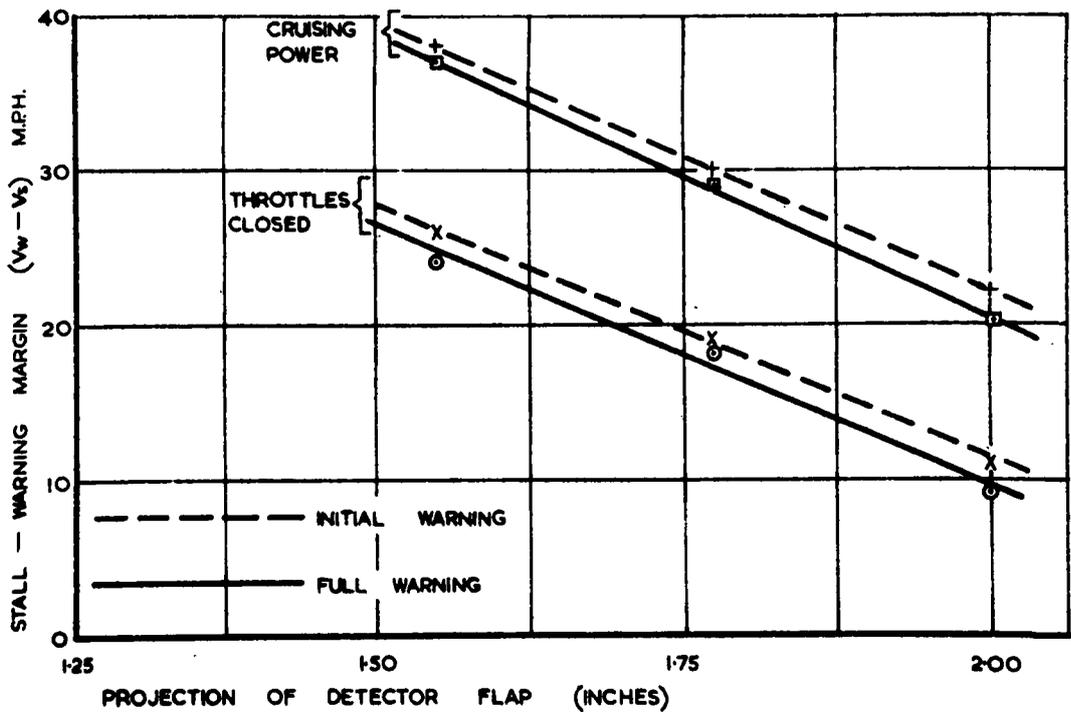
(a) LANDING FLAPS UP

(b) LANDING FLAPS 60° DOWN

EFFECT OF LENGTH OF 30° BENT DETECTOR FLAP ON STALL - WARNING MARGIN — "ANSON"

(MICRO-SWITCH POSITION = 0, I.E. AT DATUM POINT)

It was suggested that a less objectionable excrescence on the wing would be presented if the detector flap was bent backwards rather than sticking out normally to the wing profile. Fig.7 illustrates the results obtained when the protruding flap of the stall-detector was bent backwards through  $30^\circ$ . For any particular length of flap the warning speed achieved with the bent flap was higher than that obtained with the straight flap; the effect of bending the flap is comparable with the effect of trimming the straight flap. Detailed comparison of fig.5 and 7 indicates that the warning margin achieved with a flap of length  $l$  bent backwards through  $30^\circ$  is approximately equal to that achieved with a straight flap of length " $l \cos 30^\circ$ ." In other respects the bent flap worked in the same way as the straight flap.

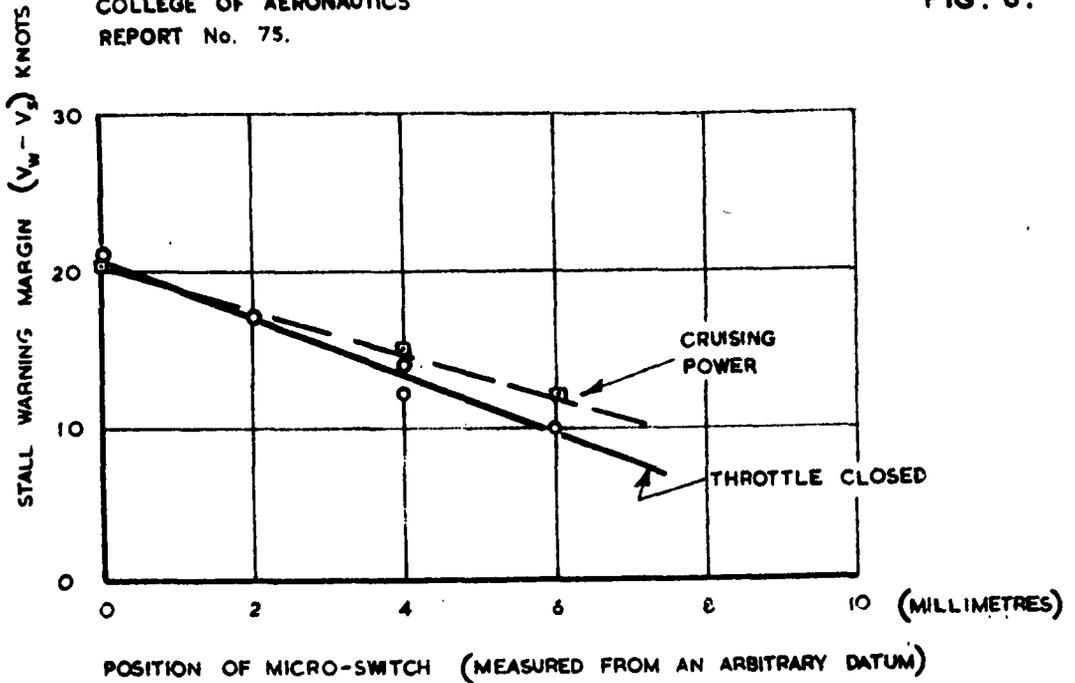
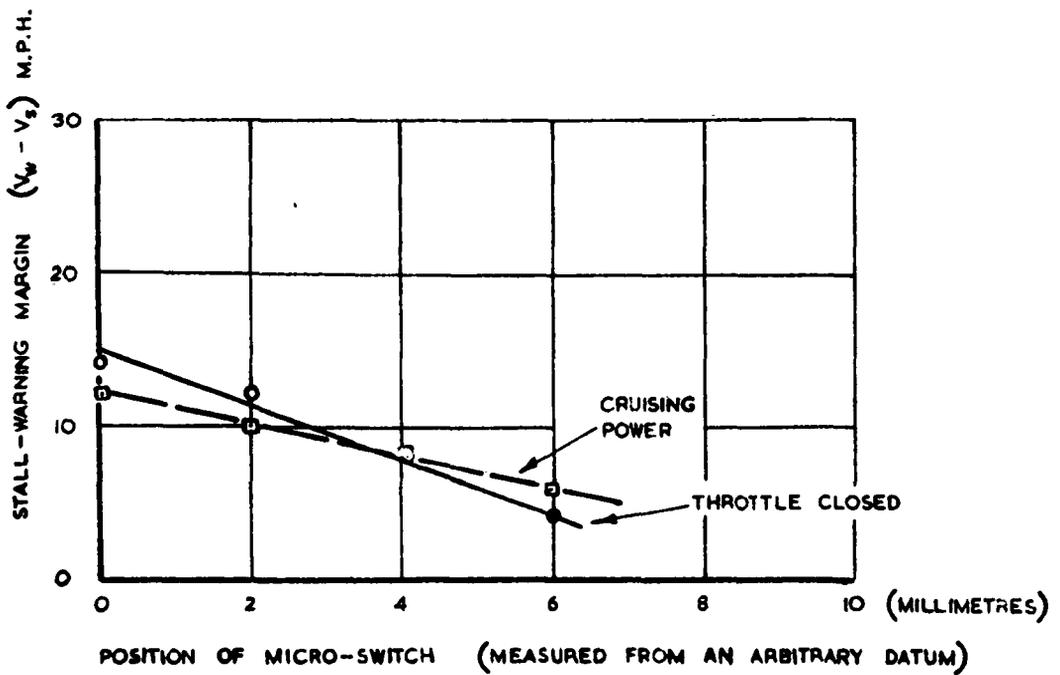
(a) LANDING FLAPS CLOSED

(b) LANDING FLAPS FULLY DOWN

EFFECT OF MICRO-SWITCH ADJUSTMENT ON  
STALL WARNING MARGINS - "PROVOST"  
(PROJECTION OF STALL DETECTOR =  $1\frac{7}{16}$ " )

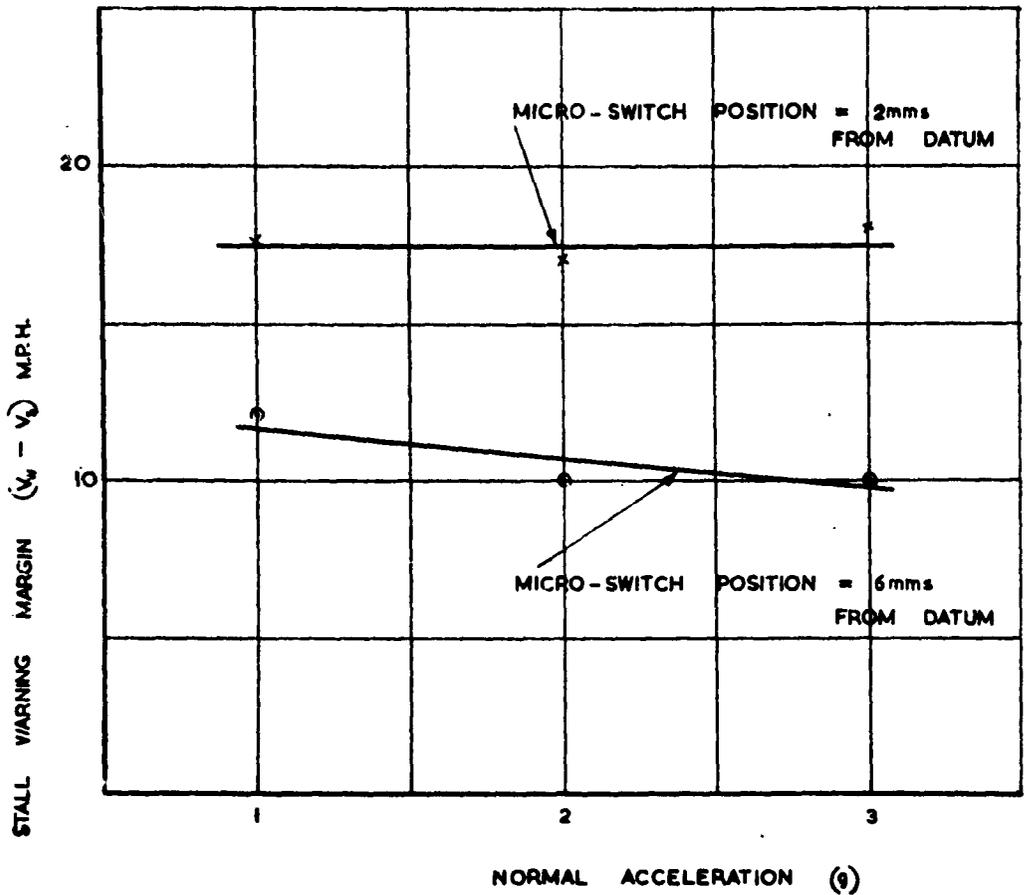
EFFECT OF NORMAL ACCELERATION

ON STALL-WARNING MARGIN
