USAAVSCOM TECHNICAL REPORT 70-8

ARMORED CREW SEAT DROP TEST PROGRAM

CONDUCTED FOR BELL HELICOPTER COMPANY

AvSER REPORT NO. M66-8

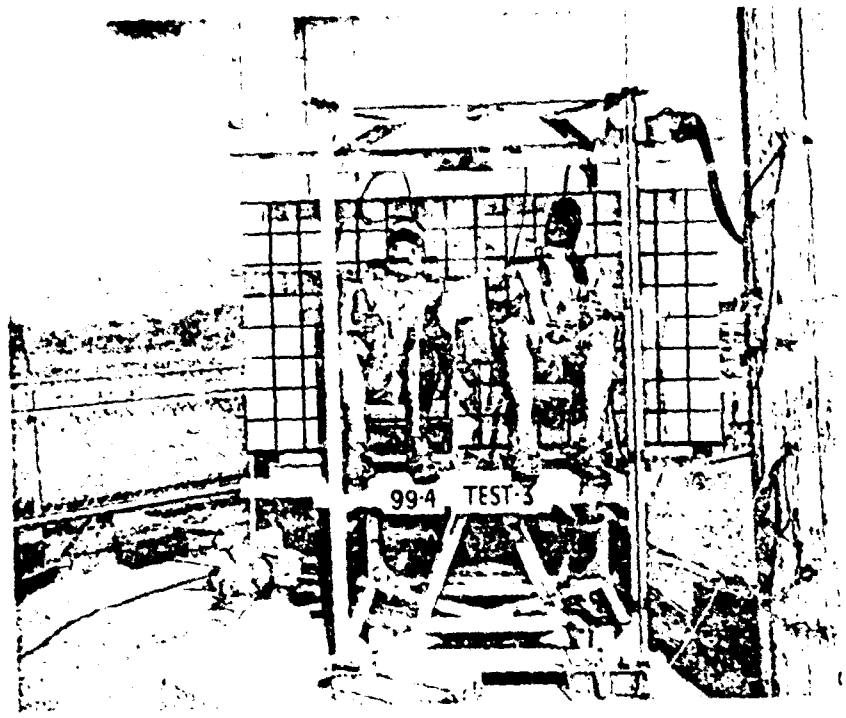
Figure 5. Typical Front View Showing Both Seats and Occupants Following an Intermediate Acceleration Level Test.

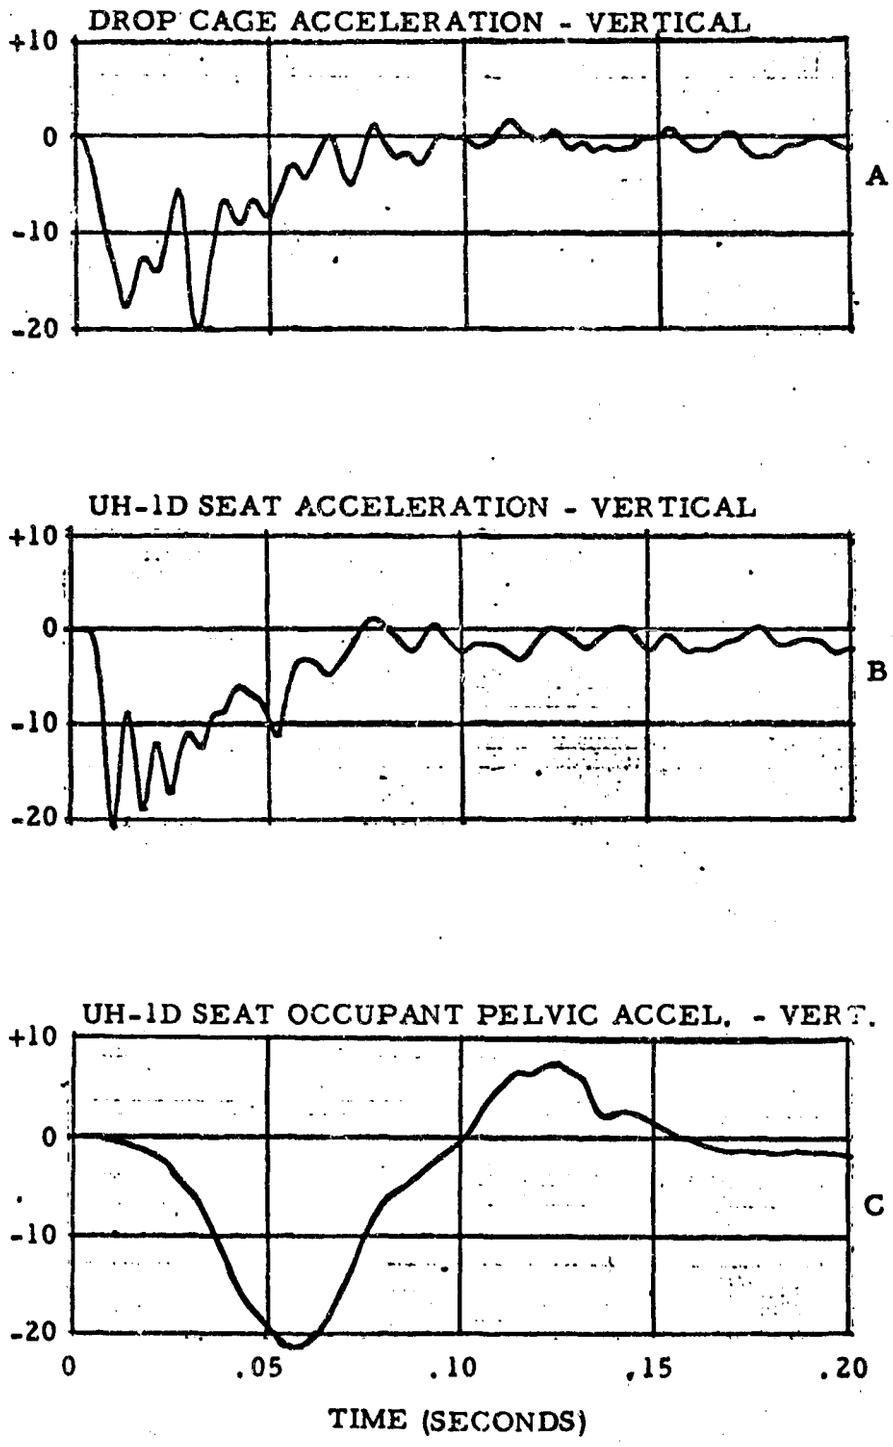
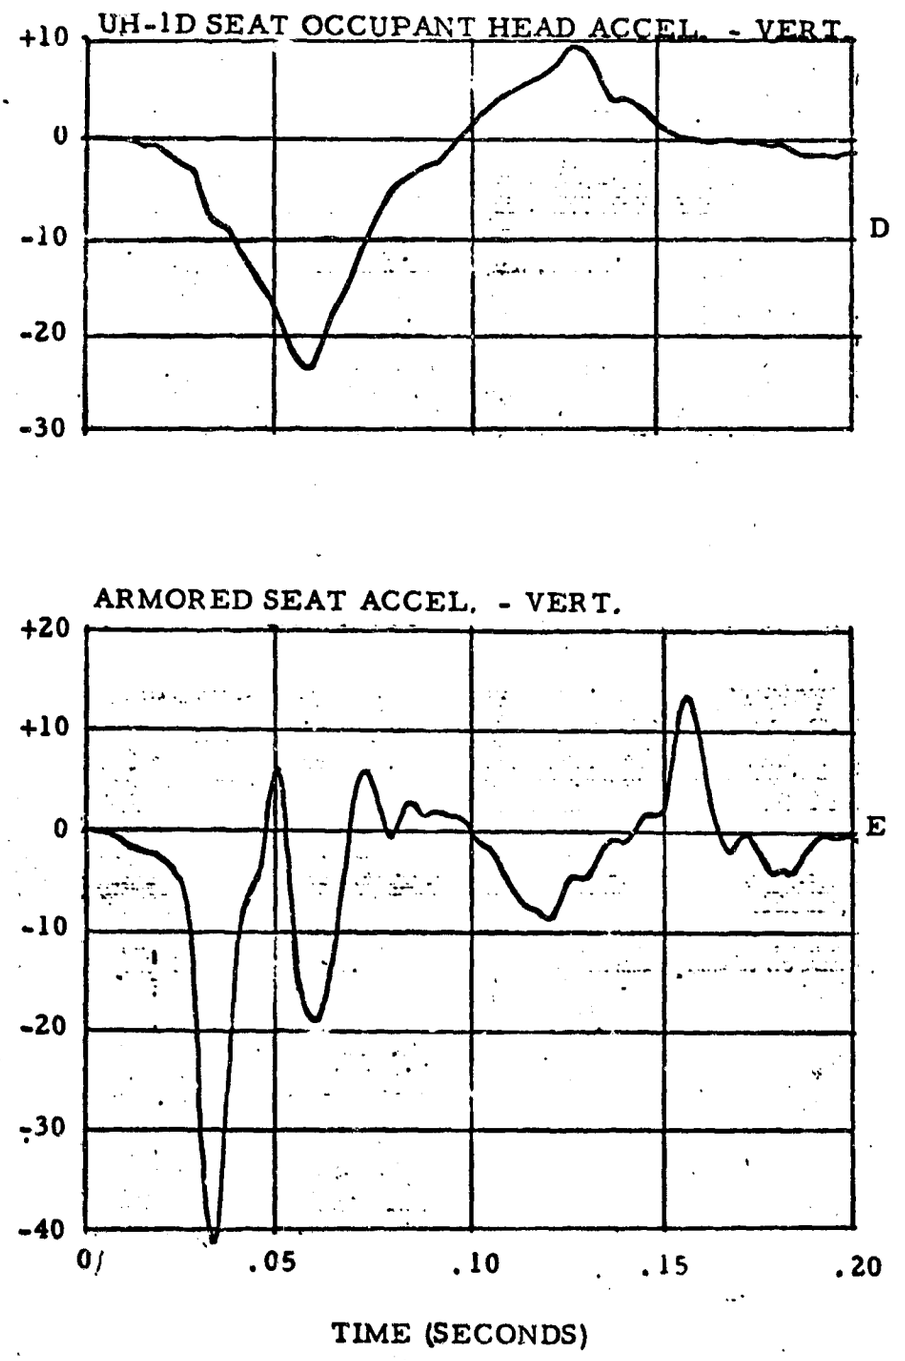
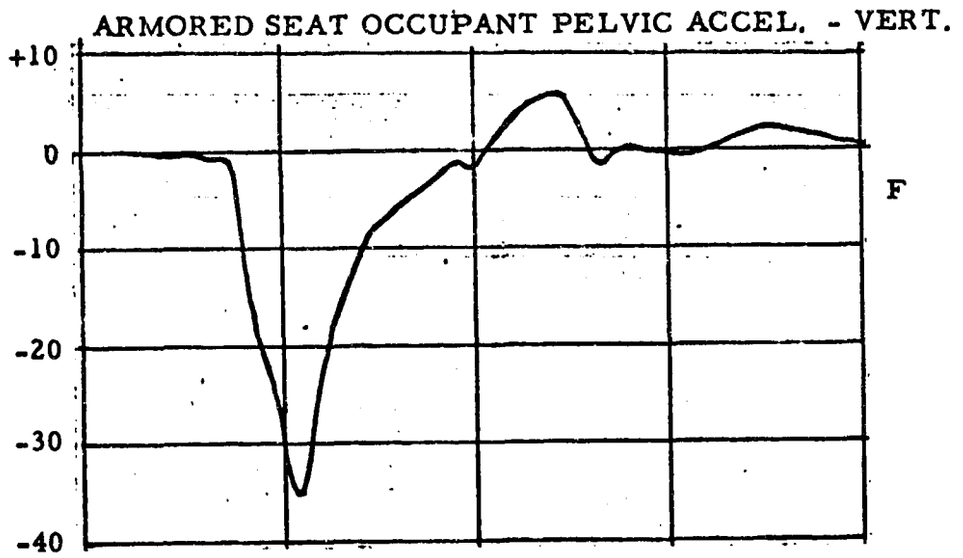
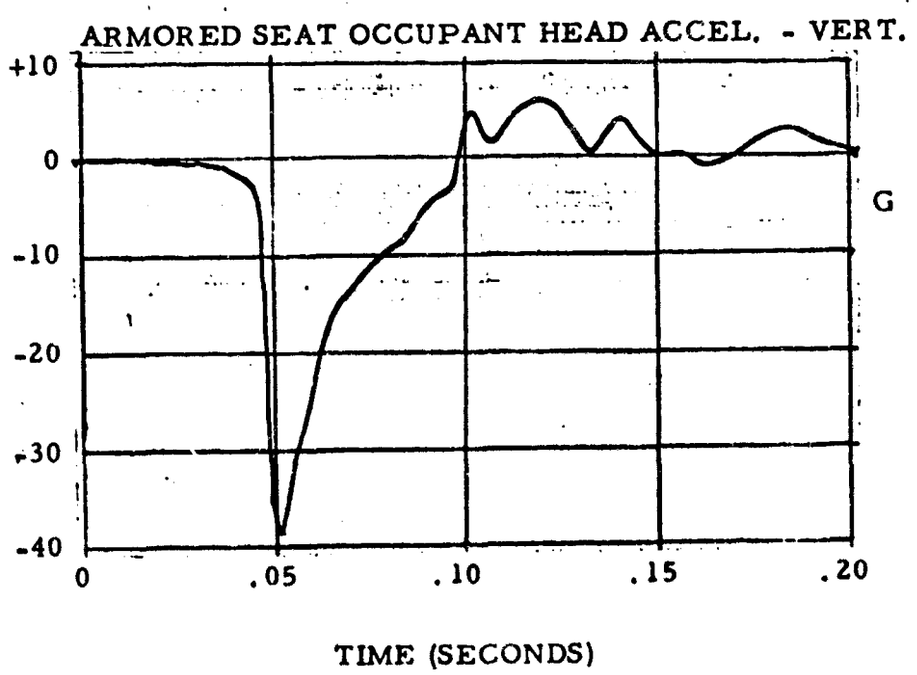
The test was conducted with the armored seat bucket in its lowest vertical adjustment position. Peak drop cage acceleration was 20G and the mean acceleration was 10G. The armored seat occupant again experienced higher pelvic acceleration than the standard UH-1D seat occupant, with peak acceleration of 35G and a mean acceleration of 20G, against standard seat occupant pelvic accelerations of 22G peak and 14G mean (reference Figure 2, Appendix).

Figure 2. - Acceleration Data - Test No. 2.
