WADC TECHNICAL REPORT 54-451
PART 1

**EVALUATION OF SURFACE TREATMENTS
FOR LOW-ALLOY STEELS**

**Part 1. Test Method for Heat-Resistant
Corrosion Protective Coatings on Steel**

SAM TOUR & CO., INC.

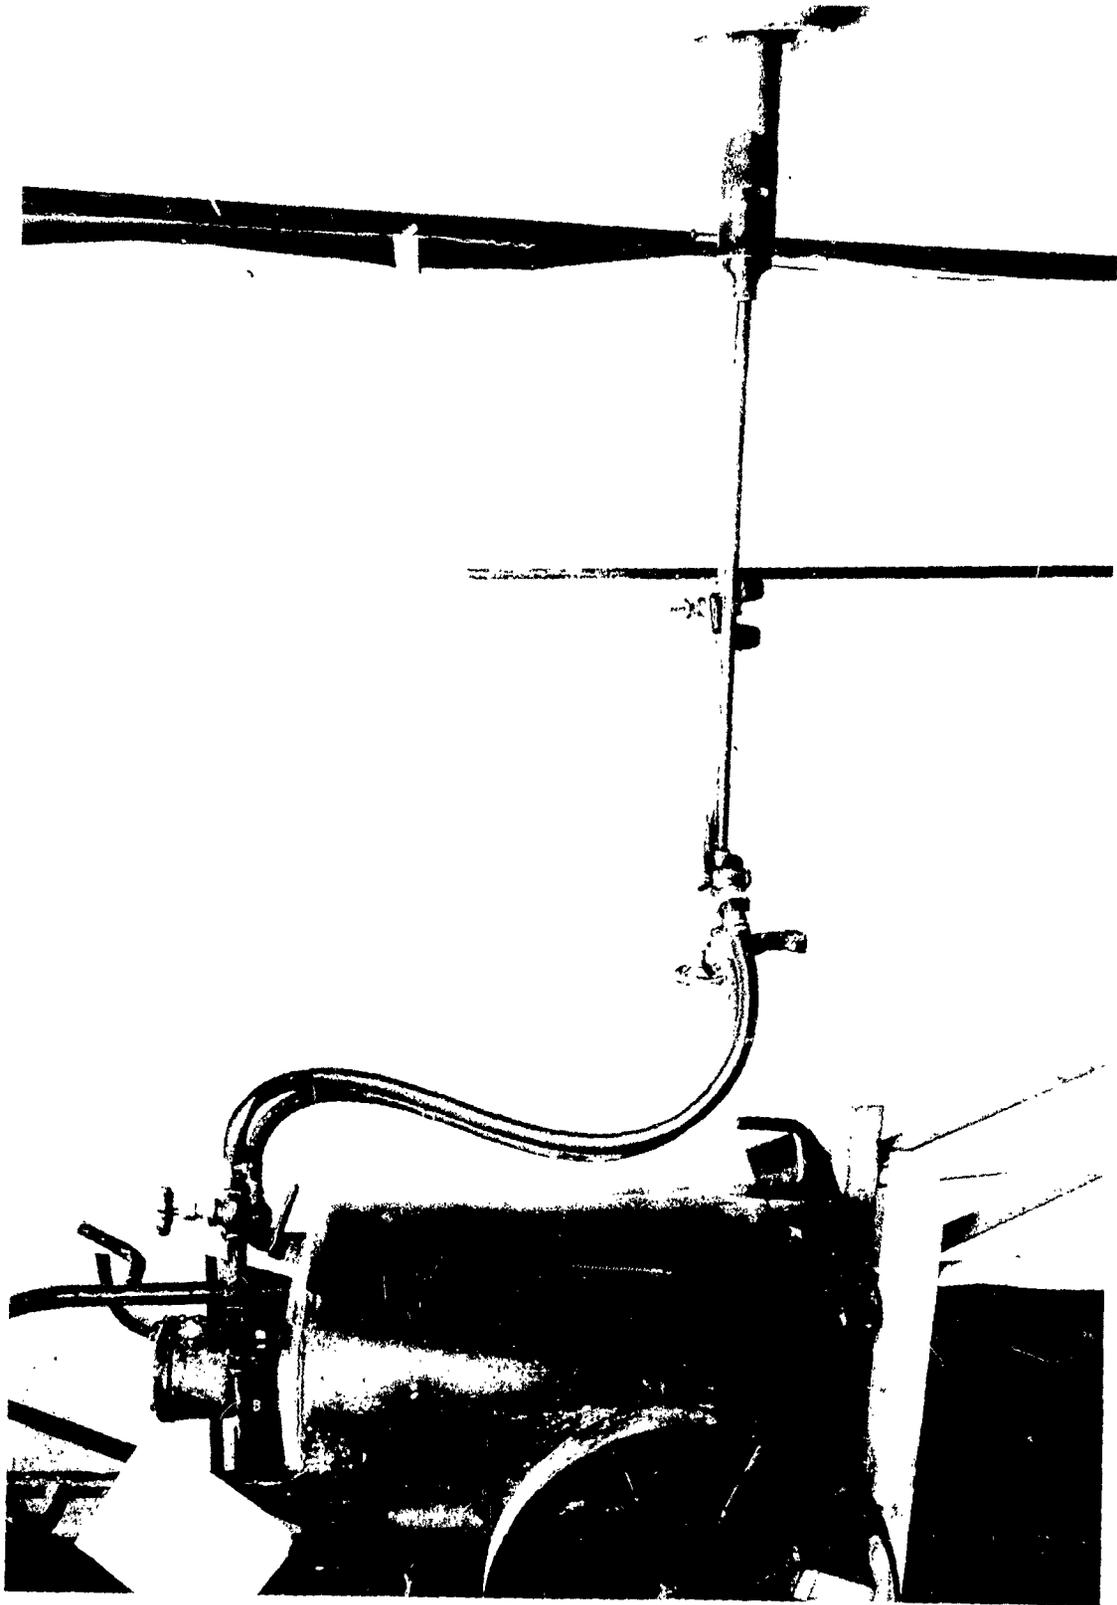
Figure 2 (Plate 15863) is a close-up of the kerosene burner regulating valves and the torch.

FIG. 2 (PLATE 15863)
KEROSENE BURNER

The kerosene torch burner which is known as a Mahr Safety Torch is often used in foundries for the skindrying of sand molds. The burner has a 15 gallon tank and required compressed air at between 50 and 125 psi. The average kerosene consumption of the burner was approximately 5 gallons per 6 hour run. The burner nozzle was directed into the first of three Venturi couplings installed in series. The piping system, beyond the last Venturi, consisted of 2" pipe and pipe fittings as shown. The additional exhaust or bleed off which was partly open during operations was found necessary to avoid back leakage through the Venturis. Most of the combustion gases from the kerosene burner went through the piping system into the muffle of the furnace.

To obtain the above ends, the following modifications were made. The air orifice, the kerosene orifice and the cap outlet on the kerosene burner were made smaller, resulting in a decrease in the intensity of the flame. The air hose and kerosene hose were shortened between the kerosene tank and the torch. The kerosene tank was raised three feet above the floor level. A regulating air valve was inserted into the air line to obtain a steady air flow into the system. The wide nozzle of the kerosene burner was replaced with a narrow one. Two such nozzles were made; one of low carbon steel and one of stainless steel. To increase the amount of oxygen present in the combustion products, the Venturi couplings were placed in series in the line to the furnace. Adjustment of the position of the entrance pipes to the Venturis made it possible to control the oxygen content of the products entering the furnace muffle.

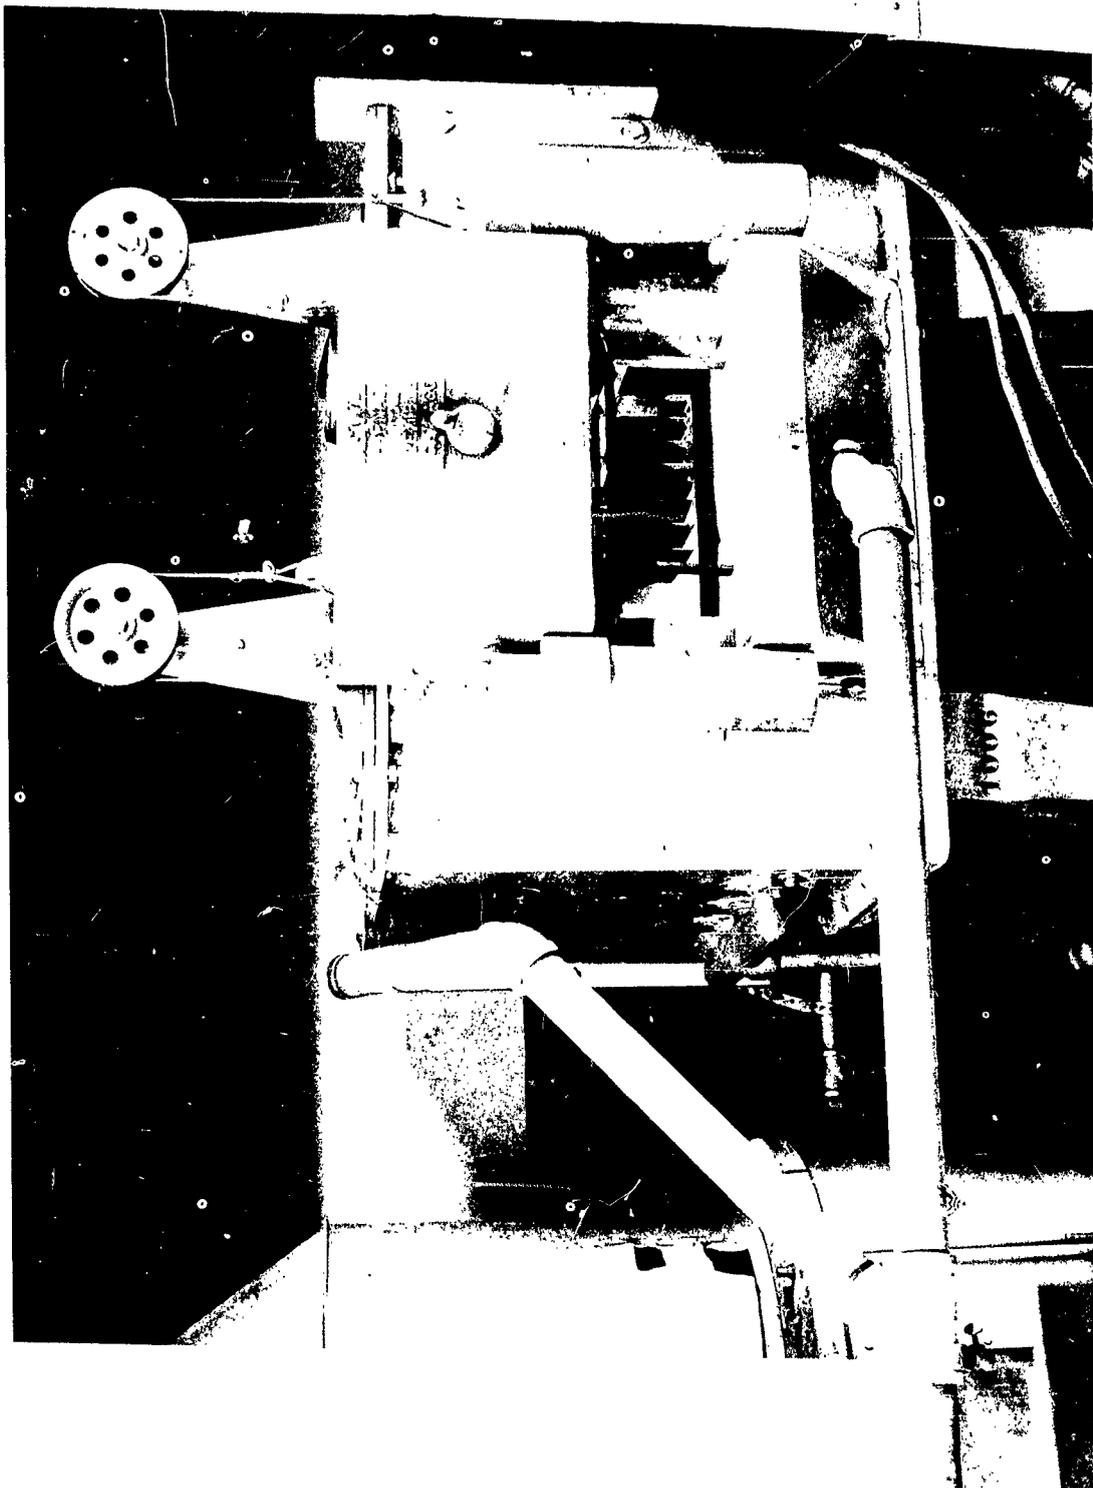
Figure 4 (Plate 15865) is a close-up of the muffle furnace with a part of the piping system. A rack with panels can be seen in the open furnace.

FIG. 4 (PLATE 15865)
MUFFLE FURNACE

The furnace was of the eight burner two manifold type, heated by city gas. The furnace was equipped with a Premix gas-air proportioning control and its own air blower system. When all eight burners were used, the maximum operating temperature in the furnace was approximately 1900°F; the lowest, 1200°F. The operating temperature was brought down much lower by using fewer burners.

HOLDERS, for about 40 panels each, were designed and constructed, one of carbon and one of stainless steel. Each holder had two bars, 5/16" in diameter, to accommodate the panels. A hole in the back wall of the muffle enabled the combustion products to pass through the muffle. During all runs, the holder was placed in the muffle in such a position that the panels were parallel to the flow of gases.

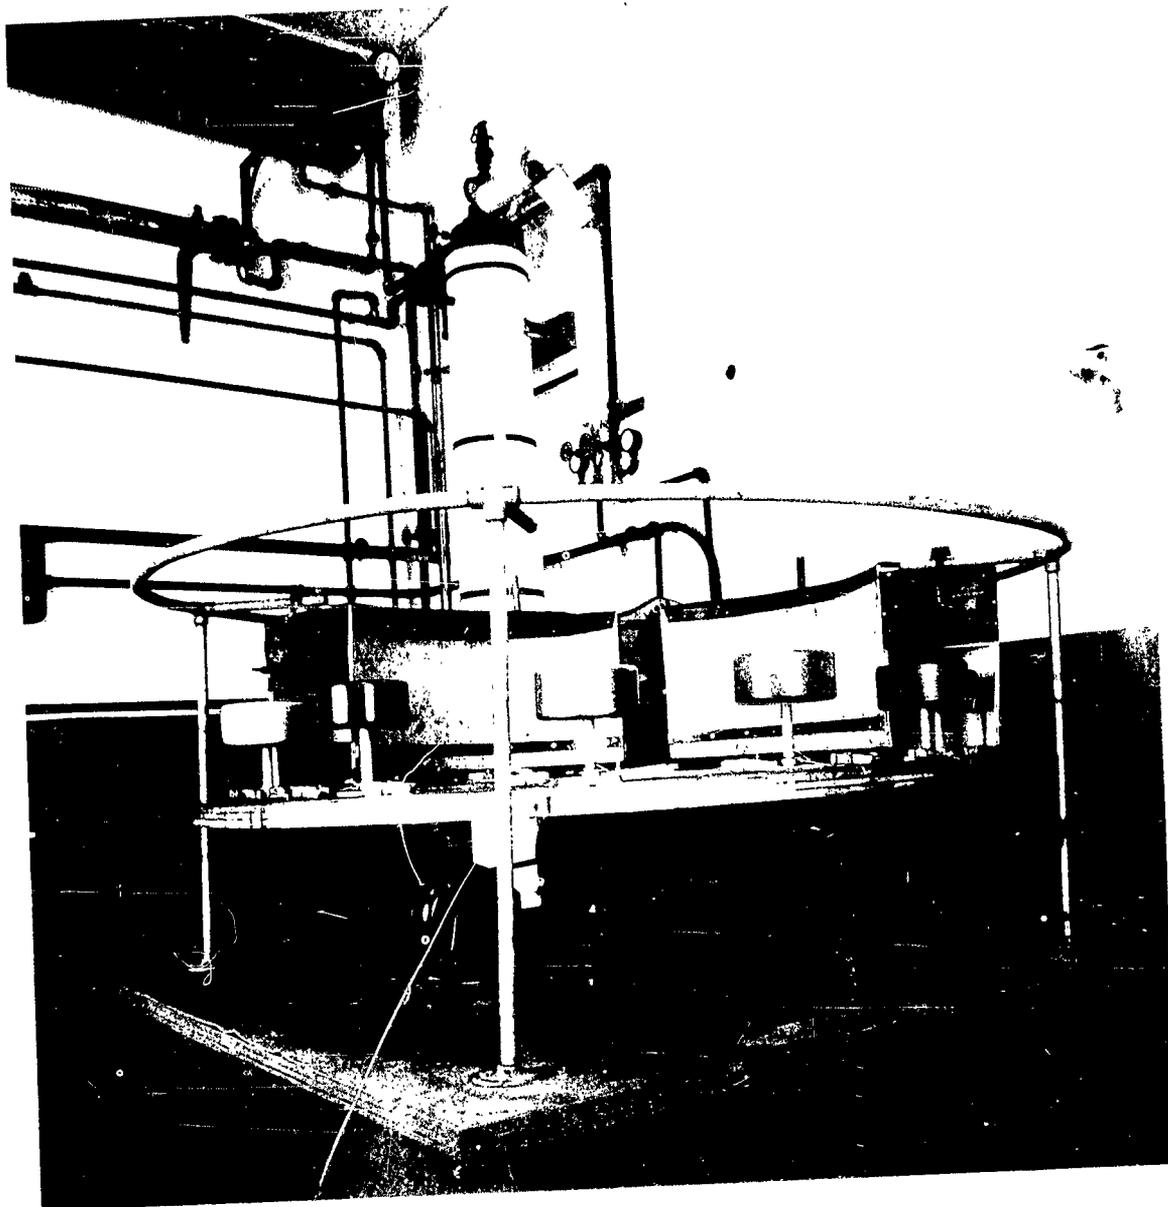
Figure 5 is a photograph of the alternate condensation tester in operation in the test of coated steel drums.

FIG. 5
ALTERNATE CONDENSATION CORROSION TESTER

The test is an accelerated test simulating service conditions more than any test yet devised. Its principle is alternate condensation of water vapor and its subsequent evaporation.
