REPORT OF PROJECT NR AVN 2656  
EFFECT OF WING-TIP VORTICES AND SONIC SHOCK  
ON ARMY AIRCRAFT IN FLIGHT

May 1957

UNITED STATES ARMY AVIATION BOARD  
Fort Rucker, Alabama

REPORT OF PROJECT NR AVN 2656

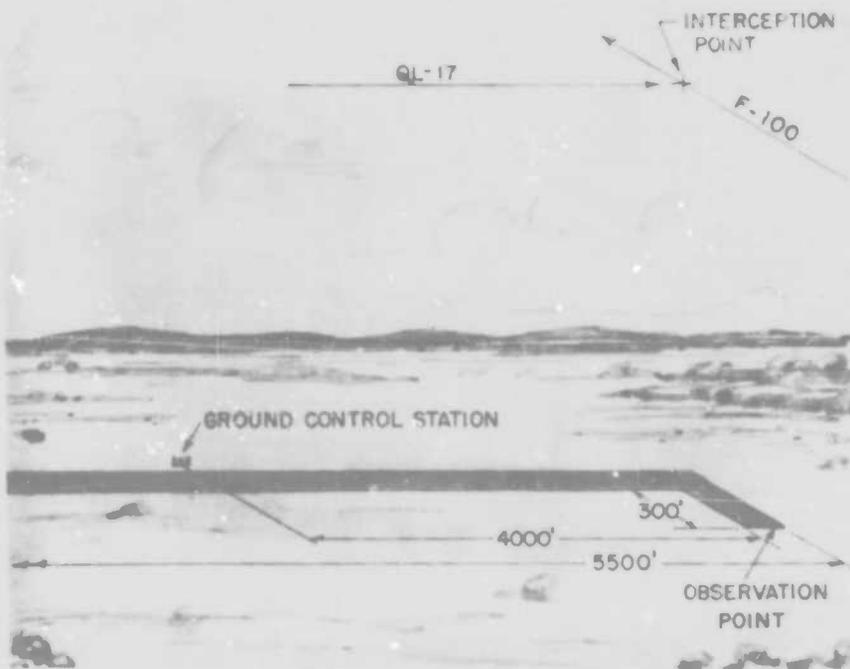
feet south of the intercept point. A second station with observers, camera crews, and a communications vehicle was established approximately 300 feet to the right of the intercept point. Aerial observation and motion pictures were taken from a helicopter which flew near the intercept point.

Figure 8.  
Test Site

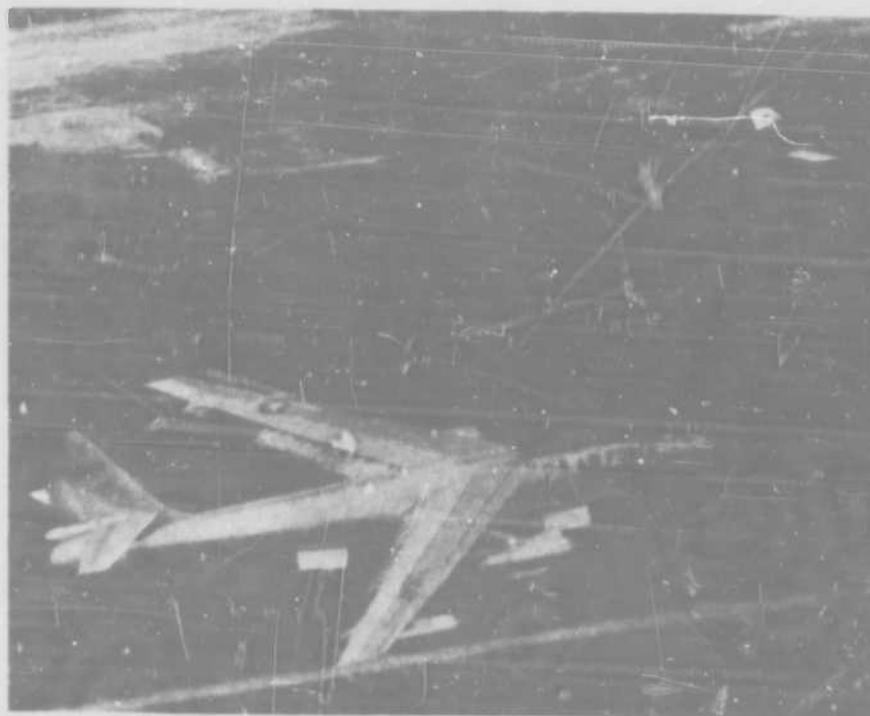
(1) To study the effect of wing-tip vortices on lightly wing-loaded aircraft, a QL-17 was used to intercept the vortex disturbances generated by F-100 and B-47 aircraft.

Figure 10.  
E-47 Passing  
Under QL-17

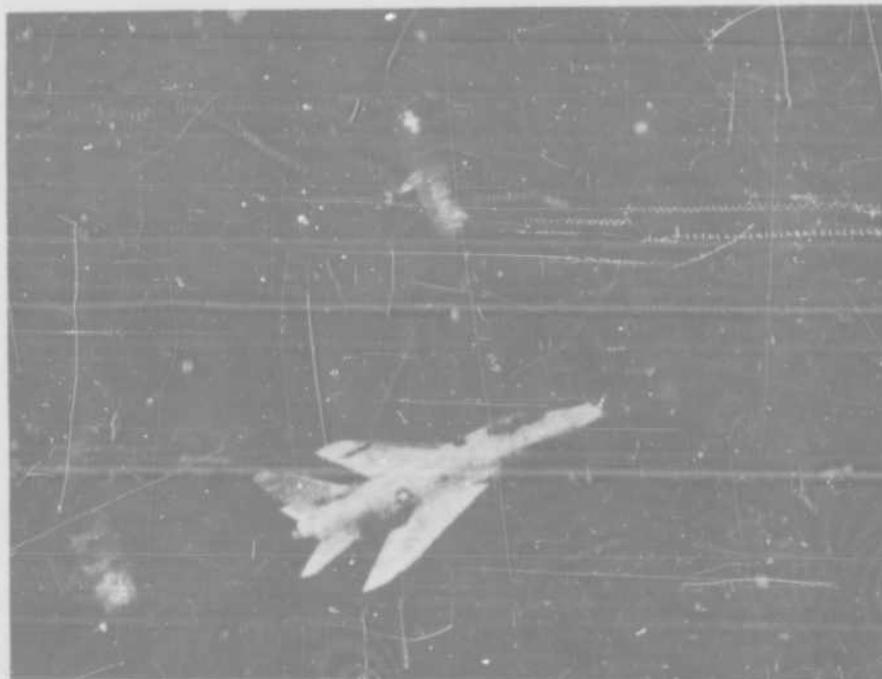
b. Piloted Penetrations. Two flights were made in which a piloted L-19, flying at 90 miles per hour, attempted to penetrate the F-100 vortices. The F-100 was flown at an airspeed of 200 knots in landing configuration at an altitude of 6,000 feet. The F-100 dispensed smoke on each of the attempted intercepts.

Figure 12. F-100 Passing Under L-19

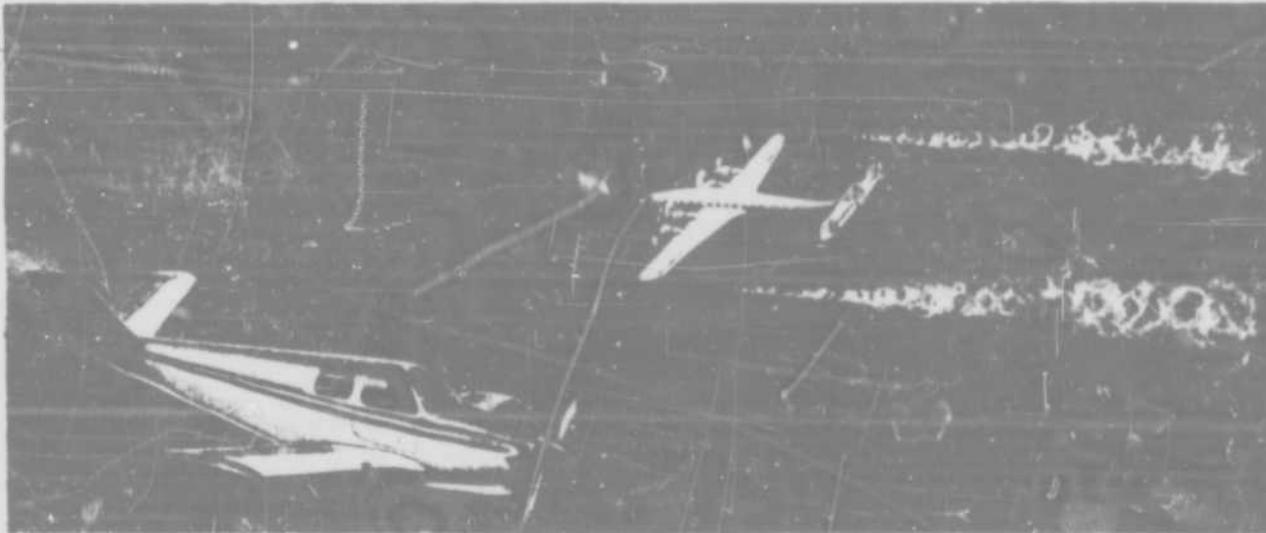
Figure 1

This figure shows the tip vortexes and swirling propeller wash trailing behind a large aircraft on its landing approach and a plane in the downwind leg of the traffic pattern.

What Causes This Hazard? Basically it is (a) the wing tip vortexes and (b) the swirling propeller wash of large aircraft that creates a turbulence which can upset another aircraft, as indicated in Figures 1 through 5 of this bulletin.

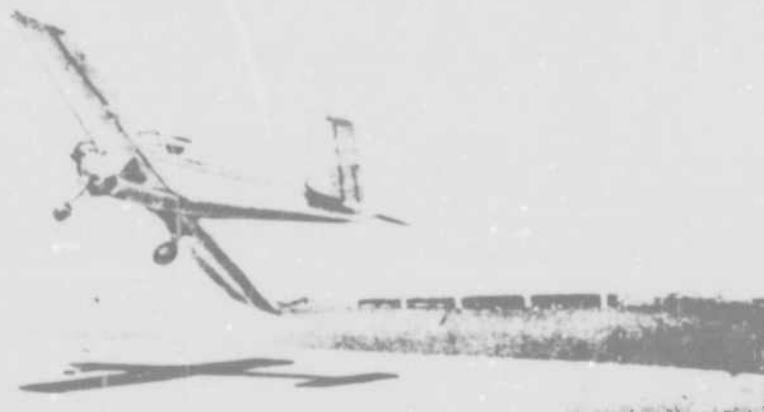
Figure 3

This figure shows the landing airplane being upset by the turbulence.

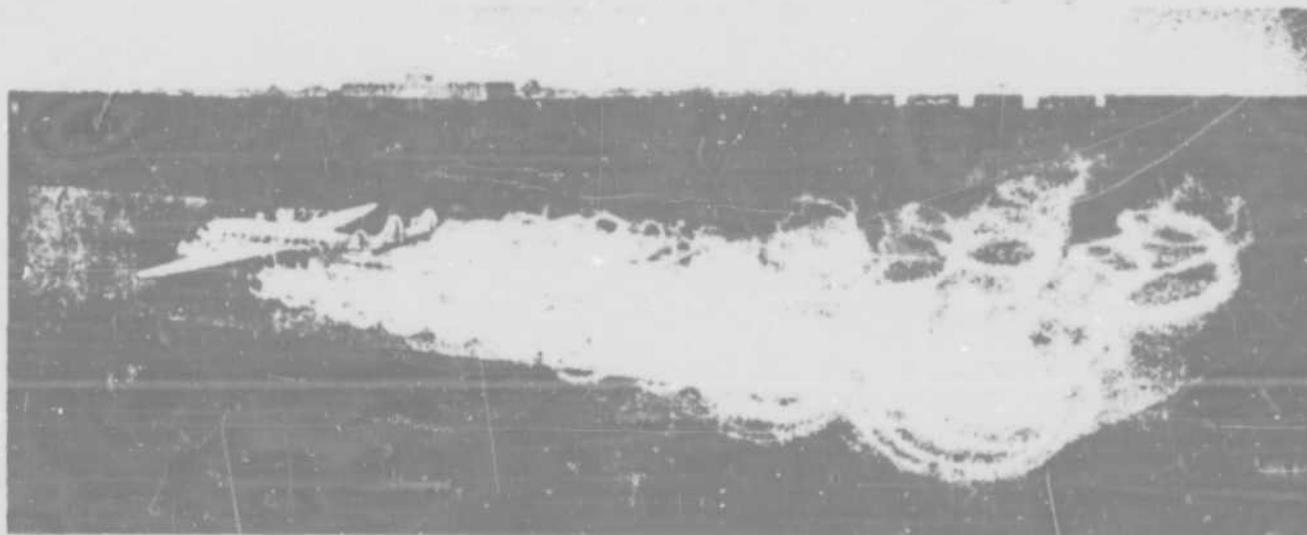
Figure 5

Vertical vortices caused by slip stream
