Expandable Airlock Experiment (D021)

QUARTERLY PROGRESS REPORT No. 9, 10, 11

GOODYEAR AEROSPACE CORPORATION

Subject: D-21 Airlock Experiment Vacuum Chamber Deployment Failure Analysis Report

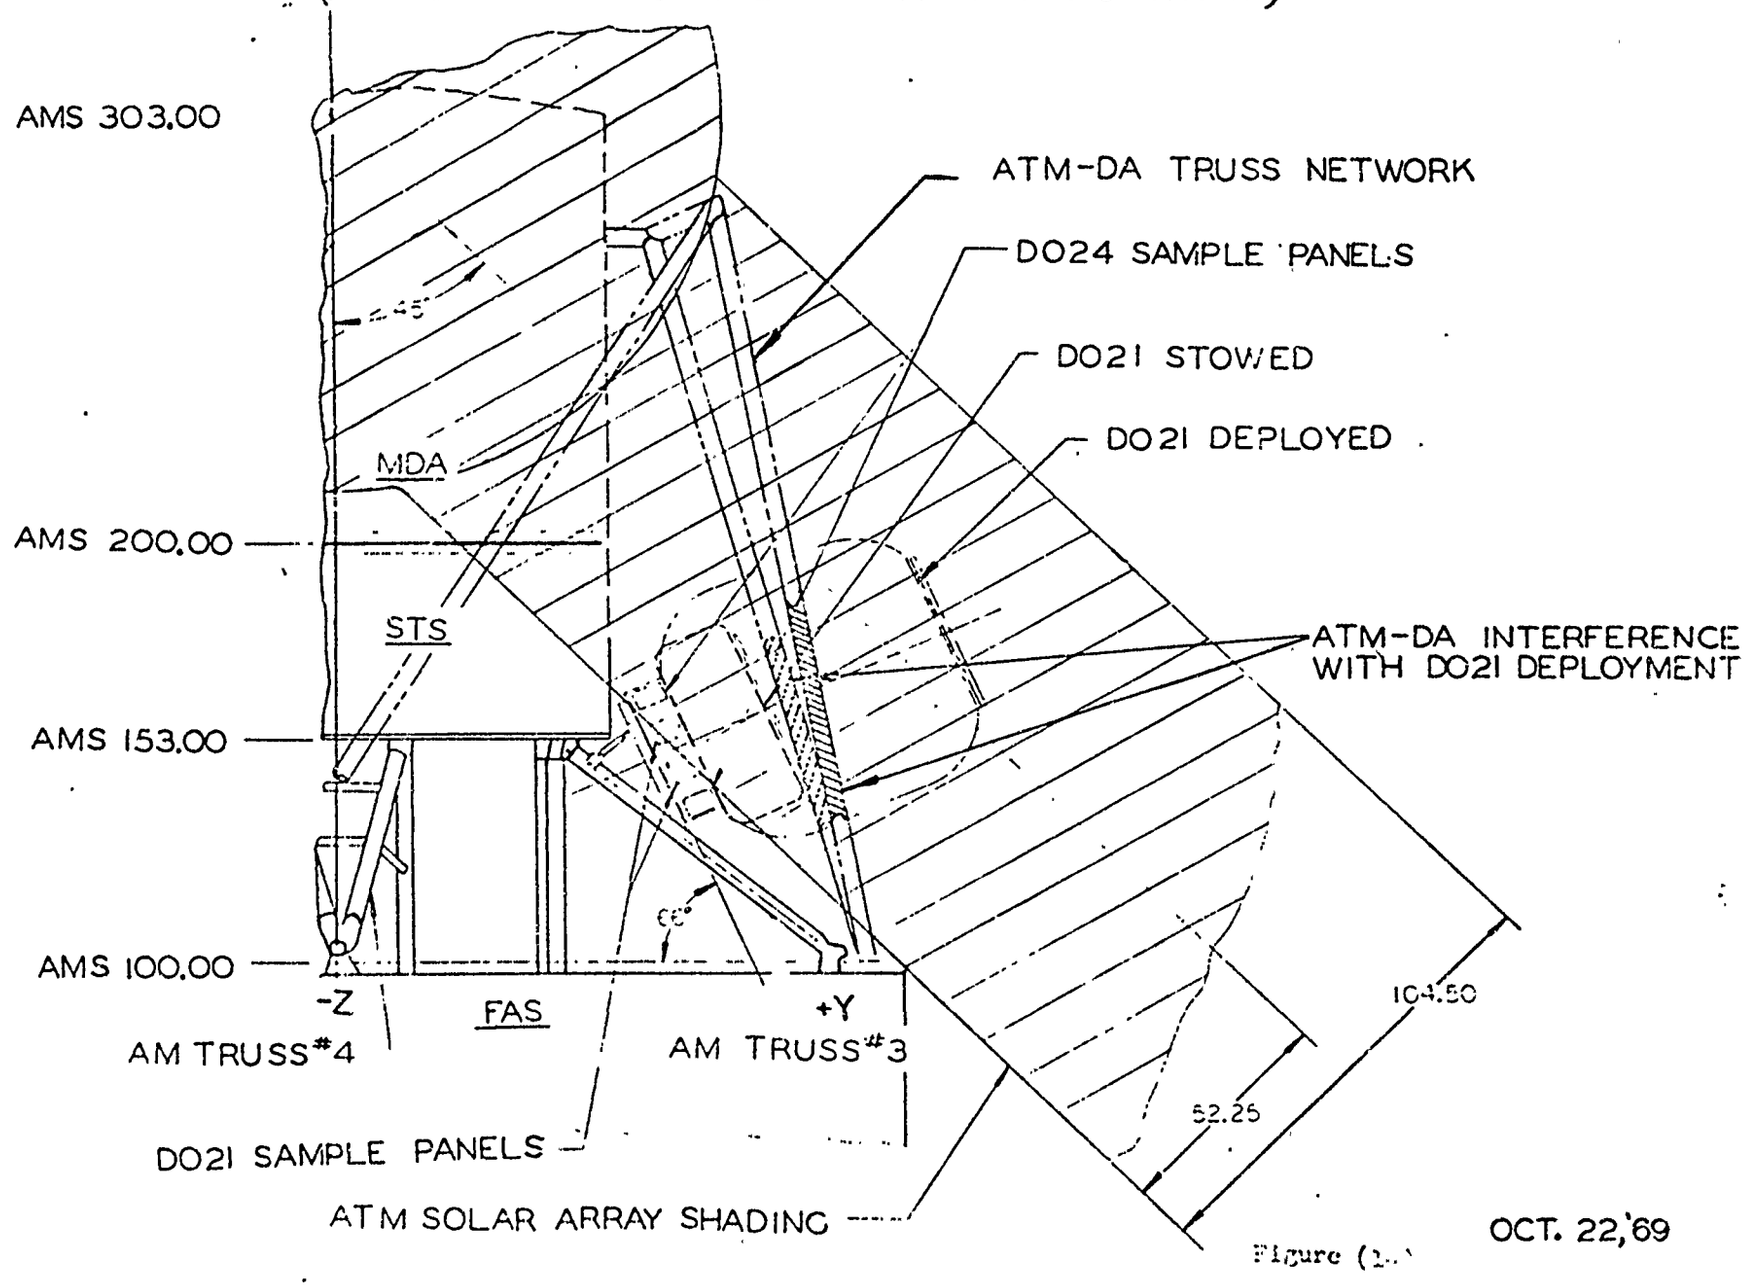
INTERFERENCE ATM-DA TRUSS WITH DO21

(FORMER POSITION DO21 EXP. ON AM TRUSS#3 SHOWN)

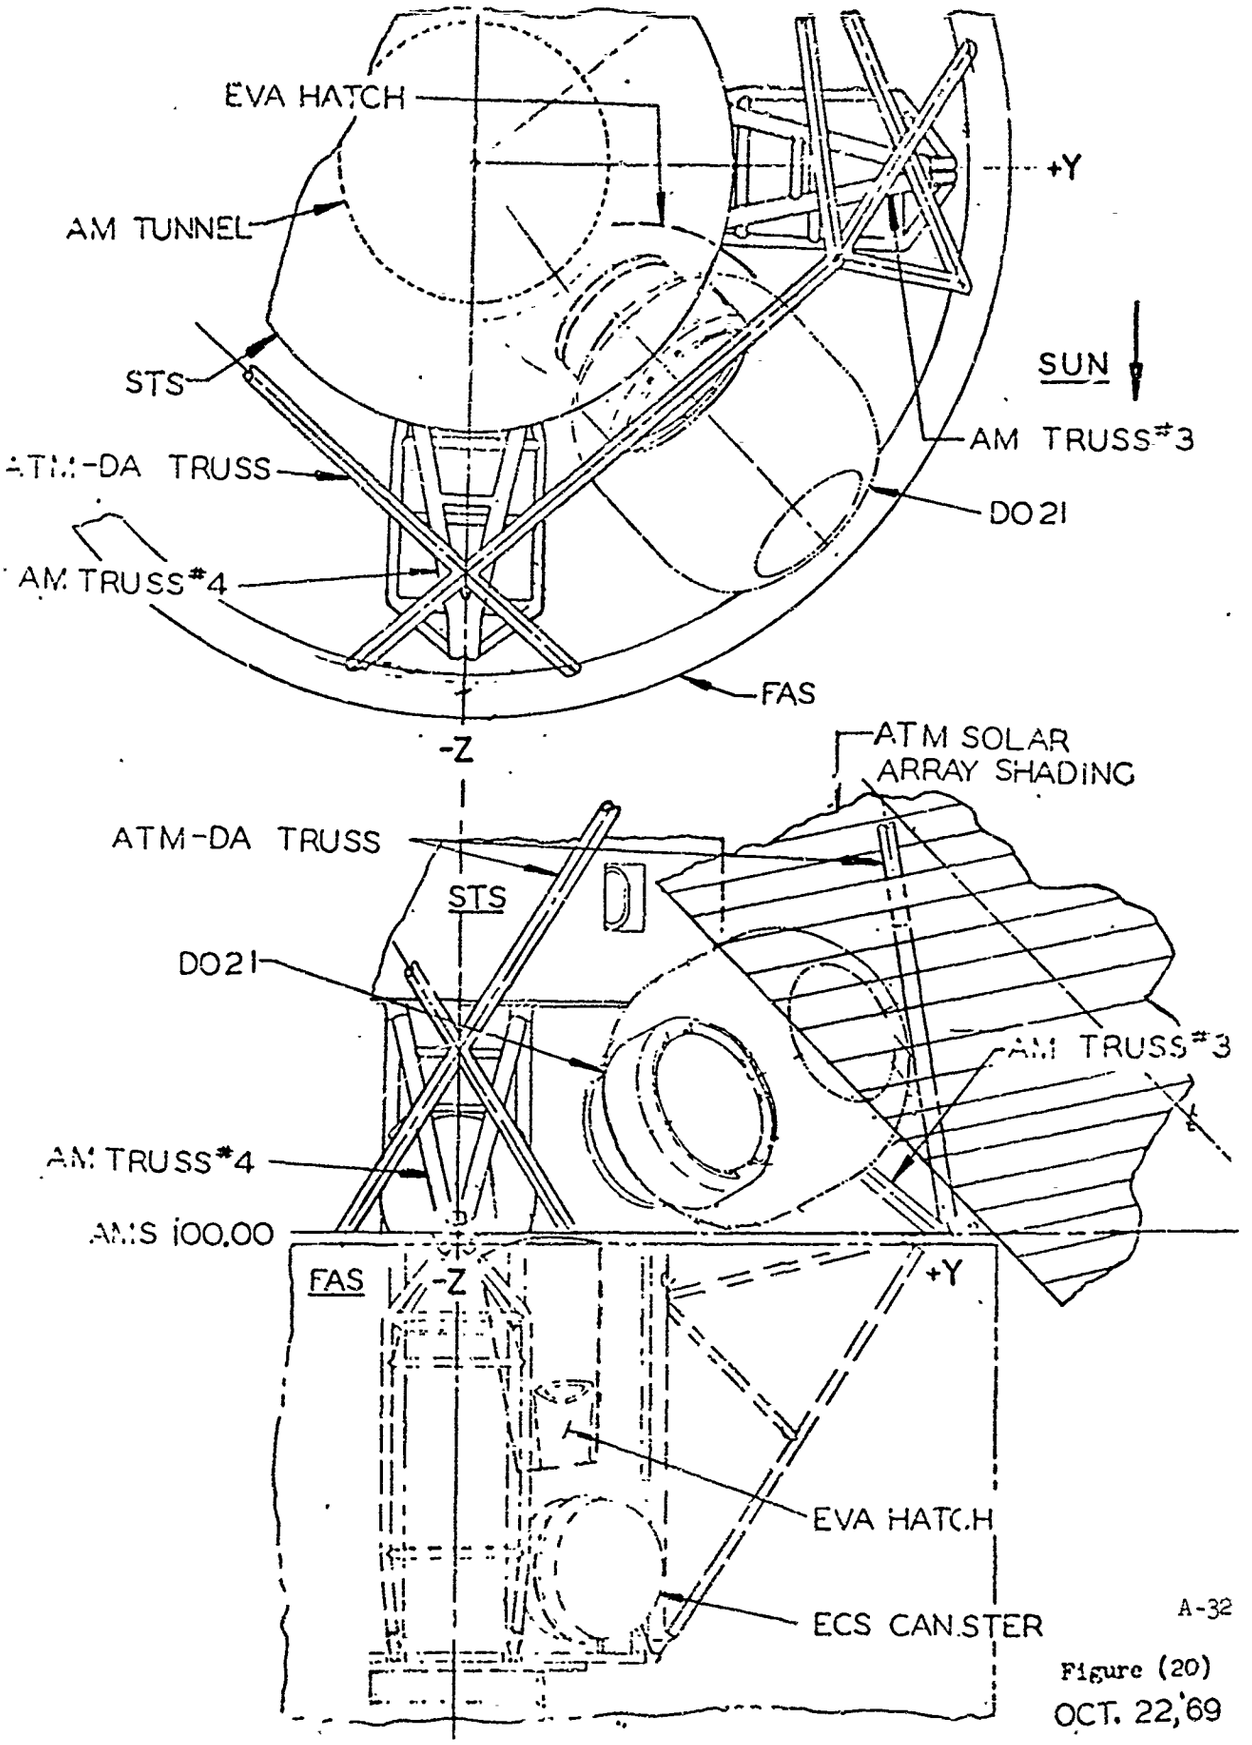
LOCATION NO. 3 - ABOVE EVA HATCH

- EXPERIMENT SUPPORT STRUCTURE INTERFACES WITH OPENING OF EVA HATCH.
- STS RADIATOR IS PARTIALLY SHADED BY EXPERIMENT.
- PACKAGED EXPERIMENT IS IN SUNLIGHT; DEPLOYED EXPERIMENT IS IN SUNLIGHT EXCEPT FOR THE INGRESS/EGRESS HATCH, WHICH IS SHADED BY THE ATM SOLAR ARRAY.
- FIELD OF VIEW FROM STS WINDOW IS REDUCED BY DEPLOYED EXPERIMENT.

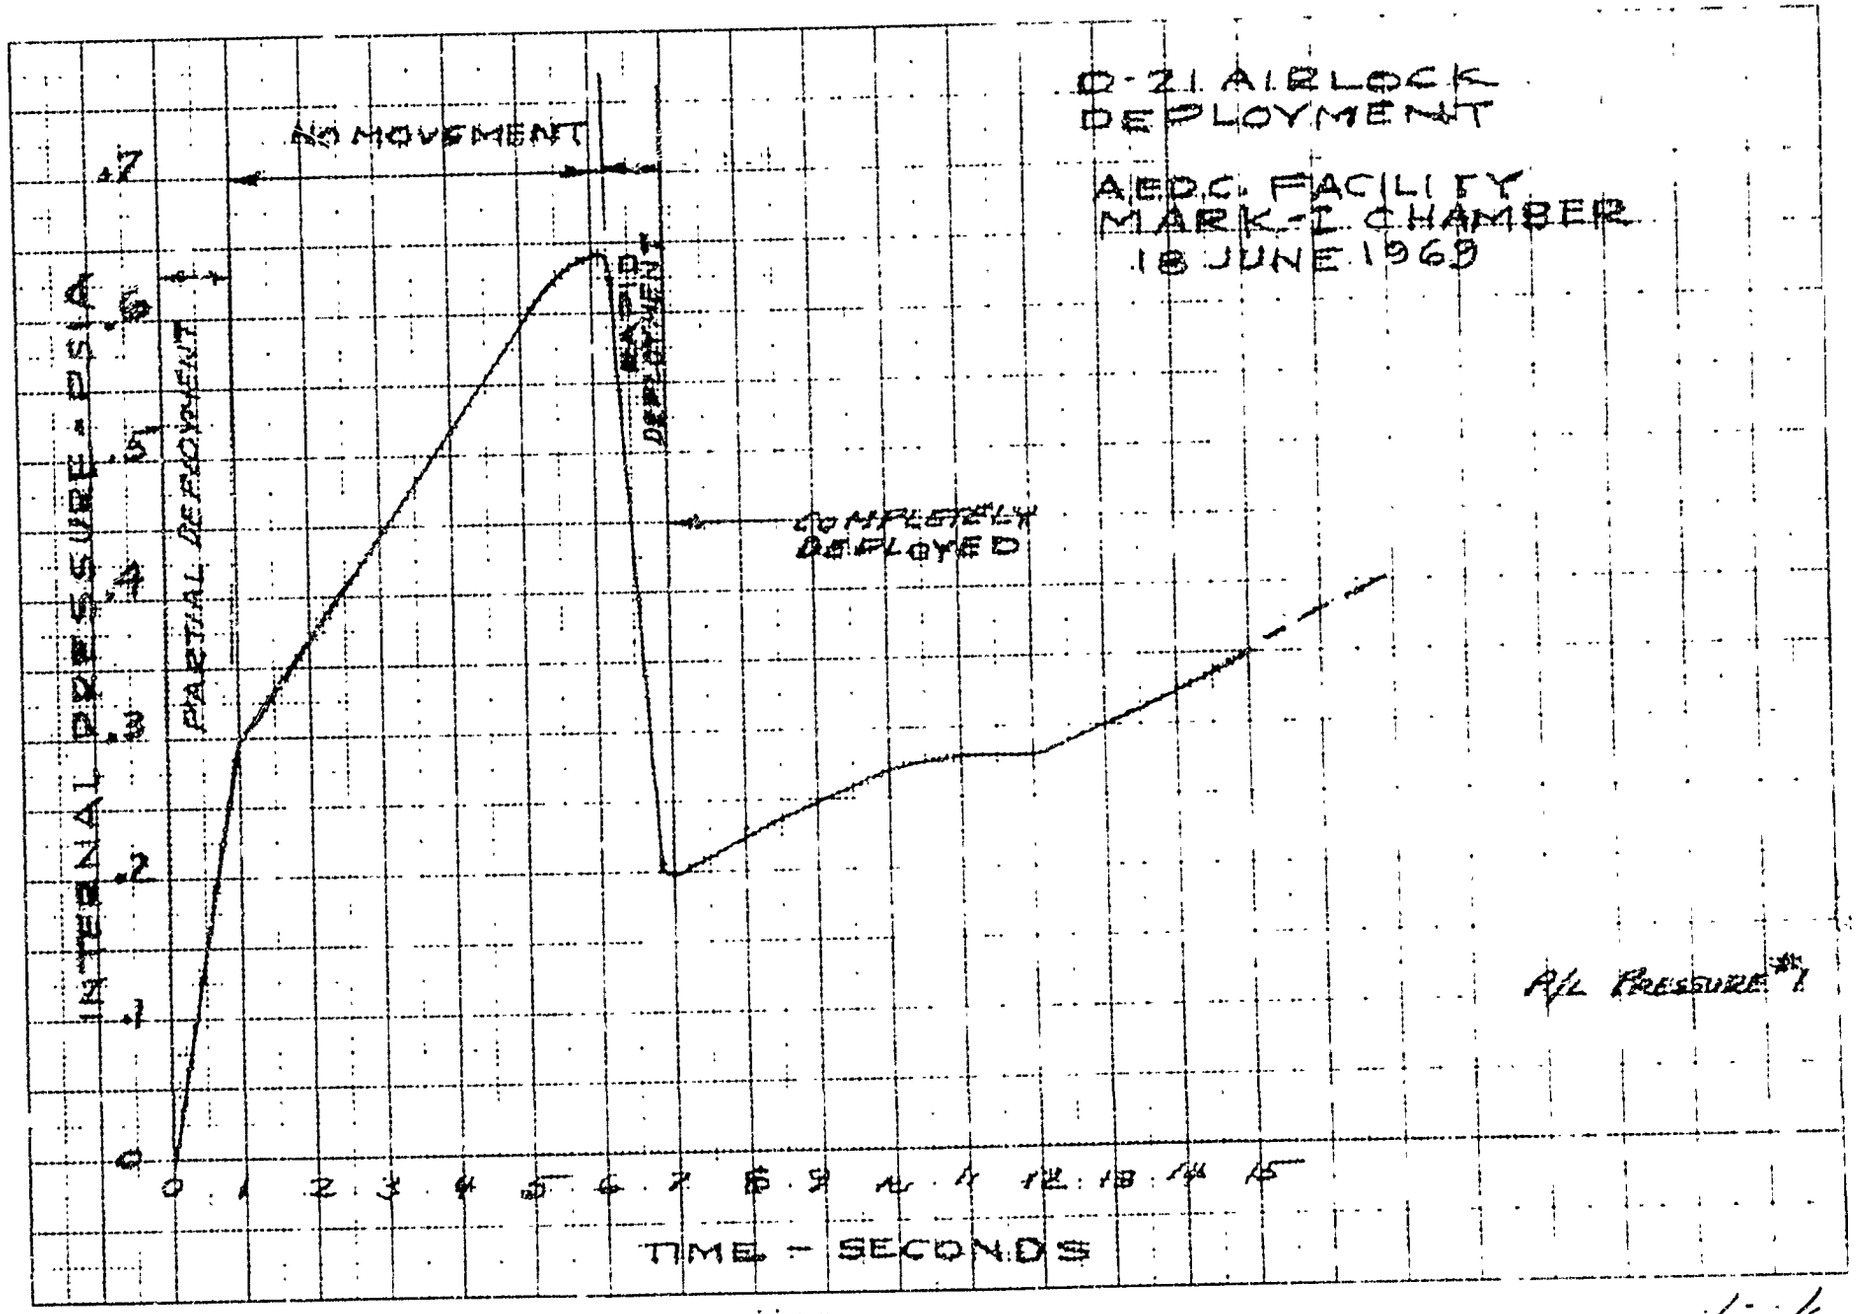
Movies taken of the airlock deployment were analyzed by comparing framing speeds against pressure rise recordings. Results are correlated on Figure 1. The sudden deployment event corresponds to the sharp drop in pressure at approximately 6.0 seconds after start.

From the above evidence, it appears that at least a portion of the expandable structure was in a "semi-frozen" state at the time of deployment. An excessive pressure rise occurred with the airlock restricted to approximately 30 percent of its expanded volume by the trapped folds of material. This pressure finally produced enough force to unwrap the folds but at this point the conversion of pneumatic potential energy to kinetic energy occurred so rapidly that damage to the structure was incurred in the unfolding process.

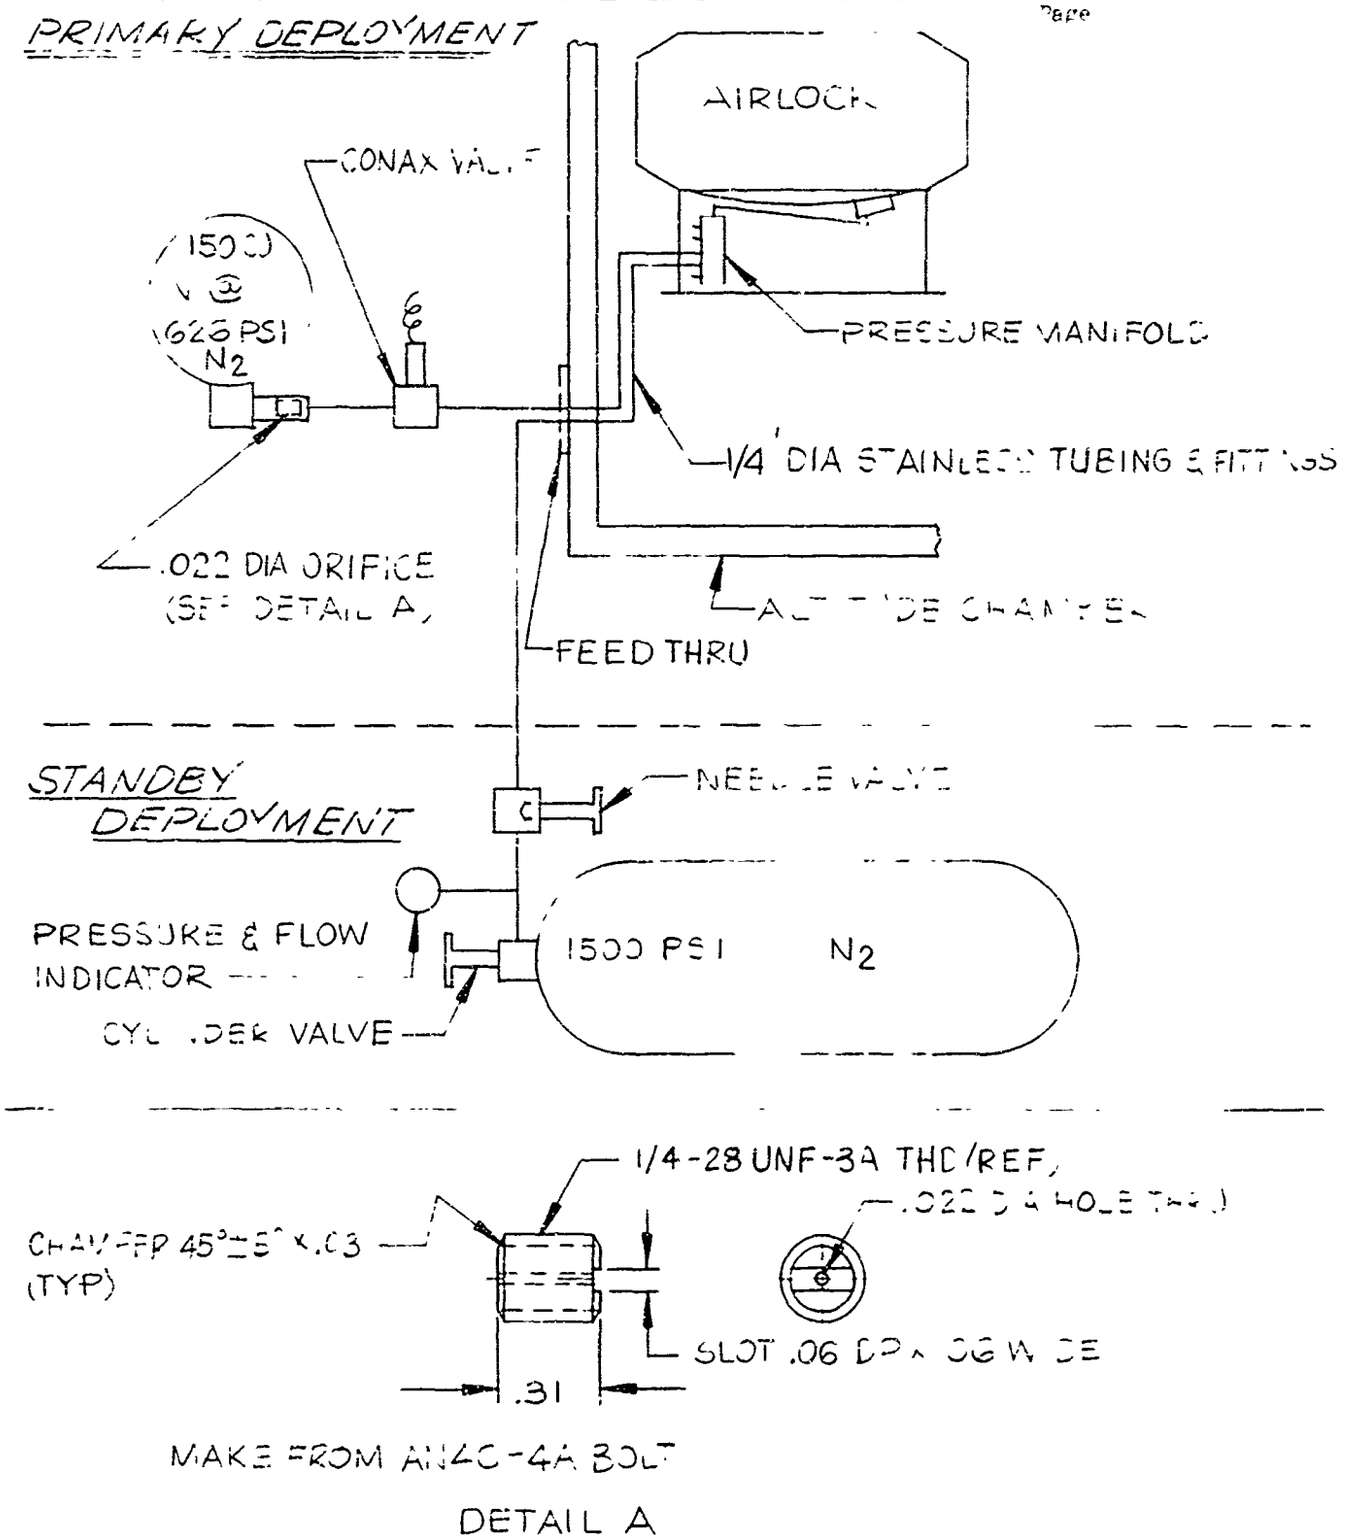
A special pressurization system as shown on Figure 4 was connected to the inflation manifold. The reason was to duplicate the design flow discharge rate but to reduce the total capacity of the system to reduce risk of damage if hang up occurred during deployment. A standby system of regulated N_2 was also connected. This system is used to maintain shape during the repressurization of the vacuum chamber.

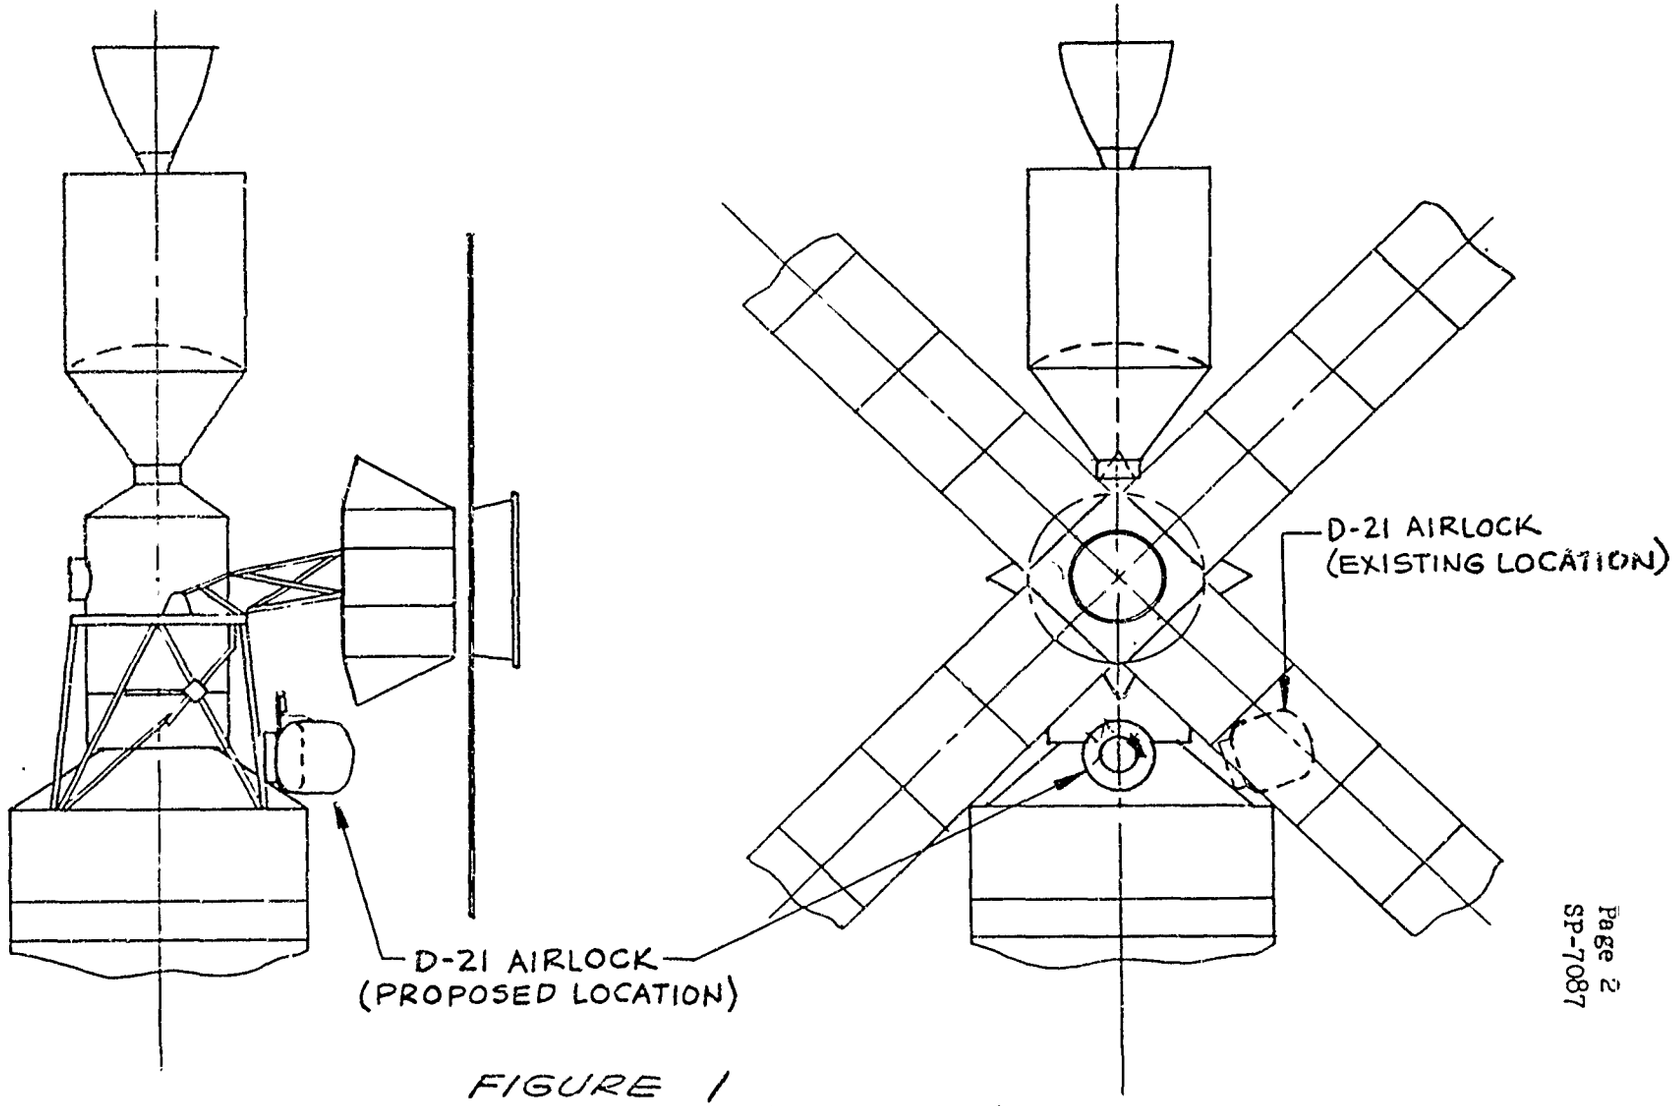
FIGURE 1
PROPOSED AIRLOCK LOCATION

The present location of the D-21 airlock in the shadow of the ATM solar array imposes severe extremes of thermal environment. If a thermal coating with "hot" properties is selected to keep the airlock warm in the shade, it proves to be too hot during those periods the airlock is exposed to the sun prior to ATM deployment or during random orientation periods. A cooler thermal coating which is suitable to control the heat flux in the sun, is found to be too cold to be satisfactory in the shade.

Although this problem exists to some degree regardless of the airlock location, there is a spot between solar cell arrays which has less extreme fluctuations in thermal flux. The D-21 is currently located on the McDonnell Douglas airlock module (AM) Strut No. 3. Relocation of the D-21 airlock to Strut No. 4 of the AM appears practical and will provide a more suitable thermal environment.

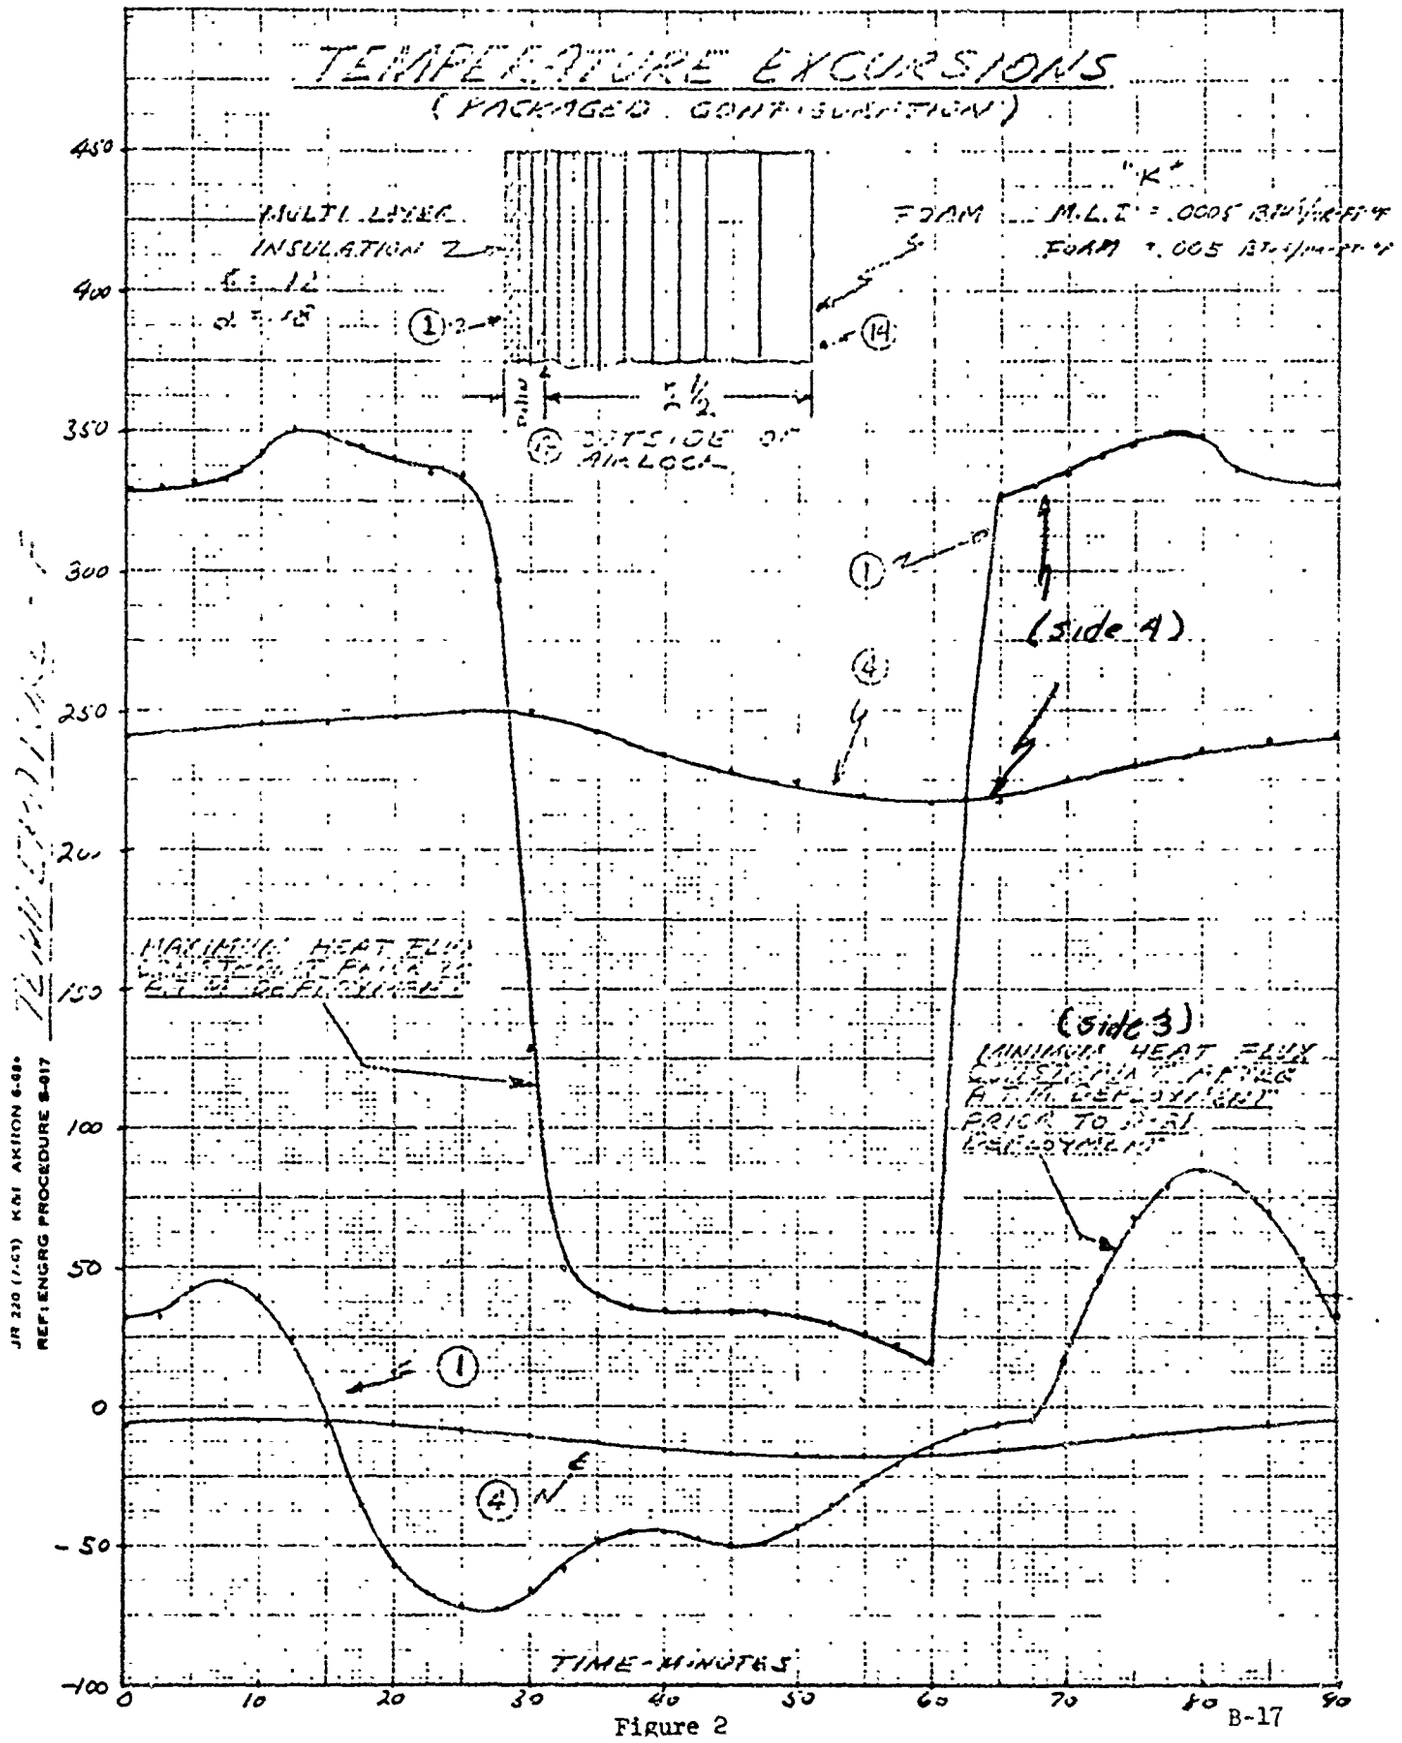
Figure 2

As can be seen from the thermal plots of Figure 2, the maximum temperature that the outer layer of the thermal blanket will achieve is +350° F prior to deployment of the ATM. The outer surface of the airlock will be kept below +250° F, under these conditions. After ATM deployment and orientation to the sun, the D-21 airlock minimum temperature will be no less than -15° F. (The micrometeoroid barrier material of the airlock increases rapidly in stiffness as the temperature is lowered below -20° F.) The outer surface of the insulative blanket will of course cycle from from a maximum of +350° F to a minimum of -75° F, during this period but low temperature

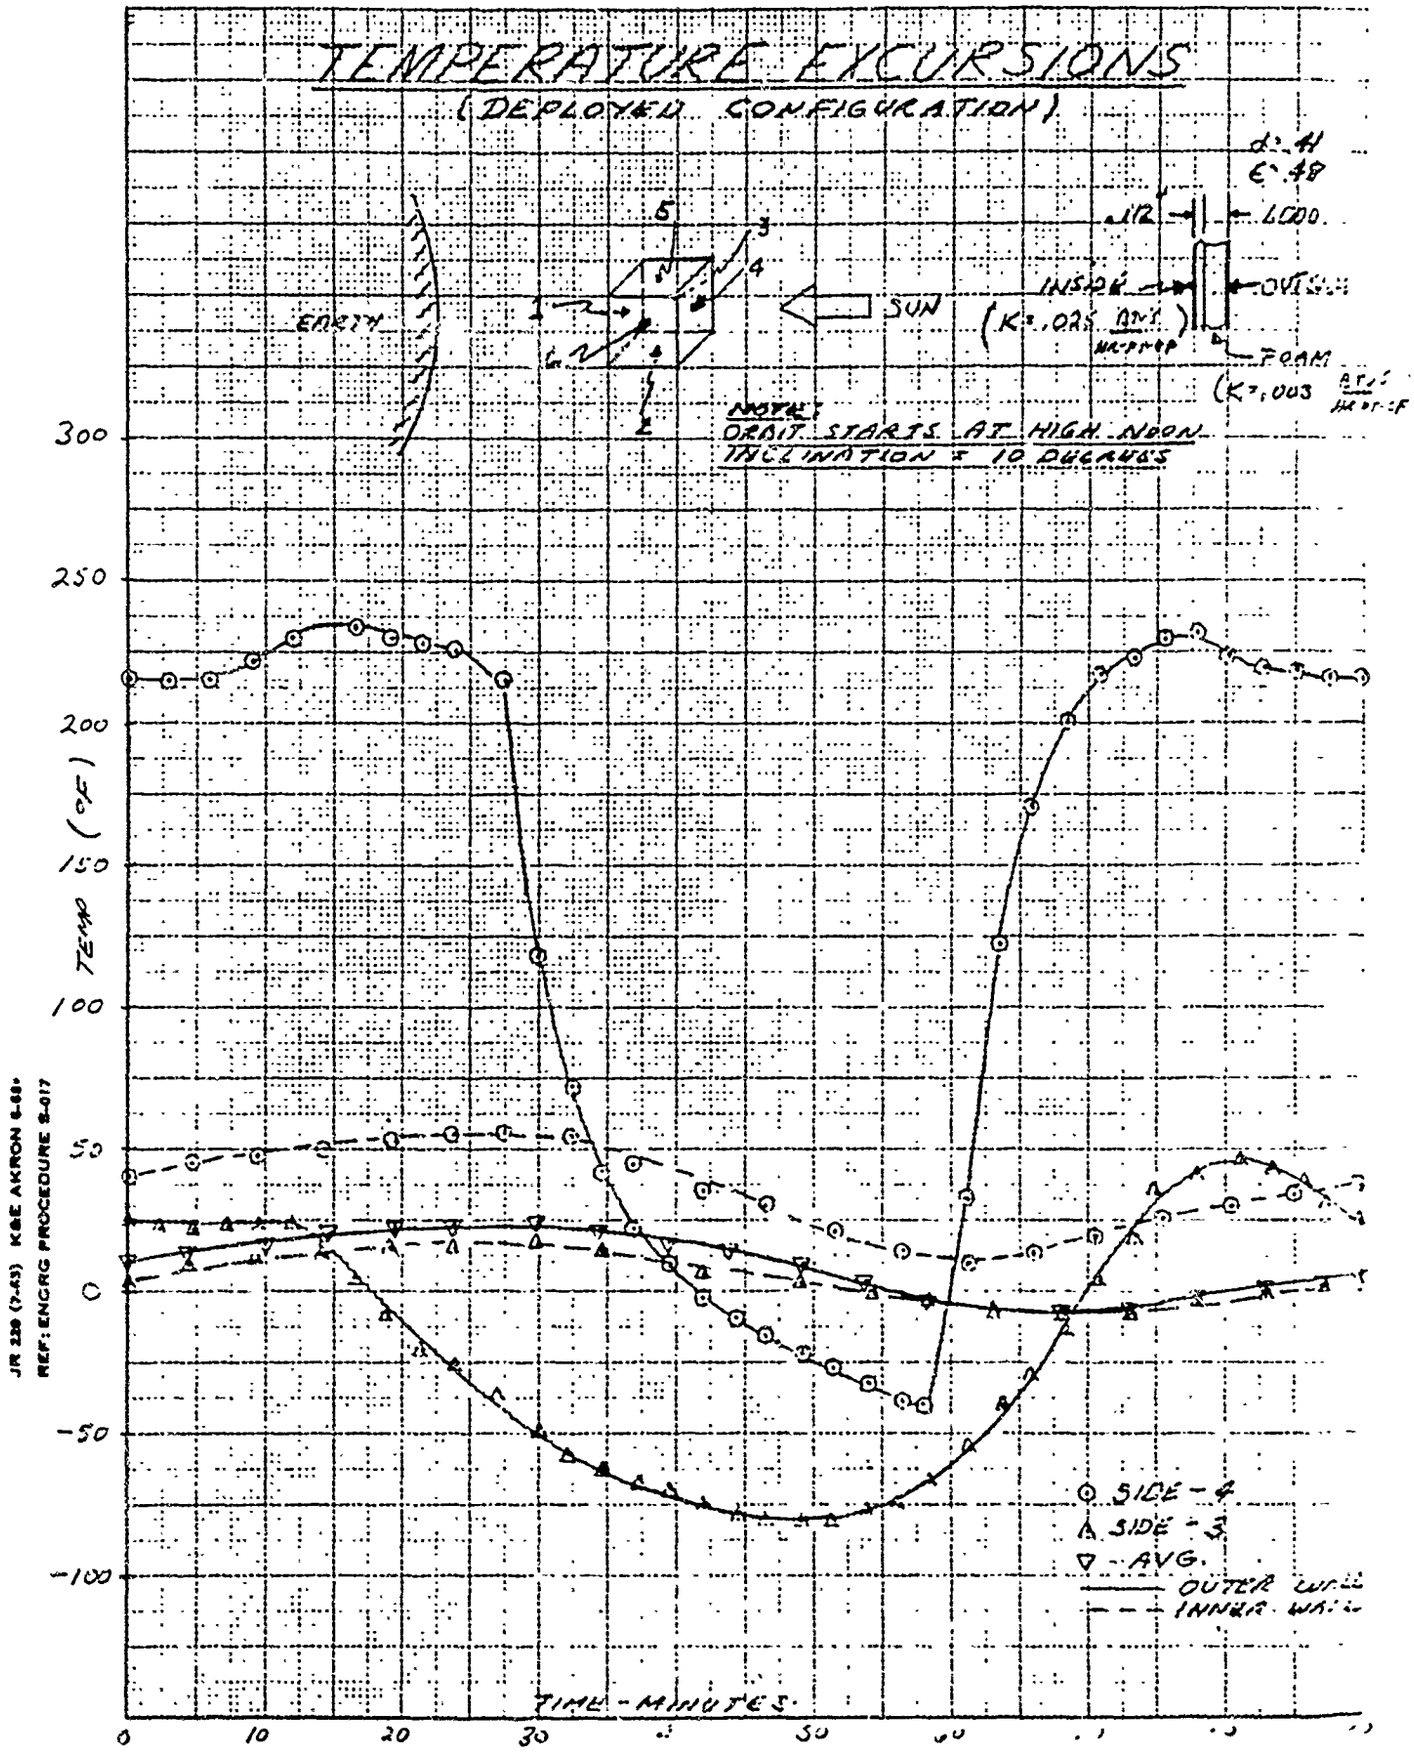
The results of this temperature analysis are shown in Figure 3 where side (4) and side (3) temperatures are shown indicating the maximum and minimum orbital temperatures respectively of the D-21 airlock. Side (4) represents the hatch end and side (3) represents the coldest part of the airlock expandable structure in the sun-orientation mode. The average internal surface temperature is also shown in this figure.

After deployment of the D-21 airlock, the thermal model becomes a hollow shell with internal radiation effects. The results of this analysis are shown on Figure 3. The maximum-minimum temperature of the outer surface ranges from +235° F to -84° F. The inner surface varies from +55° F to -5° F.

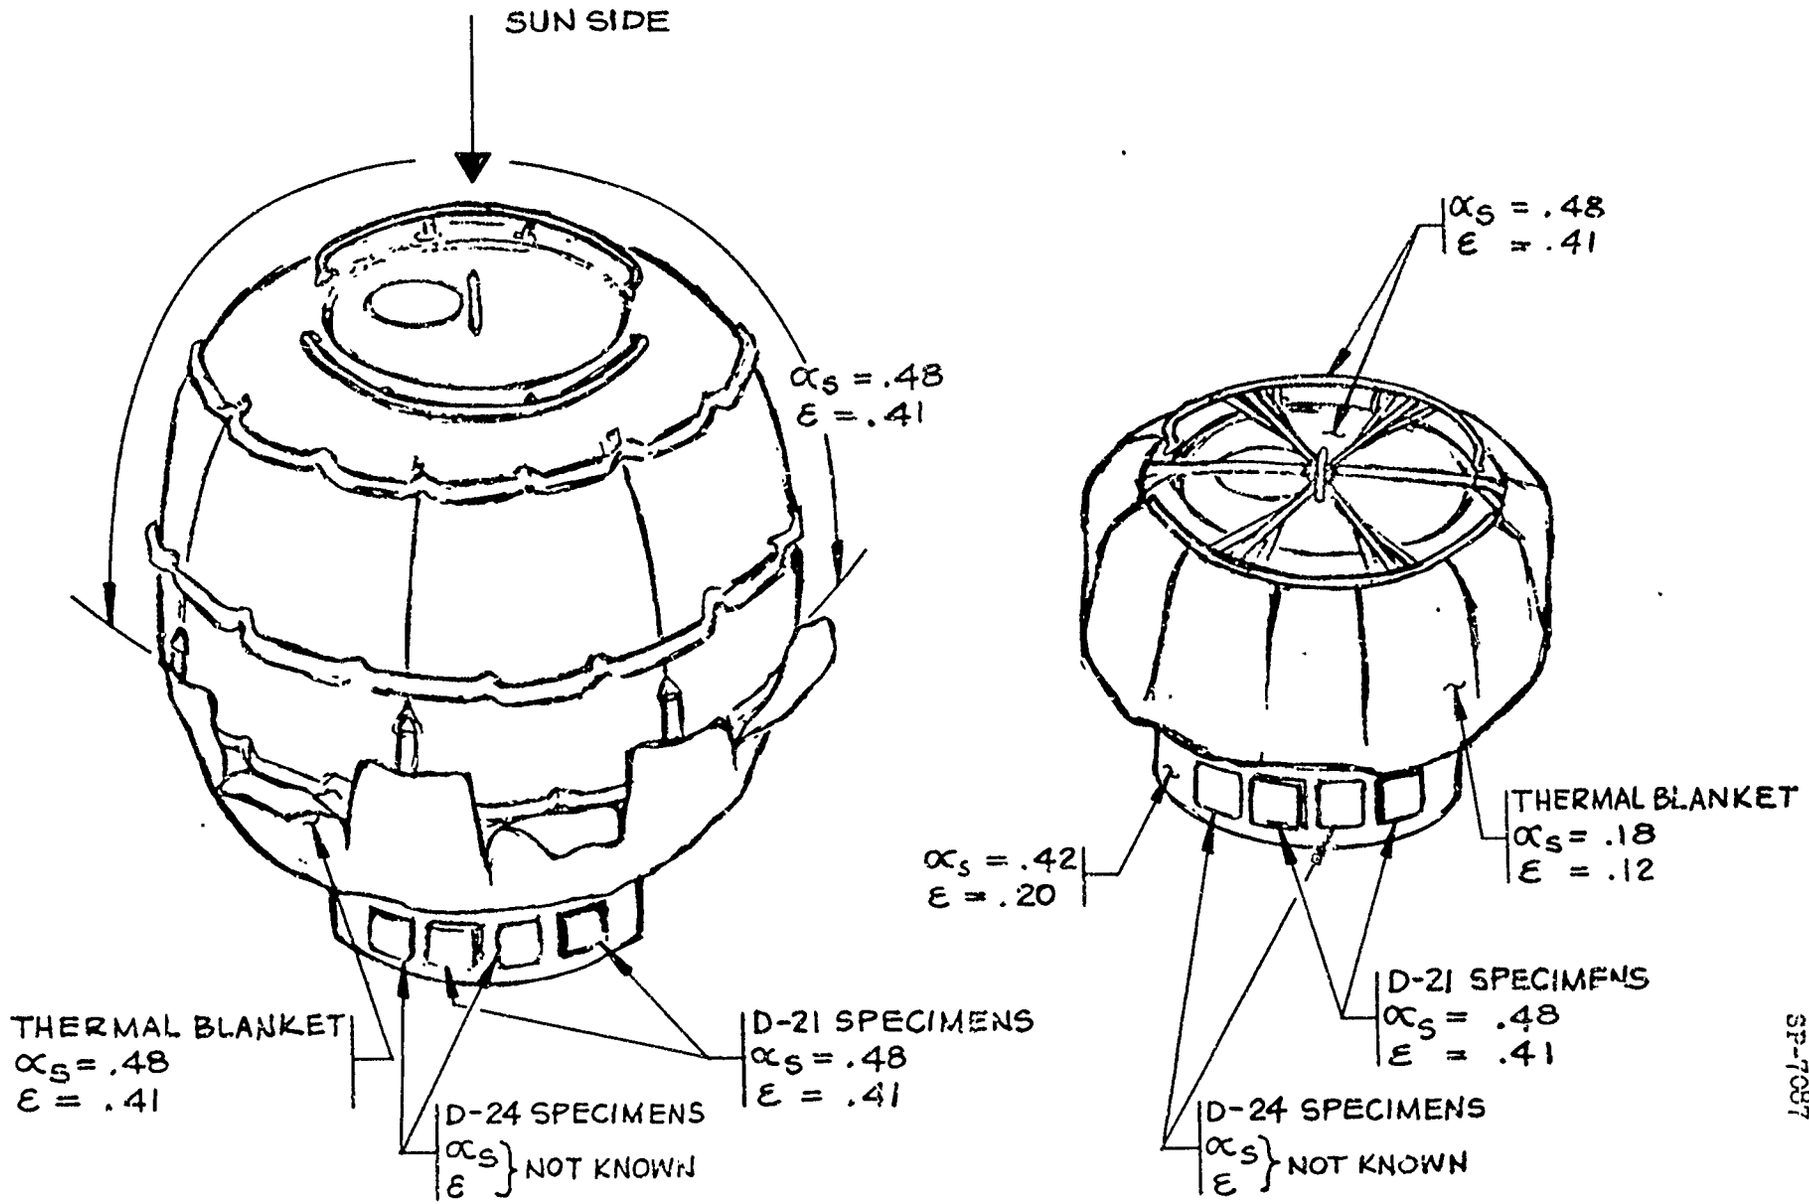
FIGURE 4

The thermal coatings selected as optimum for both the packaged and deployed airlock are defined on Figure 4.

DEPLOYED & PACKAGED THERMAL PROPERTIES

1. The D-21 airlock should be relocated from its current position on Strut No. 3 of the NASA AM to the Strut No. 4 position in order to provide an acceptable thermal environment. (See Figure 4)

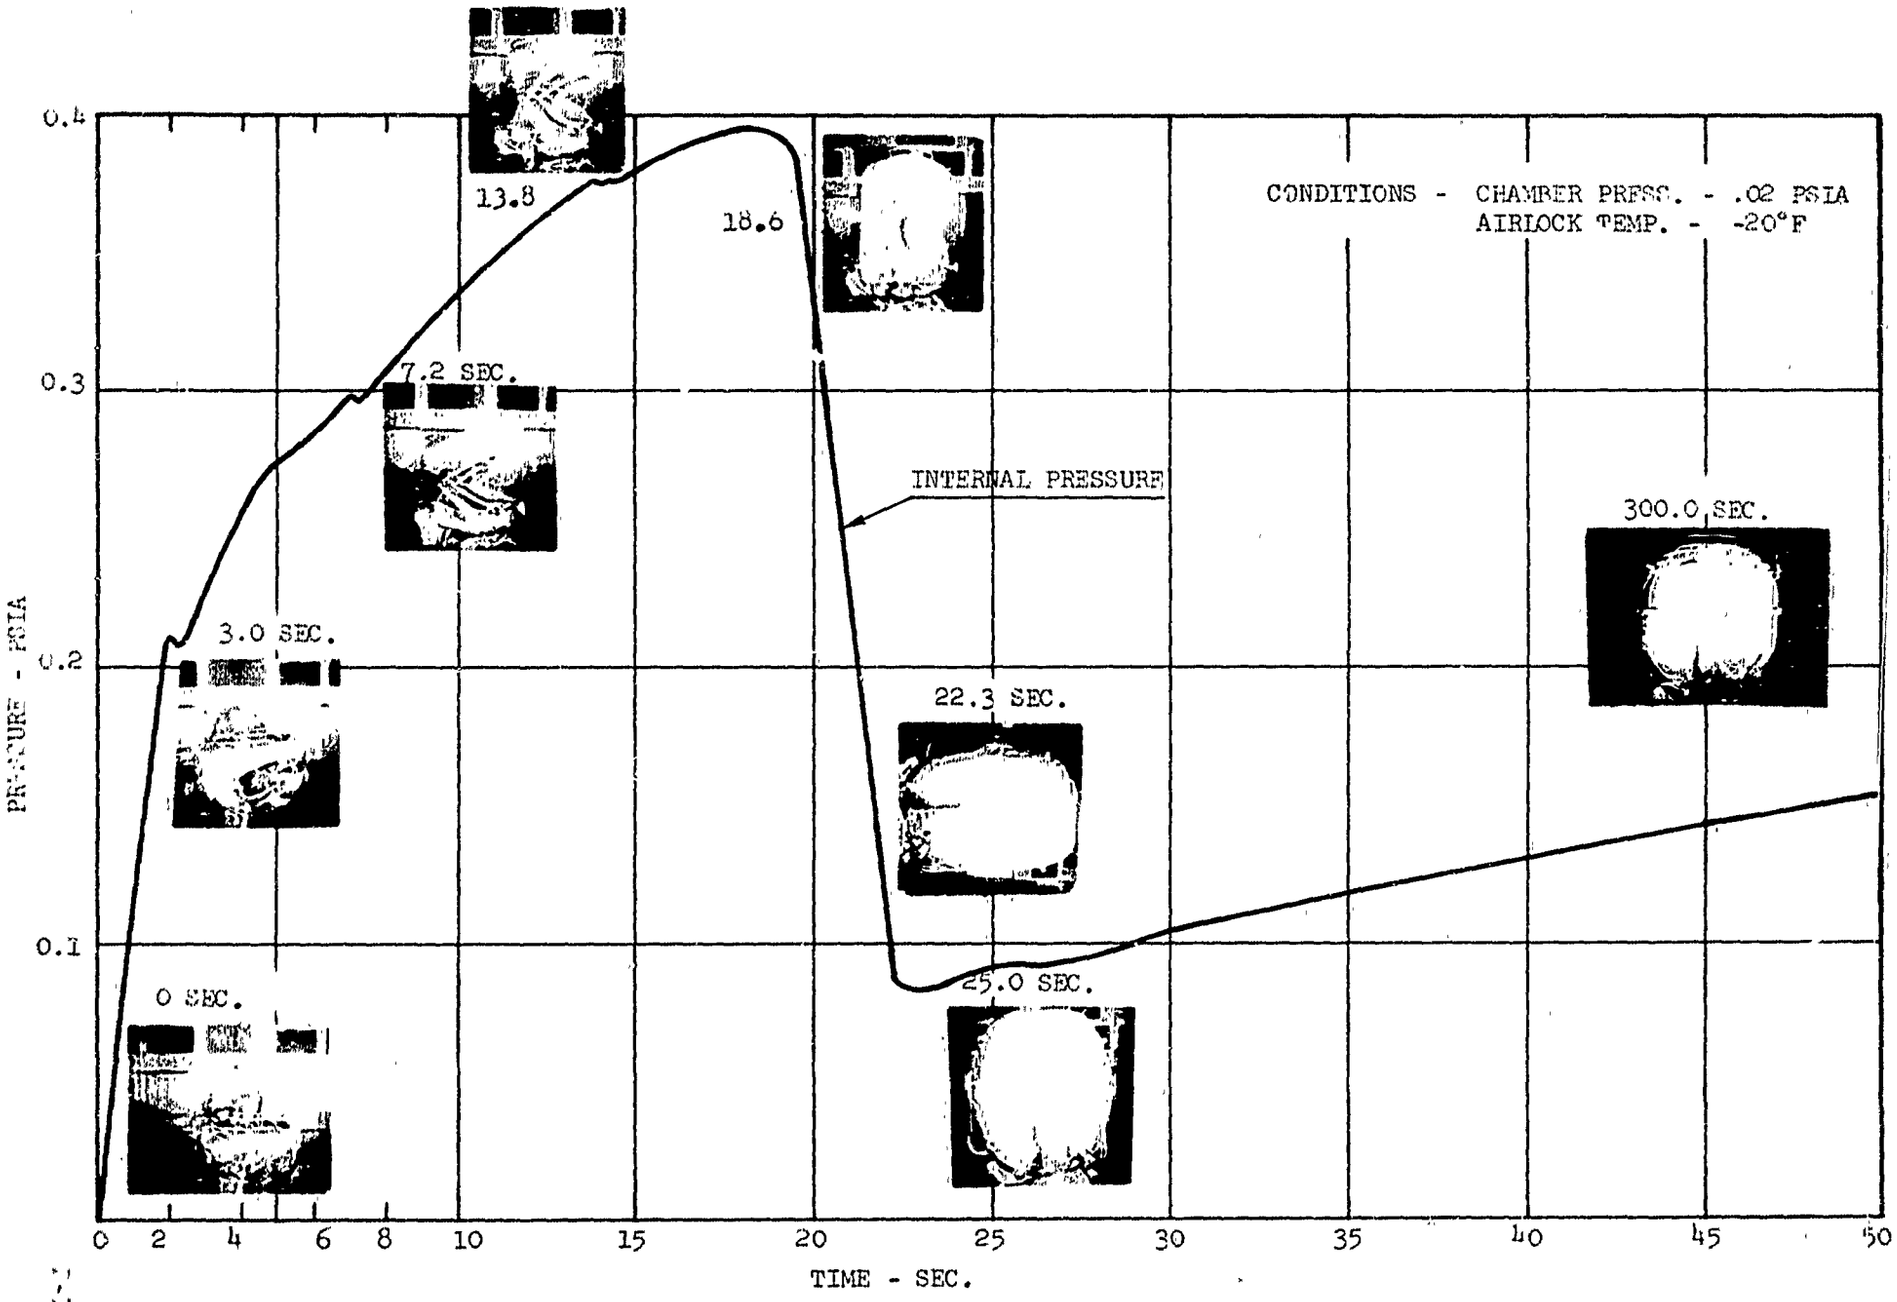
The airlock was subsequently inspected and found to be in satisfactory condition.

Figure 4. D021 Airlock Deployment
