DEPARTMENT OF THE ARMY  
OFFICE OF THE ADJUTANT GENERAL  
WASHINGTON, D.C. 20310

a. During the quarter November 1966 through January 1967, the 19th Engineer Battalion's role and main mission changed from combat support to construction. The combat support operations Thayer, Tiger Hound, and MANG HO 8 were terminated and the battalion undertook construction projects in support of the development of the Qui Nhon area. This transition, while deliberate and smoothly conducted, required readjustment from operational support to construction operations. Long range planning replaced expediency, scheduling replaced on-hand capability, and a constant job effort was necessary rather than the hasty short term mission requirement of combat support roles.

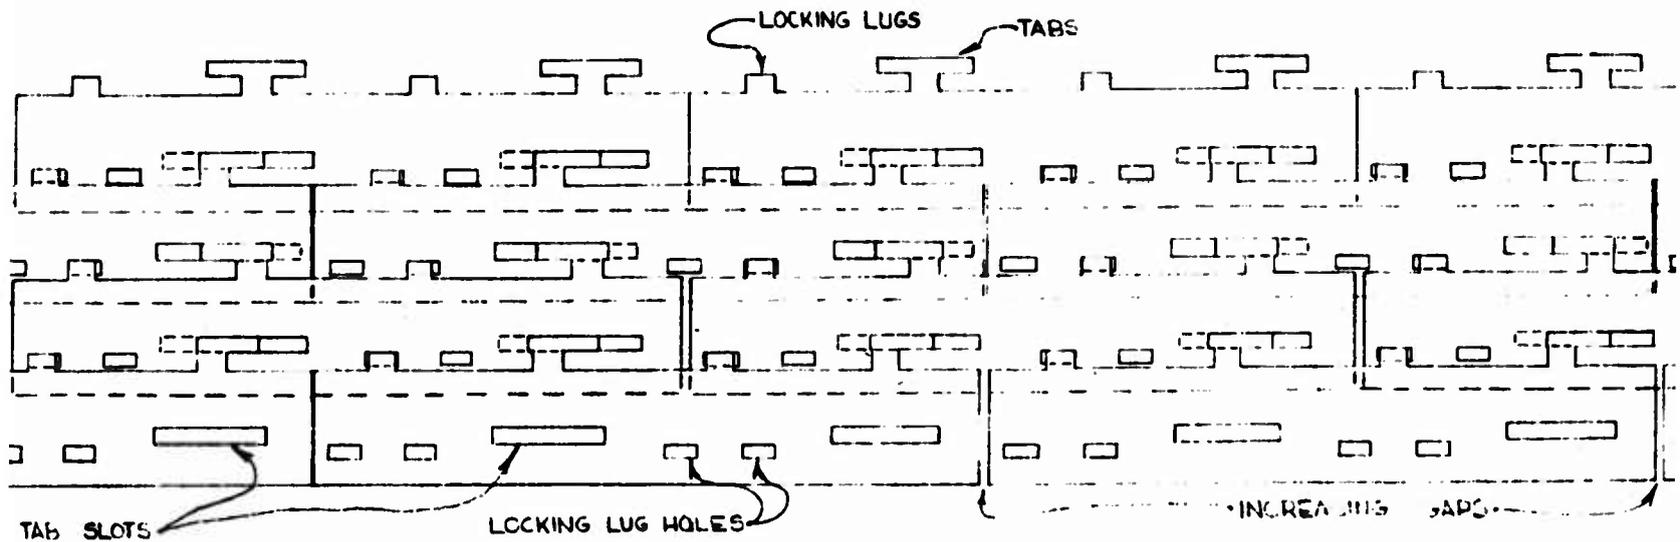
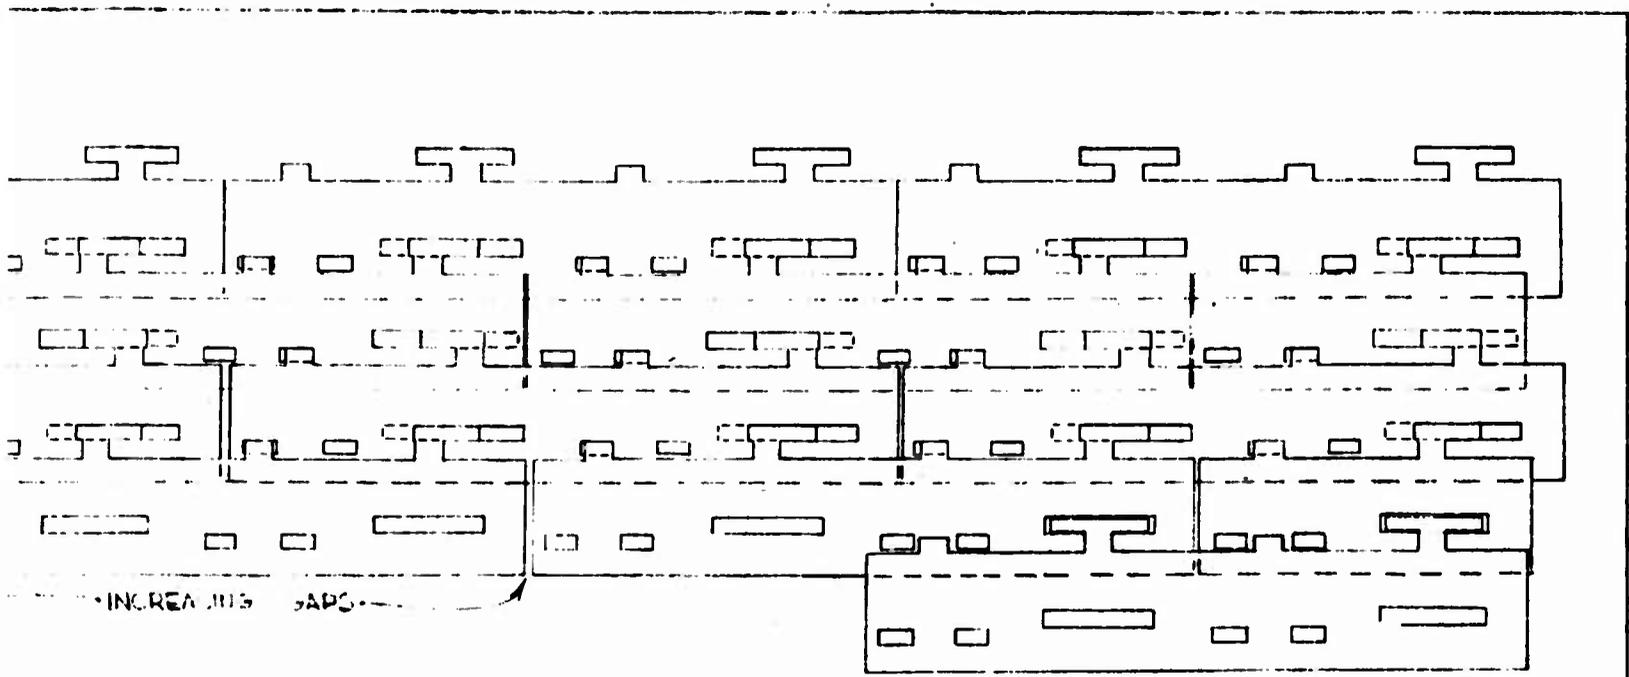
1. ASSEMBLY PROCEDURE:

TAB SLOTS  
 15° ANGLE, PANEL  
 IL LOCK LUG AND  
 KED POSITION

DIRECTION of LAYING  
 ↓ ↓ ↓ ↓ ↓ ↓

platoon, starting at the welded panels in the center of the airfield, completed the entire runway for air traffic, unloading and placing all the matting in six days. At this time, due to wet conditions prevailing in the area, original plans to cover the taxiway and parking apron with T-17 membrane changed to utilize M3A1 matting. In order to let the placing of the matting continue on schedule, the first and third platoon of "B" Company were moved to Bong Son as reinforcements to complete the anchorage system of the runway. Due to record fall of over 30" of rain during the month from November to December, and the problem of matting resupply due to impassable roads, it was not until 4 December that "B" Company was able to finish the anchorage system and return to their company headquarters at Landing Zone Crystal. On 20 December, "C" Company completed both the apron and taxiway in time for use by the advance parties of the 1st Cavalry Division. A further commitment to penetrate the airfield shoulders required that the third platoon of "C" Company remain at English Airfield after the headquarters and second platoon returned to the battalion base camp in Qui Nhon on 21 December.

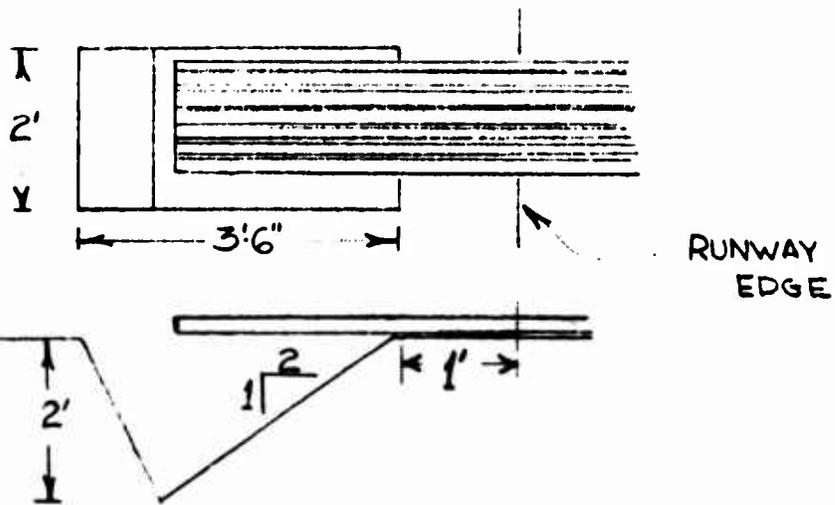
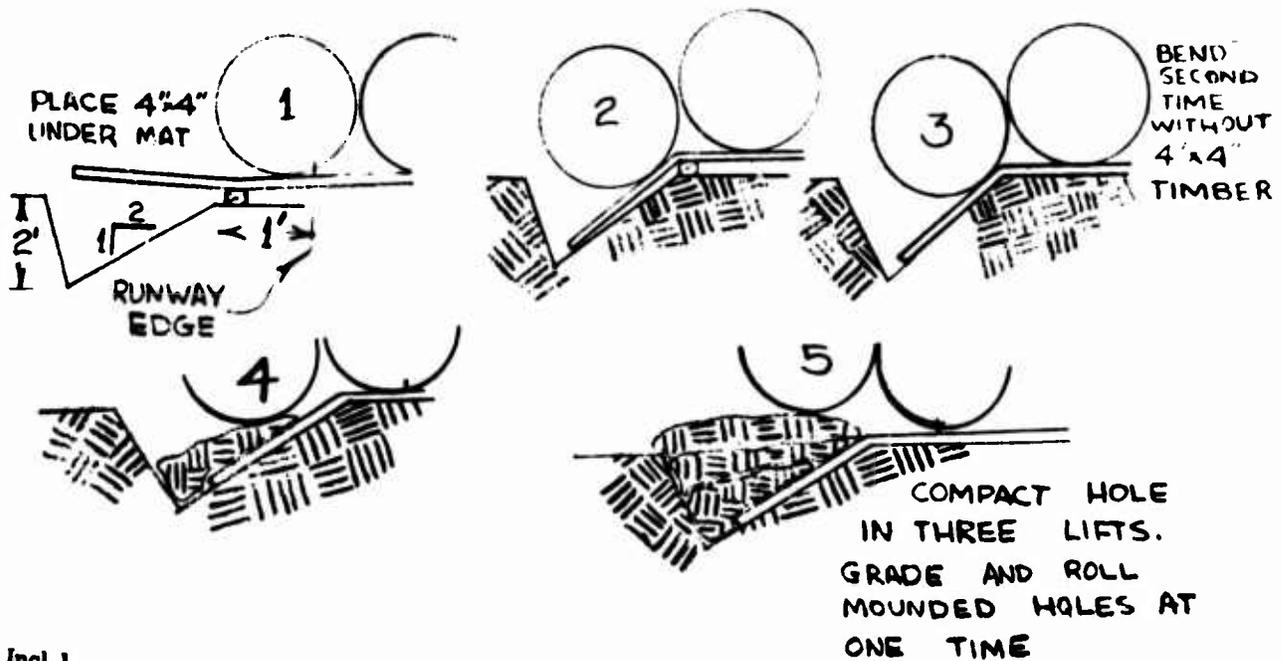
Fig 1

# ANCHORAGE of M8A1 MATTING

OBSERVATION: (1) The best power equipment for pin driving was found to be a clay spade with a squared-off chisel attachment. One air compressor with two attachments allowed a small pinning crew to easily keep up with the placing crew.

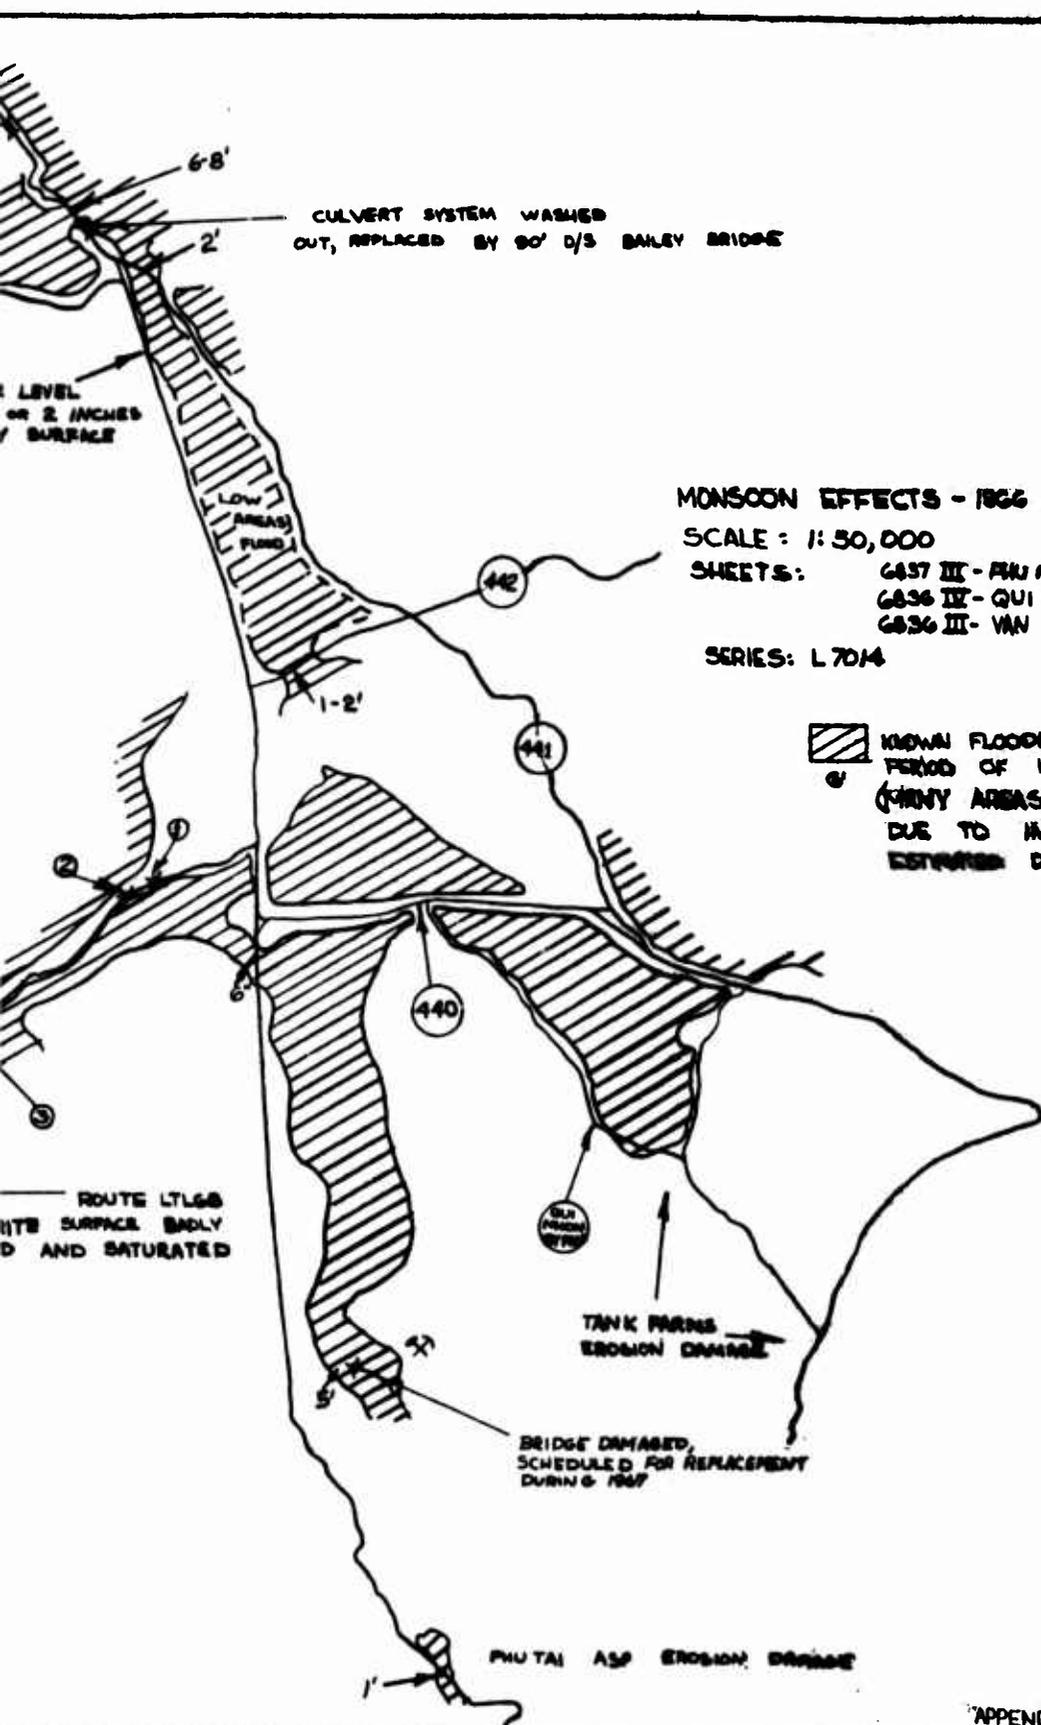
CULVERT SYSTEM WASHED OUT, REPLACED BY 90' D/S BAILEY BRIDGE

19th ENGINEER BATTALION (C)(A)		APO SAN FRANCISCO 96288	
DATE	14 FEB 67	MONSOON EFFECTS 1966	
DRAWN BY	WENTZLER		
CHECKED BY			
SCALE	1:50,000	SERIES	L 7014
